2024 ANNUAL PROGRESS REPORT SWMU-1 OILY WATER SEWER

HF SINCLAIR PUGET SOUND REFINING LLC

March 2025

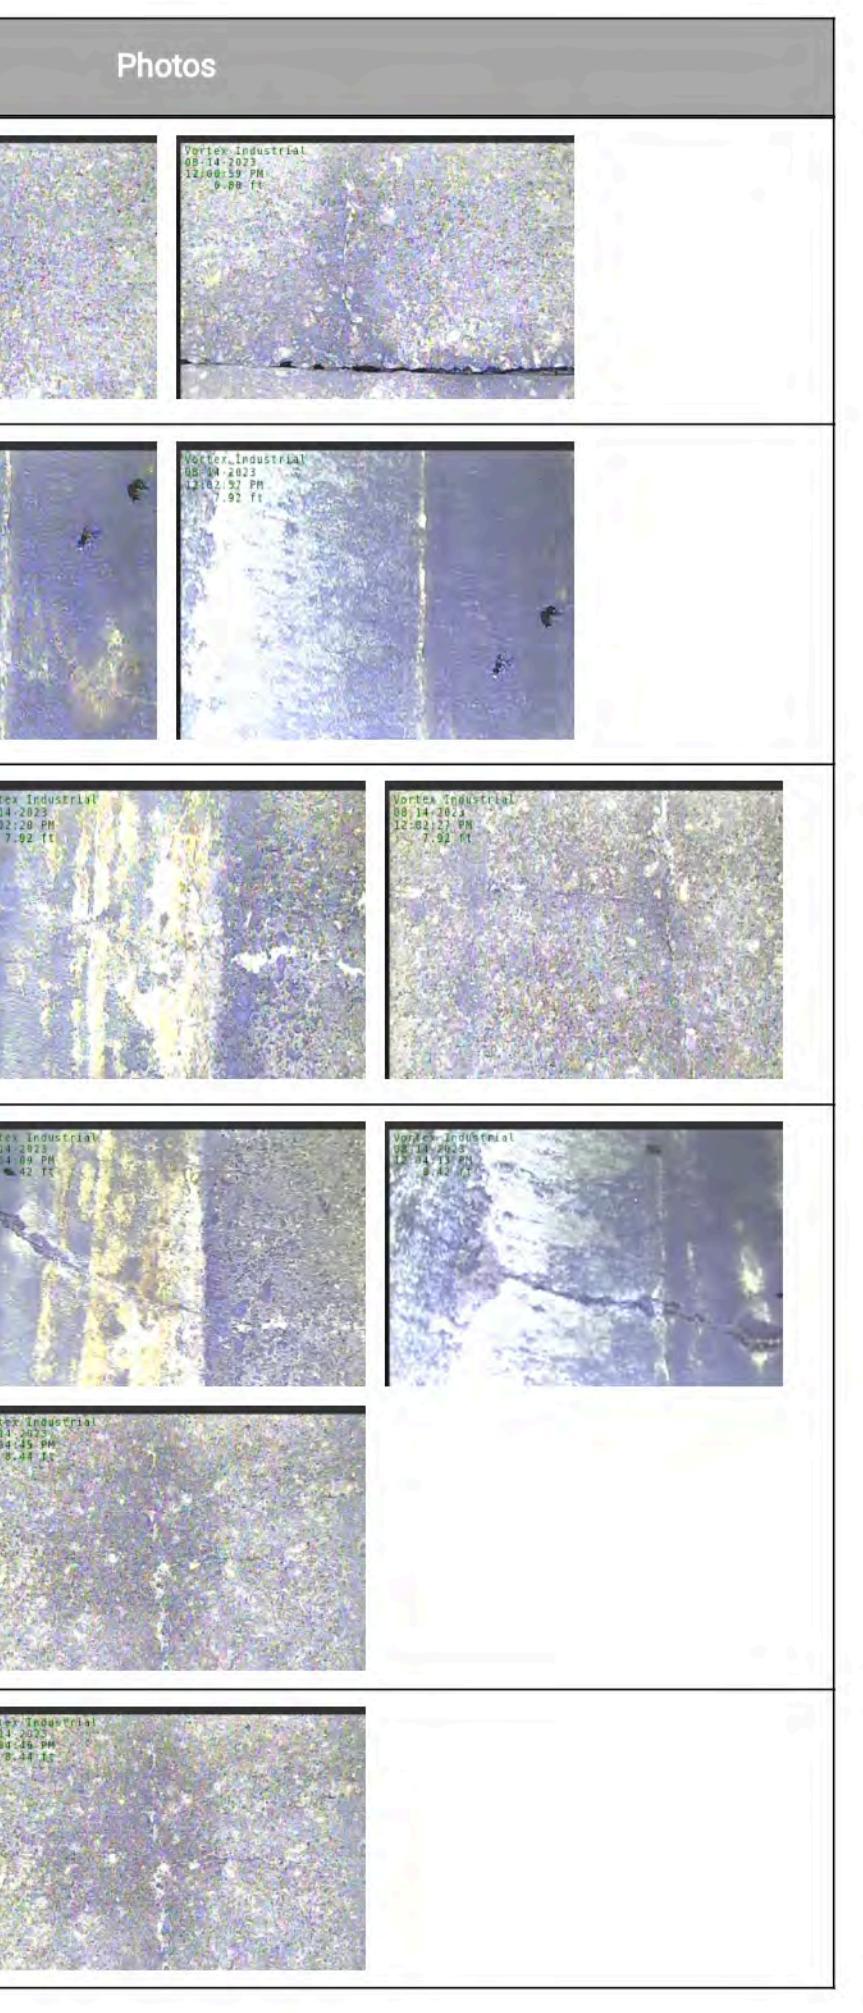
Description	Spatial Type	Distance (ft)	Туре	Percent	Clock	SR	0&M	С	PR	Remarks	
Crack Longitudinal	Point	6.8	Structural	0	11	2	0	0	1	Crack Longitudinal	Yorter Soddstriat De 14 2023 T2.80-37 PH 4 contr
Crack Longitudinal	Point	7.9	Structural	0	4	2	0	0	1	Crack Longitudinal	Yettex Industrijat de-n4-2023 12:03:00 PH 7.92 ft
Crack Multiple	Point	7.9	Structural	0	1-5	3	0	0	2	Crack Multiple	Vortes Tedus frial 08:14/2003 10:02:18:PH 7:02:11 7:02:11 7:02:11
Crack Circumferential	Point	8.4	Structural	0	10-5	1	0	0	2	Crack Circumferential	Vortex Loduştrial 12. 43.13 PP 3. 43.14 PP 3. 43.15 PP 4. 43.15 PP
Crack Longitudinal	Point	8.5	Structural	0	1	2	0	0	1	Crack Longitudinal	Yarıt 03. 22. 2

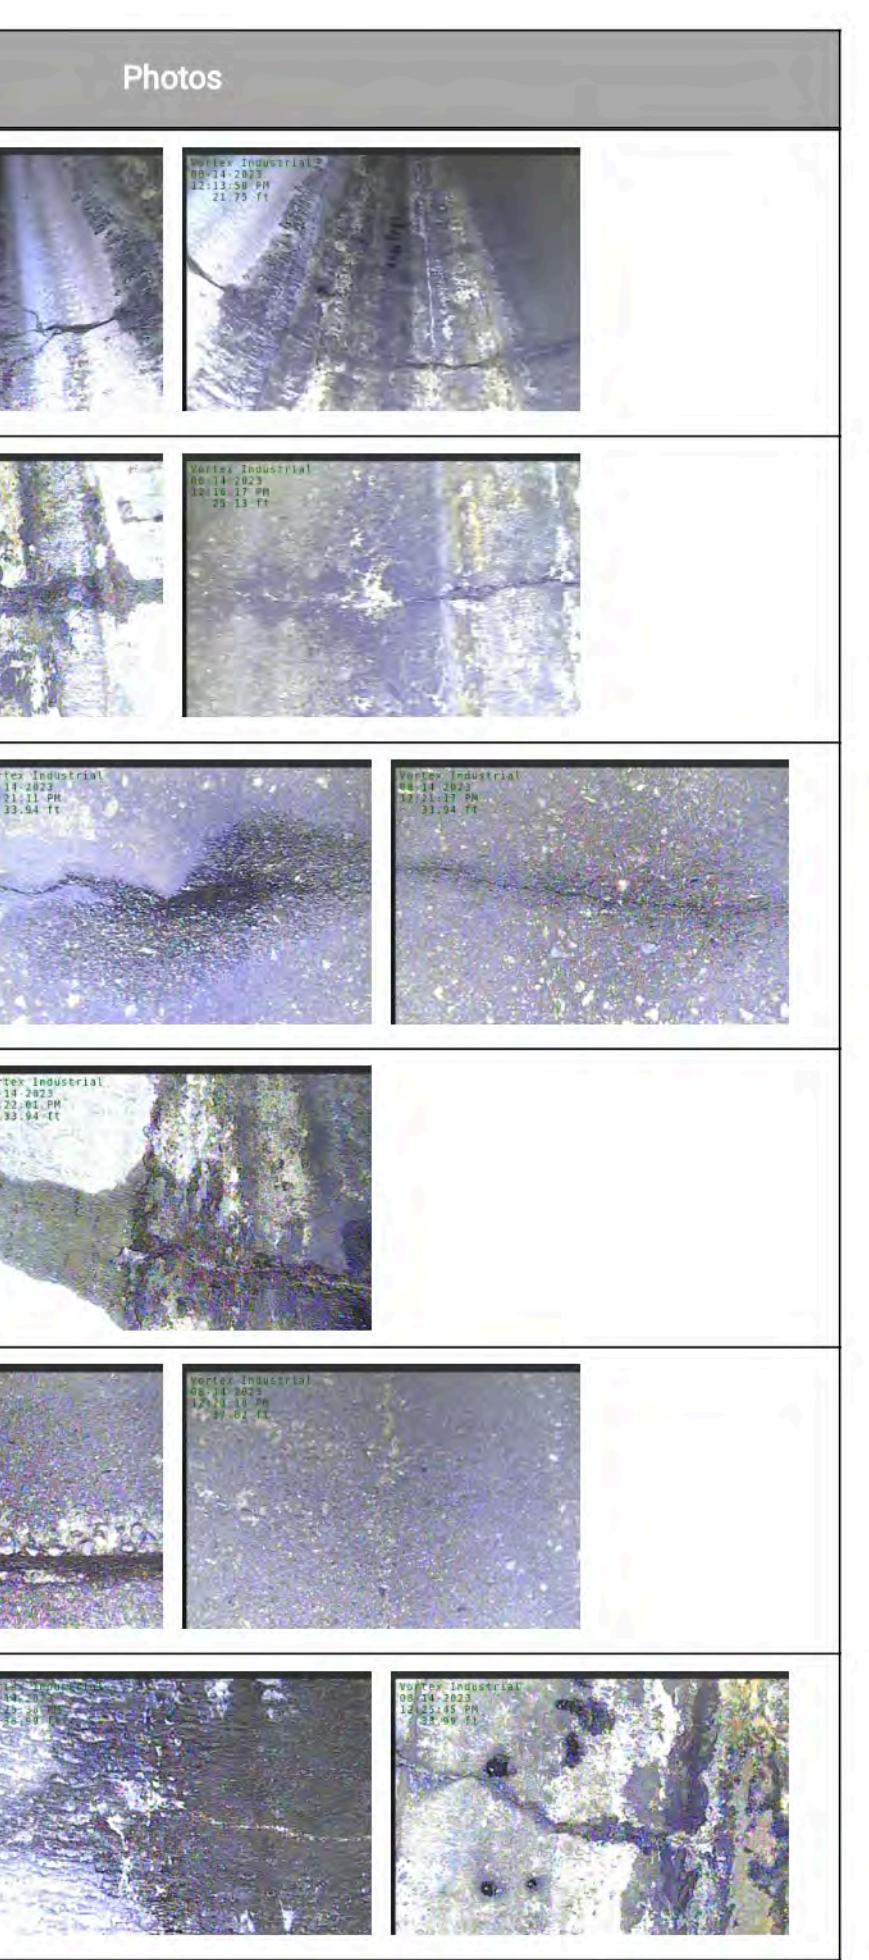
Description	Spatial Type	Distance (ft)	Туре	Percent	Clock	SR	O&M	С	PR	Remarks	
Crack Multiple	Point	22	Structural	0	7-6	3	0	0	2	Crack Multiple	Unflue Linu(s ria) 08-34-2023 12-13-14 Pri 22-23-14 Pri 22-23-14 Pri 22-23-14 Pri 22-24 Pri 22-2
Crack Circumferential	Point	25.1	Structural	0	6-10	1	0	0	2	Crack Circumferential	Vool en industrij af. Seeder af dat industrij af. Seeder af dat industrij af. Seeder af dat industrij af dat industrij af dat industrij Seeder af dat industrij af dat industrij Seeder af dat industrij af dat industrij Seeder af dat industrij Seed
Crack Circumferential	Point	33.9	Structural	0	12-5	1	0	0	2	Crack Circumferential	Vorter Trouversit
Crack Longitudinal	Point	33.9	Structural	0	4	2	0	0	2	Crack Longitudinal	¥96 82 12
Crack Longitudinal	Point	37	Structural	0	1	2	0	0	1	Crack Longitudinal	00764-61760377331 08-44-2933 12-23-84-90 70-12-11 70-12-11 75-25 7
Crack Circumferential	Point	39	Structural	0	3-9	1	0	0	2	Crack Circumferential	The second

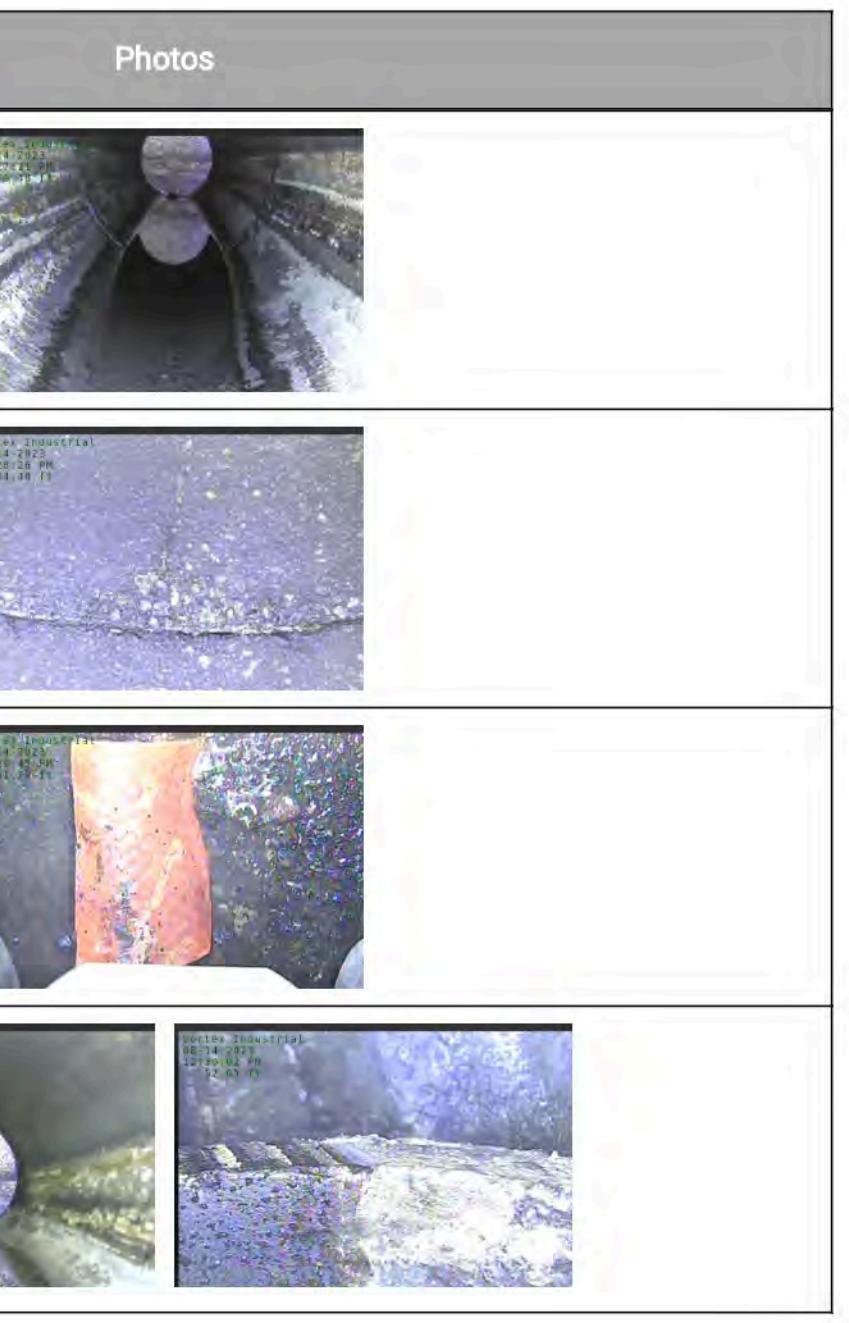
Description	Spatial Type	Distance (ft)	Туре	Percent	Clock	SR	0&M	С	PR	Remarks	
Miscellaneous Water Level	Point	40.5	Miscellaneous	10		0	0	0	0	Miscellaneous Water Level	Work
Crack Longitudinal	Point	44.4	Structural	0	12	2	0	0	1	Crack Longitudinal	907 07.3 12:2 4
Miscellaneous General Photograph	Point	51.7	Miscellaneous	0	6	0	0	0	0	Miscellaneous General Photograph	
Manhole	Point	52.6	Constructional	0		0	0	0	0	23-3	Vortex. Industriai 00 44 7757 12.19, 14 50 14 40 Tr

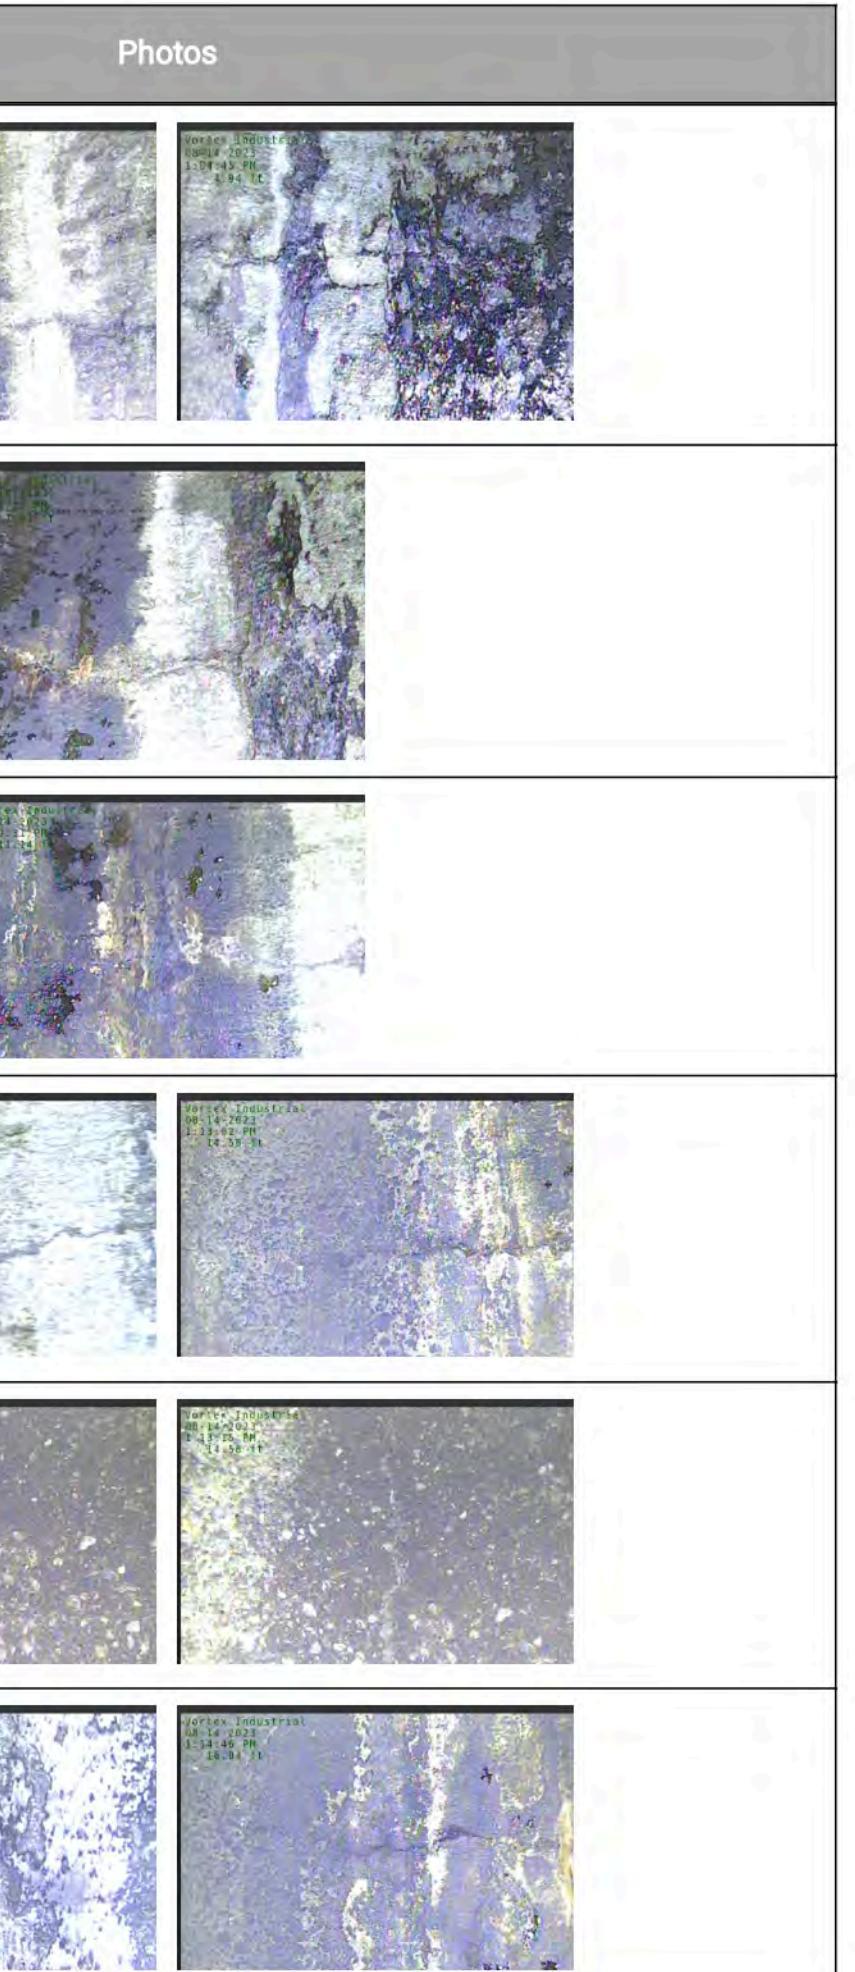
Description	Spatial Type	Distance (ft)	Туре	Percent	Clock	SR	O&M	С	PR	Remarks	
Crack Circumferential	Point	4.9	Structural	0	5-6	1	0	0	2	Crack Circumferential	
Crack Circumferential	Point	7.4	Structural	0	6-7	1	0	0	2	Crack Circumferential	
Crack Circumferential	Point	11.1	Structural	0	6-8	1	0	0	1	Crack Circumferential	
Crack Circumferential	Point	14.6	Structural	0	6-9	1	0	0	2	Crack Circumferential	Transfer Traincentral Transfer Traincentral Transfer By one Transfer Traincentral Transfer Traincentral Transfer Traincentral
Crack Longitudinal	Point	14.6	Structural	0	11	2	0	0	1	Crack Longitudinal	Jore er Chausforei Birda / 2023 Faister 27 Diff Williams
Crack Multiple	Point	16	Structural	0	6-8	3	0	0	2	Crack Multiple

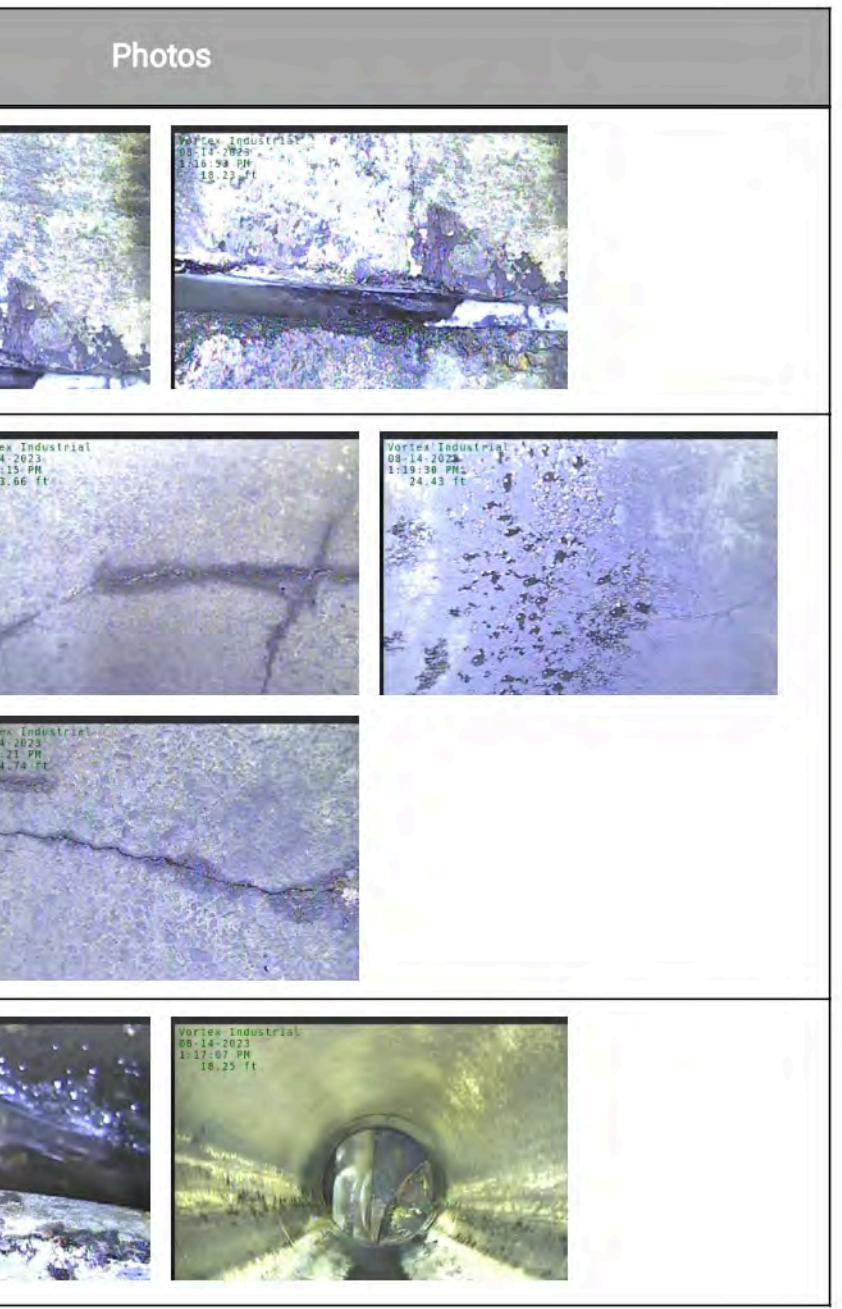
Description	Spatial Type	Distance (ft)	Туре	Percent	Clock	SR	O&M	С	PR	Remarks	
Crack Longitudinal	Point	18.2	Structural	0	5	2	0	0	1	Crack Longitudinal	ALLASS FORMATIONS
Crack Multiple	Point	23.7	Structural	0	10-6	3	0	0	2	Crack Multiple	Vortex Industrial BB 14:2023 IH2:23.66 ft 23.66 ft 11:23 24 25 25 25 25 25 25 25 25 25 25
Manhole	Point	26.1	Structural	0		0	0	0	0	23-4	Vorte Tou using the Tou to tou to the Tou to

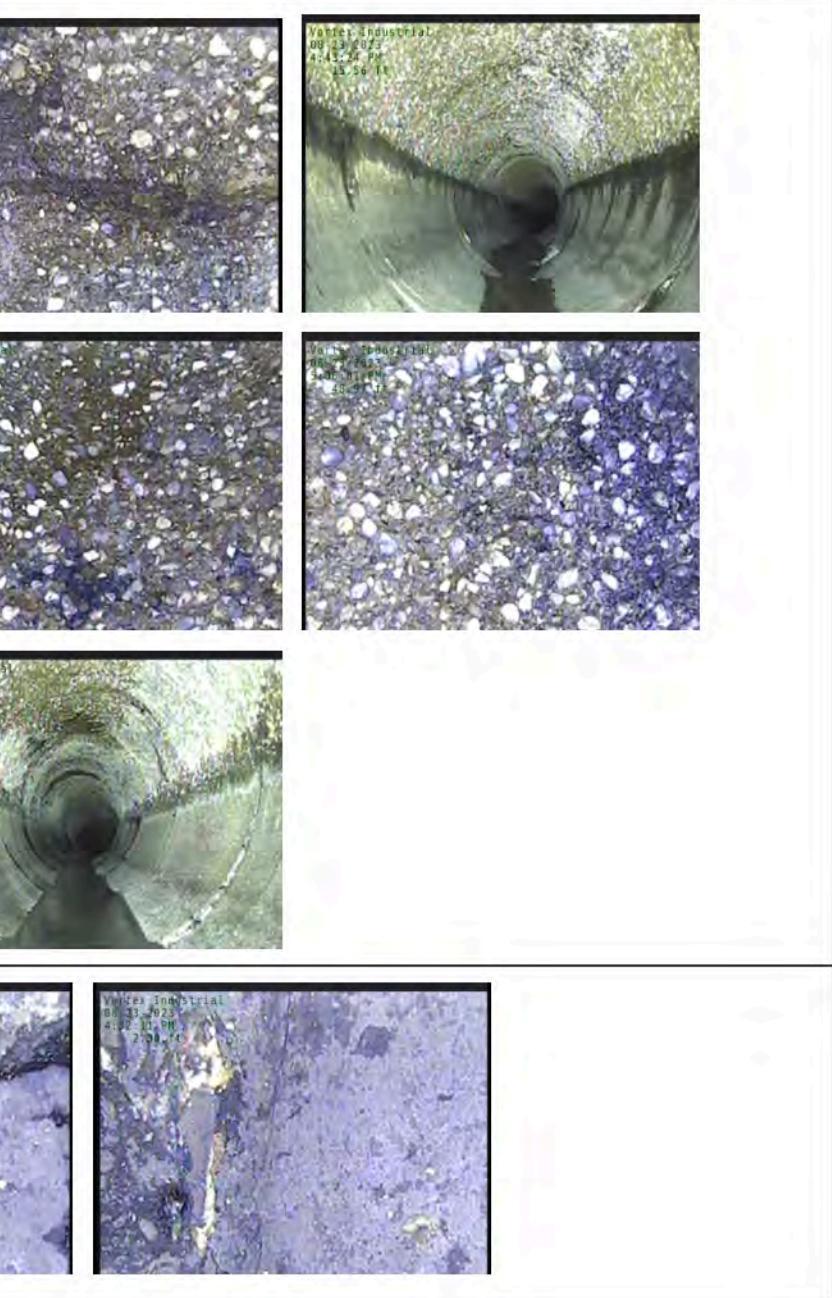
Description	Spatial Type	Distance (ft)	Туре	Percent	Clock	SR	O&M	С	PR	Remarks	
Surface Damage Aggregate Projecting	Continuous	0 - 55.8	Structural	0	9-3	3	0	0	2	Surface Damage Aggregate Projecting	
Crack Multiple	Point	2	Structural	0	8-9	3	0	0	2	Crack Multiple

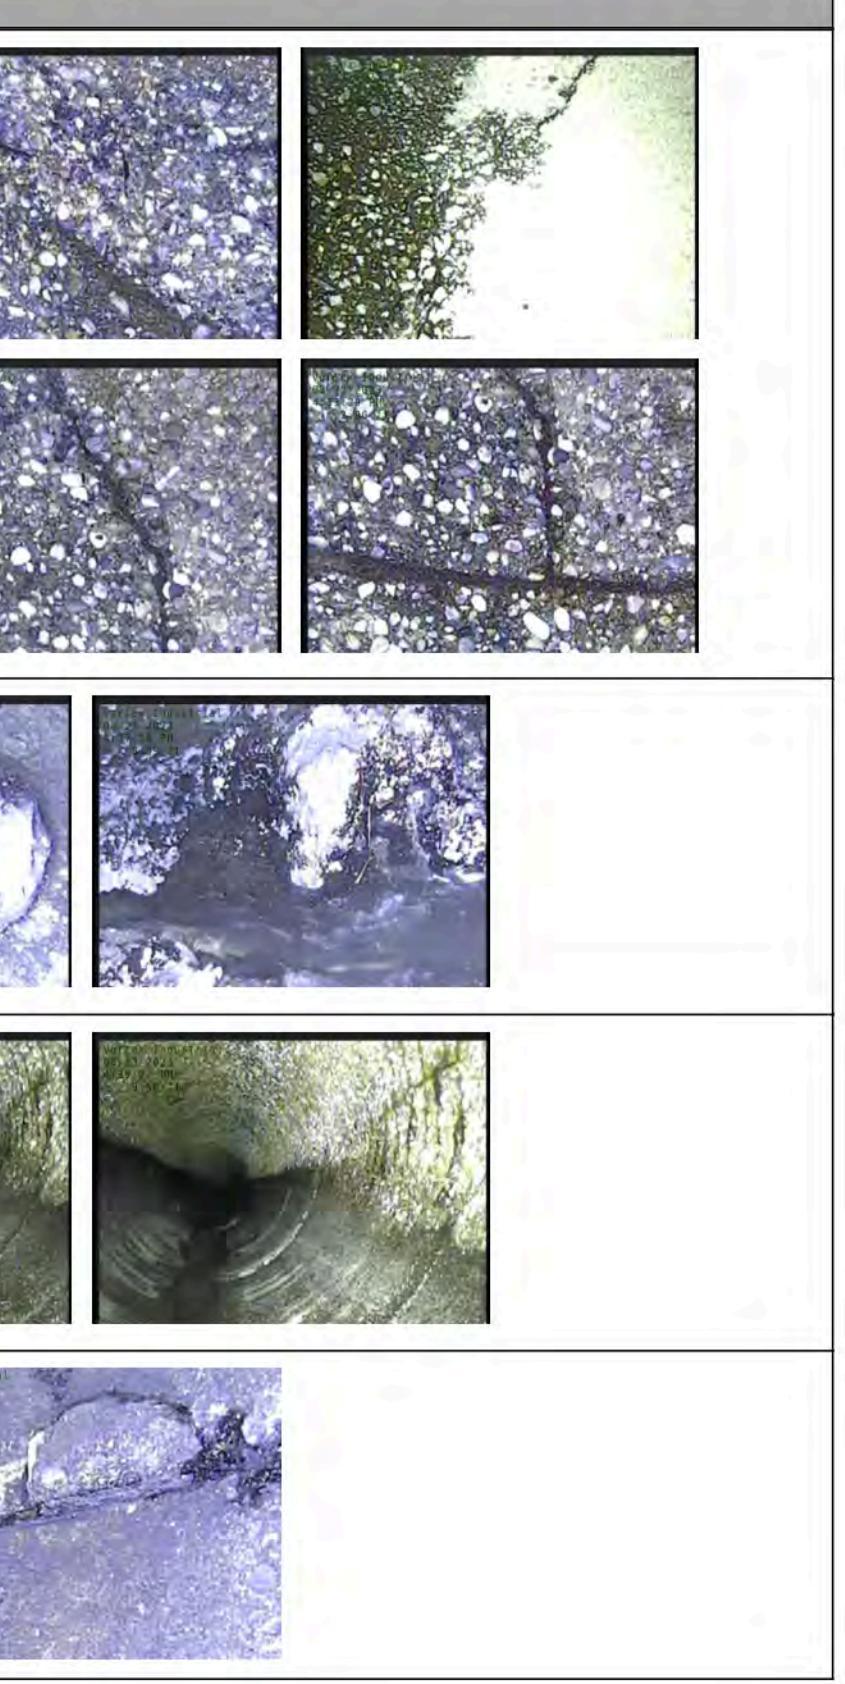
Description	Spatial Type	Distance (ft)	Туре	Percent	Clock	SR	O&M	С	PR	Remarks	
Fracture Multiple	Point	2	Structural	0	1-3	4	0	0	2	Fracture Multiple	
Deposits Attached Encrustation	Point	8.1	O&M	10	5-6	0	2	0	0	Deposits Attached Encrustation	
Surface Damage Reinforcement Visible	Point	9	Structural	0	2-3	4	0	0	3	Surface Damage Reinforcement Visible	Ut a stranger Ut
Fracture Multiple	Point	12.4	Structural	0	7-8	0	0	0	2	Fracture Multiple

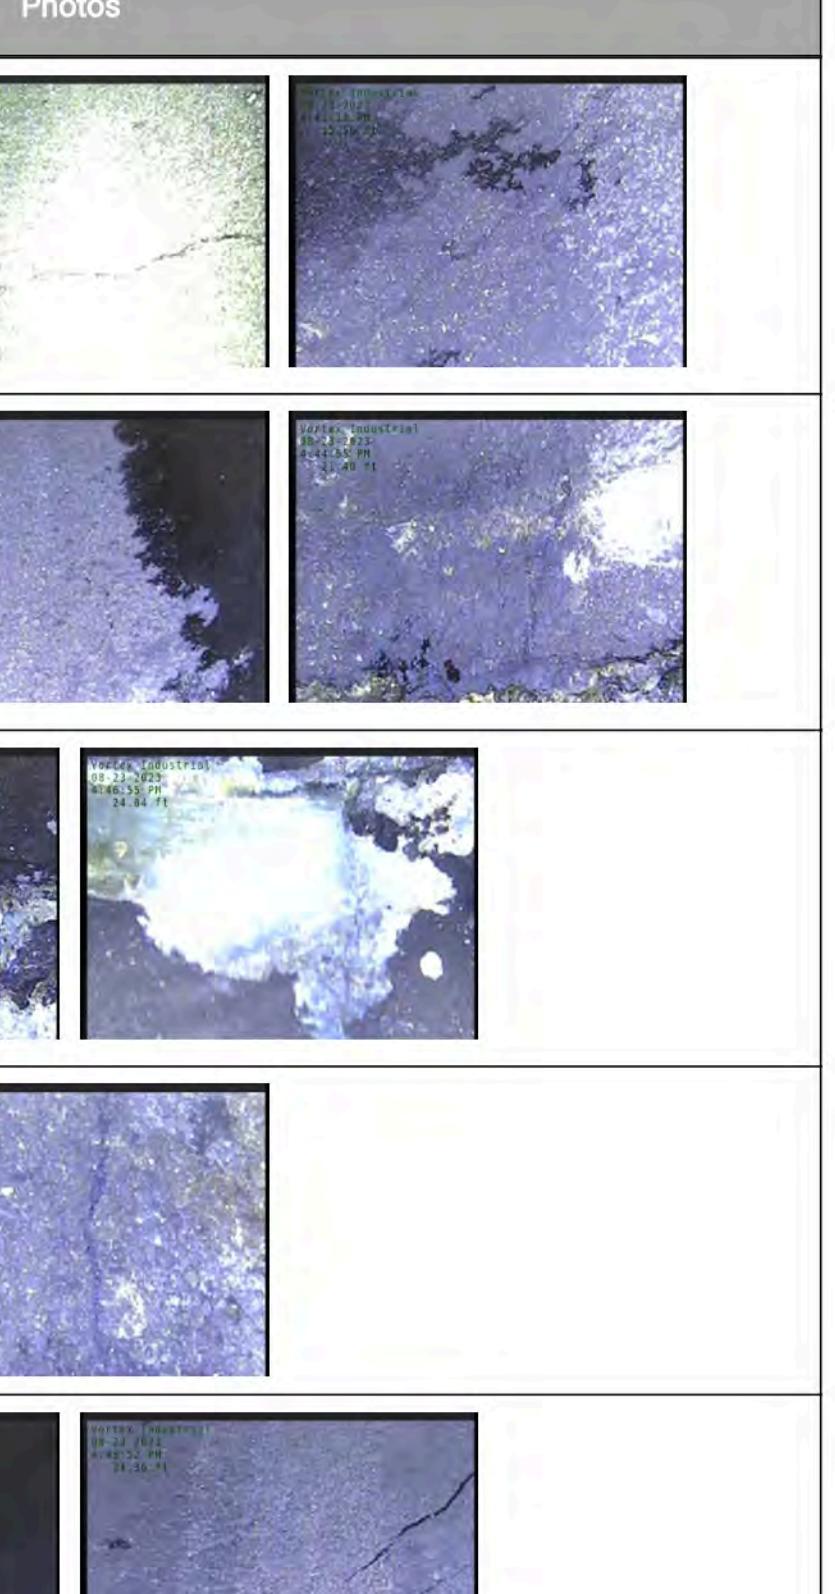
Description	Spatial Type	Distance (ft)	Туре	Percent	Clock	SR	O&M	С	PR	Remarks	
Crack Multiple	Point	15.5	Structural	0	6-7	3	0	0	2	Crack Multiple	Vertes Industrial PELAS 2008 404108 PC 13:50 PC
Crack Spiral	Point	21.4	Structural	0	7-8	2	0	0	1	Crack Spiral	This is in the constraint of the constraint
Crack Multiple	Point	24.3	Structural	0	6-7	2	0	0	2	Crack Multiple	90 TO 10 TO
Crack Longitudinal	Point	24.3	Structural	0	4	2	0	0	1	Crack Longitudinal	Vortes Industs 09:23-2423 4:38:11-PH 24:36 Tt 24:36 Tt
Crack Circumferential	Point	25.5	Structural	0	7-8	1	0	0	1	Crack Circumferential	Vortex Industrum) Bit 25-2823 Ri Alt 45-191 26-36-75

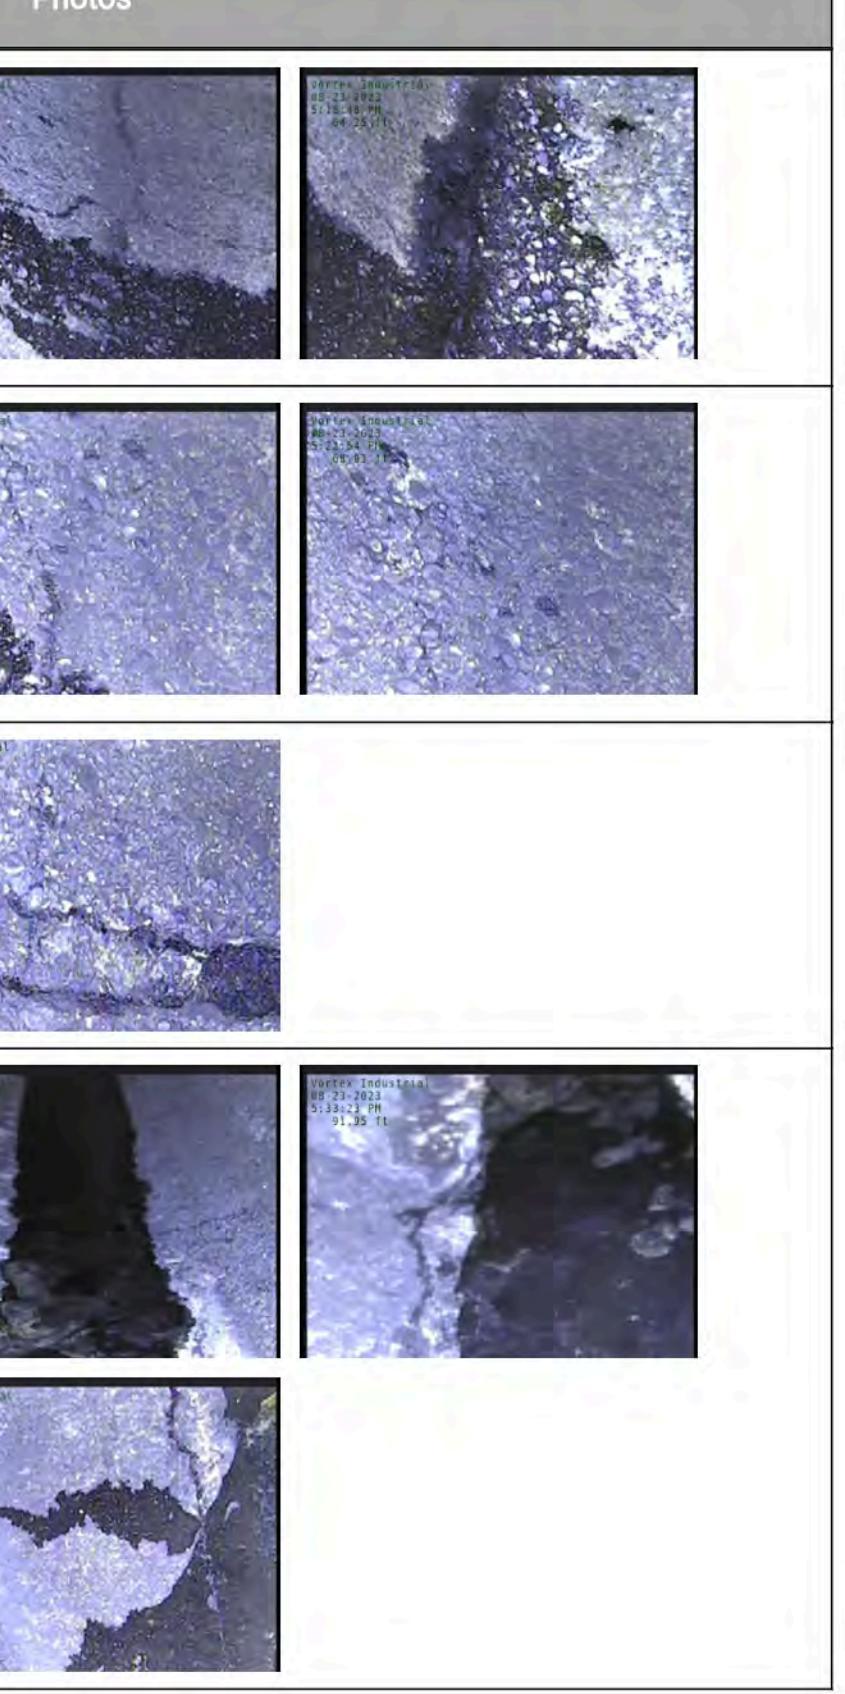
Description	Spatial Type	Distance (ft)	Туре	Percent	Clock	SR	O&M	С	PR	Remarks	
Crack Multiple	Point	64.2	Structural	0	3-5	3	0	0	2	Crack Multiple	Warter i Industrialis BER32 7723 SEIBLAR PR 64.2.5 T
Crack Longitudinal	Point	68	Structural	0	4	2	0	0	1	Crack Longitudinal	Ves fex, Sindus Frial, BE-33-2923 5122107 PF 58.01117
Crack Circumferential	Point	75.9	Structural	0	4-5	0	0	0	1	Crack Circumferential	Истект Indus Ut 08 та 2023 5:06 db 201 77 3 dd - т 7 3 dd - т
Crack Multiple	Point	91.9	Structural	0	5-8	3	0	0	2	Crack Multiple	Vertex reactions of the second s

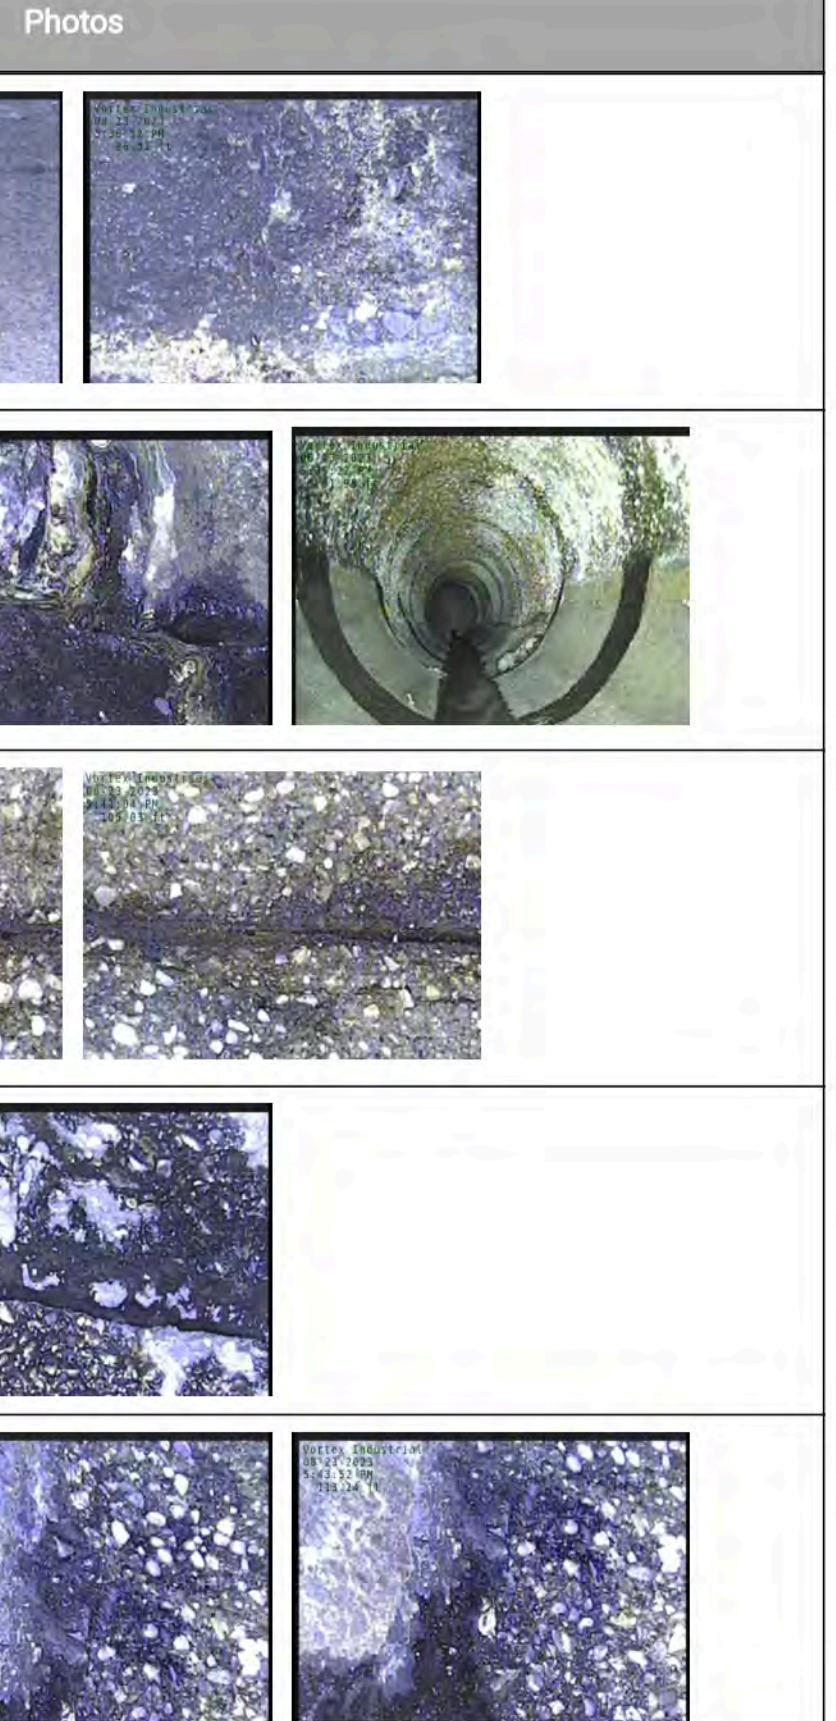
Description	Spatial Type	Distance (ft)	Туре	Percent	Clock	SR	O&M	С	PR	Remarks	
Crack Multiple	Point	96.8	Structural	0	4-6	3	0	0	1	Crack Multiple	
Deposits Attached Encrustation	Point	99	O&M	10	4-5	0	2	0	0	Deposits Attached Encrustation	Address Canadian Control of Contr
Crack Circumferential	Point	105	Structural	0	10- 12	1	0	0	1	Crack Circumferential	
Crack Longitudinal	Point	113.2	Structural	0	6	2	0	0	1	Crack Longitudinal	
Crack Longitudinal	Point	113.2	Structural	0	3	2	0	0	1	Crack Longitudinal	Vortes Industria 09:23:2623 3:32:45 Pr 113:23:41 133:28:41 134:41

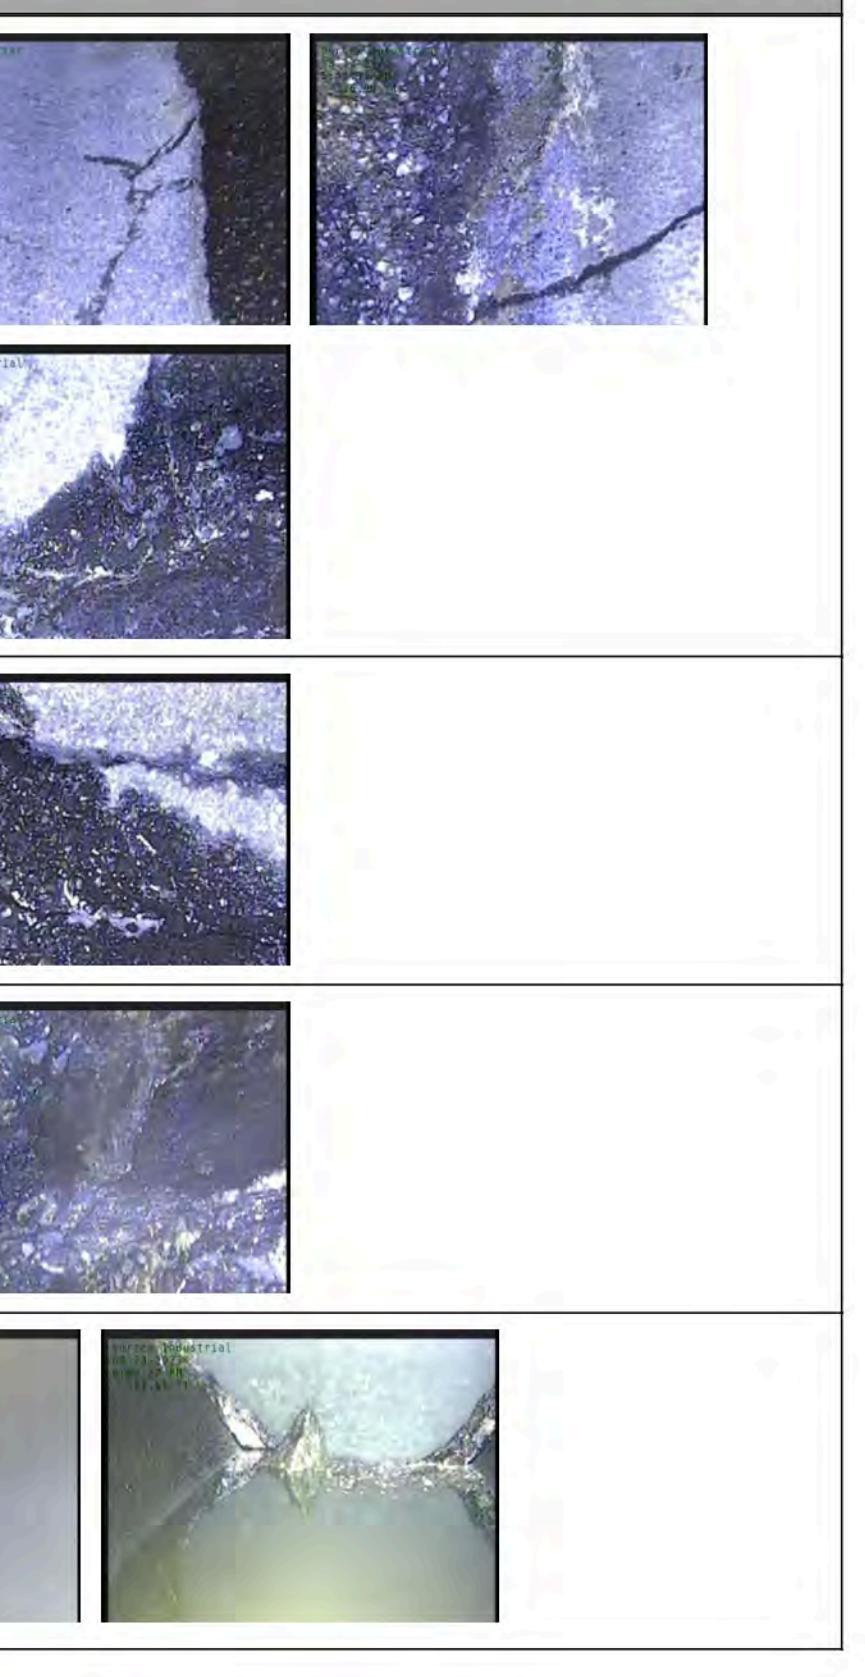
Description	Spatial Type	Distance (ft)	Туре	Percent	Clock	SR	O&M	С	PR	Remarks	
Crack Multiple	Point	116.9	Structural	0	7-8	3	0	0	2	Crack Multiple	Vortex Industrial 08:23-2023 5:45:25 PM 1:10 90 II 1:10 90 III
Crack Multiple	Point	116.9	Structural	0	5-6	3	0	0	2	Crack Multiple	
Crack Longitudinal	Point	128.6	Structural	0	8	2	0	0	1	Crack Longitudinal	Turtis Brude Bauds - Barts Sriss use Juli Star Barts
Obstruction Rocks	Point	132.6	O&M	10	7	0	0	0	0	Obstruction Rocks

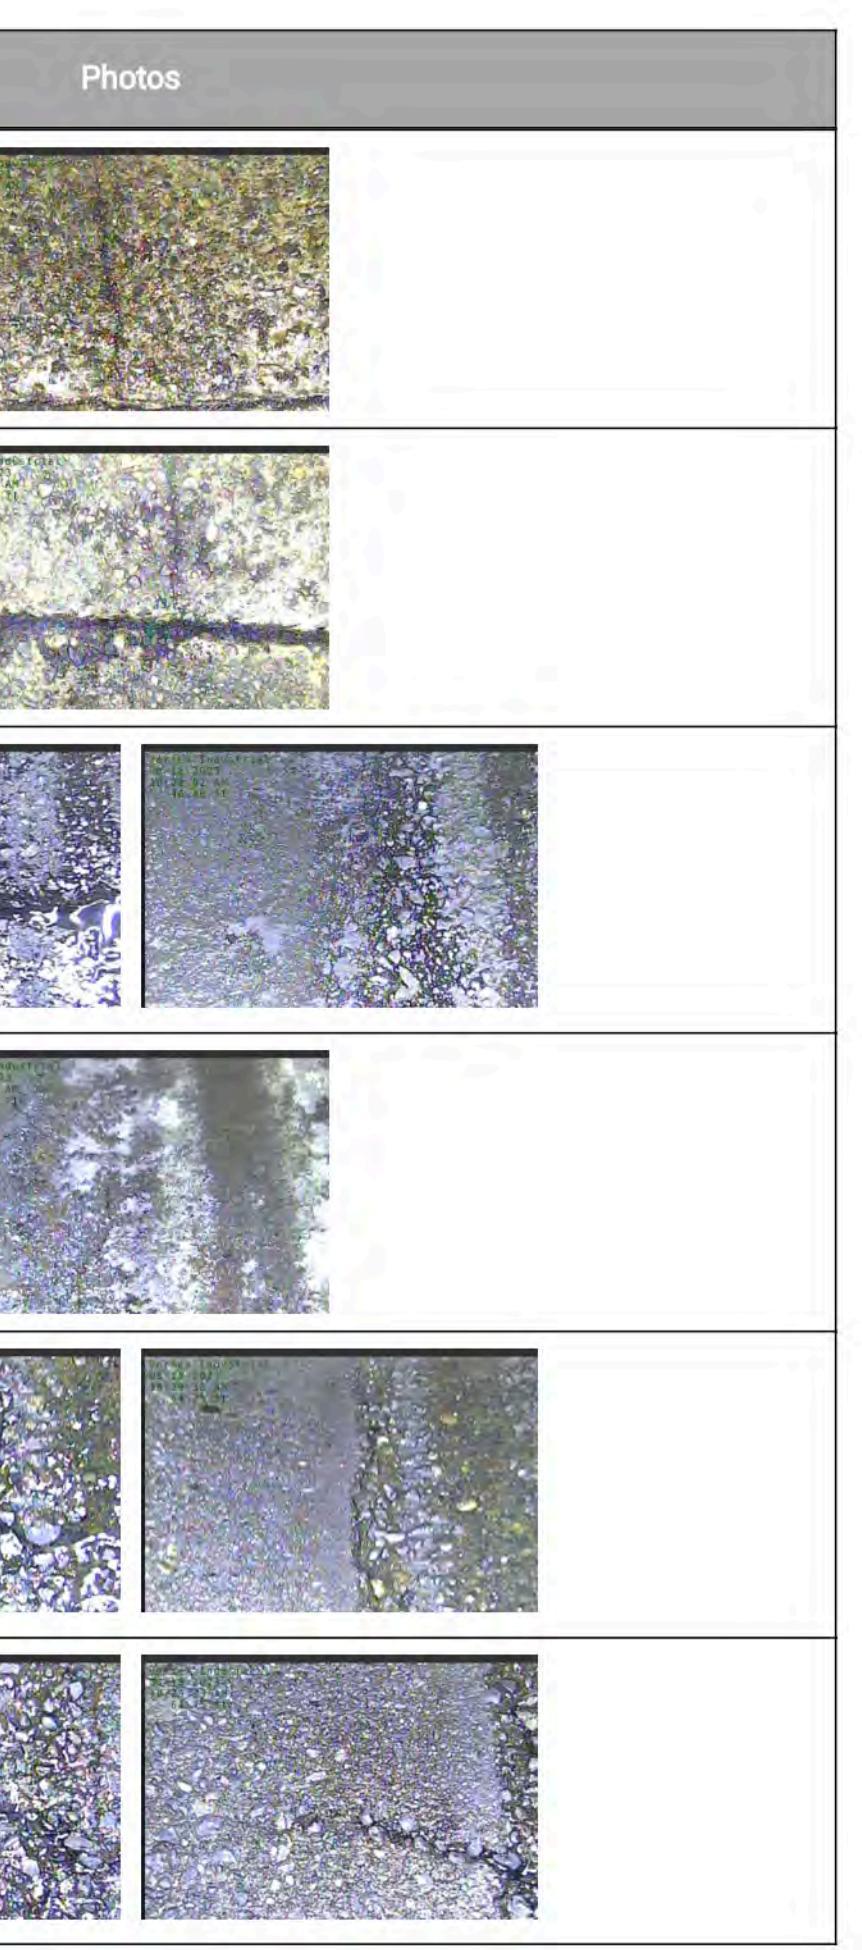
Description	Spatial Type	Distance (ft)	Туре	Percent	Clock	SR	O&M	С	PR	Remarks	
Crack Longitudinal	Point	10.2	Structural	0	2	2	0	0	1	Crack Longitudinal	
Crack Longitudinal	Point	16.7	Structural	0	2	2	0	0	1	Crack Longitudinal	
Crack Longitudinal	Point	46.5	Structural	0	6	2	0	0	1	Crack Longitudinal	
Crack Longitudinal	Point	52	Structural	0	6	2	0	0	1	Crack Longitudinal	2400.00 40 23 57.00 57.0
Crack Longitudinal	Point	64.7	Constructional	0	7	2	0	0	1	Crack Longitudinal	
Crack Circumferential	Point	64.7	Structural	0	5-7	1	0	0	1	Crack Circumferential

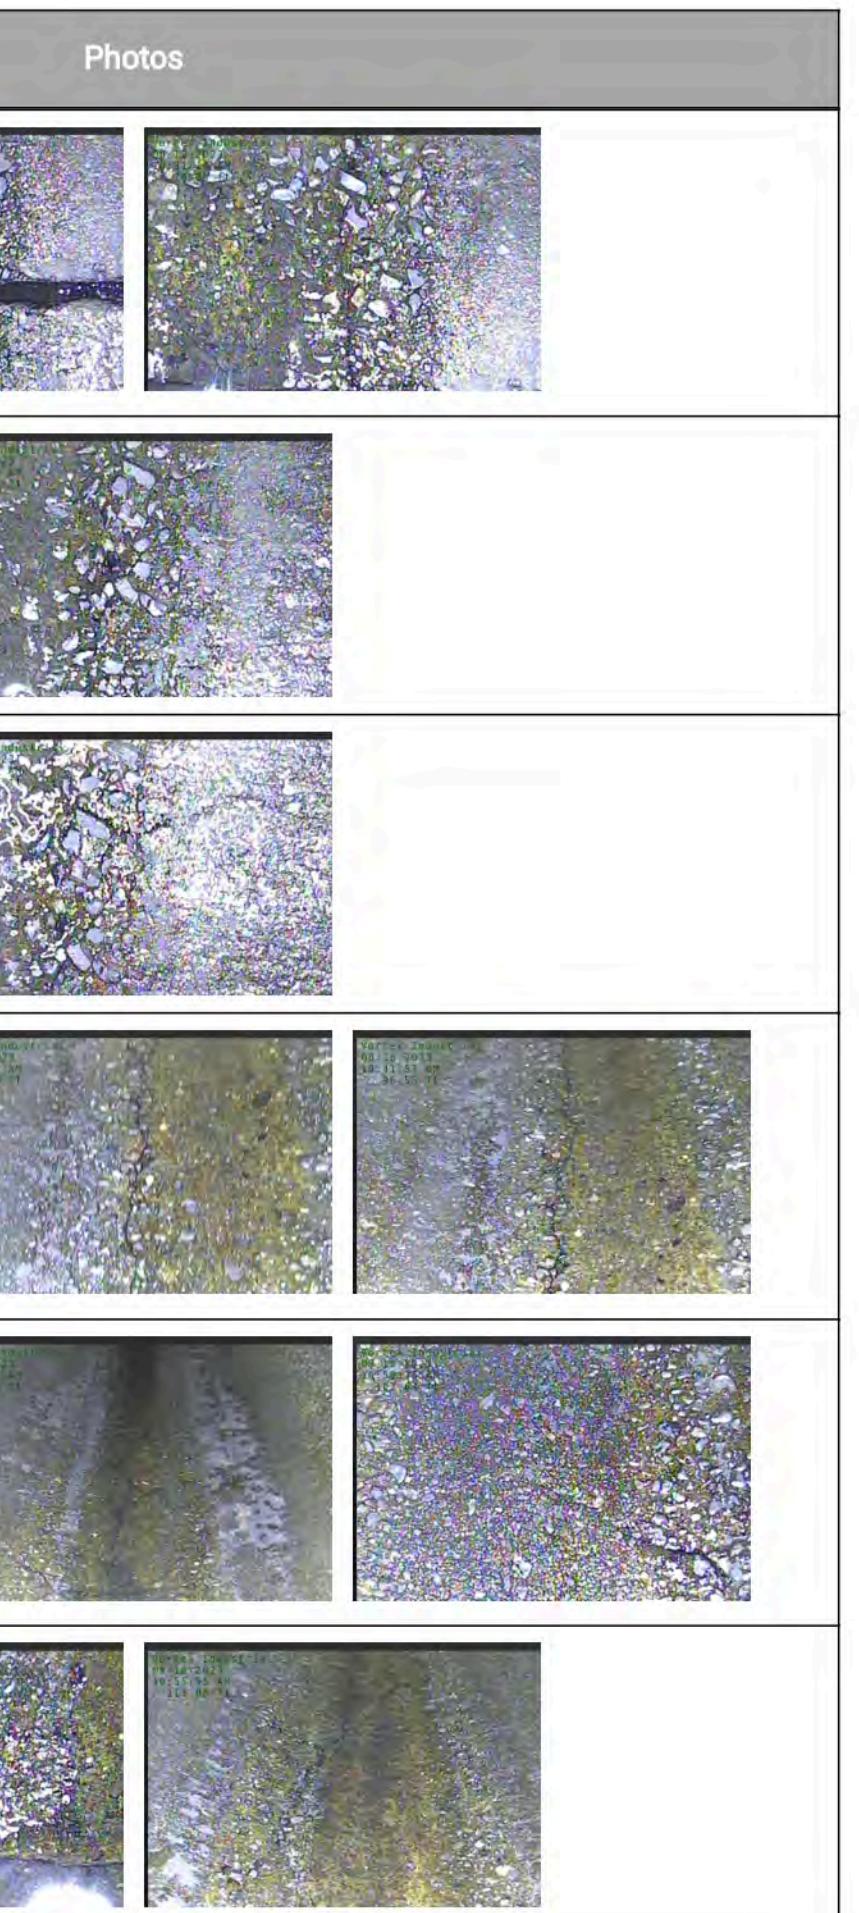
Description	Spatial Type	Distance (ft)	Туре	Percent	Clock	SR	O&M	С	PR	Remarks	
Crack Longitudinal	Point	70.3	Structural	0	6	2	0	0	1	Crack Longitudinal	
Crack Longitudinal	Point	77.6	Structural	0	6	2	0	0	1	Crack Longitudinal	
Crack Circumferential	Point	78.8	Structural	0	5-6	1	0	0	1	Crack Circumferential	
Crack Longitudinal	Point	96.6	Structural	0	6	2	0	0	1	Crack Longitudinal	
Crack Multiple	Point	102.4	Structural	0	6-7	3	0	0	1	Crack Multiple	
Crack Multiple	Point	113.1	Structural	0	6-7	3	0	0	1	Crack Multiple

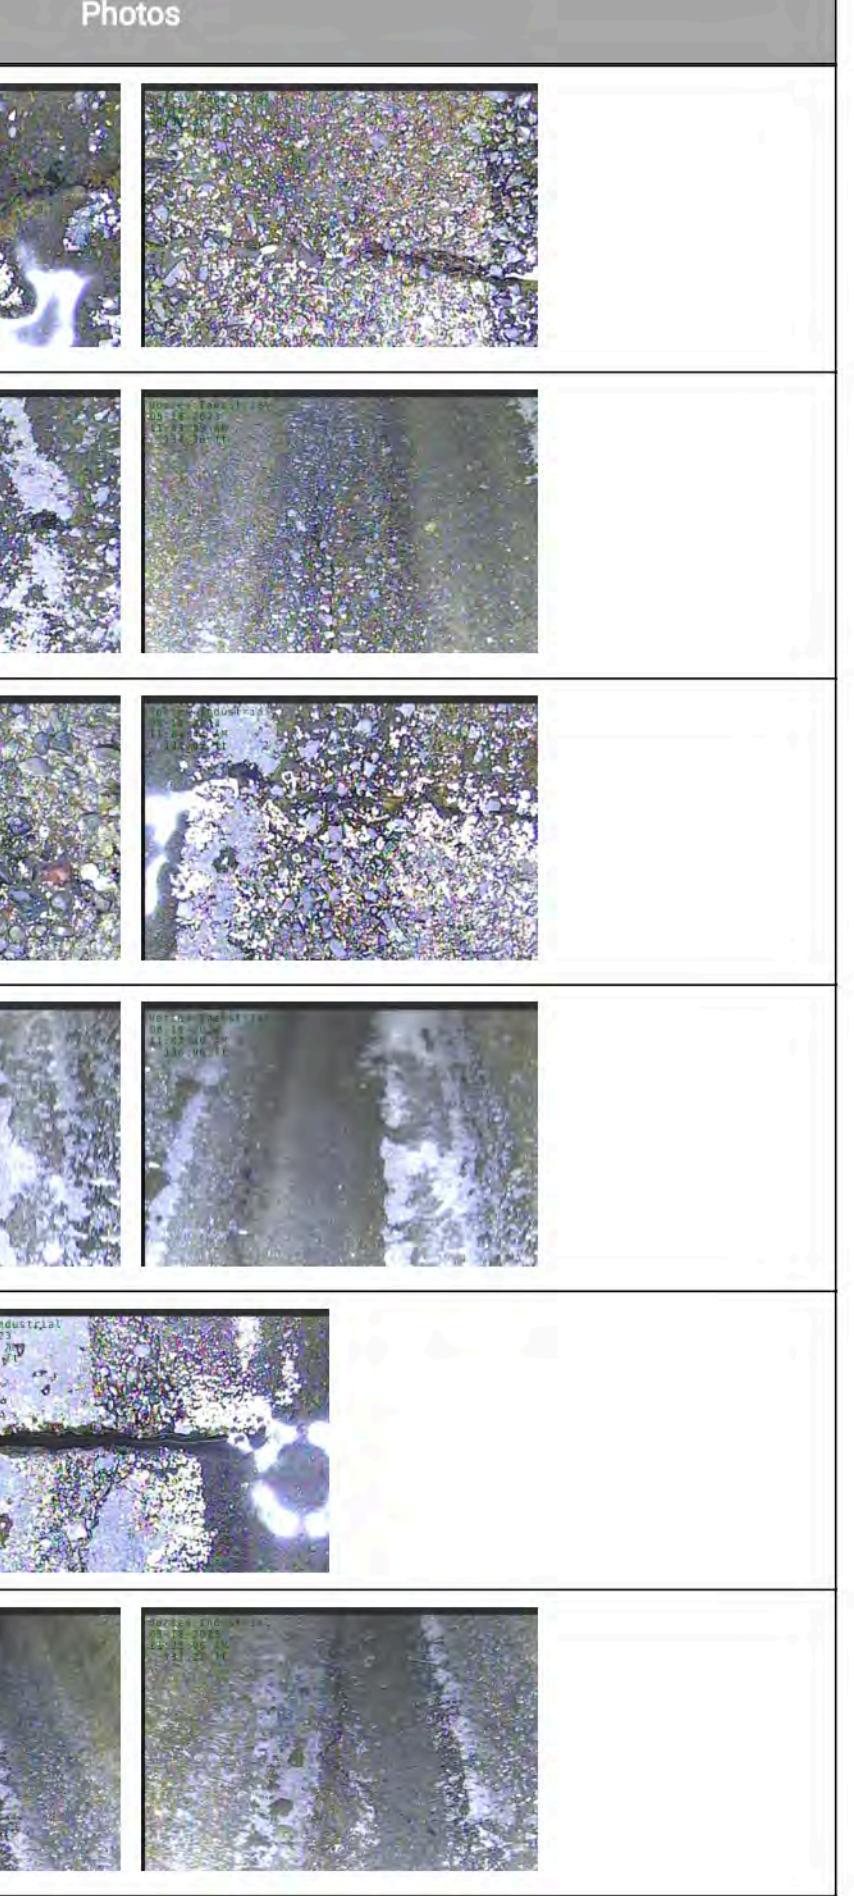
Description	Spatial Type	Distance (ft)	Туре	Percent	Clock	SR	O&M	С	PR	Remarks	
Crack Circumferential	Point	121.8	Structural	0	5-7	1	0	0	1	Crack Circumferential	
Crack Longitudinal	Point	134.4	Structural	0	6	2	0	0	1	Crack Longitudinal	
Crack Circumferential	Point	134.7	Structural	0	5-6	1	0	0	2	Crack Circumferential	
Crack Longitudinal	Point	136.1	Structural	0	6	2	0	0	1	Crack Longitudinal	
Crack Longitudinal	Point	136.8	Structural	0	6	2	0	0	1	Crack Longitudinal	
Crack Longitudinal	Point	137.3	Structural	0	6	2	0	0	1	Crack Longitudinal
