2024 ANNUAL PROGRESS REPORT SWMU-1 OILY WATER SEWER

HF SINCLAIR PUGET SOUND REFINING LLC

March 2025

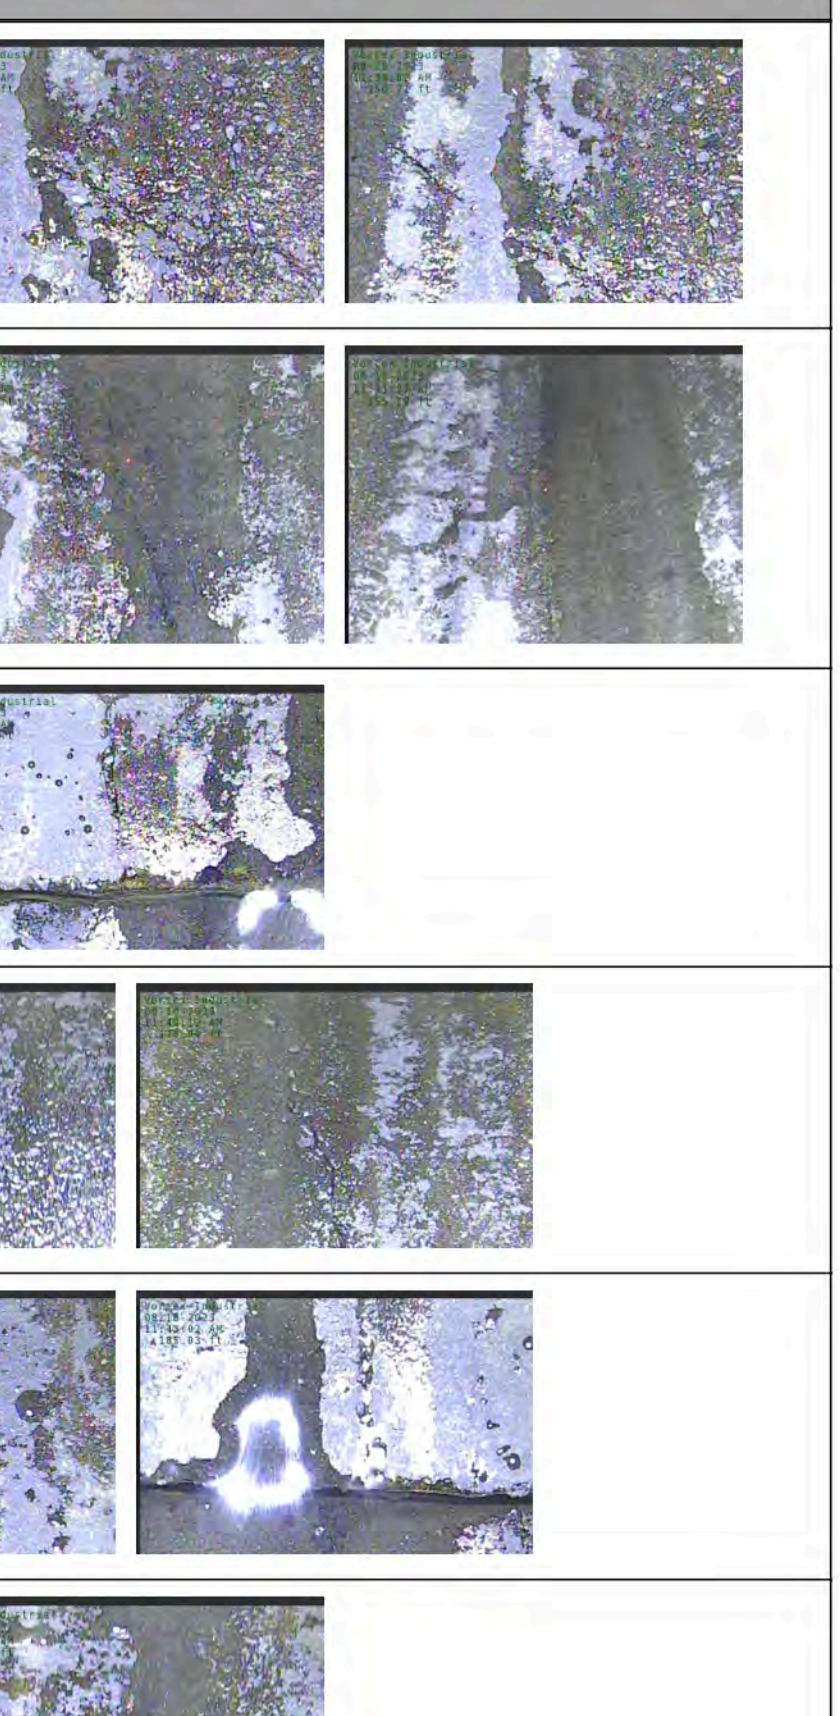
Description	Spatial Type	Distance (ft)	Туре	Percent	Clock	SR	O&M	с	PR	Remarks	
Crack Multiple	Point	150.7	Structural	0	5-8	3	0	0	1	Crack Multiple	
Crack Longitudinal	Point	155.2	Structural	0	6	2	0	0	1	Crack Longitudinal	
Crack Longitudinal	Point	166.8	Structural	0	6	2	0	0	1	Crack Longitudinal	
Crack Longitudinal	Point	179	Structural	0	6	2	0	0	1	Crack Longitudinal	
Crack Longitudinal	Point	185	Structural	0	6	2	0	0	1	Crack Longitudinal	
Crack Longitudinal	Point	216	Structural	0	6	2	0	0	1	Crack Longitudinal

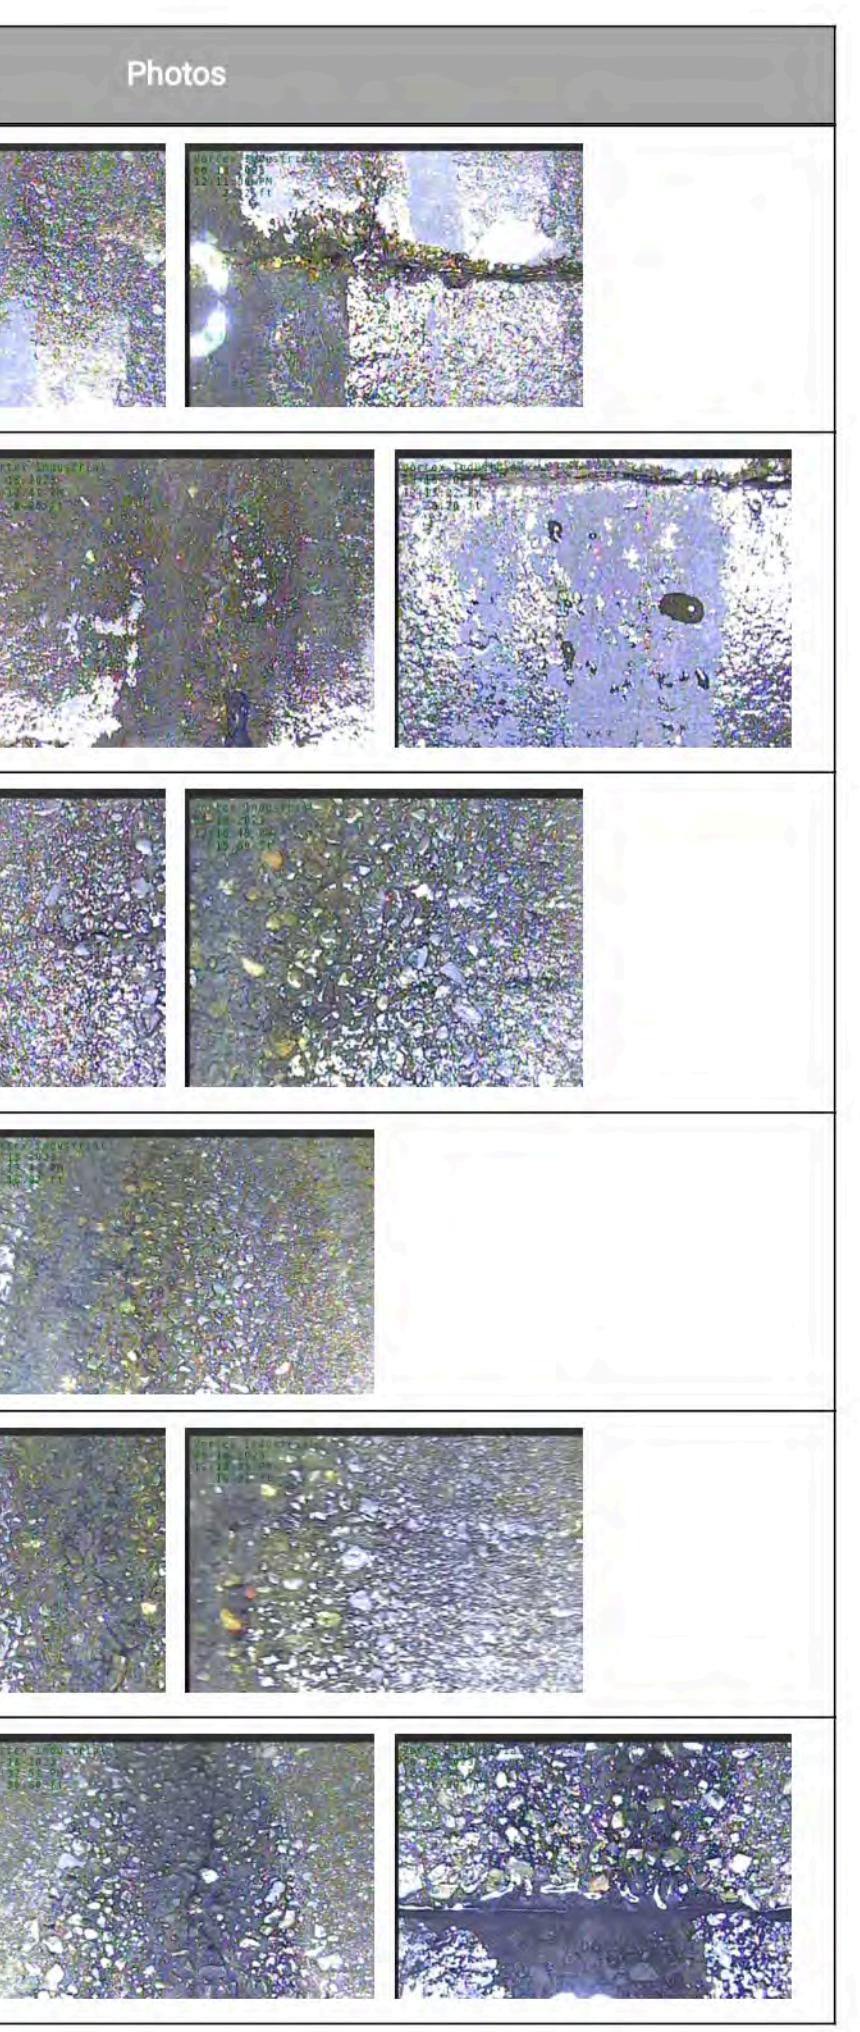
Description	Spatial Type	Distance (ft)	Туре	Percent	Clock	SR	0&M	С	PR	Remarks	
Crack Longitudinal	Point	2.5	Structural	0	6	2	0	0	1	Crack Longitudinal	
Crack Longitudinal	Point	8.2	Structural	0	6	2	0	0	1	Crack Longitudinal	
Crack Circumferential	Point	15.7	Structural	0	5-7	1	0	0	1	Crack Circumferential	
Crack Longitudinal	Point	16.1	Structural	0	6	2	0	0	1	Crack Longitudinal	
Crack Circumferential	Point	16.9	Structural	0	5-7	1	0	0	1	Crack Circumferential	
Crack Longitudinal	Continuous	36.8 - 42.9	Structural	0	6	2	0	0	1	Crack Longitudinal	Vertex success of the second s

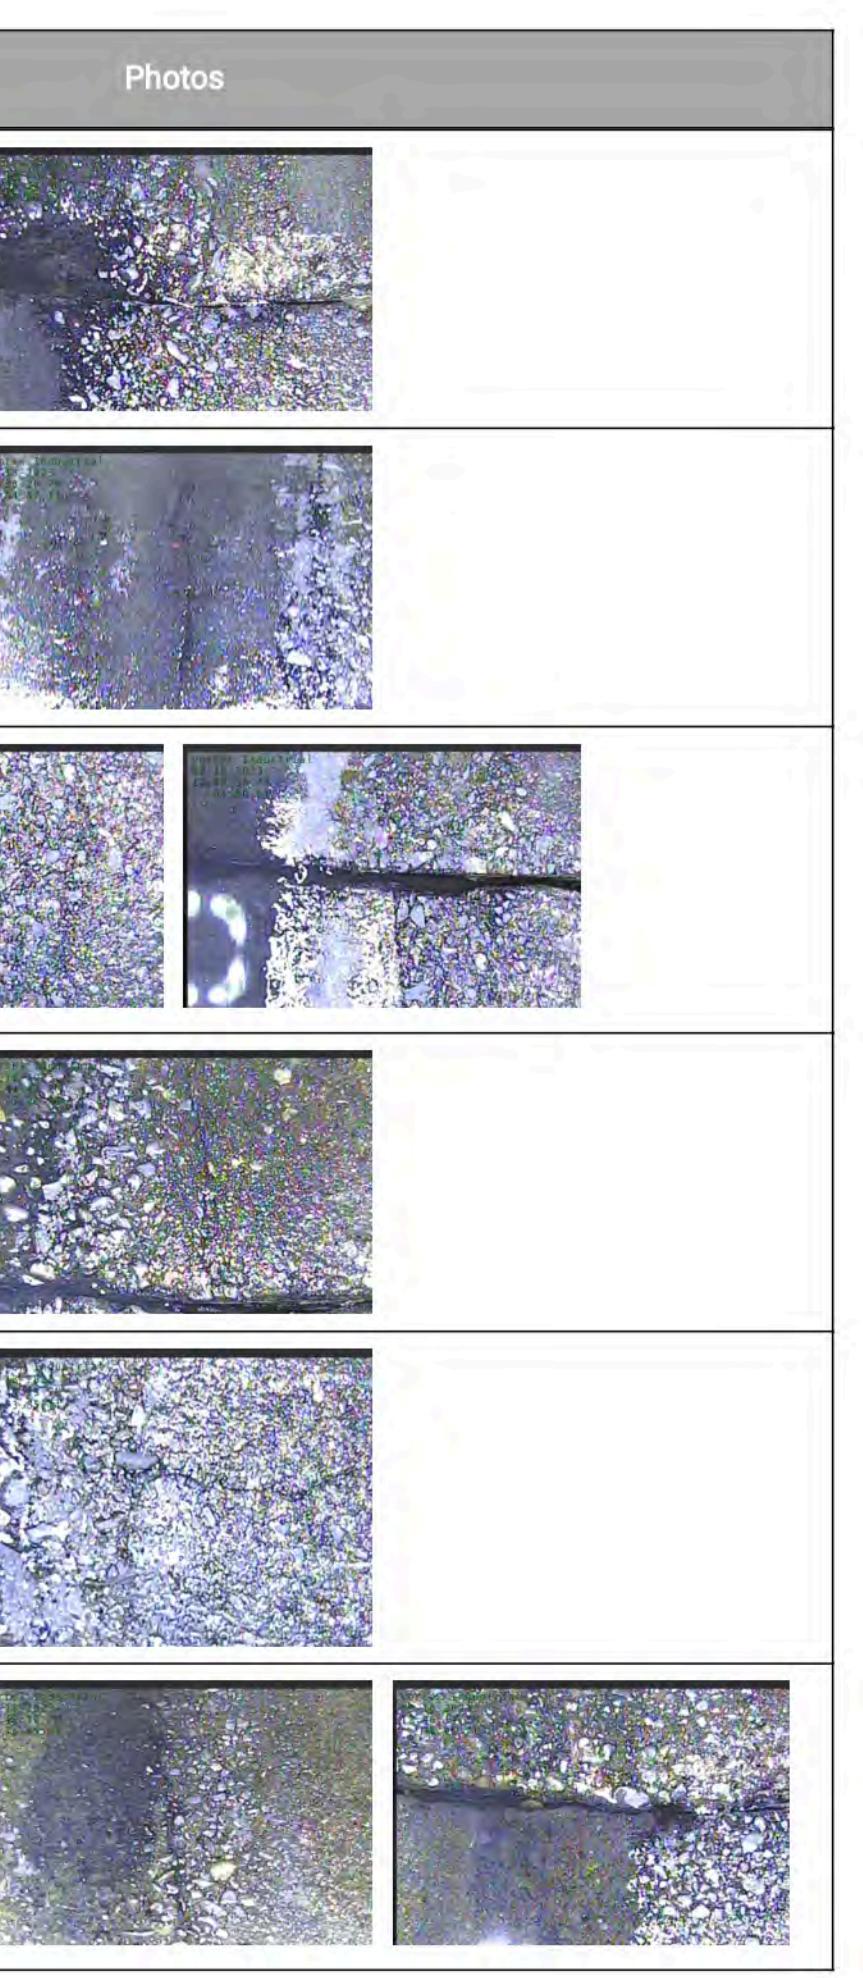
Description	Spatial Type	Distance (ft)	Туре	Percent	Clock	SR	O&M	С	PR	Remarks	
Crack Longitudinal	Point	49	Structural	0	6	2	0	0	1	Crack Longitudinal	
Crack Longitudinal	Point	54.9	Structural	0	6	2	0	0	1	Crack Longitudinal	
Crack Longitudinal	Point	61	Structural	0	6	2	0	0	1	Crack Longitudinal	
Crack Longitudinal	Point	73	Structural	0	6	2	0	0	1	Crack Longitudinal	
Crack Circumferential	Point	73.8	Structural	0	5-6	1	0	0	1	Crack Circumferential	
Crack Longitudinal	Point	79	Structural	0	6	2	0	0	1	Crack Longitudinal

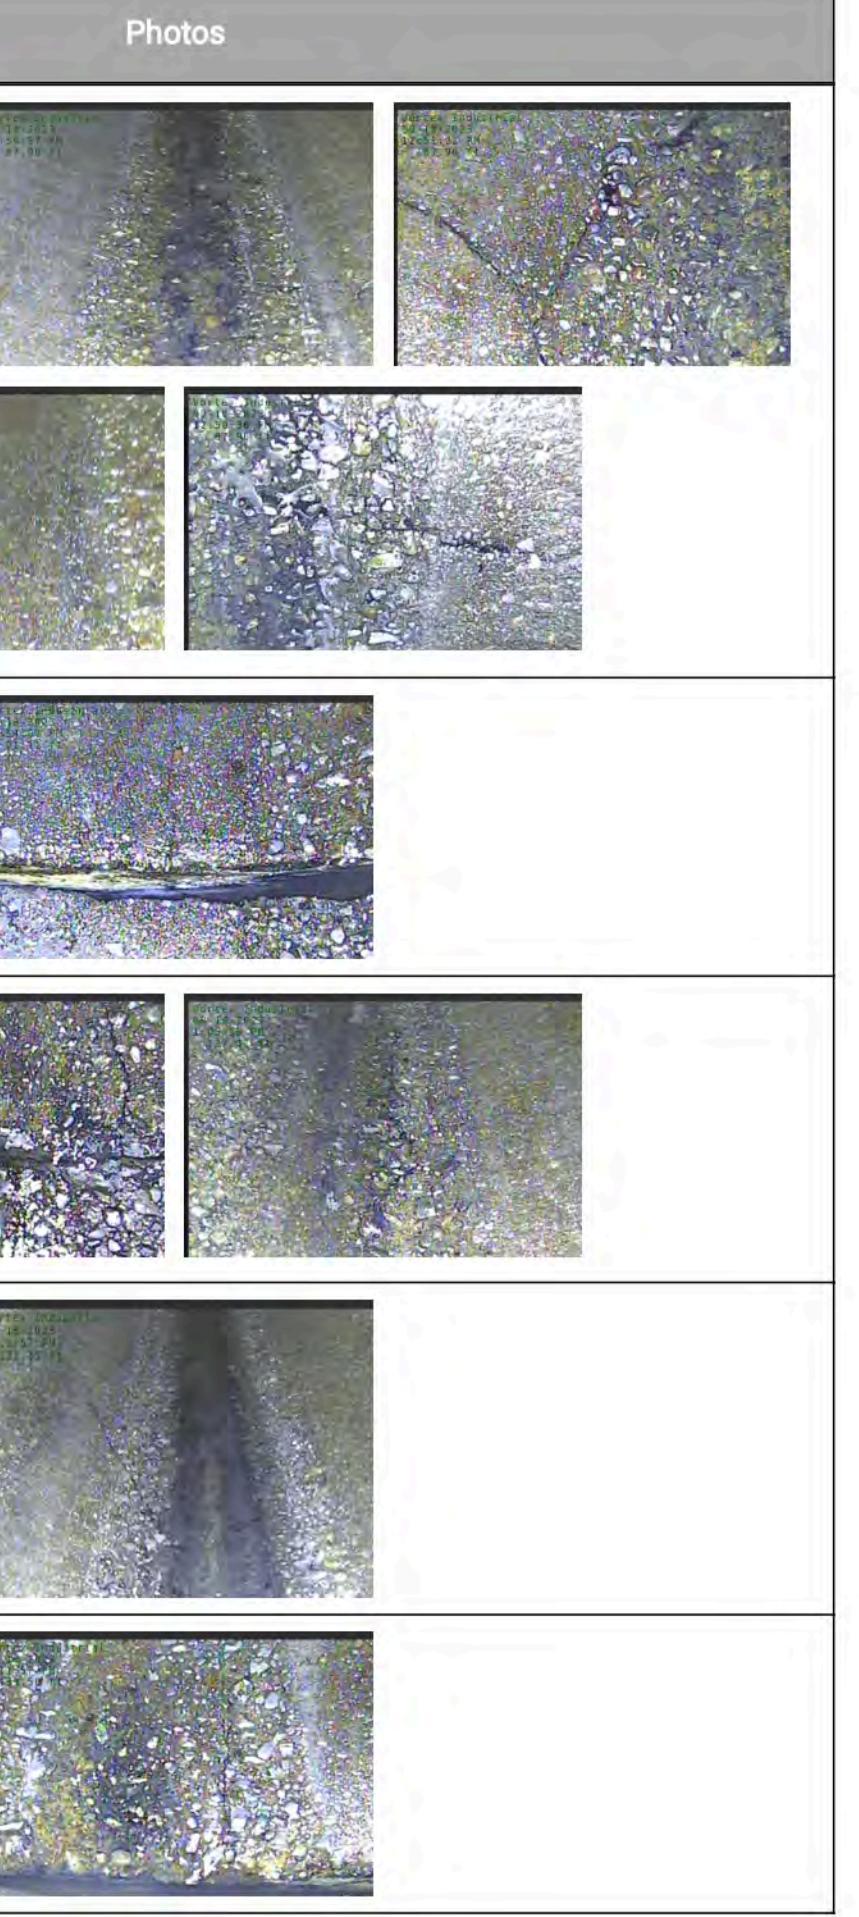
Description	Spatial Type	Distance (ft)	Туре	Percent	Clock	SR	0&M	с	PR	Remarks	
Crack Multiple	Point	87.9	Structural	0	6-8	3	0	0	2	Crack Multiple	
Crack Longitudinal	Point	91.1	Structural	0	6	2	0	0	1	Crack Longitudinal	
Crack Longitudinal	Point	127.4	Structural	0	6	2	0	0	1	Crack Longitudinal	
Crack Longitudinal	Point	134	Structural	0	6	2	0	0	1	Crack Longitudinal	
Crack Longitudinal	Point	139.5	Structural	0	6	2	0	0	1	Crack Longitudinal

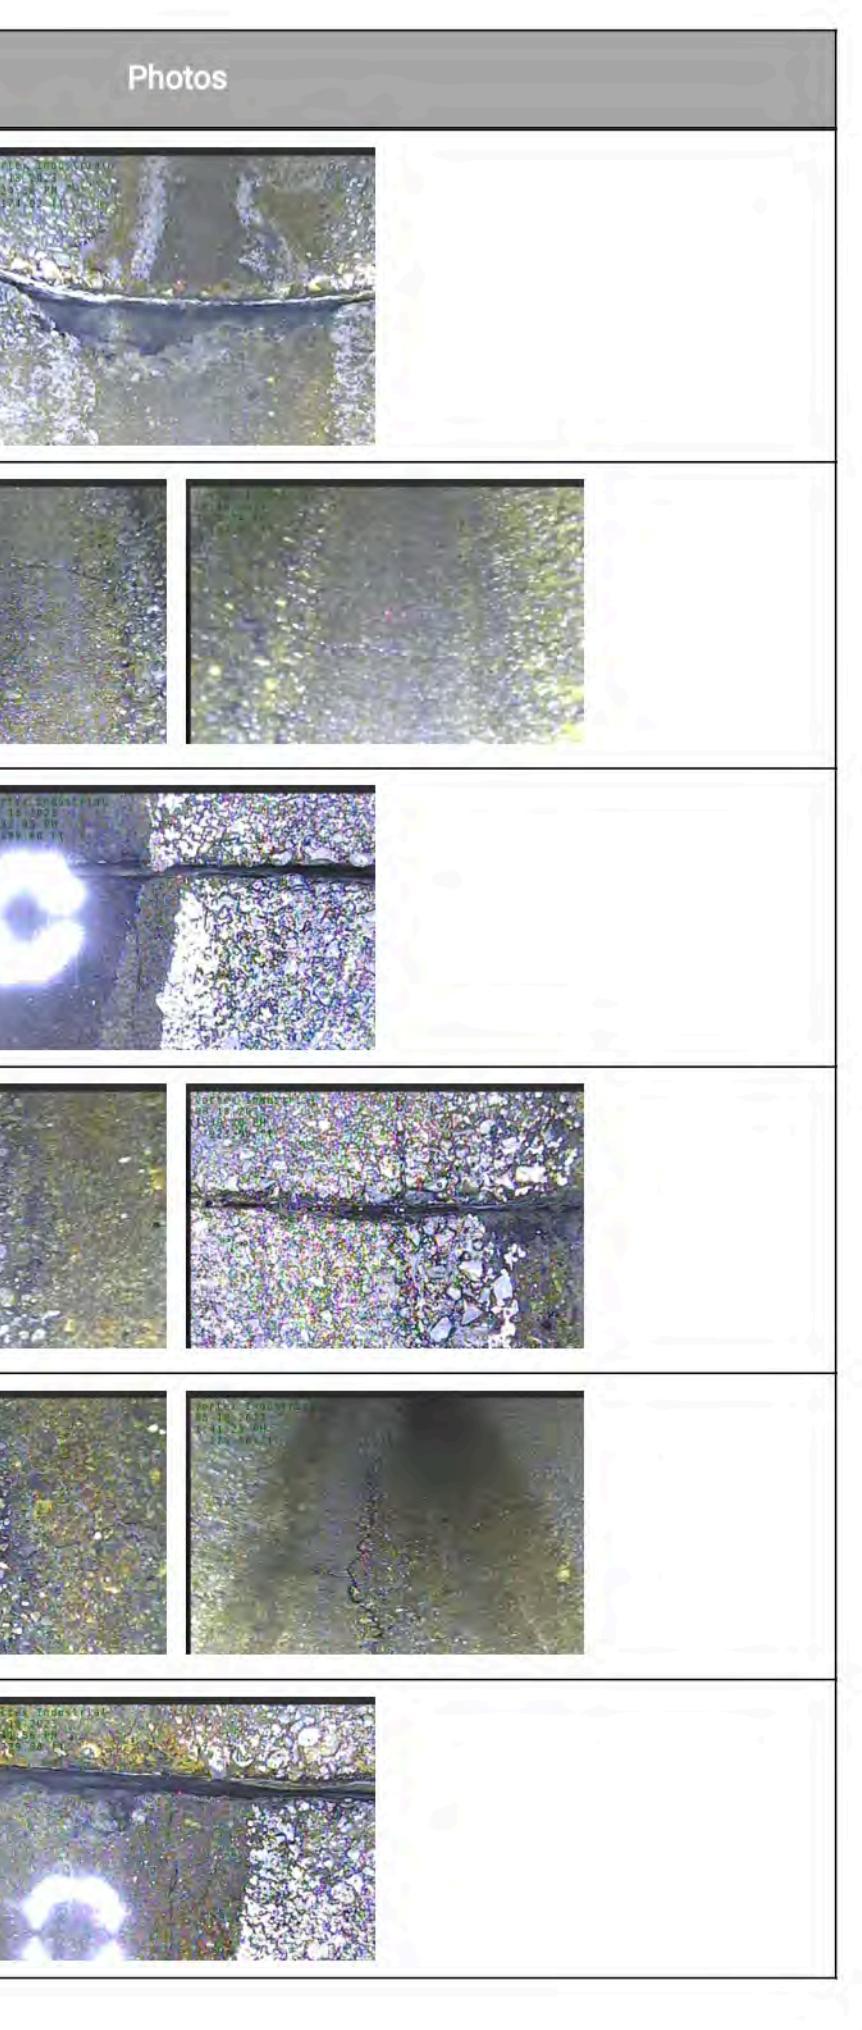
Description	Spatial Type	Distance (ft)	Туре	Percent	Clock	SR	O&M	С	PR	Remarks	
Fracture Circumferential	Point	175.6	Structural	0	6-7	2	0	0	2	Fracture Circumferential	
Crack Circumferential	Point	188	Structural	0	5-7	1	0	0	1	Crack Circumferential	
Crack Longitudinal	Point	199.9	Structural	0	6	2	0	0	1	Crack Longitudinal	
Crack Multiple	Point	224	Structural	0	6-7	3	0	0	1	Crack Multiple	Worther ID Guist CLAI WART ID GUIST CLAI No LLA ST AN AD LLA ST AN AD LLA ST AN AD LLA ST AN AD LLA ST AN AD
Crack Longitudinal	Point	225.5	Structural	0	6	2	0	0	2	Crack Longitudinal	June fene Junuit, sed nyf. Bergerige 1932 fan sjer 1935 fa
Crack Longitudinal	Point	229.9	Structural	0	6	2	0	0	1	Crack Longitudinal

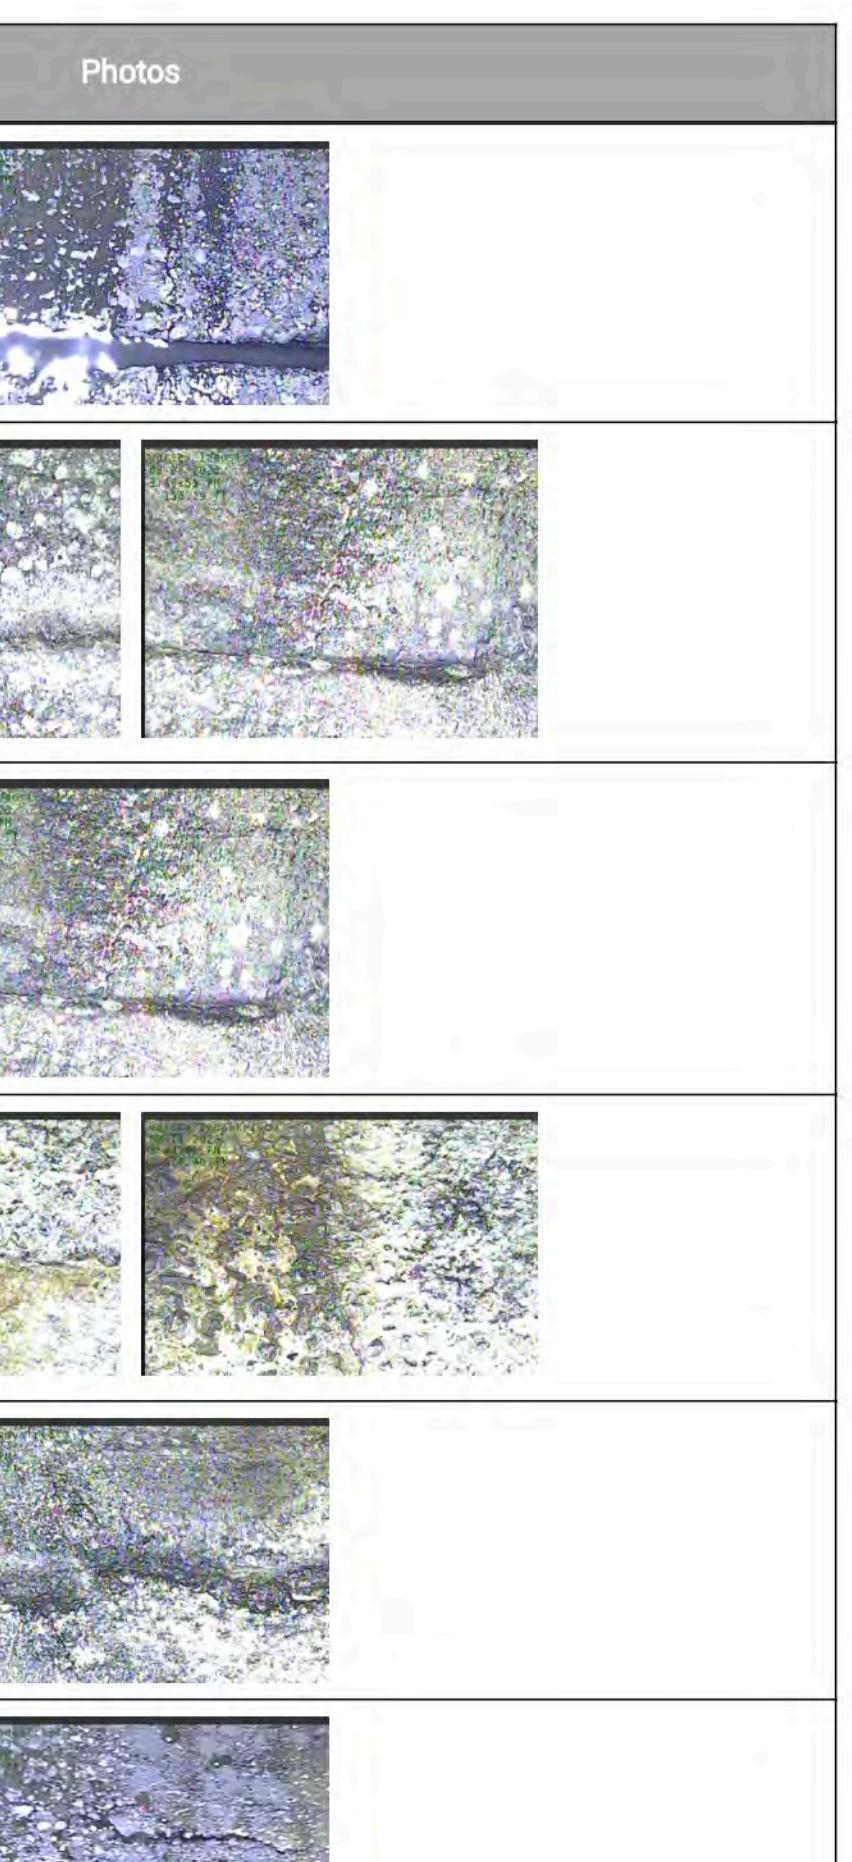
Description	Spatial Type	Distance (ft)	Туре	Percent	Clock	SR	0&M	С	PR	Remarks	
Crack Longitudinal	Point	6.9	Structural	0	6	2	0	0	1	Crack Longitudinal	
Crack Longitudinal	Point	85.8	Structural	0	6	2	0	0	1	Crack Longitudinal	
Crack Longitudinal	Point	158.3	Structural	0	3	2	0	0	1	Crack Longitudinal	
Crack Longitudinal	Point	170.4	Structural	0	4	2	0	0	1	Crack Longitudinal	
Crack Longitudinal	Point	176.3	Structural	0	12	2	0	0	1	Crack Longitudinal	
Crack Circumferential	Point	245.7	Structural	0	5-6	1	0	0	1	Crack Circumferential

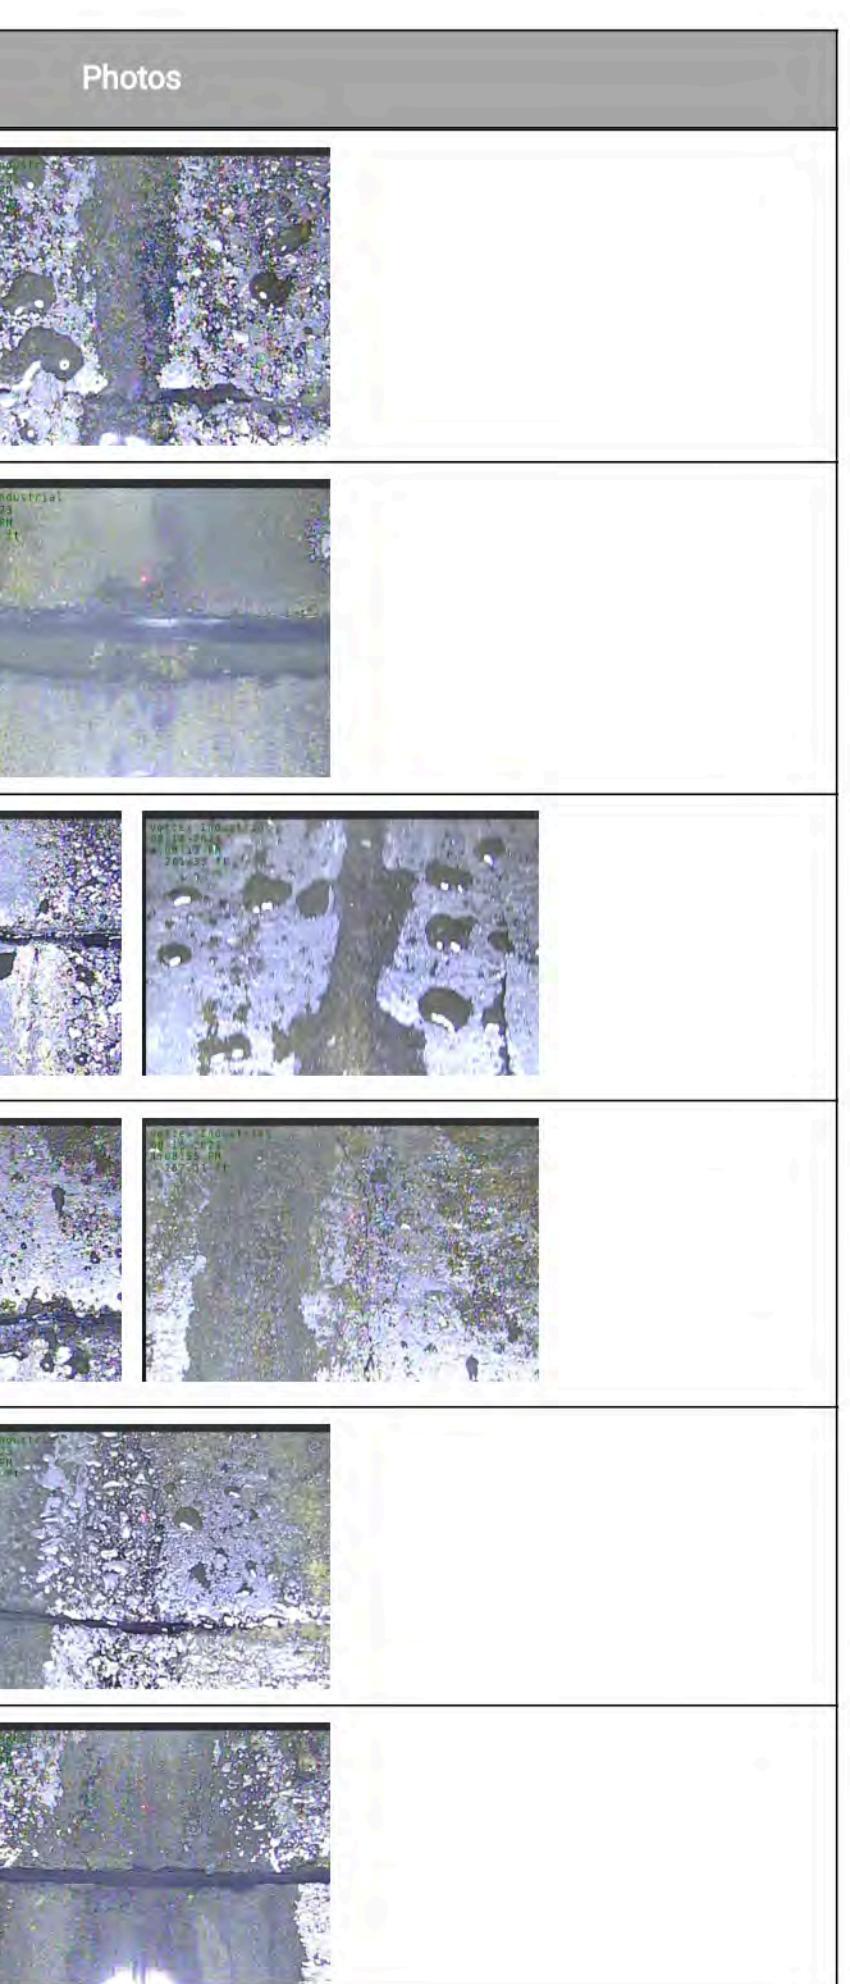
Description	Spatial Type	Distance (ft)	Туре	Percent	Clock	SR	O&M	с	PR	Remarks	
Crack Longitudinal	Point	249.2	Structural	0	6	2	0	0	1	Crack Longitudinal	
Crack Longitudinal	Point	255.1	Structural	0	6	2	0	0	1	Crack Longitudinal	00 0 = x 1 4 = 50 - 32 = 12 - 32 = 12
Crack Longitudinal	Point	261.3	Structural	0	6	2	0	0	1	Crack Longitudinal	
Crack Longitudinal	Point	267.3	Structural	0	6	2	0	0	1	Crack Longitudinal	
Crack Longitudinal	Point	279.3	Structural	0	6	2	0	0	1	Crack Longitudinal	907 E.S. 1 41 (1) 20 27 (3)
Crack Longitudinal	Point	303.3	Structural	0	6	2	0	0	1	Crack Longitudinal

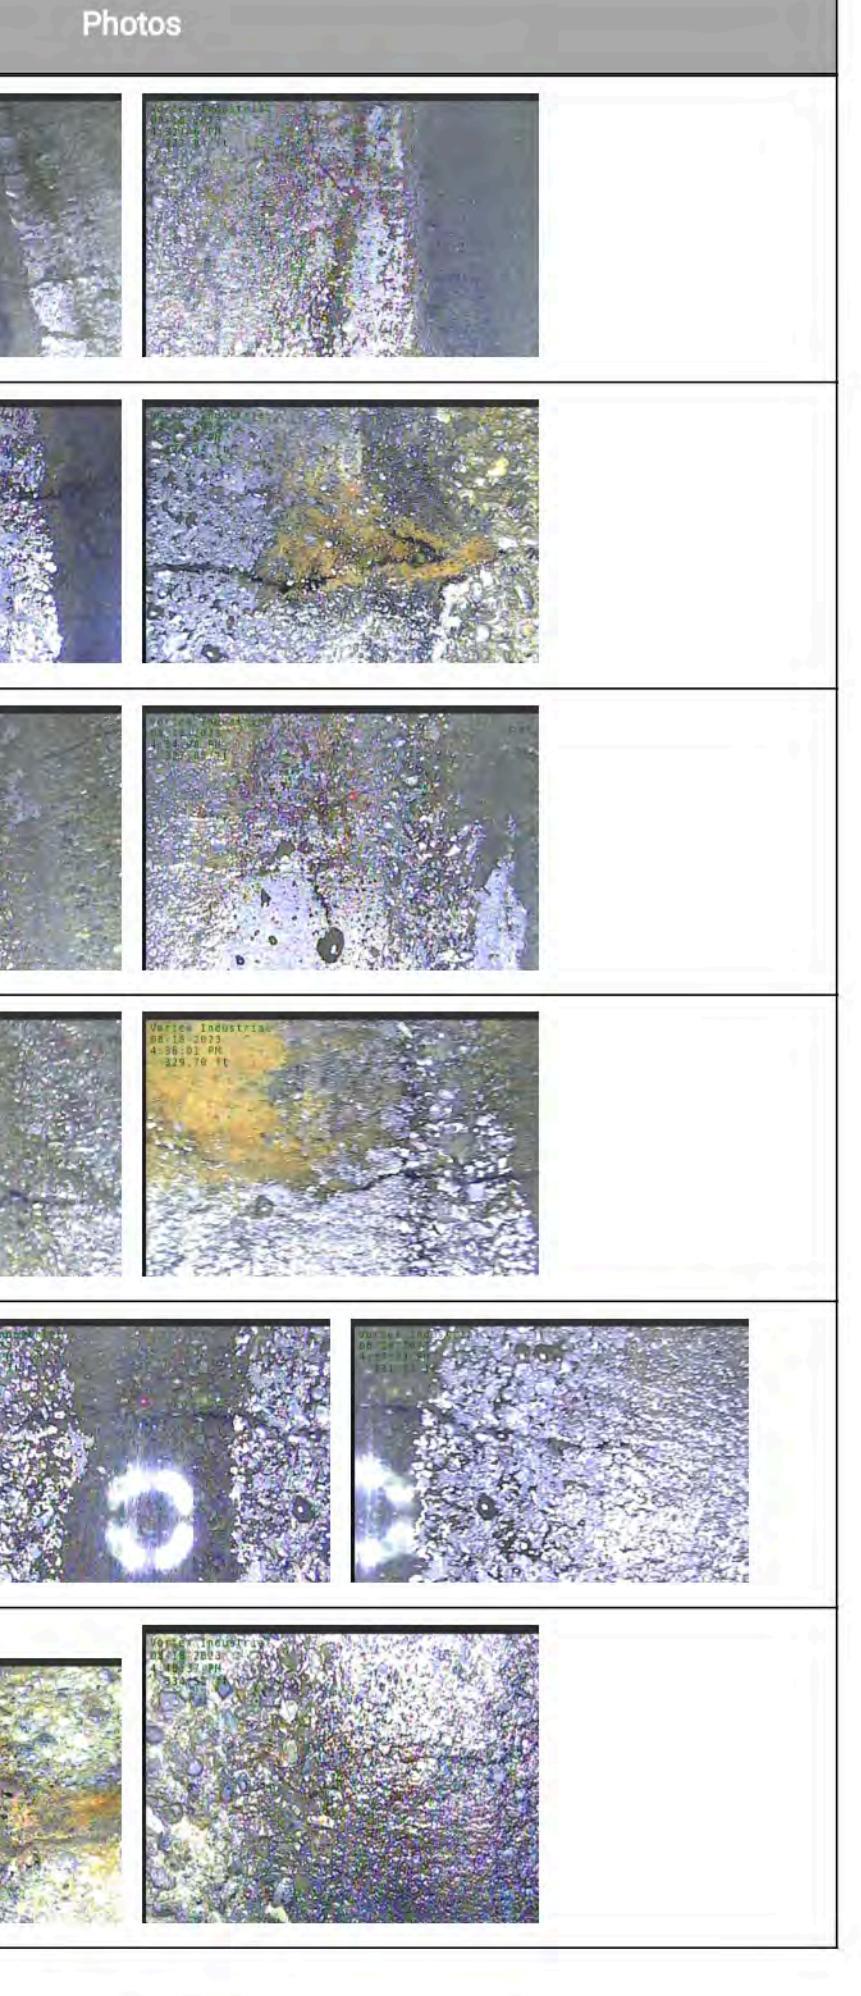
Description	Spatial Type	Distance (ft)	Туре	Percent	Clock	SR	0&M	с	PR	Remarks	
Crack Longitudinal	Point	323.8	Structural	0	7	2	0	0	1	Crack Longitudinal	
Crack Circumferential	Point	323.8	Structural	0	4-7	1	0	0	1	Crack Circumferential	
Crack Longitudinal	Point	327.8	Structural	0	7	2	0	0	1	Crack Longitudinal	
Crack Circumferential	Point	329.7	Structural	0	5-7	1	0	0	1	Crack Circumferential	
Crack Circumferential	Point	331.3	Structural	0	5-7	1	0	0	1	Crack Circumferential	
Crack Circumferential	Point	334.1	Structural	0	5-7	1	0	0	1	Crack Circumferential

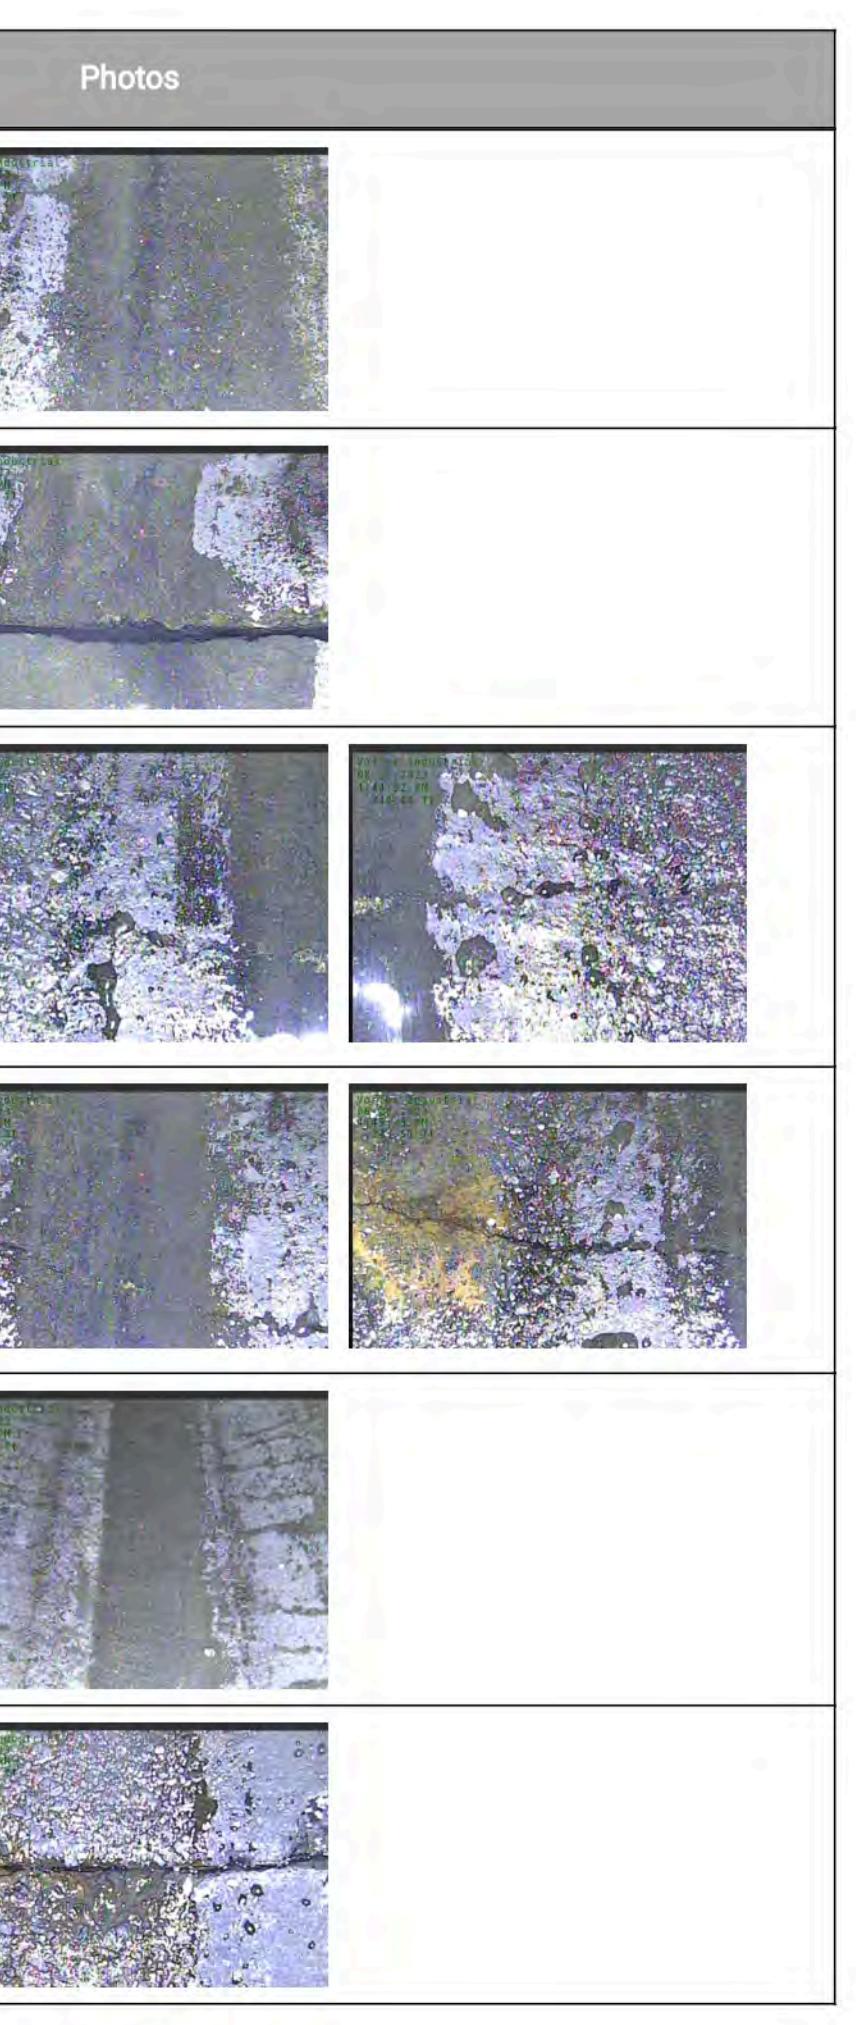
Description	Spatial Type	Distance (ft)	Туре	Percent	Clock	SR	O&M	с	PR	Remarks	
Crack Longitudinal	Point	336.5	Structural	0	6	2	0	0	1	Crack Longitudinal	
Crack Longitudinal	Point	339.8	Structural	0	6	2	0	0	1	Crack Longitudinal	
Crack Circumferential	Point	340.4	Structural	0	5-7	1	0	0	1	Crack Circumferential	
Crack Circumferential	Point	343.5	Structural	0	5-7	1	0	0	2	Crack Circumferential	
Crack Longitudinal	Point	346.6	Structural	0	6	2	0	0	1	Crack Longitudinal	
Crack Longitudinal	Point	352.1	Structural	0	7	2	0	0	1	Crack Longitudinal

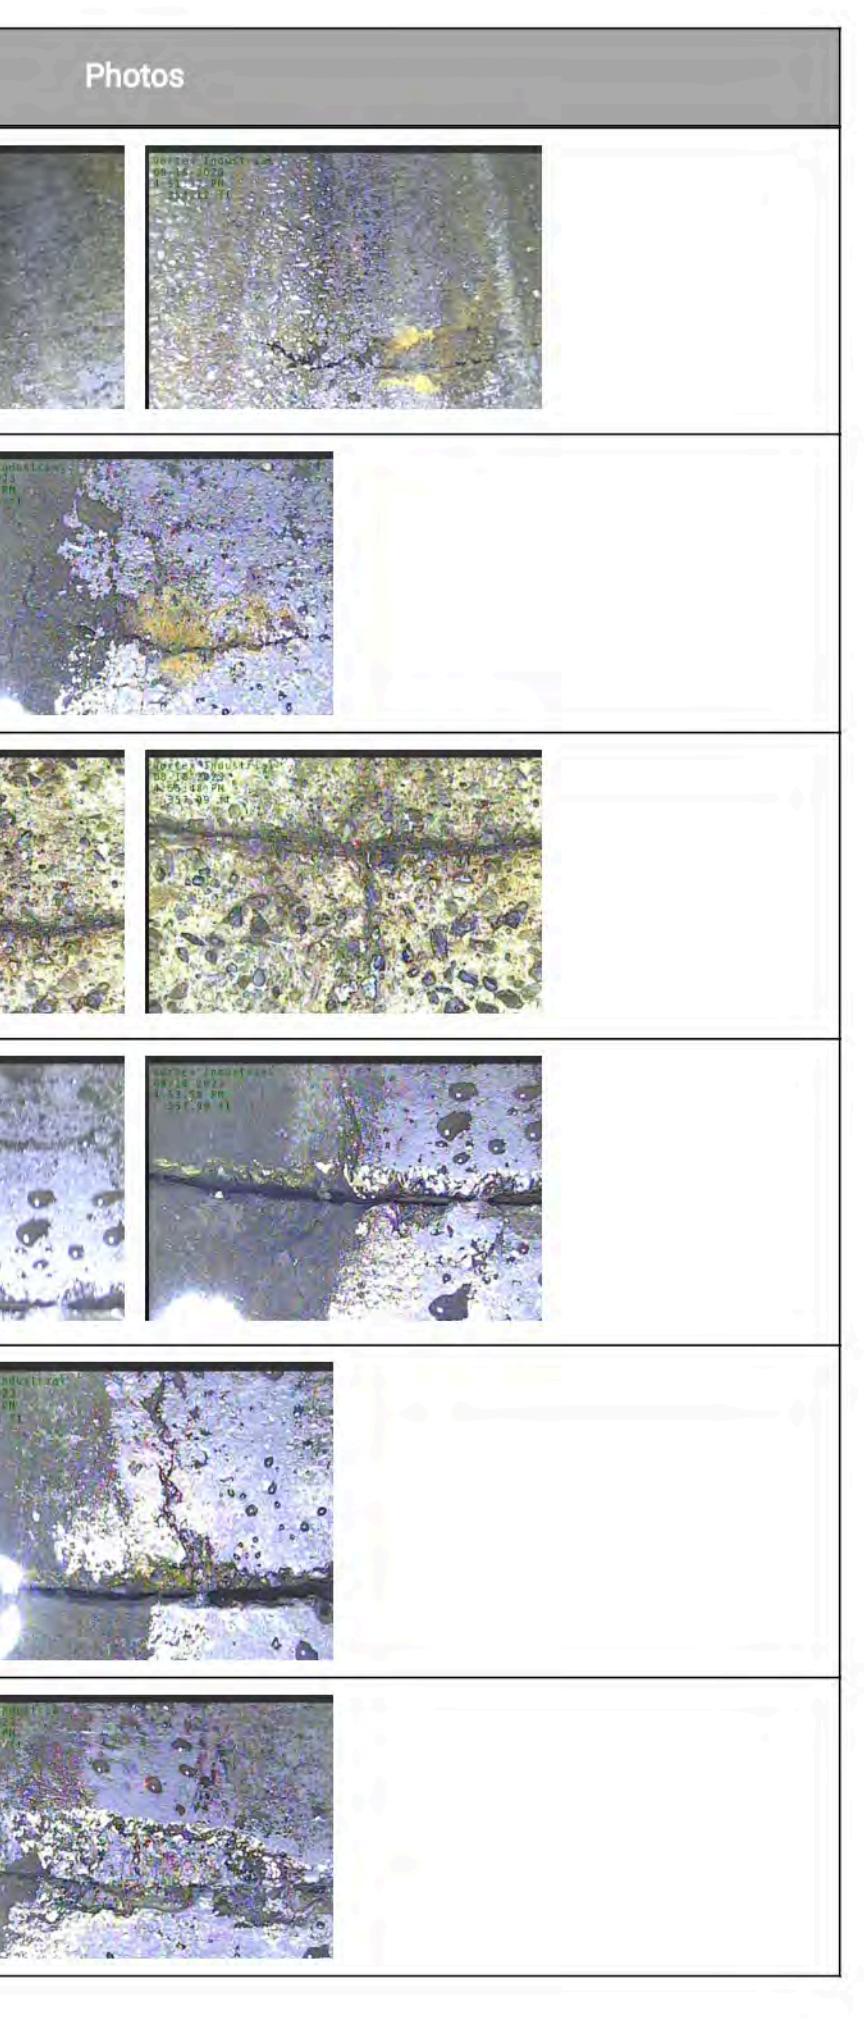
Description	Spatial Type	Distance (ft)	Туре	Percent	Clock	SR	0&M	С	PR	Remarks	
Crack Multiple	Point	353.4	Structural	0	6-7	3	0	0	1	Crack Multiple	
Crack Multiple	Point	355.4	Structural	0	5-6	3	0	0	1	Crack Multiple	
Crack Longitudinal	Point	358	Structural	0	11	2	0	0	1	Crack Longitudinal	
Crack Longitudinal	Point	358	Structural	0	6	2	0	0	2	Crack Longitudinal	Wettes Industrial Wettes Industrial Wildson Wit 3572.00 Tr
Crack Longitudinal	Point	364.2	Structural	0	6	2	0	0	2	Crack Longitudinal	
Fracture Circumferential	Point	370.2	Structural	0	5-6	2	0	0	2	Fracture Circumferential

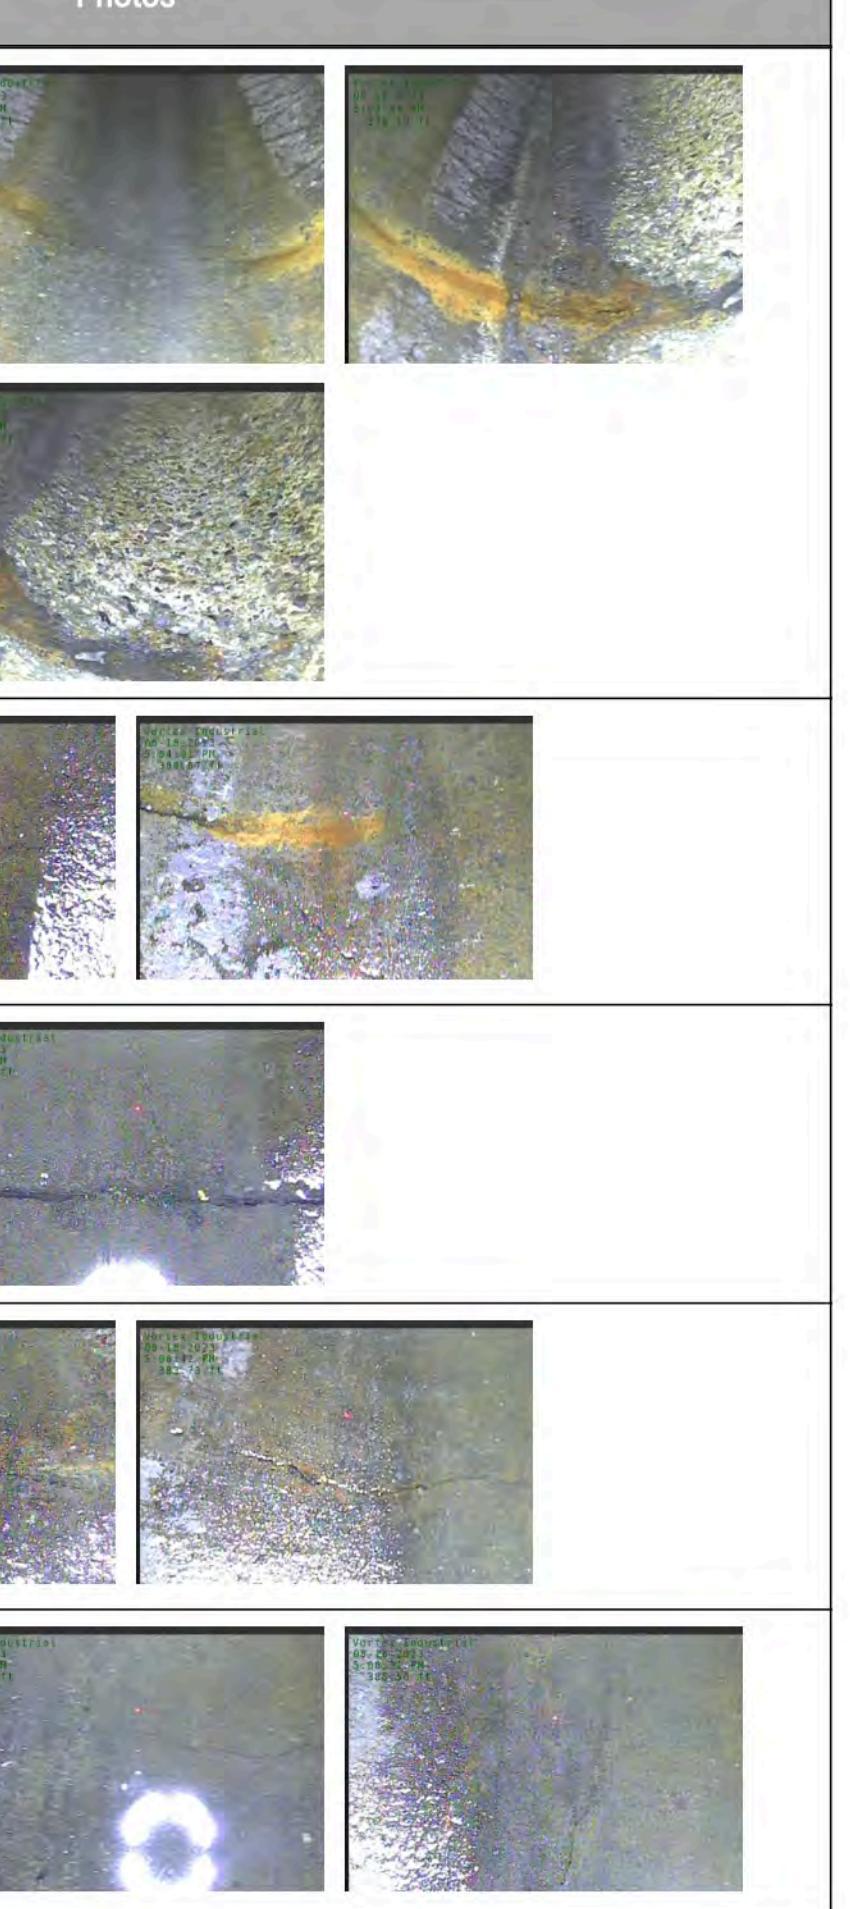
Description	Spatial Type	Distance (ft)	Туре	Percent	Clock	SR	0&M	С	PR	Remarks	States and
Crack Circumferential	Point	378.2	Structural	0	2-10	1	0	0	1	Crack Circumferential	vortex Industrial 98 18 2023 5 d l 39 PP 376 J2 /t : 98 4 19 00 000000000000000000000000000000000
Crack Circumferential	Point	380.7	Structural	0	5-7	1	0	0	1	Crack Circumferential	Yor vas Tokas I vas 44 - 023 34 - 13 - 023 34 -
Crack Longitudinal	Point	382.3	Structural	0	6	2	0	0	1	Crack Longitudinal	
Crack Circumferential	Point	383.7	Structural	0	5-7	1	0	0	2	Crack Circumferential	Vortes Industrial 88.18/2023 5:80:37 PH 2037/3 F1
Crack Multiple	Point	385.5	Structural	0	5-6	3	0	0	2	Crack Multiple

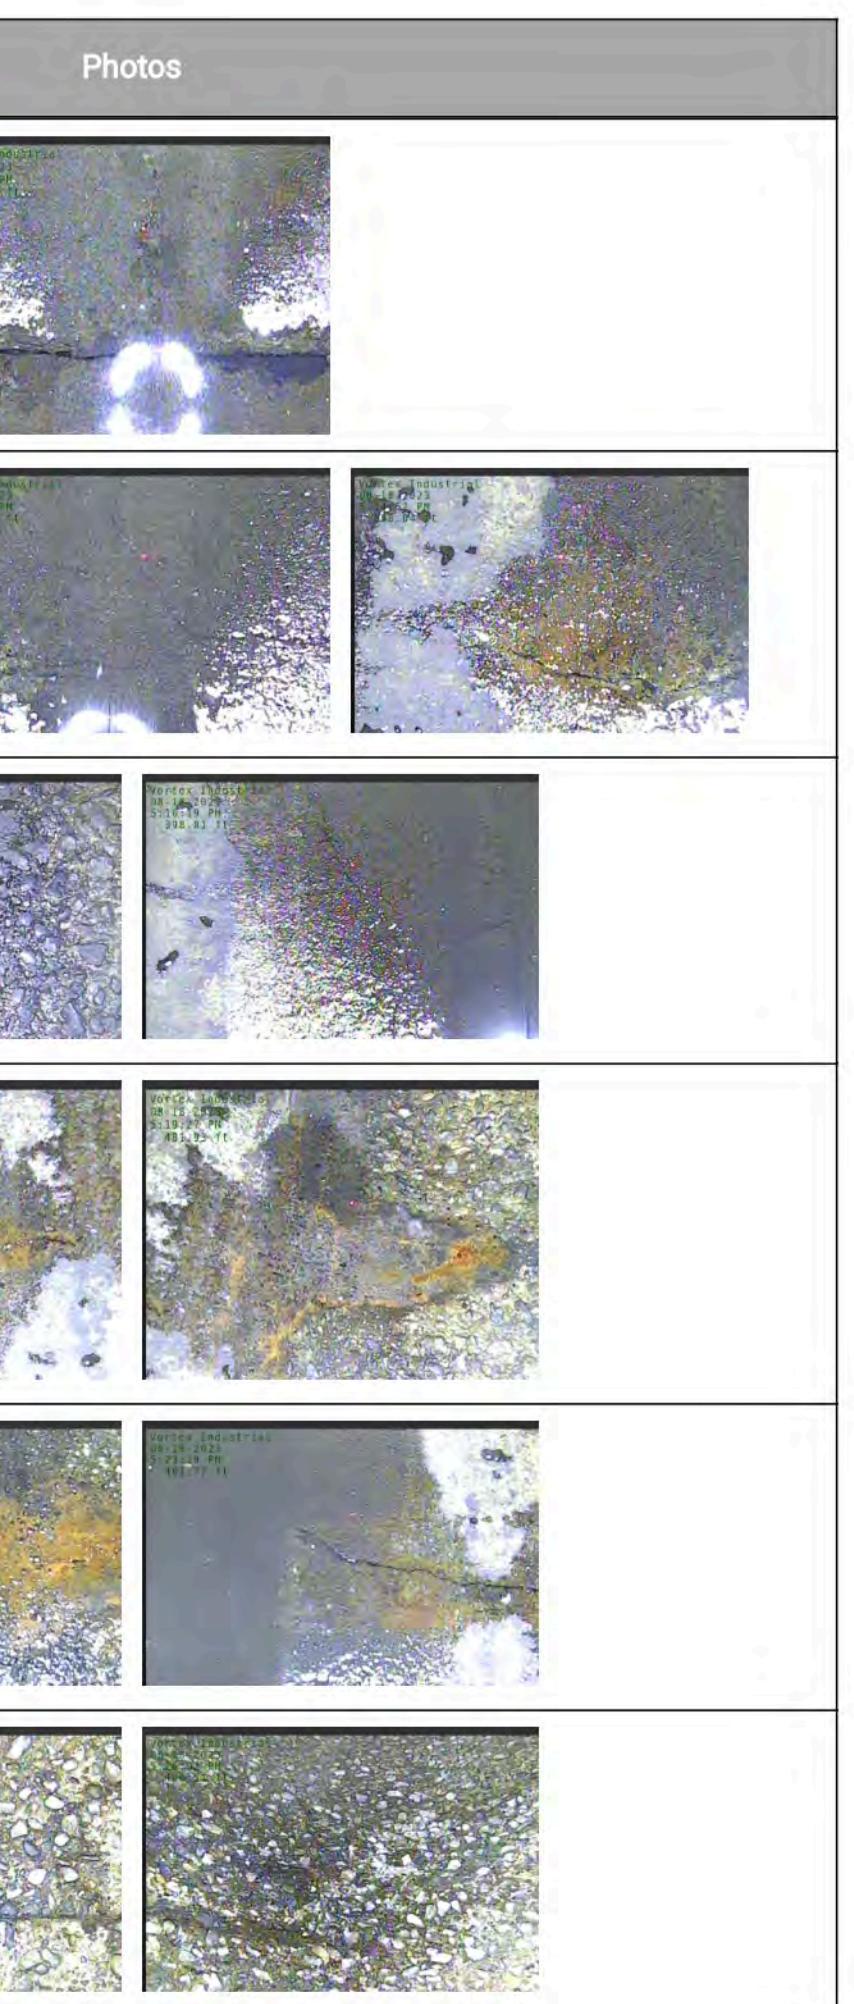
Description	Spatial Type	Distance (ft)	Туре	Percent	Clock	SR	O&M	С	PR	Remarks	
Crack Longitudinal	Point	394.5	Structural	0	6	2	0	0	1	Crack Longitudinal	Vor e and Bis 12 and Sis 12 and S
Crack Multiple	Point	398	Structural	0	5-7	3	0	0	2	Crack Multiple	
Crack Multiple	Point	398.8	Structural	0	4-6	3	0	0	1	Crack Multiple	Vortev Industrial
Crack Circumferential	Point	401.9	Structural	0	4-6	1	0	0	1	Crack Circumferential	70776 TORNATINA 10776 TORNATINA 107776 TORNATINA 107777 TORNATINA 1077777 TORNATINA 107777 TORNATINA 107777 TORNATINA 107777 TORNATINA 107777 TORNATINA 107777 TORNATINA 107777 TORNATINA 107777 TORNATINA 107777 TORNATINA 1077777 TORNATINA 107777 TORNATINA 1077777 TORNATINA 107777 TORNA
Crack Circumferential	Point	403.8	Structural	0	5-6	1	0	0	1	Crack Circumferential	Worren Industria 17.1520 Min Andrea 18.171 Fill 18.171 Fill 19.171
Crack Longitudinal	Point	406.5	Structural	0	2	2	0	0	1	Crack Longitudinal	Verwein, modern († 18) 9. Bestellen 2013 – 11 2013 – 11
