2024 ANNUAL PROGRESS REPORT SWMU-1 OILY WATER SEWER

HF SINCLAIR PUGET SOUND REFINING LLC

March 2025

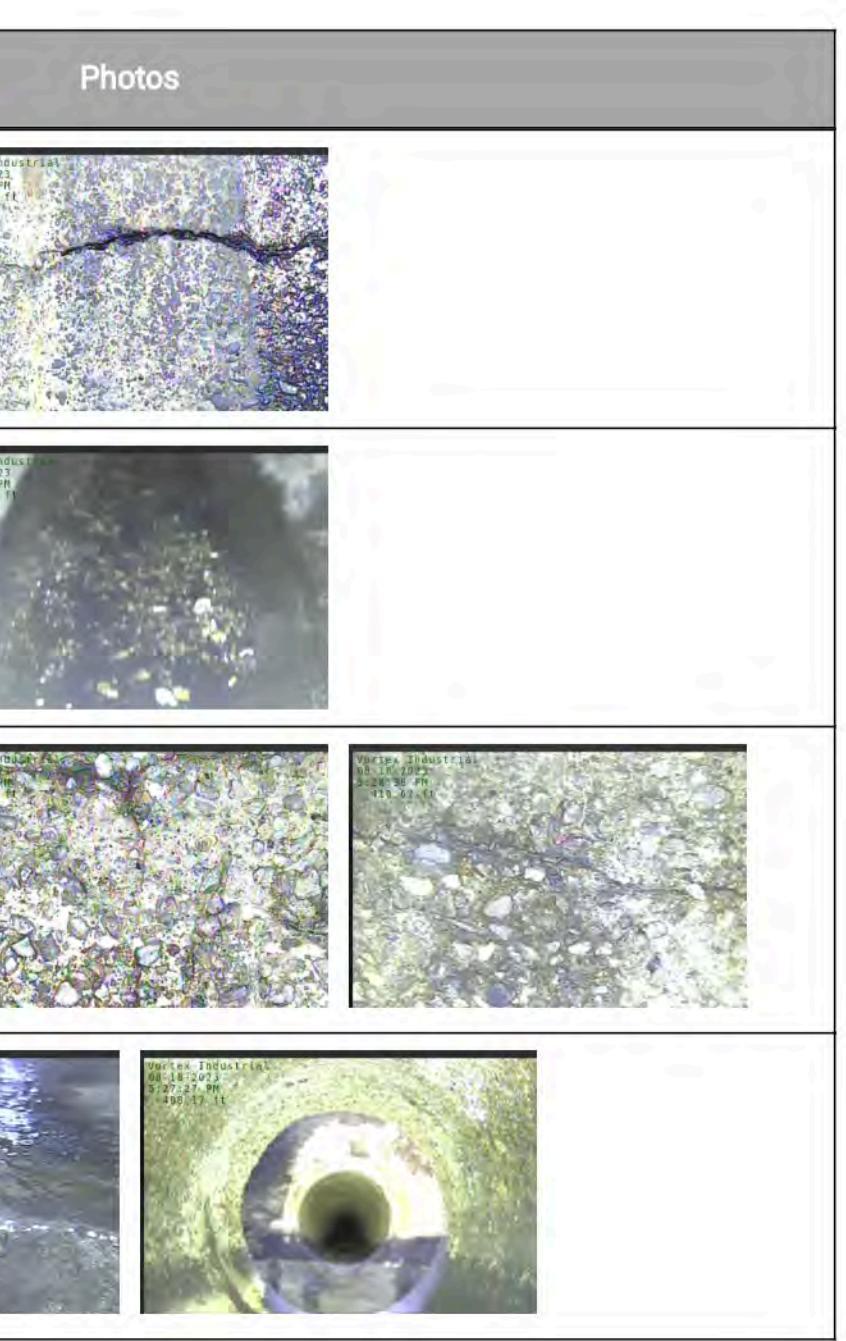
Description	Spatial Type	Distance (ft)	Туре	Percent	Clock	SR	0&M	С	PR	Remarks	
Crack Circumferential	Point	406.5	Structural	0	6-7	1	0	0	2	Crack Circumferential	
Deposits Settled Gravel	Point	407	O&M	10	6	0	2	0	0	Deposits Settled Gravel	Vortex 1 98 - 18 - 26 53 - 26 - 56 - 386 - 51
Crack Multiple	Point	410.6	Structural	0	10-2	3	0	0	1	Crack Multiple	
Manhole	Point	412	Constructional	0		0	0	0	0	D-4.1	Durites Tuzastrast 115 - 2023 1-20-322 Pri - 422 10 11

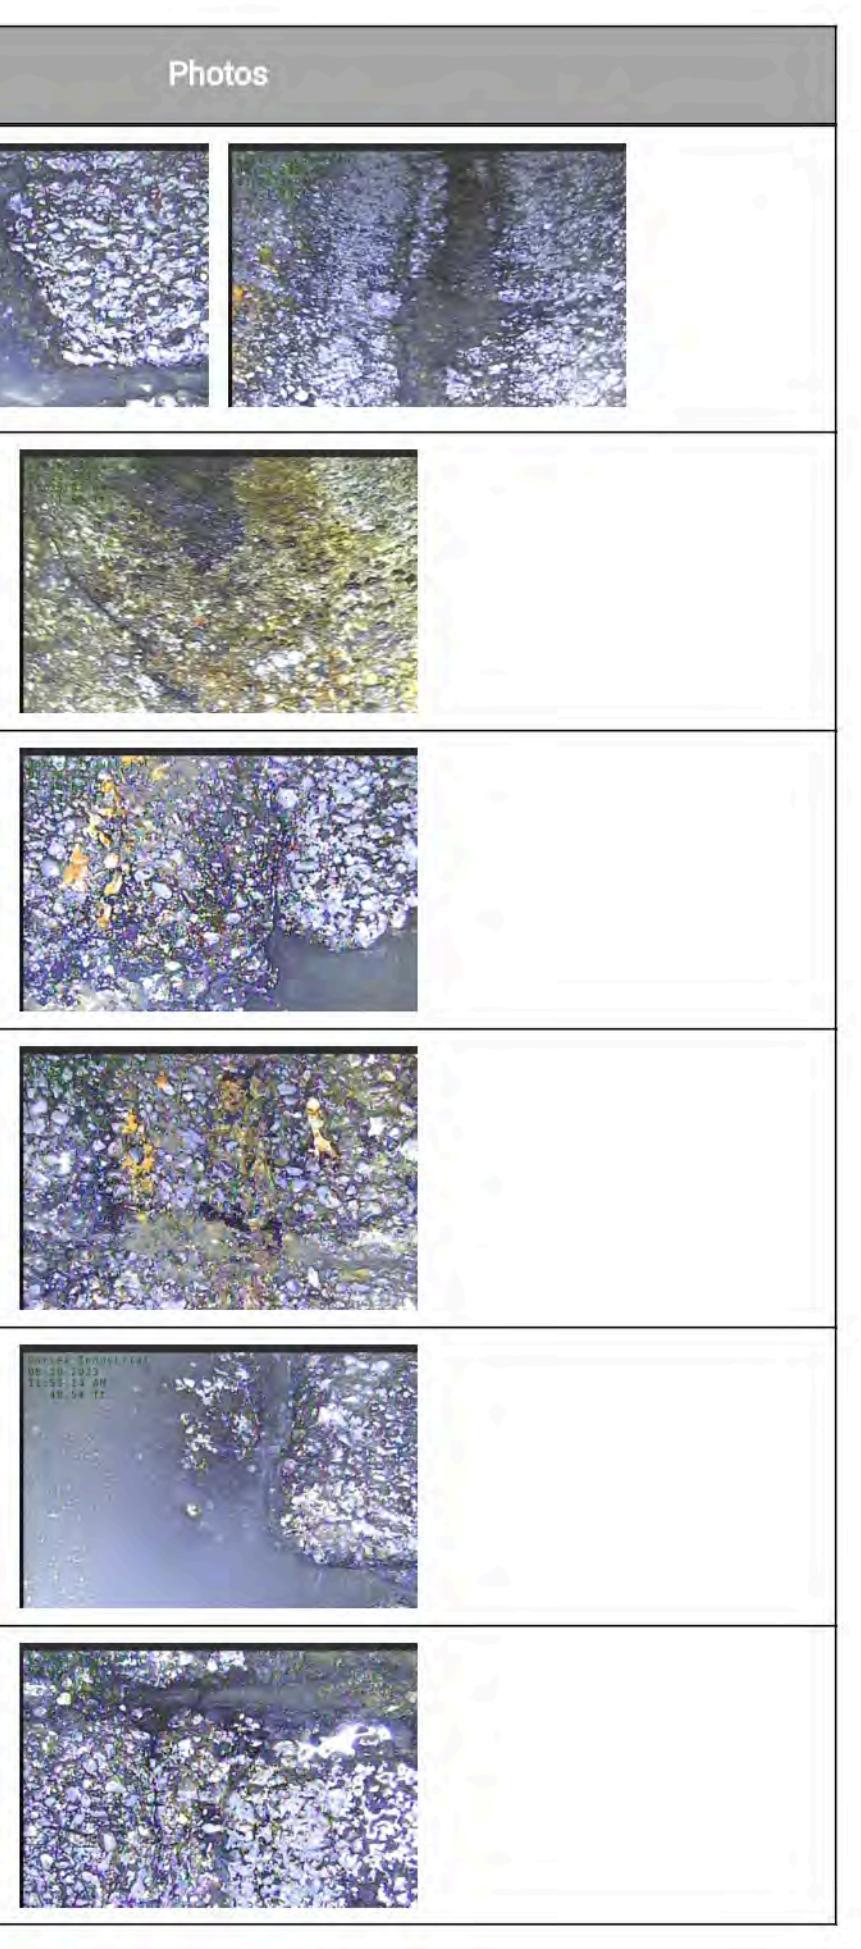
Description	Spatial Type	Distance (ft)	Туре	Percent	Clock	SR	0&M	С	PR	Remarks	
Fracture Longitudinal	Point	11.9	Structural	0	6	3	0	0	2	Fracture Longitudinal	
Crack Spiral	Point	11.9	Structural	0	3-5	2	0	0	1	Crack Spiral	
Crack Longitudinal	Point	24.3	Structural	0	6	2	0	0	1	Crack Longitudinal	
Crack Longitudinal	Point	44.5	Structural	0	5	2	0	0	1	Crack Longitudinal	
Fracture Longitudinal	Point	48.5	Structural	0	6	3	0	0	2	Fracture Longitudinal	
Crack Longitudinal	Point	52.7	Structural	0	6	2	0	0	1	Crack Longitudinal

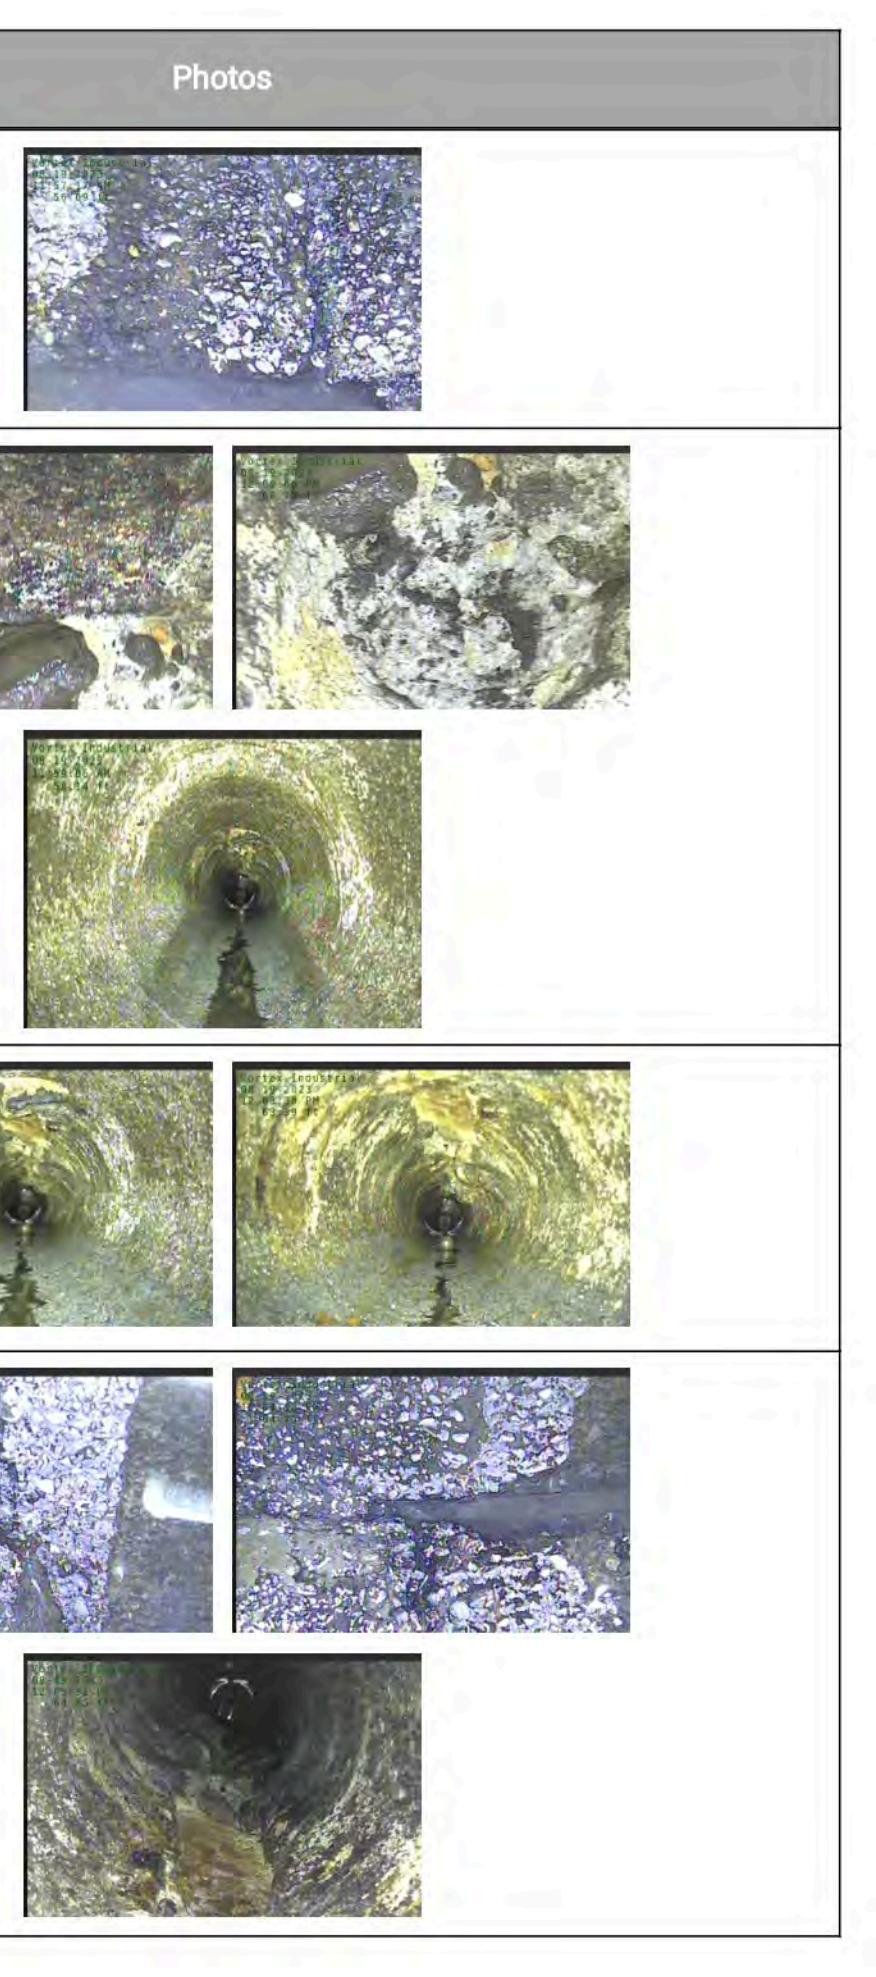
Description	Spatial Type	Distance (ft)	Туре	Percent	Clock	SR	0&M	с	PR	Remarks	
Crack Longitudinal	Point	56.7	Structural	0	6	2	0	0	2	Crack Longitudinal	
Point Repair Patch	Point	60.7	Structural	0	12	0	0	0	3	Point Repair Patch	
Point Repair Patch Defective	Continuous	64 - 73.4	Structural	10	12-1	4	0	0	3	Point Repair Patch Defective	
Crack Longitudinal	Point	64.9	Structural	0	6	2	0	0	2	Crack Longitudinal

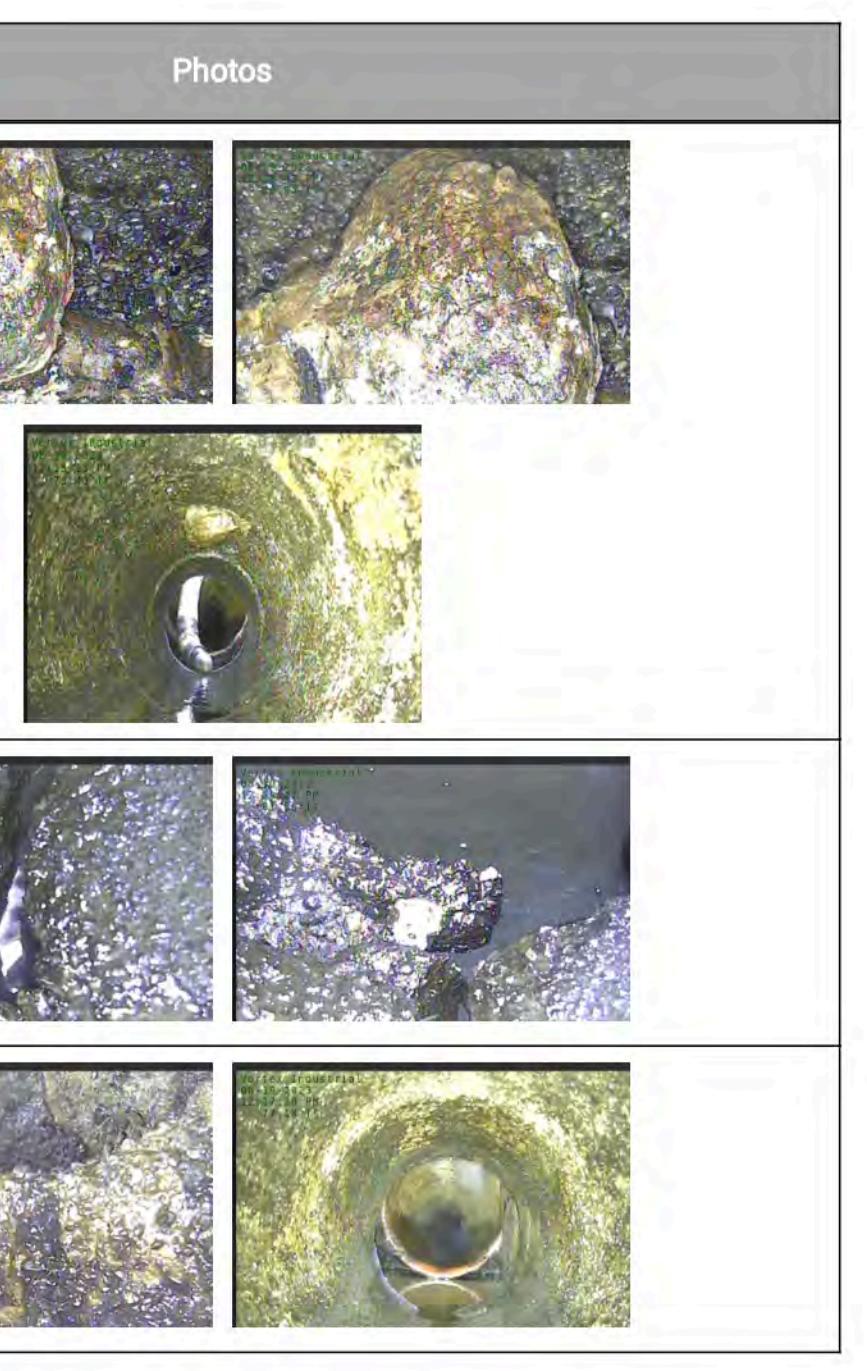
Description	Spatial Type	Distance (ft)	Туре	Percent	Clock	SR	0&M	С	PR	Remarks	
Deposits Attached Encrustation	Point	76.9	O&M	10	12-1	0	2	0	0	Deposits Attached Encrustation	
Fracture Longitudinal	Point	81.2	Structural	0	6	3	0	0	3	Fracture Longitudinal	
Manhole	Point	82.3	Constructional	0		0	0	0	0	D-19	Yorisk Industriat

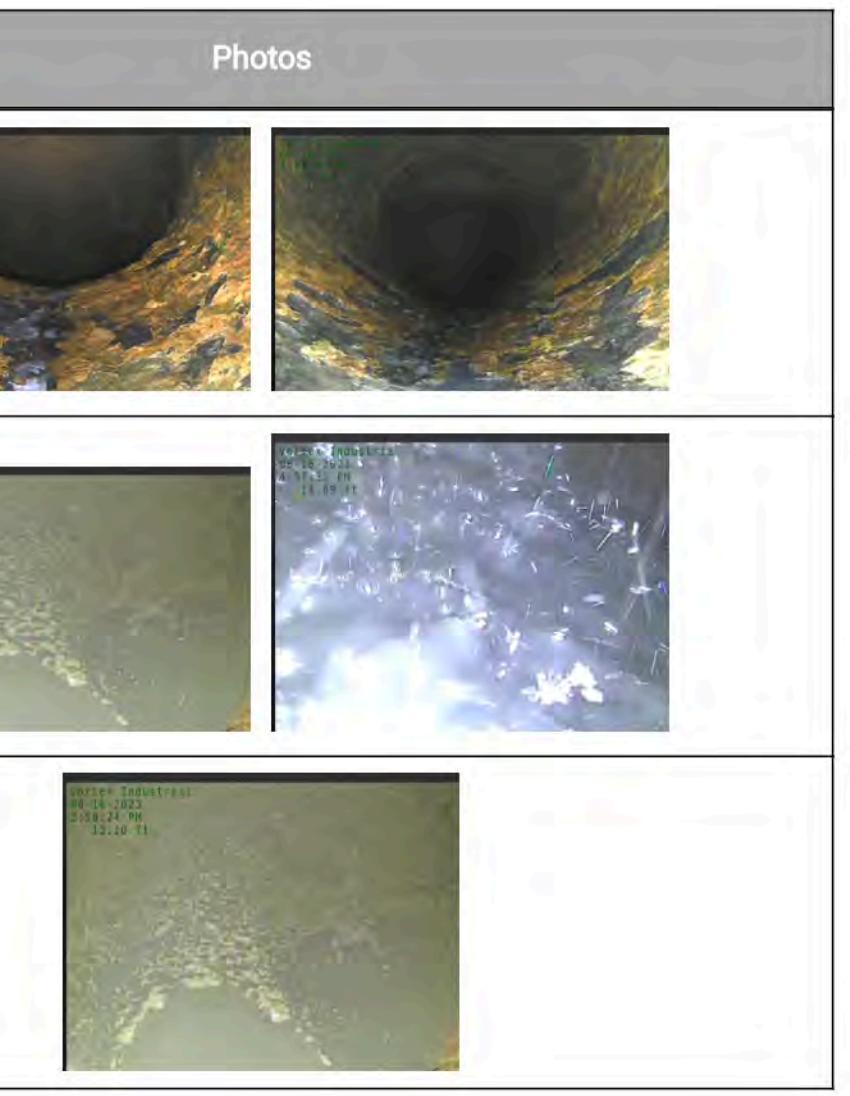
Description	Spatial Type	Distance (ft)	Туре	Percent	Clock	SR	O&M	С	PR	Remarks	
Line Down	Point	5.7	Constructional	100		0	4	4	0	Line Down	
Miscellaneous Survey Abandoned	Point	14.9	Miscellaneous	0		0	0	0	0	Impassable High Water Level	The second secon
Miscellaneous Water Level	Point	14.9	Miscellaneous	100		0	0	0	0	Miscellaneous Water Level

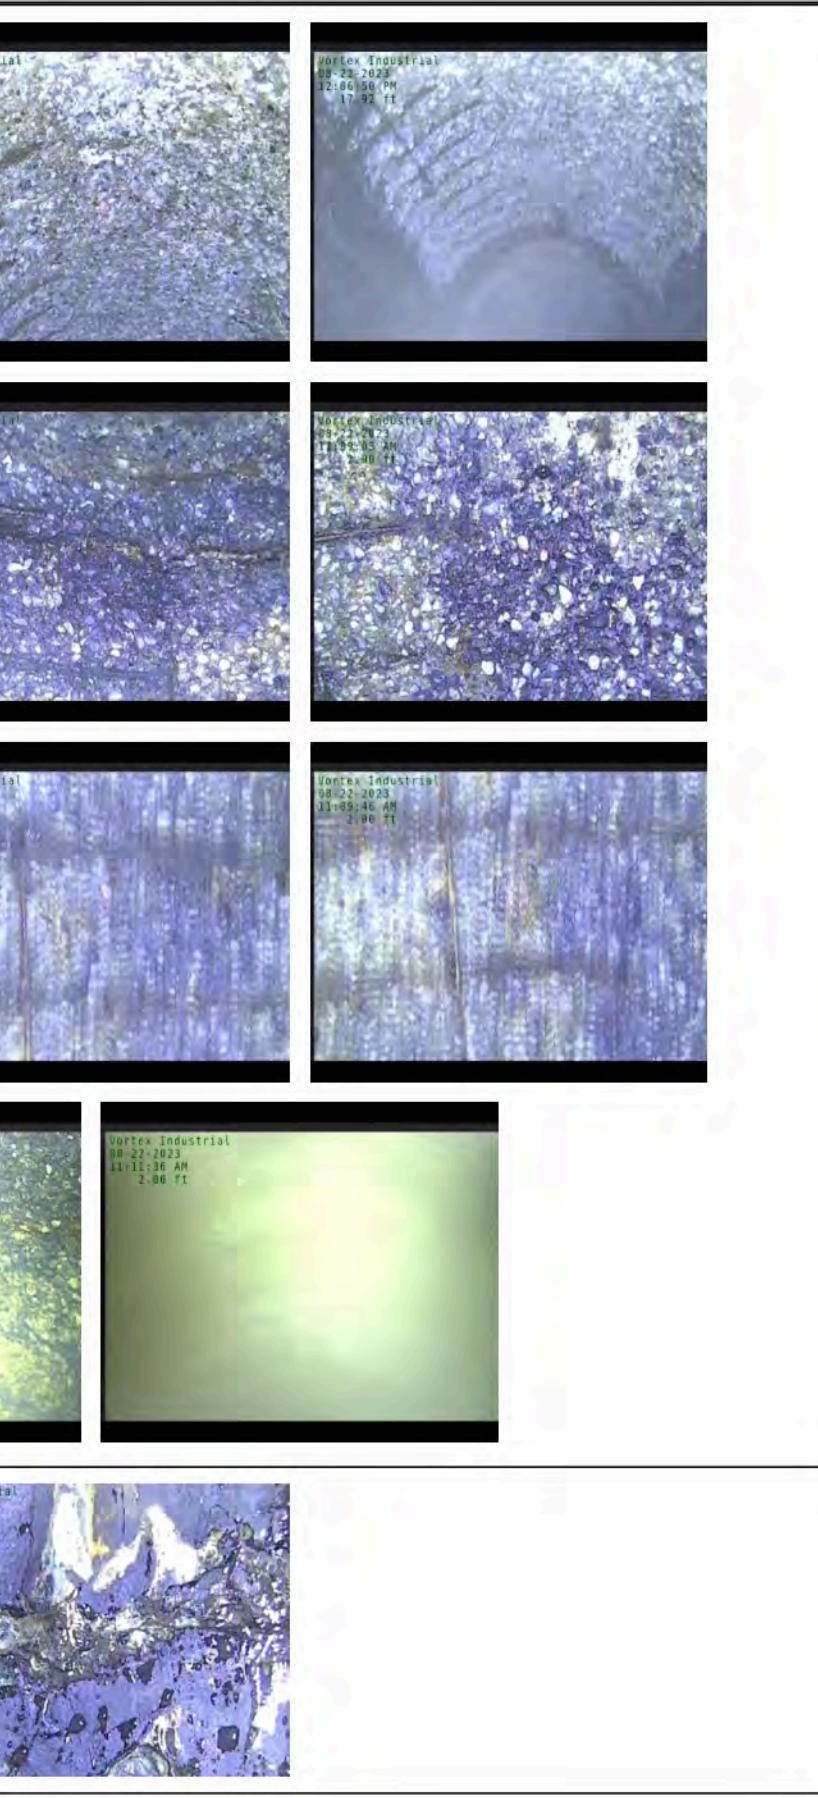
Description	Spatial Type	Distance (ft)	Туре	Percent	Clock	SR	O&M	С	PR	Remarks	
Surface Damage Reinforcement Visible	Continuous	2-61.3	Structural	0	10-2	4	0	0	3	Surface Damage Reinforcement Visible	
Crack Multiple	Point	5.9	Structural	0	6-7	0	0	0	2	Crack Multiple	Portie Industrial 12.22 July av 12.3 98 VO 2.3 2.3 2.3 2.3 2.3 2.3 2.3 2.3

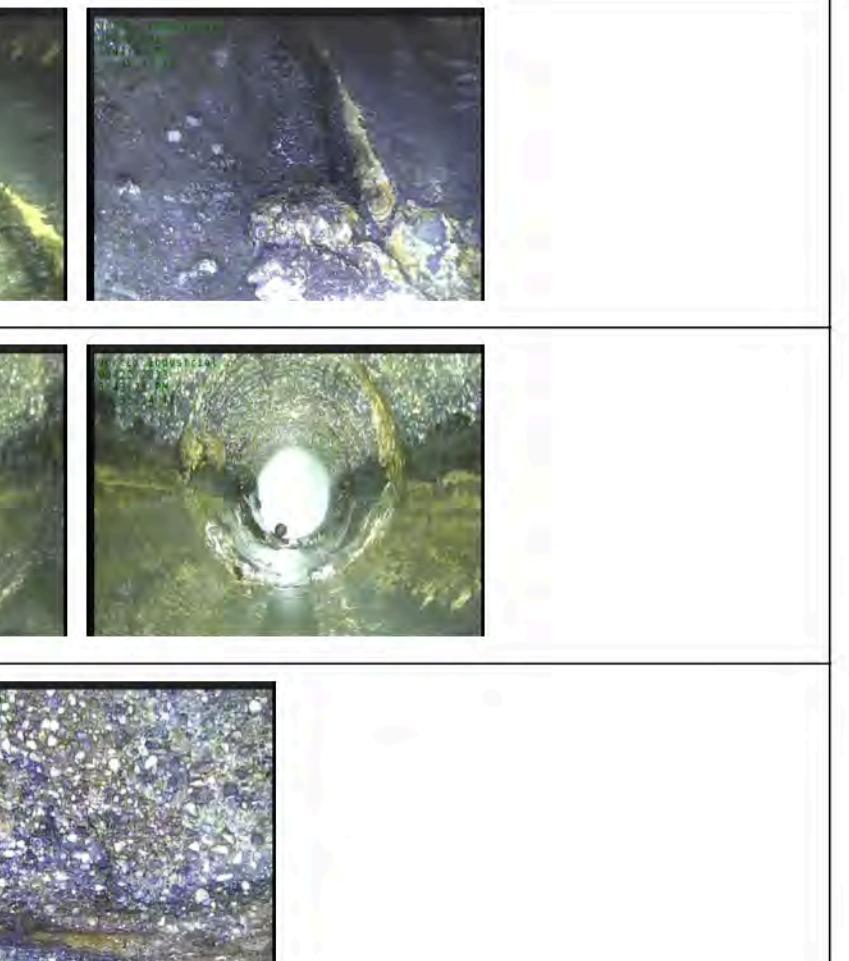
Description	Spatial Type	Distance (ft)	Туре	Percent	Clock	SR	0&M	С	PR	Remarks	
Deposits Attached Encrustation	Point	34.4	O&M	10	7	0	2	0	0	Deposits Attached Encrustation	
Crack Longitudinal	Point	35.5	Structural	0	8	2	0	0	2	Crack Longitudinal	
Crack Longitudinal	Point	38.3	Structural	0	5	2	0	0	2	Crack Longitudinal	
Crack Longitudinal Hinge, 2	Point	38.3	Structural	0	9-3	2	0	0	2	Crack Longitudinal Hinge, 2	
Crack Longitudinal	Point	42.5	Structural	0	11	2	0	0	1	Crack Longitudinal

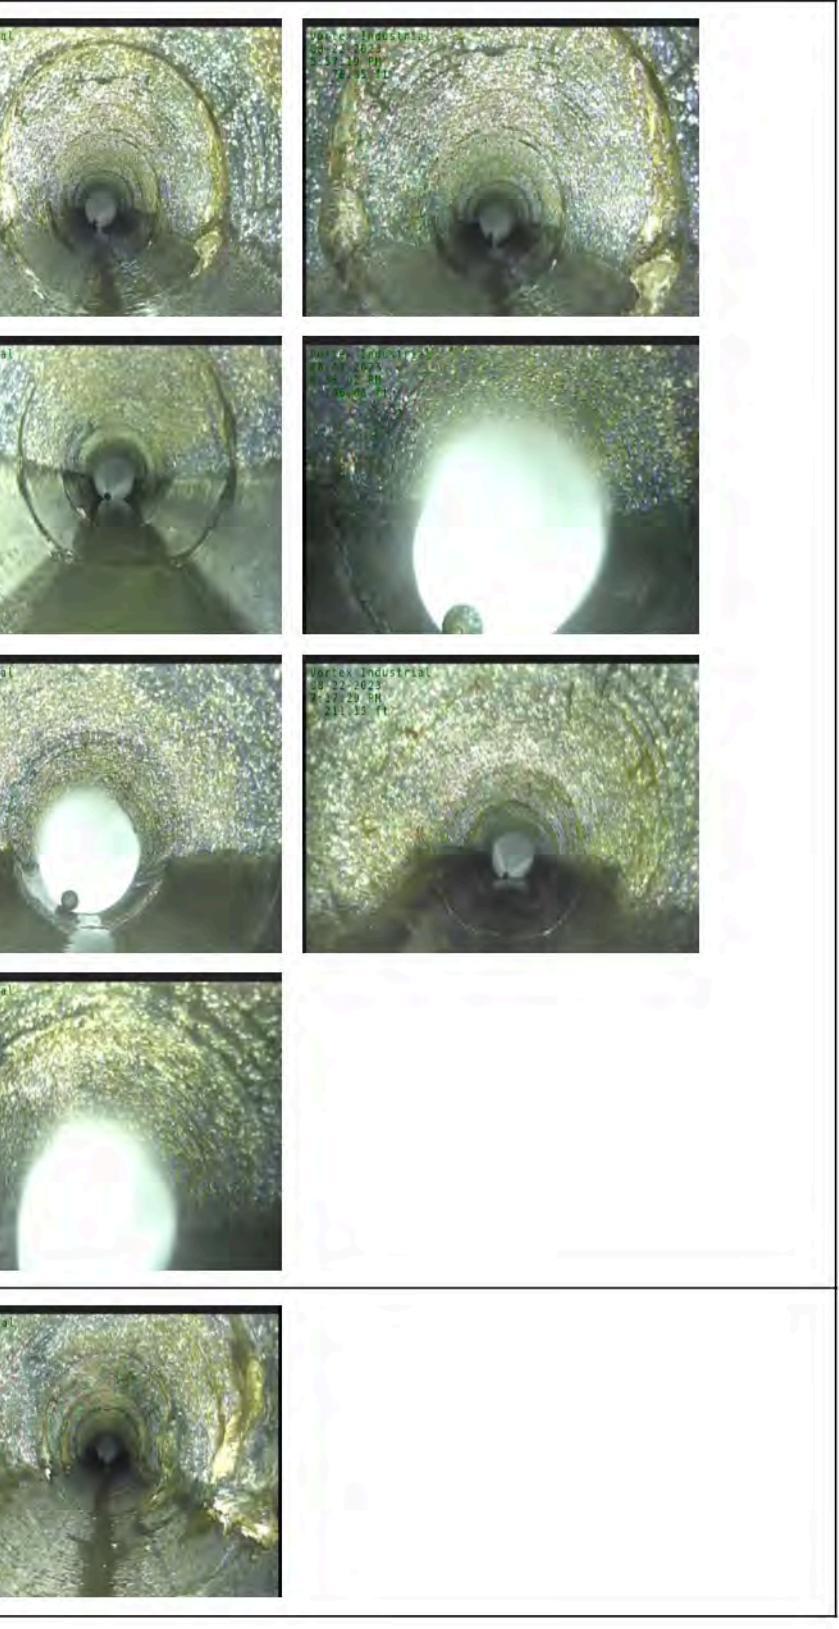
Description	Spatial Type	Distance (ft)	Туре	Percent	Clock	SR	O&M	С	PR	Remarks	
Surface Damage Reinforcement Visible	Continuous	61.4 - 234	Structural	0	8-4	4	0	0	3	Surface Damage Reinforcement Visible	
Deposits Attached Encrustation	Point	67.3	O&M	10	2-4	0	2	0	0	Deposits Attached Encrustation	Motter Longa (r) Bodriss (r) B

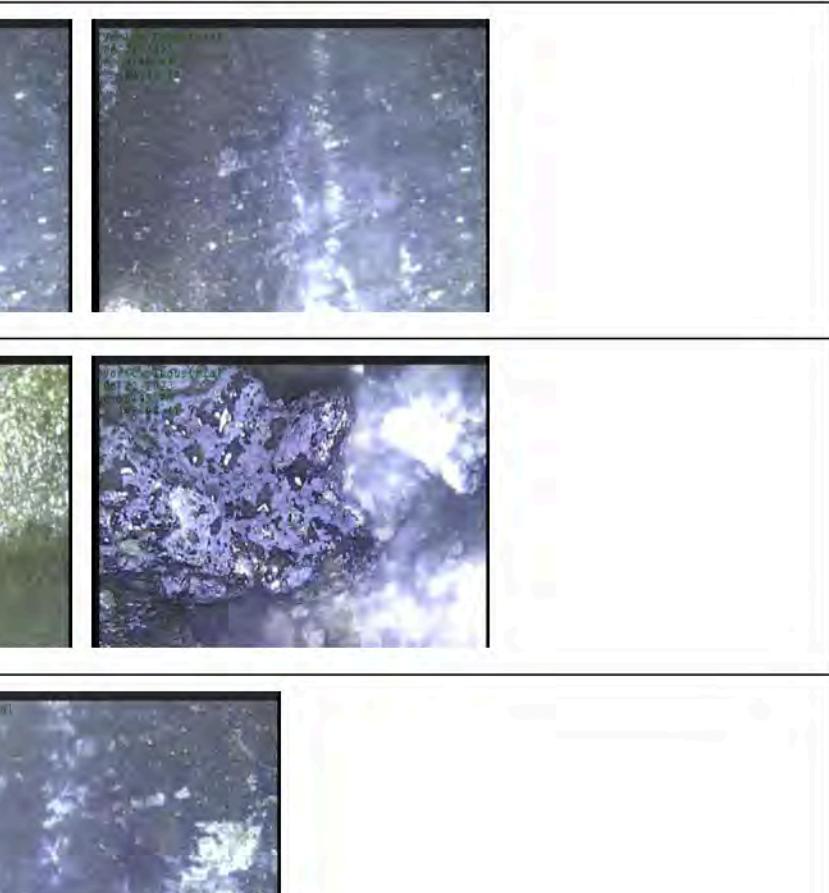
Description	Spatial Type	Distance (ft)	Туре	Percent	Clock	SR	0&M	С	PR	Remarks	
Crack Longitudinal	Point	132.5	Structural	0	1	2	0	0	1	Crack Longitudinal	Unite - Lindu cut 1 19 2 2 0/2 19 3 3 5 (P) 2 2 2 1 4 (t)
Crack Longitudinal	Point	139.5	Structural	0	6	2	0	0	1	Crack Longitudinal	
Crack Longitudinal	Point	144.7	Structural	0	6	2	0	0	1	Crack Longitudinal	
Deposits Attached Encrustation	Point	148.9	O&M	10	7-8	0	2	0	0	Deposits Attached Encrustation	North Carl 200 Best 1/301 Second Second Sec
Crack Longitudinal	Point	157.1	Structural	0	6	2	0	0	1	Crack Longitudinal	A COLUMN 111 35 D 2 PT 352 10 TA

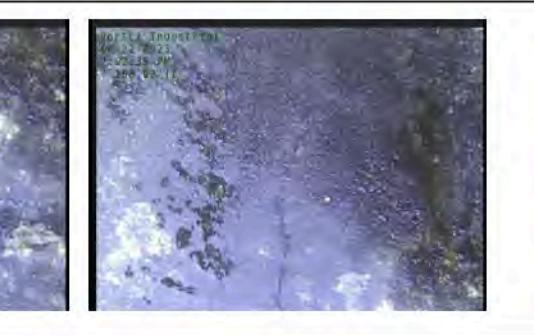
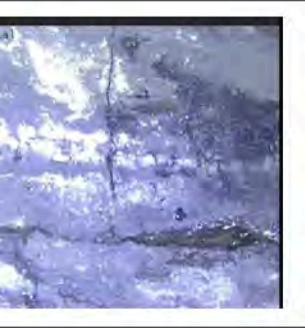
Description	Spatial Type	Distance (ft)	Туре	Percent	Clock	SR	O&M	С	PR	Remarks	
Crack Longitudinal	Point	177.1	Structural	0	12	2	0	0	1	Crack Longitudinal	
Crack Longitudinal	Point	184.7	Structural	0	6	2	0	0	1	Crack Longitudinal	
Crack Circumferential	Point	195.5	Structural	0	3-9	1	0	0	1	Crack Circumferential	Verife Indestrial UB 22:2953 7 klour Hr 204/2* T
Crack Longitudinal	Point	213.6	Structural	0	2	2	0	0	1	Crack Longitudinal	
Crack Longitudinal	Point	213.6	Structural	0	6	2	0	0	1	Crack Longitudinal

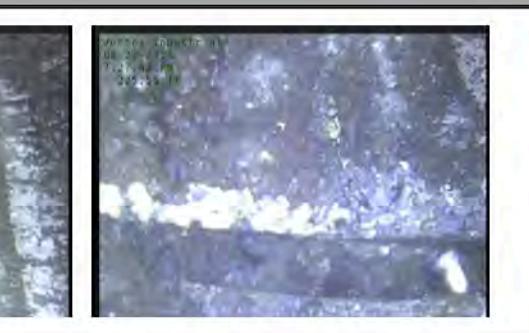
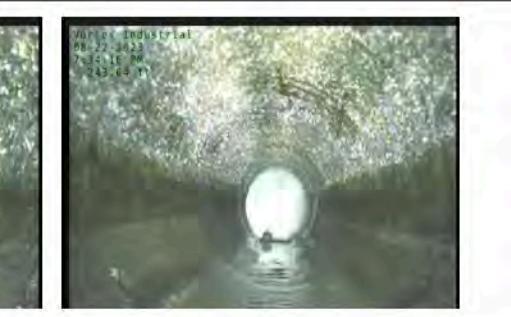
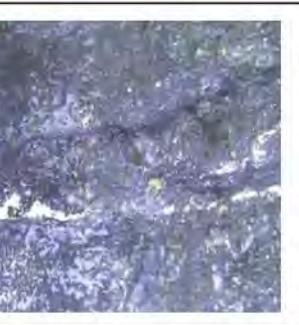
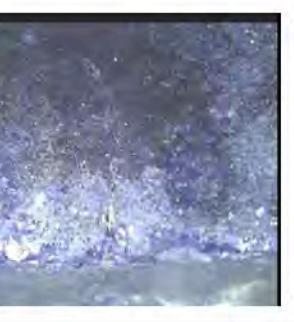
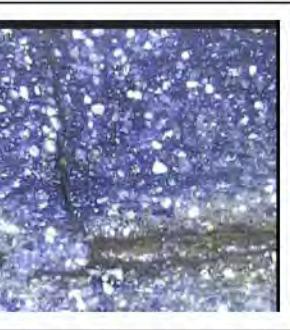
Description	Spatial Type	Distance (ft)	Туре	Percent	Clock	SR	O&M	С	PR	Remarks	
Crack Longitudinal	Point	257.5	Structural	0	9	2	0	0	1	Crack Longitudinal	
Crack Longitudinal	Point	263.7	Structural	0	4	2	0	0	1	Crack Longitudinal	
Manhole	Point	268	Constructional	0		0	0	0	0	5-F	North & Andrea Marsail Andrea

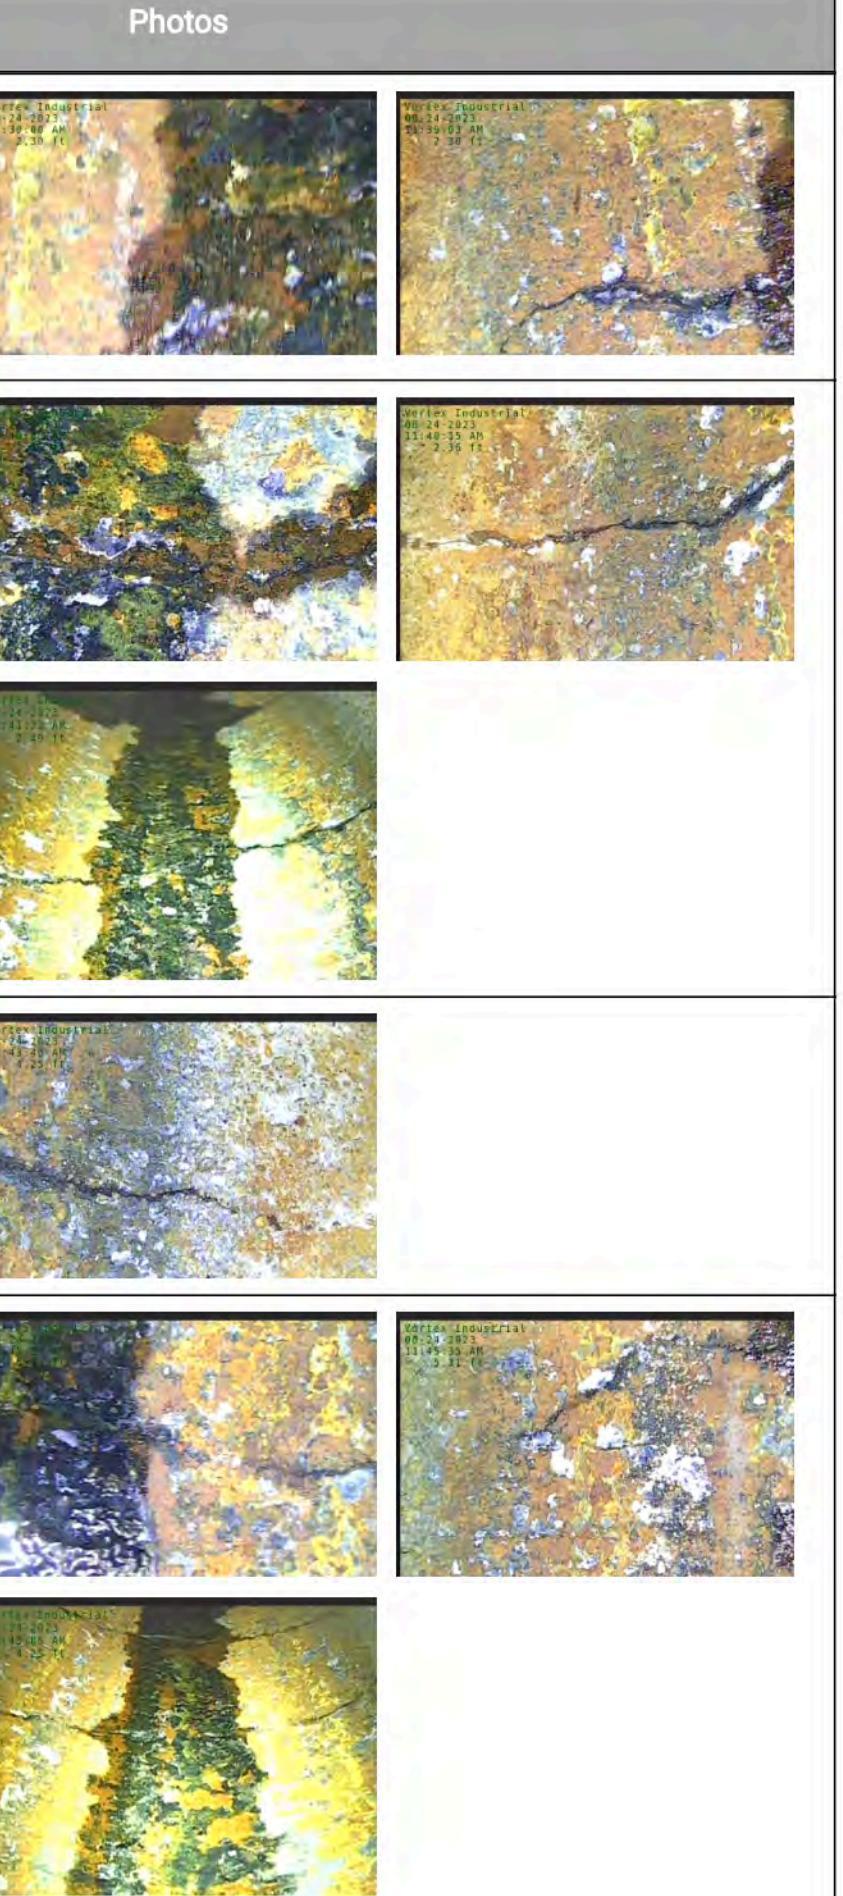
Description	Spatial Type	Distance (ft)	Туре	Percent	Clock	SR	O&M	С	PR	Remarks	
Crack Circumferential	Point	6	Structural	0	4-8	1	0	0	1	Crack Circumferential	
Crack Circumferential	Point	6.9	Structural	0	5-7	1	0	0	1	Crack Circumferential	
Crack Circumferential	Point	7.5	Structural	0	5-8	1	0	0	1	Crack Circumferential	Image: Sector

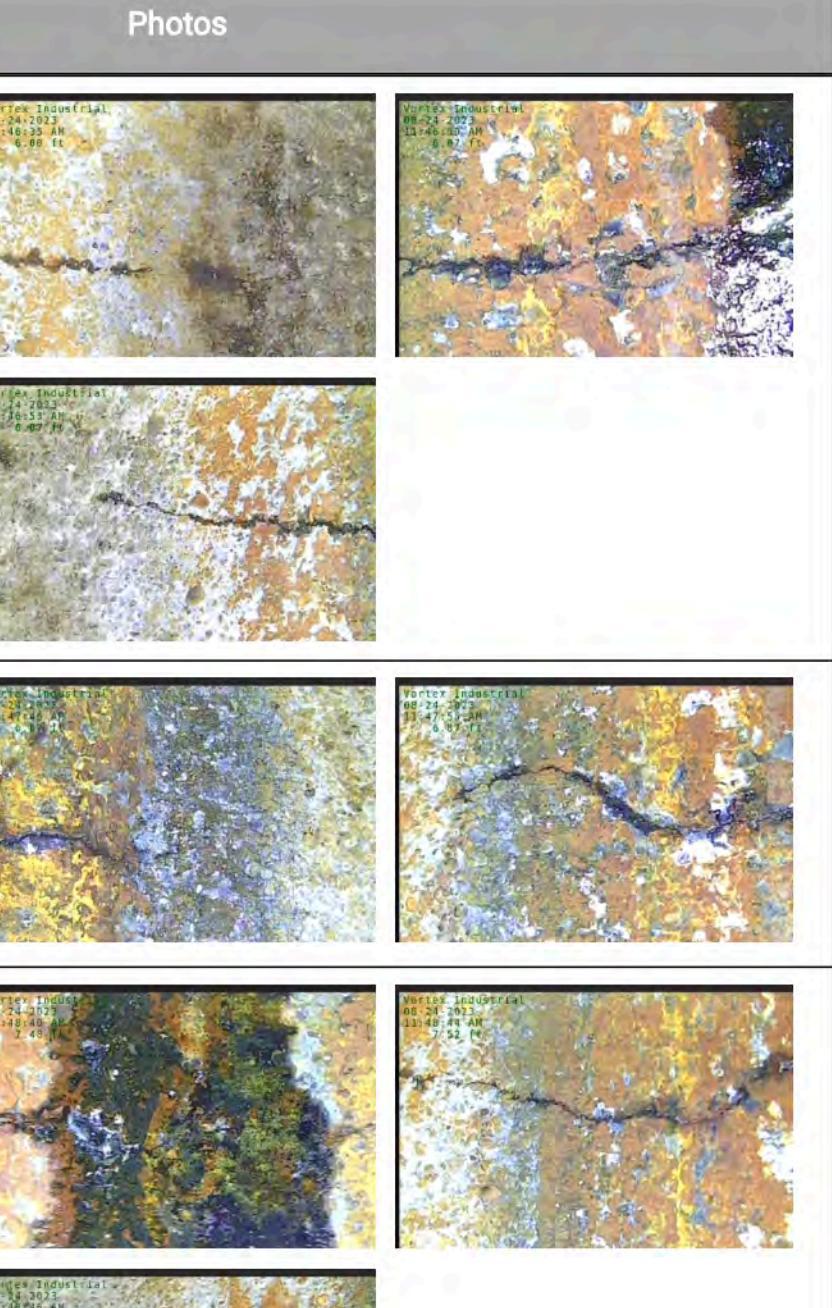
Description	Spatial Type	Distance (ft)	Туре	Percent	Clock	SR	0&M	С	PR	Remarks	
Crack Circumferential	Point	9.1	Structural	0	3-8	1	0	0	1	Crack Circumferential	Vorrey Industrial US-24-223 II-31-09-24 US-27-10
Crack Circumferential	Point	11.3	Structural	0	5-8	1	0	0	1	Crack Circumferential	ror cor Lingustradi. Bisz zwoda Tradi, art tu vit international and the second se
Crack Circumferential	Point	12.8	Structural	0	4-7	1	0	0	1	Crack Circumferential	VICE 64 Podest, 10 WILL SA ARE VICE 94 ARE VICE 95 ARE
Crack Circumferential	Point	17.6	Structural	0	4-8	1	0	0	2	Crack Circumferential	Worker Theorem Hand

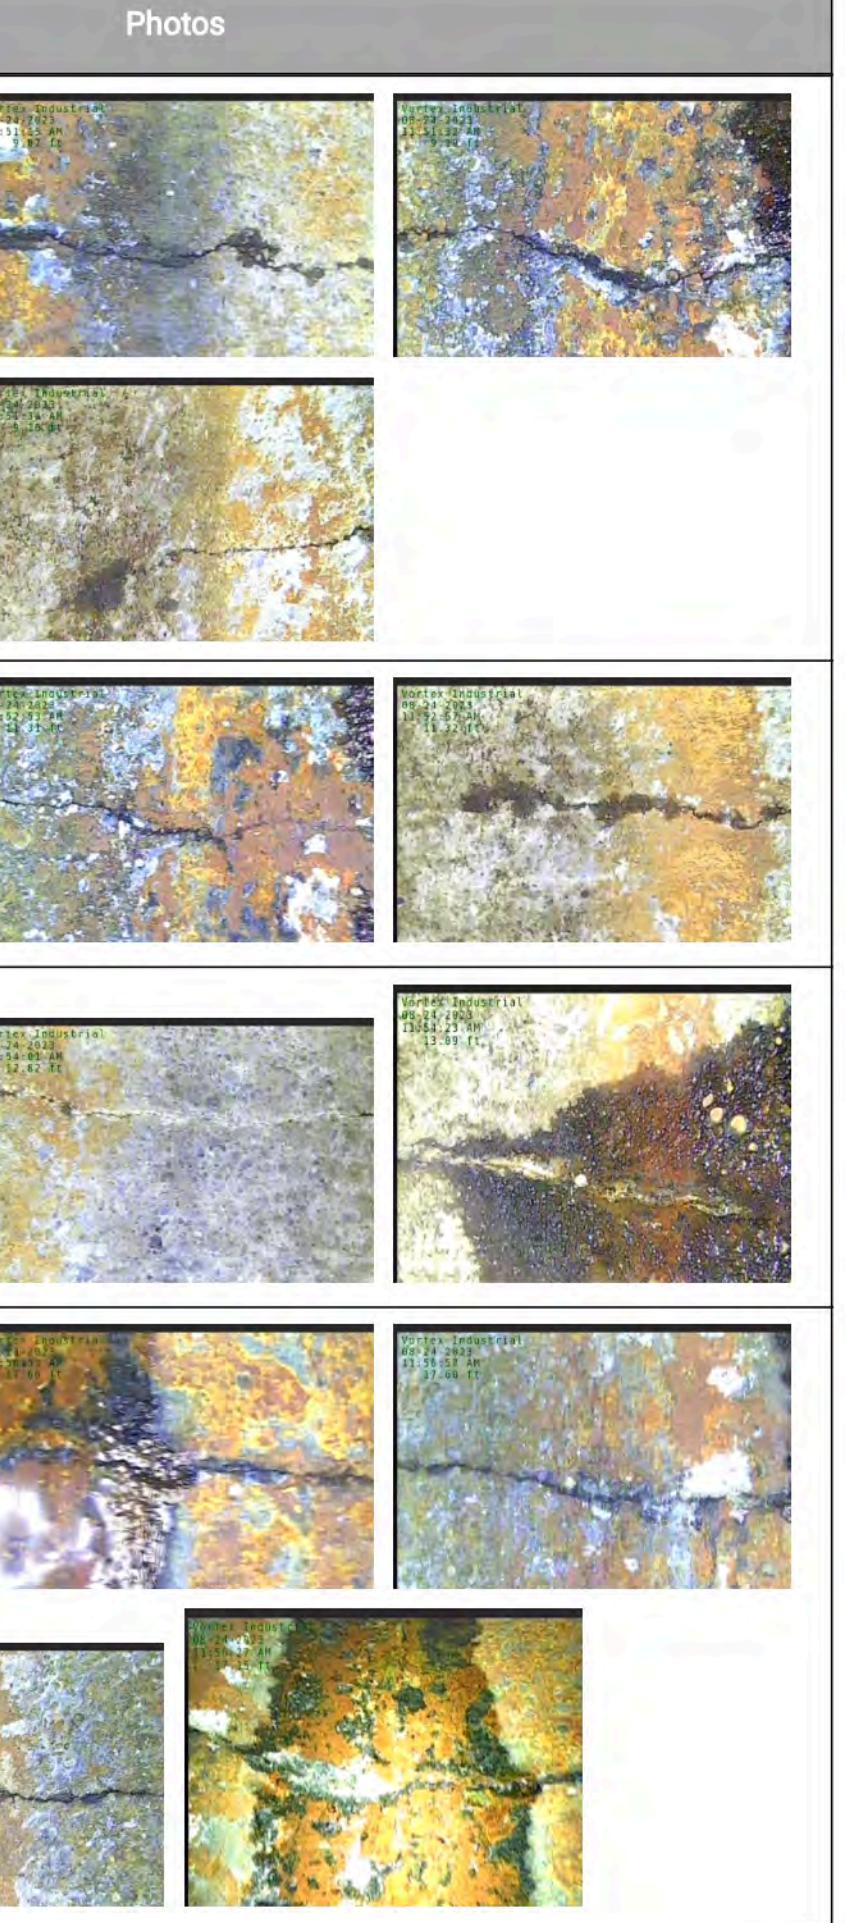
Description	Spatial Type	Distance (ft)	Туре	Percent	Clock	SR	0&M	С	PR	Remarks	
Crack Circumferential	Point	20.2	Structural	0	4-7	1	0	0	1	Crack Circumferential	
Crack Circumferential	Point	24.2	Structural	0	5-7	1	0	0	2	Crack Circumferential	
Crack Circumferential	Point	27.5	Structural	0	5-7	1	0	0	1	Crack Circumferential	Veren industeant B8 24 2003 12 401 TP Pr 27,52, TT TP TT TP TT TP TT TP TT TP TT TP TT
Crack Longitudinal	Point	30.6	Structural	0	6	2	0	0	1	Crack Longitudinal	Abr of andorst fail Abr of an another an

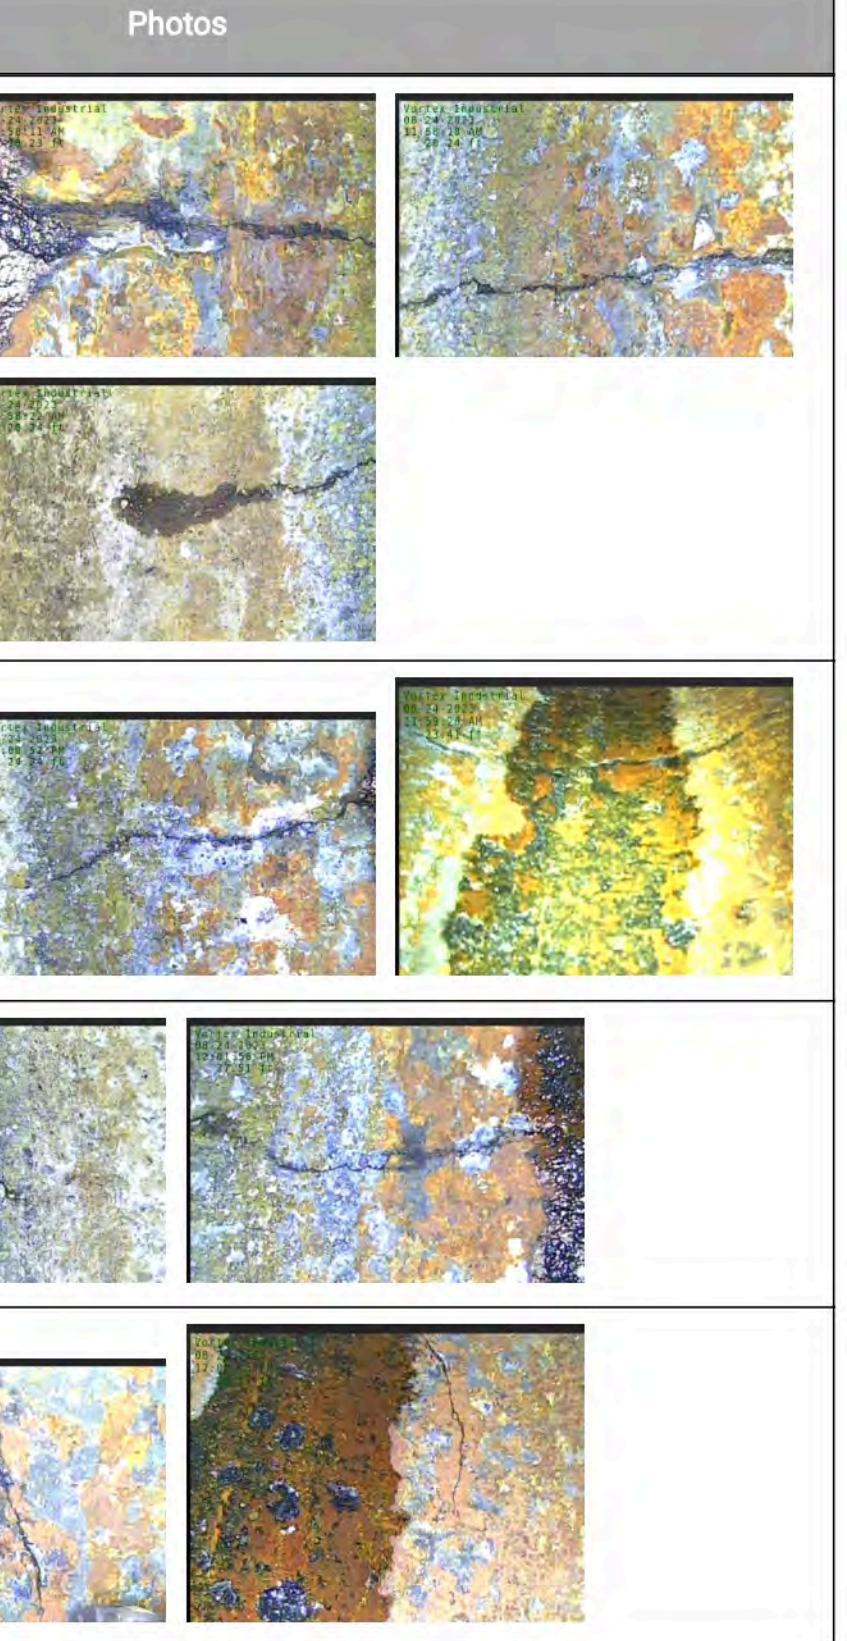
Description	Spatial Type	Distance (ft)	Туре	Percent	Clock	SR	0&M	С	PR	Remarks	
Crack Multiple	Point	31.1	Structural	0	5-7	3	0	0	-	Crack Multiple	
Crack Circumferential	Point	34.9	Structural	0	4-8	1	0	0	1	Crack Circumferential	
Crack Multiple	Point	36.1	Structural	0	5-8	3	0	0	1	Crack Multiple	Verter Industrial 88-33-2023 12:07:25 PH 89-95 10:07:05 PH 80-95 10:07:05 PH 10:07:05 PH 10:07:
Crack Multiple	Point	38.5	Structural	0	6-7	3	0	0	1	Crack Multiple

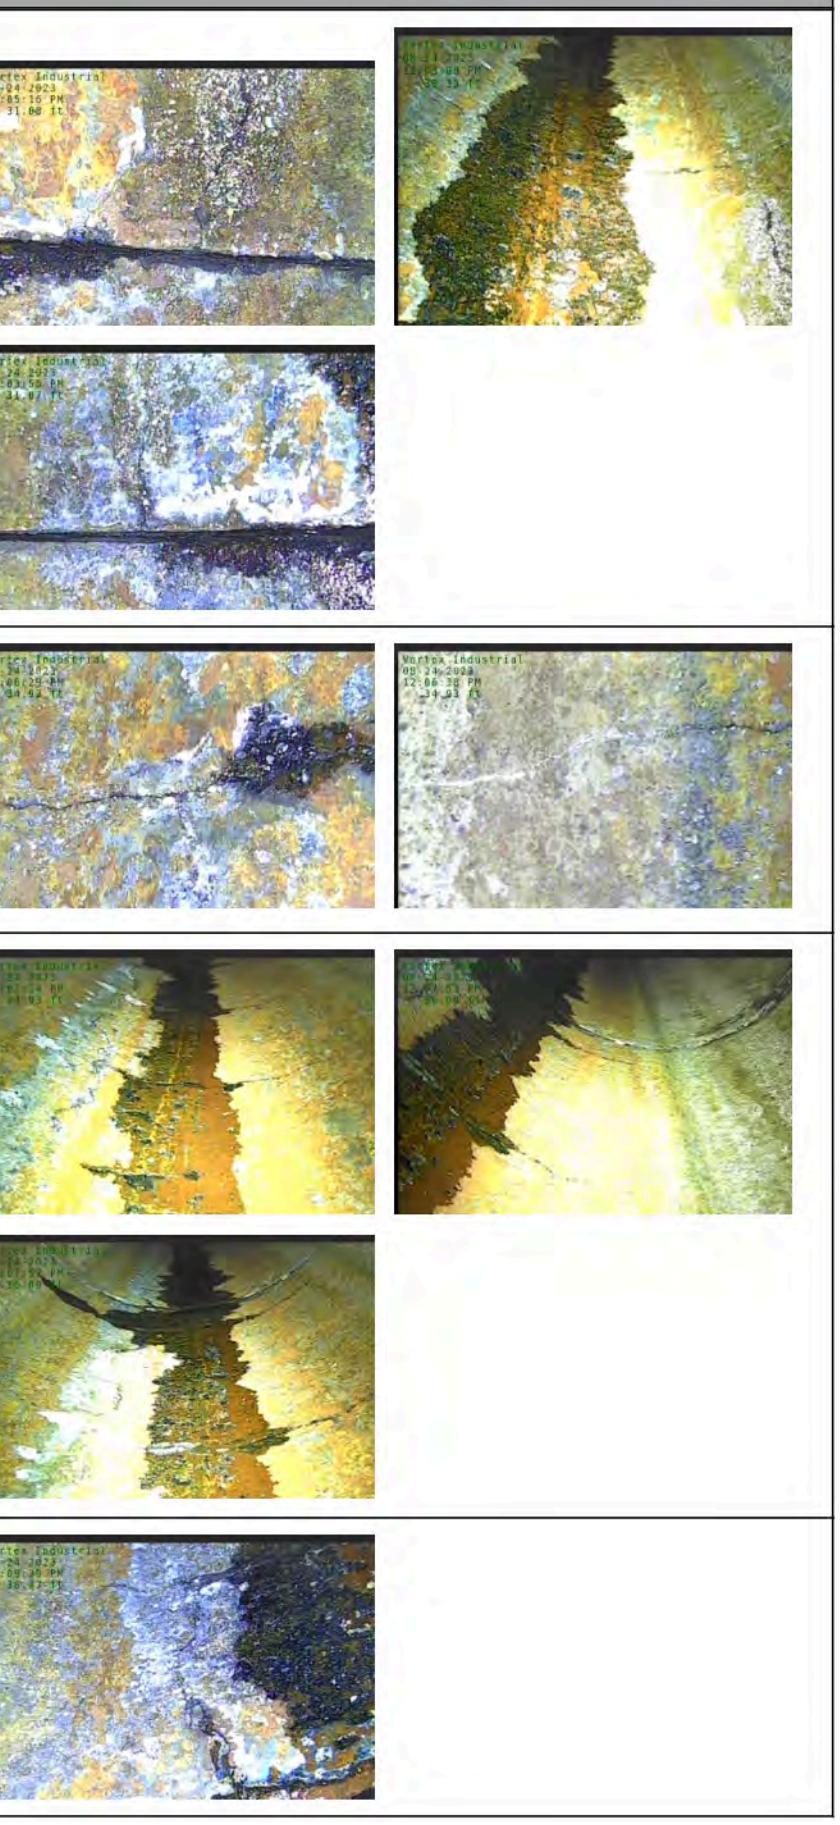
Description	Spatial Type	Distance (ft)	Туре	Percent	Clock	SR	0&M	С	PR	Remarks	
Crack Circumferential	Point	41.5	Structural	0	6-7	1	0	0	1	Crack Circumferential	rer i en ladita trial 55-24-7025 73 il 55 r/r - 41/35 r e
Crack Circumferential	Point	42.4	Structural	0	5-6	1	0	0	1	Crack Circumferential	11 10 4 10 4 10 10 10 10 10 10 10 10 10 10 10 10 10
Crack Circumferential	Point	43.9	Structural	0	6-8	1	0	0	2	Crack Circumferential	And an
Crack Circumferential	Point	45.1	Structural	0	5-7	1	0	0	1	Crack Circumferential	
Crack Circumferential	Point	47.1	Structural	0	6-7	1	0	0	1	Crack Circumferential	
Crack Circumferential	Point	49.6	Structural	0	5-7	1	0	0	1	Crack Circumferential

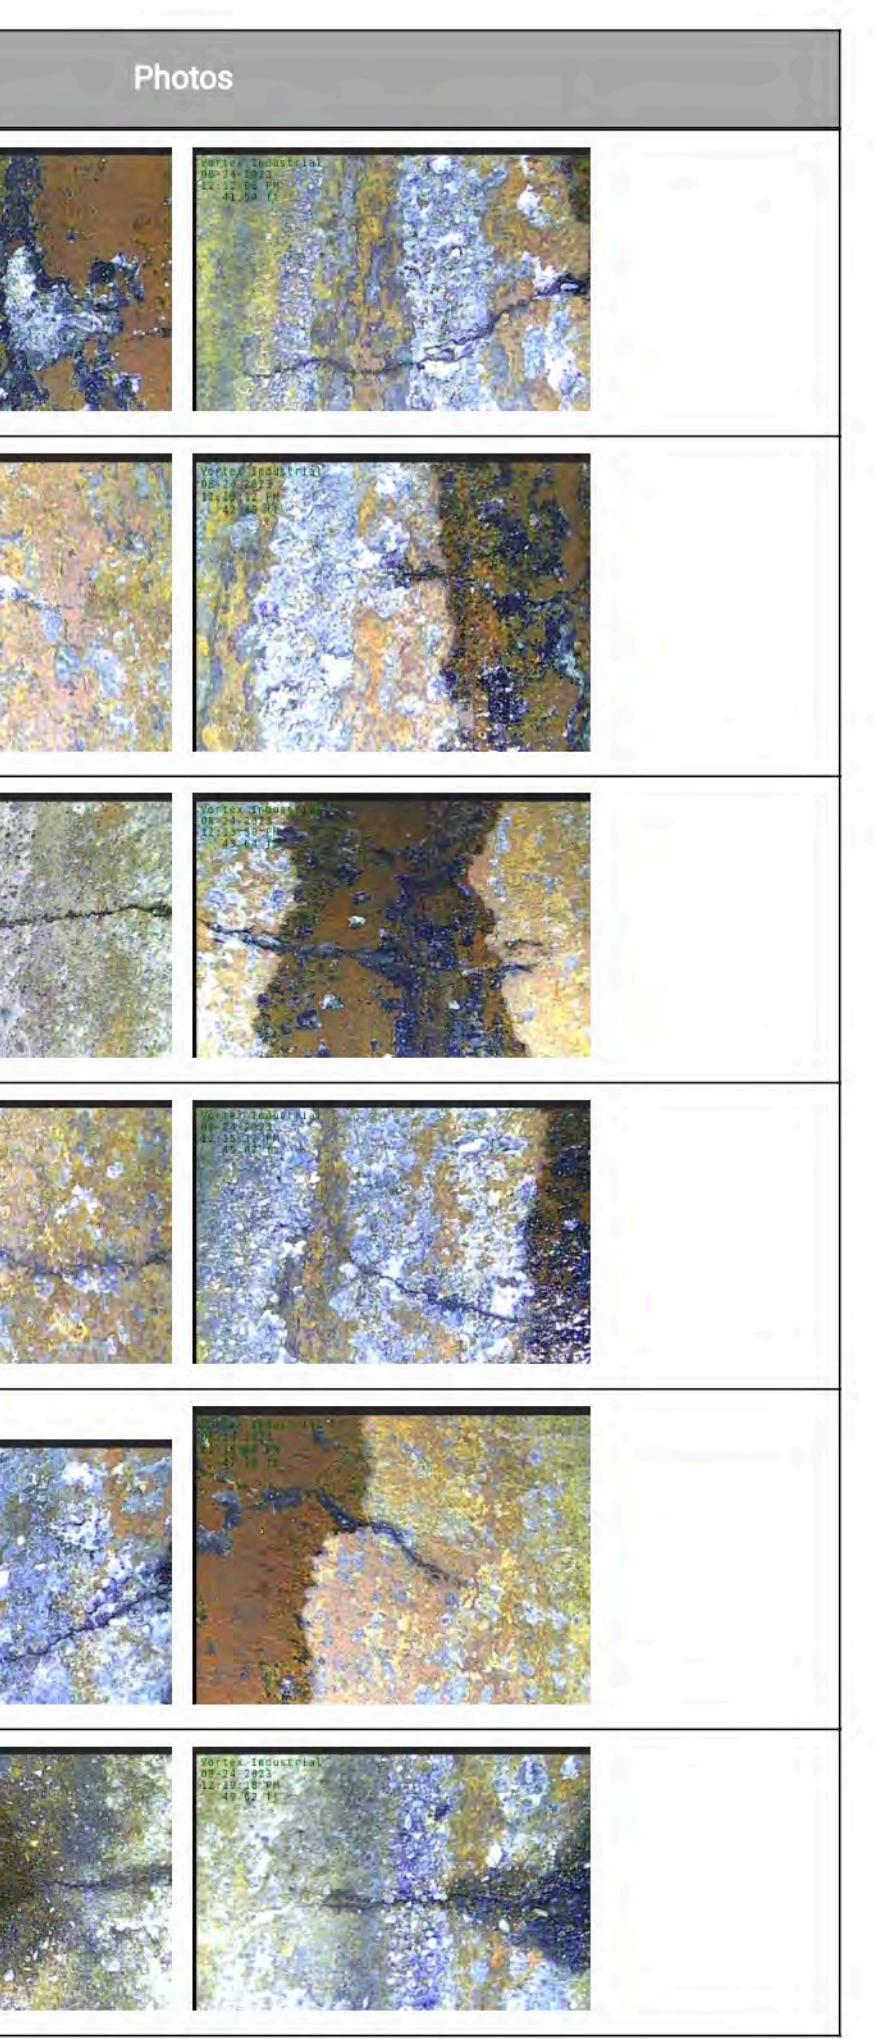
Description	Spatial Type	Distance (ft)	Туре	Percent	Clock	SR	0&M	С	PR	Remarks	
Crack Circumferential	Point	51.1	Structural	0	5-7	1	0	0	1	Crack Circumferential	
Crack Multiple	Point	52.1	Structural	0	6-7	1	0	0	1	Crack Circumferential	
Crack Longitudinal	Point	54.2	Structural	0	2	2	0	0	1	Crack Longitudinal	
Crack Multiple	Point	54.6	Structural	0	5-7	3	0	0	1	Crack Multiple	
Crack Multiple	Point	58.4	Structural	0	4-9	1	0	0	1	Crack Circumferential
