2024 ANNUAL PROGRESS REPORT SWMU-1 OILY WATER SEWER

HF SINCLAIR PUGET SOUND REFINING LLC

March 2025

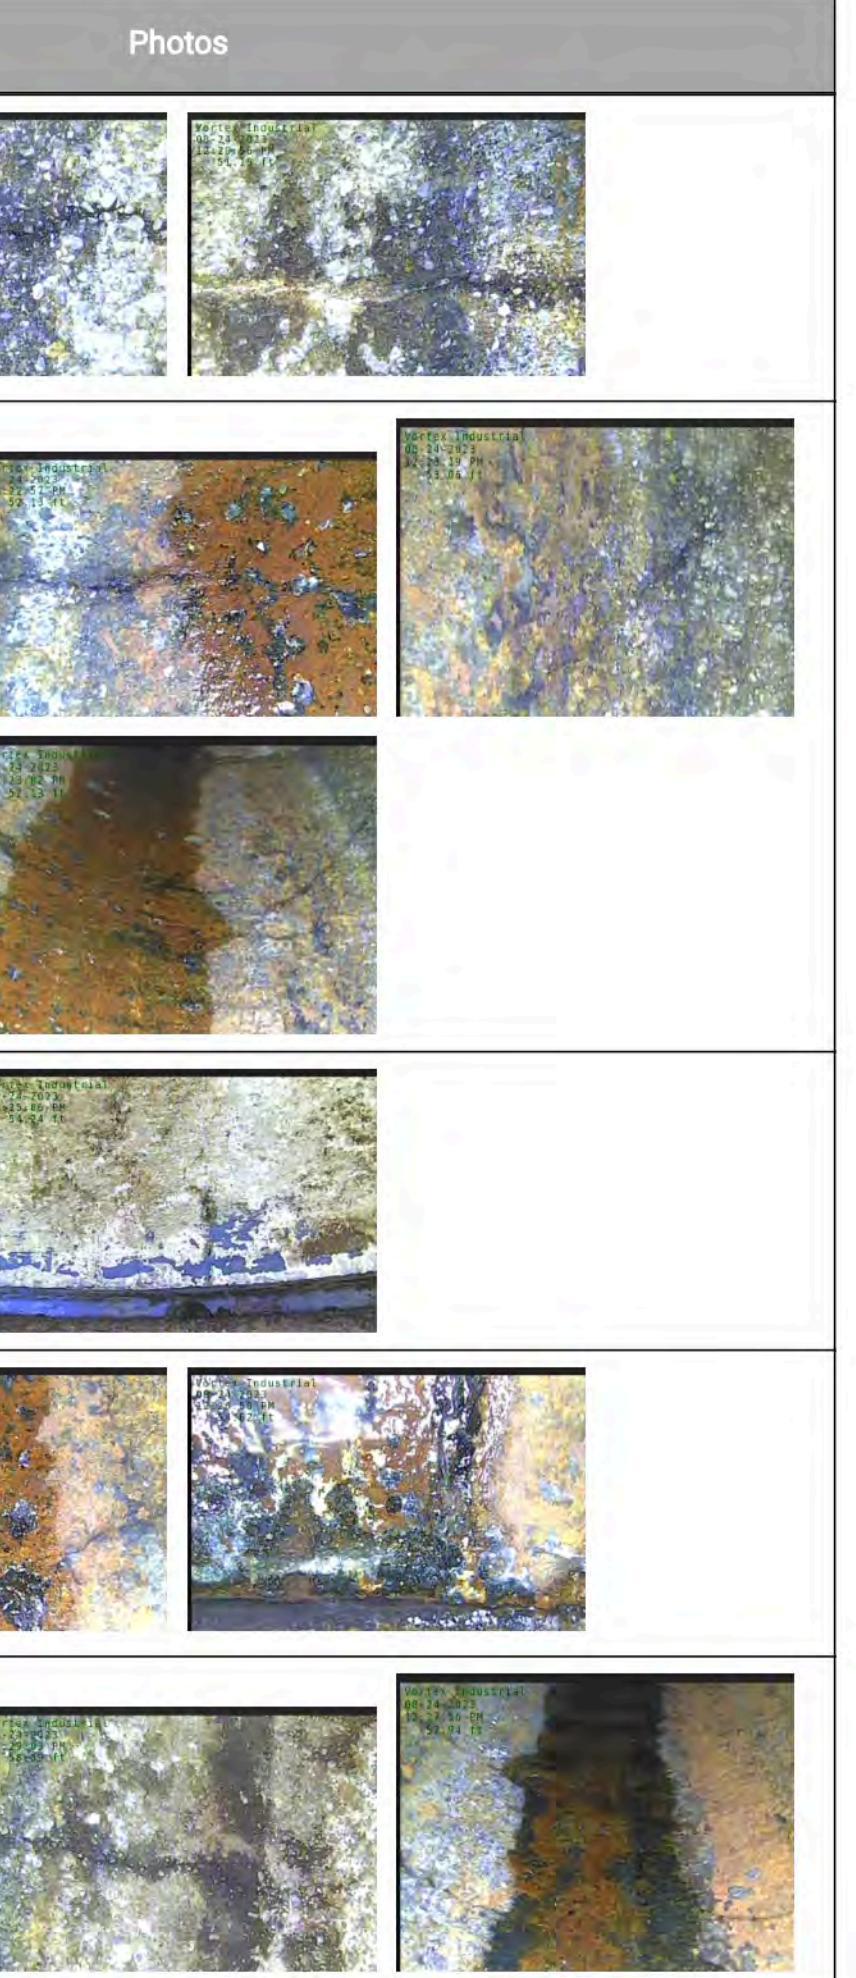
Description	Spatial Type	Distance (ft)	Туре	Percent	Clock	SR	0&M	С	PR	Remarks	
Crack Spiral	Point	60	Structural	0	4-6	2	0	0	1	Crack Spiral	
Crack Longitudinal	Point	61.8	Structural	0	2	2	0	0	1	Crack Longitudinal	
Crack Longitudinal	Point	61.8	Structural	0	7	2	0	0	1	Crack Longitudinal	V III A VIII A VIIII A VIII A VIIII A VIIIII A VIIII A VIIIII A VIIII A VIIIII A VIIIII A VIIII A VIIII A VIIII A VIIIII A VIIIII A
Crack Multiple	Point	62.5	Structural	0	5-6	3	0	0	1	Crack Multiple

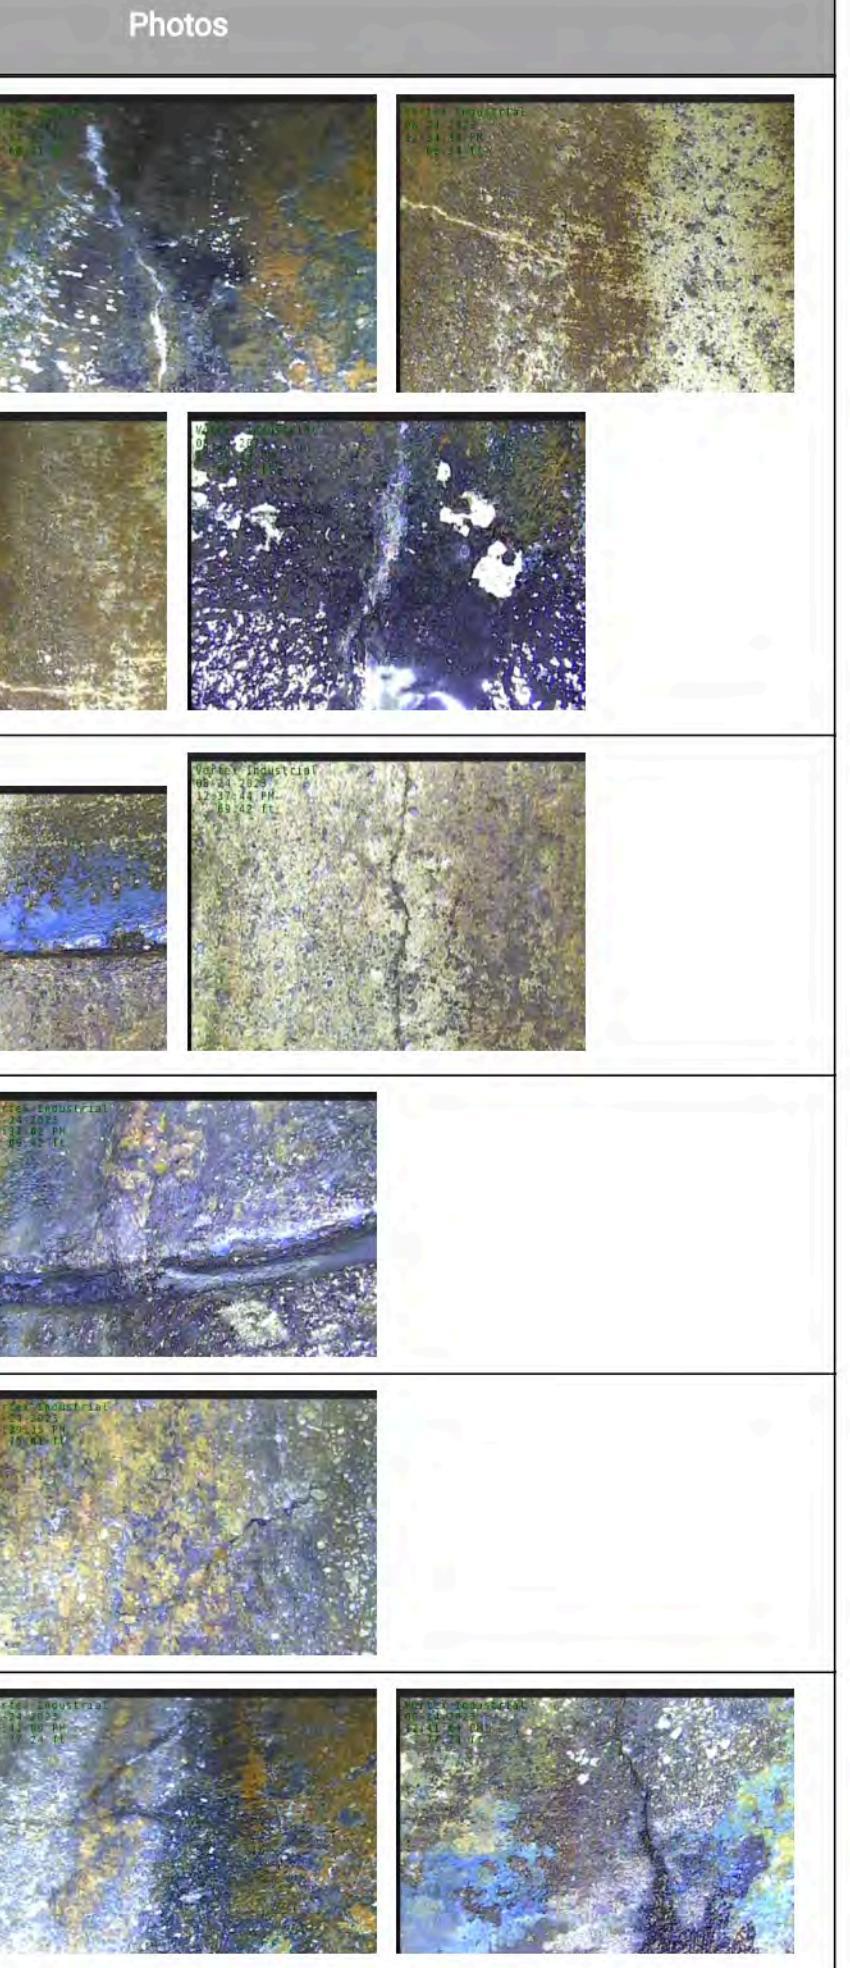
Description	Spatial Type	Distance (ft)	Туре	Percent	Clock	SR	0&M	С	PR	Remarks	
Crack Circumferential	Point	79	Structural	0	5-7	1	0	0	1	Crack Circumferential	
Crack Circumferential	Point	87.3	Structural	0	3-9	1	0	0	1	Crack Circumferential	
Crack Longitudinal	Point	100.1	Structural	0	6	2	0	0	1	Crack Longitudinal	
Crack Longitudinal	Point	107.9	Structural	0	6	2	0	0	1	Crack Longitudinal

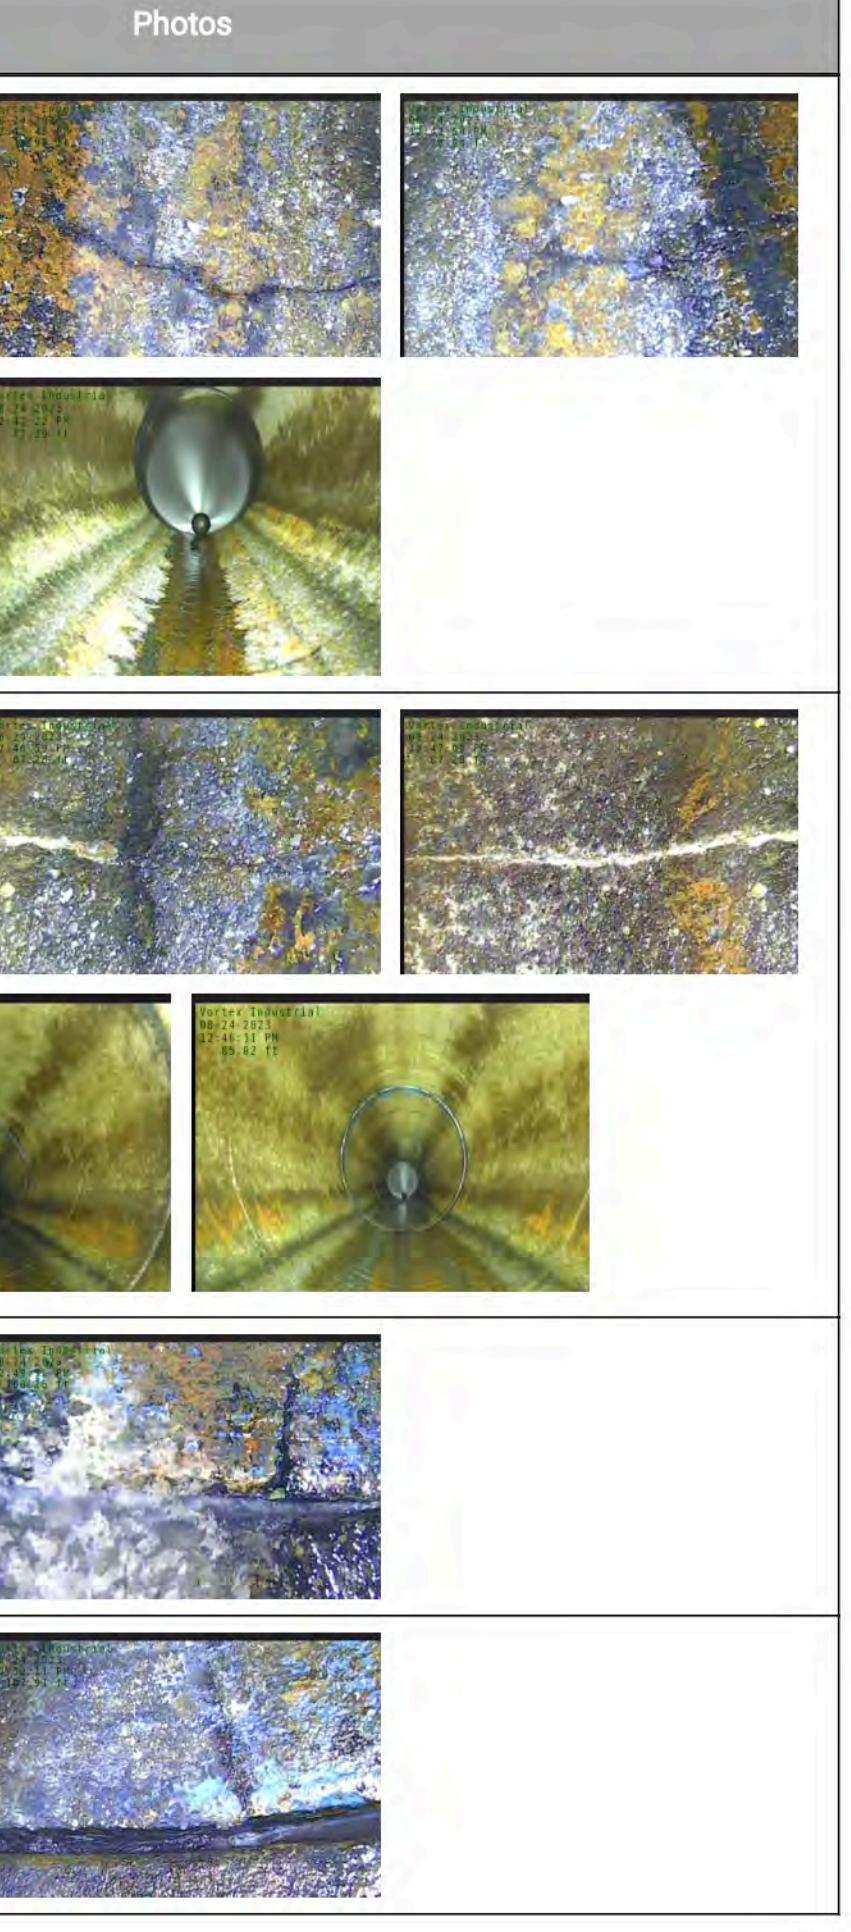
Description	Spatial Type	Distance (ft)	Туре	Percent	Clock	SR	0&M	С	PR	Remarks	
Crack Multiple	Point	119.7	Structural	0	4-6	2	0	0	1	Crack Multiple	
Crack Longitudinal	Point	123.2	Structural	0	10	2	0	0	1	Crack Longitudinal	
Crack Circumferential	Point	126.8	Structural	0	4-8	1	0	0	1	Crack Circumferential	
Crack Circumferential	Point	131.6	Structural	0	5-6	1	0	0	1	Crack Circumferential	
Crack Multiple	Point	133.7	Structural	0	6-7	3	0	0	1	Crack Multiple	Wet is the set of the

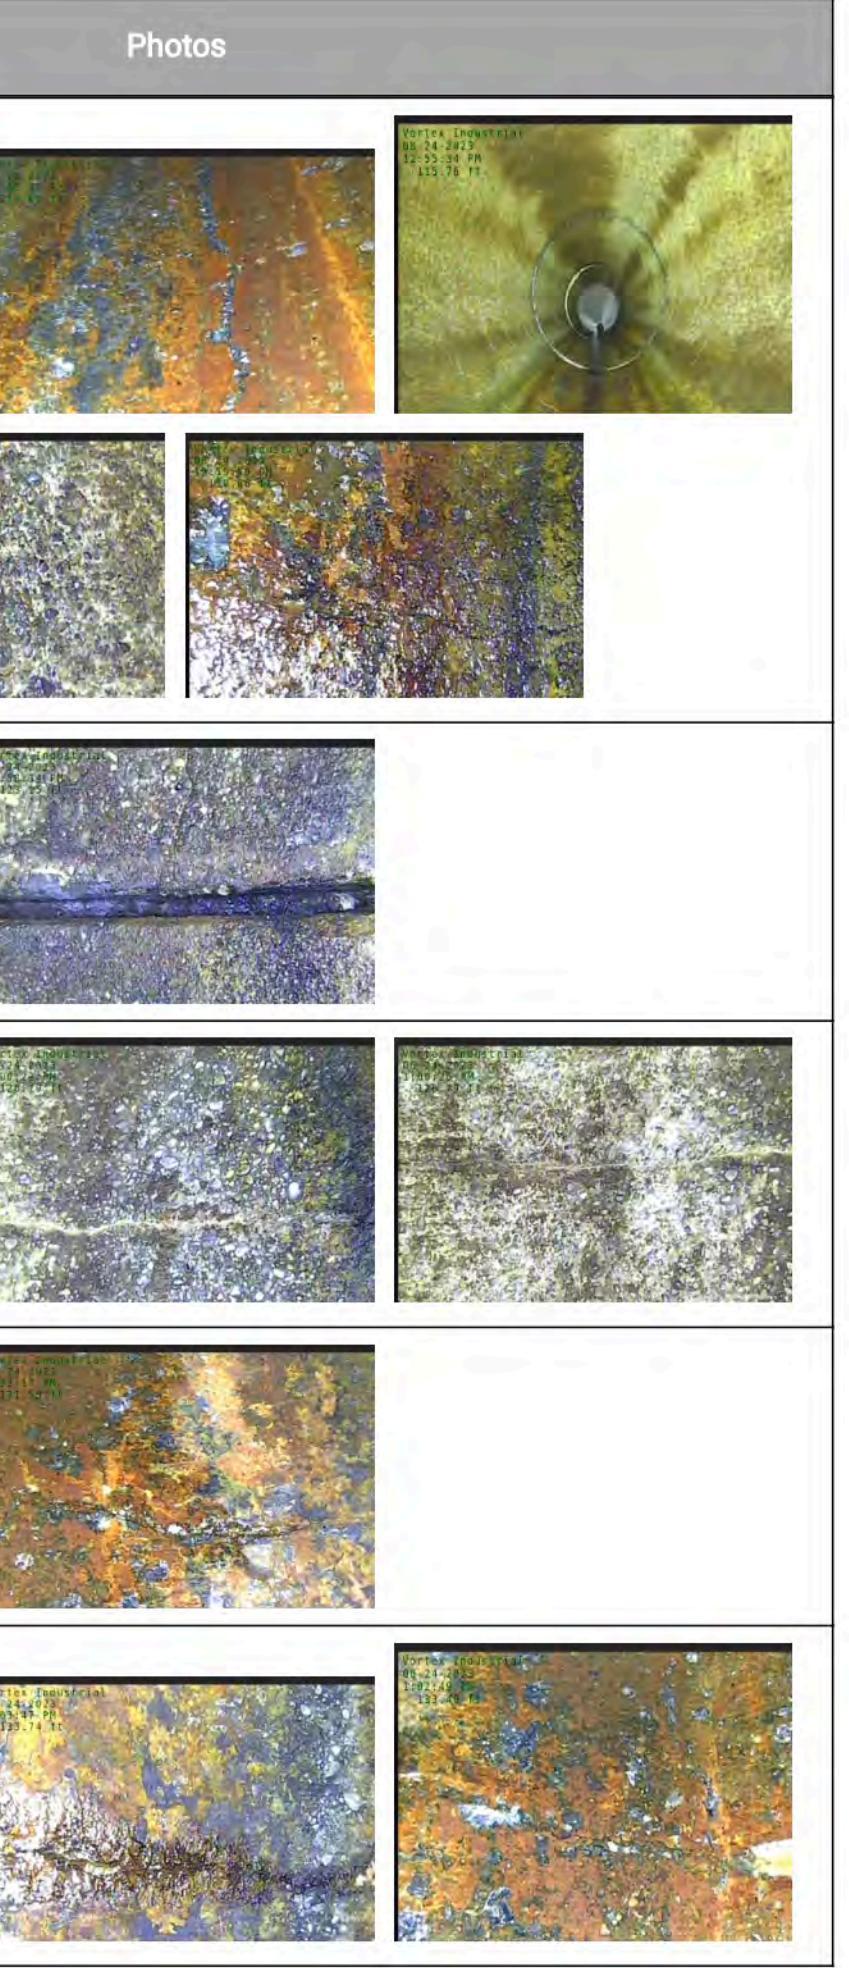
Description	Spatial Type	Distance (ft)	Туре	Percent	Clock	SR	0&M	С	PR	Remarks	
Crack Longitudinal	Point	134.4	Structural	0	2	2	0	0	1	Crack Longitudinal	
Crack Circumferential	Point	138.3	Structural	0	12- 12	1	0	0	2	Crack Circumferential	the strate trace of the strate
Crack Multiple	Point	139.1	Structural	0	5-7	3	0	0	1	Crack Multiple	for here industrial of the ind
Crack Multiple	Point	143	Structural	0	4-7	3	0	0	1	Crack Multiple	
Crack Longitudinal	Point	145.9	Structural	0	3	2	0	0	1	Crack Longitudinal	Vin Sterndustrink de 14 1024 11 584 ref 13 5 ref 14 ref 1

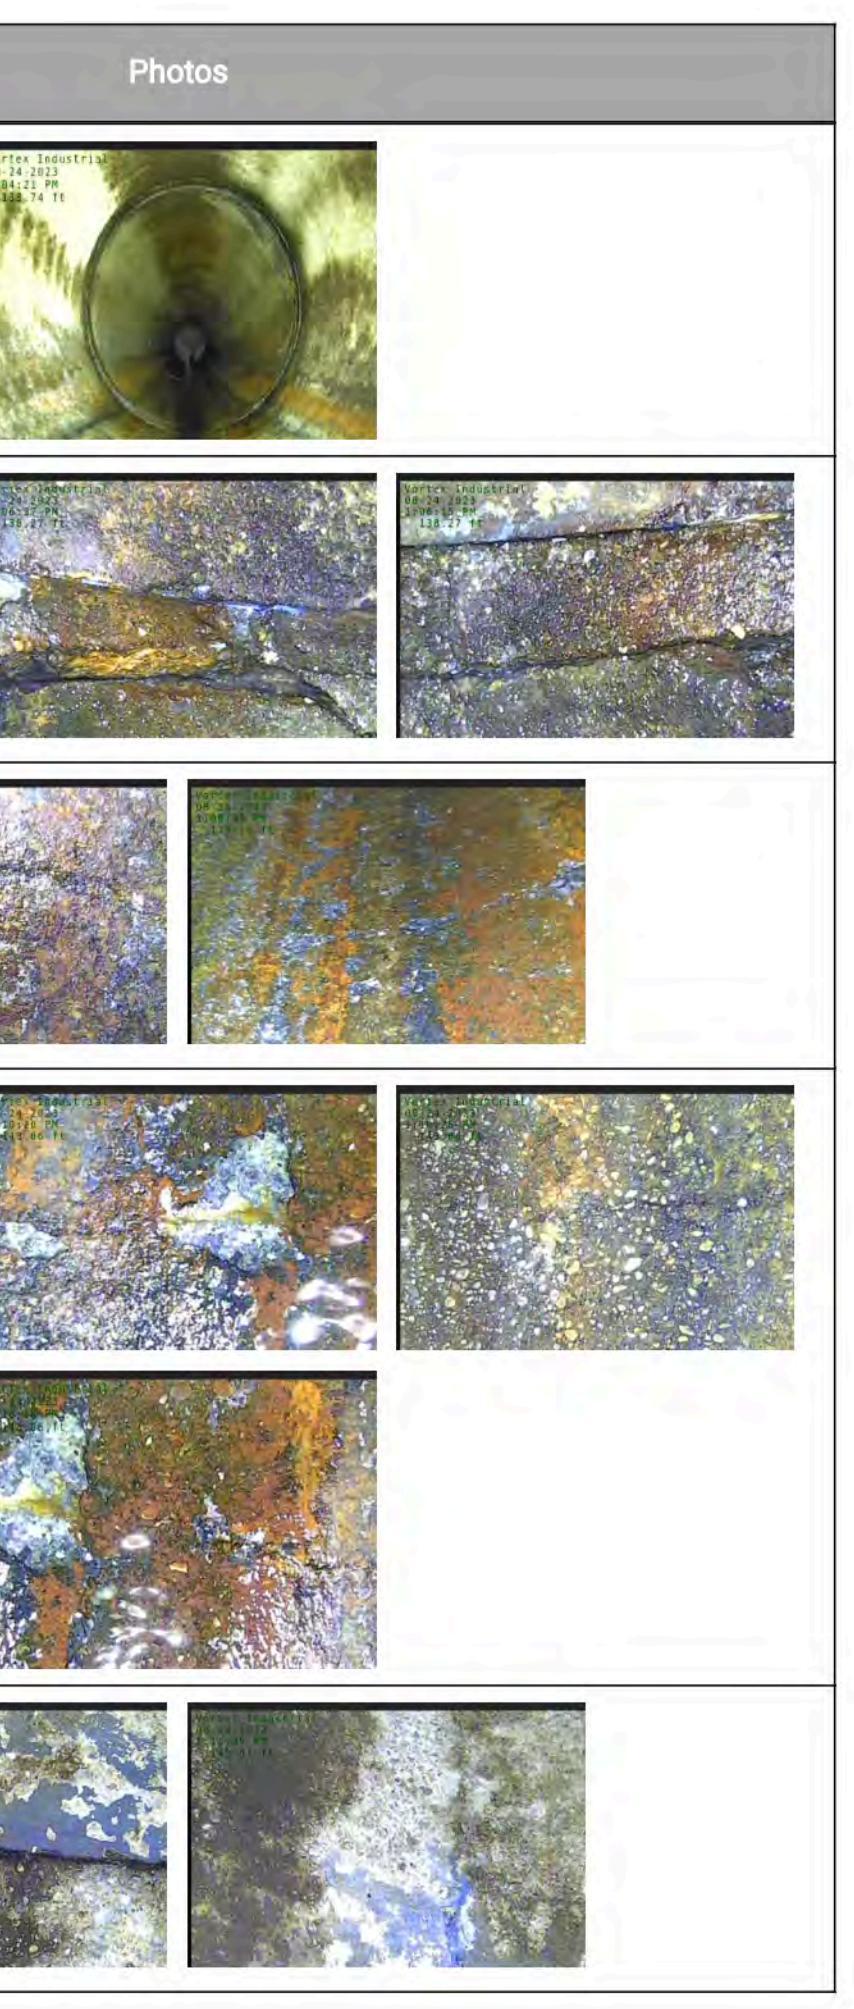
Description	Spatial Type	Distance (ft)	Туре	Percent	Clock	SR	O&M	С	PR	Remarks	
Crack Longitudinal	Point	145.9	Structural	0	6	2	0	0	1	Crack Longitudinal	
Crack Multiple	Continuous	146.7 - 150	Structural	0	4-8	3	0	0	2	Crack Multiple	
Crack Multiple	Continuous	153.6 - 158.8	Structural	0	4-9	3	0	0	1	Crack Multiple

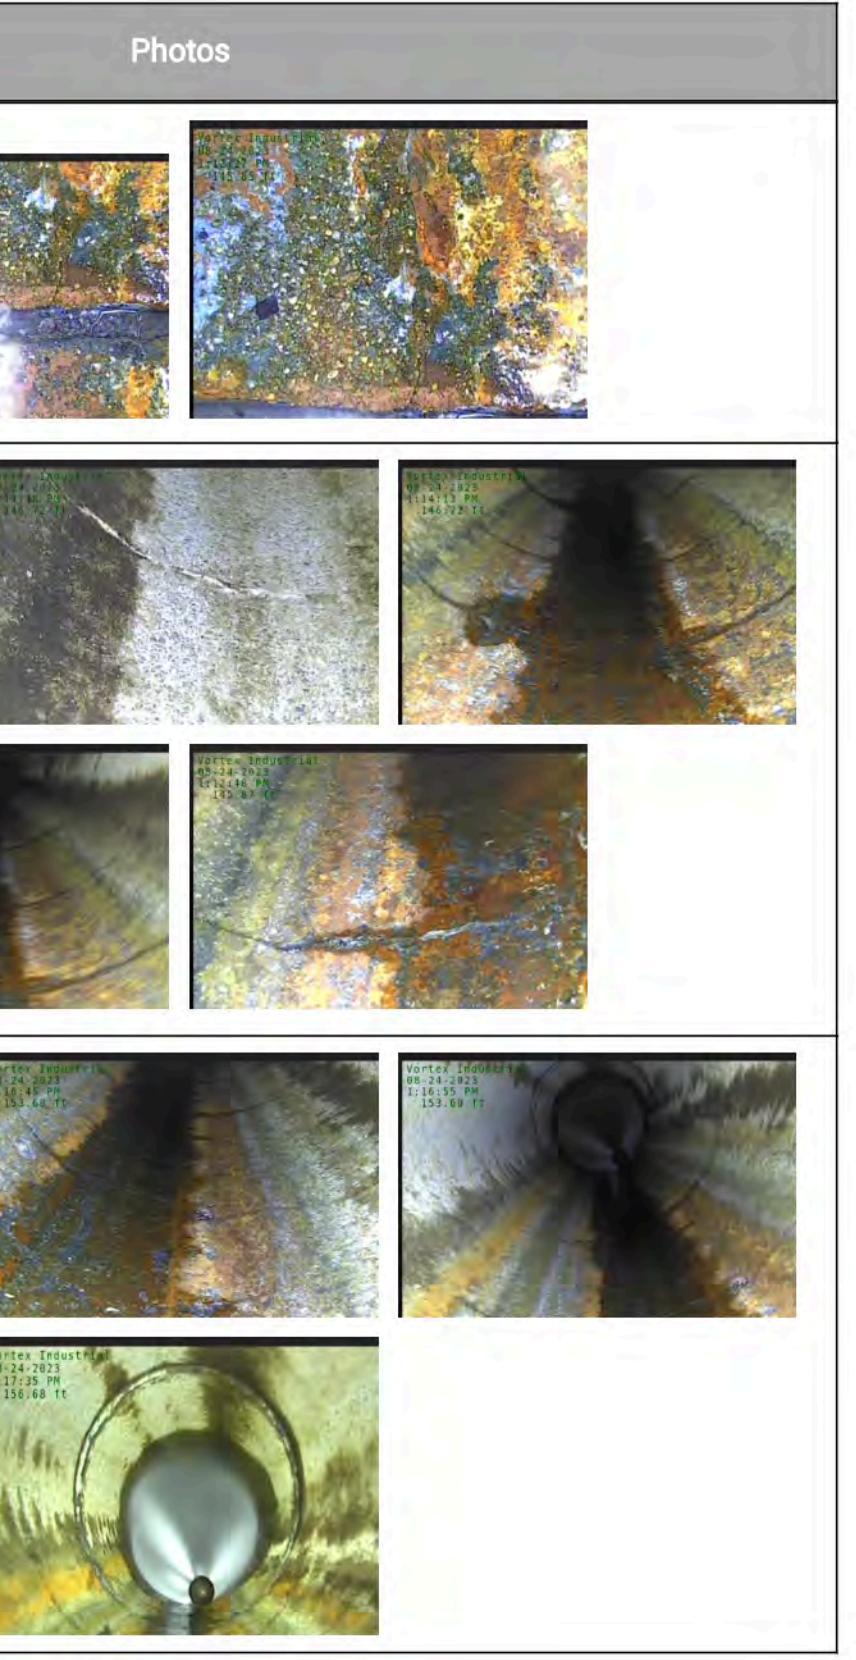
Description	Spatial Type	Distance (ft)	Туре	Percent	Clock	SR	O&M	С	PR	Remarks	
Crack Spiral	Point	161.2	Structural	0	5-7	2	0	0	2	Crack Spiral	
Crack Circumferential	Point	165.9	Structural	0	6-8	1	0	0	1	Crack Circumferential	
Crack Circumferential	Point	174	Structural	0	3-9	1	0	0	1	Crack Circumferential	
Crack Longitudinal	Point	176.7	Structural	0	6	2	0	0	1	Crack Longitudinal

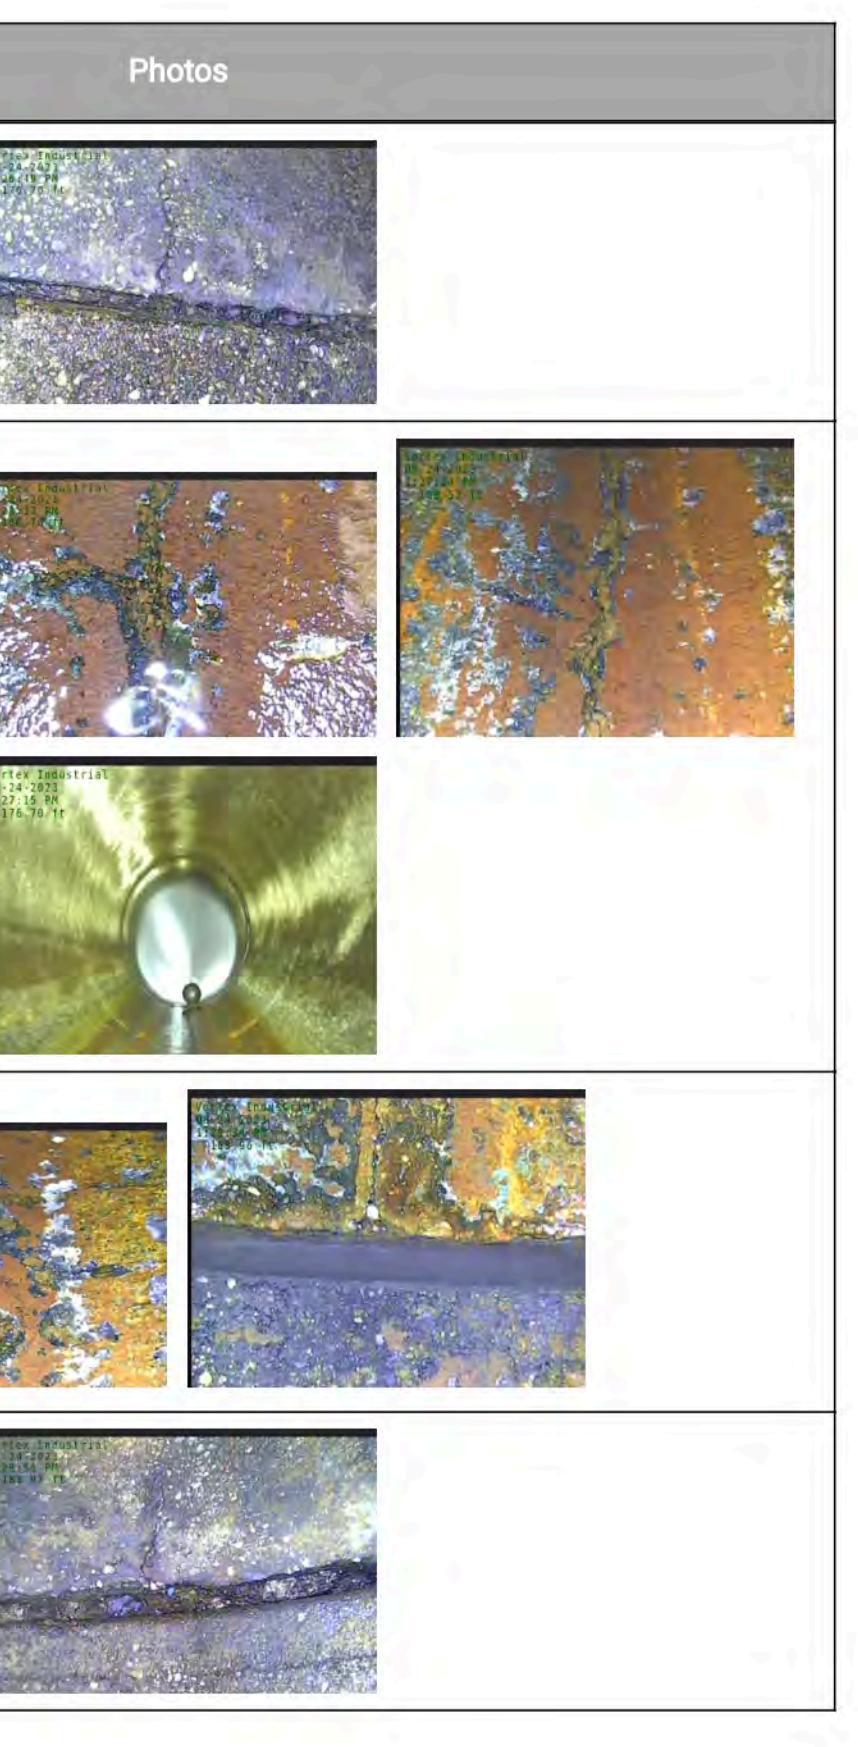
Description	Spatial Type	Distance (ft)	Туре	Percent	Clock	SR	O&M	С	PR	Remarks	
Fracture Circumferential	Point	206	Structural	0	7-5	2	0	0	2	Fracture Circumferential	orreineustres a state a stat
Manhole	Point	207.7	Constructional	0		0	0	0	0	5-0	Vortex Indústrial 08/24/2023 1/99/29 PM 207/10 T

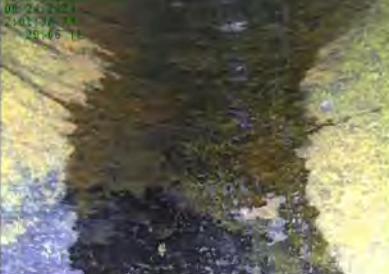
Description	Spatial Type	Distance (ft)	Туре	Percent	Clock	SR	O&M	С	PR	Remarks	
Crack Longitudinal	Point	51.5	Structural	0	5	2	0	0	1	Crack Longitudinal	Yur ex draustriat 18-24-2023 2:8334.PM -45-70 TC
Crack Longitudinal	Point	51.5	Structural	0	7	2	0	0	1	Crack Longitudinal	Vortex Industrien 78-24-2027 2-183-14-5Pk
Crack Longitudinal	Point	73.8	Structural	0	6	2	0	0	1	Crack Longitudinal	
Crack Longitudinal	Point	80.5	Structural	0	6	2	0	0	1	Crack Longitudinal	Burdies, Londustrian Burdies, Londustrian Burdies, Strate Burdies, Londustrian Burdies, Londu
Manhole	Point	82	Constructional	0		0	0	0	0	5-M	Vortex Industrial 06-24-2023 2:33:13 PM 51.96 Tt 51.96 Tt

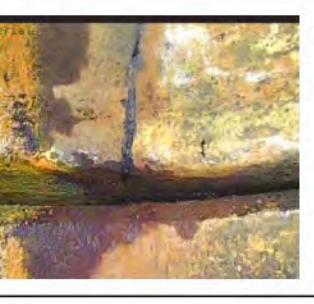
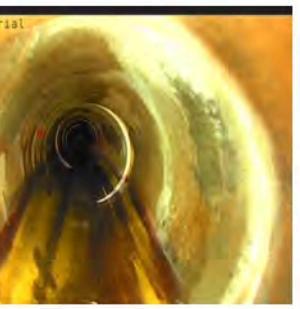
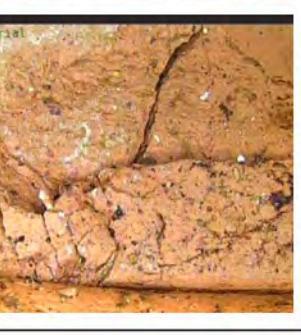
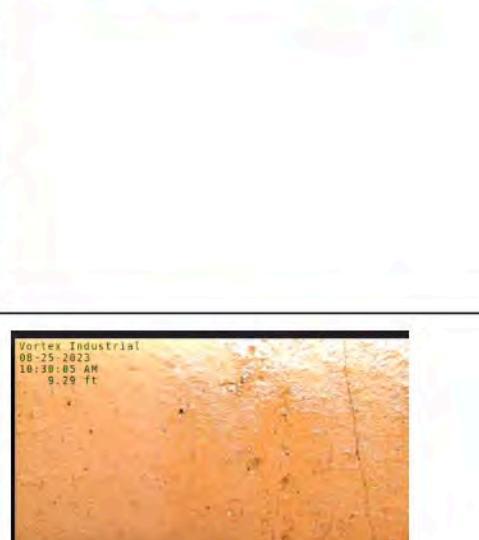
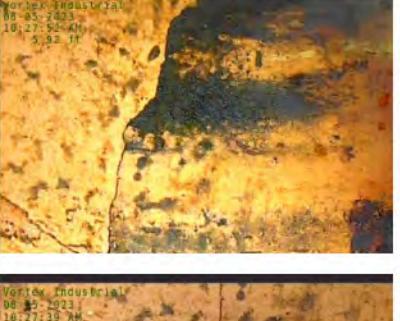
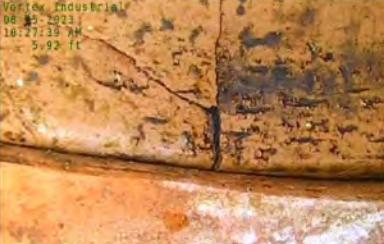
Description	Spatial Type	Distance (ft)	Туре	Percent	Clock	SR	O&M	С	PR	Remarks	
Fracture Multiple	Point	13.6	Structural	0	12- 12	3	0	0	3	Fracture Multiple	Wortes Industrie Wortes Industrie Wortes Industrie
Crack Multiple	Point	17.6	Structural	0	5-6	3	0	0	1	Crack Multiple	
Crack Multiple	Point	17.6	Structural	0	10-1	3	0	0	2	Crack Multiple	vortex_Endboartal 08-25-2023 10-33:33 AM 17.55 ft 10-32:43 AM 17.55 ft
Fracture Spiral	Point	17.6	Structural	0	6-7	3	0	0	2	Fracture Spiral	Vortex Industri 00-25-2023 10:33:25 AN 17.55 ft

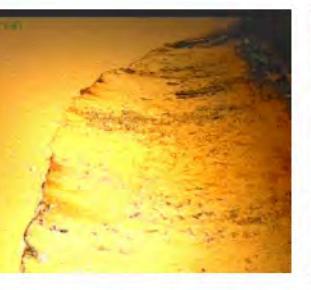
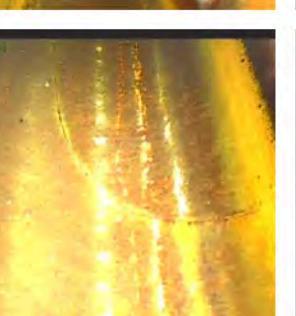
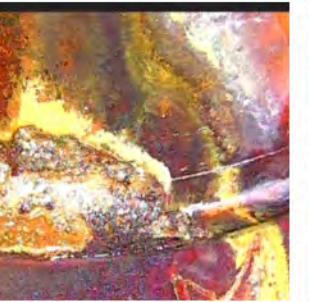
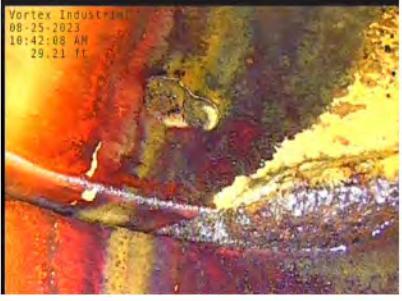
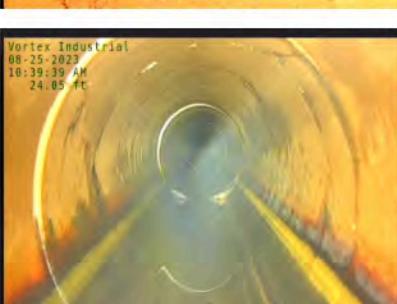
Description	Spatial Type	Distance (ft)	Туре	Percent	Clock	SR	O&M	С	PR	Remarks	
Crack Longitudinal	Point	29.2	Structural	0	2	2	0	0	1	Crack Longitudinal	Vorter Indust EB.25-2023 IU.33-42 AP 25.23 T
Crack Longitudinal	Point	33.5	Structural	0	6	2	0	0	1	Crack Longitudinal	
Crack Longitudinal	Point	33.5	Structural	0	7	2	0	0	1	Crack Longitudinal	Vo * 25 · 10 · 10 · 10 · 10 · 10 · 10 · 10 · 1
Crack Longitudinal	Continuous	33.5 - 36.8	Structural	0	10	2	0	0	1	Crack Longitudinal	Vortes Industrial' - 88 25-2022 10/3/2014 AM 32-85 FT 33-85 FT
Crack Spiral	Point	37.4	Structural	0	3-5	2	0	0	1	Crack Spiral	Vortex Tonustraal 88-25-2023 10:30:55.49 31-34 17
Crack Longitudinal	Point	37.4	Structural	0	6	2	0	0	1	Crack Longitudinal

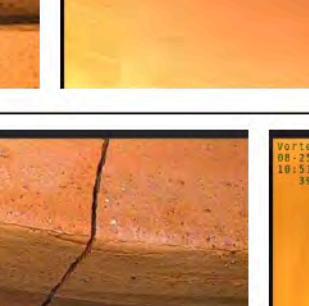
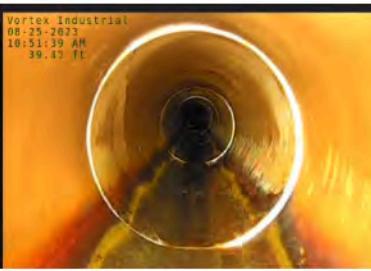
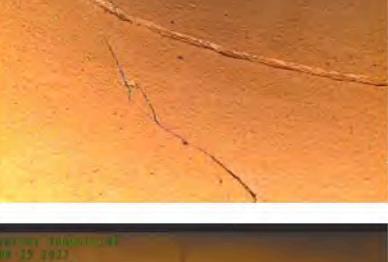
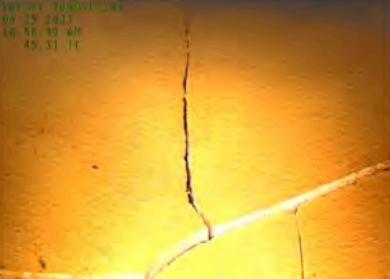
Description	Spatial Type	Distance (ft)	Туре	Percent	Clock	SR	O&M	С	PR	Remarks	
Crack Multiple	Point	49.5	Structural	0	12- 12	3	0	0	2	Crack Multiple	
Fracture Multiple	Point	53.4	Structural	0	12- 12	3	0	0	3	Fracture Multiple	Vortex Industria 06-23-2023 III (22:48-67 12:22:48-67 13:22:48-67 14:22:48-67 15:22:48-7 15:28-7 15:28-7 15:28-7 15:28-7

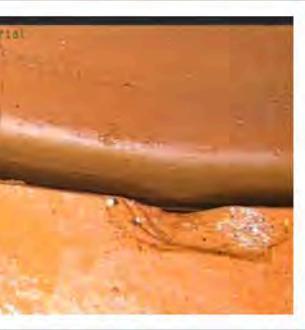
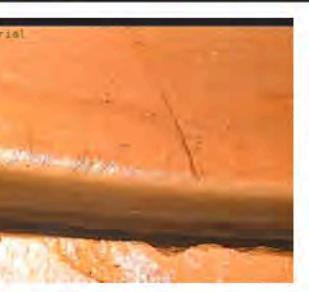
Description	Spatial Type	Distance (ft)	Туре	Percent	Clock	SR	O&M	С	PR	Remarks	
Crack Multiple	Point	57.4	Structural	0	3-7	3	0	0	1	Crack Multiple	
Crack Longitudinal	Point	57.4	Structural	0	12	2	0	0	1	Crack Longitudinal	Vortes Indust 88-25-2023 11:86-22 AV 57-30 T
Fracture Spiral	Point	57.4	Structural	0	10- 11	3	0	0	2	Fracture Spiral	Vortex Indust. 68-25-2023 II:86:20 AM 37:40 Pt
Crack Longitudinal	Point	61.7	Structural	0	10	2	0	0	1	Crack Longitudinal	Vortex Indust 08-35-2023 11:09-03 AH 63.68 ft

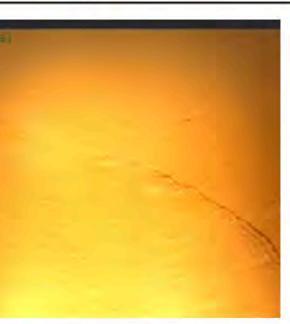
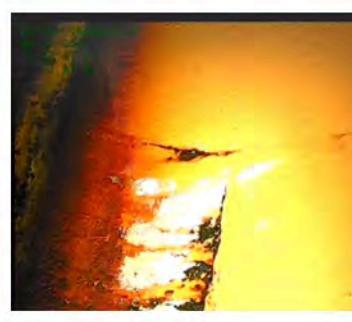
Description	Spatial Type	Distance (ft)	Туре	Percent	Clock	SR	O&M	С	PR	Remarks	
Fracture Multiple	Point	81.6	Structural	0	2-5	3	0	0	2	Fracture Multiple	vortex Industrial 88-25-2023 11:26:52 AM 81:62 Ft
Crack Longitudinal	Point	85.8	Structural	0	1	2	0	0	2	Crack Longitudinal	Vir tex Induct 11,25,32423 11,25,45, AM 15,52 Tt
Deposits Attached Encrustation	Point	85.8	O&M	10	5-7	0	2	0	0	Deposits Attached Encrustation	Verter Industriet 08-25-2023 11:27:40 AH 03.82 ft
Crack Longitudinal	Point	85.8	Structural	0	9	2	0	0	2	Crack Longitudinal	Transfer Totosterial att-22,723 Transfer 2 Ad 23, 12 Tr
Crack Longitudinal	Point	85.8	Structural	0	4	2	0	0	1	Crack Longitudinal	the second secon

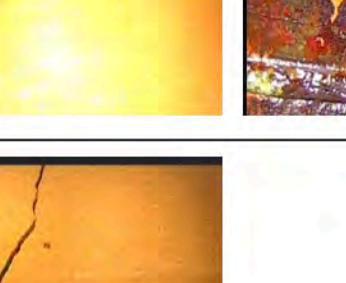
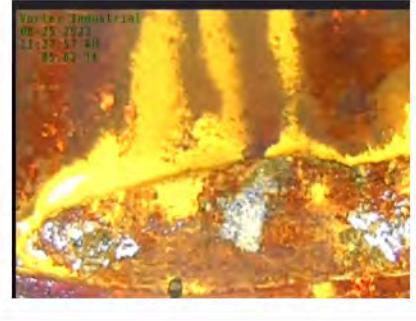
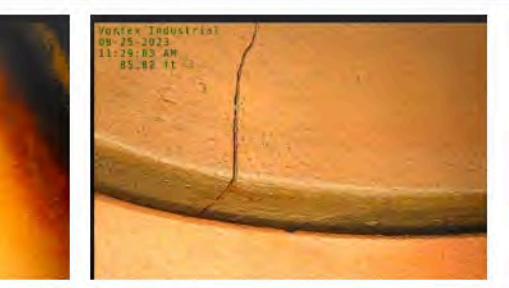
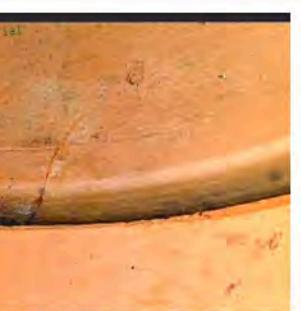
Description	Spatial Type	Distance (ft)	Туре	Percent	Clock	SR	O&M	С	PR	Remarks	
Crack Multiple	Point	89.6	Structural	0	12- 12	3	0	0	2	Crack Multiple	Urtes Trais Be 25:2023 11:31:47 AR 95:75 ft Vertes Trais 11:32:17 AR 85:75 ft Vertes Trais 11:32:17 AR 85:75 ft
Crack Multiple	Point	93.4	Structural	0	12- 12	3	0	0	2	Crack Multiple	
Crack Longitudinal	Point	98	Structural	0	5	2	0	0	1	Crack Longitudinal

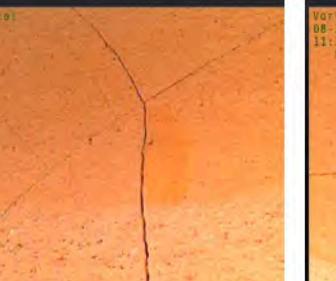
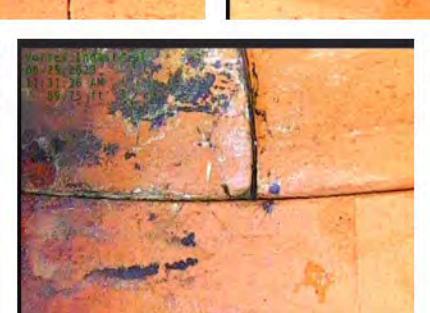
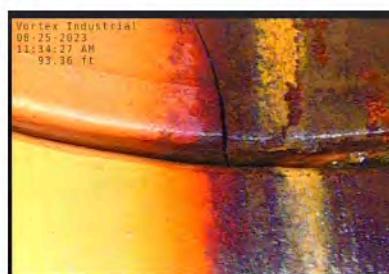
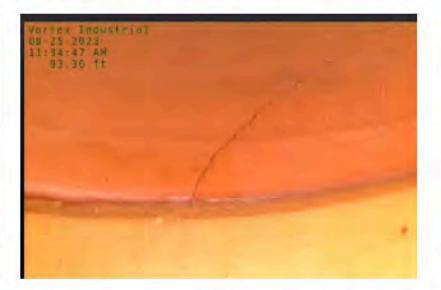
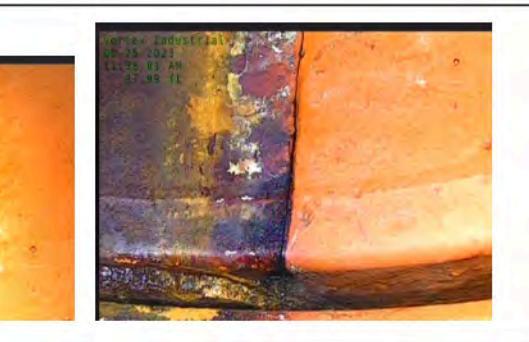
Description	Spatial Type	Distance (ft)	Туре	Percent	Clock	SR	O&M	С	PR	Remarks	
Crack Spiral	Point	98	Structural	0	7-11	3	0	0		Crack Spiral	Vortex Industr 11 di 22 AW 17
Crack Multiple	Point	101.7	Structural	0	6-12	3	0	0	2	Crack Multiple	yortex.IndustClat 05-25-2023 11:40:135 AM 101,72 ft 101,71 ft
Deposits Settled Hard/Compacted	Point	101.7	O&M	10	6-7	0	2	0	0	Deposits Settled Hard/Compacted	WITTER MANUELTITELE CONTROL OF AND

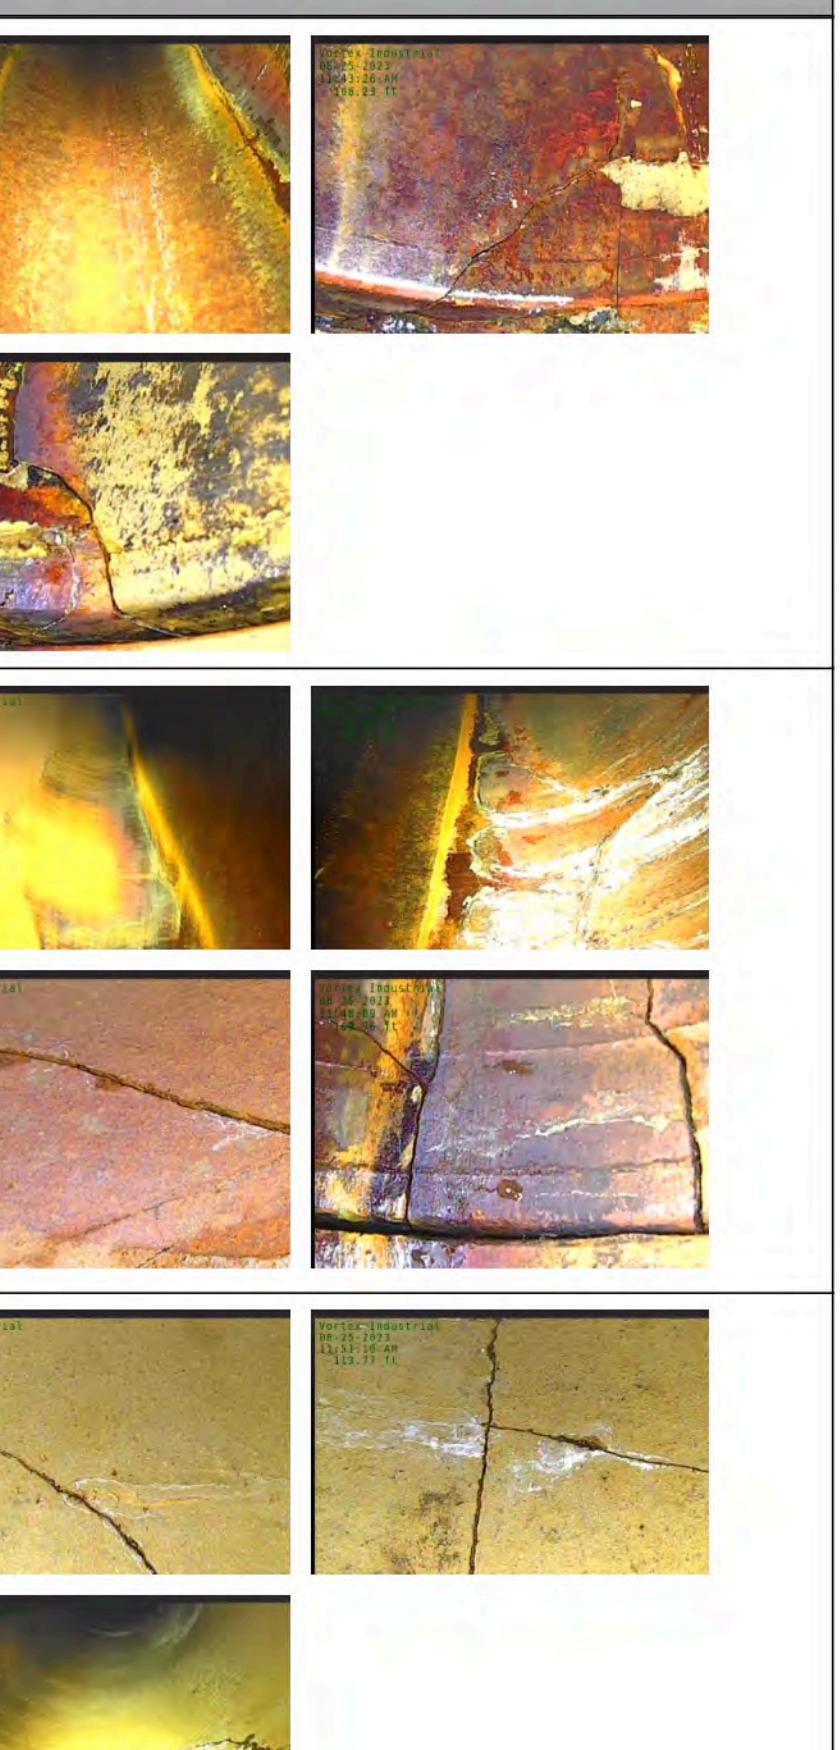
Description	Spatial Type	Distance (ft)	Туре	Percent	Clock	SR	O&M	С	PR	Remarks	
Crack Multiple	Point	106.2	Structural	0	5-7	3	0	0	2	Crack Multiple	Image: the transmission of the tran
Fracture Multiple	Point	109.8	Structural	0	12- 12	3	0	0	3	Fracture Multiple	Implementation Implementation Implementation Implementa
Crack Multiple	Point	113.8	Structural	0	12- 12	3	0	0	2	Crack Multiple	vortex industrial 11:59:14 AN 11:57:77 11:5

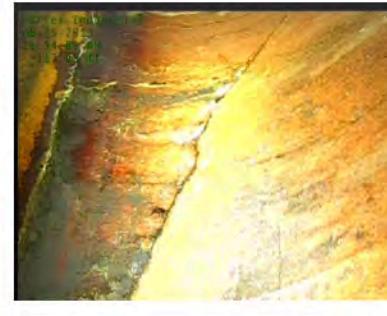
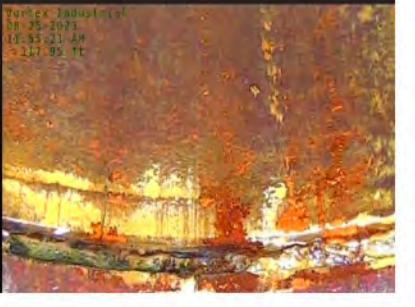
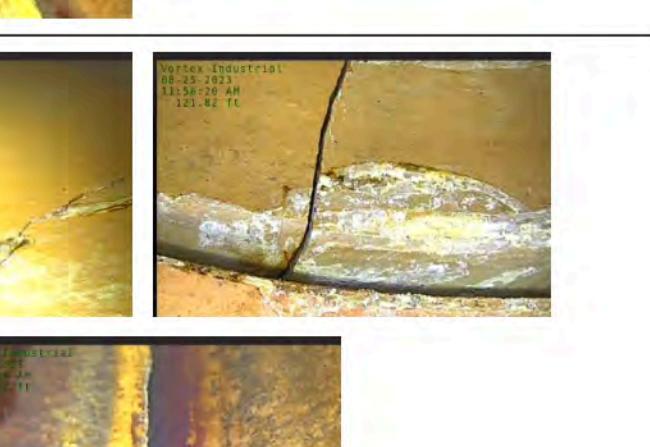
Description	Spatial Type	Distance (ft)	Туре	Percent	Clock	SR	O&M	С	PR	Remarks	
Crack Multiple	Point	118	Structural	0	12-6	3	0	0	2	Crack Multiple	PP 12 - 10 00 11 12 12 1 21 22 12 23 41 - 127 25 71 -
Crack Spiral	Point	118	Structural	0	6-8	2	0	0	1	Crack Spiral	Nortex Industriat 98-25-2023 11:53:80 AX 117,95-71
Joint Offset Medium	Point	121.8	Structural	0		3	0	0	1	Joint Offset Medium	Vorter Industri 88-55-2023 1139-36 ft 119-36 ft
Crack Multiple	Point	121.8	Structural	0	12- 12	3	0	0	2	Crack Multiple	Uprise Industrial Uprise Industrial <t< td=""></t<>

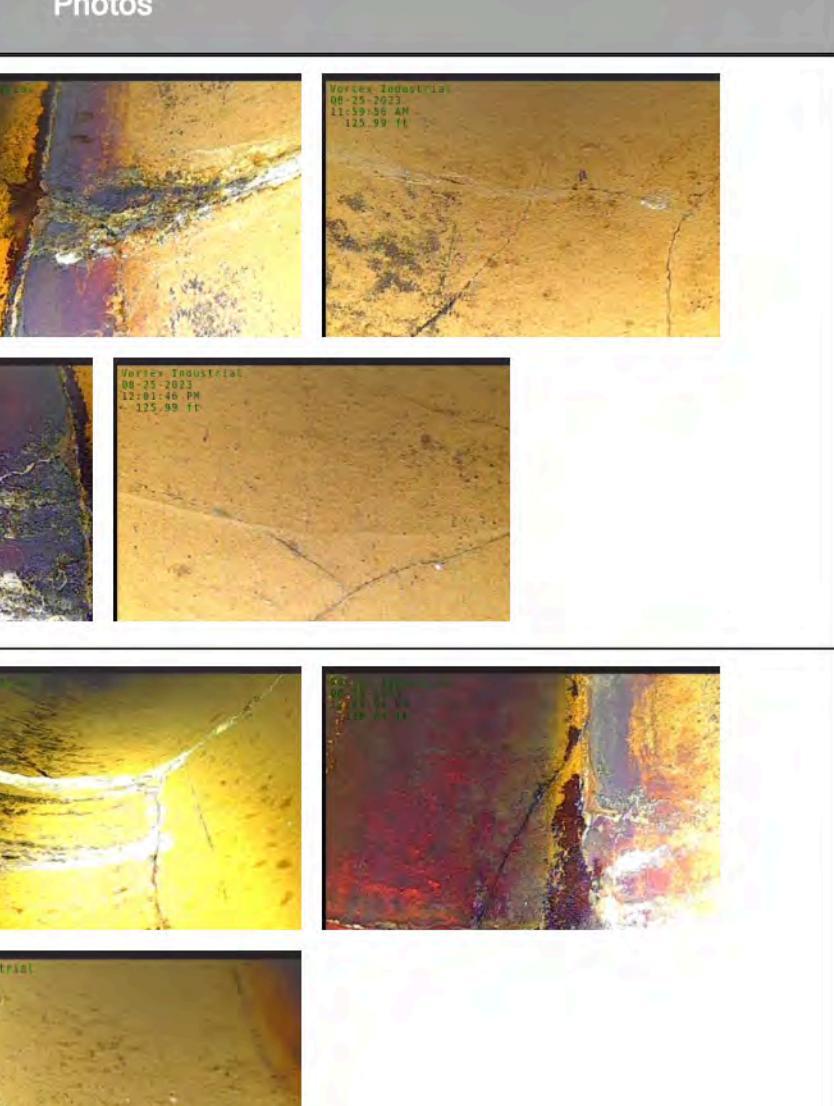
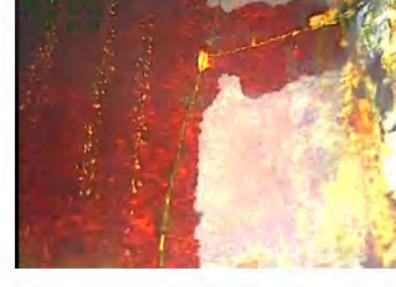
Description	Spatial Type	Distance (ft)	Туре	Percent	Clock	SR	O&M	С	PR	Remarks	
Crack Multiple	Point	126	Structural	0	12- 12	3	0	0	1	Crack Multiple	
Crack Multiple	Point	130.4	Structural	0	12- 12	3	0	0	2	Crack Multiple	Vortee Industration
Crack Multiple	Point	133.8	Structural	0	2-6	2	0	0	2	Crack Multiple	W0 * 5.8 * 3028 12 * 00 * 3.9 * 0° 12 * 00 * 3.9 * 0° 12 * 00 * 3.9 * 0° 12 * 00 * 3.9 * 0° 12 * 00 * 3.9 * 0° 12 * 00 * 3.9 * 0° 12 * 00 * 3.9 * 0° 12 * 00 * 0.9 * 0° 12 * 00 * 0.9 * 0° 12 * 00 * 0.9 * 0° 12 * 0.0 * 0.

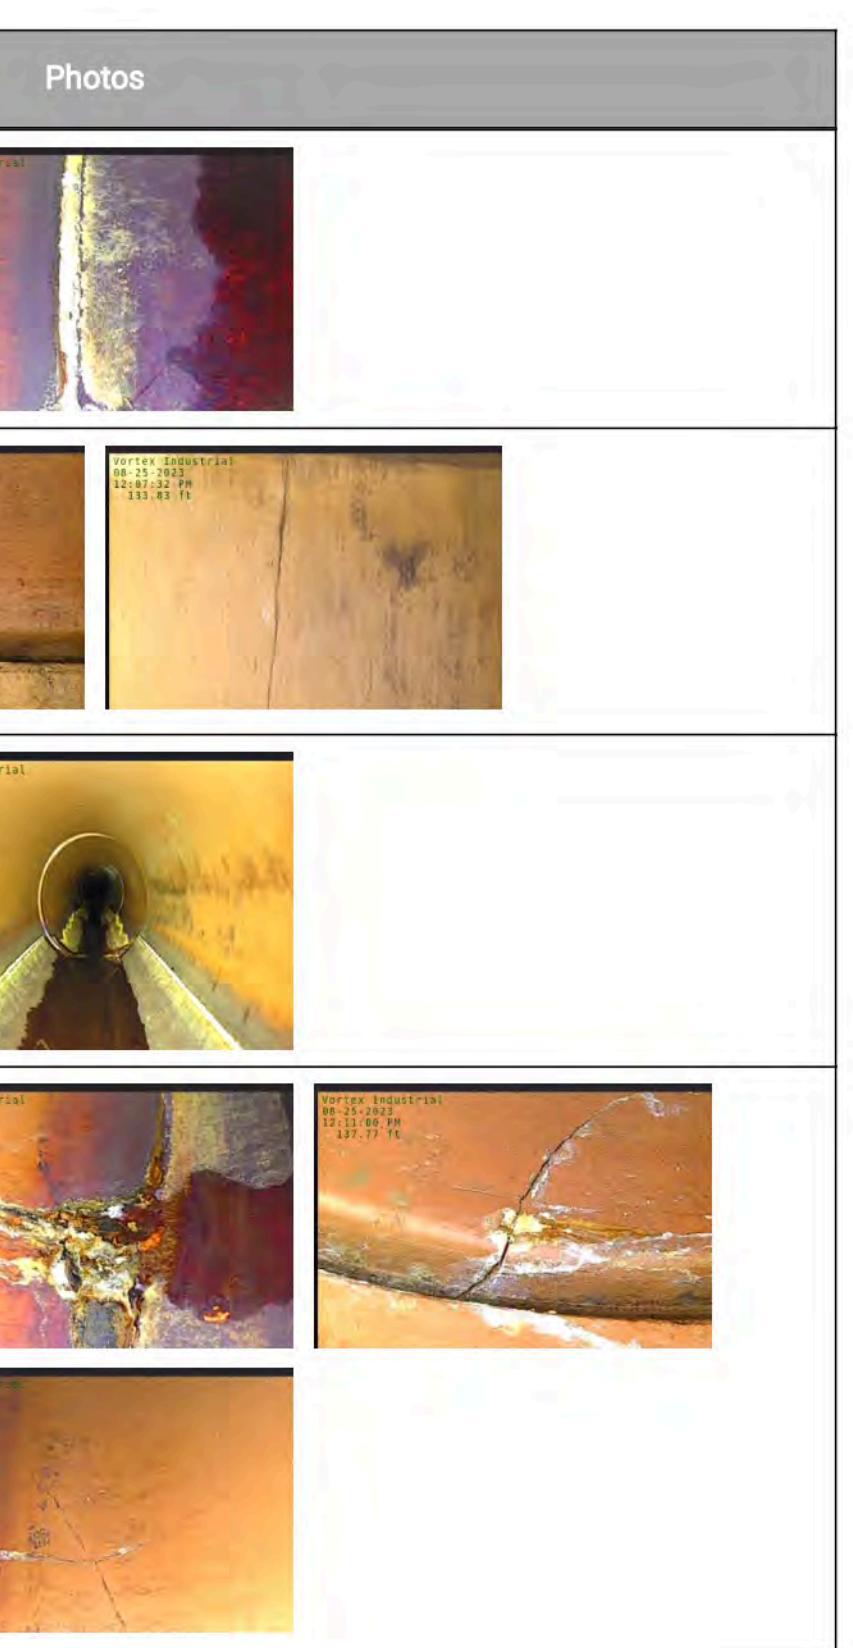
Description	Spatial Type	Distance (ft)	Туре	Percent	Clock	SR	O&M	С	PR	Remarks	
Crack Longitudinal	Point	133.8	Structural	0	7	2	0	0	1	Crack Longitudinal	Vortex Indust 09:25.8023 12:06:53 Pt 353.83 Pt
Crack Longitudinal	Point	133.8	Structural	0	9	2	0	0	1	Crack Longitudinal	Vortex Industrial 88-25-2073 12:07132 PH 133-83 TF
Crack Circumferential	Point	134.4	Structural	0	7-10	1	0	0	1	Crack Circumferential	Vortex Indust 198-25-2023 12:09:03 PM 133.83 ft
Crack Multiple	Point	137.8	Structural	0	4-9	3	0	0	1	Crack Multiple	Vortex Industrial 13:23-23/23 13:29 13:29
