2024 ANNUAL PROGRESS REPORT SWMU-1 OILY WATER SEWER

HF SINCLAIR PUGET SOUND REFINING LLC

March 2025

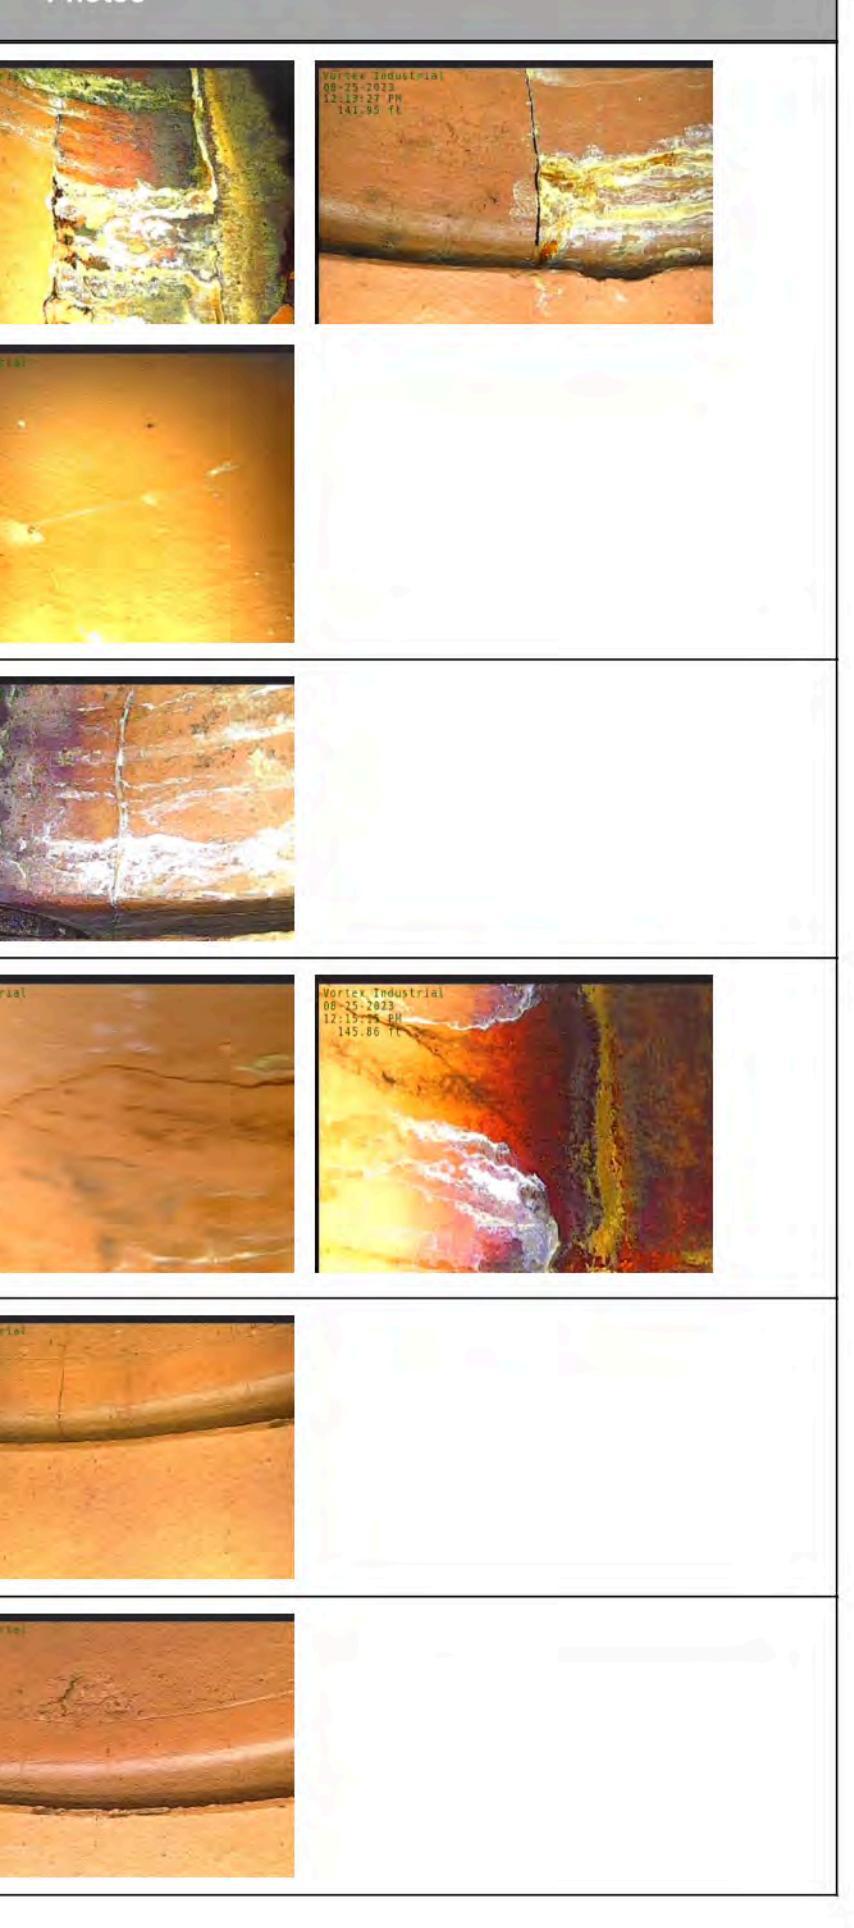
Description	Spatial Type	Distance (ft)	Туре	Percent	Clock	SR	0&M	С	PR	Remarks	
Crack Multiple	Point	142	Structural	0	12- 12	3	0	0	1	Crack Multiple	Wortes induction Image: Account of the second of the s
Crack Longitudinal	Point	145.9	Structural	0	5	2	0	0	1	Crack Longitudinal	
Crack Spiral	Point	145.9	Structural	0	6-9	2	0	0	1	Crack Spiral	Vorter Industrial 08-25-2023 12:13:06 PM -435-86 ft
Crack Longitudinal	Point	149.7	Structural	0	3	2	0	0	1	Crack Longitudinal	dar tex. Tadus tr 88 33-7023 121.10:23 43 139.72 43
Crack Longitudinal	Point	149.7	Structural	0	2	2	0	0	1	Crack Longitudinal	00+10+1 THOUGH 00-25,2023 12:13:15 PM 149.73 ft 149.73 ft

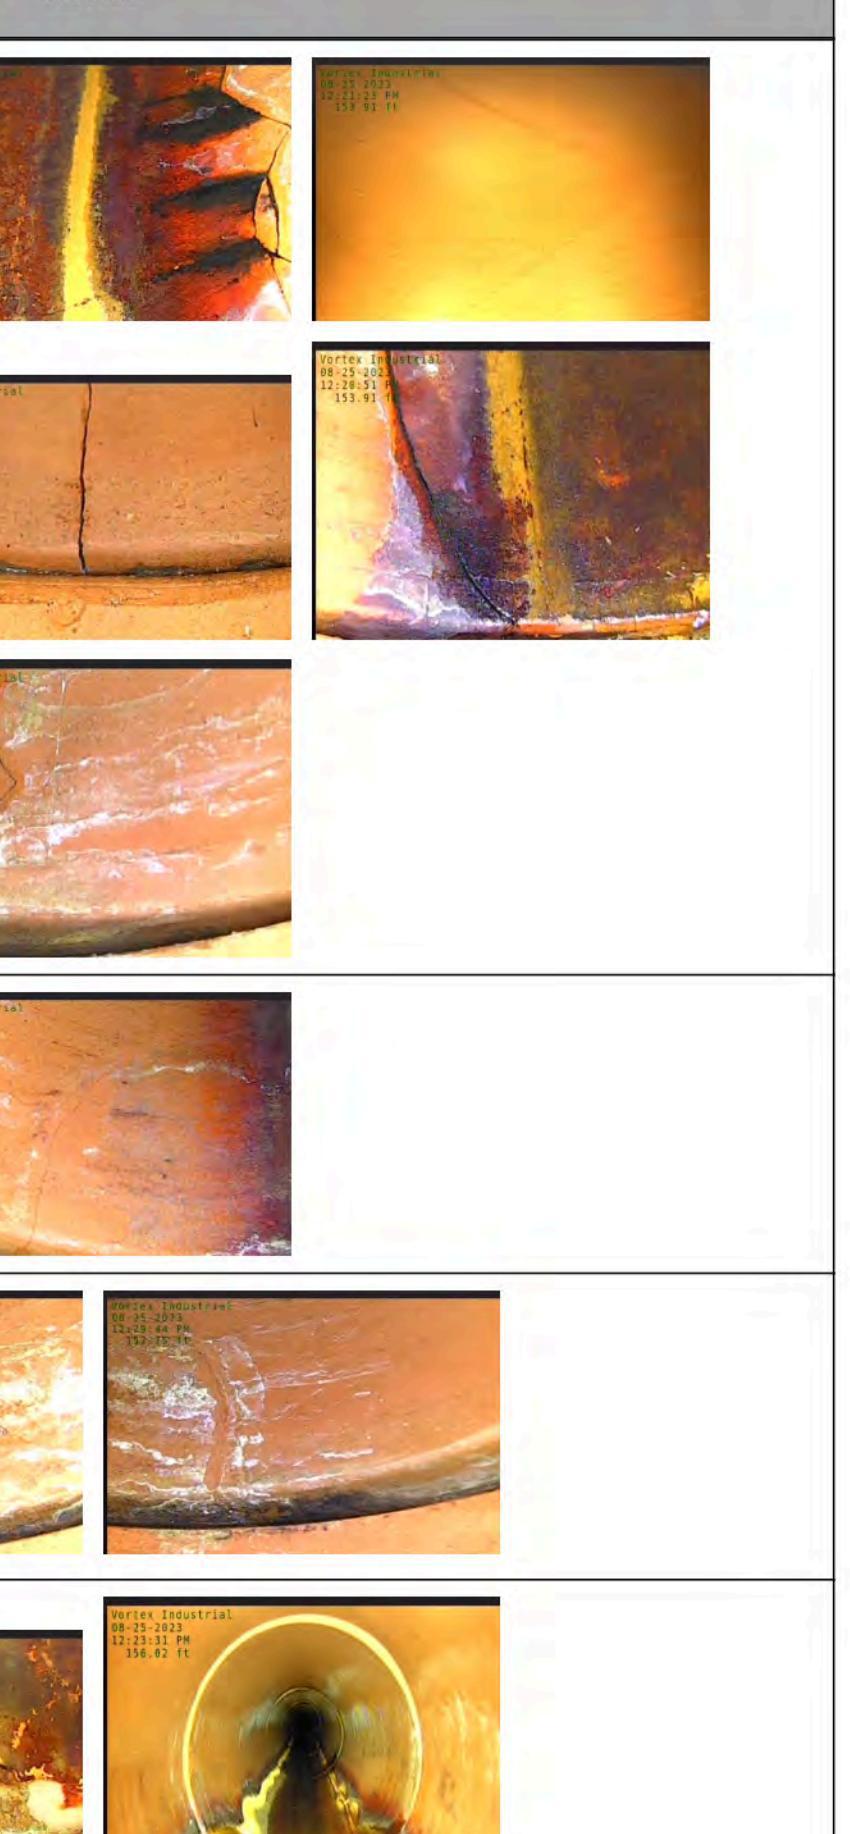
Description	Spatial Type	Distance (ft)	Туре	Percent	Clock	SR	O&M	С	PR	Remarks	No. Contractor and the
Crack Multiple	Point	153.9	Structural	0	12- 12	3	0	0	2	Crack Multiple	Werker, approximation Werker, approximation 12 22 20 approximation Werker, approximation 12 20 approximation Werker, approximation <td< th=""></td<>
Crack Longitudinal	Point	157.7	Structural	0	8	2	0	0	1	Crack Longitudinal	Vortex Industr 08-25-2023 12:28:33 PM 137-75 ft
Crack Spiral	Point	157.7	Structural	0	4-5	2	0	0	1	Crack Spiral	
Deposits Settled Hard/Compacted	Point	157.7	O&M	10	6	0	2	0	0	Deposits Settled Hard/Compacted

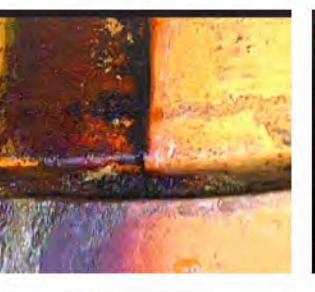
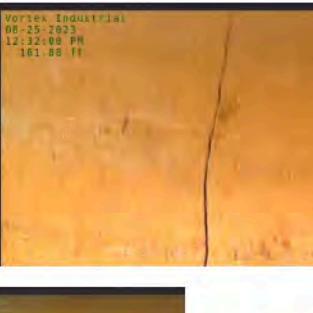
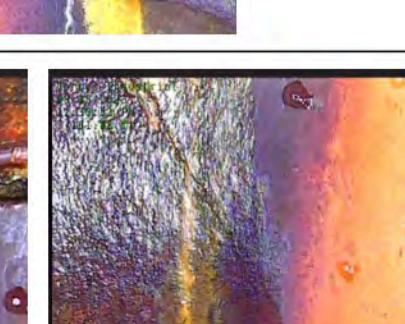
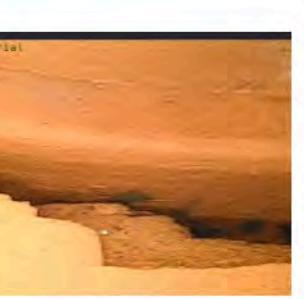
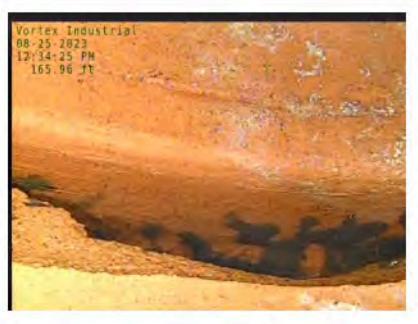
Description	Spatial Type	Distance (ft)	Туре	Percent	Clock	SR	O&M	С	PR	Remarks	
Crack Longitudinal	Point	157.7	Structural	0	7	2	0	0	1	Crack Longitudinal	Vortex Indust 08-25-2023 12:28:52 Ft 157.22
Crack Multiple	Point	161.9	Structural	0	12-5	3	0	0	1	Crack Multiple	
Crack Longitudinal	Point	161.9	Structural	0	7	2	0	0	1	Crack Longitudinal	Worts Indust 88:25-3625 12:33:31 Pt 161.08 Ft
Crack Longitudinal	Point	161.9	Structural	0	6	2	0	0	1	Crack Longitudinal	
Fracture Circumferential	Point	166	Structural	0	10- 11	2	0	0	2	Fracture Circumferential	Vortex Industrial 08-25-2023 12:34-22 20 105:96 ft 105:96 ft

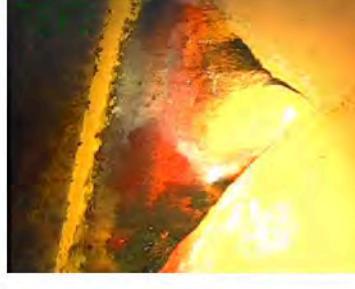
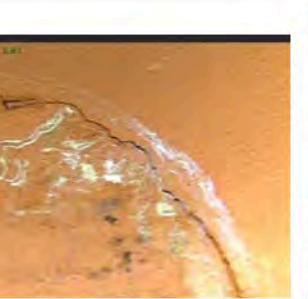
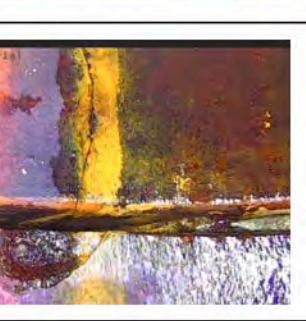
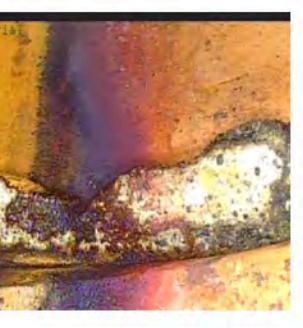
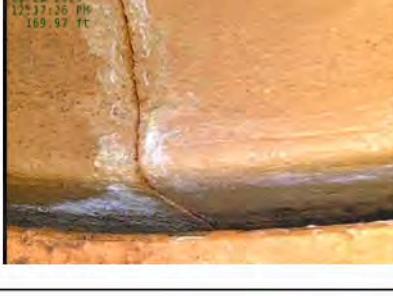
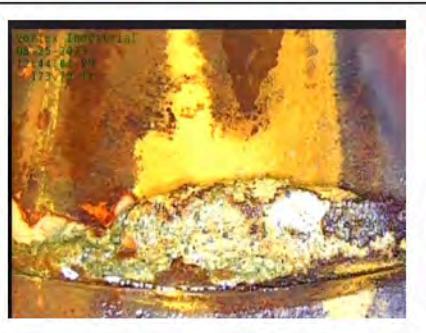
Description	Spatial Type	Distance (ft)	Туре	Percent	Clock	SR	O&M	С	PR	Remarks	
Crack Multiple	Point	166	Structural	0	7-9	3	0	0	1	Crack Multiple	Vortex Indust 00.25.2023 12:33:30 PH 155.90 Pt
Crack Multiple	Point	166	Structural	0	3-5	2	0	0	1	Crack Multiple	Dorfter - Todas / / / / / / / / / / / / / / / / / / /
Crack Multiple	Point	170	Structural	0	2-5	3	0	0	1	Crack Multiple	Description of the second seco
Crack Longitudinal	Point	170	Structural	0	7	2	0	0	1	Crack Longitudinal	Wortex Industr 08 25-2023 12:50-06 ft
Deposits Attached Encrustation	Point	173.8	O&M	10	4-6	0	2	0	0	Deposits Attached Encrustation	Portex Industrial BE-25-2023 12:42:21 PM 271.77 ft

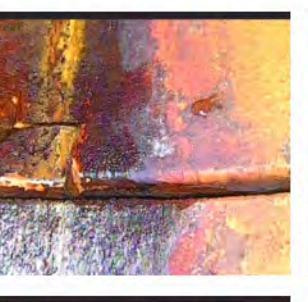
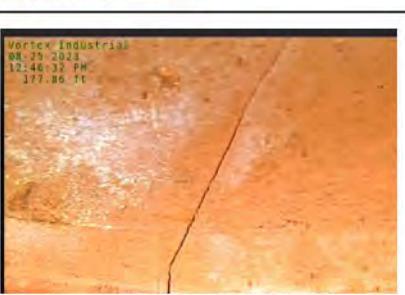
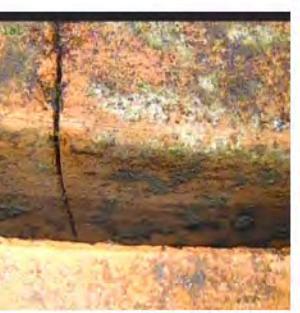
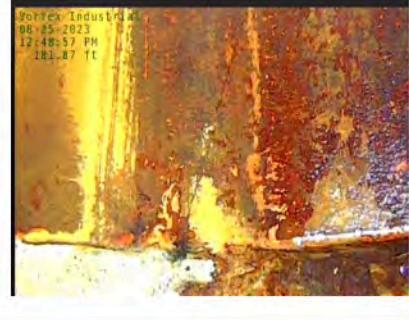
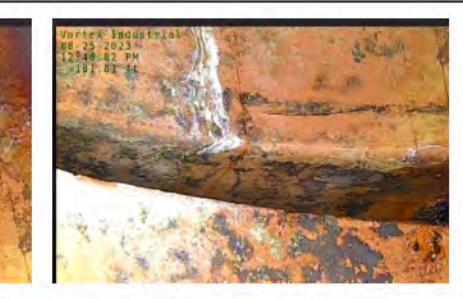
Description	Spatial Type	Distance (ft)	Туре	Percent	Clock	SR	O&M	С	PR	Remarks	
Crack Longitudinal	Point	173.8	Structural	0	8	2	0	0	1	Crack Longitudinal	Vortex Industr 08-25-2023 12:43:30 PM 173.70 ft
Crack Multiple	Point	177.9	Structural	0	6-9	3	0	0	1	Crack Multiple	Image: State of the state
Crack Longitudinal	Point	177.9	Structural	0	12	2	0	0	1	Crack Longitudinal	
Crack Spiral	Point	181.9	Structural	0	1-6	2	0	0	1	Crack Spiral	We to Ke Industrial We are the training of th
Crack Multiple	Point	181.9	Structural	0	7-8	3	0	0	1	Crack Multiple	Vortez Tradu 670,00 86 55 2003 17:457,55 PM 1931,48 51

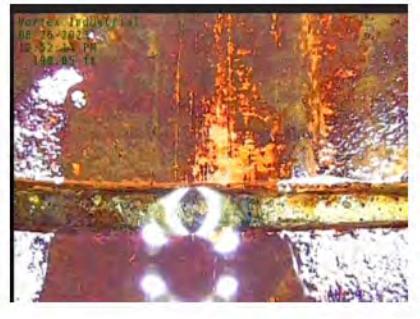
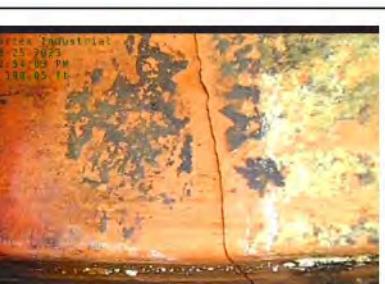
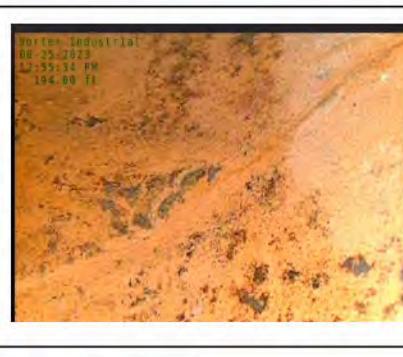
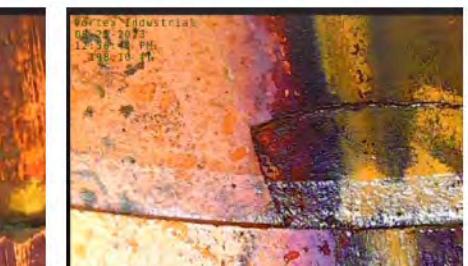
Description	Spatial Type	Distance (ft)	Туре	Percent	Clock	SR	O&M	С	PR	Remarks	
Crack Longitudinal	Point	186	Structural	0	7	2	0	0	1	Crack Longitudinal	90/tsv Industr 08/25-2023 12:50:58 PM 180:04 ft
Crack Spiral	Point	190.1	Structural	0	6-10	2	0	0	2	Crack Spiral	Vertex Industre Marza-2923 13:52:54 FM 196-05 71
Crack Spiral	Point	190.1	Structural	0	4-5	2	0	0	1	Crack Spiral	
Crack Spiral	Point	194	Structural	0	2-5	2	0	0	1	Crack Spiral	00/fter Industrial 02/fter 20 PM 12/57/20 PM 194.00 Tt
Crack Spiral	Point	198.1	Structural	0	6-7	1	0	0	1	Crack Spiral

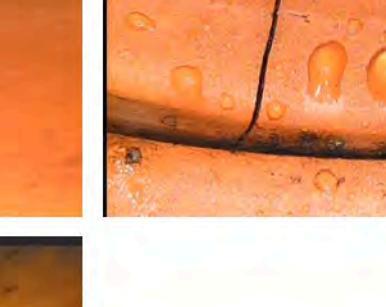
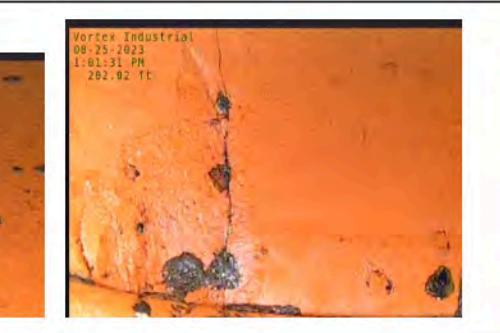
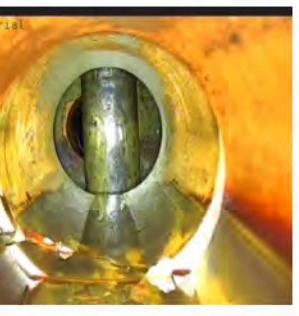
Description	Spatial Type	Distance (ft)	Туре	Percent	Clock	SR	O&M	С	PR	Remarks	
Crack Longitudinal	Point	198.1	Structural	0	4	2	0	0	1	Crack Longitudinal	Uff que 1 - 3 adus 1 off 425 - 2023 12 (37) 49 Pm 196-10 7 1 1 1 1 1 1 1 1 1 1 1 1 1 1
Crack Multiple	Point	202	Structural	0	11-4	3	0	0	2	Crack Multiple	Vorter Industrial 1932 52 2023 1932 12 PF 202.02 ft 202.02 ft 1930 10 PF 202.02 ft 1930 10 PF 1930 10 PF 193
Crack Longitudinal	Point	202	Structural	0	11	2	0	0	1	Crack Longitudinal	Vortes Industrial 86 25 2023 1:01:37 PM 202.02 st
Joint Offset Medium	Point	206	Structural	0		3	0	0	2	Joint Offset Medium	Wortex Indust 88-25-2023 1:122:53 PH 284.16 ft

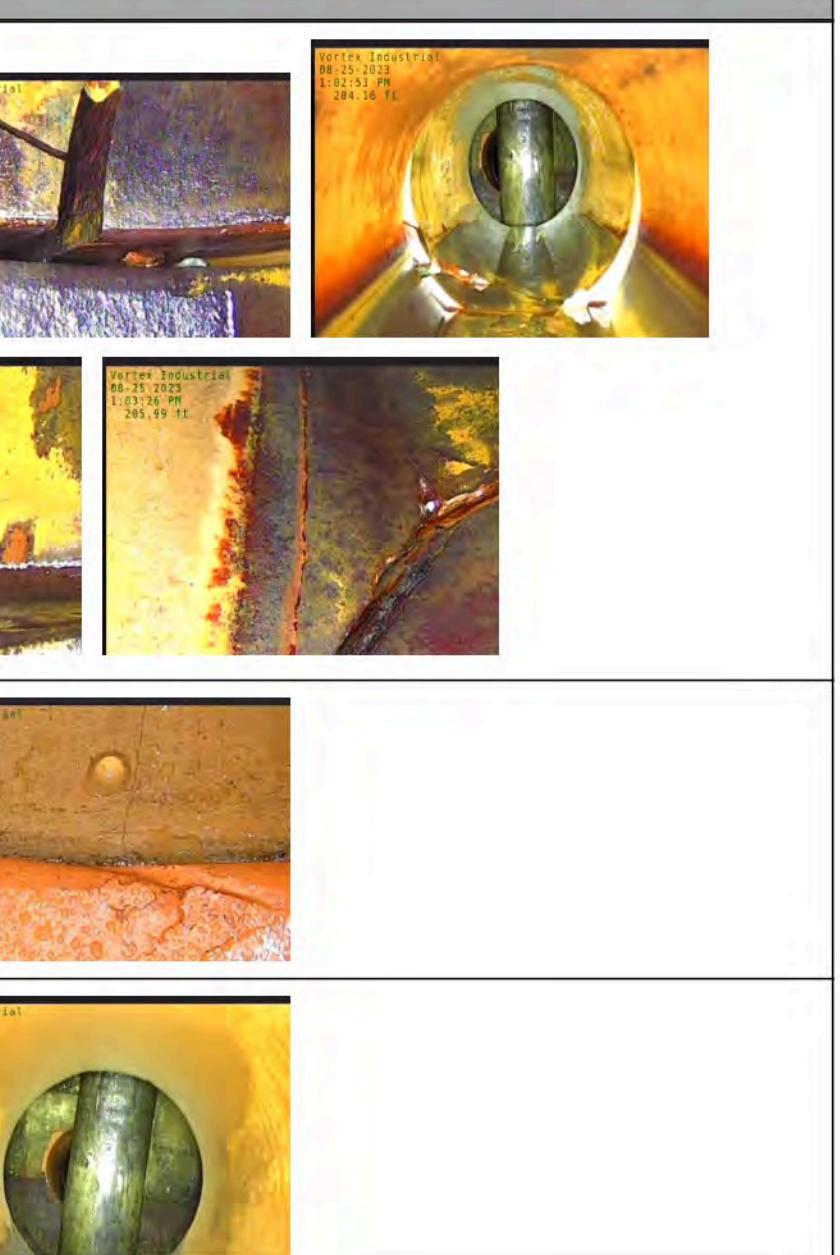
Description	Spatial Type	Distance (ft)	Туре	Percent	Clock	SR	O&M	С	PR	Remarks	
Broken	Point	206	Structural	0	5-8	4	0	0	4	Broken	
Crack Longitudinal	Point	206	Structural	0	1	2	0	0	1	Crack Longitudinal	99116x Indusf 00/25-2623 I-24-34 PT 205,35 ft 4 4
Manhole	Point	208.7	Constructional	0		0	0	0	0	В-3	Vortex Indust 06-25-2023 1:03:23 Pf 205:39 ft

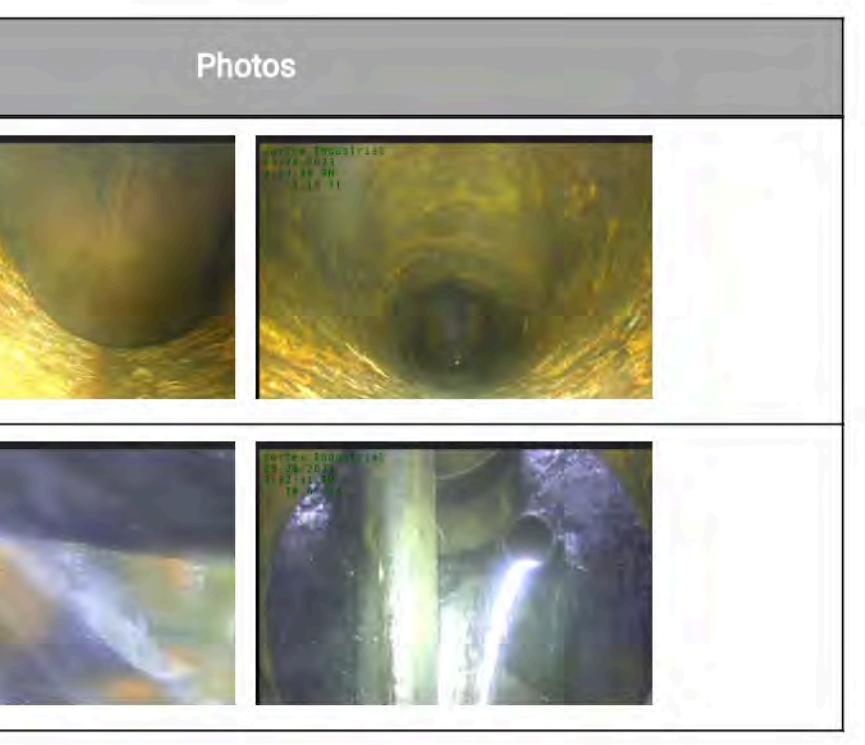
Setup ID	2023-32	2 Insp	ection Date	Aug 28, 202	23 In	spected	Lengt	h (ft)	2	1.5	Defects Rated ≥3	0	Peak Structural Rating	3	Tetal DD Defects	
Segment ID	D-21:D-2	2 Primary	/ Pipe Materi	al SP		Pipe Dia	meter	(in)	3	30	Peak Prioritization Rating	2	Peak C/O&M Rating	4	Total PR Defects	
Descrip	otion	Spatial Type	Distance (ft)	Туре	Percen	t Clock	SR	O&M	С	PR	Remarks		Ph	otos		
Manho	ole	Point	0	Constructional	0		0	0	0	0	D-21		The P is a second			
Miscellaneo Leve	ous Water el	Point	0	Miscellaneous	scellaneous 0 0 0		0	0	Water Level at Start of Survey							
Surface Da Corros	amage	Continuous	0 - 21.5	Structural	0	12- 12	3	0	0	2	Surface Damage Corrosion

Description	Spatial Type	Distance (ft)	Туре	Percent	Clock	SR	0&M	С	PR	Remarks	
Line Down	Point	5.1	Constructional	100		0	4	4	0	Line Down	рец на 1 ланияти и и н - 2 л 2013 и - 2 л 2013 и - 2 л 2014 2 74 - 1
Manhole	Point	21.5	Constructional	0		0	0	0	0	D-22	To see

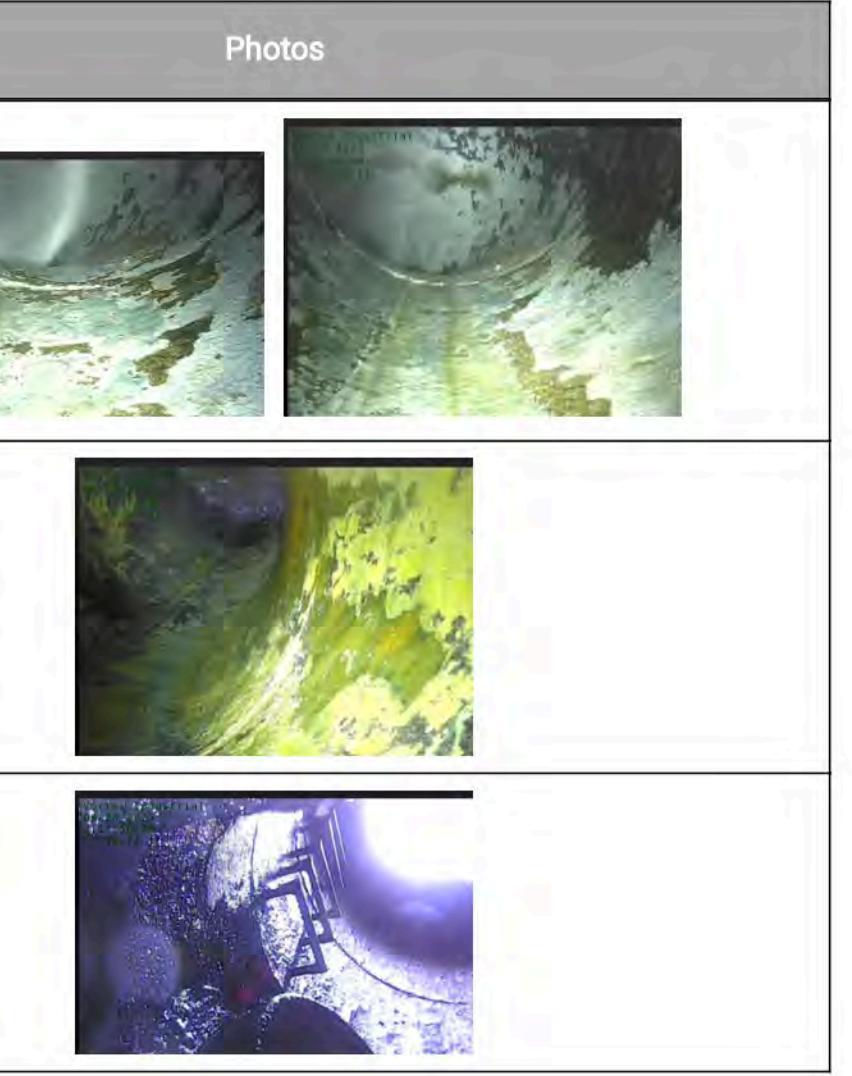
Setup ID	2023-33	Inspectio	n Date	Aug 28, 2023	Inspec	ted Leng	gth (ft)	16.2	Defects Rated ≥3			Peak Structural Rating	2	Total PR Defects	1
Segment ID	D-20C:D-22	Primary Pip	e Material	SP	Pipe	Diamete	er (in)		30	L.C	Peak Prioritization Rating	1	Peak C/O&M Rating	4	TOTALER DELECTS	
Desc	cription	Spatial Type	Distance (ft)	Туре	Percent	Clock	SR	0&M	С	PR	Remarks	E		Photos		
Mai	inhole	Point	0	Constructional	0		0	0	0	0	D-20C					
Miscellaneou	Miscellaneous Water Level		0	Miscellaneous	0		0	0	0	0	Water Level at Start of Survey		a constraint a de anotación a de a de a de a de a de a de a de a de			
Surface Dar Spa	mage Surface alling	Continuous	0 - 16.2	Structural	0	12- 12	2	0	0	1	Surface Damage Surface Spalling

Description	Spatial Type	Distance (ft)	Туре	Percent	Clock	SR	0&M	С	PR	Remarks	
Line Left Down	Point	6.2	Constructional	50		0	4	4	0	Line Left Down	
Line Right	Point	10.2	Constructional	15		0	4	2	0	Line Right	
Manhole	Point	16.2	Constructional	0		0	0	0	0	D-22

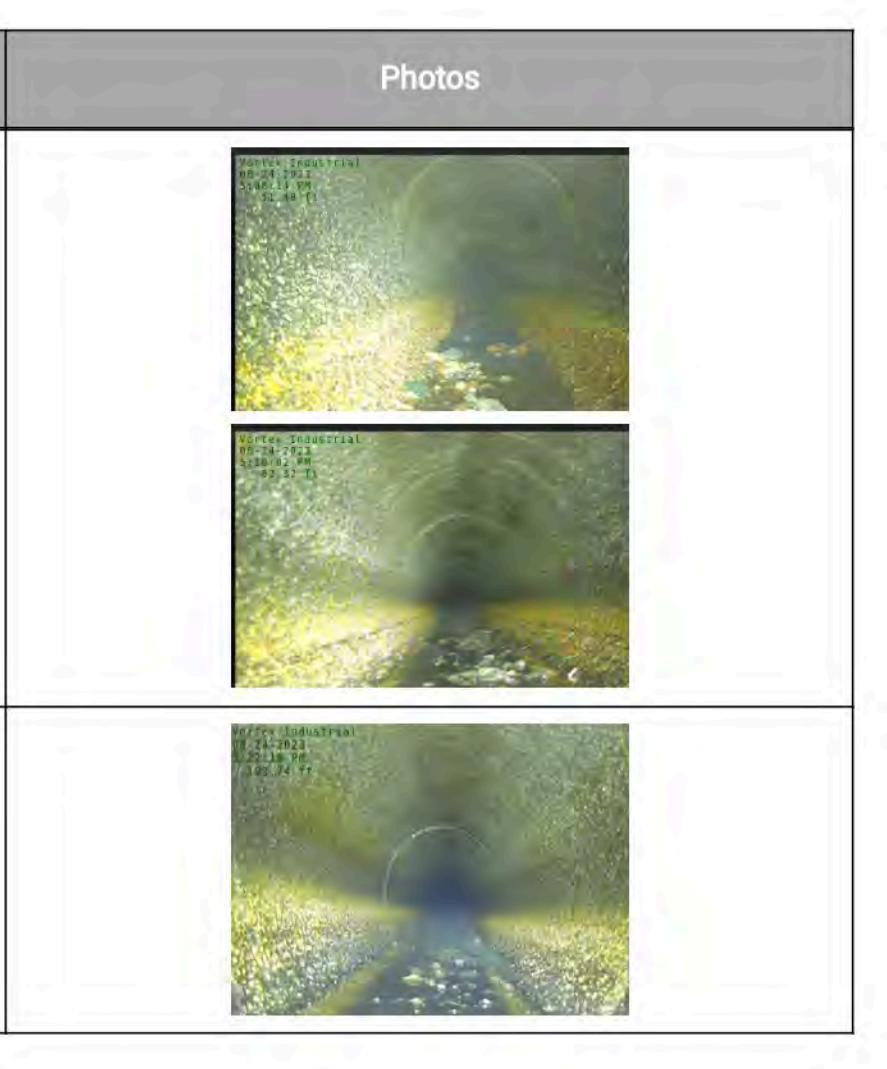
Setup ID Segment ID	2023-34 5-M:D-12	lns Prima	pection Date ry Pipe Materia	Aug 24,	2023 Inspecter	ed Lengtl iameter	n (ft) (in)	53. 21	4	Peal	Defect: k Priori	efects Rated ≥3 0 Prioritization Rating 2			uctural Rating O&M Rating	1	Total PR Defects	1
	Description		Spatial Type	Distance (ft)	Туре	Percent	Clock	SR	O&M	С	PR	R	emarks				Photos	
	Manhole		Point	0	Constructional	0		0 0 0 0 0 5-M				Vortes TrausIfial ne-24,222 radius pri SL 46 (r						
Miscella	aneous Water Lev	vel	Point	52.6	Miscellaneous	10		0	0	0	0	Water Level	Water Level at Start of Survey			Romon Jonan (1997) Henry Constraint State of the State State of the State State State of the State		
Surface I	Damage Roughne Increased	ess	Continuous	52.6 - 106	Structural	10	12- 12	1	0	0	2	Surface Damage Roughness Increased				Norte Insustrial Bardings Sumer Sume

Description	Spatial Type	Distance (ft)	Туре	Percent	Clock	SR	O&M	С	PR	Remarks
Deposits Settled Gravel	Continuous	52.6 - 106	O&M	10	6	0	2	0	0	Deposits Settled Gravel
Miscellaneous Survey Abandoned	Point	106	Miscellaneous	0		0	0	0	0	End of Inspection

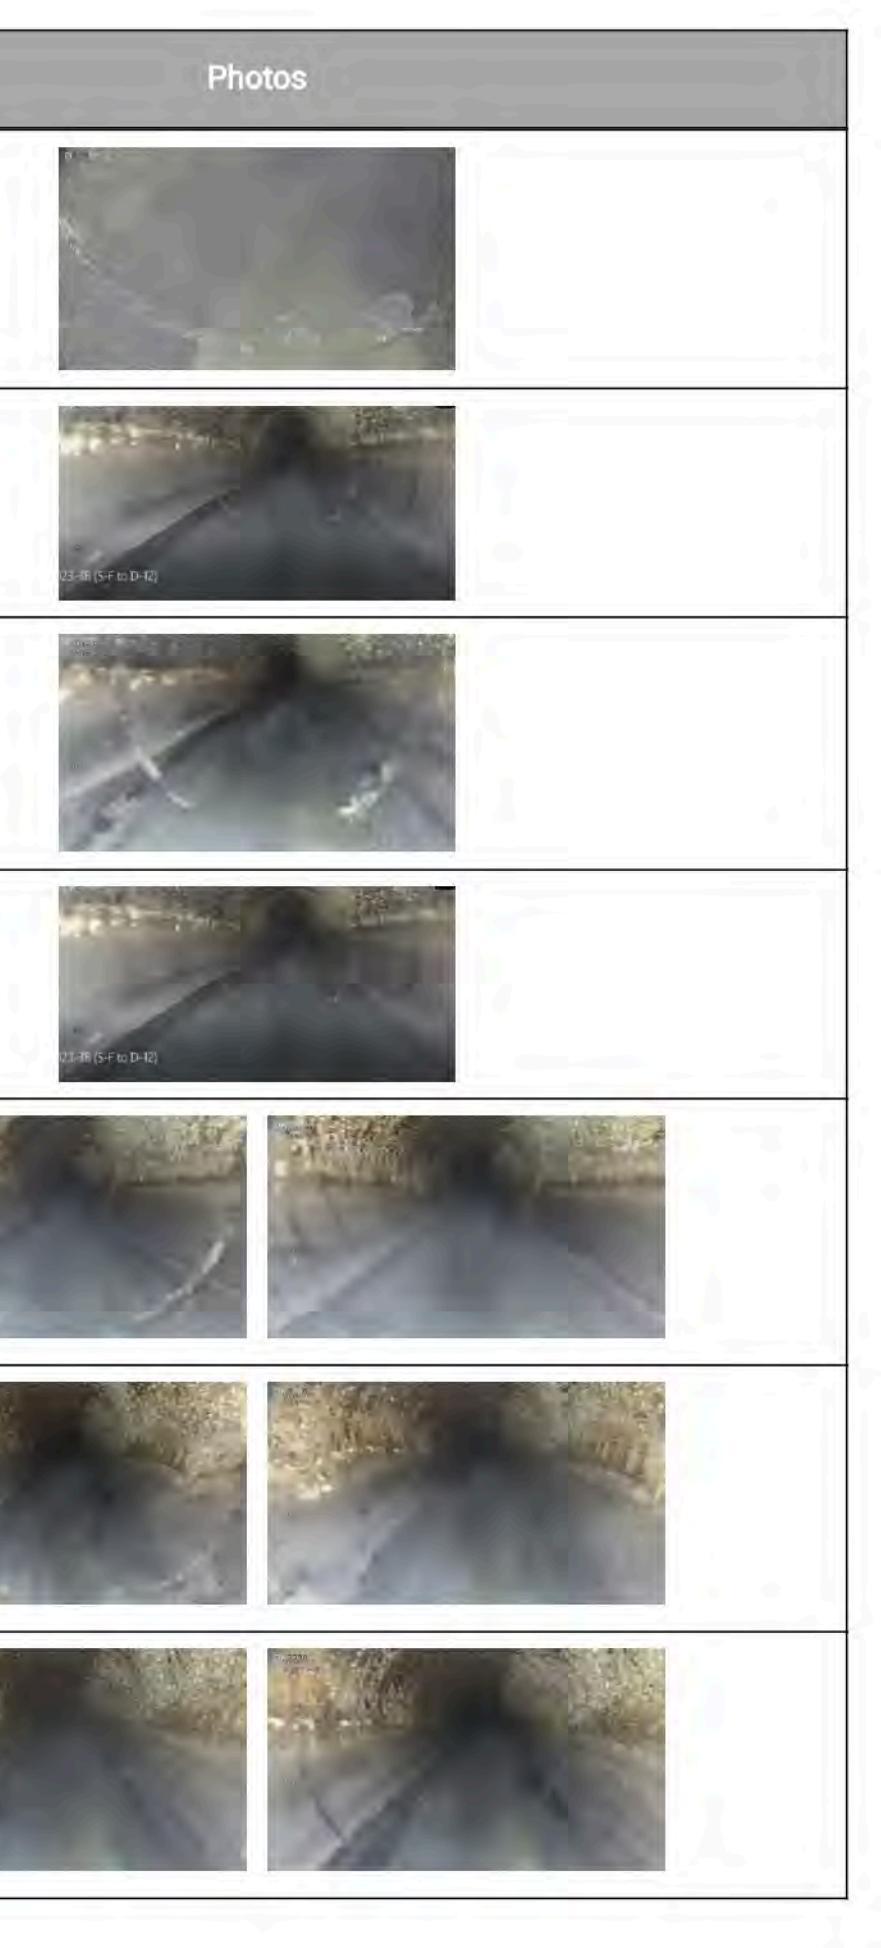
Setup ID	2023-36	Inspectio	on Date	Jan 17, 2024	1 Insp	ected L	ength	(ft)	136	.9	Defects Rated ≥3	2	Peak Structural Rating	4	Total DD Defects	10
Segment ID	5-F:D-12	Primary Pip	oe Material	RCP	Pip	e Diam	eter (ir	n)	21		Peak Prioritization Rating	3	Peak C/O&M Rating	2	Total PR Defects	19
Desc	ription	Spatial Type	Distance (ft)	Туре	Percent	Clock	SR	O&M	С	PR	Remarks		Ph	otos		
Mar	nhole	Point	0	Structural	0	111	0	0	0	0	5-F					
Miscellaneou	us Water Level	Point	0	Miscellaneous	0		0	0	0	0	Water Level at Start of Survey					
Surface Dam Vis	age Aggregate sible	Continuous	0 - 136.9	Structural	0	8-4	2	0	0	1	Surface Damage Aggregate Visible					
Surface Dam Mis	age Aggregate ssing	Point	5.6	Structural	0	8-9	4	0	0	2	Surface Damage Aggregate Missing	•

Description	Spatial Type	Distance (ft)	Туре	Percent	Clock	SR	O&M	С	PR	Remarks	
Deposits Attached Encrustation	Point	7.3	O&M	10	5-6	0	2	0	0	Deposits Attached Encrustation	
Crack Multiple	Point	23	Structural	0	8-10	1	0	0	1	Crack Multiple	
Intruding Sealing Material Grout	Point	26.4	Constructional	10	4-5	0	2	2	0	Intruding Sealing Material Grout	
Crack Circumferential	Point	28	Structural	0	3-4	1	0	0	1	Crack Circumferential	
Crack Multiple	Point	34.8	Structural	0	9-11	3	0	0	1	Crack Multiple	
Crack Longitudinal	Point	38.9	Structural	0	8	2	0	0	1	Crack Longitudinal	
Crack Circumferential	Point	40.8	Structural	0	8-10	1	0	0	1	Crack Circumferential

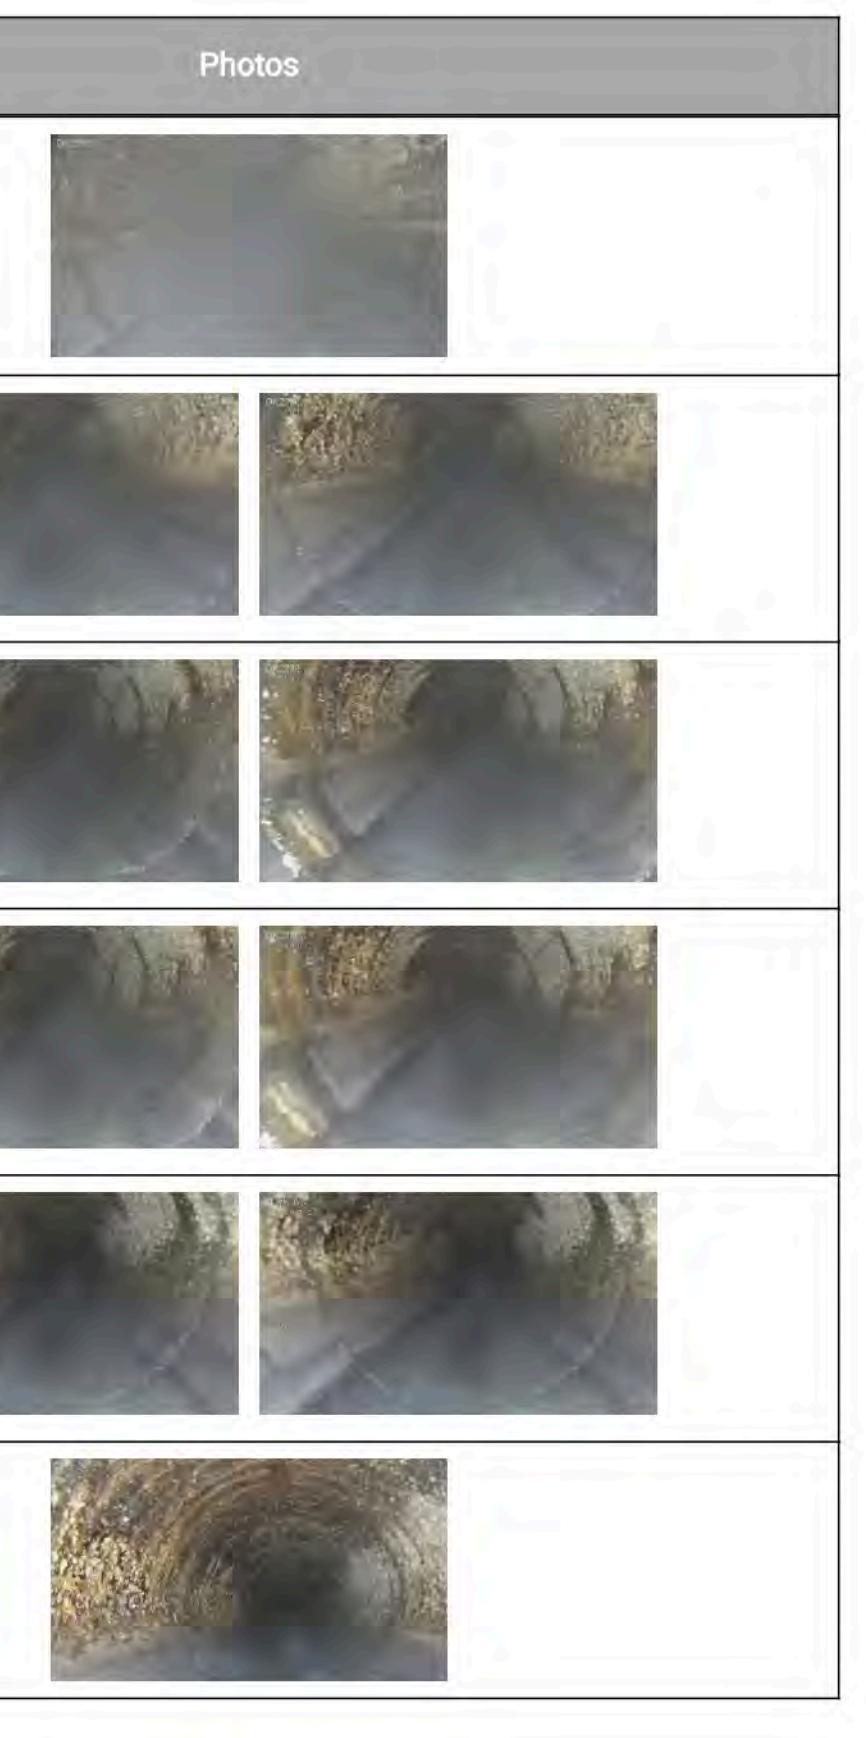
Description	Spatial Type	Distance (ft)	Туре	Percent	Clock	SR	O&M	C	PR	Remarks	
Crack Circumferential	Point	53.5	Structural	0	8-10	1	0	0	1	Crack Circumferential	
Crack Multiple	Point	59.7	Structural	0	7-10	3	0	0	1	Crack Multiple	
Crack Circumferential	Point	63.8	Structural	0	7-8	1	0	0	1	Crack Circumferential	
Surface Damage Aggregate Missing	Point	63.8	Structural	0	10	4	0	0	2	Surface Damage Aggregate Missing	
Surface Damage Aggregate Missing	Point	66.5	Structural	0	10	4	0	0	2	Surface Damage Aggregate Missing	
Surface Damage Reinforcement Visible	Point	69.3	Structural	0	9-3	4	0	0	3	Surface Damage Reinforcement Visible

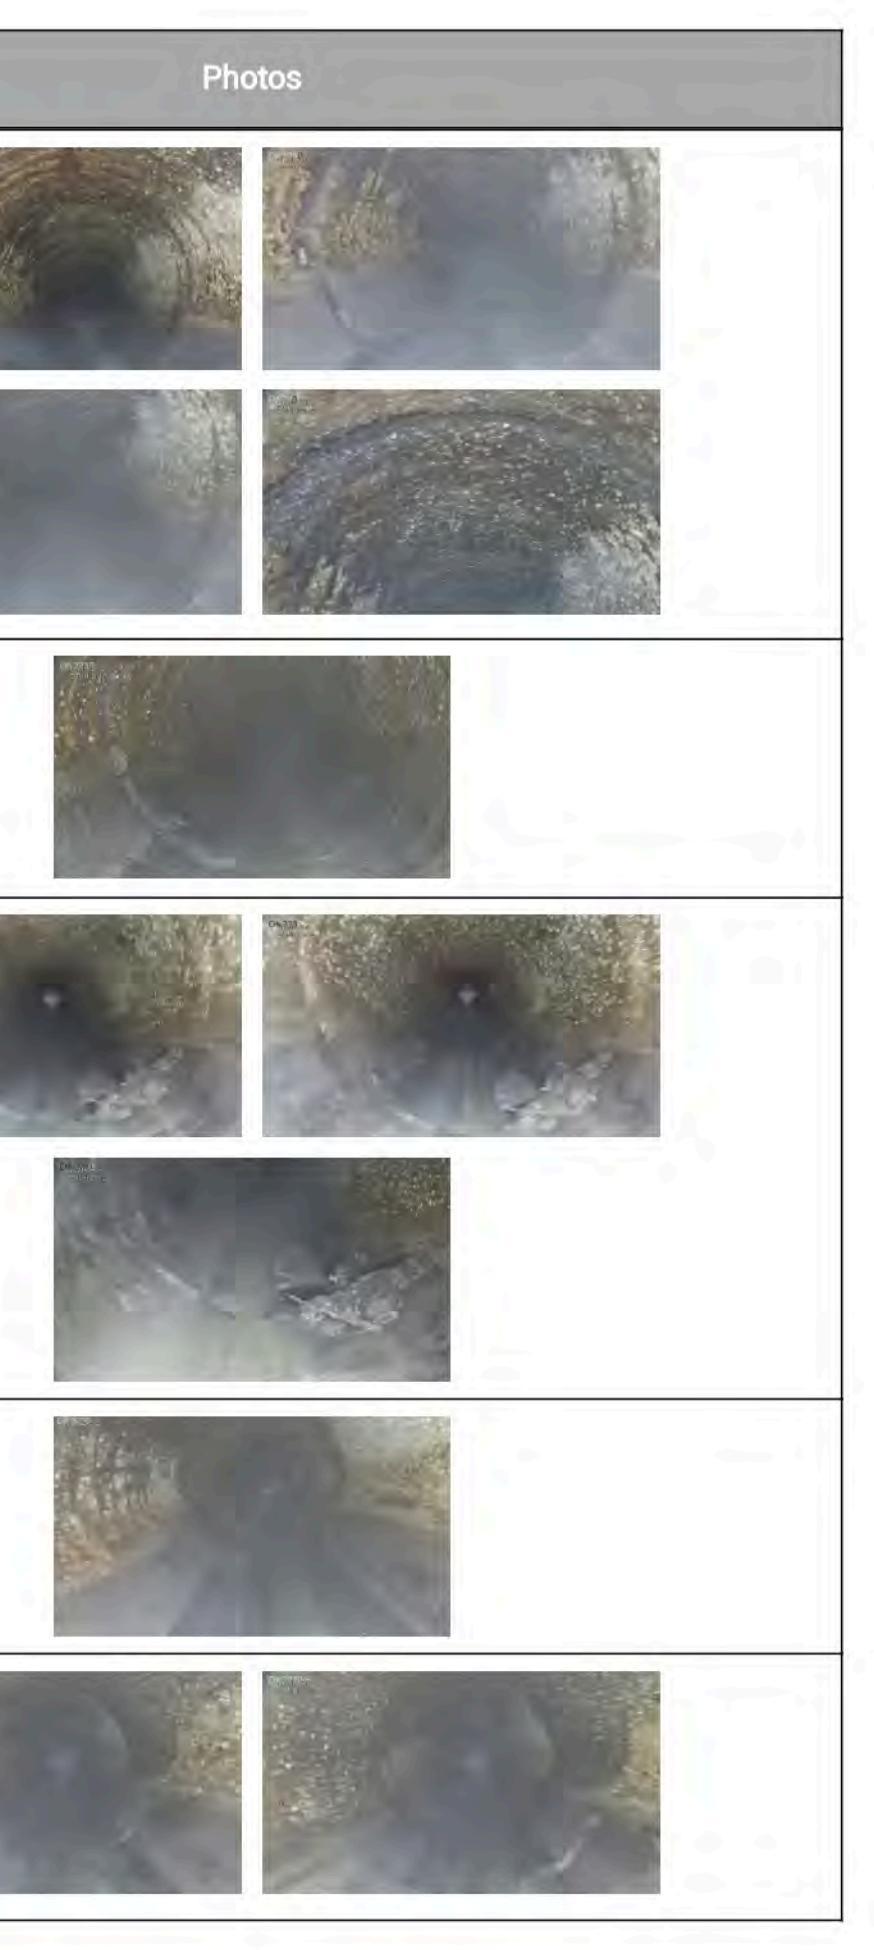
Description	Spatial Type	Distance (ft)	Туре	Percent	Clock	SR	O&M	С	PR	Remarks	1993
Joint Separated Medium	Point	72.2	Structural	0		3	0	0	1	Joint Separated Medium	
Intruding Sealing Material Grout	Point	79	O&M	10	6-9	0	2	0	1	Intruding Sealing Material Grout	
Deposits Settled Fine	Point	100.1	O&M	10	4-6	0	2	0	0	Deposits Settled Fine	
Surface Damage Reinforcement Visible	Point	111.8	Structural	0	9-10	4	0	0	3	Surface Damage Reinforcement Visible	
Crack Circumferential	Point	117	Structural	0	3-6	1	0	0	1	Crack Circumferential

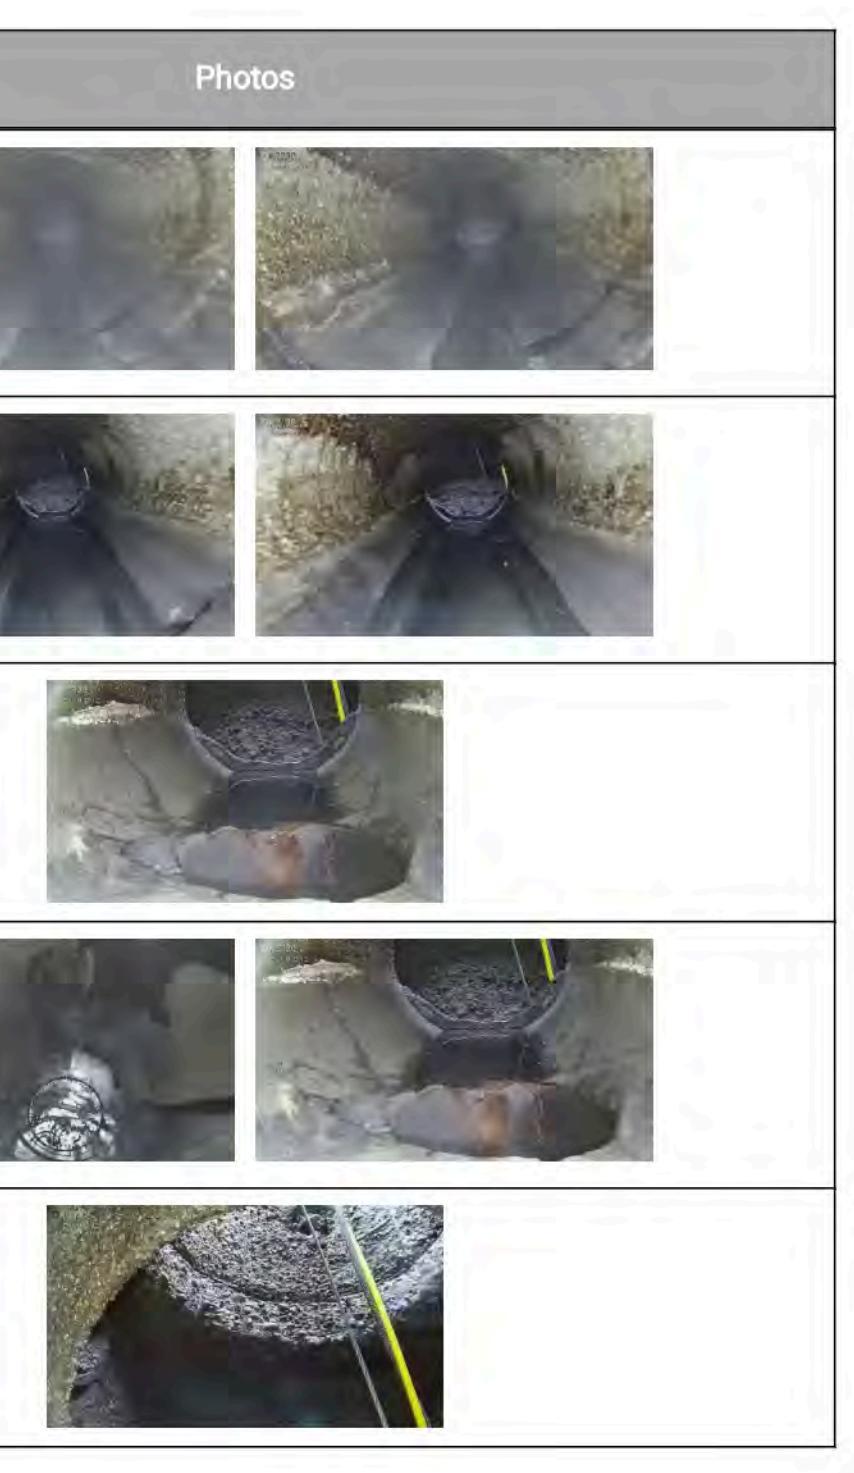
Description	Spatial Type	Distance (ft)	Туре	Percent	Clock	SR	O&M	С	PR	Remarks	
Crack Spiral	Point	124.1	Structural	0	3-6	2	0	0	1	Crack Spiral	
Miscellaneous Water Level	Point	127.5	Miscellaneous	10		0	0	0	0	Miscellaneous Water Level	
Crack Longitudinal	Point	134.1	Structural	0	7	2	0	0	1	Crack Longitudinal	
Tap Factory	Point	134.1	Constructional	0	6	0	0	0	0	Tap Factory	
Manhole	Point	136.9	Miscellaneous	0		0	0	0	0	D-12

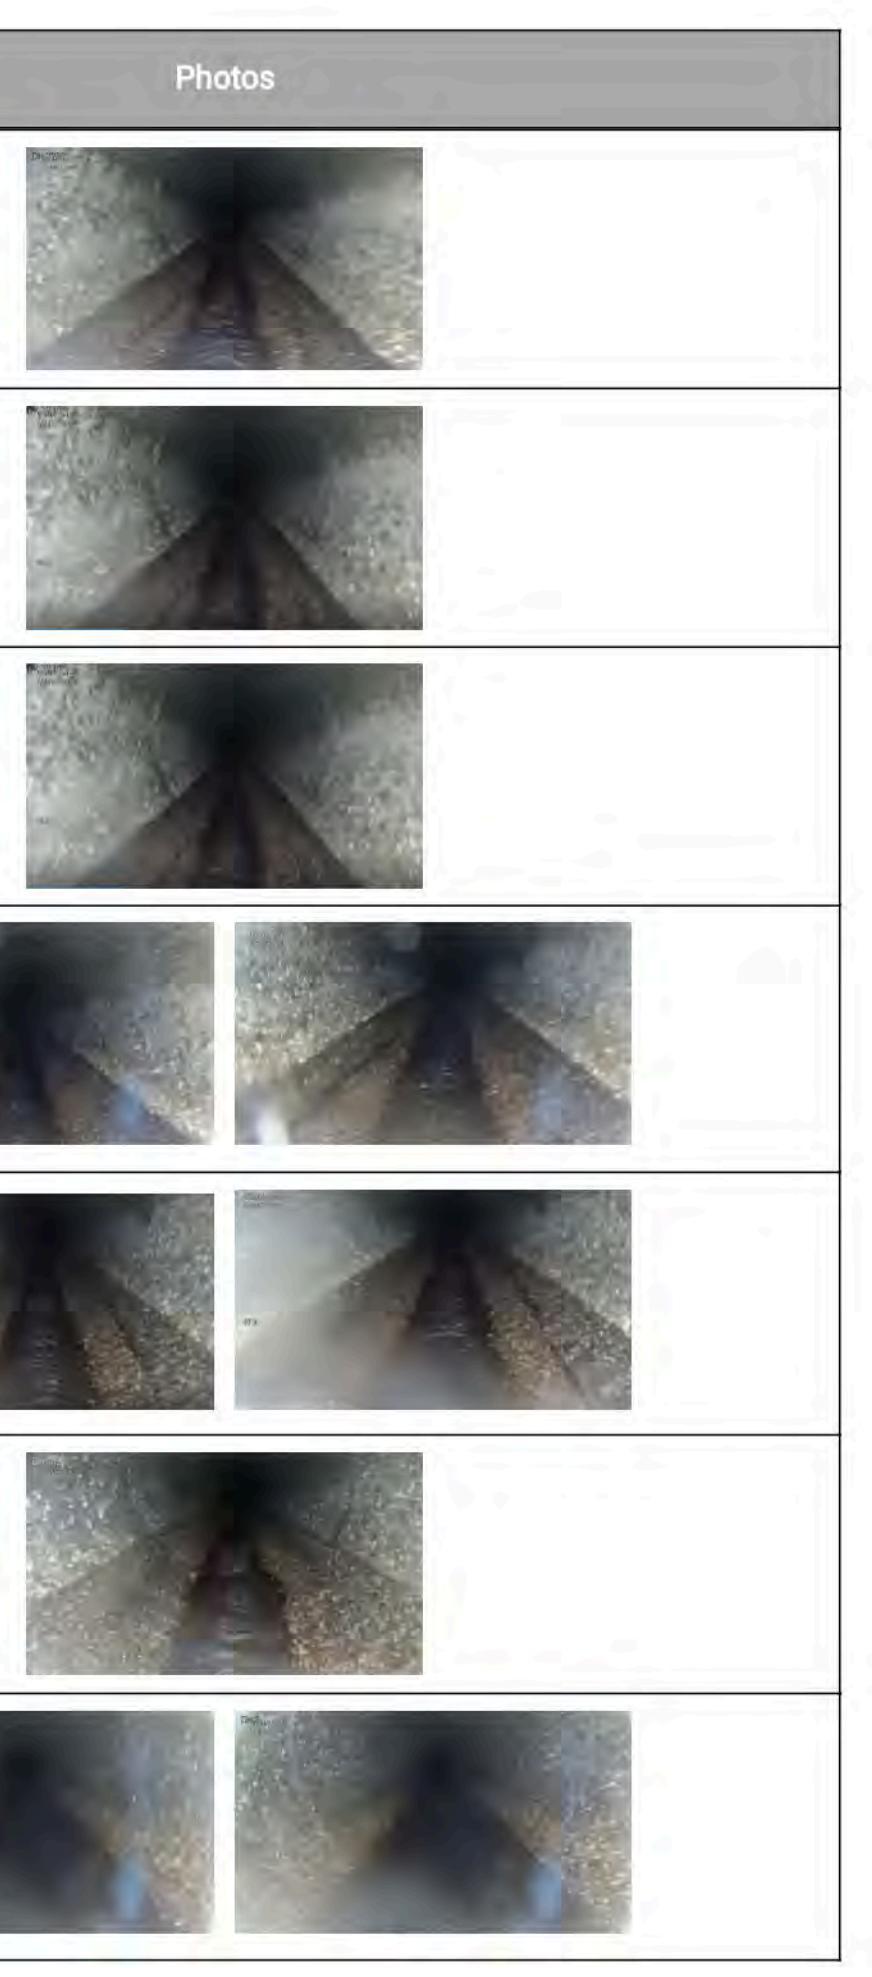
Description	Spatial Type	Distance (ft)	Туре	Percent	Clock	SR	0&M	С	PR	Remarks	
Miscellaneous Water Level	Point	15.8	Miscellaneous	0		0	0	0	0	Miscellaneous Water Level	
Crack Longitudinal	Point	17	Structural	0	7	2	0	0	2	Crack Longitudinal	
Crack Longitudinal	Point	17	Structural	0	5	2	0	0	2	Crack Longitudinal	
Crack Longitudinal	Point	22.5	Structural	0	7	3	0	0	2	Crack Longitudinal	
Crack Longitudinal	Continuous	27 - 31	Structural	0	4	2	0	0	1	Crack Longitudinal	
Miscellaneous Water Level	Point	32.2	Miscellaneous	10		0	0	0	0	Miscellaneous Water Level	
Miscellaneous Water Level	Point	55.9	Miscellaneous	20		0	0	0	0	Miscellaneous Water Level

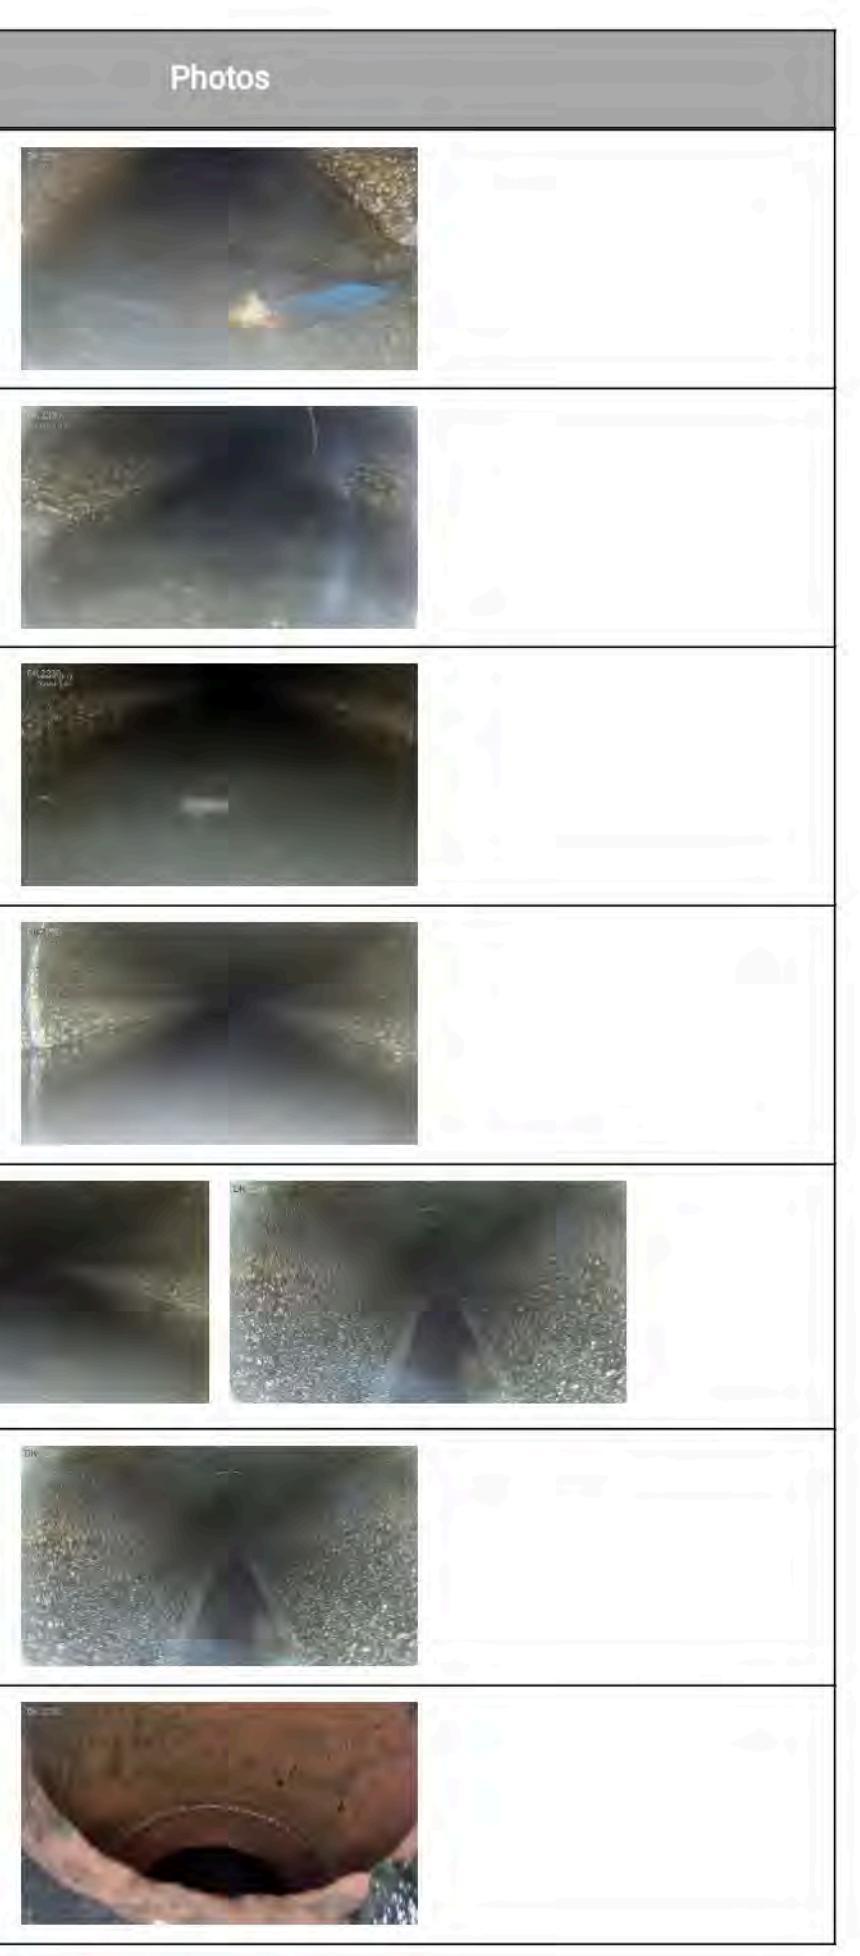
Description	Spatial Type	Distance (ft)	Туре	Percent	Clock	SR	0&M	С	PR	Remarks	
Intruding Sealing Ring	Point	67.4	O&M	10	5-7	0	2	0	0	Intruding Sealing Ring	
Miscellaneous Water Level	Point	130.4	Miscellaneous	30		0	0	0	0	Miscellaneous Water Level	
Miscellaneous Water Level	Point	157.7	Miscellaneous	40		0	0	0	0	Miscellaneous Water Level	
Miscellaneous Water Level	Point	164.1	Miscellaneous	50		0	0	0	0	Miscellaneous Water Level	
Miscellaneous General Observation	Point	165	Miscellaneous	0		0	0	0	0	Video cuts and resumes without distance counter	
Miscellaneous Water Level	Point	165	Miscellaneous	0		0	0	0	0	Miscellaneous Water Level	
Tap Factory	Point	200.6	Constructional	0	6	0	0	0	0	Tap Factory
