2024 ANNUAL PROGRESS REPORT SWMU-1 OILY WATER SEWER

HF SINCLAIR PUGET SOUND REFINING LLC

March 2025

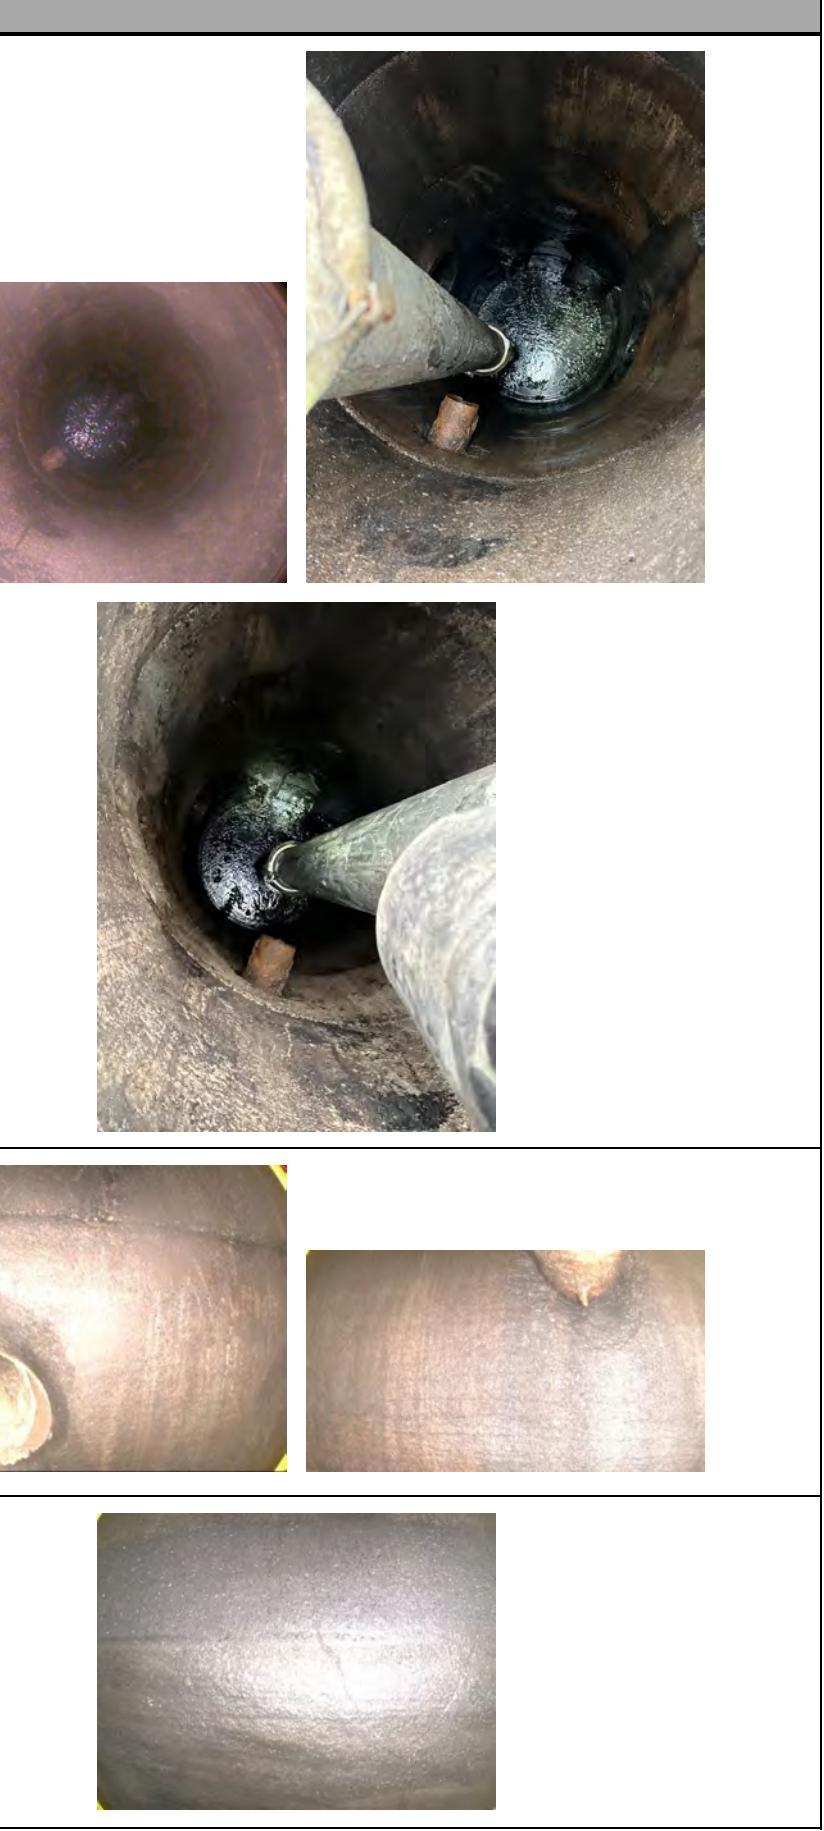
Description	Spatial Type	Distance (ft)	Туре	Percent	Clock	SR	O&M	С	ER	Remarks	
Miscellaneous General Photograph	Point	0	Miscellaneous	0		0	0	0	0	View Down Structure	
Surface Damage Aggregate Missing	Point	4	Structural	0	3	4	0	0	1	Surface Damage Aggregate Missing	
Crack Longitudinal	Point	8.4	Structural	0	5	2	0	0	1	Crack Longitudinal

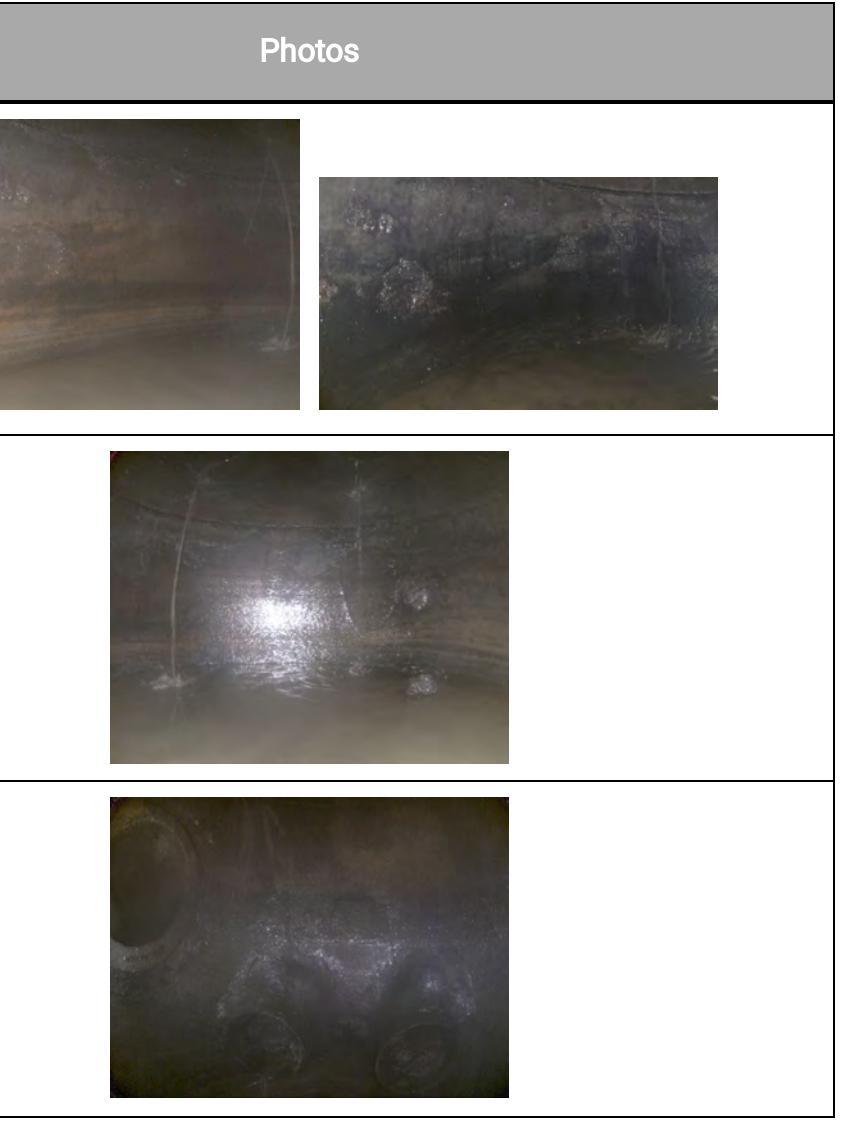
Description	Spatial Type	Distance (ft)	Туре	Percent	Clock	SR	O&M	С	ER	Remarks	
Surface Damage Aggregate Missing	Point	11.7	Structural	0	5	4	0	0	1	Surface Damage Aggregate Missing	
Surface Damage Aggregate Visible	Point	12	Structural	0	8	2	0	0	1	Surface Damage Aggregate Visible	
Surface Damage Roughness Increased	Point	12	Structural	0	7-9	1	0	0	1	Surface Damage Roughness Increased

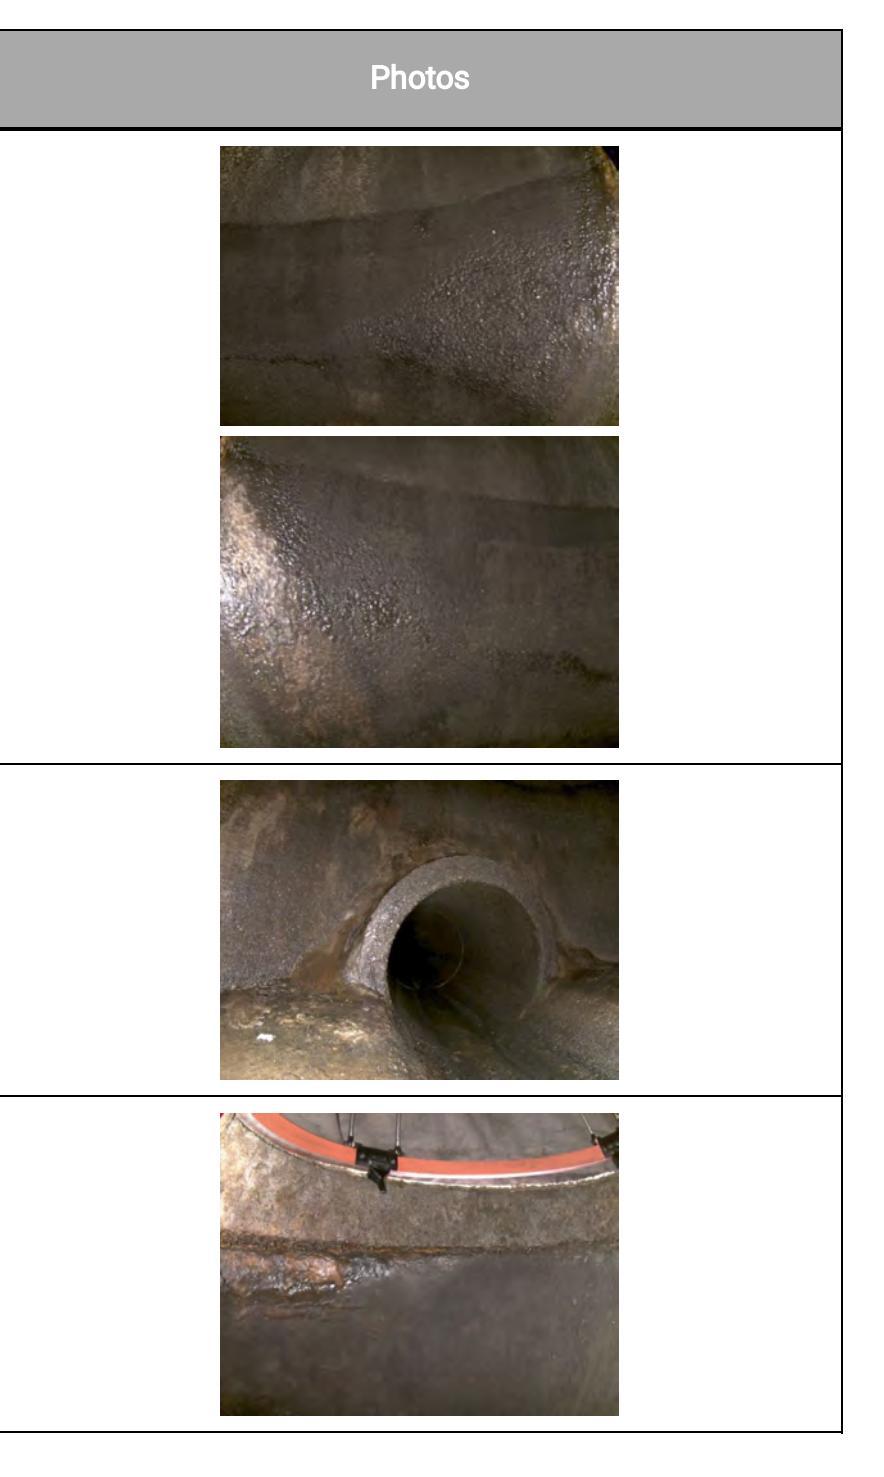
Description	Spatial Type	Distance (ft)	Туре	Percent	Clock	SR	O&M	С	ER	Remarks
Surface Damage Roughness Increased	Point	4	Structural	0	12-5	1	0	0	1	Surface Damage Roughness Increased
Surface Damage Roughness Increased	Point	6.2	Structural	0	6	1	0	0	1	Surface Damage Roughness Increased
Surface Damage Aggregate Missing	Point	12	Structural	0	2	4	0	0	2	Surface Damage Aggregate Missing

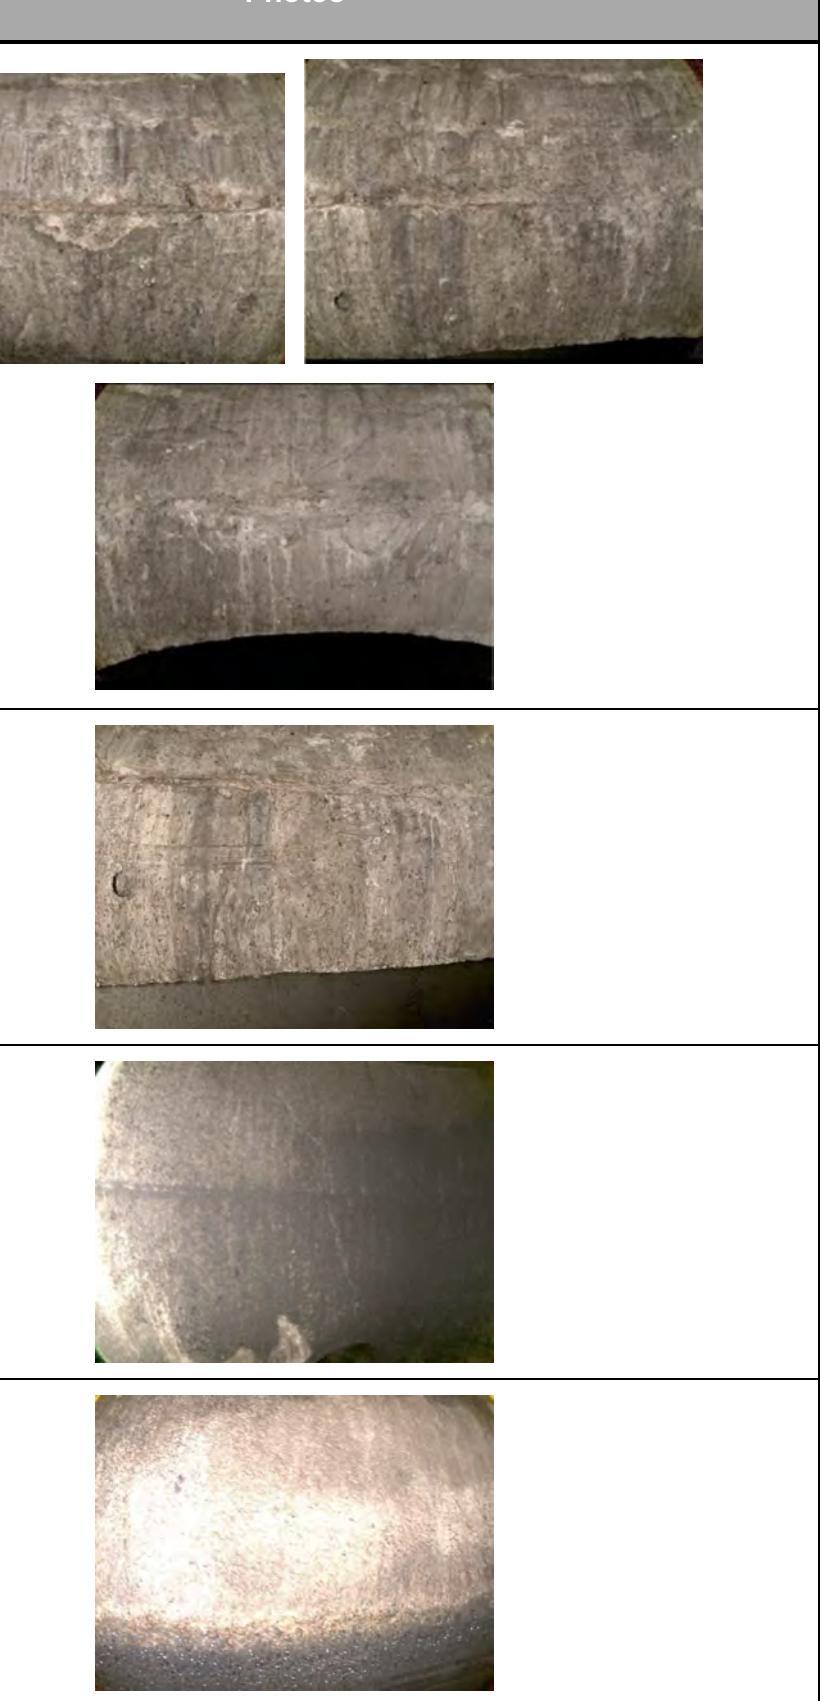
Description	Spatial Type	Distance (ft)	Туре	Percent	Clock	SR	O&M	С	ER	Remarks	
Fracture Circumferential	Point	1.8	Structural	0	12- 12	3	0	0	1	Fracture Circumferential	
Fracture Circumferential	Point	3	Structural	0	2-3	3	0	0	2	Fracture Circumferential	
Crack Longitudinal	Point	3.5	Structural	0	05	2	0	0	2	Crack Longitudinal	
Surface Damage Roughness Increased	Point	6.7	Structural	0	12- 12	1	0	0	1	Surface Damage Roughness Increased

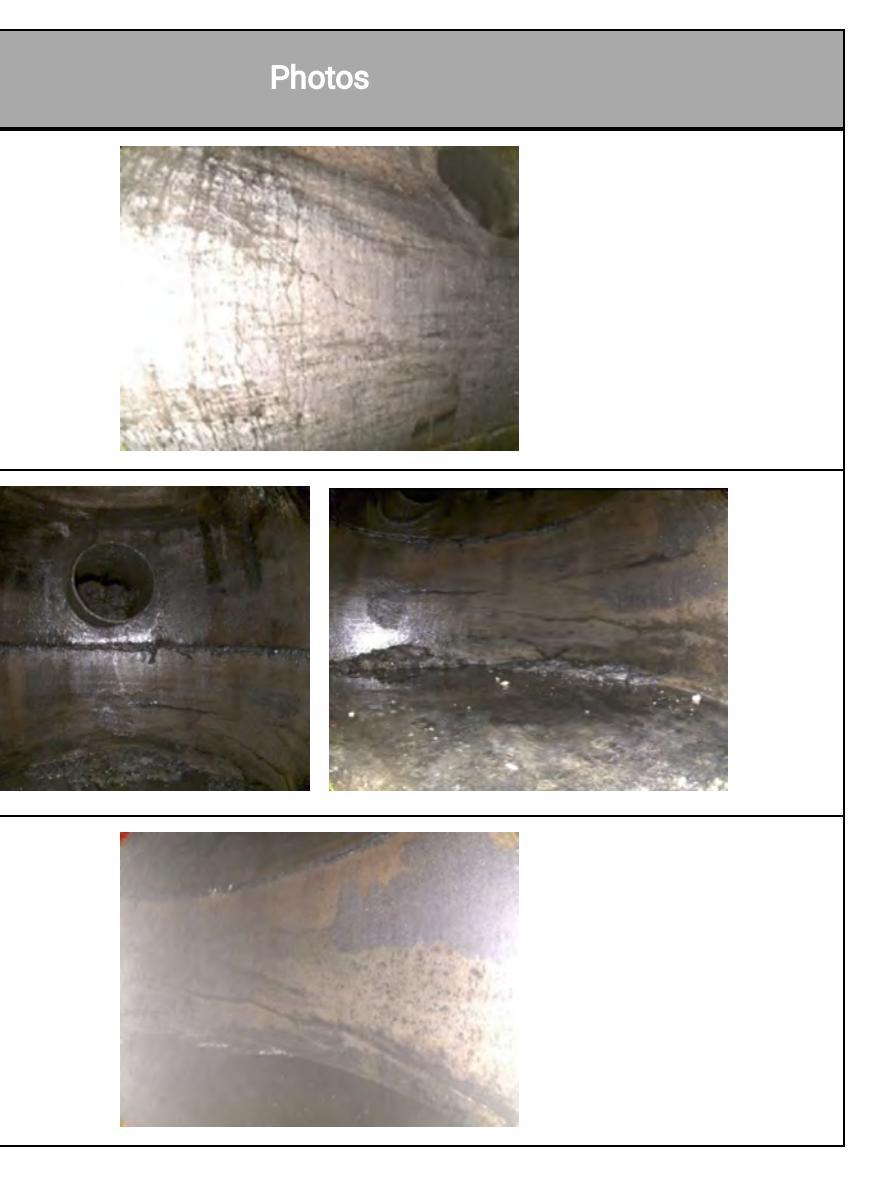
Description	Spatial Type	Distance (ft)	Туре	Percent	Clock	SR	O&M	С	ER	Remarks	
Crack Circumferential	Point	8	Structural	0	4-5	2	0	0	2	Crack Circumferential	
Deposits Other	Point	10	O&M	0	5	0	0	0	0	Deposits Other	
Crack Circumferential	Point	11	Structural	0	11- 03	2	0	0	2	Crack Circumferential

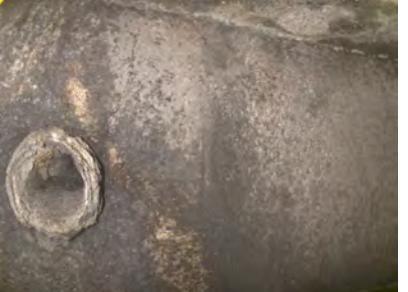
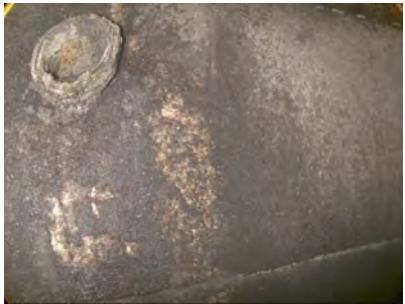
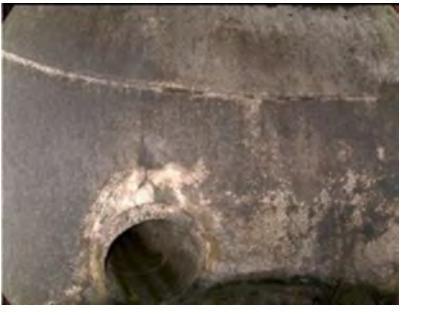
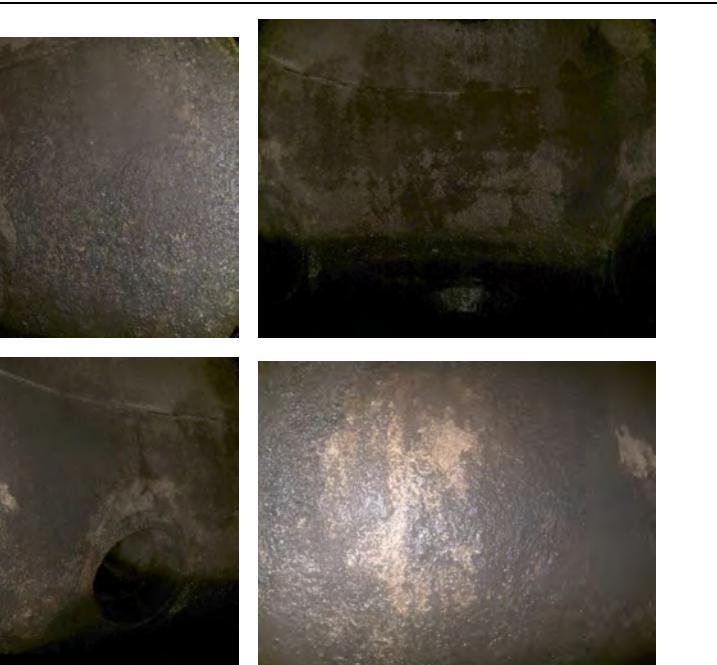
Description	Spatial Type	Distance (ft)	Туре	Percent	Clock	SR	O&M	С	ER	Remarks	
Surface Damage Roughness Increased	Point	2	Structural	0	9-10	1	0	0	1	Surface Damage Roughness Increased	
Crack Longitudinal	Point	3	Structural	0	6	2	0	0	2	Crack Longitudinal	
Surface Damage Roughness Increased	Continuous	3.5 - 5.2	Structural	0	12- 12	1	0	0	1	Surface Damage Roughness Increased

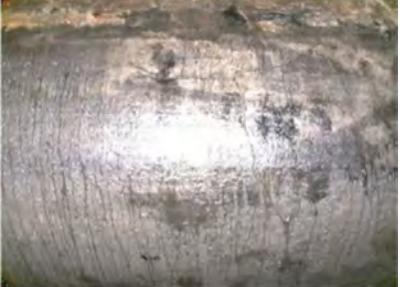
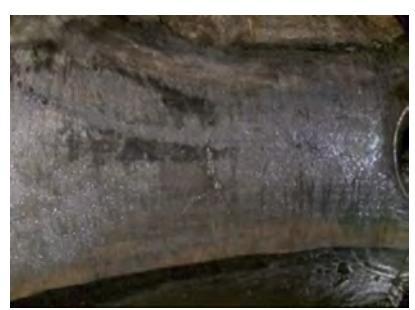
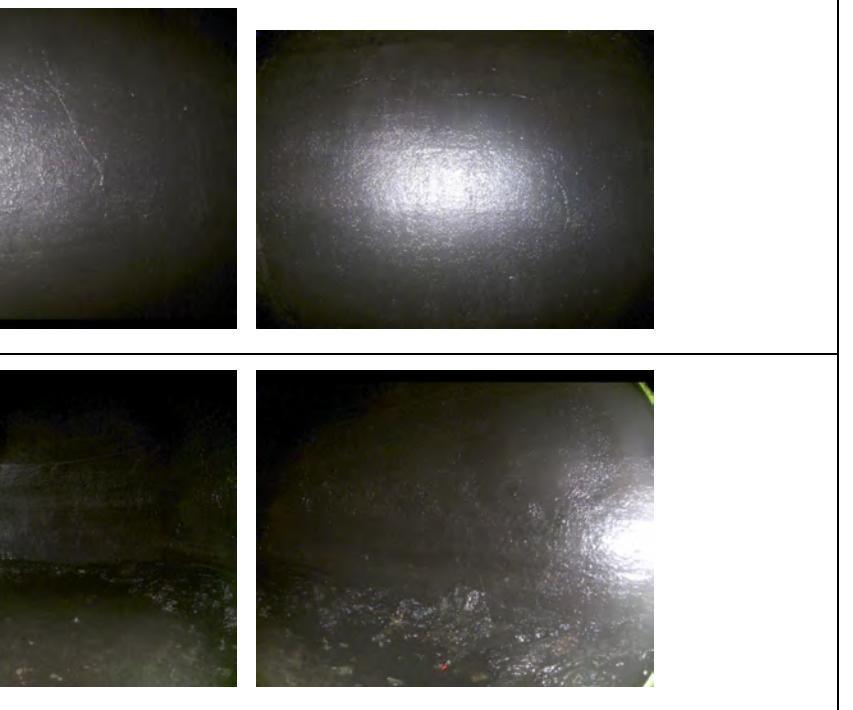
Descriptio	n	Spatial Type	Distance (ft)	Туре	Percent	Clock	SR	0&M	С	ER	Remarks	
Crack Multi	ple	Point	5.5	Structural	0	2-3	3	0	0	1	Crack Multiple	
Crack Longitu	dinal	Point	5.5	Structural	0	11	2	0	0	1	Crack Longitudinal	
Crack Longitu	dinal	Point	6	Structural	0	9	2	0	0	1	Crack Longitudinal	
Deposits Settle	d Other	Point	8	O&M	0	12- 12	0	0	0	0	Deposits Settled Other

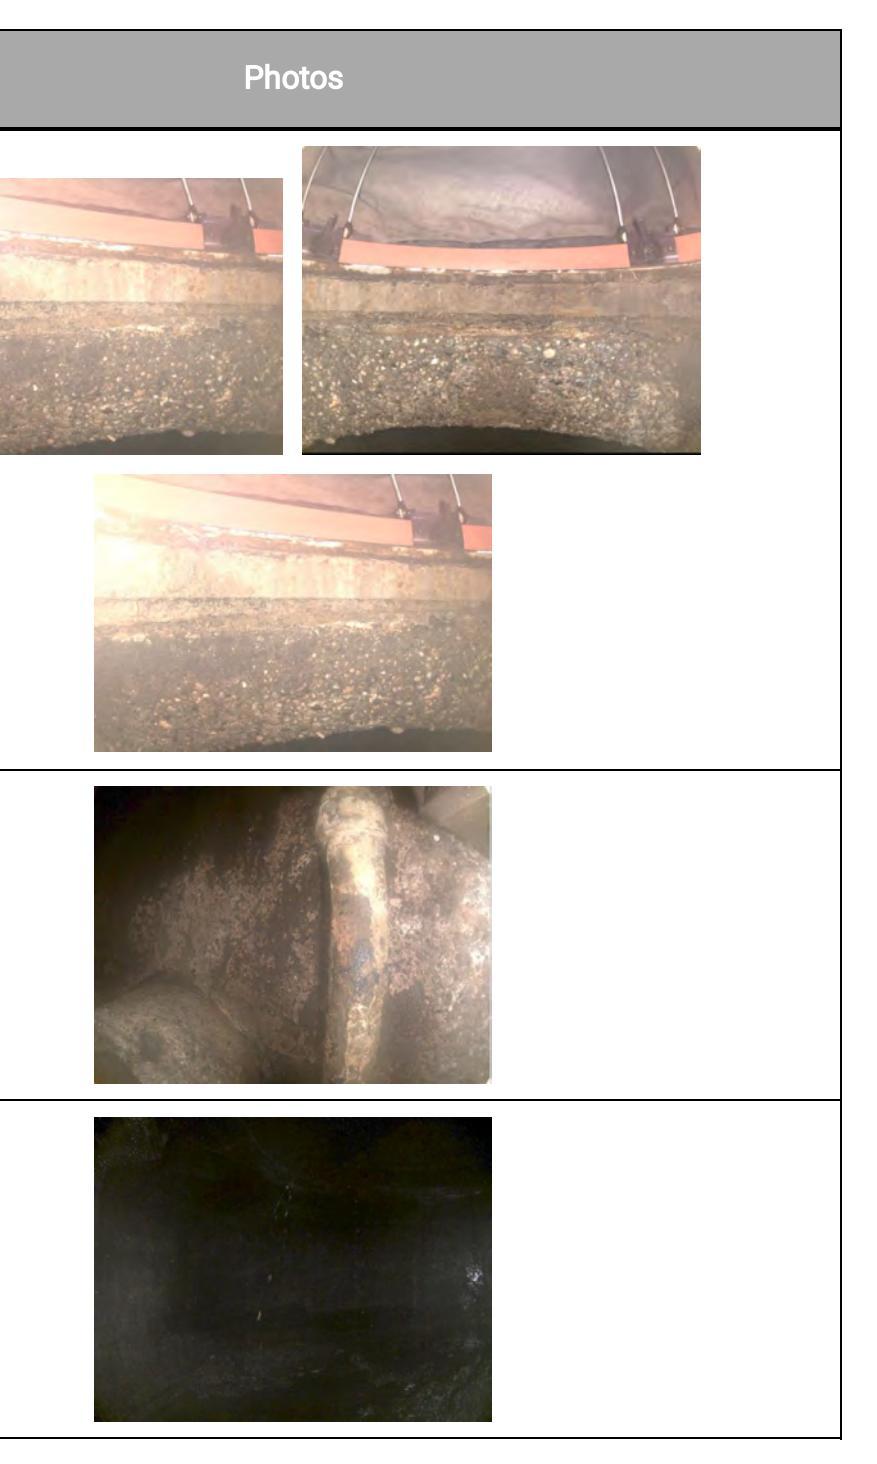
Description	Spatial Type	Distance (ft)	Туре	Percent	Clock	SR	O&M	С	ER	Remarks	
Surface Damage Aggregate Visible	Point	1	Structural	0	12- 12	2	0	0	1	Surface Damage Aggregate Visible	
Surface Damage Aggregate Visible	Continuous	2 - 4.4	Structural	0	9-2	2	0	0	1	Surface Damage Aggregate Visible	
Deposits Fine Settled	Point	7	O&M	10	12- 12	0	0	0	0	Deposits Fine Settled

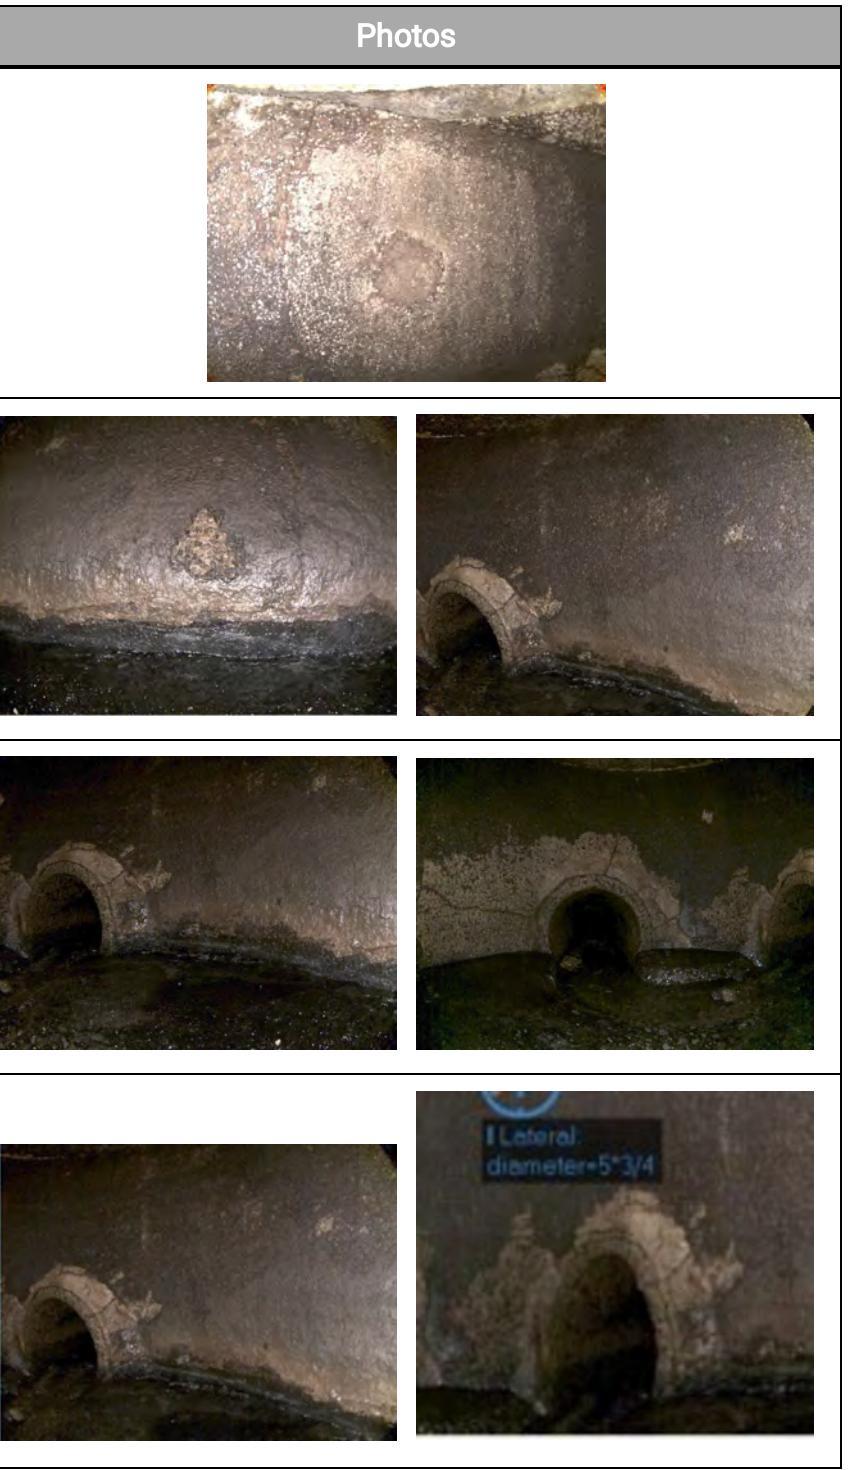
Description	Spatial Type	Distance (ft)	Туре	Percent	Clock	SR	O&M	С	ER	Remarks
Surface Damage Aggregate Missing	Point	1.3	Structural	0	2	4	0	0	1	Surface Damage Aggregate Missing
Surface Damage Aggregate Visible	Point	1.7	O&M	0	12	2	0	0	1	Surface Damage Aggregate Visible
Crack Multiple	Continuous	2 - 3	Structural	0	4-7	3	0	0	2	Crack Multiple
Crack Multiple	Point	2.5	Structural	0	9-10	3	0	0	2	Crack Multiple

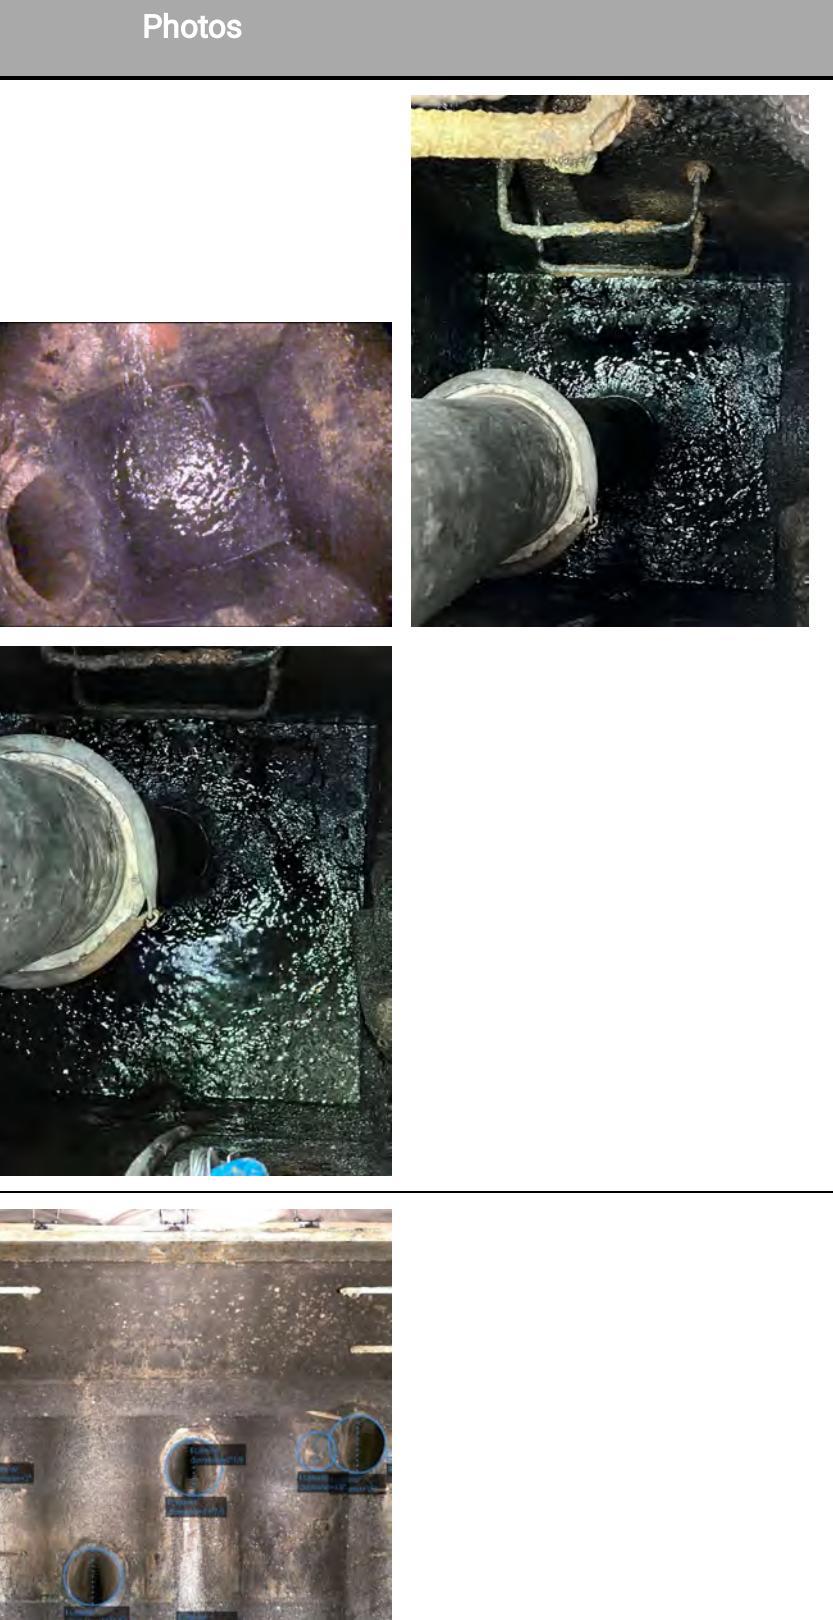
Description	Spatial Type	Distance (ft)	Туре	Percent	Clock	SR	O&M	С	ER	Remarks	
Miscellaneous General Photograph	Point	0	Miscellaneous	0		0	0	0	0	View Down Structure	
Miscellaneous General Photograph	Point	0	Miscellaneous	0		0	0	0	0	Side View of Structure

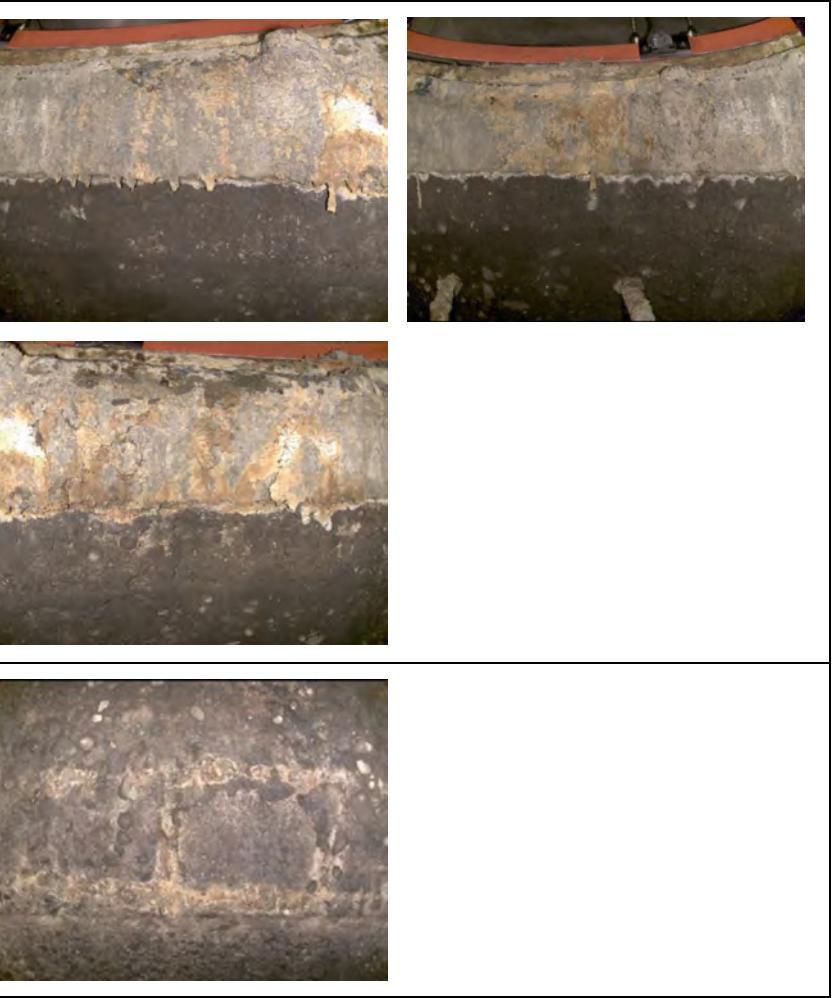
Description	Spatial Type	Distance (ft)	Туре	Percent	Clock	SR	0&M	С	ER	Remarks	
Surface Damage Roughness Increased	Continuous	1 - 2	Structural	0	12- 12	1	0	0	1	Surface Damage Roughness Increased	
Crack Multiple	Point	2.5	Structural	0	6-9	3	0	0	1	Crack Multiple

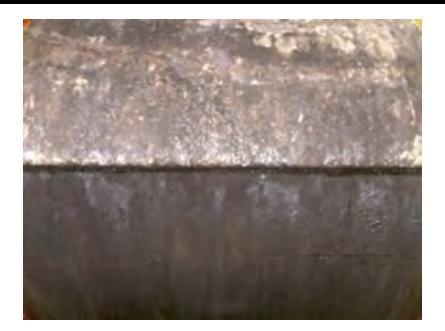
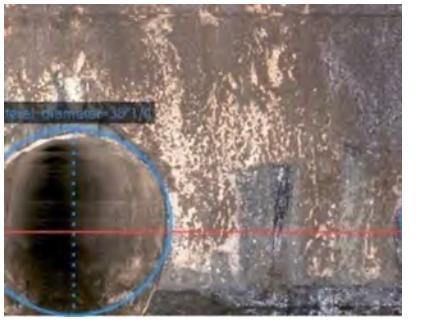
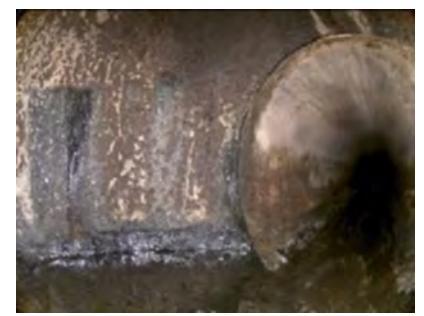
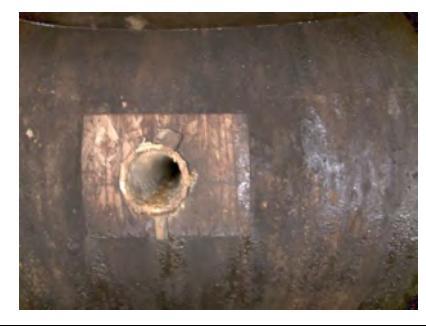
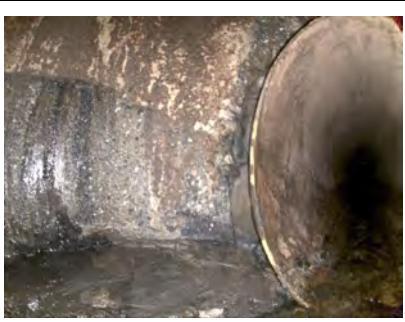
Description	Spatial Type	Distance (ft)	Туре	Percent	Clock	SR	0&M	С	ER	Remarks	
Crack Longitudinal	Point	1.5	Structural	0	9	2	0	0	1	Crack Longitudinal	
Crack Multiple	Point	2	Structural	0	5-7	3	0	0	2	Crack Multiple	
Surface Damage Roughness Increased	Point	4	Structural	0	8	1	0	0	1	Surface Damage Roughness Increased	
Deposits Settled Fine	Point	10	O&M	10	10	0	0	0	0	Deposits Settled Fine

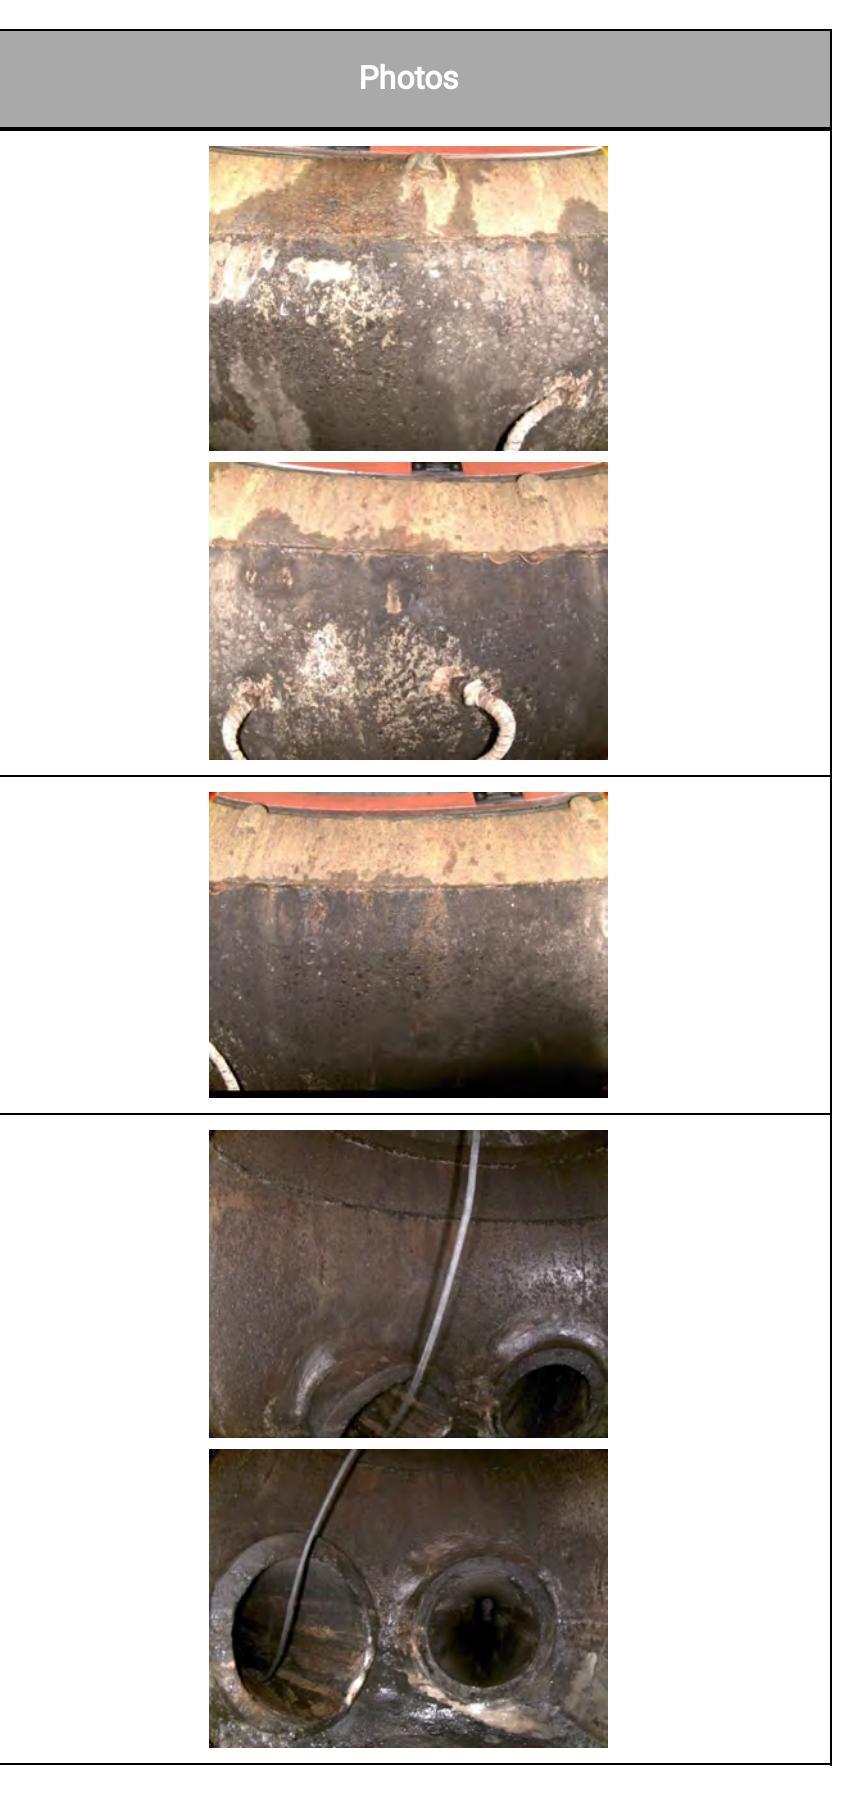
Description	Spatial Type	Distance (ft)	Туре	Percent	Clock	SR	O&M	С	ER	Remarks
Surface Damage Aggregate Visible	Point	0.5	Structural	0	9-10	2	0	0	1	Surface Damage Aggregate Visible
Surface Damage Roughness Increased	Point	1	Structural	0	5-9	1	0	0	1	Surface Damage Roughness Increased
Crack Longitudinal	Point	3.8	Constructional	0	6	2	0	0	1	Crack Longitudinal

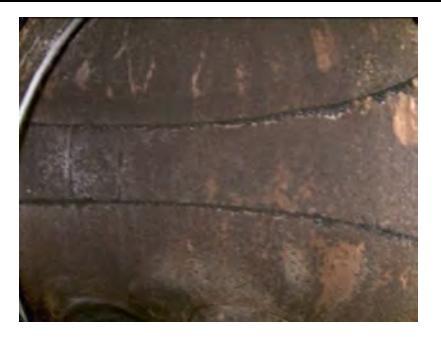
Description	Spatial Type	Distance (ft)	Туре	Percent	Clock	SR	0&M	С	ER	Remarks
Crack Longitudinal	Point	3.8	Structural	0	7	2	0	0	1	Crack Longitudinal

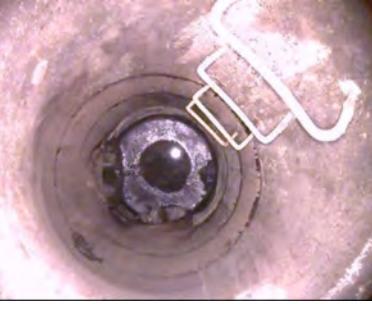
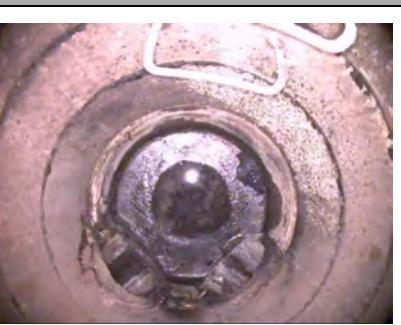
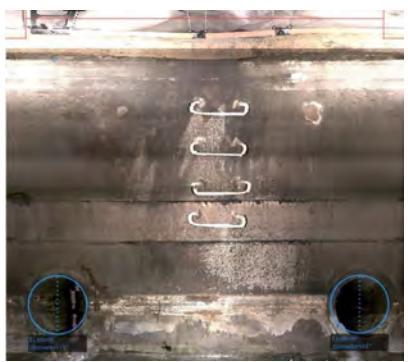
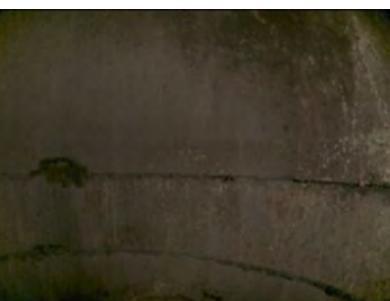
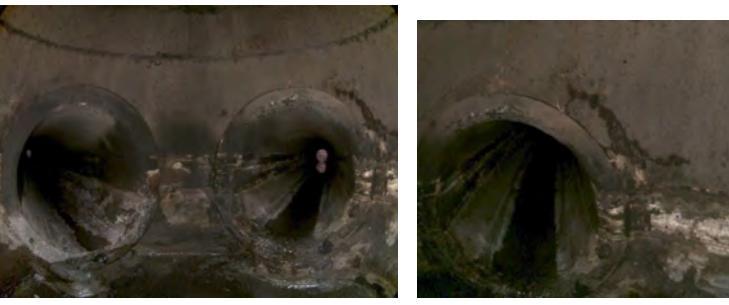
Setup ID	2023-ST-10		Inspection	date	Aug 14, 2023	Defe	ects Rat	ed ≥3		0 Peak Structural Rating 4			4	Rim to Invert (ft) - Lowest Outgoing Pipe	7
Structure ID	23-2	Peak	< Environme	ntal Rating	2	Peak	C/0&M	Ratin	g	0		Rim to Bottom (ft)	8.6	Total ER Defects	4
Desc	cription	S	patial Type	Distance (ft)	Туре	Percent	Clock	SR	O&M	С	ER	Remarks		Photos	
Miscellaneous G	General Photogra	aph	Point	0	Miscellaneous	0		0	0	0	0	View Down Struct	ure		
Miscellaneous G	General Photogra	aph	Point	0	Miscellaneous	0		0	0	0	0	Side View of Struct	ture		
Surface Damage	e Aggregate Miss	sing	Point	4	Structural	0	8	4	0	0	2	Surface Damage Aggrega	te Missing		
Crack Lo	ongitudinal		Point	6	Structural	0	9	2	0	0	1	Crack Longitudin	al

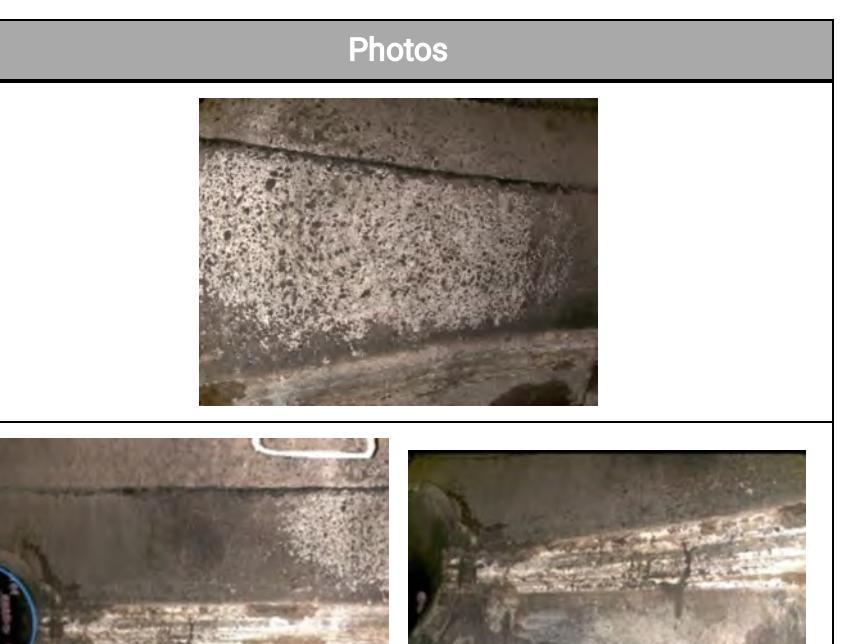
Description	Spatial Type	Distance (ft)	Туре	Percent	Clock	SR	O&M	С	ER	Remarks	
Surface Damage Aggregate Visible	Point	6	Structural	0	1-4	2	0	0	1	Surface Damage Aggregate Visible	
Crack Longitudinal	Point	7	Structural	0	12	2	0	0	1	Crack Longitudinal

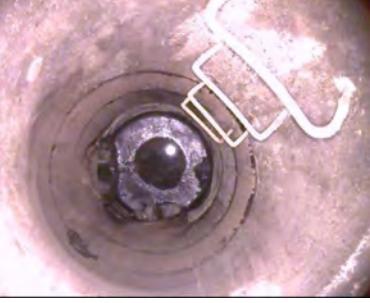
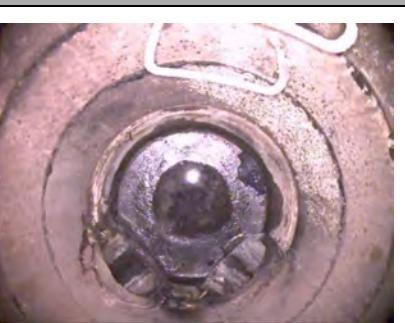
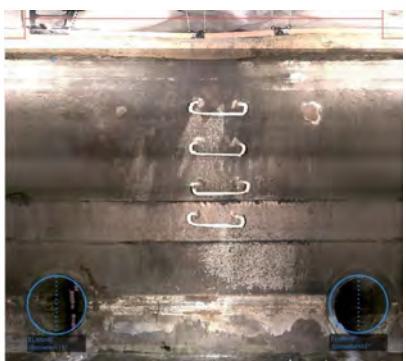
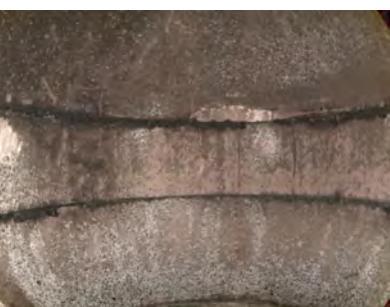
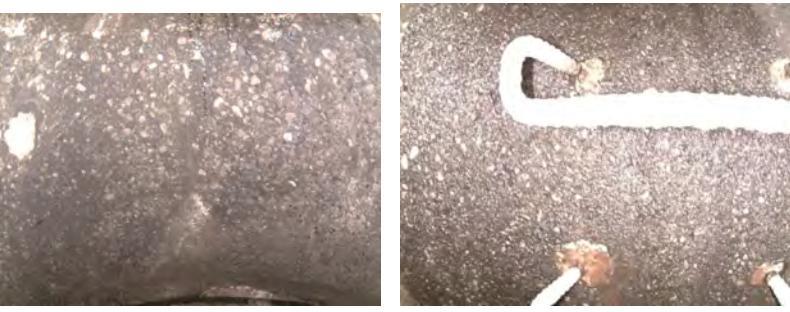
Setup ID	2023-ST-11	Inspection	n date	Aug 14, 2023	Defe	ects Rat	ed ≥3		0		Peak Structural Rating	2	Rim to Invert (ft) - Lowest Outgoing Pipe	7.8
Structure ID	23-3	Peak Environme	ental Rating	1	Peak	C/O&M	Rating		0		Rim to Bottom (ft)	8.1	Total ER Defects	4
De	scription	Spatial Type	Distance (ft)	Туре	Percent	Clock	SR (D&M	С	ER	Remarks		Photos	
Miscellaneous	General Photograph	Point	0	Miscellaneous	0		0	0	0	0	View Down Struct	ure		
Miscellaneous	General Photograph	Point	0	Miscellaneous	0		0	0	0	0	Side View of Struc	ture		
Surface Damag	ge Aggregate Visible	Continuous	1.5 - 4	Structural	0	2-6	2	0	0	1	Surface Damage Aggrega	ate Visible		
Surface Damag	ge Aggregate Visible	Point	4	Structural	0	11	2	0	0	1	Surface Damage Aggrega	ate Visible

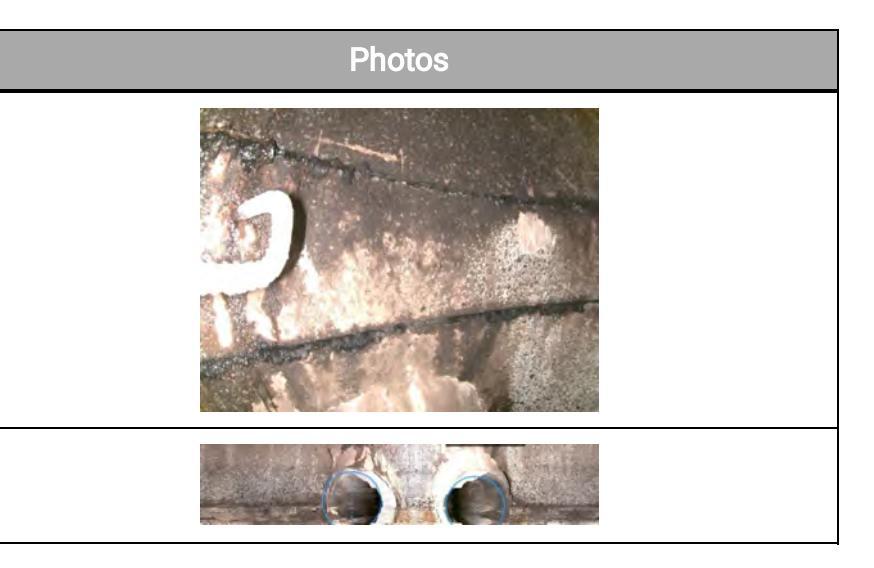
Description	Spatial Type	Distance (ft)	Туре	Percent	Clock	SR	O&M	С	ER	Remarks	
Surface Damage Aggregate Visible	Point	5	Structural	0	6	2	0	0	1	Surface Damage Aggregate Visible	
Surface Damage Aggregate Visible	Point	6.5	Structural	0	7	2	0	0	1	Surface Damage Aggregate Visible

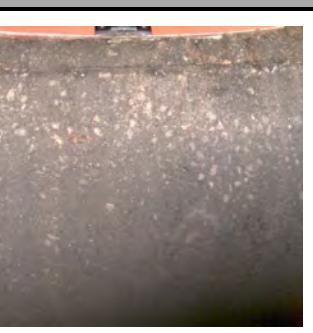
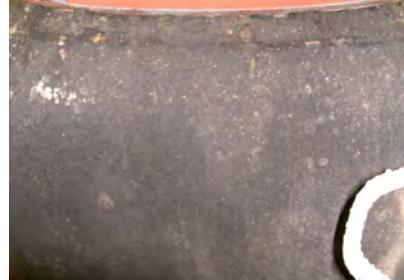
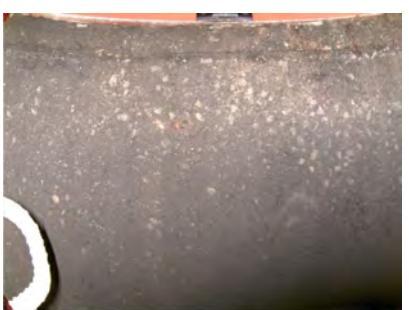
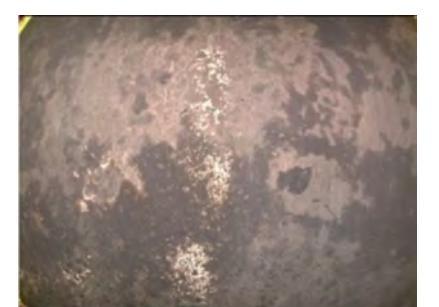
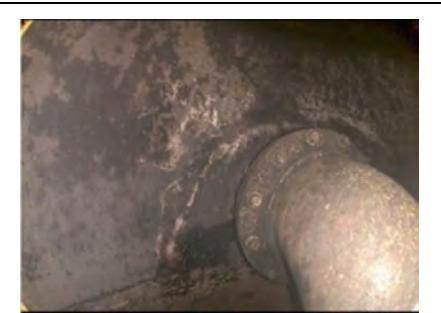
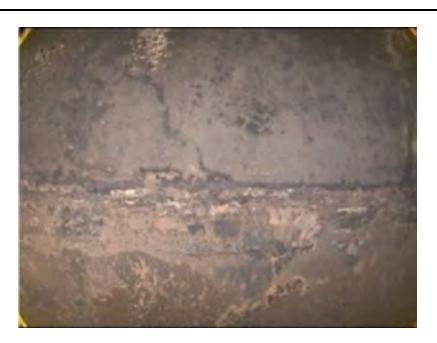
Description	Spatial Type	Distance (ft)	Туре	Percent	Clock	SR	O&M	С	ER	Remarks	
Surface Damage Roughness Increased	Point	0.2	Structural	0	12- 12	1	0	0	1	Surface Damage Roughness Increased	
Surface Damage Aggregate Visible	Point	5.5	Structural	0	9	2	0	0	1	Surface Damage Aggregate Visible	
Crack Multiple	Point	6	Structural	0	11- 12	3	0	0	1	Crack Multiple	
Crack Multiple	Point	7	Structural	0	9-10	3	0	0	1	Crack Multiple

Description	Spatial Type	Distance (ft)	Туре	Percent	Clock	SR	0&M	С	ER	Remarks	
Crack Circumferential	Point	7.3	Structural	0	9-10	2	0	0	1	Crack Circumferential

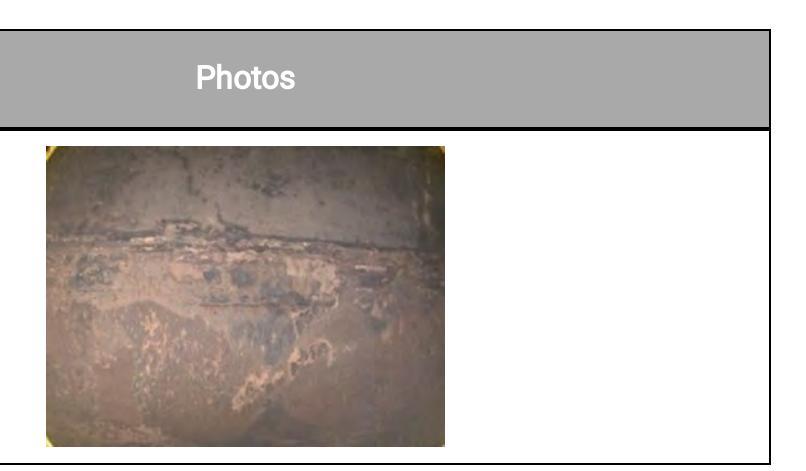
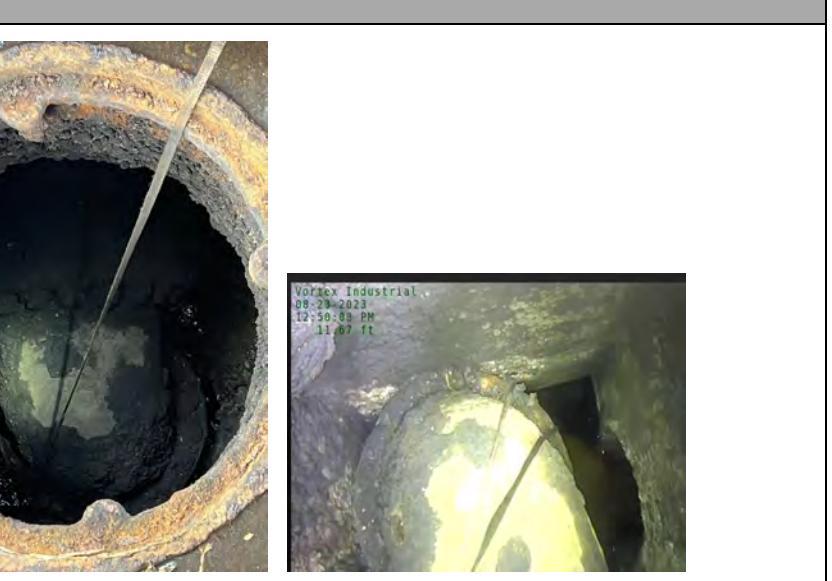
Description	Spatial Type	Distance (ft)	Туре	Percent	Clock	SR	O&M	С	ER	Remarks	
Surface Damage Aggregate Visible	Continuous	0 - 9.8	Structural	0	12- 12	2	0	0	2	Surface Damage Aggregate Visible	
Crack Longitudinal	Point	4.5	Structural	0	12	2	0	0	1	Crack Multiple

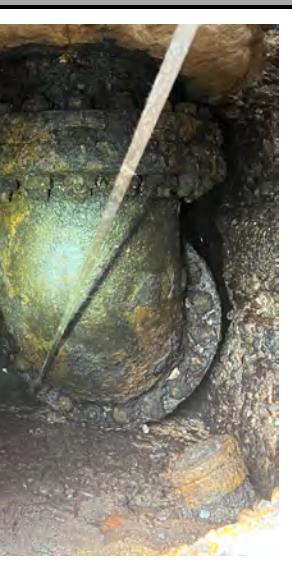
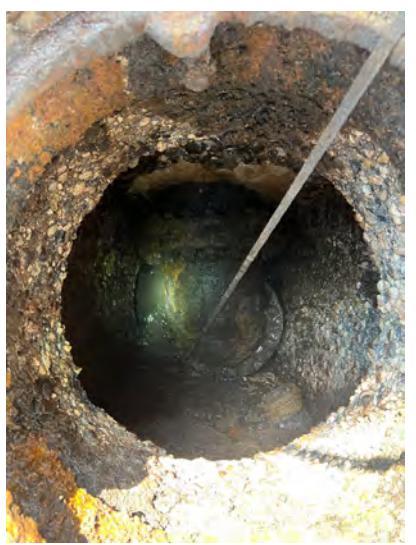
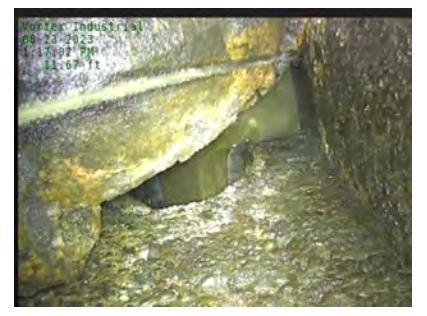
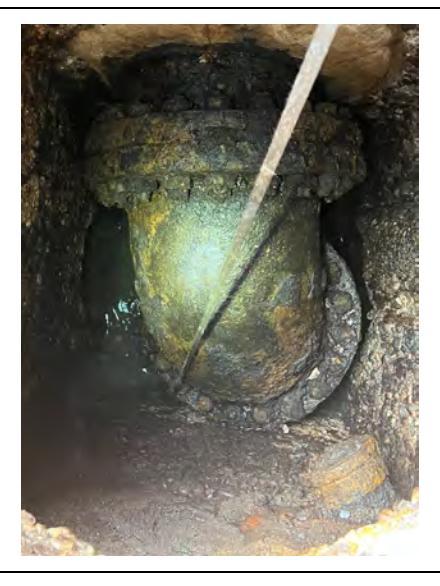
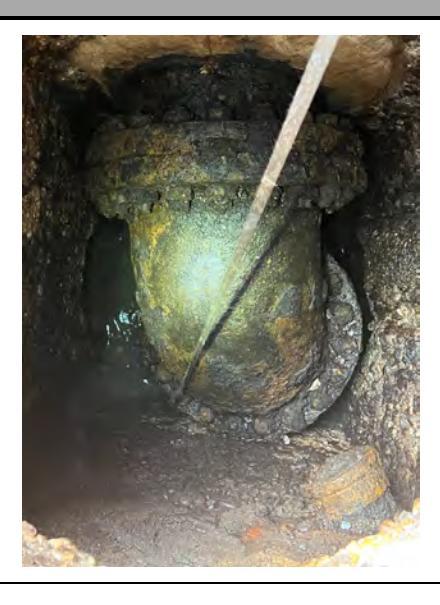
Description	Spatial Type	Distance (ft)	Туре	Percent	Clock	SR	O&M	С	ER	Remarks	
Crack Longitudinal	Point	4.5	Structural	0	1	2	0	0	1	Crack Longitudinal
