2024 ANNUAL PROGRESS REPORT SWMU-1 OILY WATER SEWER

HF SINCLAIR PUGET SOUND REFINING LLC

March 2025

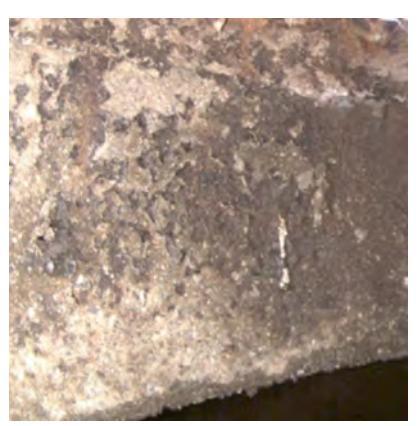
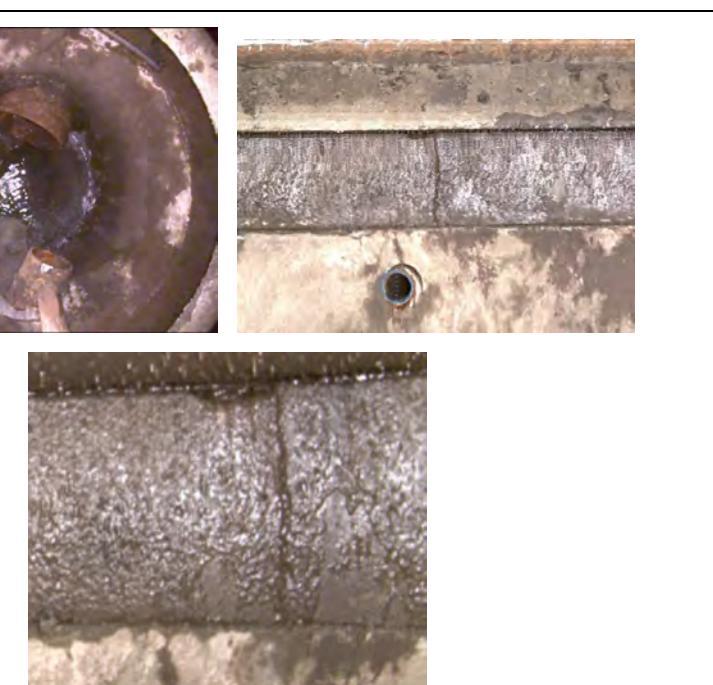
Description	Spatial Type	Distance (ft)	Туре	Percent	Clock	SR	O&M	С	ER	Remarks	
Surface Damage Roughness Increased	Point	0.3	Structural	0	12- 12	1	0	0	1	Surface Damage Roughness Increased	
Crack Longitudinal	Point	1.3	Structural	0	4	2	0	0	1	Crack Longitudinal

Description	Spatial Type	Distance (ft)	Туре	Percent	Clock	SR	O&M	С	ER	Remarks	
Miscellaneous General Observation	Continuous	4 - 6	Structural	0	12-5	0	0	0	0	Concrete Shelf	
Crack Longitudinal	Point	4.7	Structural	0	3	2	0	0	1	Crack Longitudinal	
Surface Damage Aggregate Missing	Point	7.6	Structural	0	12- 12	4	0	0	2	Surface Damage Aggregate Missing

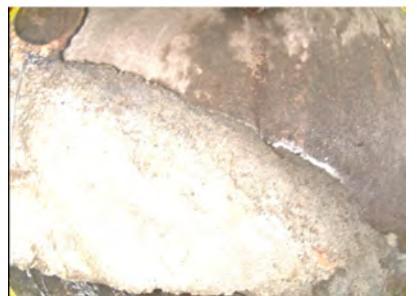
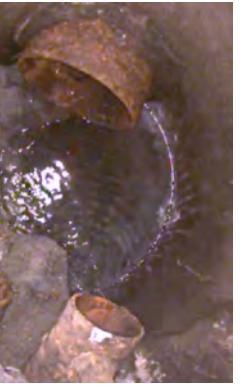
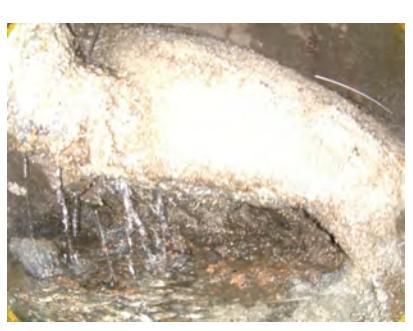
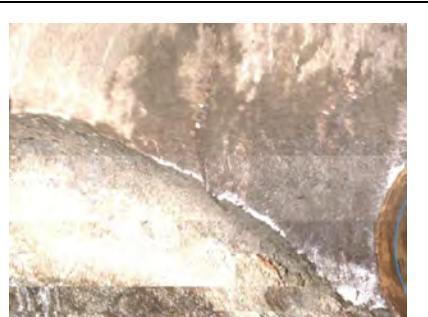
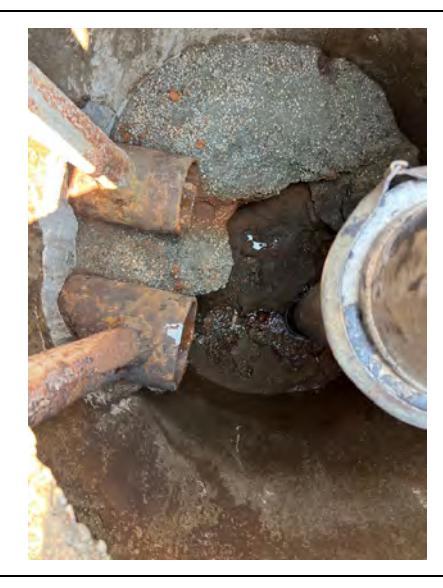
Description	Spatial Type	Distance (ft)	Туре	Percent	Clock	SR	O&M	С	ER	Remarks	
Deposits Settled Compacted	Point	7.6	O&M	10	12- 12	0	0	0	0	Deposits Settled Compacted

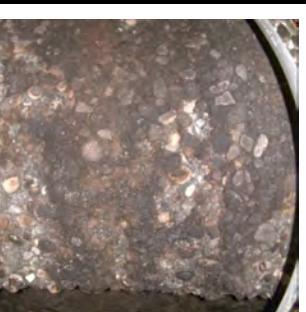
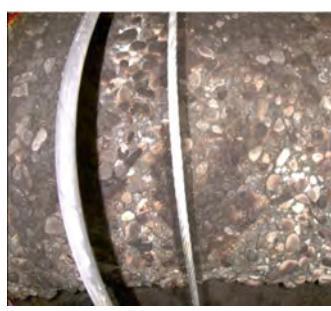
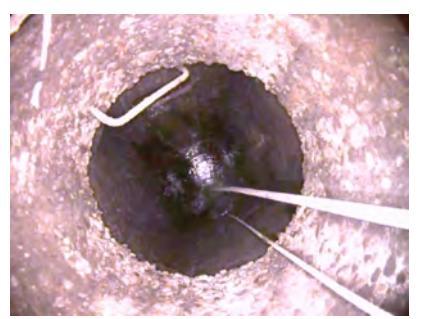
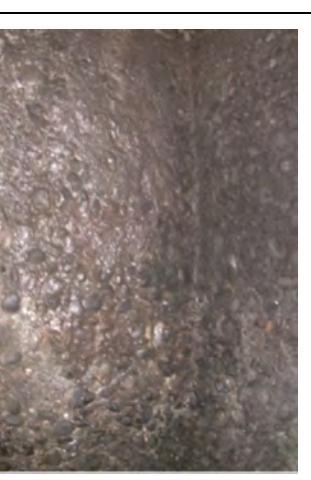
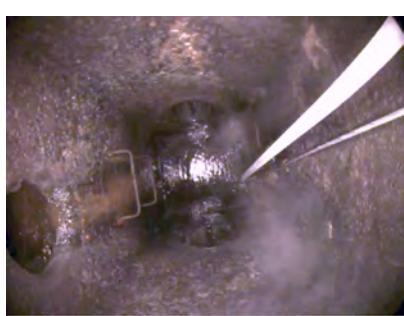
Description	Spatial Type	Distance (ft)	Туре	Percent	Clock	SR	O&M	С	ER	Remarks	
Surface Damage Aggregate Visible	Continuous	1 - 2.6	Structural	0	12- 12	2	0	0	1	Surface Damage Aggregate Visible	
Surface Damage Aggregate Visible	Continuous	4.5 - 7	Structural	0	12- 12	2	0	0	1	Surface Damage Aggregate Visible	
Surface Damage Aggregate Missing	Continuous	4.9 - 6.5	Structural	0	6	4	0	0	2	Surface Damage Aggregate Missing

Description	Spatial Type	Distance (ft)	Туре	Percent	Clock	SR	O&M	С	ER	Remarks	
Surface Damage Aggregate Missing	Point	5.7	Structural	0	9	4	0	0	2	Surface Damage Aggregate Missing	
Surface Damage Aggregate Missing	Point	6.3	Structural	0	11	4	0	0	2	Surface Damage Aggregate Missing	
Surface Damage Roughness Increased	Continuous	8 - 10.8	Structural	0	12- 12	1	0	0	2	Surface Damage Roughness Increased

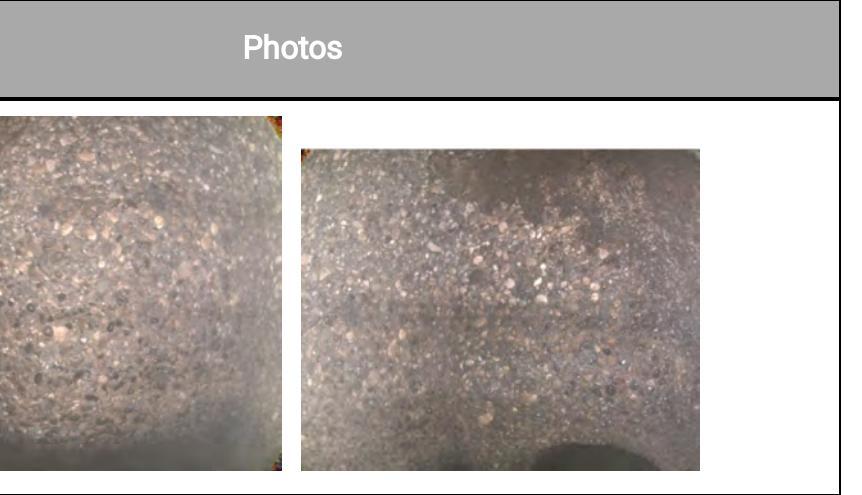
Description	Spatial Type	Distance (ft)	Туре	Percent	Clock	SR	0&M	С	ER	Remarks	
Surface Damage Aggregate Visible	Continuous	2.5 - 6	Structural	0	12-6	2	0	0	2	Surface Damage Aggregate Visible

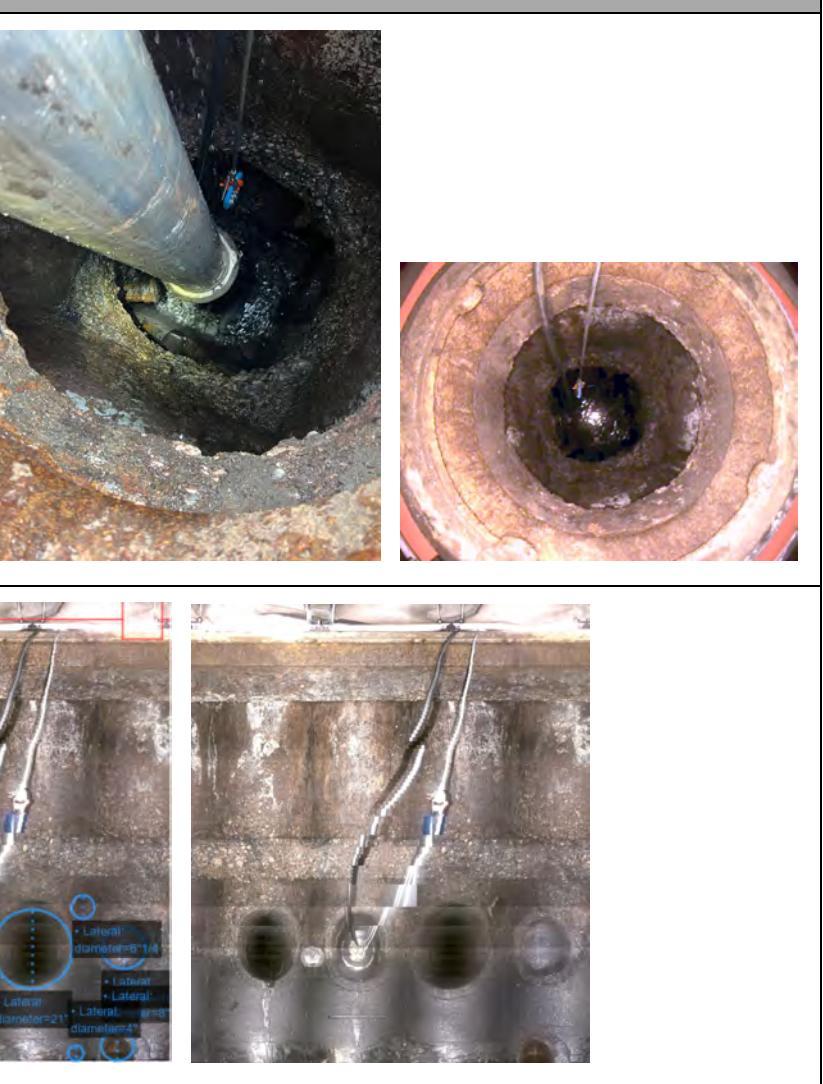
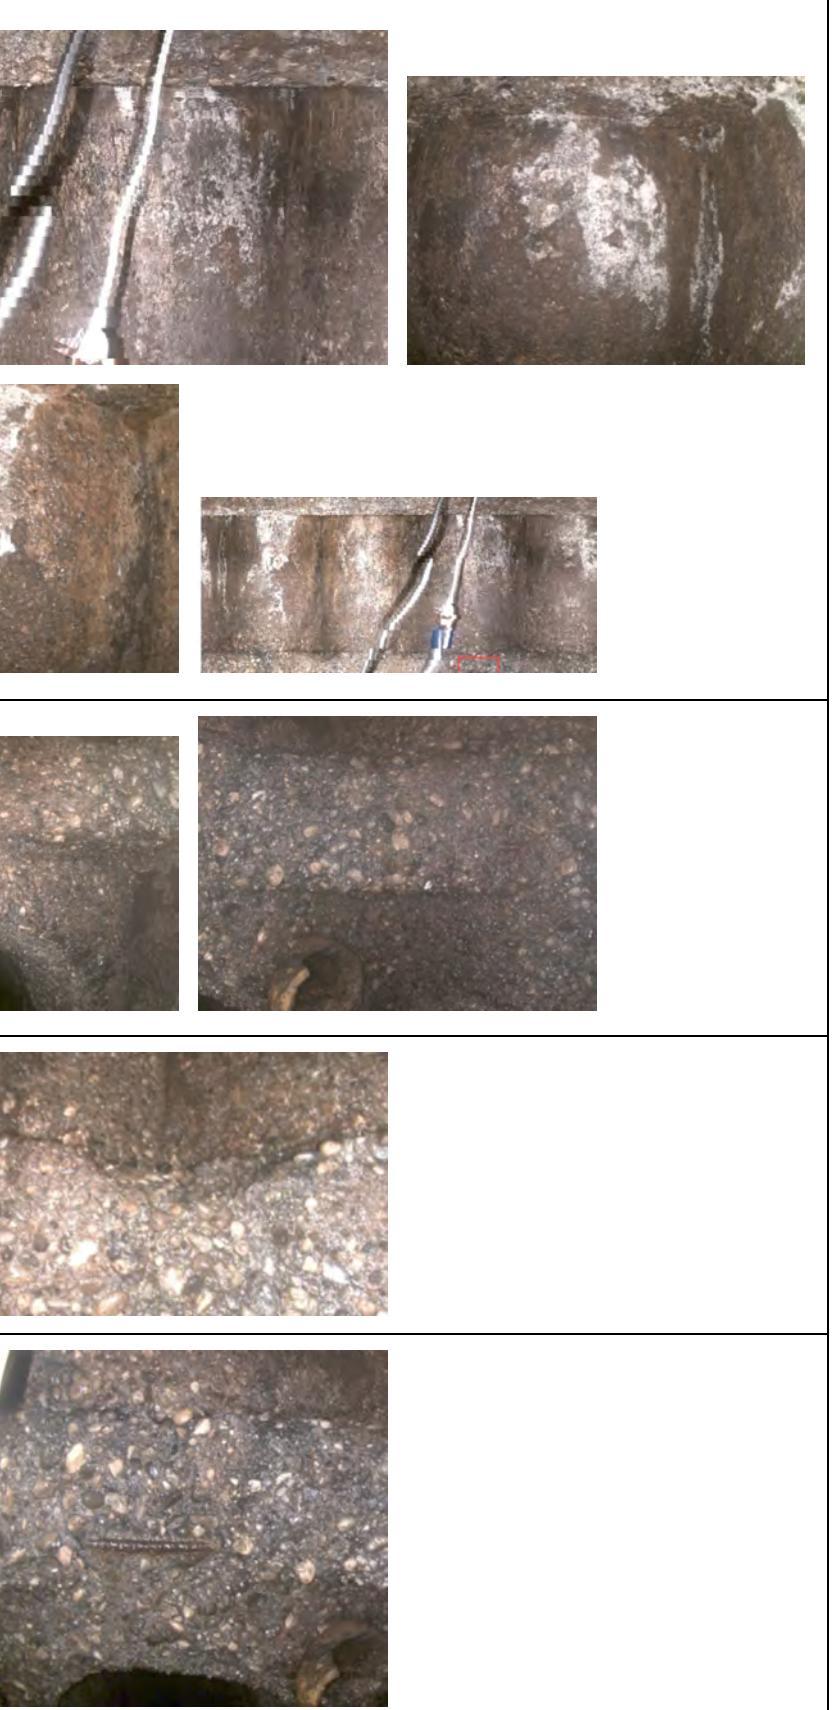
Description	Spatial Type	Distance (ft)	Туре	Percent	Clock	SR	O&M	С	ER	Remarks	
Surface Damage Roughness Increased	Continuous	1.3 - 3.8	Structural	0	12- 12	1	0	0	1	Surface Damage Roughness Increased	
Surface Damage Aggregate Visible	Continuous	3.8 - 6.5	Structural	0	12- 12	2	0	0	1	Surface Damage Aggregate Visible	
Surface Damage Aggregate Missing	Point	4.8	Structural	0	1	4	0	0	2	Surface Damage Aggregate Missing	
Surface Damage Reinforcement Visible	Point	5	Structural	0	6	5	0	0	2	Surface Damage Reinforcement Visible

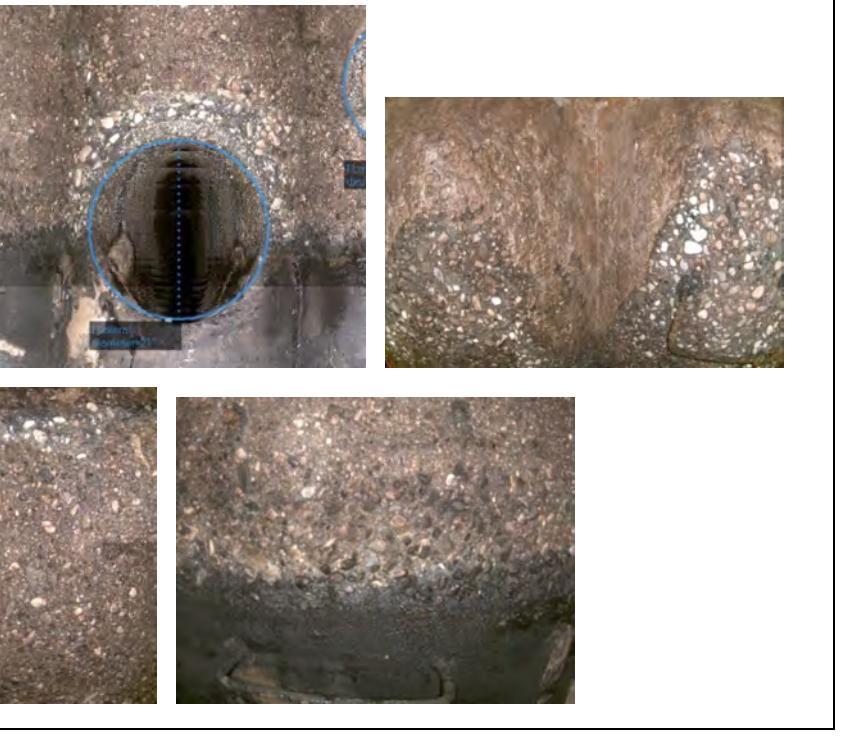
Description	Spatial Type	Distance (ft)	Туре	Percent	Clock	SR	O&M	С	ER	Remarks	
Surface Damage Aggregate Visible	Point	0.7	Structural	0	12- 12	2	0	0	1	Surface Damage Aggregate Visible	
Surface Damage Aggregate Visible	Continuous	2.3 - 8.5	Structural	0	12	2	0	0	2	Surface Damage Aggregate Visible

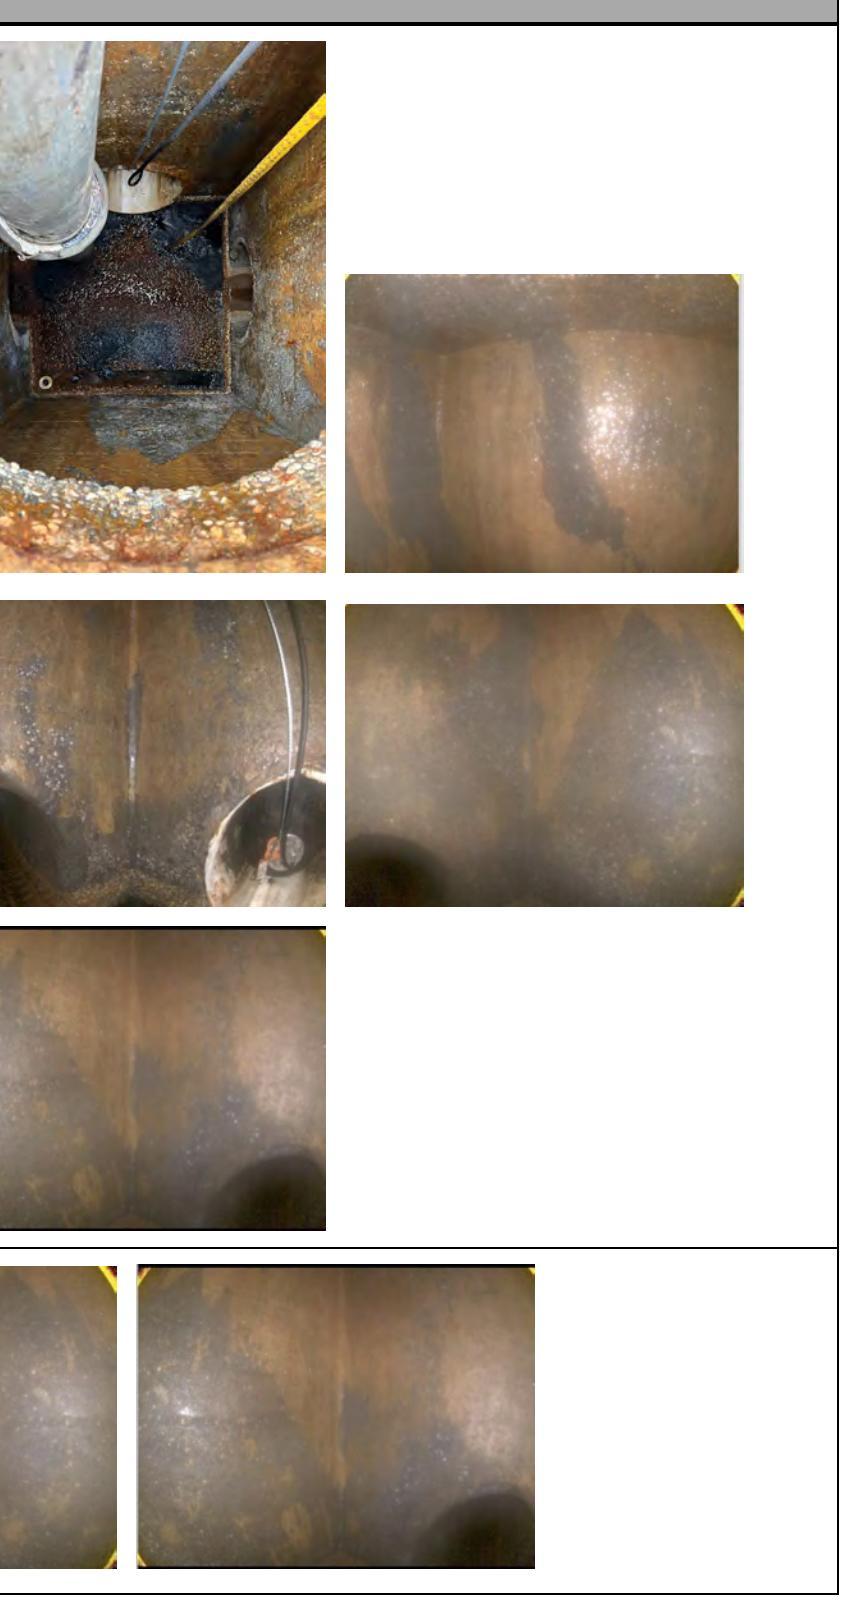
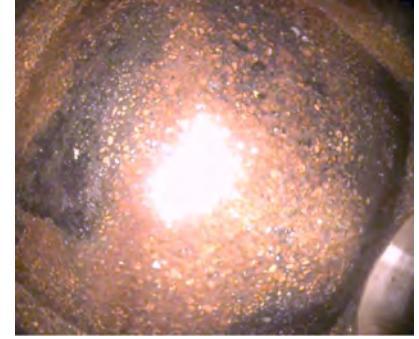
Description	Spatial Type	Distance (ft)	Туре	Percent	Clock	SR	O&M	С	ER	Remarks	
Surface Damage Roughness Increased	Continuous	1 - 7.5	Structural	0	12- 12	1	0	0	1	Surface Damage Roughness Increased	
Surface Damage Roughness Increased	Continuous	4.8 - 6.8	Structural	0	2	1	0	0	0	Surface Damage Roughness Increased

Description	Spatial Type	Distance (ft)	Туре	Percent	Clock	SR	O&M	С	ER	Remarks	
Surface Damage Aggregate Visible	Point	7.6	Structural	0	12- 12	2	0	0	2	Surface Damage Aggregate Visible

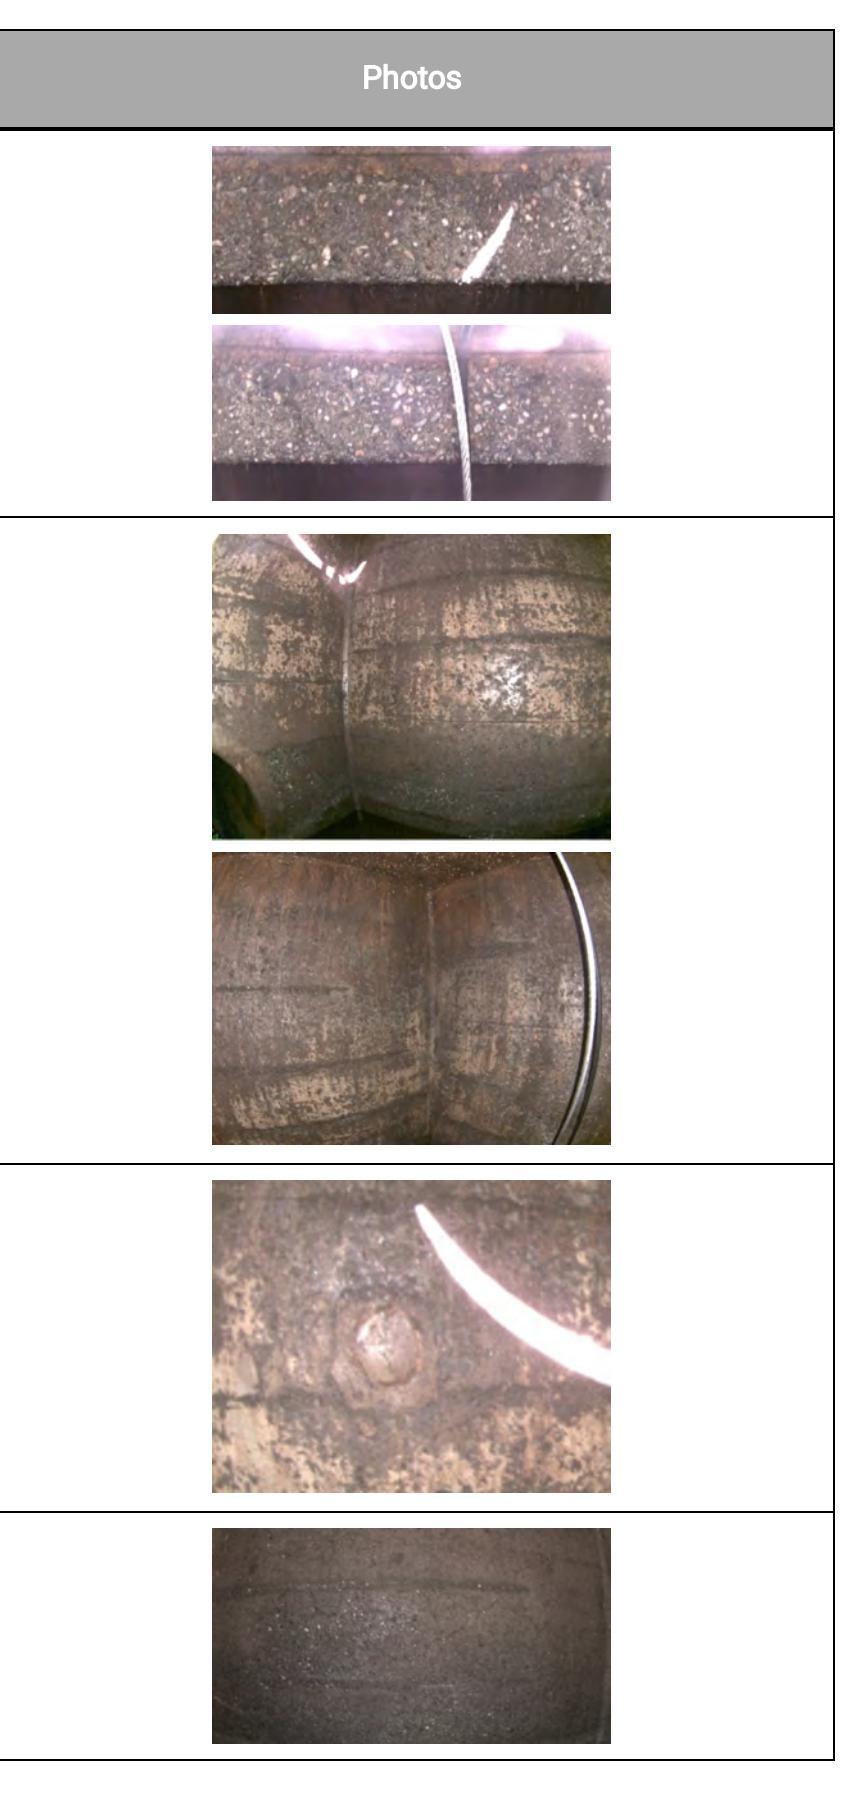
Description	Spatial Type	Distance (ft)	Туре	Percent	Clock	SR	O&M	С	ER	Remarks
Surface Damage Aggregate Visible	Point	0.5	Structural	0	12- 12	2	0	0	1	Surface Damage Aggregate Visible
Surface Damage Roughness Increased	Continuous	0.6 - 6.2	Structural	0	12- 12	1	0	0	1	Surface Damage Roughness Increased
Surface Damage Aggregate Missing	Point	2.6	Structural	0	6	4	0	0	1	Surface Damage Aggregate Missing
Crack Spiral	Point	5.5	Structural	0	2-4	2	0	0	1	Crack Spiral

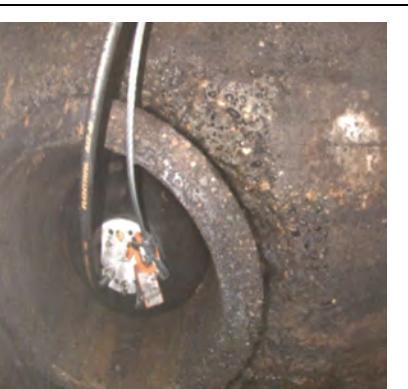
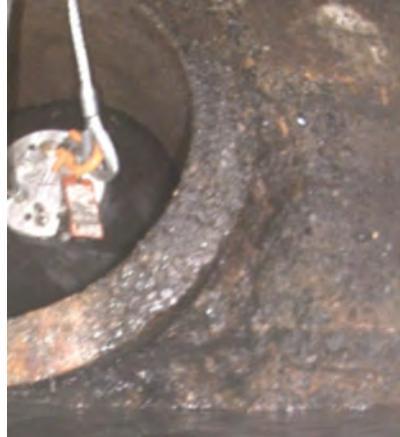
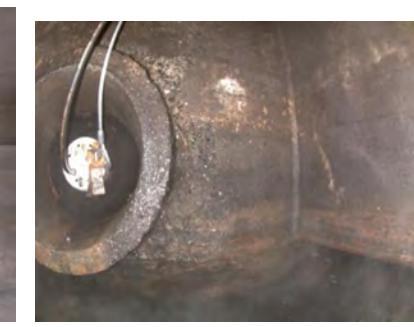
Description	Spatial Type	Distance (ft)	Туре	Percent	Clock	SR	O&M	С	ER	Remarks	
Surface Damage Aggregate Missing	Point	3	Structural	0	12	4	0	0	1	Surface Damage Aggregate Missing	
Surface Damage Aggregate Missing	Point	4.8	Structural	0	12	4	0	0	2	Surface Damage Aggregate Missing	
Crack Longitudinal	Point	5.2	Structural	0	2	2	0	0	1	Crack Longitudinal

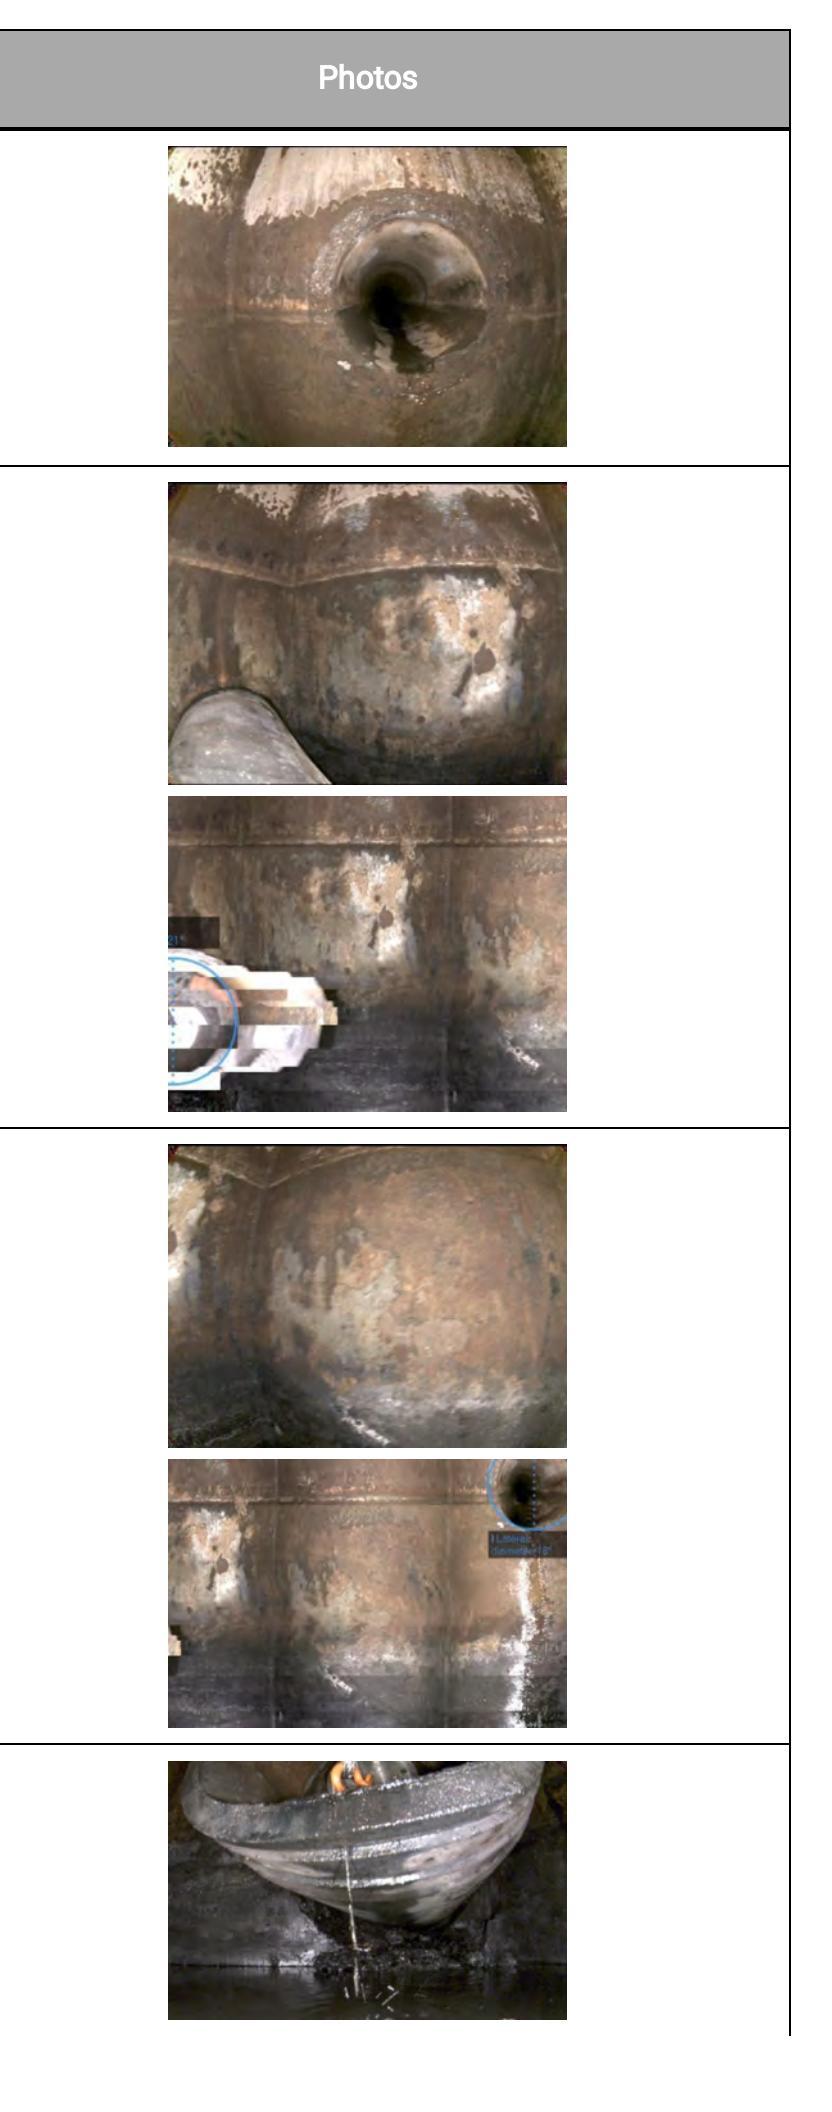
Description	Spatial Type	Distance (ft)	Туре	Percent	Clock	SR	O&M	С	ER	Remarks
	Surface Damage Roughness Increased	Point	5.5	Structural	0	6	1	0	0	1	Surface Damage Roughness Increased
	Surface Damage Surface Spalling	Point	6.5	Structural	0	12	2	0	0	1	Surface Damage Surface Spalling
	Surface Damage Surface Spalling	Point	7.2	Structural	0	3	2	0	0	1	Surface Damage Surface Spalling
Ра	Surface Damage Aggregate Missing ge 2 of 3 $C = Construction: O&M = 0$	Point Operation and I	9 Maintenance: E	Structural R = Environment	0 al Rating:	11 SR = St	4	0 al Ratin	0	2	Surface Damage Aggregate Missing

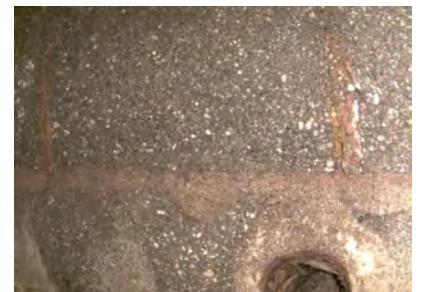
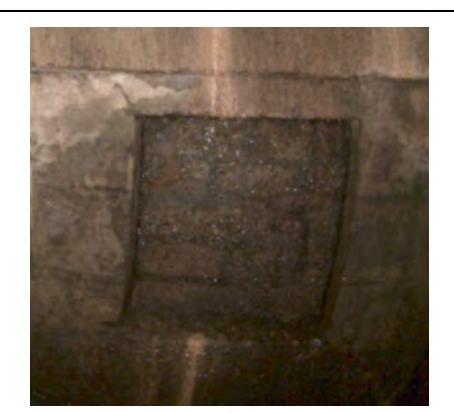
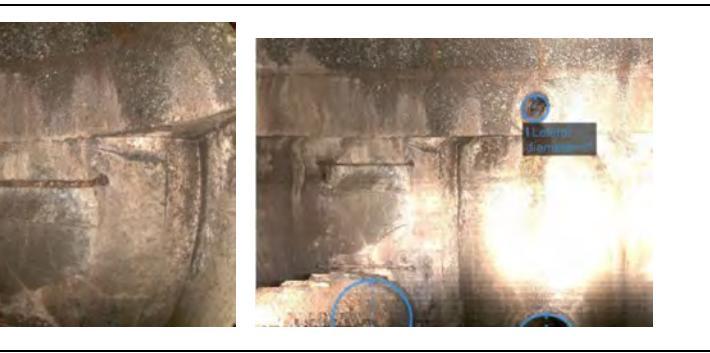
Setup ID 2023-ST-23	In	spection da	ate Au	ıg 25, 202	23	Defects F	Rated	l≥3		0	Peak Structural Ratin	ting	5	Rim to Invert (ft) - Lowest Outgoing Pipe	6.9
Structure ID B-1	Peak Er	vironmenta	al Rating	2	Р	eak C/O8	&M Ra	ating		0	Rim to Bottom (ft)	τt)	8.8	Total ER Defects	5
Description	Spatial Type	Distance (ft)	Туре	Percent	Clock	SR O	δM	С	ER		Remarks			Photos	
Miscellaneous General Photograph	Point	0	Miscellaneous	0		0 (D	0	0	View	v Down Structure				
Miscellaneous General Photograph	Point	0	Miscellaneous	0		0 (0	0	0	Side	View of Structure				
Surface Damage Roughness Increased	Continuous	0.6 - 2.5	Structural	0	12- 12	1 (0	0	1	Su Roug	Irface Damage ghness Increased

Description	Spatial Type	Distance (ft)	Туре	Percent	Clock	SR	O&M	С	ER	Remarks	
Surface Damage Reinforcement Visible	Point	2.6	Structural	0	12- 12	5	0	0	2	Surface Damage Reinforcement Visible	
Miscellaneous General Photograph	Point	3.6	Miscellaneous	0	12	0	0	0	0	Cut Out Wall	
Crack Multiple	Point	3.8	Structural	0	3-4	3	0	0	2	Crack Multiple

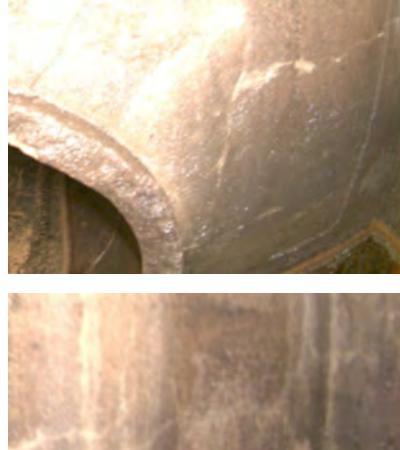
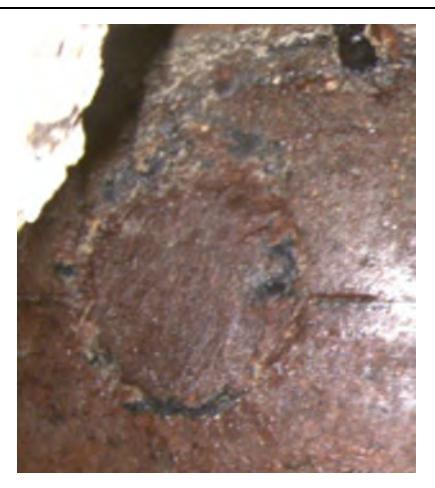
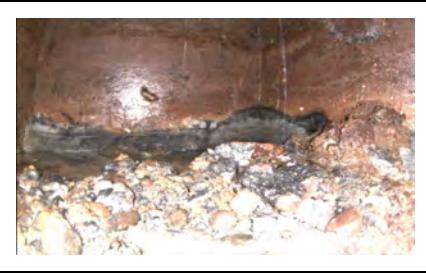
Description	Spatial Type	Distance (ft)	Туре	Percent	Clock	SR	O&M	С	ER	Remarks	
Crack Multiple	Point	5	Structural	0	5-10	3	0	0	2	Crack Multiple	
Surface Damage Aggregate Missing	Point	7.5	Structural	0	3	4	0	0	1	Surface Damage Aggregate Missing	
Deposits Settled Gravel	Point	8.7	O&M	0	12- 12	0	0	0	0	Deposits Settled Gravel

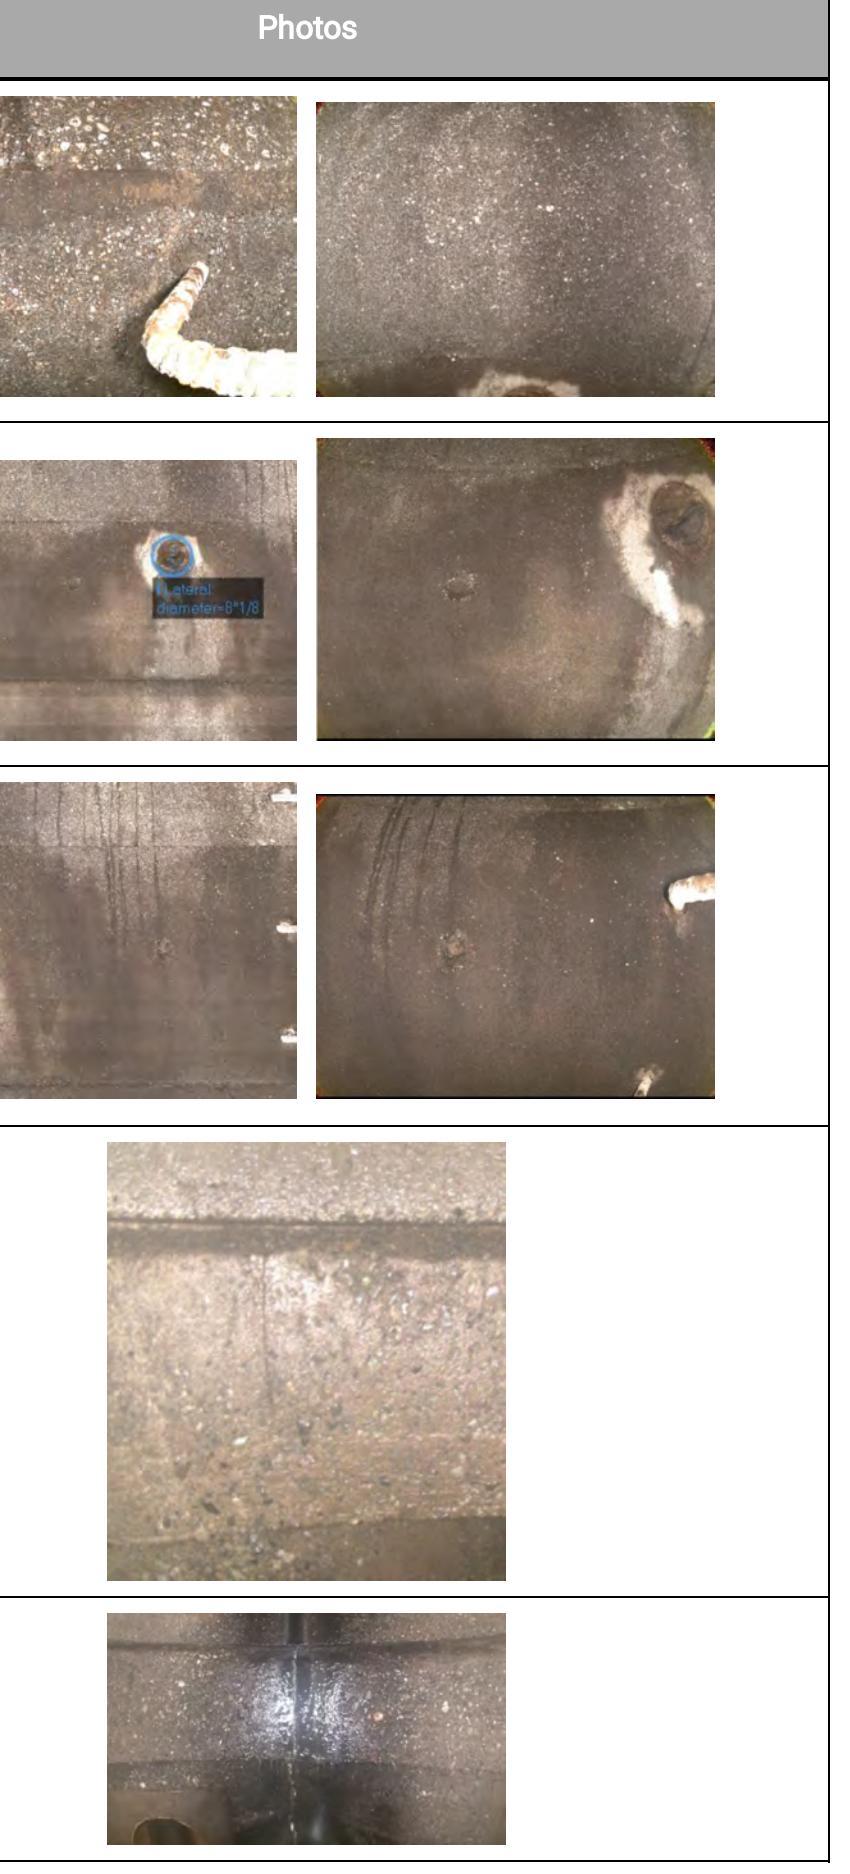
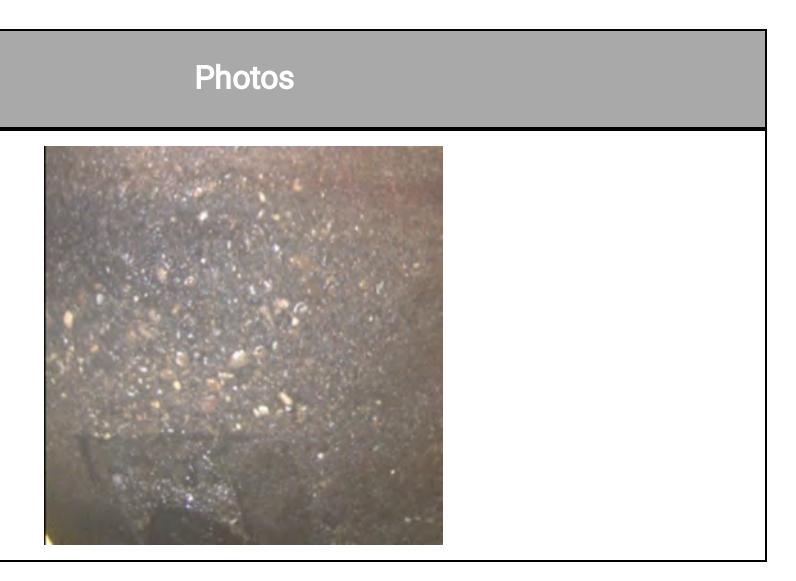
Setup ID	2023-ST-24	Inspec	ction date	Aug 25,	2023	Defe	ects Ra	ted ≥3		0	Peak Structural Rating	4	Rim to Invert (ft) - Lowest Outgoing Pipe	12.9
Structure ID	B-3	Peak Enviror	nmental Rat	ing 1		Peak (C/O&N	/I Ratin	g	0	Rim to Bottom (ft)	14.9	Total ER Defects	6
Des	scription	Spatial Type	Distance (ft)	Туре	Percent	Clock	SR	O&M	С	ER	Remarks		Photos	
Miscellan Phot	eous General tograph	Point	0	Miscellaneous	0		0	0	0	0	Side View of Structure		Lateral: ciameter=8"1/8 Ciameter=8" Ciameter=8" Ciameter=10"1/4 Ciameter=4":teral ciameter=10"1/4	
Miscellan Phot	eous General tograph	Point	0	Miscellaneous	0		0	0	0	0	View Down Structure		<image/>

Description	Spatial Type	Distance (ft)	Туре	Percent	Clock	SR	O&M	С	ER	Remarks	
Surface Damage Roughness Increased	Continuous	0.5 - 3.7	Structural	0	12- 12	1	0	0	1	Surface Damage Roughness Increased	
Surface Damage Aggregate Missing	Point	4.8	Structural	0	12	4	0	0	1	Surface Damage Aggregate Missing	
Surface Damage Aggregate Missing	Point	4.9	Structural	0	6	4	0	0	1	Surface Damage Aggregate Missing	San and a second
Crack Longitudinal	Point	10.5	Structural	0	6	2	0	0	1	Crack Longitudinal	
Surface Damage Aggregate Visible	Point	10.5	Structural	0	12-3	2	0	0	1	Surface Damage Aggregate Visible

Description	Spatial Type	Distance (ft)	Туре	Percent	Clock	SR	0&M	С	ER	Remarks	
Surface Damage Aggregate Visible	Point	13	Structural	0	3	2	0	0	1	Surface Damage Aggregate Visible

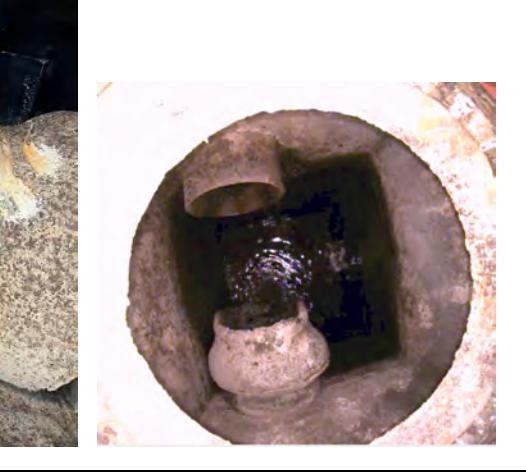
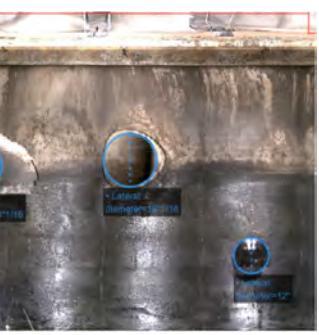
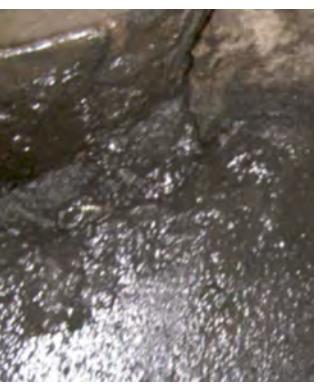
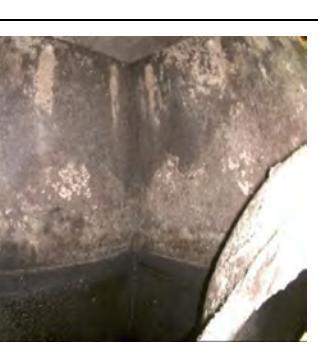
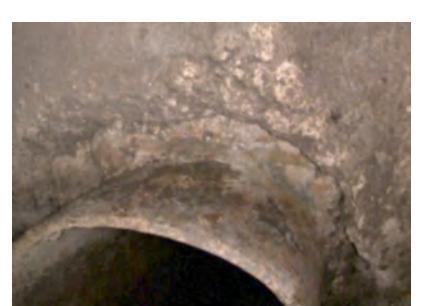
Setup ID 2023	-ST-25	Inspec	tion date	Aug	27, 20	23	Defe	ects Ra	ated ≥	3 0	Peak Structural Rating	4	Rim to Invert (ft) - Lowest Outgoing Pipe	4.4
Structure ID D	-19	Peak Enviror	nmental Rating		2		Peak	C/0&I	M Rati	ing O	Rim to Bottom (ft)	8.6	Total ER Defects	3
Description	Spatial Type	Distance (ft)	Туре	Percent	Clock	SR	O&M	С	ER	Remarks			Photos	
Surface Damage Roughness Increased	Continuou	s 0-8.2	Structural	0	12- 12	1	0	0	1	Surface Damage Roughness Increased

Description	Spatial Type	Distance (ft)	Туре	Percent	Clock	SR	O&M	С	ER	Remarks	
Miscellaneous General Photograph	Point	0	Miscellaneous	0		0	0	0	0	View Down Structure	
Miscellaneous General Photograph	Point	0	Miscellaneous	0		0	0	0	0	Side View of Structure	
Surface Damage Aggregate Missing	Continuous	2.5 - 4.1	Structural	0	6	4	0	0	2	Surface Damage Aggregate Missing	
Surface Damage Roughness Increased	Point	2.9	Structural	0	11	1	0	0	1	Surface Damage Roughness Increased

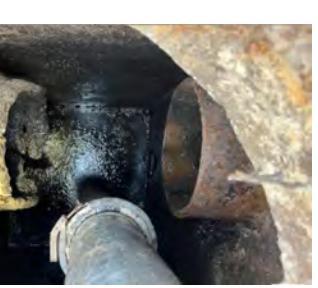
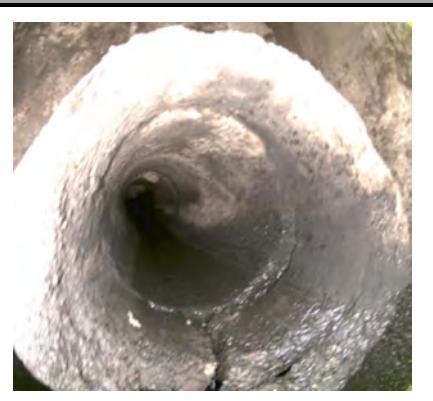
Description	Spatial Type	Distance (ft)	Туре	Percent	Clock	SR	O&M	С	ER	Remarks	
Miscellaneous General Photograph	Point	5	Miscellaneous	0	12	0	0	0	0	Broken Pipe

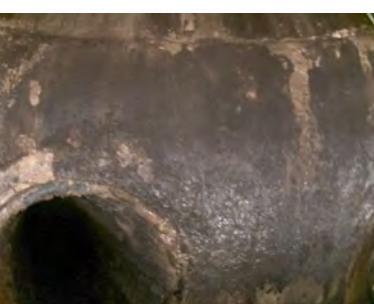
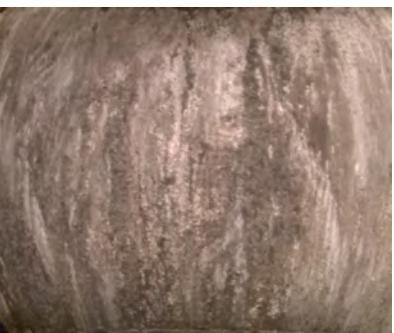
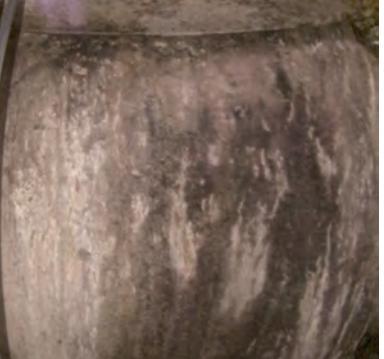
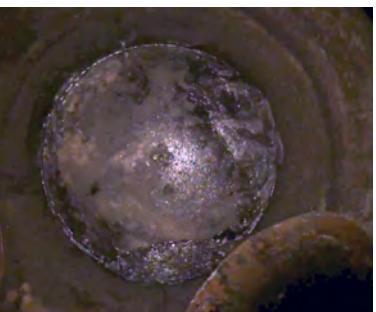
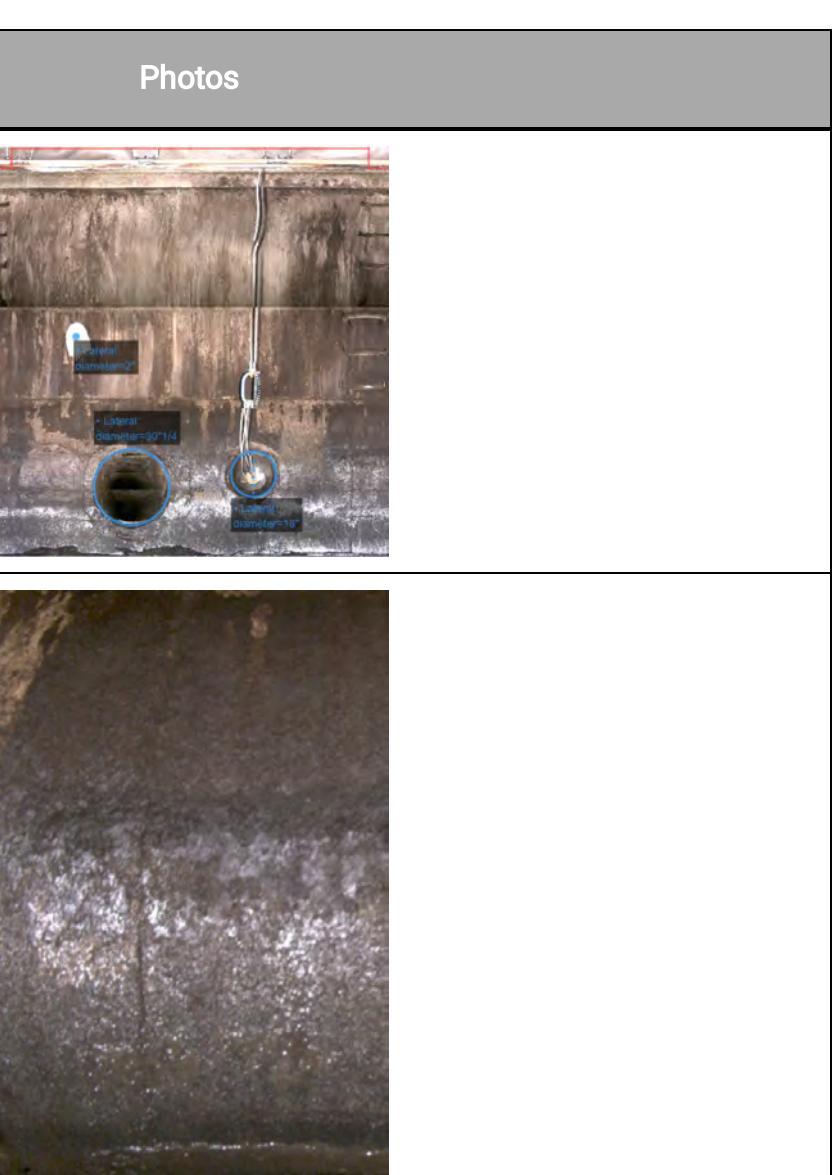
Setup ID	2023-ST-2	6	Inspection	n date	Aug 27, 2	2023	De	efects	Rated ≥	3	0	Peak Str	uctural Rating	2	Rim to Invert (ft) - Lowest Outgoing Pipe	12
Structure ID	D-20C	Peak	Environme	ental Rating	1		Pea	1k C/08	&M Rati	ing	0	Rim to	Bottom (ft)	13	Total ER Defects	2
Descrip	otion	Spatial Type	Distance (ft)	Туре	Percent	Clock	SR	O&M	С	ER	Rema	ırks			Photos	
Surface Da Roughness I	amage ncreased	Continuous	0 - 10	Structural	0	12- 12	1	0	0	1	Surface D Roughness	amage Increased				
Miscellaneou Photogr	ıs General raph	Point	0	Miscellaneous	0		0	0	0	0	View Down	Structure

Description	Spatial Type	Distance (ft)	Туре	Percent	Clock	SR	O&M	С	ER	Remarks	
Miscellaneous General Photograph	Point	0	Miscellaneous	0		0	0	0	0	Side View of Structure	
Crack Longitudinal	Continuous	8.7 - 13	Structural	0	12	2	0	0	1	Crack Longitudinal

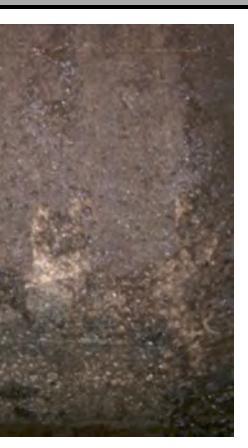
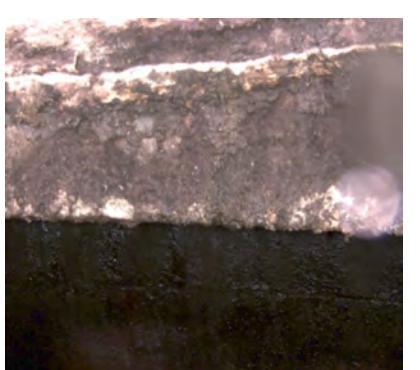
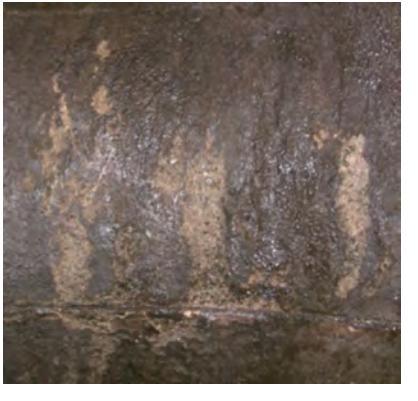
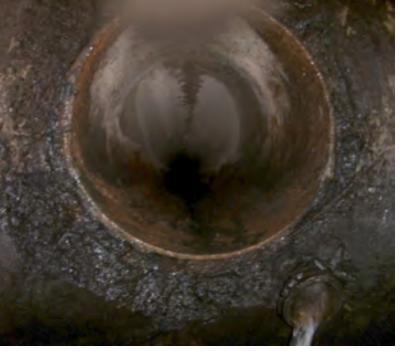
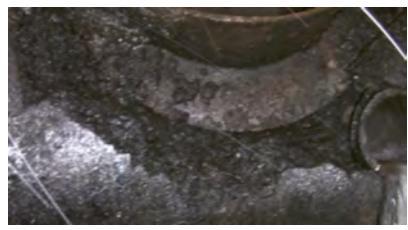
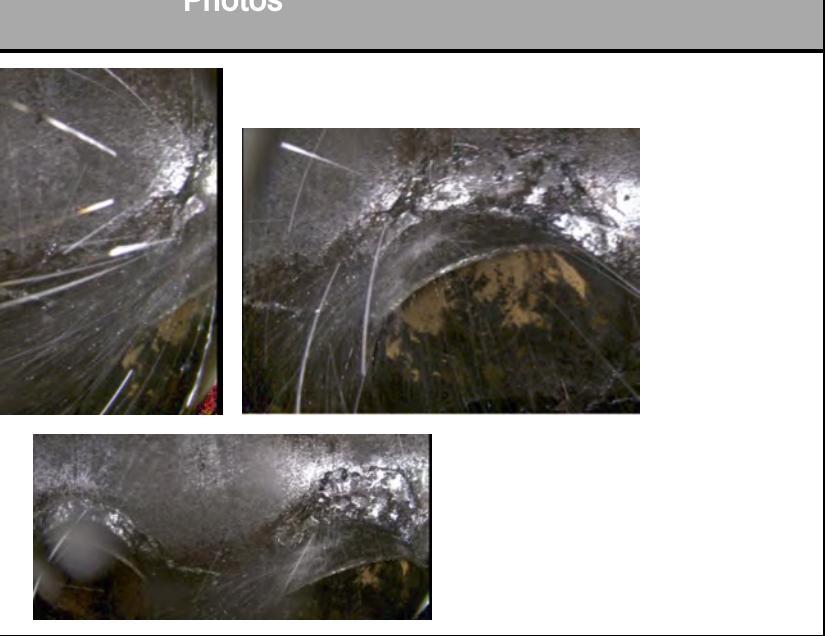
Setup ID	2023-ST-27	Ins	spection da	te	Aug 28, 202	23 Defe	cts Rate	ed ≥3		0	Peak Structural	l Rating	4	Rim to Invert (ft) - Lowest Outgoing Pipe	11.4
Structure ID	D-22	Peak En	vironmenta	l Rating	2	Peak C	C/O&M F	Rating	J	0	Rim to Bottor	m (ft)	16.3	Total ER Defects	3
Descri	ription	Spatial Type	Distance (ft)	Туре	Percent	Clock SR	O&M	С	ER		Remarks			Photos	
Miscellanec	ous General ograph	Point	0	Miscellane	ous 0	0	0	0	0	View	Down Structure			<image/>

Description	Spatial Type	Distance (ft)	Туре	Percent	Clock	SR	0&M	С	ER	Remarks	
Surface Damage Roughness Increased	Continuous	0 - 16.3	Structural	0	12- 12	1	0	0	1	Surface Damage Roughness Increased	
Surface Damage Aggregate Missing	Continuous	8.6 - 13	Structural	0	6	4	0	0	2	Surface Damage Aggregate Missing

Description	Spatial Type	Distance (ft)	Туре	Percent	Clock	SR	O&M	С	ER	Remarks	
Crack Circumferential	Point	13	Structural	0	12-2	2	0	0	2	Crack Circumferential

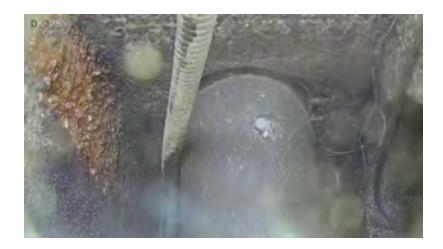
Setup ID	2023-ST-28	Ins	pection dat	te	Jan 16, 2024	. [efects R	ated ≥	≥3	0 Peak Structu	ral Rating 5		Rim to Invert (ft) - Lowest Outgoing Pipe	NM		
Structure ID	D-12	Peak Env	ironmental	Rating	2	Pe	ak C/O&	M Rat	ting	0 Rim to Bot	tom (ft)	NM	Total ER Defects	3		
Descr	ription	Spatial Type	Distance (ft)	Туре	Percent Clo	ck SR	O&M	С	ER	Remarks		Photos				
Surface Reinforcem	Damage nent Visible	Continuous	0 - 2	Structural	0 12	5	0	0	2	Surface Damage Reinforcement Visible			<image/>			
Surface Dama Visi	age Aggregate ible	Continuous	2 - 7.5	Structural	0 12 12	2	0	0	2	Surface Damage Aggregate Visible		V16/2024	10:02:20 AM CU313984 MF4 2.0 ft. Image: Augregate Visible 10:03:30 AM CU010984 MF4 Image: Augregate Visible CU010

Description	Spatial Type	Distance (ft)	Туре	Percent	Clock	SR	0&M	С	ER	Remarks
Surface Damage Aggregate Visible	Point	8	Structural	0	12-2	2	0	0	2	Surface Damage Aggregate Visible
