# Project Completion Report

Dickman Mill Piling and Debris Removal Project

Water Quality Certification Order No. 22587

Prepared by  
Herrera Environmental Consultants, Inc.

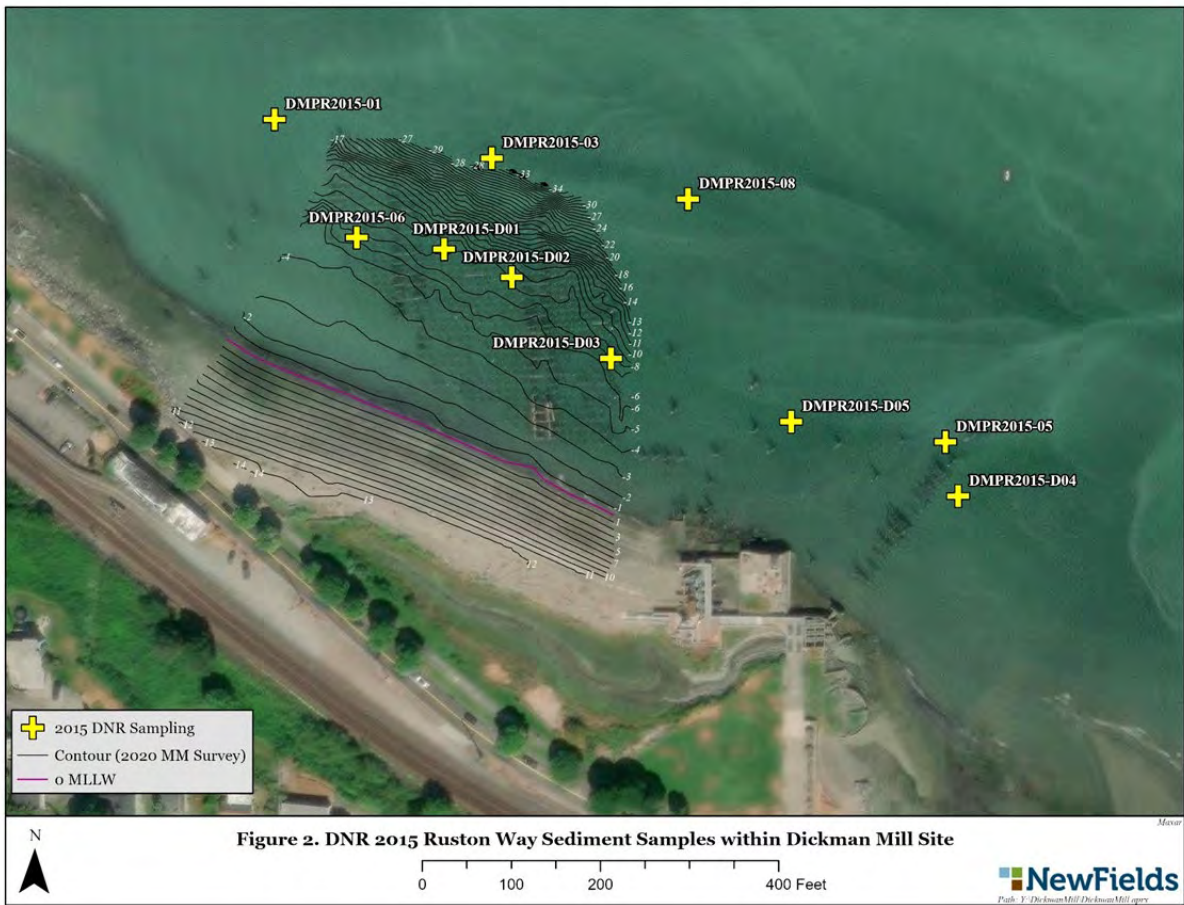
Figure 1. 2015 Subtidal Sediment Sampling Locations at Dickman Mill.

In 2015, the DNR collected 10 surface sediment samples within and surrounding the remnant piling fields adjacent to the Site (Figure 1) (Mott MacDonald 2020). Each sample was analyzed for metals and semi-volatile organic compounds (SVOCs), including PAHs, total petroleum hydrocarbons (TPH), polychlorinated biphenyls (PCBs), total organic carbon (TOC), sulfide, ammonia, total volatile solids (TVS), total solids, and grain size. Five samples were additionally analyzed for dioxins/furans. A slight sheen was observed in two samples within the northeast and southeast quadrants of the northwest pile field. and in two samples immediately adjacent to the seaward end of the relict pier. Heavy sheen was observed in one sample within the center of the northwest piling field.

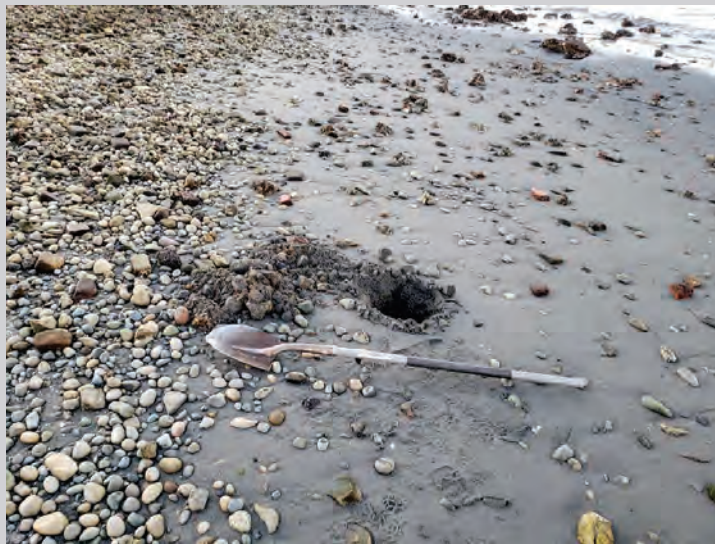
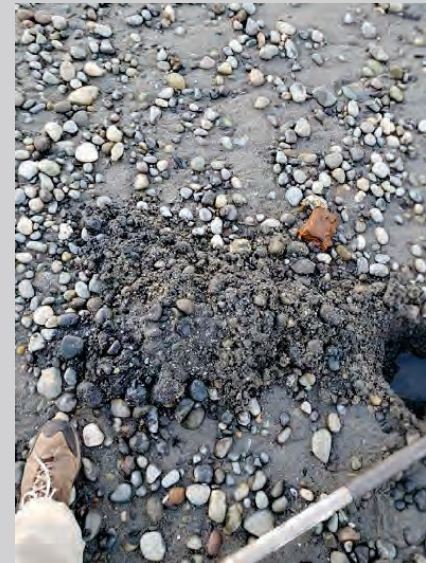
3. Test pits at +2 ft MLLW showed gravel cap material mixed with deposited sand and shell hash to bottom of pits at 1-2 ft deep.

One of two test pits in central cap area with gravel, sand, and shell
