# **Harris Avenue Shipyard In-water Condition Assessment Report**

**Port of Bellingham  
Harris Avenue Shipyard**

**November 2022**

**WSP USA  
33301 Ninth Avenue South, Suite 300  
Federal Way, Washington 98003-2600**

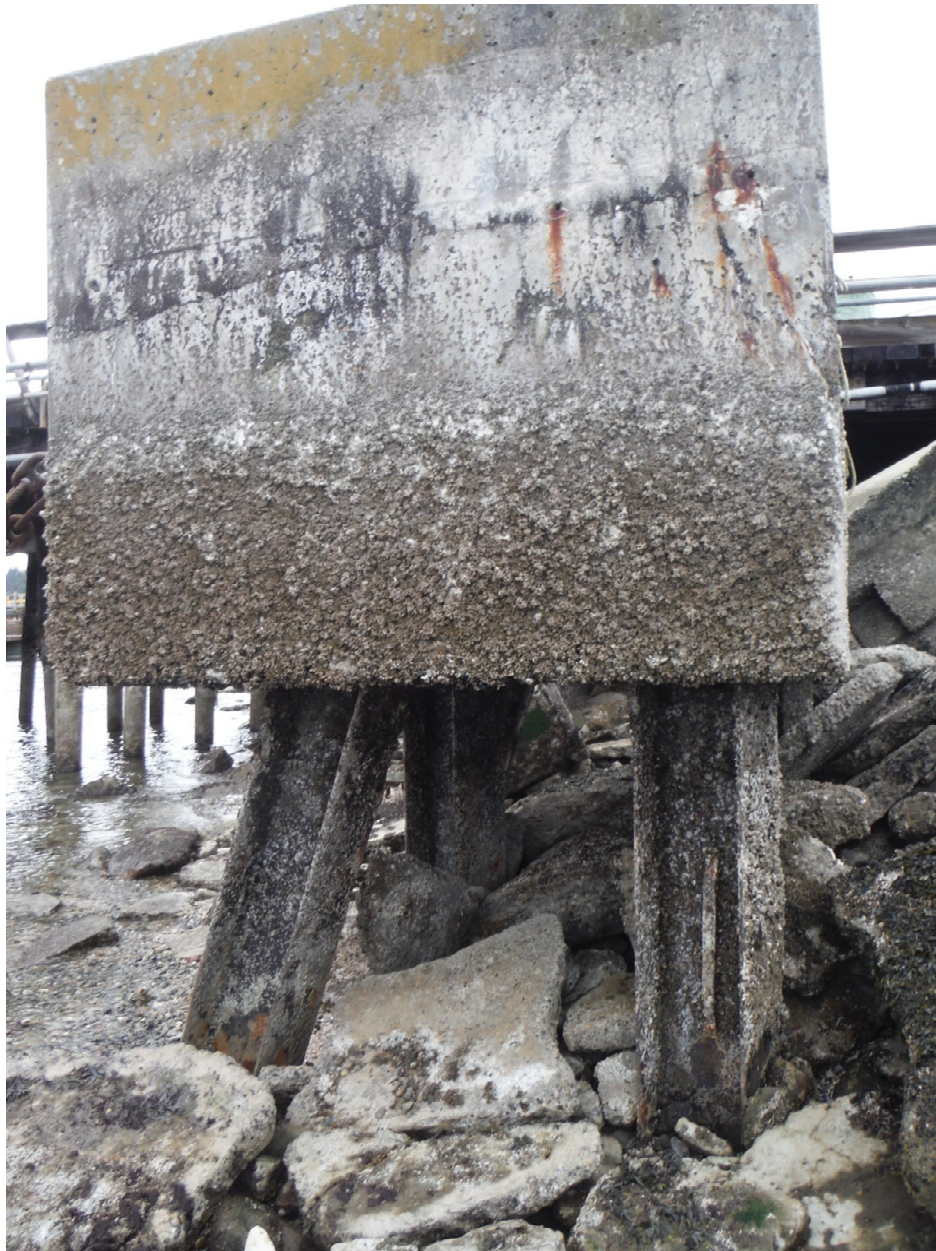
Photo 11 – Southwest Dolphin

The Southwest Dolphin is located along the shoreline to the west of the West Dock and is approximately 7.25 feet by 10 feet in plan. The 6-foot-thick concrete pile cap contains one mooring bollard and is supported by three plumb and two battered steel H-12 piles. (See Photo 11 in Appendix A.)

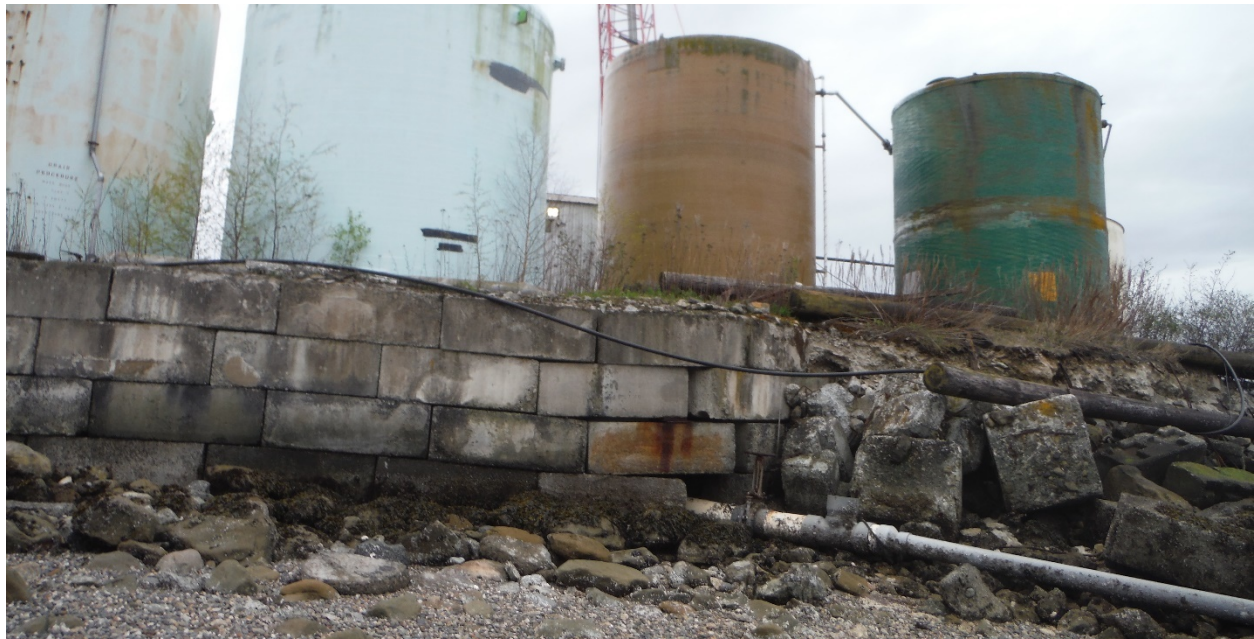
Photo 12 – Ecology Wall

The Ecology Wall runs in the east/west direction along the shoreline between the Southeast Dolphin and the Marine Railway. The first 40 feet near the Southeast Dolphin is a steep armored slope consisting of concrete rubble, ecology blocks, and timber piling. The armored slope then transitions to a uniform 2x2 by 6-foot interlocked concrete ecology block system that is approximately 8 feet tall at its maximum height. At the east end, the wall returns to the south along the Marine Railway for approximately 70 feet. (See Photo 12 in Appendix A.)

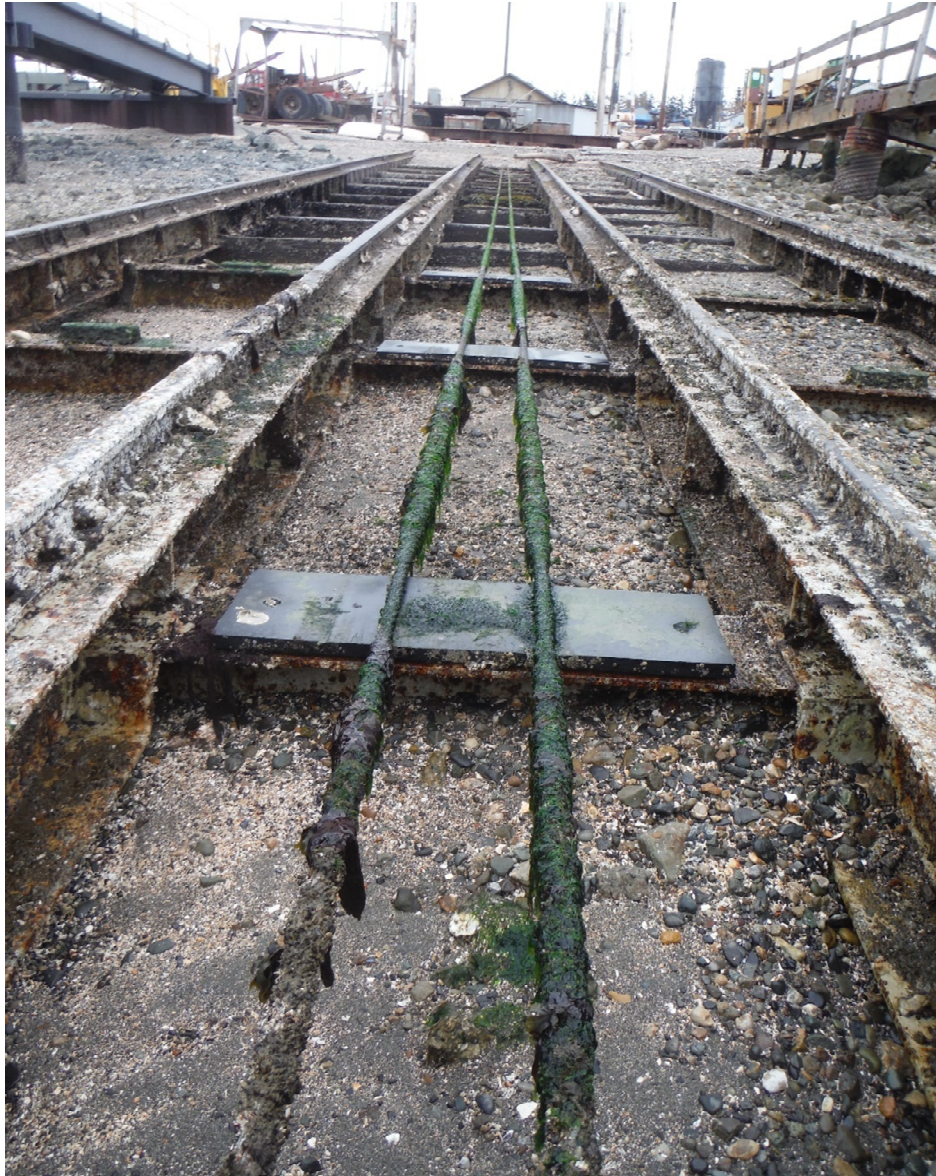
Photo 14 – Marine Railway

The Marine Railway is oriented perpendicular to shore consisting of a series of four parallel rails. Rails are supported on at-grade steel beams that bear on timber or steel pile caps. The pile caps are supported by timber piles, though the piles were visible during the assessment. The beams and ties below Elevation +7 mean lower low water (MLLW) are constructed of steel and timber. Beams and ties located upland of Elevation +7 MLLW are constructed with timber members only. (See Photo 14 in Appendix A.)
