**2024 LAND USE CONTROL INSPECTIONS TECHNICAL MEMORANDUM  
SITES 302 303 AND 304 AND TANK 50 NAVAL BASE KITSAP MANCHESTER  
KITSAP COUNTY WASHINGTON  
04/28/2025  
LIBERTY JOINT VENTURE (JV)**

# **2024 Land Use Control Inspections Technical Memorandum**

**Sites 302, 303, and 304 and Tank 50**

**Naval Base Kitsap Manchester, Kitsap County,  
Washington**

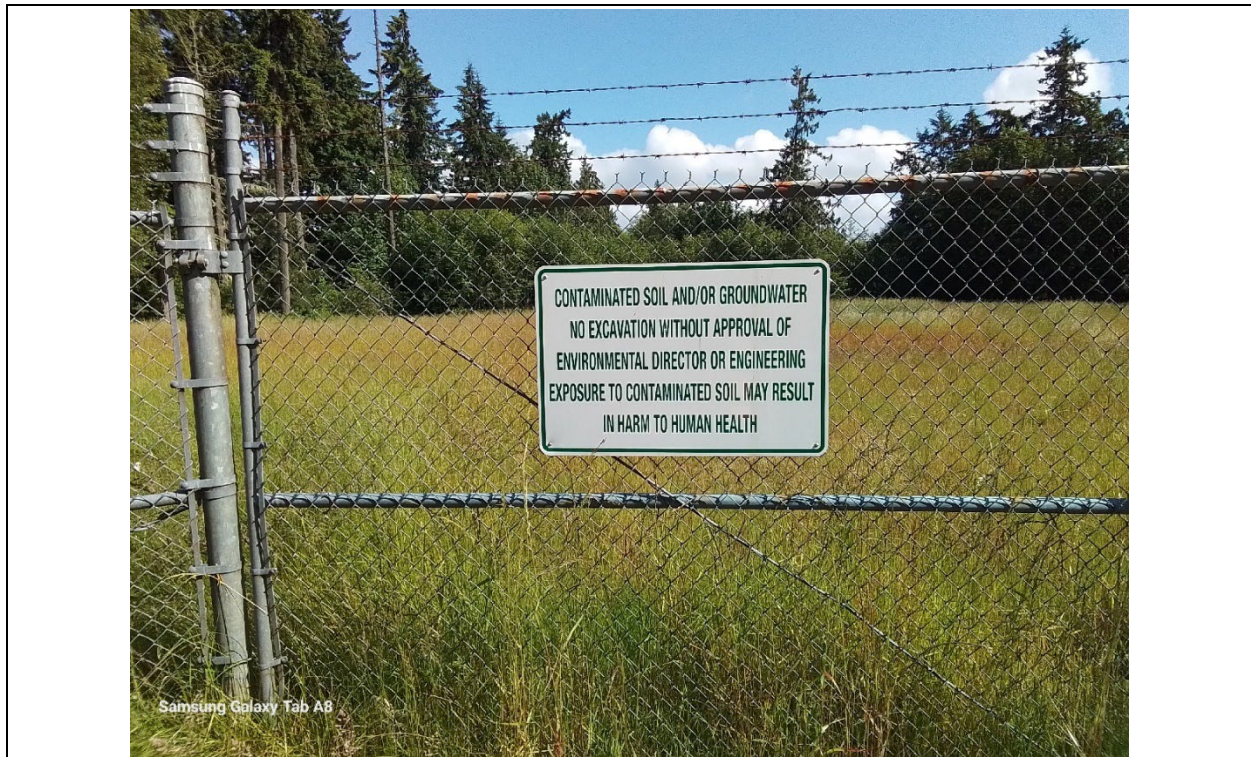
**Photograph 1**  
LUC signage located on south side of site, facing north.

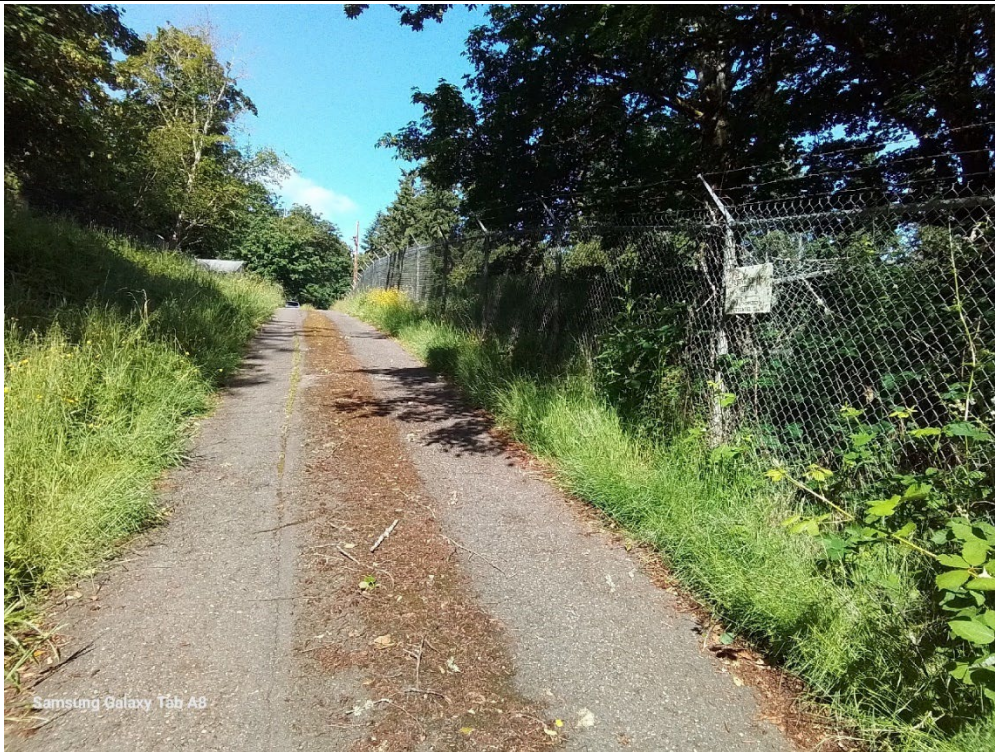
**Photograph 3**  
LUC signage at southeast corner, facing west.

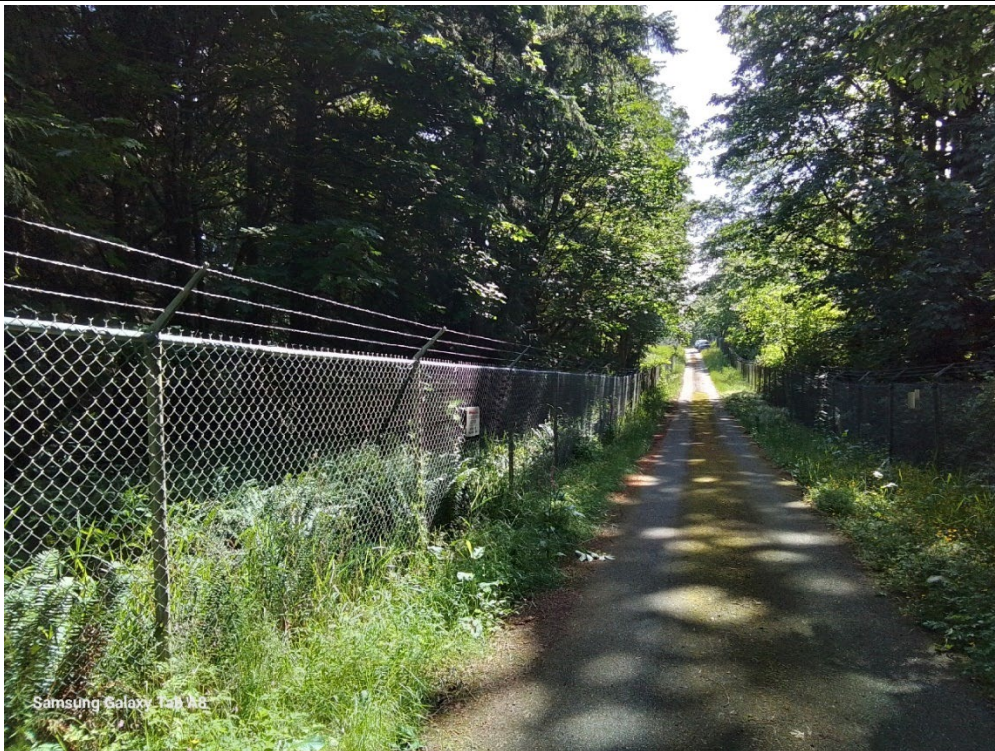
**Photograph 4**  
Fencing along southwestern boundary of site, facing northeast.

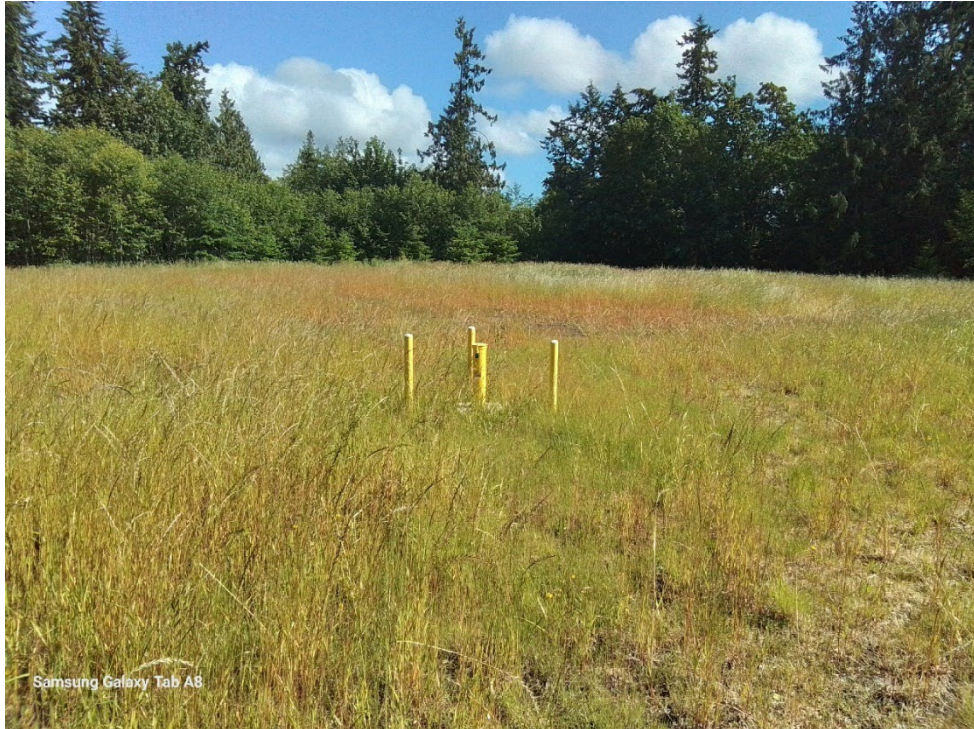
**Photograph 6**  
South central area of site and new PFAS groundwater monitoring well MFD-S302-MW03, facing north.

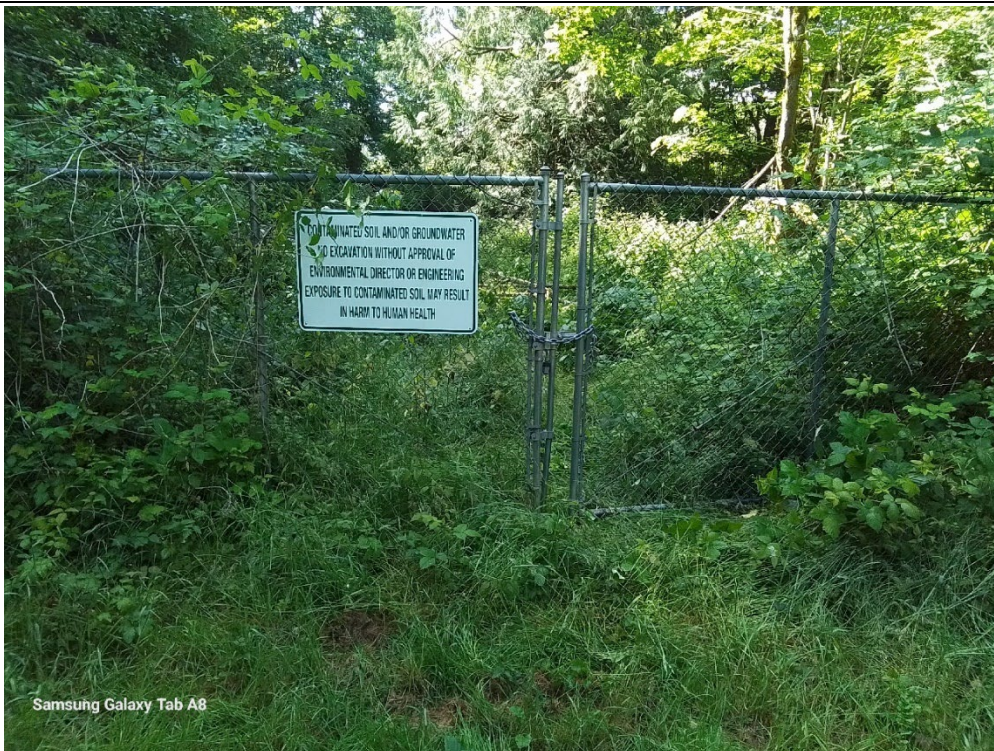
**Photograph 16**  
Locked access gate and LUC signage located on north side of site, facing south.

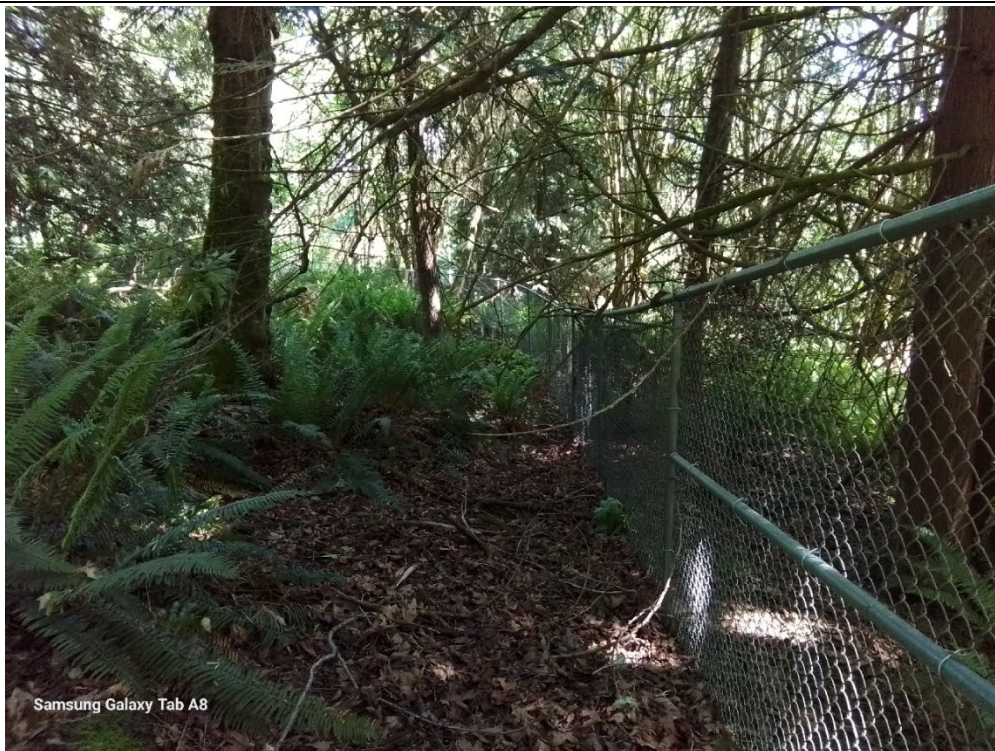
**Photograph 18**  
East perimeter fence line, facing north.

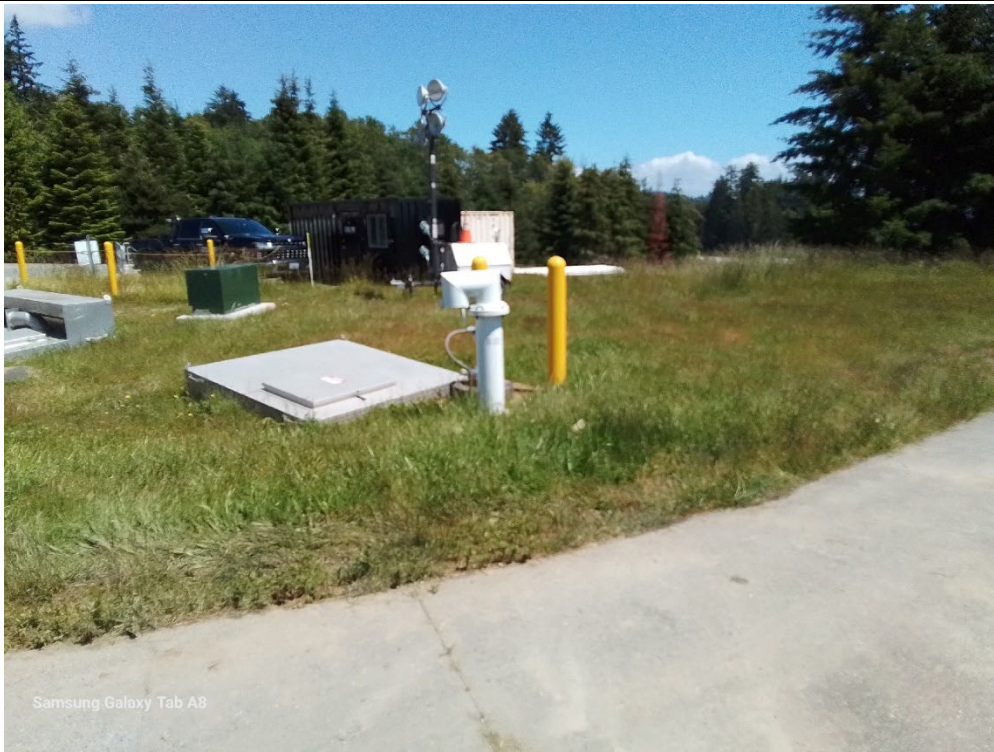
**Photograph 3**  
Locations of former vapor monitoring wells and installed vault, facing northeast.
