2 May 2017

Subject: Cap Integrity Monitoring
BNSF Railway Company, Parkwater Rail Yard
Spokane, Washington
K/J 1796110.00

East and West Debris Area
2017 Cap Integrity Monitoring
Parkwater Rail Yard Site

Former Koch Asphalt Lease Area
2017 Cap Integrity Monitoring
Parkwater Rail Yard Site

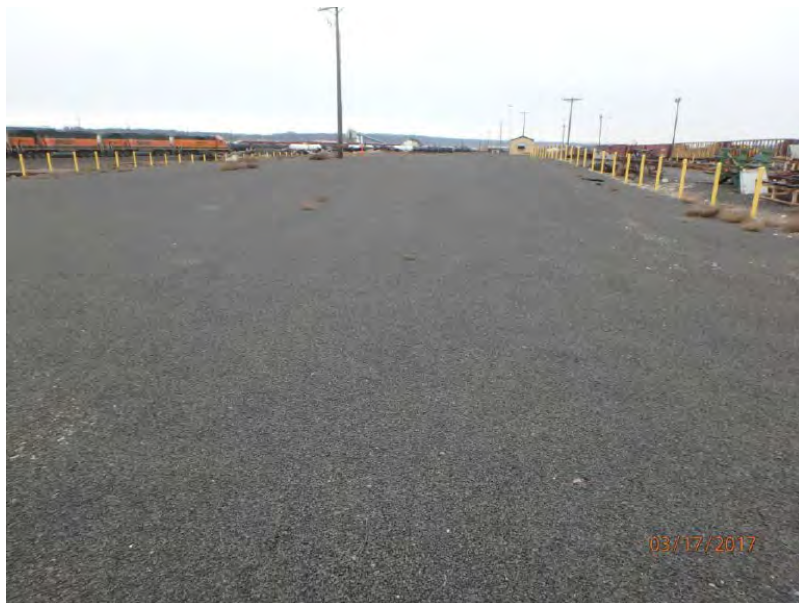
Photograph 1 – Looking to southwest.

- For the East and West Debris Area:
 - No indications of settlement or erosion of the cap were observed.
 - No indications of damage, degradation, or vandalism of the cap were observed.
 - No puddles or other depressions were observed.

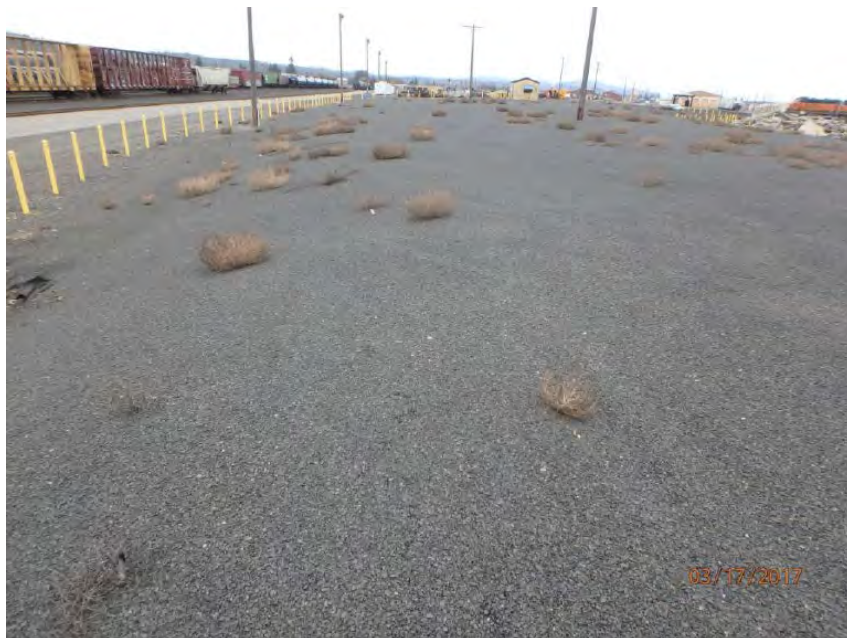
Photograph 4 – Looking to northeast. Standing near southwestern end of cap.

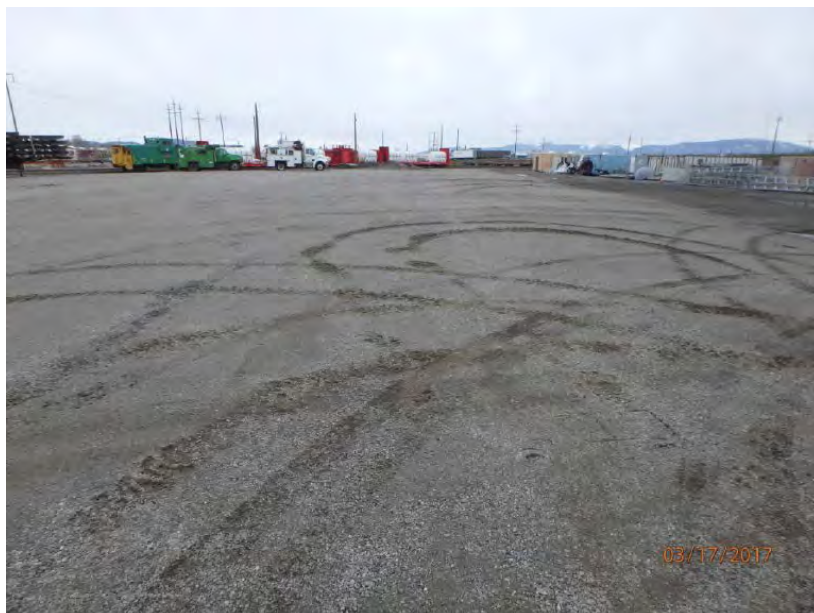
Photograph 1 – Looking to east.

- Limited vegetation was noted on the cap.
- The perimeter fencing was observed to be in good condition.
- For the Former Koch Asphalt Area:
 - No indications of settlement or erosion of the cap were observed.
 - No indications of vandalism of the cap were observed.
 - No puddles or other depressions were observed on the cap.
 - No vegetation was noted on the cap.
 - BNSF is utilizing the area to store equipment/trailers. Shallow tire tracks were observed.

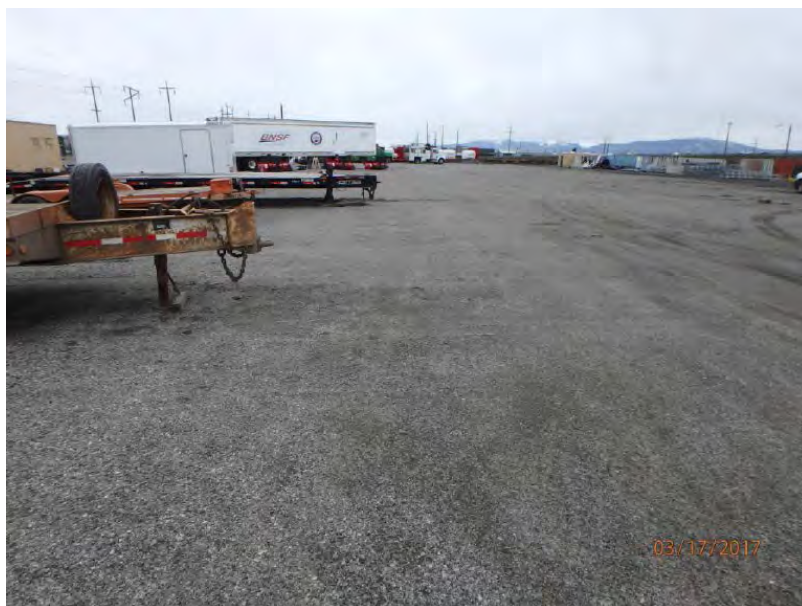
Photograph 2 – Looking to east. Closer to western end.
