Subject: Cap Integrity Monitoring  
BNSF Railway Company, Parkwater Rail Yard  
Spokane, Washington  
KJ 1896110.00

This letter provides the results of the June 2018 cap integrity monitoring at the BNSF Railway Company (BNSF) Parkwater Rail Yard (Site) located at 5302 East Trent Avenue in Spokane, Washington. The Site is in the cleanup process under the Model Toxics Control Act (MTCA) through the Washington State Department of Ecology (Ecology). The cleanup is being implemented by BNSF under Consent Decree No. 12202548-1, dated 19 July 2012.

Cap integrity monitoring included walking the perimeters and surfaces of the capped areas and inspecting for damage, degradation, or vandalism; puddles or other depressions; and animal burrows. Based on the field activities performed on 28 June 2018, the following conditions were noted:

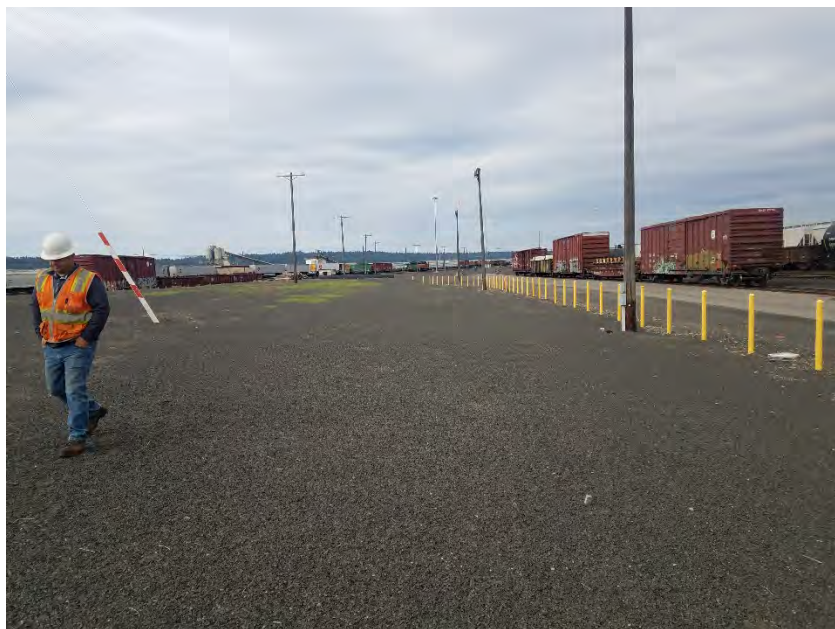
**Photograph 1** – Looking to west.  
6/28/2018

- For the East and West Debris Area:
  - No indications of settlement or erosion of the cap were observed.
  - No indications of damage, degradation, or vandalism of the cap were observed.
  - No puddles or other depressions were observed.
  - Limited vegetation was noted on the cap.
  - The perimeter fencing was observed to be in good condition apart from minor damage to the cable on the southwestern corner of the fence, which was repaired on 28 June 2018.

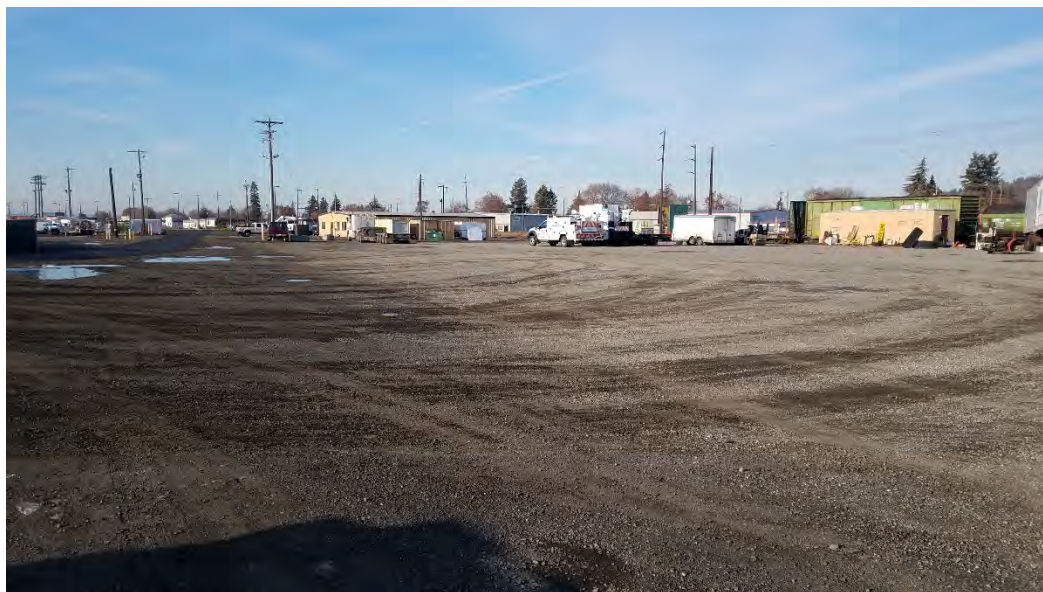
**Photograph 1** – Looking to west.  
6/28/2018

- For the Former Koch Asphalt Area:
  - No indications of settlement or erosion of the cap were observed.
  - No indications of vandalism of the cap were observed.
  - No puddles or other depressions were observed on the cap.
  - No vegetation was noted on the cap.
  - BNSF is utilizing the area to store equipment/trailers as intended. Shallow tire tracks were observed, but are expected.
