**PHASE I ENVIRONMENTAL SITE ASSESSMENT  
1900/1916 BOREN DEVELOPMENT  
1900 AND 1916 BOREN AVENUE  
SEATTLE, WASHINGTON**

**JULY 8, 2021**

**1350.020.01\_Rev1**

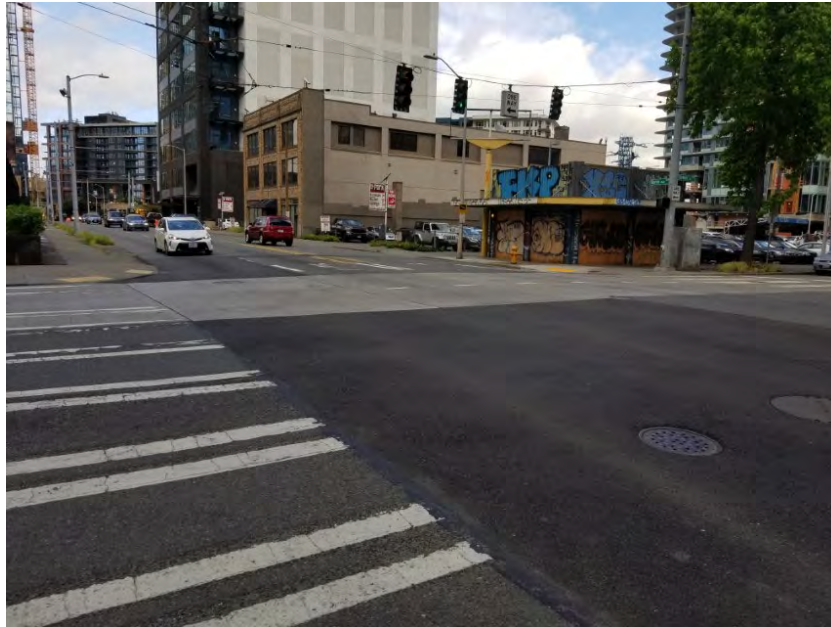
**Photo 1.** View Direction: North  
Viewing the subject property from the intersection of Boren Avenue and Stewart Street. The 1900 Boren Avenue building to the right, 1916 Boren Avenue is building center-left.

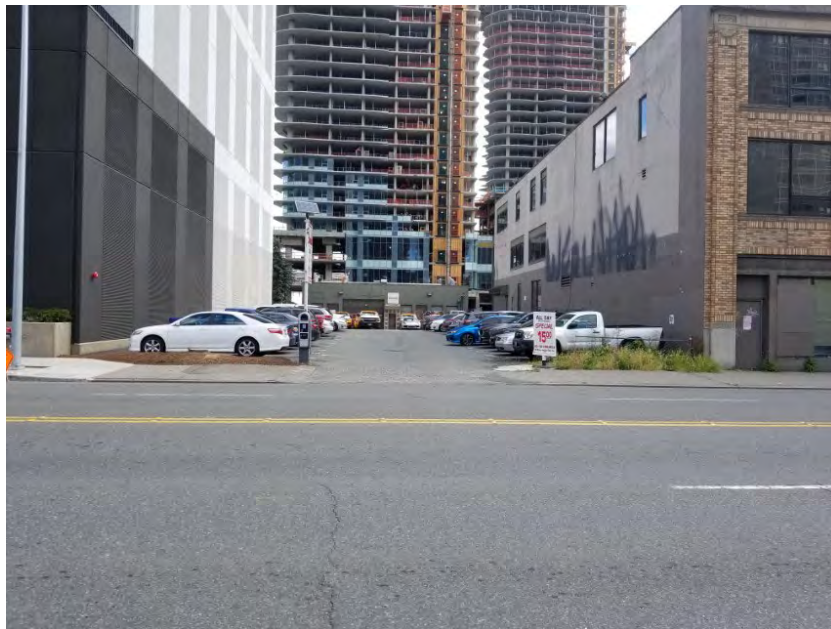
**Photo 2.** View Direction: Northeast  
Viewing the parking lot northwest of the 1916 Boren Avenue building (right) from Boren Avenue.

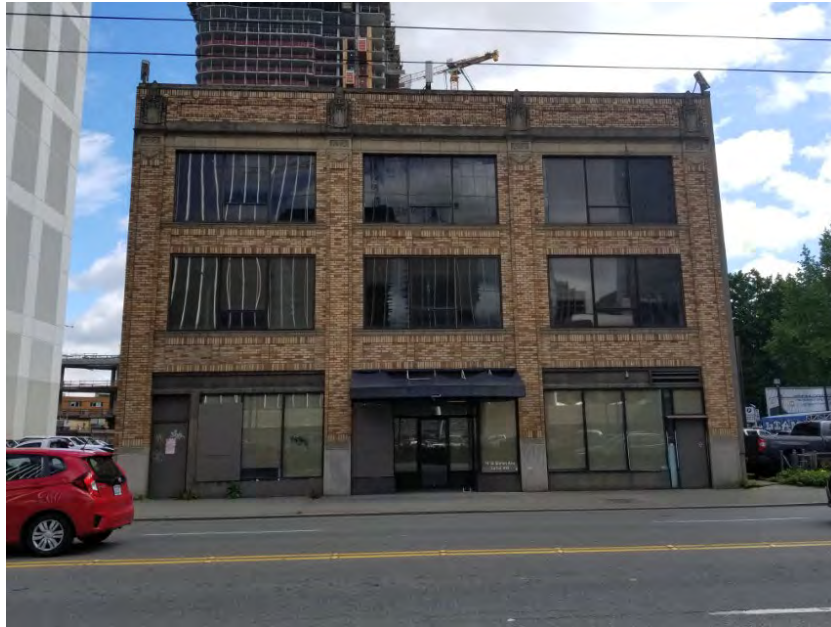
**Photo 3.** View Direction: Northeast  
Viewing 1916 Boren Avenue building from across Boren Avenue.

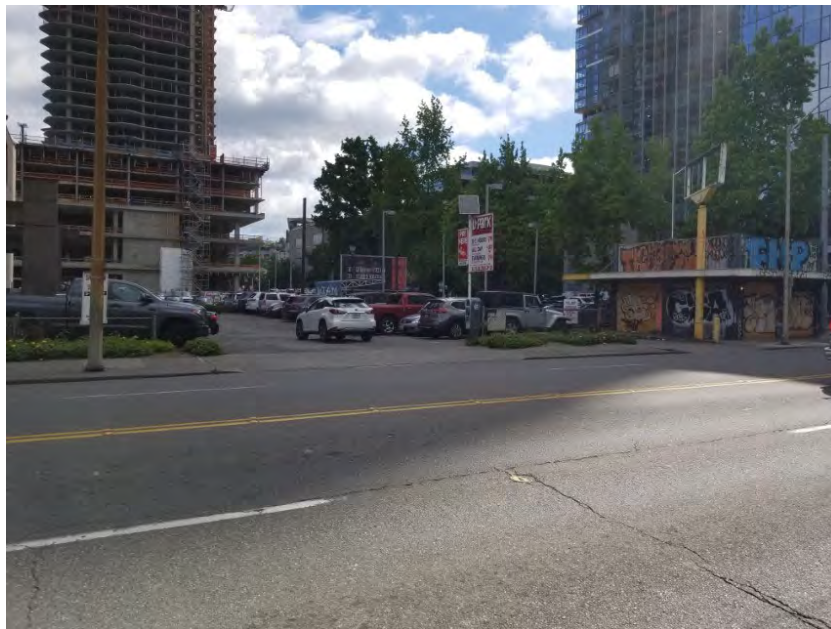
**Photo 4.** View Direction: Southeast  
Viewing the parking lot (left) and the 1900 Boren Avenue building (right) at the southeast end of the subject property from across Boren Avenue.

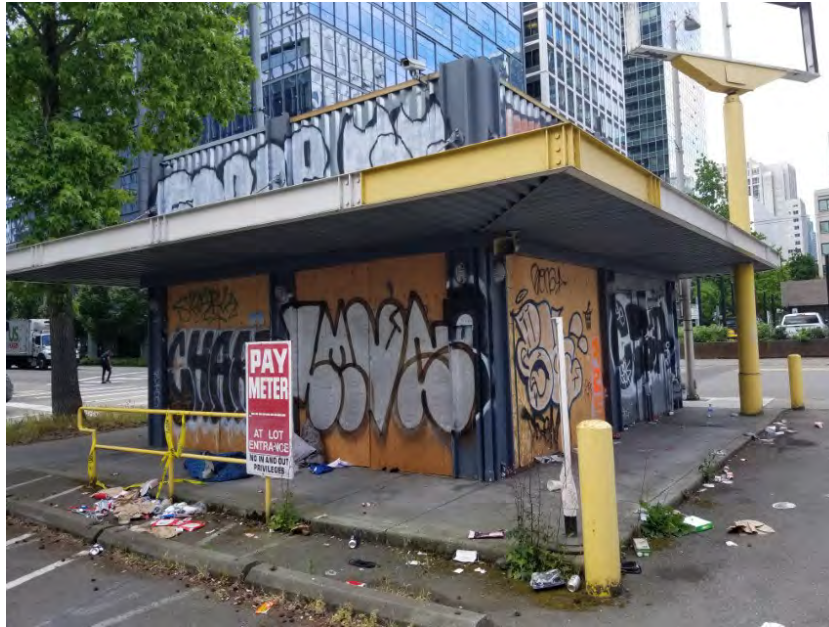
PES returned to the subject property on June 23, 2021, to conduct the inspection of the interior of the 1900 Boren Avenue building (Photo 5). The building is currently vacant and is boarded up to keep out vagrants. Mr. Cummings arranged to have the plywood sheeting removed from the front door on the northeast side of the building allowing PES to inspect the interior. The building is divided into three rooms: a lobby, an office, and a restroom. A storage room with access to the roof is located through a separate door on the northwest side of the building. Heat for the building is provided by electric wall heaters and a rooftop HVAC is fueled by natural gas. Several 1- and 5-gallon partially-filled containers of paint were noted in the lobby. The metal 1-gallon containers were rusty but none of the paint had appeared to have leaked onto the carpeted floor (Photo 36).

**Photo 5.** View Direction: South  
Viewing the 1900 Boren Avenue building from the south parking lot. Behind the building is Boren Avenue (right) and Stewart Street (left).

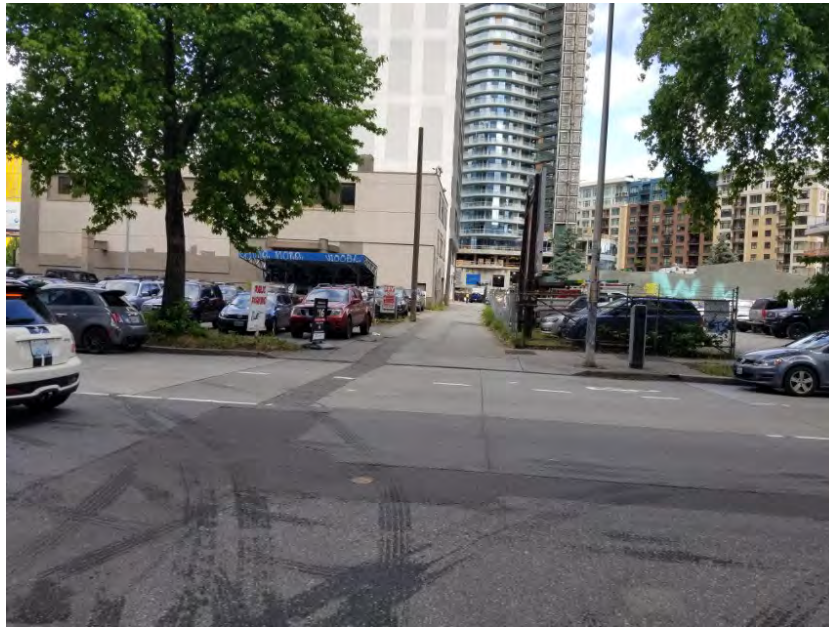
**Photo 6.** View Direction: Northwest  
Viewing the alleyway northeast of the subject property from Stewart Street. The southern parking lot is near left and the 1916 Boren Avenue building is in the distance (left).

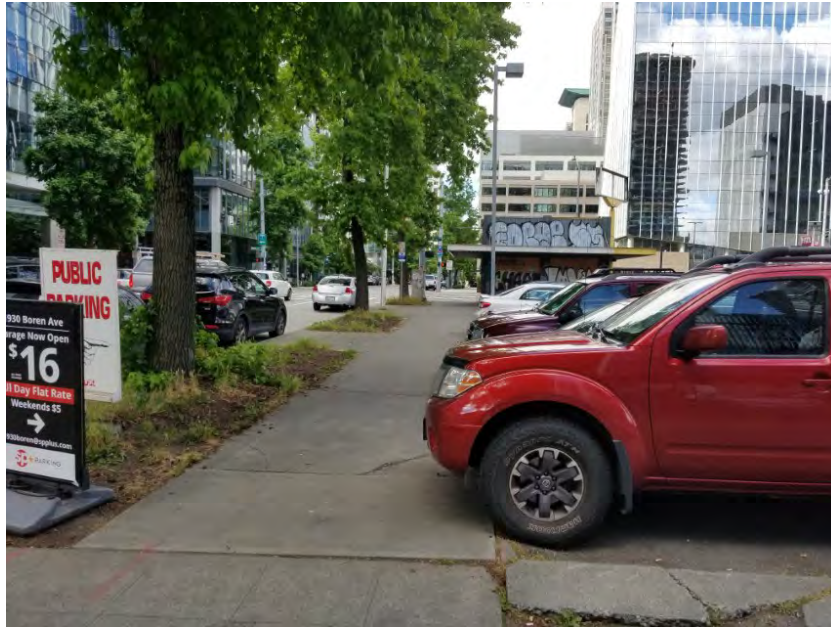
**Photo 7.** View Direction: Southwest  
Viewing the southeastern boundary of the subject property and adjacent sidewalk. The 1900 Boren Avenue building is in the distance.

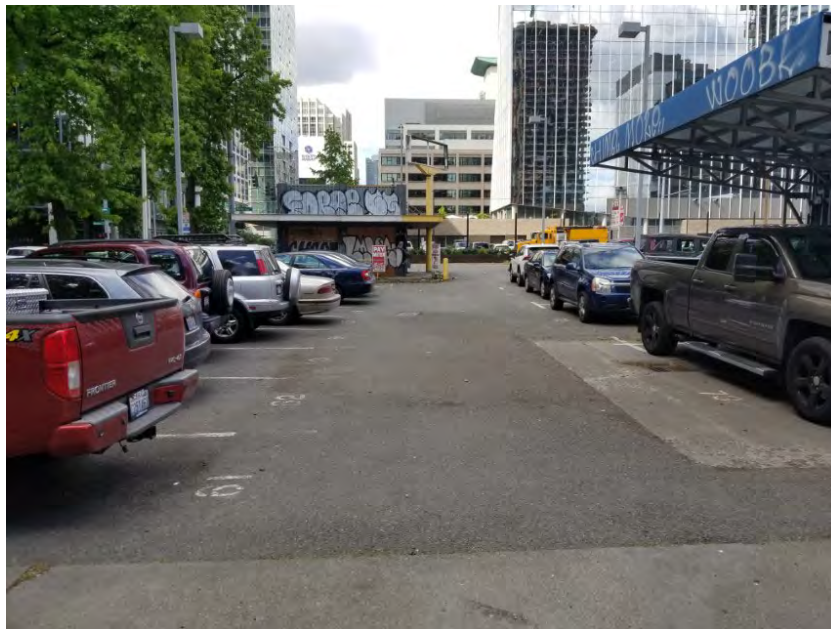
**Photo 8.** View Direction: Southwest  
Viewing the southeastern parking lot of the subject property and 1900 Boren Avenue building in the distance. The oil-water separator and car wash rack are in the right foreground.

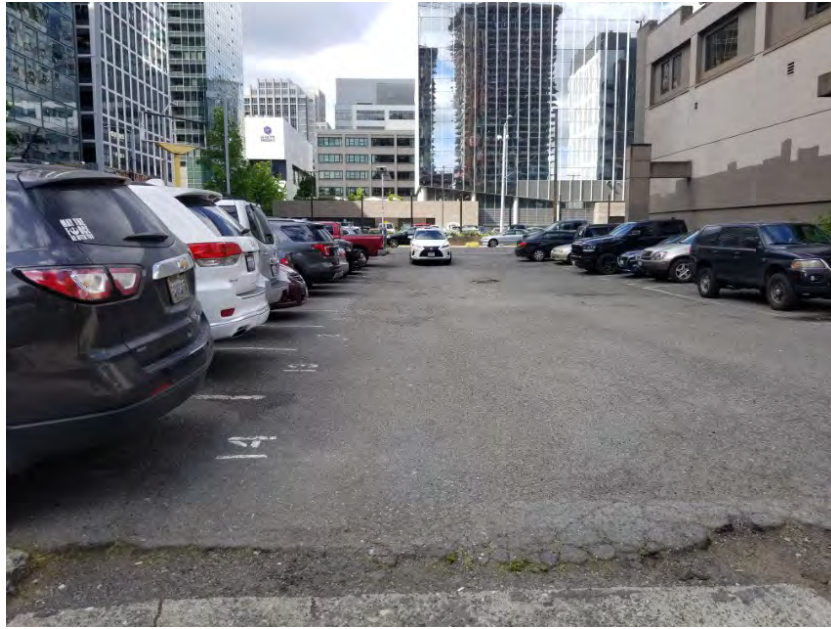
**Photo 9.** View Direction: Southwest  
Viewing the parking lot southeast of the 1916 Boren Avenue building (right) from the alley way.

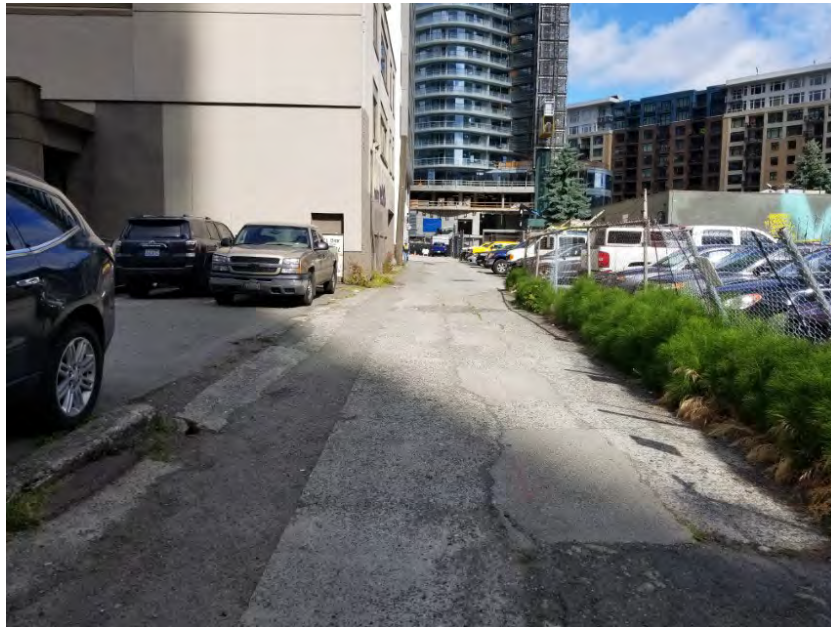
**Photo 10.** View Direction: Northwest  
Viewing the alleyway northeast of the subject property. The parking lot southeast of the 1916 Boren Avenue building is in the right foreground. The 1916 Boren Avenue building is in the background (left). An unpaved commercial parking lot is to the right.

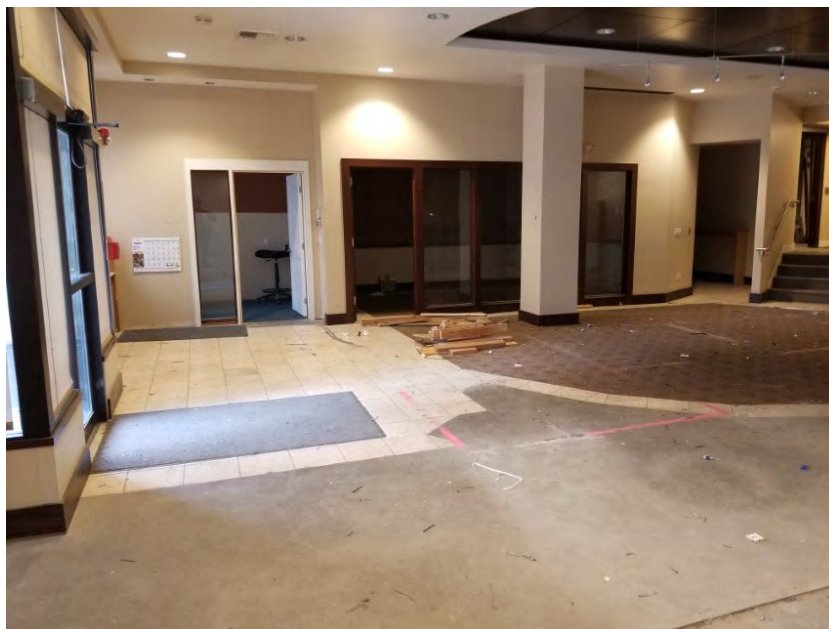
The following summarizes the observations during the inspection of the interior. The tour progressed from the main entrance at the Boren Avenue side of the subject property continuing to the upper levels to the roof ending at the entrance to the basement. The front entrance area includes a reception area (Photo 22), adjacent offices, and a restroom. The street level front entrance is situated at a lower level than the first floor which is accessed via a set of stairs opposite the front door entrance.

**Photo 22.** View Direction: North  
Viewing the street level entrance lobby of 1916 Boren Avenue building. The stairway to the first floor is to the right.

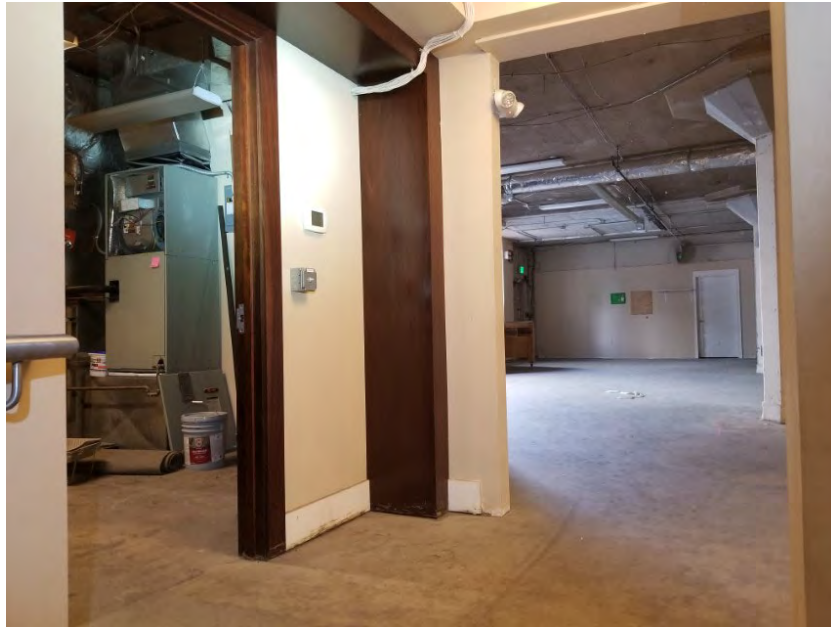
**Photo 23.** View Direction: Northeast  
Viewing mechanical/fire alarm room (right) and first floor (left) of the 1916 Boren Avenue building. The small warehouse at the northeast corner of the building is through the doorway in the background (right).

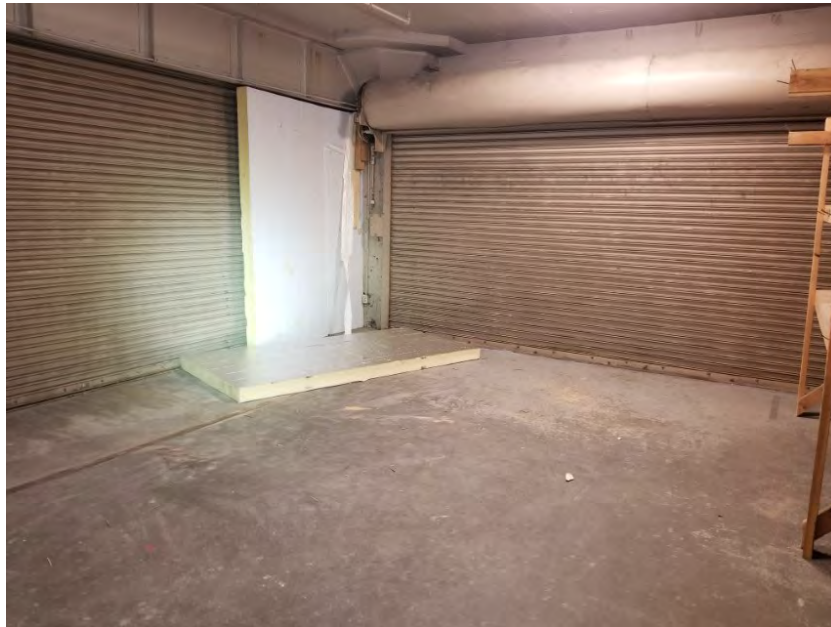
A small warehouse area is located at the north corner of the building that is accessed via a single man-door and two rollup doors, one opening to the adjacent alley and the other opening to the northwest parking lot (Photo– 24). The fire control room contained the fire alarm panel, natural gas-powered furnaces and air handlers, and electrical power panel (Photos 28 - 29). A small opening in the wall of this room (approximately 5 feet above the floor), appeared to be an access to a water heater as well as storage of building supplies (i.e., i.e., ceiling light cans and carpeting).

**Photo 24.** View Direction: North  
Viewing small warehouse area at the northeast corner of the 1916 Boren Avenue building. The left roll-up door leads to the northwest parking lot. The right roll-up door leads to the alley-way.

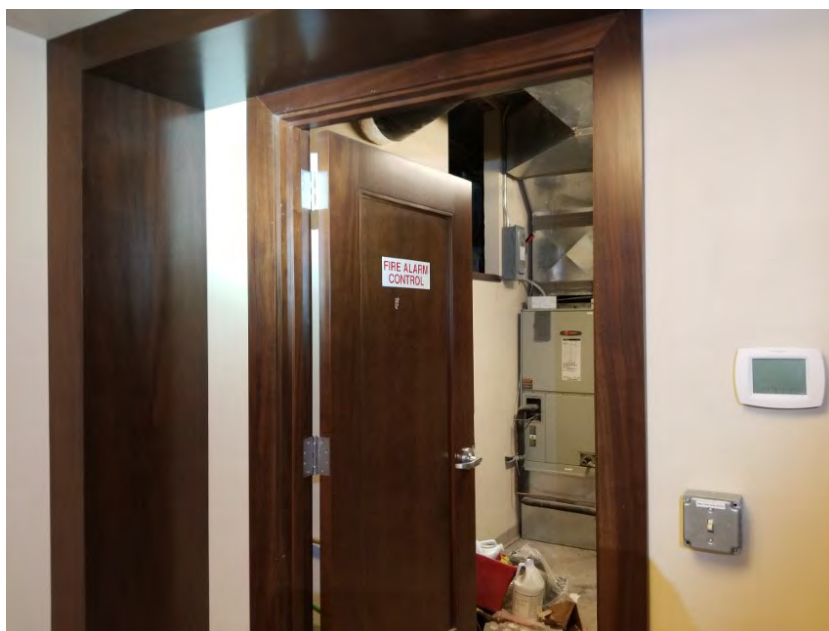
**Photo 28.** View Direction: South  
Viewing fire alarm control room on the first floor of the 1916 Boren Avenue building.

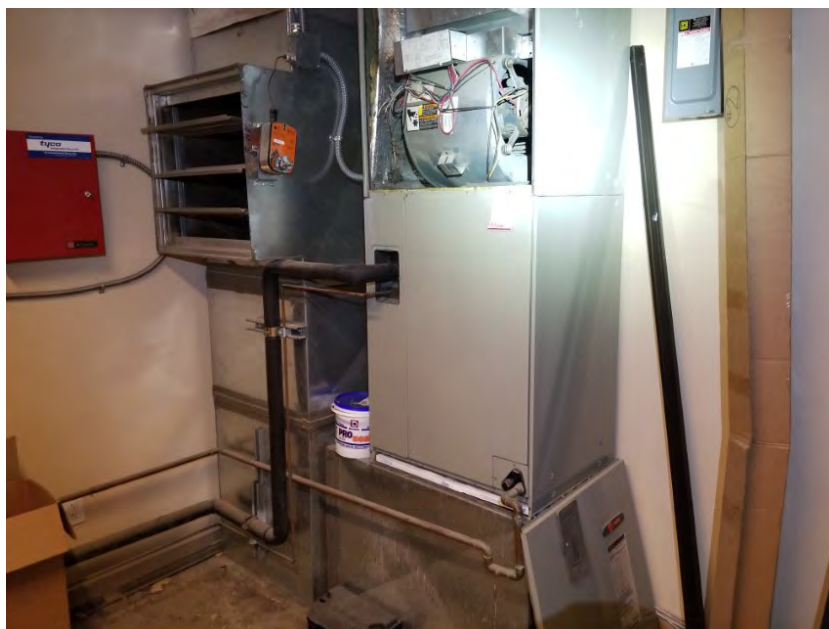
**Photo 29.** View Direction: Southeast  
Viewing natural gas furnace and air handler in the fire alarm control room on the first floor of the 1916 Boren Avenue building.

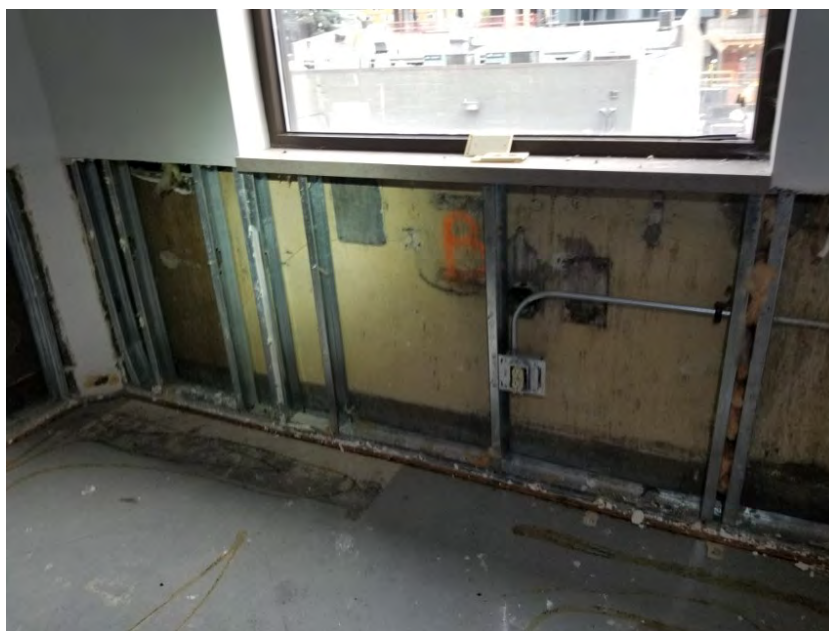
General features of all three floors included various floor finishes (i.e., carpet, sheet vinyl, and bare concrete), in some areas carpeting and/or tile had been removed exposing bare concrete floors; walls were constructed with aluminum studs/supports with painted gypsum sheetrock walls (Photos 30 – 31). Ceilings were a mix of finished drywall, unfinished concrete, and suspended acoustical tile. Exposed electrical, heat ducting, and water and fire suppression piping in the ceilings in most areas were noted throughout. While the walls were mostly intact, several areas had the dry wall removed below some windows (Photo 31).

**Photo 30.** View Direction: East  
Viewing a wall on the third floor of the 1916 Boren Avenue building with drywall and insulation removed revealing concrete wall aluminum studs.

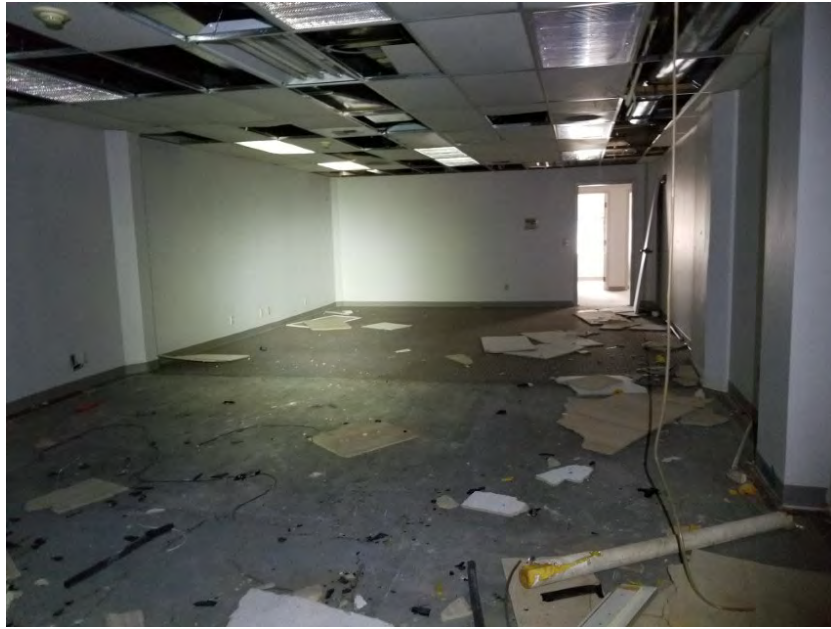
**Photo 31.** View Direction: Southwest  
Viewing a second floor office area of the 1916 Boren Avenue building. Half the carpeting in this space is removed (foreground) revealing the concrete floor.

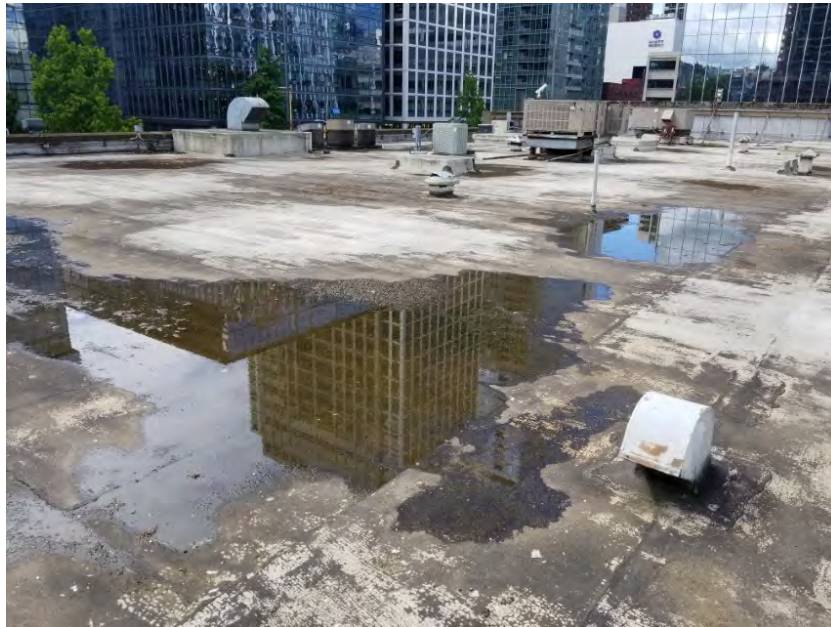
**Photo 32.** View Direction: South  
Viewing the rooftop of the 1916 Boren Avenue building.

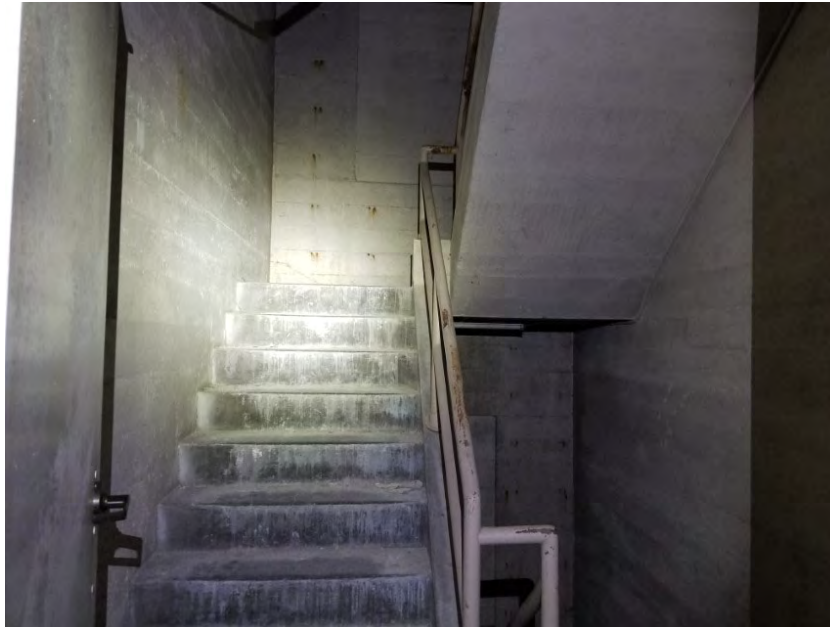
**Photo 33.** View Direction: Northeast  
Viewing the southeast stairway in the 1916 Boren Avenue building. Stairwell to the right leads to the boiler room in the basement of the building.
