# Environmental Cap and Drainage System Inspection Report

Former Louisiana Pacific/Pony Lumber Facility  
(Ecology Facility ID #1209)

December 4, 2024

Project No. M0615.24.002

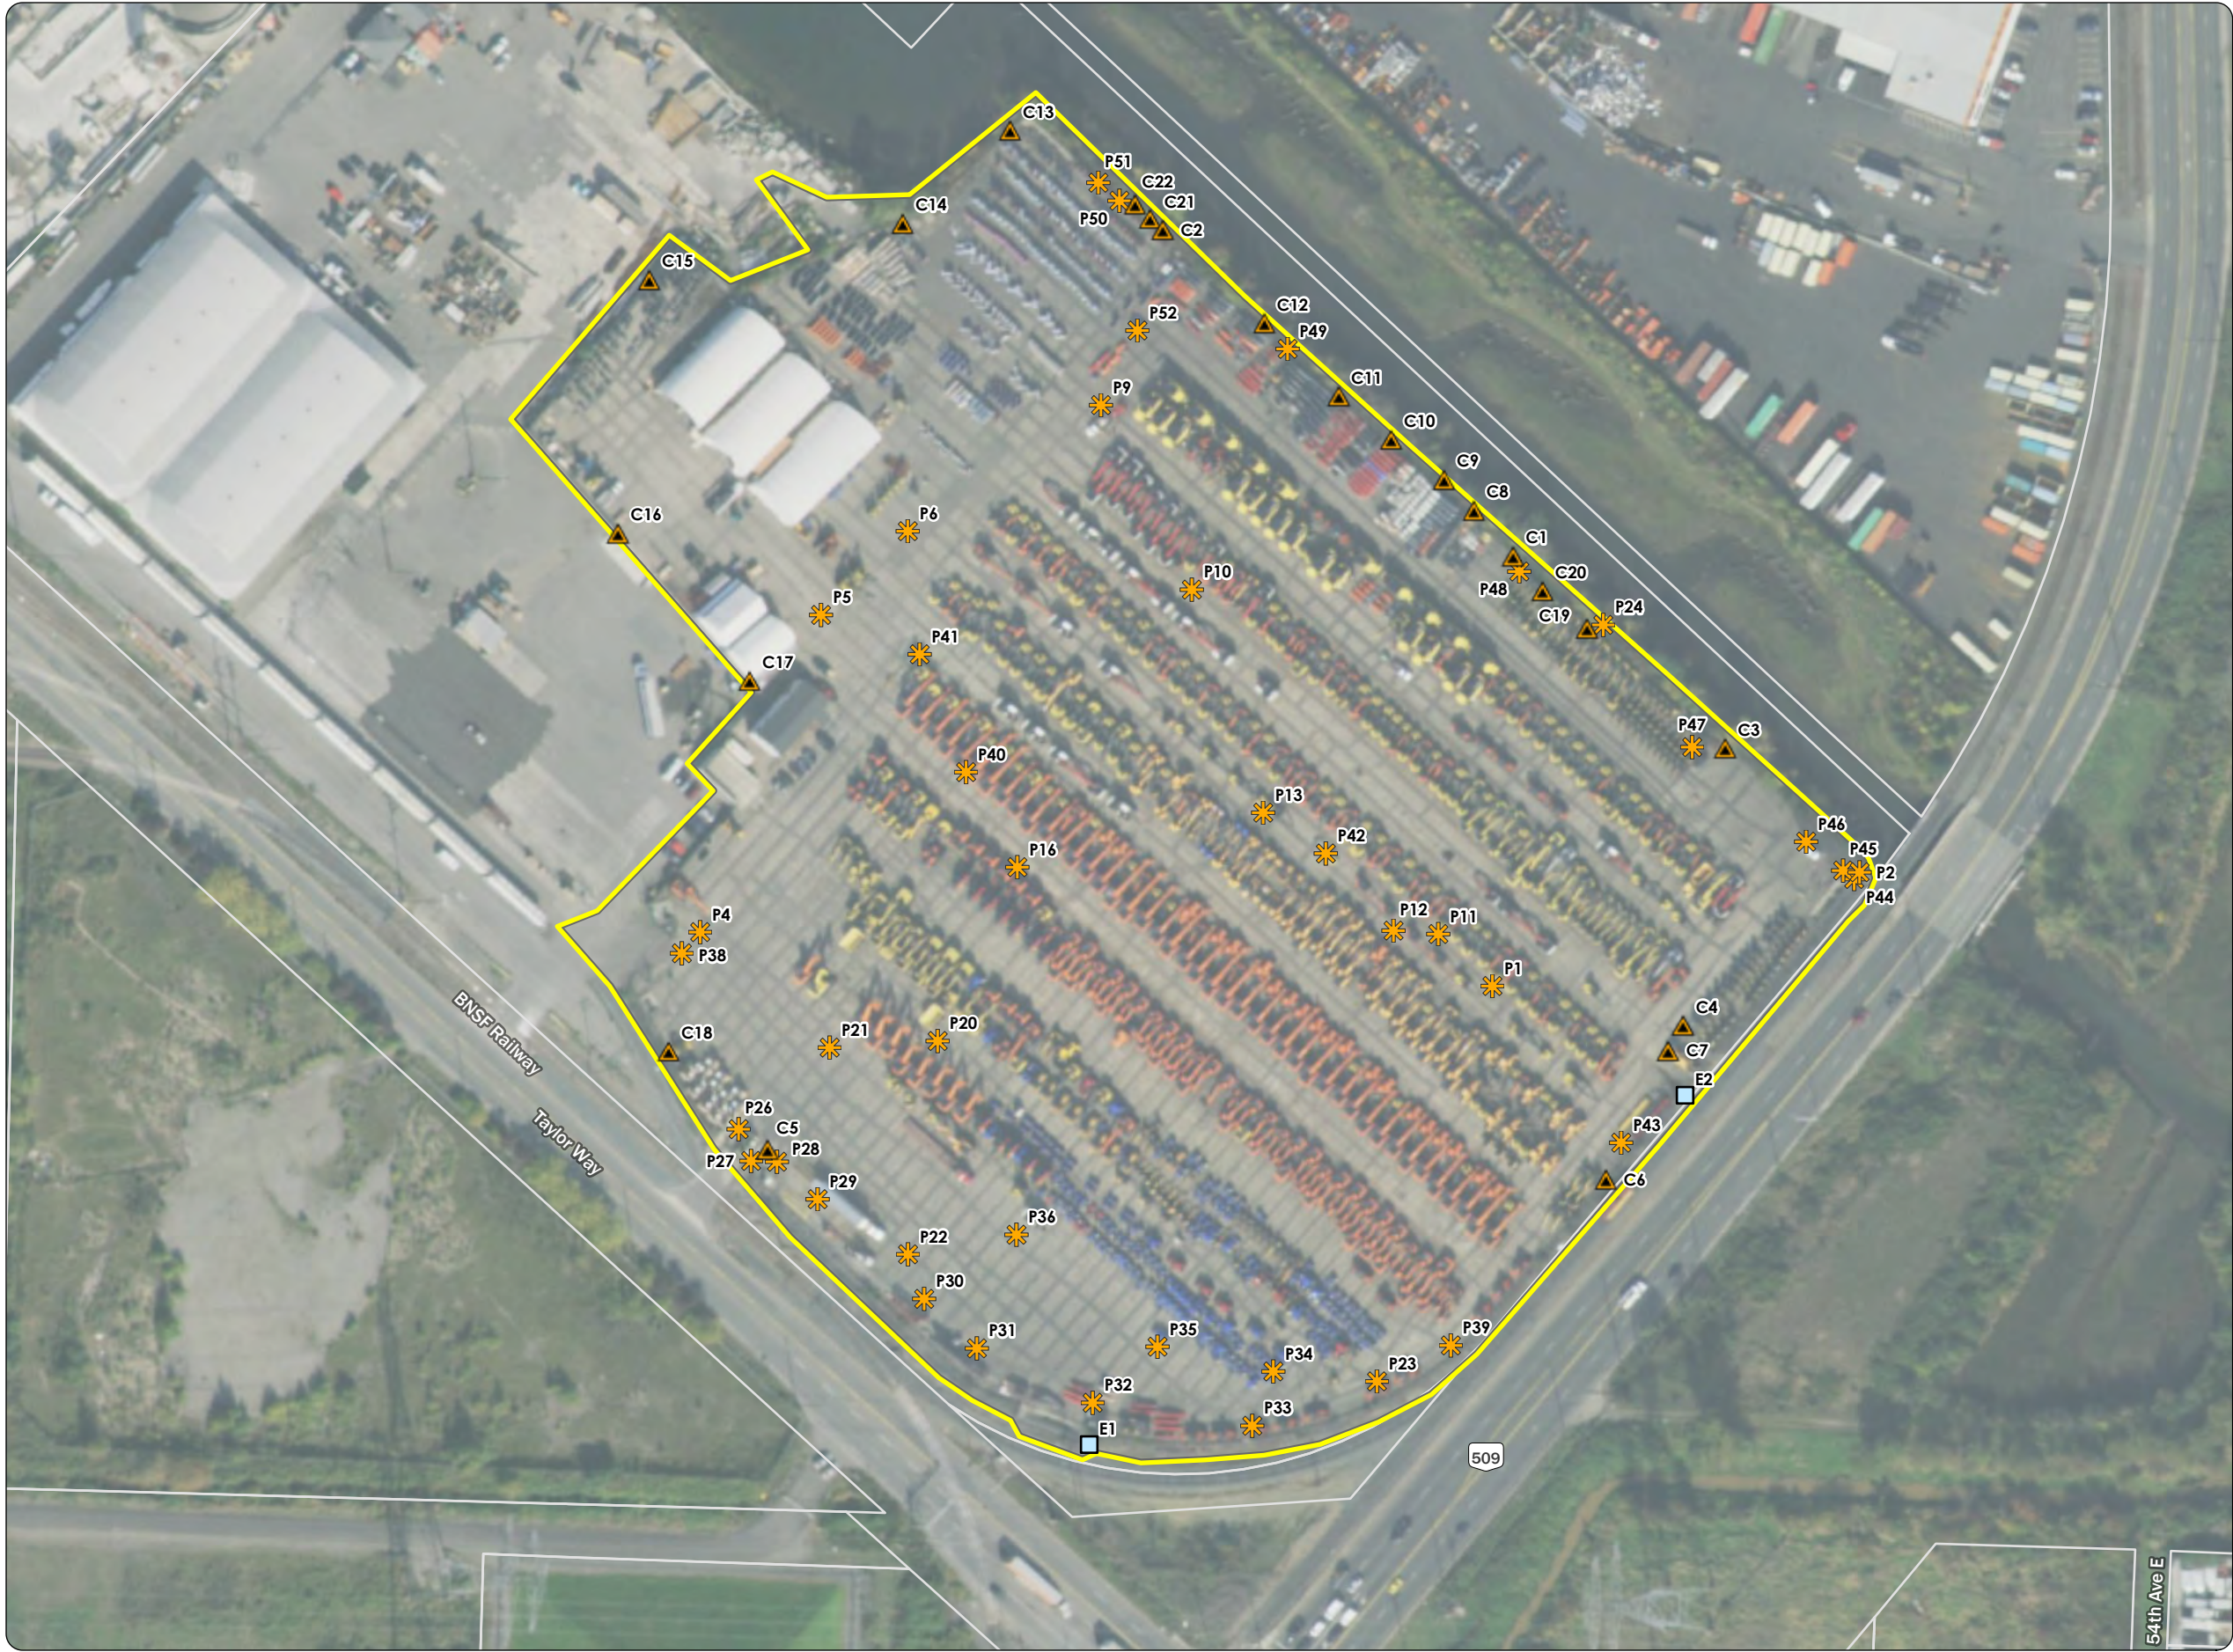
**Figure 2-1  
Environmental Cap  
Issues Observations**

| Required Inspection Element | Observed Condition | Recommended Action |
|---|---|---|
| Presence of cracks wider than 1/8 inch | Cracks wider than 1/8 inch were observed across the Site and in concrete structures | Repair pavement as shown in Figure 2-1 and described in Table 2-1 |
| Degradation, subsidence, general appearance | Surficial divots observed in asphalt across site; alligator cracking observed in portions of asphalt; damage to curb structures, damaged wheel stops; significant cracking and wear on concrete structures | Locations of pavement deterioration are shown in Figure 2-1 and described in Table 2-1. The more severe cracks should be prioritized for repair first. |

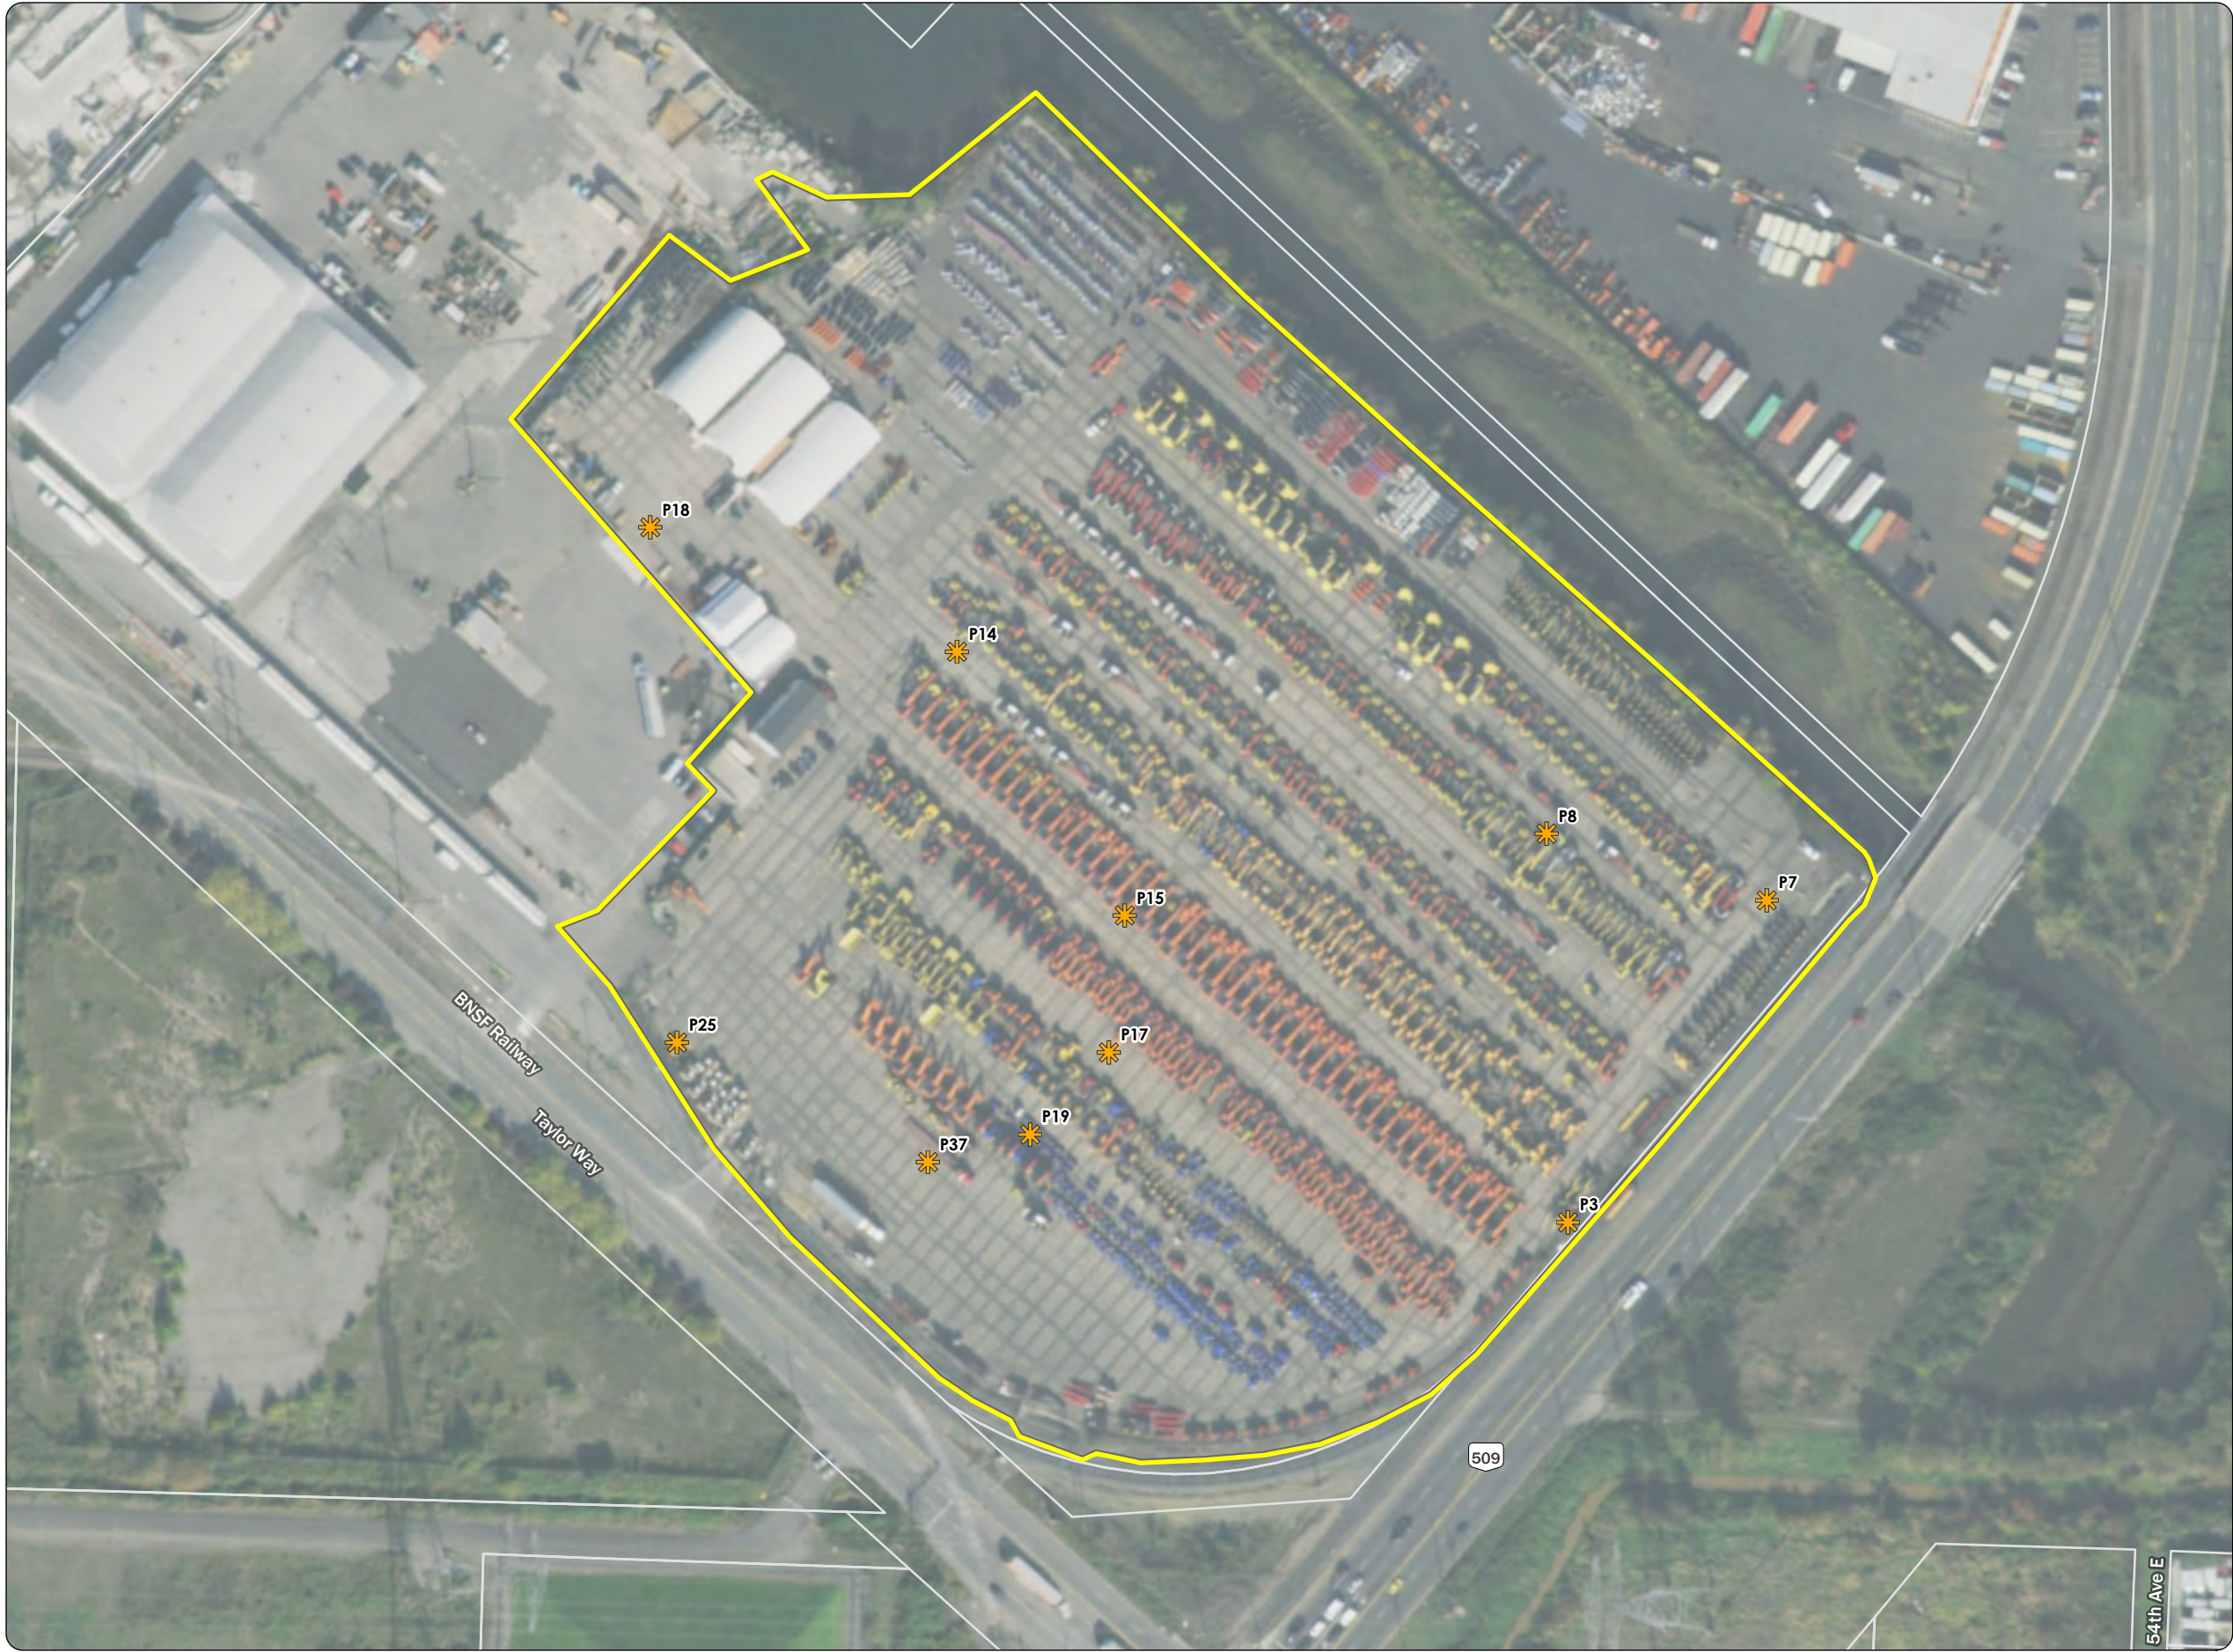
**Figure 2-2**  
**Environmental Cap**  
**Repairs Observations**  
Former Louisiana Pacific/Pony Lumber  
3701 Taylor Way  
Tacoma, Washington

Cap repairs were also observed during the 2024 inspection. Cap repairs are presented in Figure 2-2 and are summarized in Table 2-2. Pavement repairs associated with the electrified fence installation are also described in Appendix A. Pavement seals were observed in good condition with no action required.

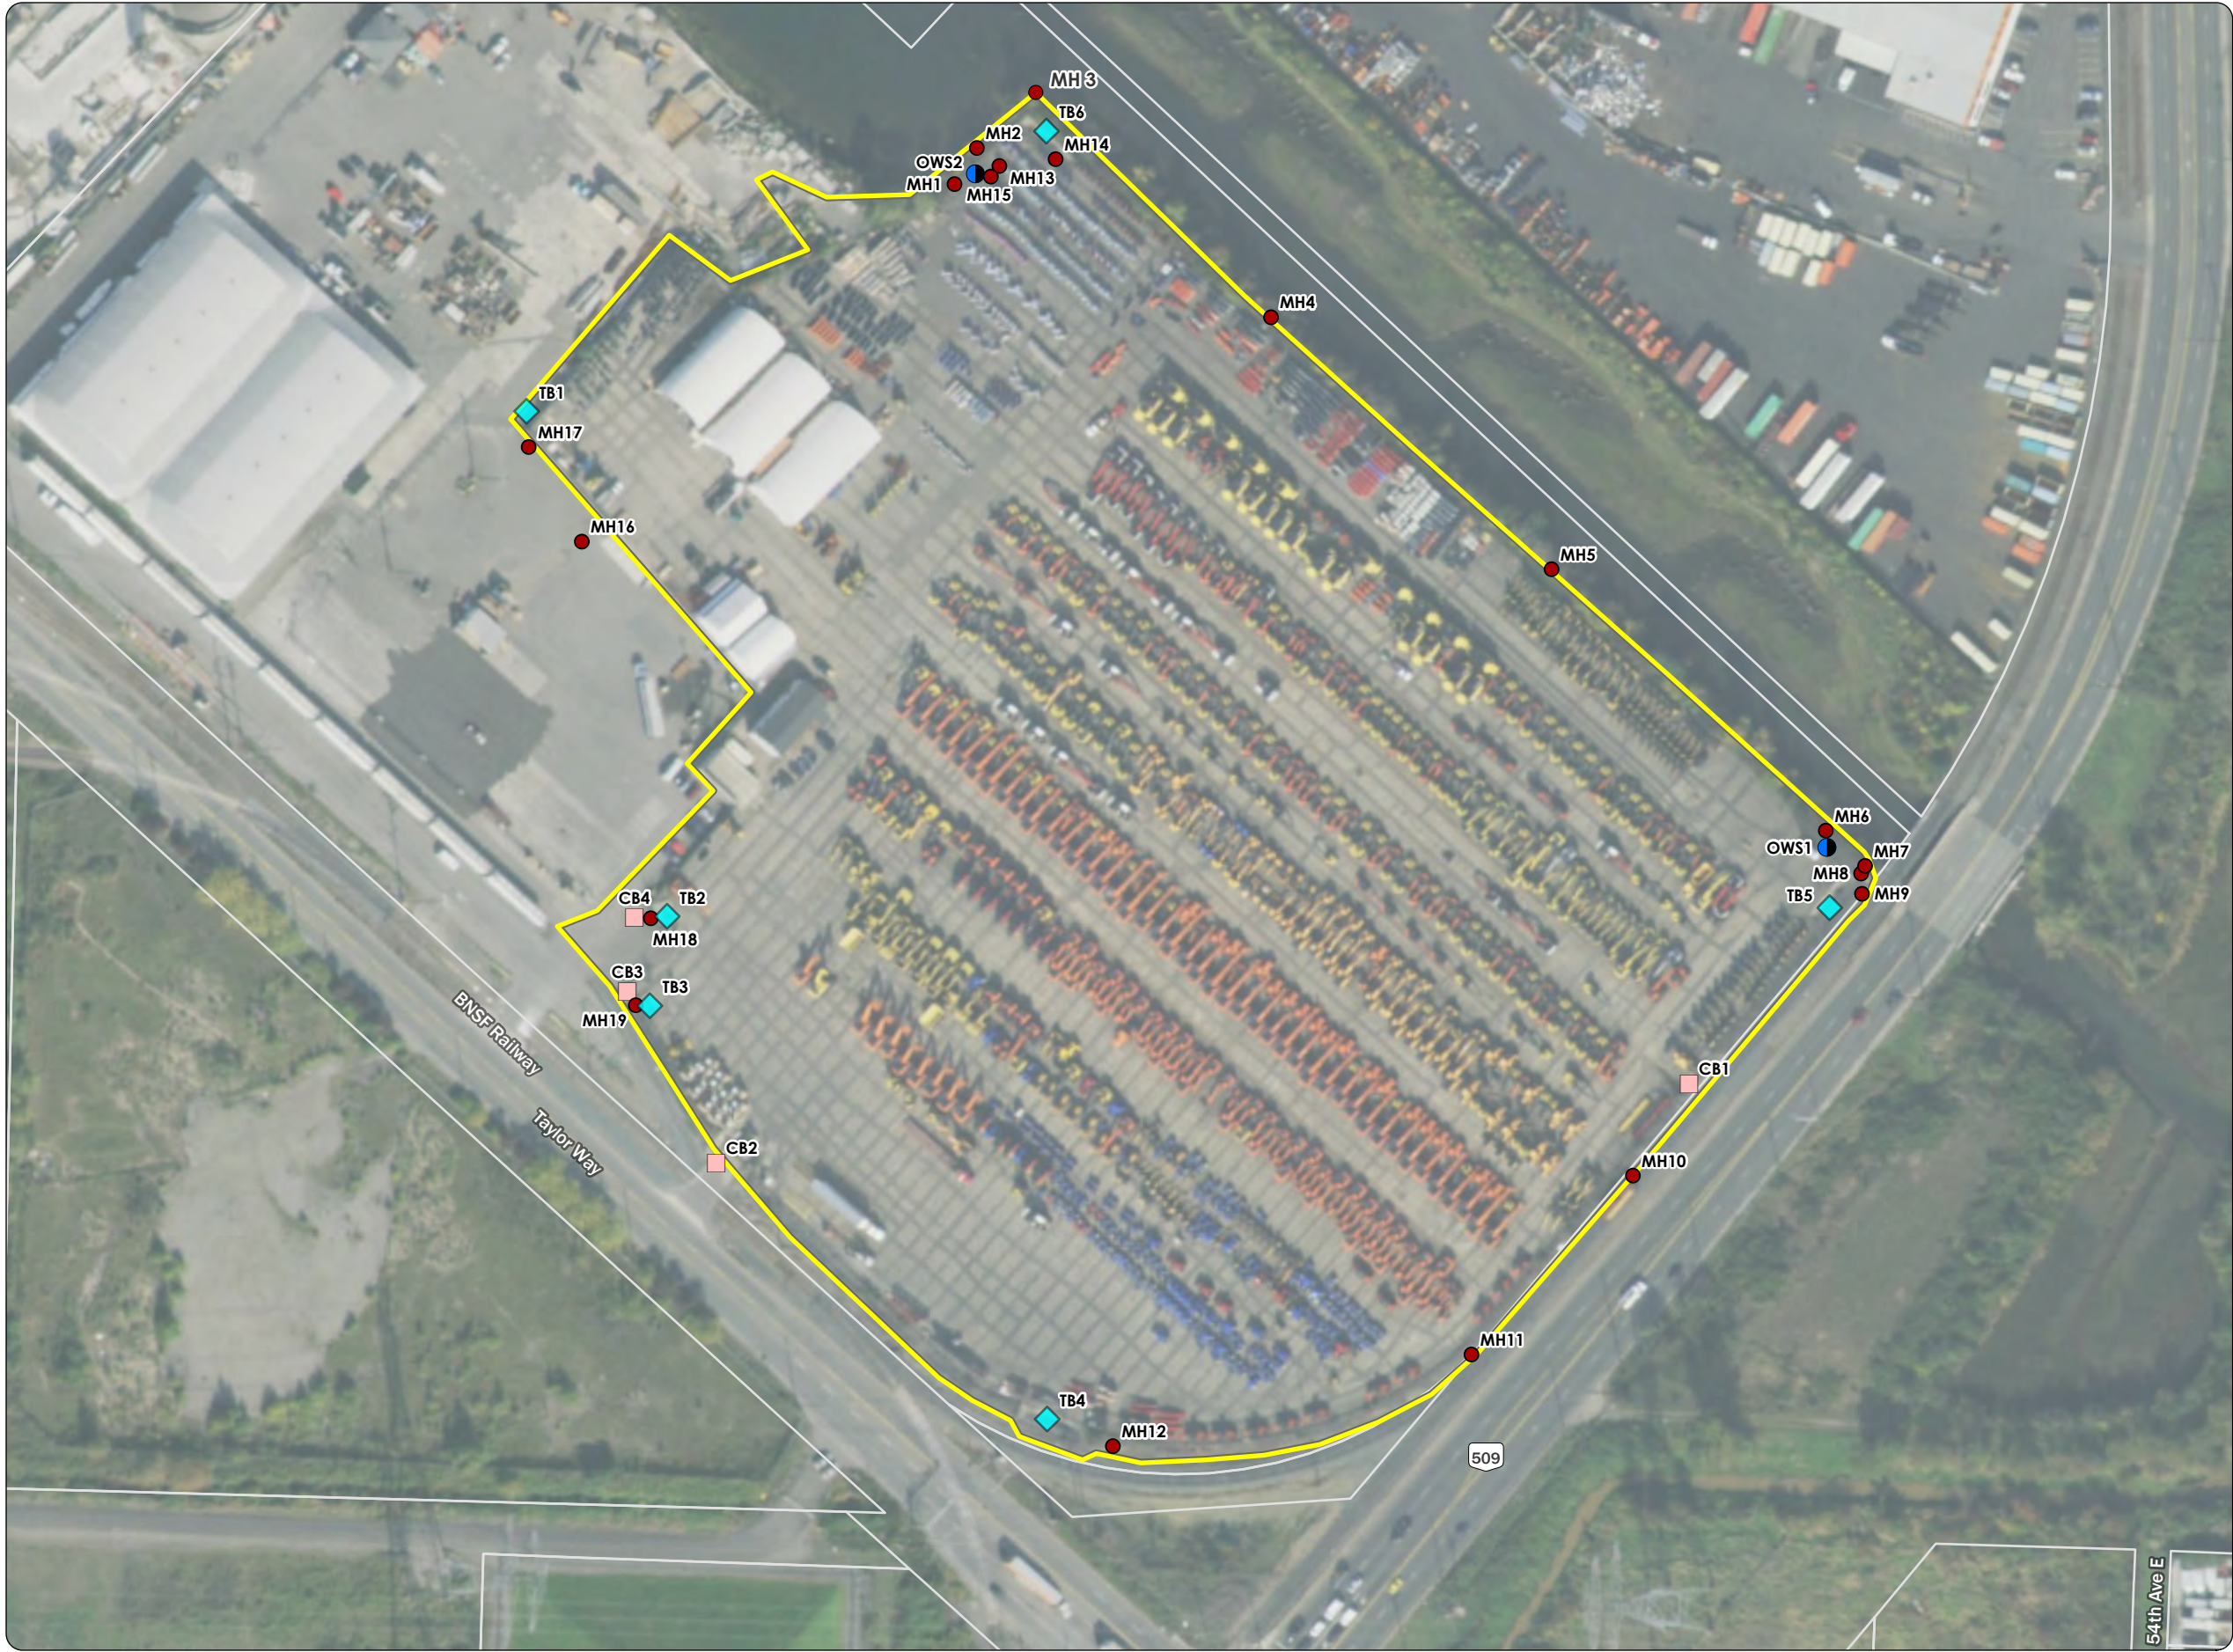
## Fig 2-3 Stormwater Drainage System Observations

NOTE:  
1. Inspection completed on August 21 and 22, 2024 and September 17, 2024.  
2. Location of maintenance hole MH3 is approximate; structure was not observed during 2024 or 2022 cap inspections due to dense vegetation.

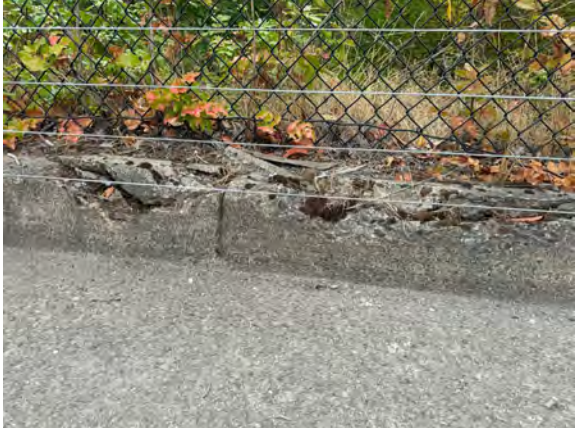
| ID <sup>1</sup> | Type of Structure | Observation | Recommended Actions | Photograph |
|---|---|---|---|---|
| C1 | Curb | Curb damage extending approximately 4 lf; damage limited to top 2 to 3 inches of curb; curb continues to function to control runoff | Monitor and reevaluate for repair during next inspection cycle | |

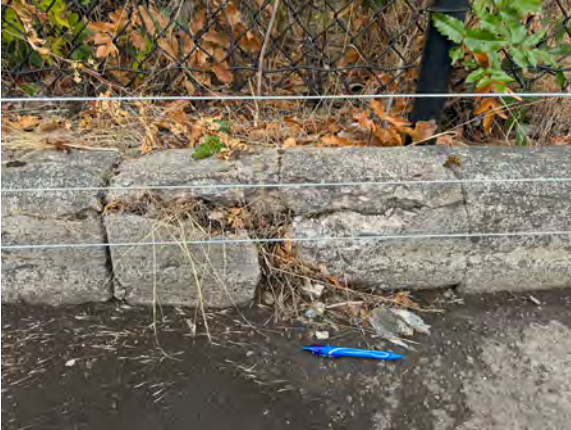
| ID <sup>1</sup> | Type of Structure | Observation | Recommended Actions | Photograph |
|---|---|---|---|---|
| C3 | Curb | Curb damage through vertical profile; concrete crumbling and loose pieces falling out | Repair curb | |

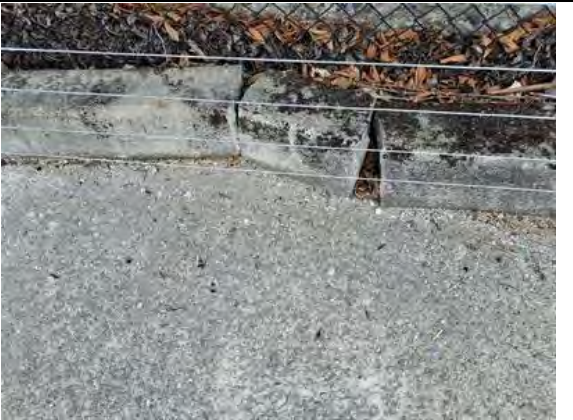
| ID <sup>1</sup> | Type of Structure | Observation | Recommended Actions | Photograph |
|---|---|---|---|---|
| C14 | Curb | Curb damage through vertical profile | Repair curb | |

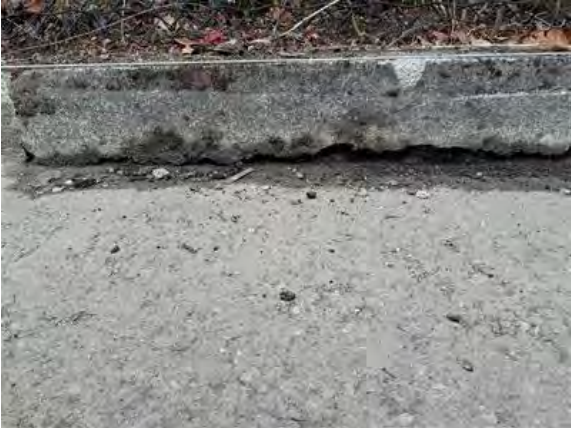
| ID <sup>1</sup> | Type of Structure | Observation | Recommended Actions | Photograph |
|---|---|---|---|---|
| C21 | Curb | Curb damage approximately 3 lf;<br>bottom of curb damaged<br>approximately 1 inch deep in places | Repair curb | |

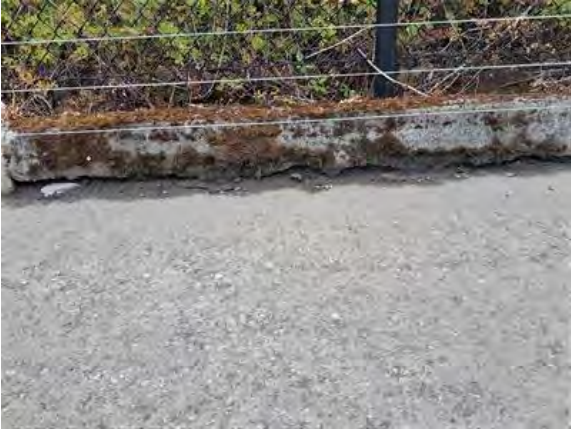
| ID <sup>1</sup> | Type of Structure | Observation | Recommended Actions | Photograph |
|---|---|---|---|---|
| C22 | Curb | Curb damage approximately 4 lf;<br>bottom of curb damaged<br>approximately 1.5 inches deep in<br>places | Repair curb | |

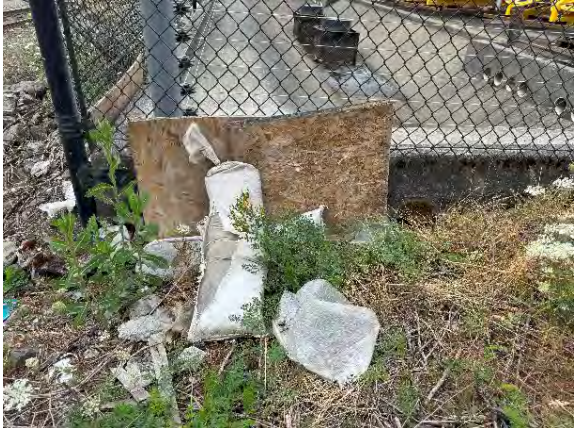
| ID <sup>1</sup> | Type of Structure | Observation | Recommended Actions | Photograph |
|---|---|---|---|---|
| E1 | Edge | Material eroding from underneath cap near treatment basin 4; void covered by particleboard and sandbags | Fill void under concrete slab to prevent further erosion and/or cap failure | |

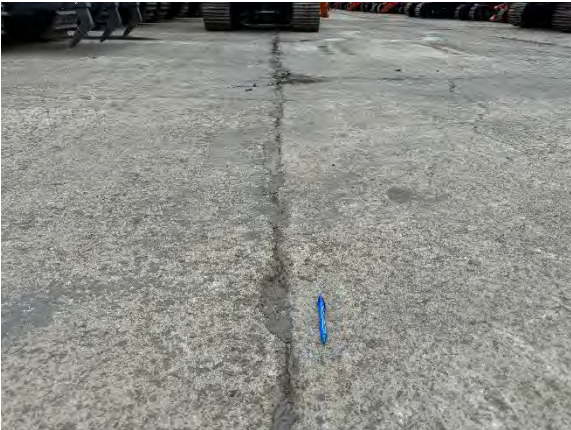
| ID <sup>1</sup> | Type of Structure | Observation | Recommended Actions | Photograph |
|---|---|---|---|---|
| P6 | Pavement | Approximately 200 lf crack with sealant wear; as wide as 2 inches and as deep as 1 inch in places | Seal crack | |

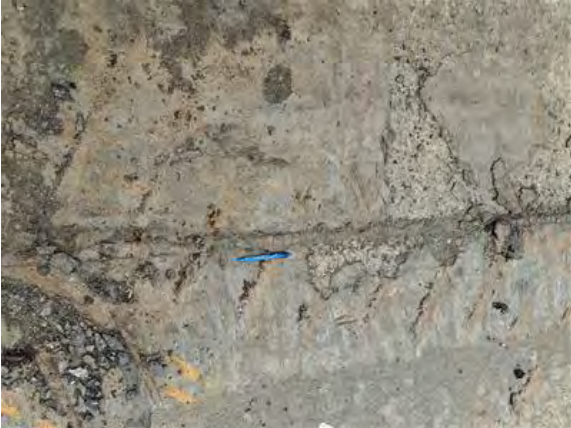
| ID <sup>1</sup> | Type of Structure | Observation | Recommended Actions | Photograph |
|---|---|---|---|---|
| P10 | Pavement | Previously sealed crack with deteriorated sealant in places; extends length of equipment row several hundred feet | Monitor and reevaluate for repair during next inspection cycle | |

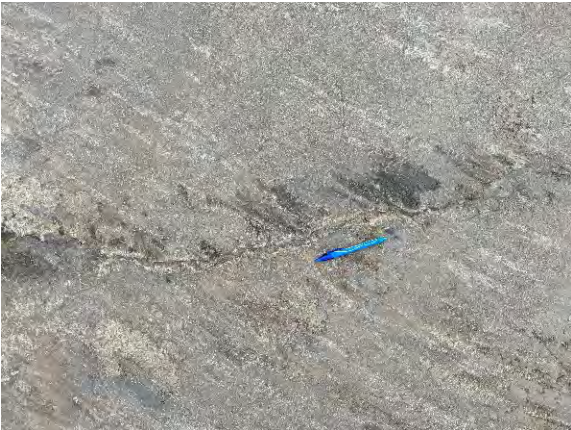
| ID <sup>1</sup> | Type of Structure | Observation | Recommended Actions | Photograph |
|---|---|---|---|---|
| P23 | Pavement | Previously sealed crack with sealant missing in places; approximately 20 lf | Reseal crack | |

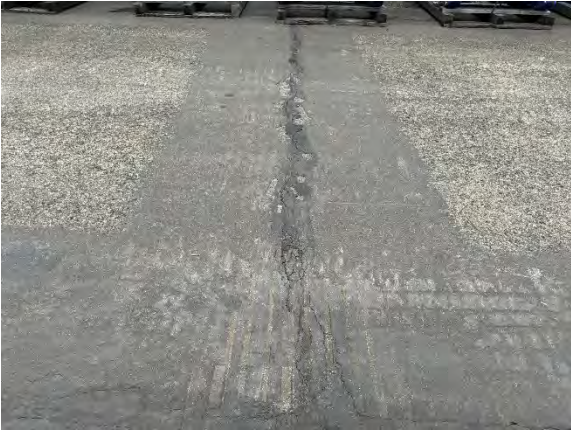
| ID <sup>1</sup> | Type of Structure | Observation | Recommended Actions | Photograph |
|---|---|---|---|---|
| P24 | Pavement | Previously sealed crack with sealant missing in places; approximately 50 lf | Reseal crack | |

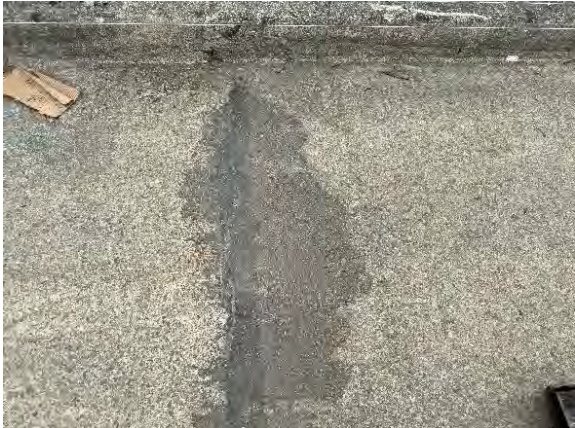
| ID <sup>1</sup> | Type of Structure | Observation | Recommended Actions | Photograph |
|---|---|---|---|---|
| P3 | Pavement | Slurry seal | None. | |

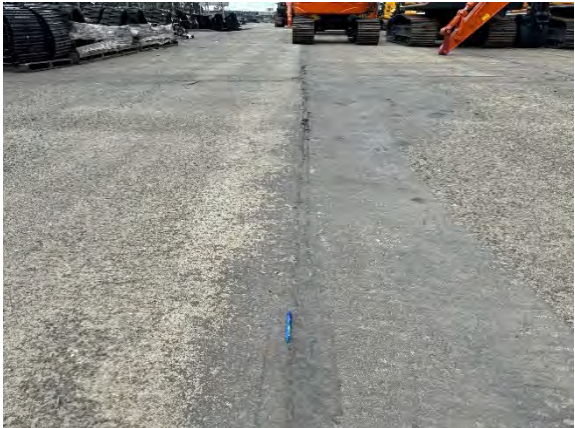
| ID <sup>1</sup> | Type of Structure | Observation | Recommended Actions | Photograph |
|---|---|---|---|---|
| P7 | Pavement | Sealed crack approximately 100 lf | None | |

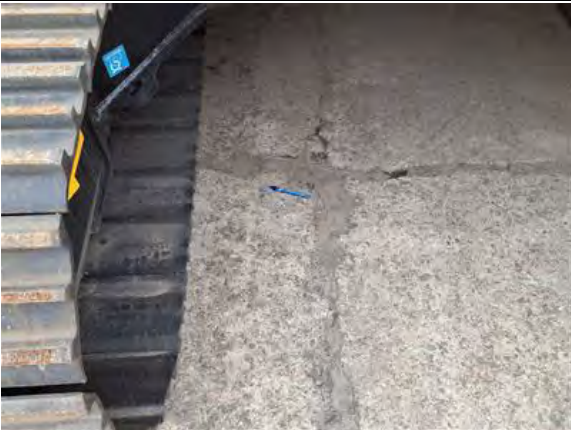
| ID <sup>1</sup> | Type of Structure | Observation | Recommended Actions | Photograph |
|---|---|---|---|---|
| P14 | Pavement | Sealed crack; approximately 15 lf | None | |

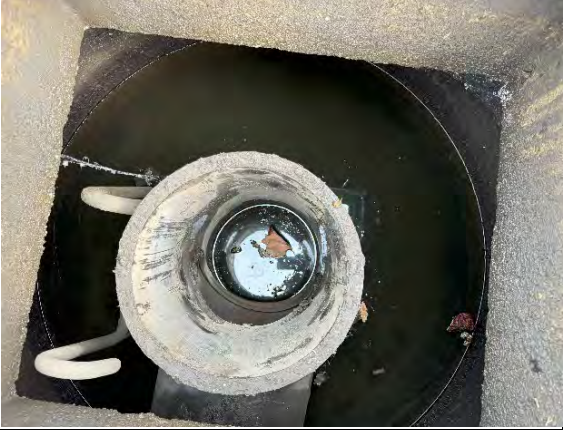
| ID | Type of Structure | Observation | Sediment Accumulation | Additional Observations | Recommended Actions | Photograph |
|---|---|---|---|---|---|---|
| CB1 | Catch basin | Structurally sound; functioning normally | Visible sediment accumulation in filter; water in structure is too deep to measure | Floating debris on surface | Remove sediment and debris from insert and structure in accordance with stormwater maintenance requirements | |

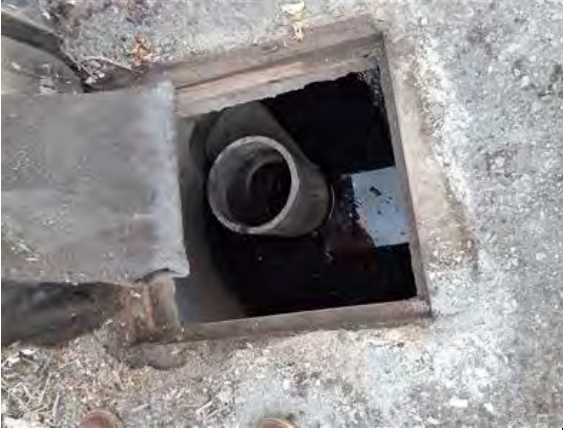
| ID | Type of Structure | Observation | Sediment Accumulation | Additional Observations | Recommended Actions | Photograph |
|---|---|---|---|---|---|---|
| CB2 | Catch basin | Structurally sound; functioning normally | Visible sediment accumulation in filter; water present in structure and too deep to measure | Insert in catch basin; sediment accumulation and tear in insert; floating debris on surface | Replace insert; remove floating debris in accordance with stormwater maintenance requirements | |

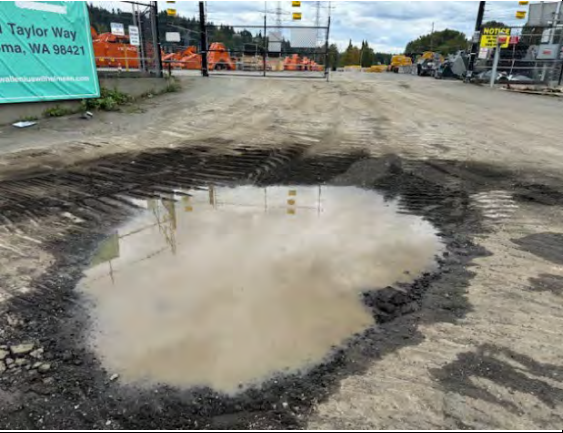
| ID | Type of Structure | Observation | Sediment Accumulation | Additional Observations | Recommended Actions | Photograph |
|---|---|---|---|---|---|---|
| CB4 | Catch basin | Unable to observe due to ponding over the structure | Gravel and sediment appear to be clogging the catch basin | Unable to inspect | Coordinate with Port or tenant to remove grate. Removal of grate may require equipment; recommend reinspection | |

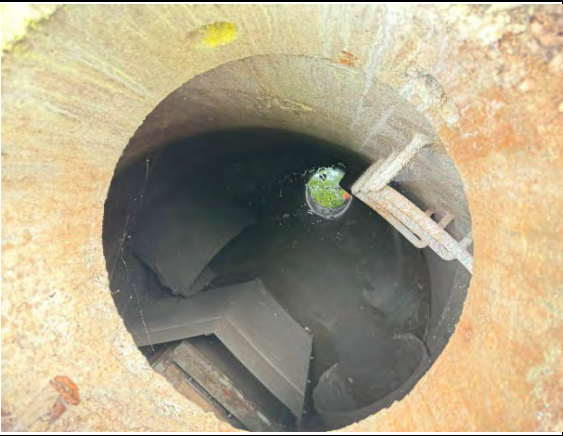
| ID | Type of Structure | Observation | Sediment Accumulation | Additional Observations | Recommended Actions | Photograph |
|---|---|---|---|---|---|---|
| MH1 | Maintenance Hole | Structurally sound; functioning normally | Visible sediment accumulation on pipes and structure walls; water present in structure and too deep to measure | Visible debris and floatables on surface | Remove debris and floatables from structure in accordance with stormwater maintenance requirements | |

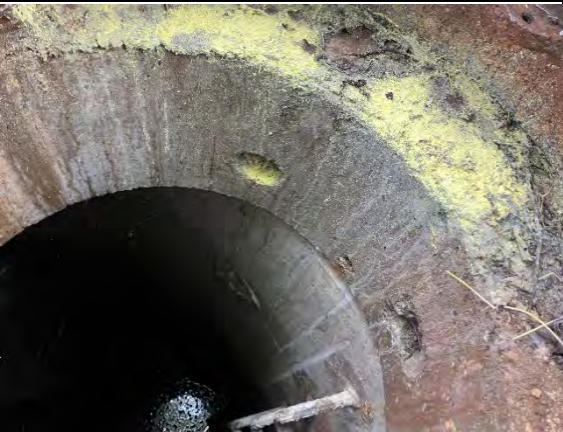
| ID | Type of Structure | Observation | Sediment Accumulation | Additional Observations | Recommended Actions | Photograph |
|---|---|---|---|---|---|---|
| MH2 | Maintenance hole | Structurally sound; functioning normally | Water present in structure and too deep to measure | Floatables on surface; yellow powder material present around rim of structure; material and source are unknown | Remove debris and floatables from structure in accordance with stormwater maintenance requirements | |

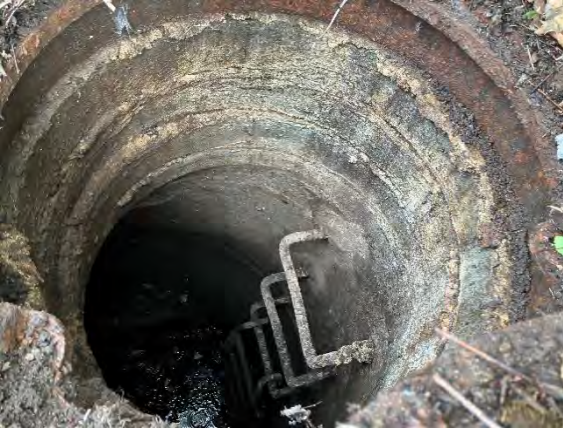
| ID | Type of Structure | Observation | Sediment Accumulation | Additional Observations | Recommended Actions | Photograph |
|---|---|---|---|---|---|---|
| MH4 | Maintenance hole | Structurally sound; functioning normally | Grout appears weathered; no evidence of groundwater entering structure; water present in structure and too deep to measure | Floatables on surface | Remove debris and floatables from structure in accordance with stormwater maintenance requirements | |

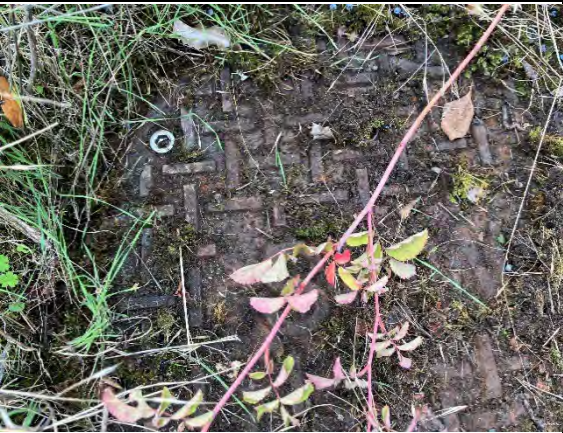
| ID | Type of Structure | Observation | Sediment Accumulation | Additional Observations | Recommended Actions | Photograph |
|---|---|---|---|---|---|---|
| MH5 | Maintenance hole | Unable to inspect structure | Unable to inspect | Lid locked with large hex bolts, unable to access | Coordinate with Port to remove bolts; recommend reinspect. | |

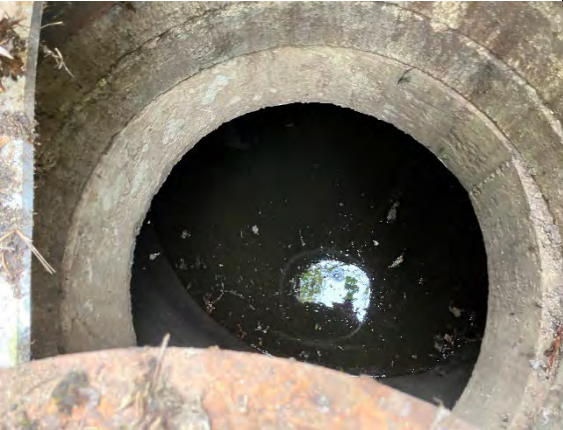
| ID | Type of Structure | Observation | Sediment Accumulation | Additional Observations | Recommended Actions | Photograph |
|---|---|---|---|---|---|---|
| MH6 | Maintenance hole | Structurally sound; functioning normally | Water in structure and too deep to measure | Floatables on surface | Remove debris and floatables from structure in accordance with stormwater maintenance requirements | |

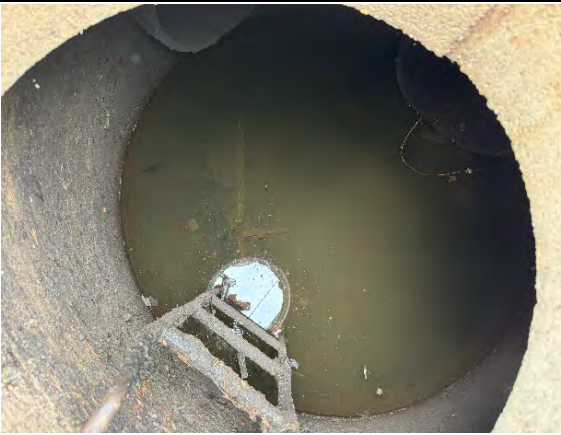
| ID | Type of Structure | Observation | Sediment Accumulation | Additional Observations | Recommended Actions | Photograph |
|---|---|---|---|---|---|---|
| MH7 | Maintenance hole | Structurally sound; functioning normally | Water in structure and too deep to measure | None | None | |

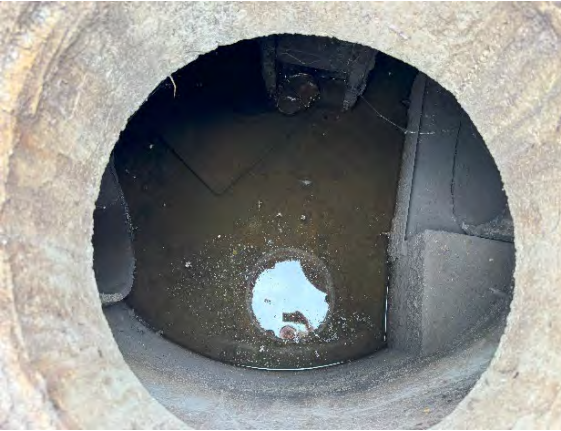
| ID | Type of Structure | Observation | Sediment Accumulation | Additional Observations | Recommended Actions | Photograph |
|---|---|---|---|---|---|---|
| MH8 | Maintenance hole | Structurally sound; functioning normally | Minor sediment accumulation in structure; water in structure and too deep to measure | Trace floatables on surface | None | |

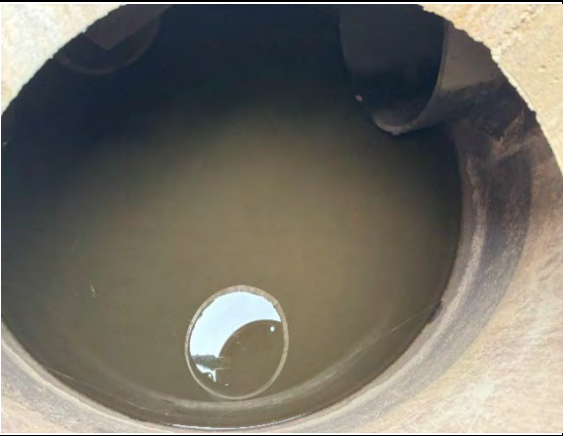
| ID | Type of Structure | Observation | Sediment Accumulation | Additional Observations | Recommended Actions | Photograph |
|---|---|---|---|---|---|---|
| MH9 | Maintenance hole | Structurally sound; functioning normally | Water in structure and too deep to measure | None | None | |

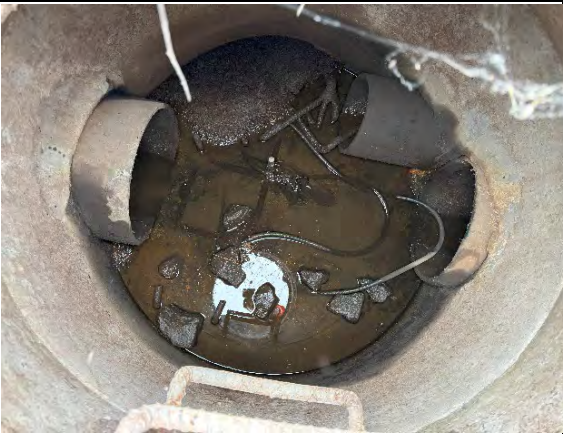
| ID | Type of Structure | Observation | Sediment Accumulation | Additional Observations | Recommended Actions | Photograph |
|---|---|---|---|---|---|---|
| MH10 | Maintenance hole | Structurally sound; functioning normally | Visible sediment accumulation up to pipe invert; too deep to measure | Rebar, hose, and other debris in structure | Remove accumulated sediment and debris from structure in accordance with stormwater maintenance requirements | |

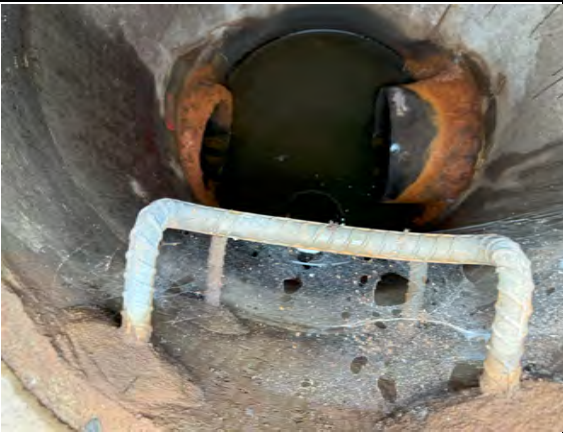
| ID | Type of Structure | Observation | Sediment Accumulation | Additional Observations | Recommended Actions | Photograph |
|---|---|---|---|---|---|---|
| MH11 | Maintenance hole | Structurally sound; functioning normally | Water in structure and too deep to measure | Floatables on surface | Remove floatables in accordance with stormwater maintenance requirements | |

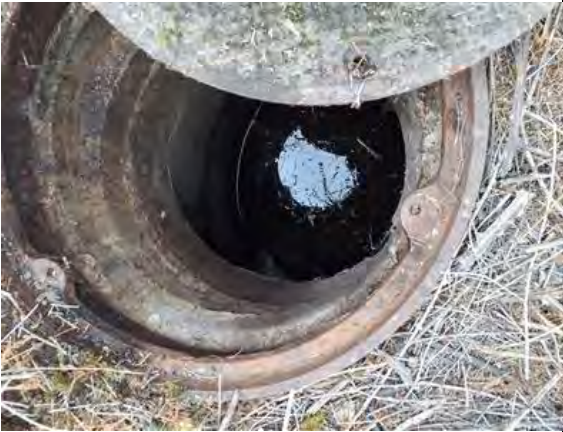
| ID | Type of Structure | Observation | Sediment Accumulation | Additional Observations | Recommended Actions | Photograph |
|---|---|---|---|---|---|---|
| MH12 | Maintenance hole | Structurally sound; functioning normally | Water in structure and too deep to measure | Organic debris on surface | Remove debris in accordance with stormwater maintenance requirements | |

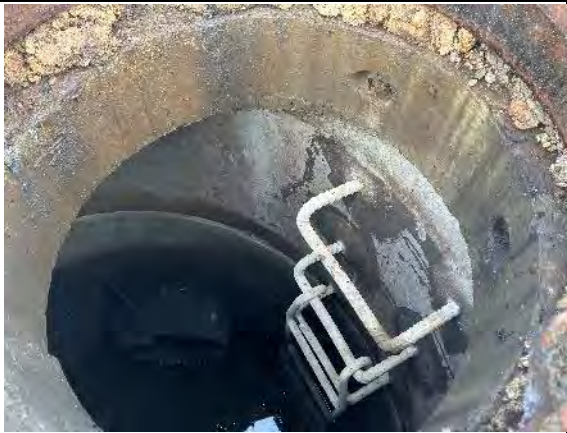
| ID | Type of Structure | Observation | Sediment Accumulation | Additional Observations | Recommended Actions | Photograph |
|---|---|---|---|---|---|---|
| MH13 | Maintenance hole | Structurally sound; functioning normally | Minor sediment accumulation in structure, water in structure and too deep to measure | None | Remove accumulated sediment in accordance with stormwater maintenance requirements | |

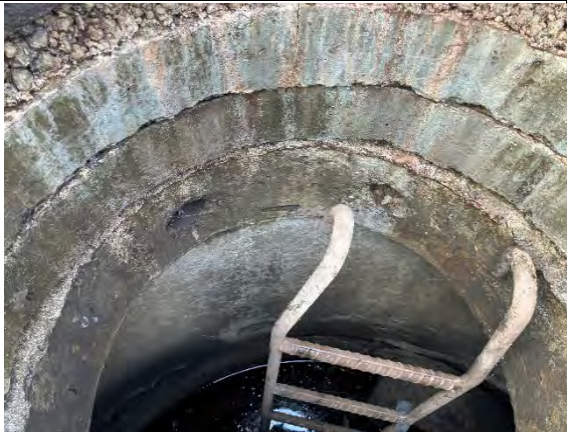
| ID | Type of Structure | Observation | Sediment Accumulation | Additional Observations | Recommended Actions | Photograph |
|---|---|---|---|---|---|---|
| MH14 | Maintenance hole | Structurally sound; functioning normally | Minor sediment accumulation in structure; water in structure and too deep to measure | None | Remove accumulated sediment in accordance with stormwater maintenance requirements | |

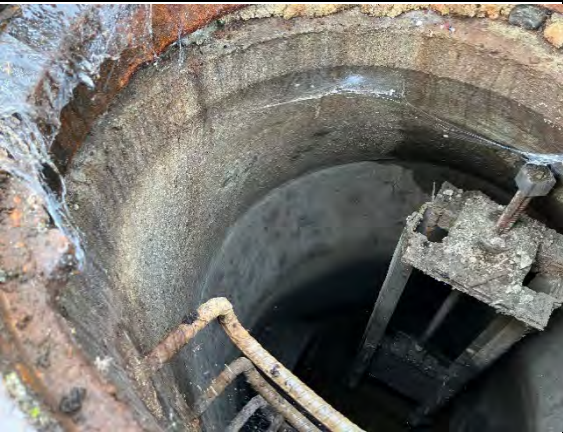
| ID | Type of Structure | Observation | Sediment Accumulation | Additional Observations | Recommended Actions | Photograph |
|---|---|---|---|---|---|---|
| MH15 | Maintenance hole | Structurally sound; functioning normally | Water in structure and too deep to measure | Moisture observed near top of structure; source unknown | Monitor and reevaluate during the next inspection cycle | |

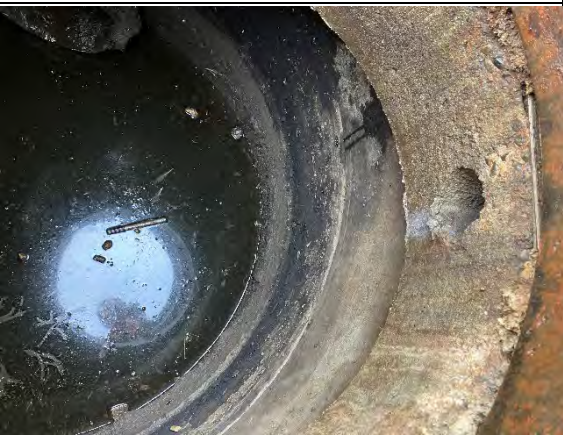
| ID | Type of Structure | Observation | Sediment Accumulation | Additional Observations | Recommended Actions | Photograph |
|---|---|---|---|---|---|---|
| MH16 | Maintenance hole | Structurally sound; functioning normally | Water in structure and too deep to measure | Floatables and debris on surface | Remove floatables and debris in accordance with stormwater maintenance requirements | |

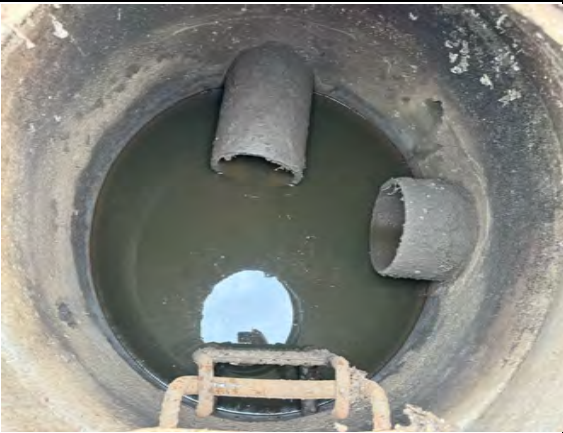
| ID | Type of Structure | Observation | Sediment Accumulation | Additional Observations | Recommended Actions | Photograph |
|---|---|---|---|---|---|---|
| MH17 | Maintenance hole | Structurally sound; functioning normally | Slight sediment accumulation in pipes; water in structure and too deep to measure | Minor organic floatables on surface | Remove accumulated sediment and floatables in accordance with stormwater maintenance requirements | |

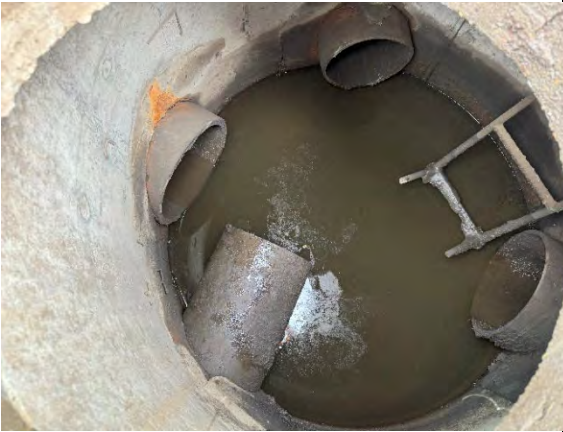
| ID | Type of Structure | Observation | Sediment Accumulation | Additional Observations | Recommended Actions | Photograph |
|---|---|---|---|---|---|---|
| MH18 | Maintenance hole | Structurally sound; functioning normally | Visible sediment accumulation; water present in structure and too deep to measure | Floatables present on surface | Remove accumulated sediment and floatables in accordance with stormwater maintenance requirements | |
