# Environmental Cap and Drainage System Inspection Report

Former Louisiana Pacific/Pony Lumber Facility  
(Ecology Facility ID #1209)

December 4, 2024

Project No. M0615.24.002

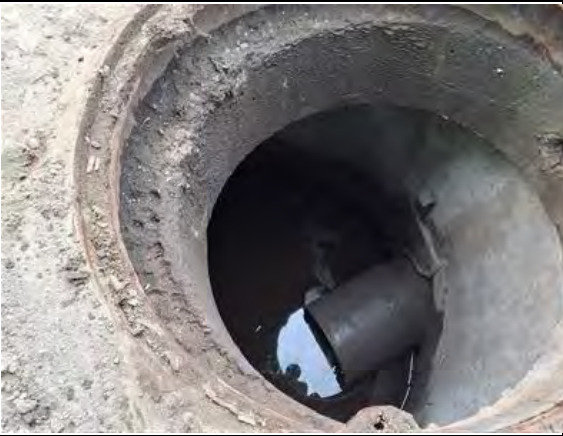
| ID | Type of Structure | Observation | Sediment Accumulation | Additional Observations | Recommended Actions | Photograph |
|---|---|---|---|---|---|---|
| MH19 | Maintenance hole | Structurally sound; functioning normally | Water in structure and too deep to measure | Small amount of organic debris on surface | Remove floatables in accordance with stormwater maintenance requirements | |

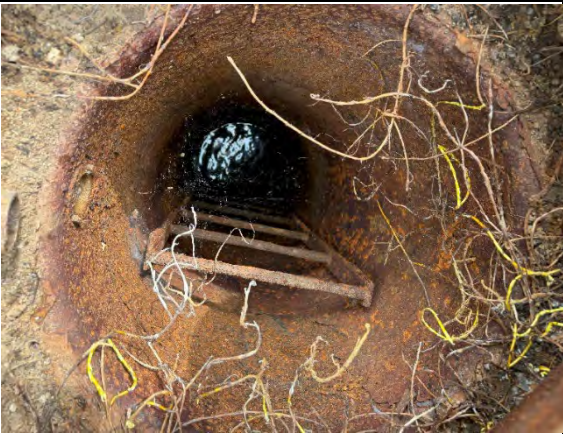
| ID | Type of Structure | Observation | Sediment Accumulation | Additional Observations | Recommended Actions | Photograph |
|---|---|---|---|---|---|---|
| OWS1 | Oil/water separator | Functioning normally | Water in structure too deep to measure | Metal structure with signs of corrosion; floatables and sheen visible on water surface | Pump out the oil/water separator for inspection; have a corrosion engineer evaluate maintenance hole walls for integrity | |

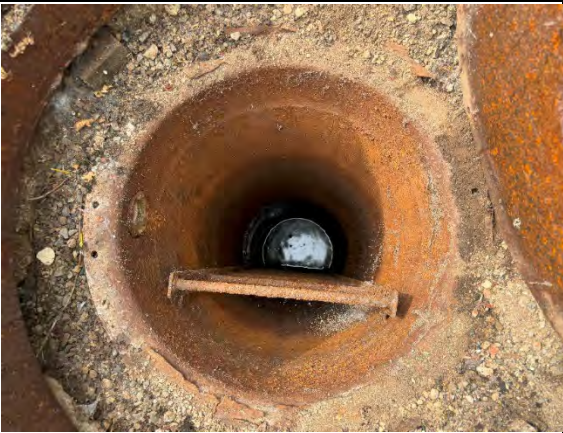
| ID | Type of Structure | Observation | Sediment Accumulation | Additional Observations | Recommended Actions | Photograph |
|---|---|---|---|---|---|---|
| OWS2 | Oil/water separator | Functioning normally | Water in structure too deep to measure | Metal structure with signs of corrosion; flotables and sheen visible on water surface | Pump out the oil/water separator for inspection; have a corrosion engineer evaluate maintenance hole walls for integrity | |

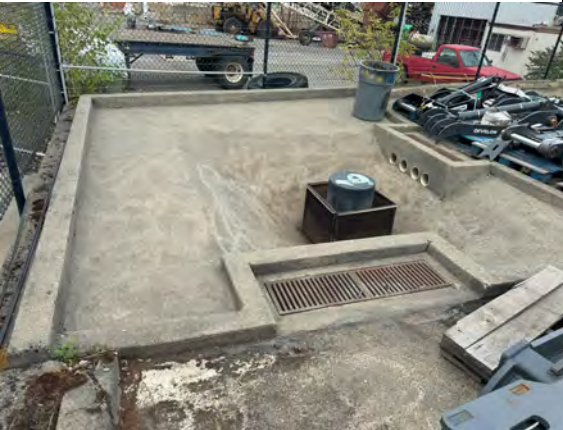
| ID | Type of Structure | Observation | Sediment Accumulation | Additional Observations | Recommended Actions | Photograph |
|---|---|---|---|---|---|---|
| TB1 | Treatment basin | Structurally sound; functioning normally | None | Some deterioration of curb on east corners of basin; rebar exposed | Repair curb | |

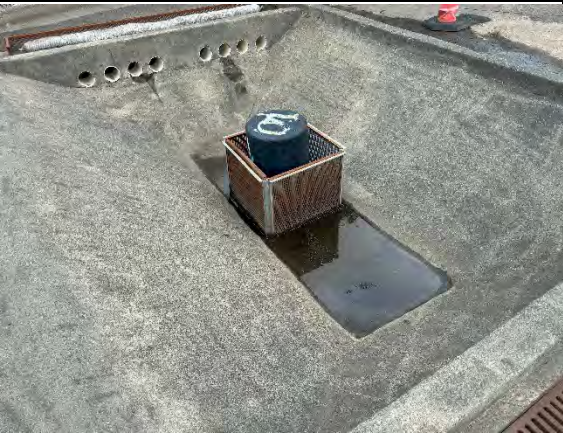
| ID | Type of Structure | Observation | Sediment Accumulation | Additional Observations | Recommended Actions | Photograph |
|---|---|---|---|---|---|---|
| TB2 | Treatment basin | Structurally sound; functioning normally | Trace sediment accumulation around screen | Screens and basin in good condition | None | |

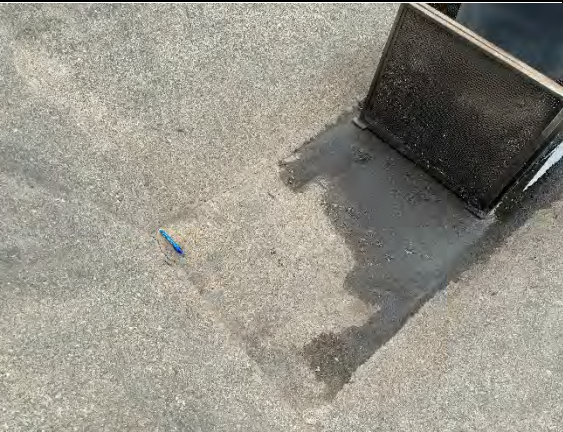
| ID | Type of Structure | Observation | Sediment Accumulation | Additional Observations | Recommended Actions | Photograph |
|---|---|---|---|---|---|---|
| TB3 | Treatment basin | Structurally sound; functioning normally | Minimal sediment accumulation adjacent to screen | Screen in good condition; cracks in corner of concrete | Seal cracks in concrete; remove sediment in accordance with stormwater maintenance requirements | |

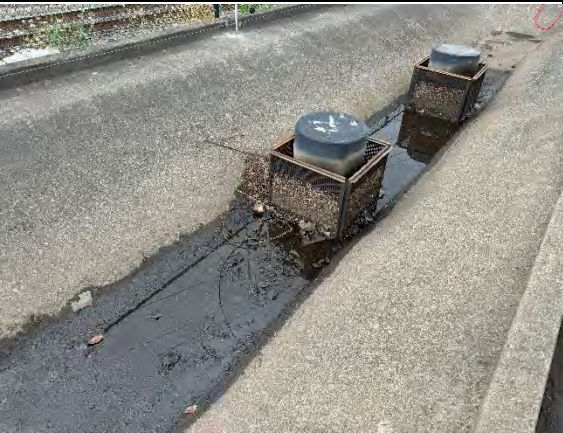
| ID | Type of Structure | Observation | Sediment Accumulation | Additional Observations | Recommended Actions | Photograph |
|---|---|---|---|---|---|---|
| TB4 | Treatment basin | Structurally sound; functioning normally | Approximately 1 inch sediment accumulation in basin | Debris over screens | Remove accumulated debris in accordance with stormwater maintenance requirements | |

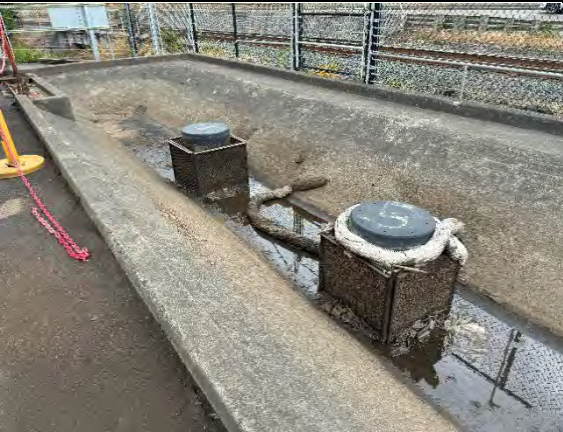
| ID | Type of Structure | Observation | Sediment Accumulation | Additional Observations | Recommended Actions | Photograph |
|---|---|---|---|---|---|---|
| TB5 | Treatment basin | Structurally sound; functioning normally | About 1 inch sediment accumulation in basin | Visible sediment accumulation around screens; organic and inorganic debris in basin; southwest grate is cracked and covered with leafy debris | Remove sediment accumulation and debris in basin in accordance with stormwater maintenance requirements; clear screens and grates | |

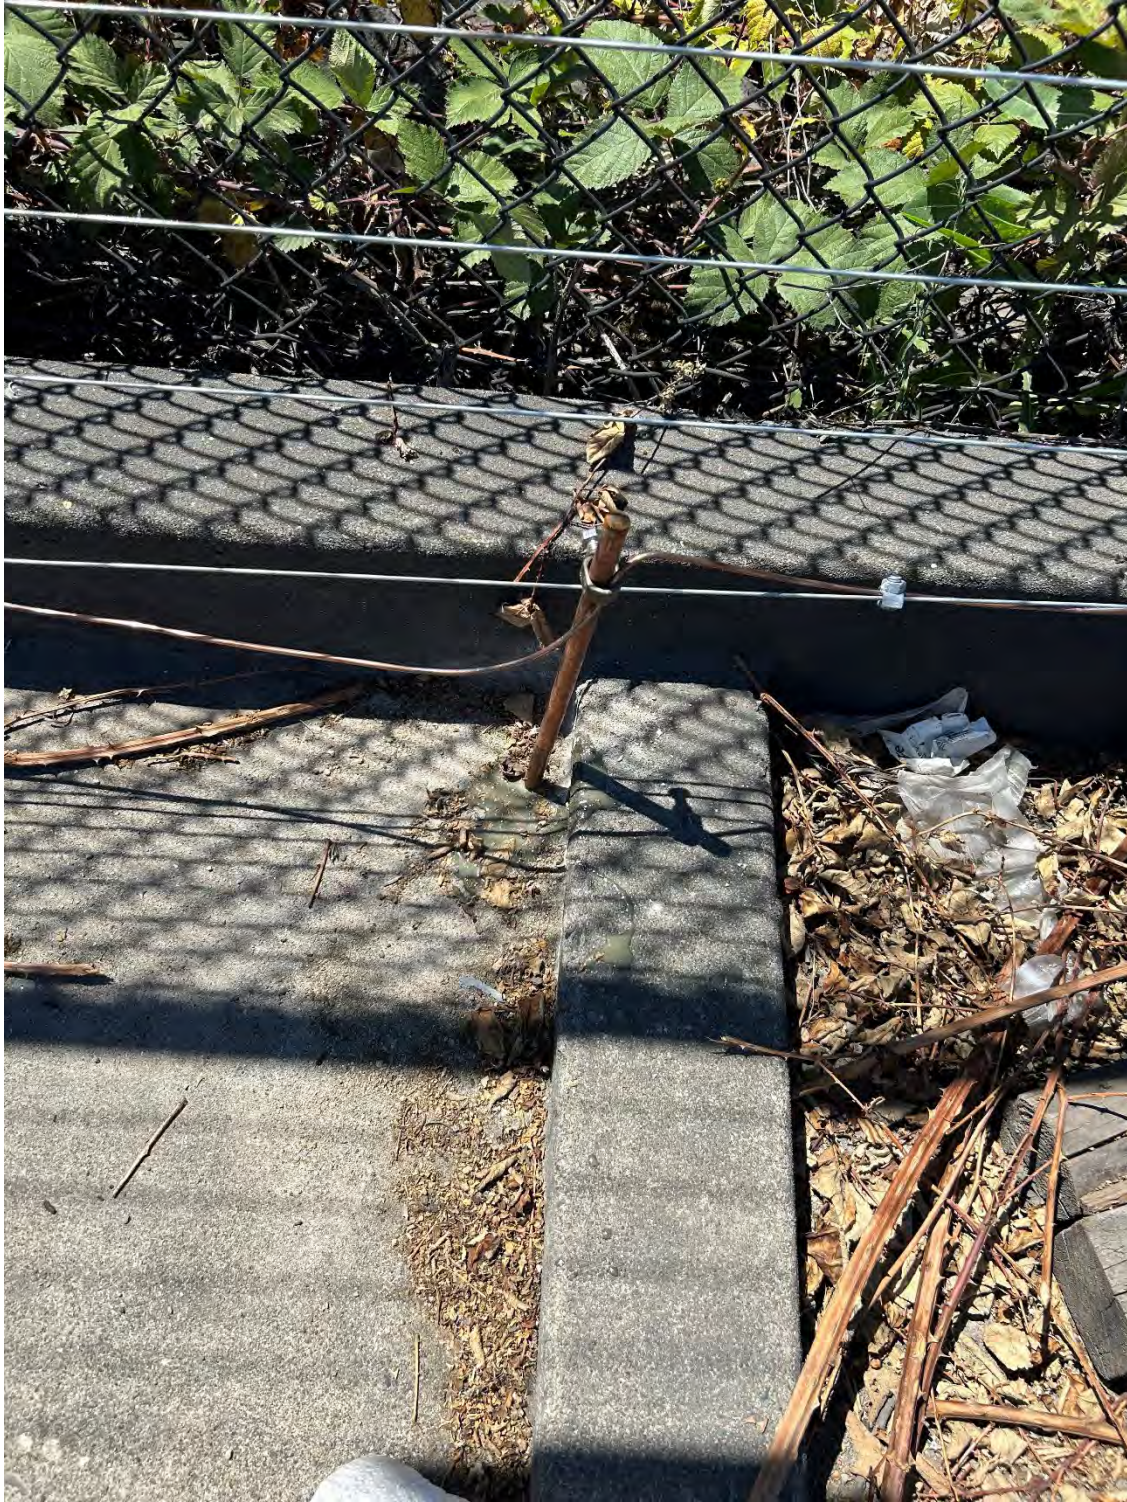
Ground rod installation is similar to intermediate posts shown on previous picture.
