DATE: September 10, 2025  
TO: Mark Jusayan, Seattle Public Utilities  
Ashley Piatek, CenterPoint Properties  
FROM: Laura Lee and Alexander Leshner, EIT  
SUBJECT: South Park Landfill 2025 Annual Landfill Cap Inspection  
CC: Ryan Gardiner, Washington State Department of Ecology  
PROJECT NUMBER: 553-1550-067  
PROJECT NAME: South Park Landfill Site Coordinator

This technical memorandum summarizes the findings of the May 2025 annual landfill cap inspection at the South Park Landfill in Seattle, Washington. The inspection fulfills the requirements of the Cleanup Action Plan (CAP), which is a component of the Consent Decree signed on March 26, 2019.

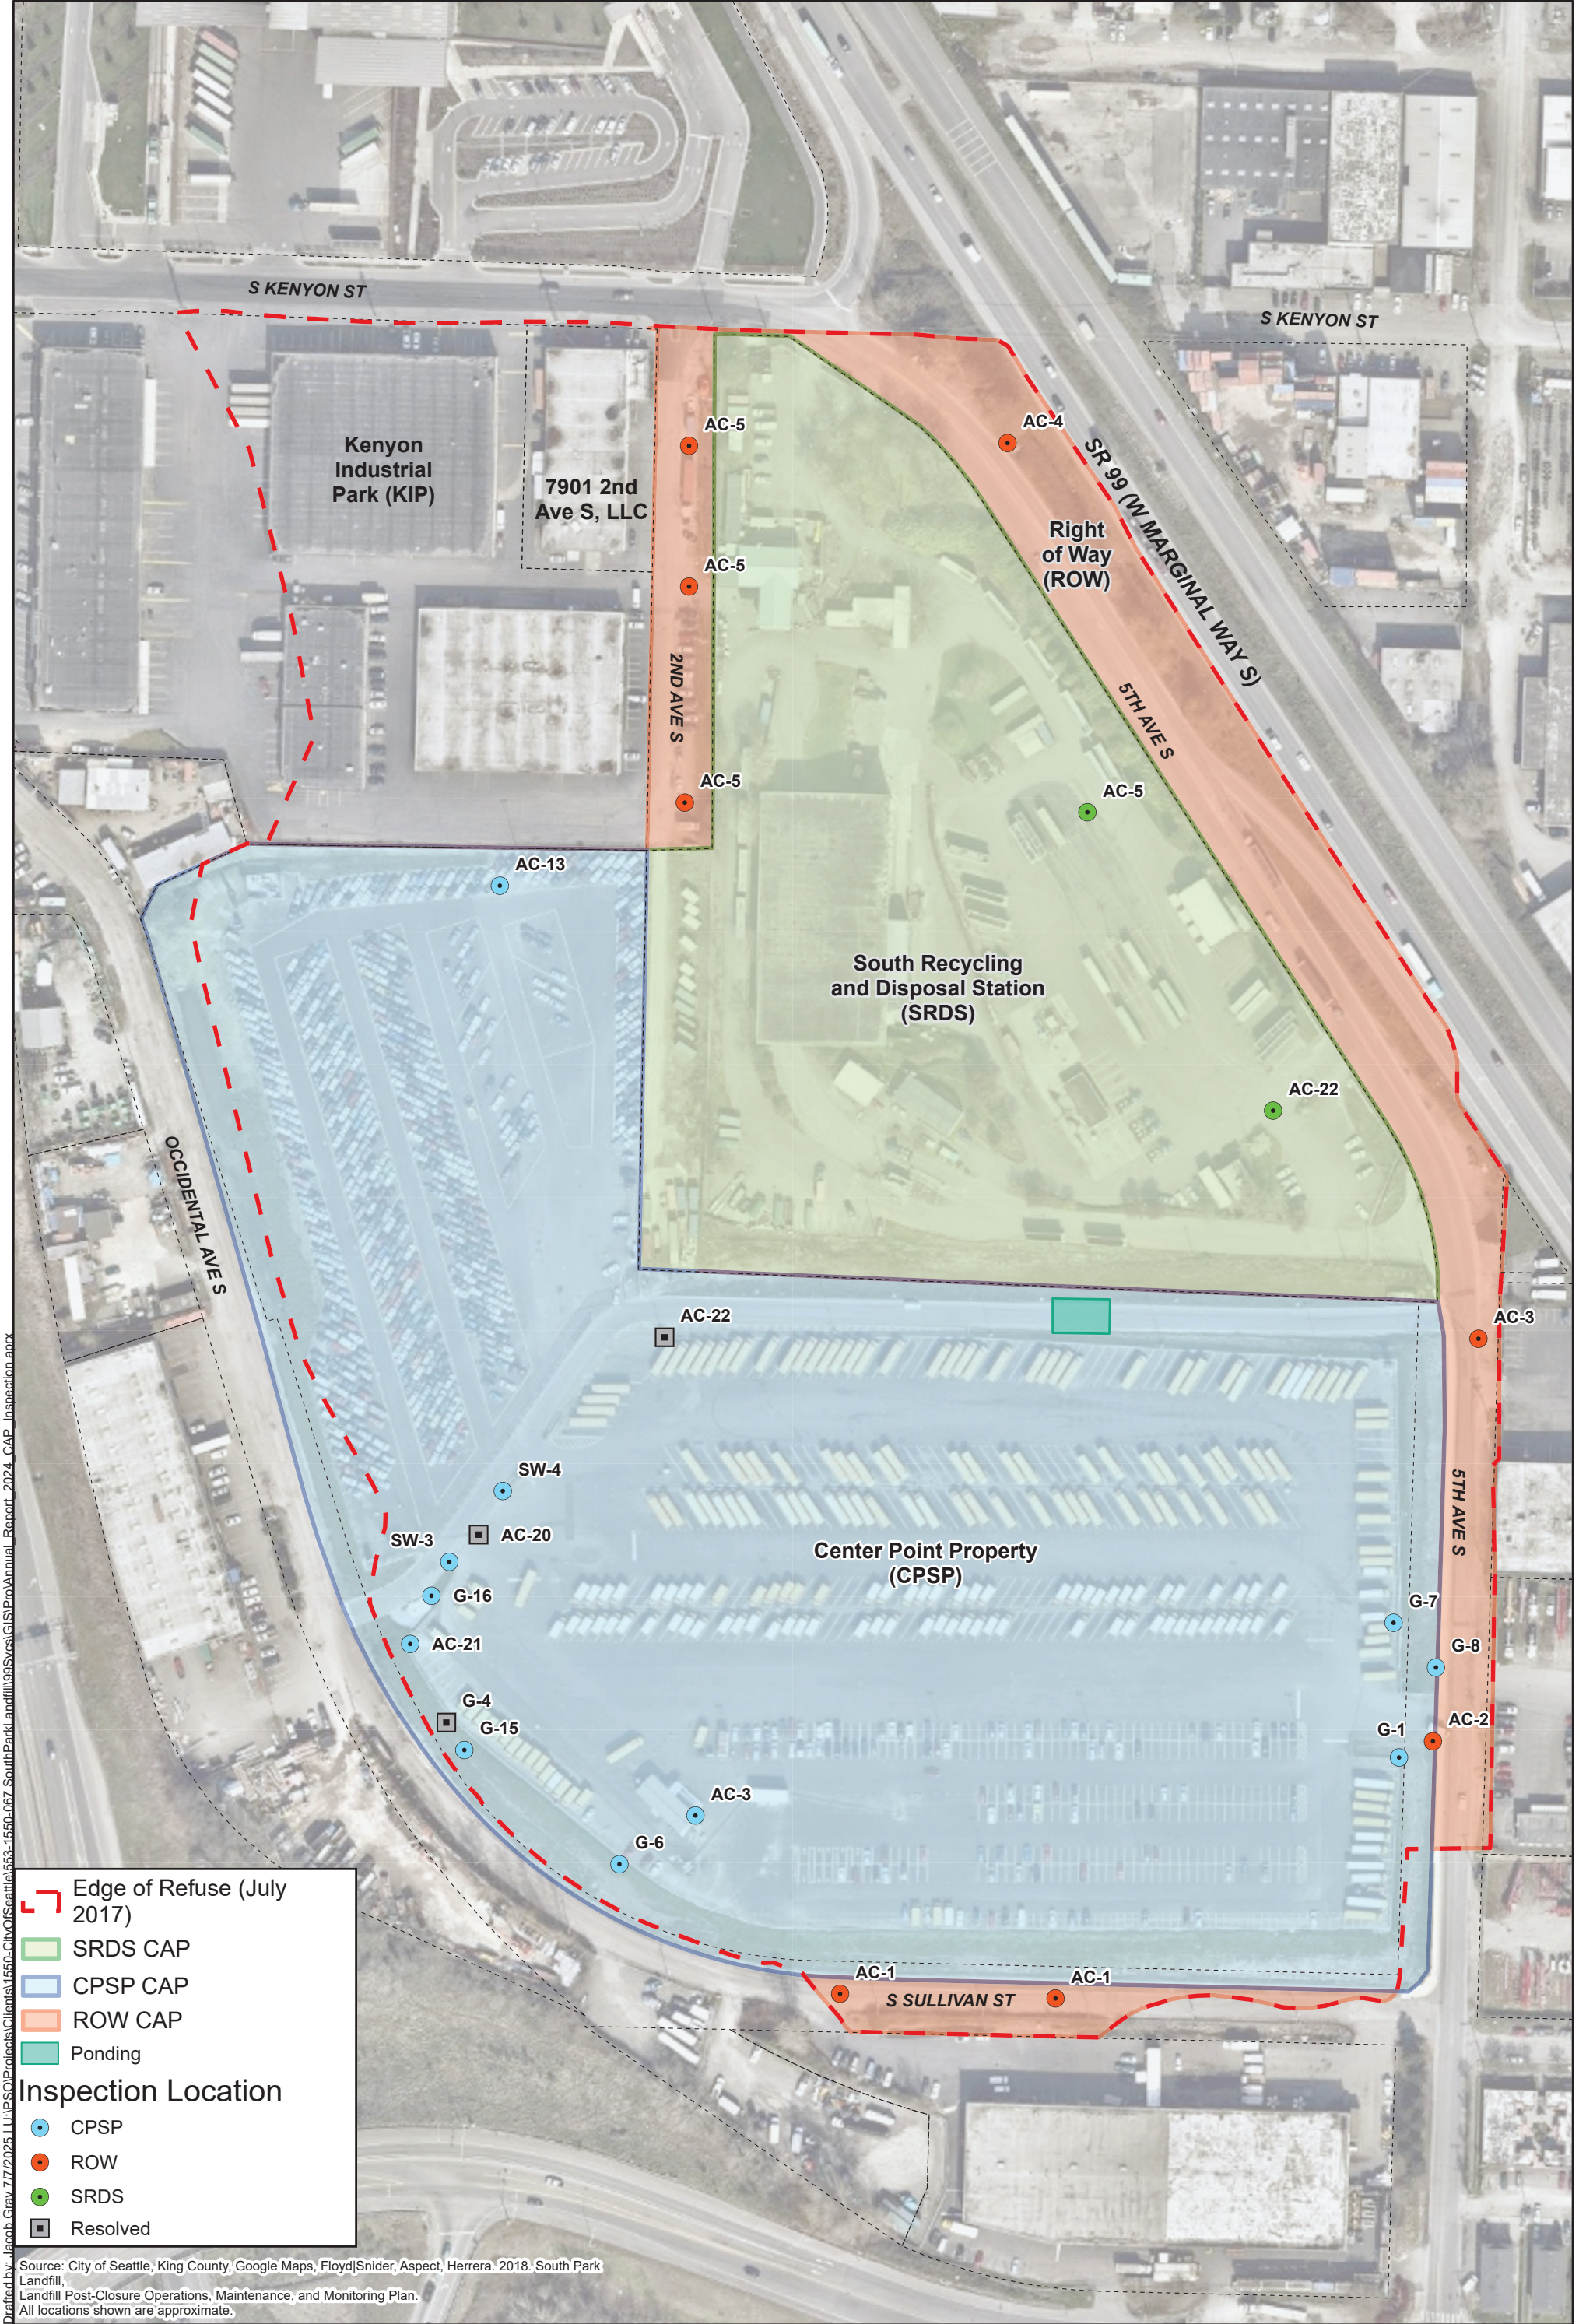
# Figure 1

Figure 1 shows the SRDS CAP boundary and marks the numbered locations of concern that correspond to entries in Table 1.

Figure 1 shows the CPSP CAP boundary and marks the numbered locations of concern that correspond to entries in Table 2.

Figure 1 shows the ROW CAP boundary and marks the numbered locations of concern that correspond to entries in Table 3.
