Aladdin Plating Site Groundwater Monitoring Results, 2024: Data Summary Report

Environmental Assessment Program

Publication 25-03-022

December 2025

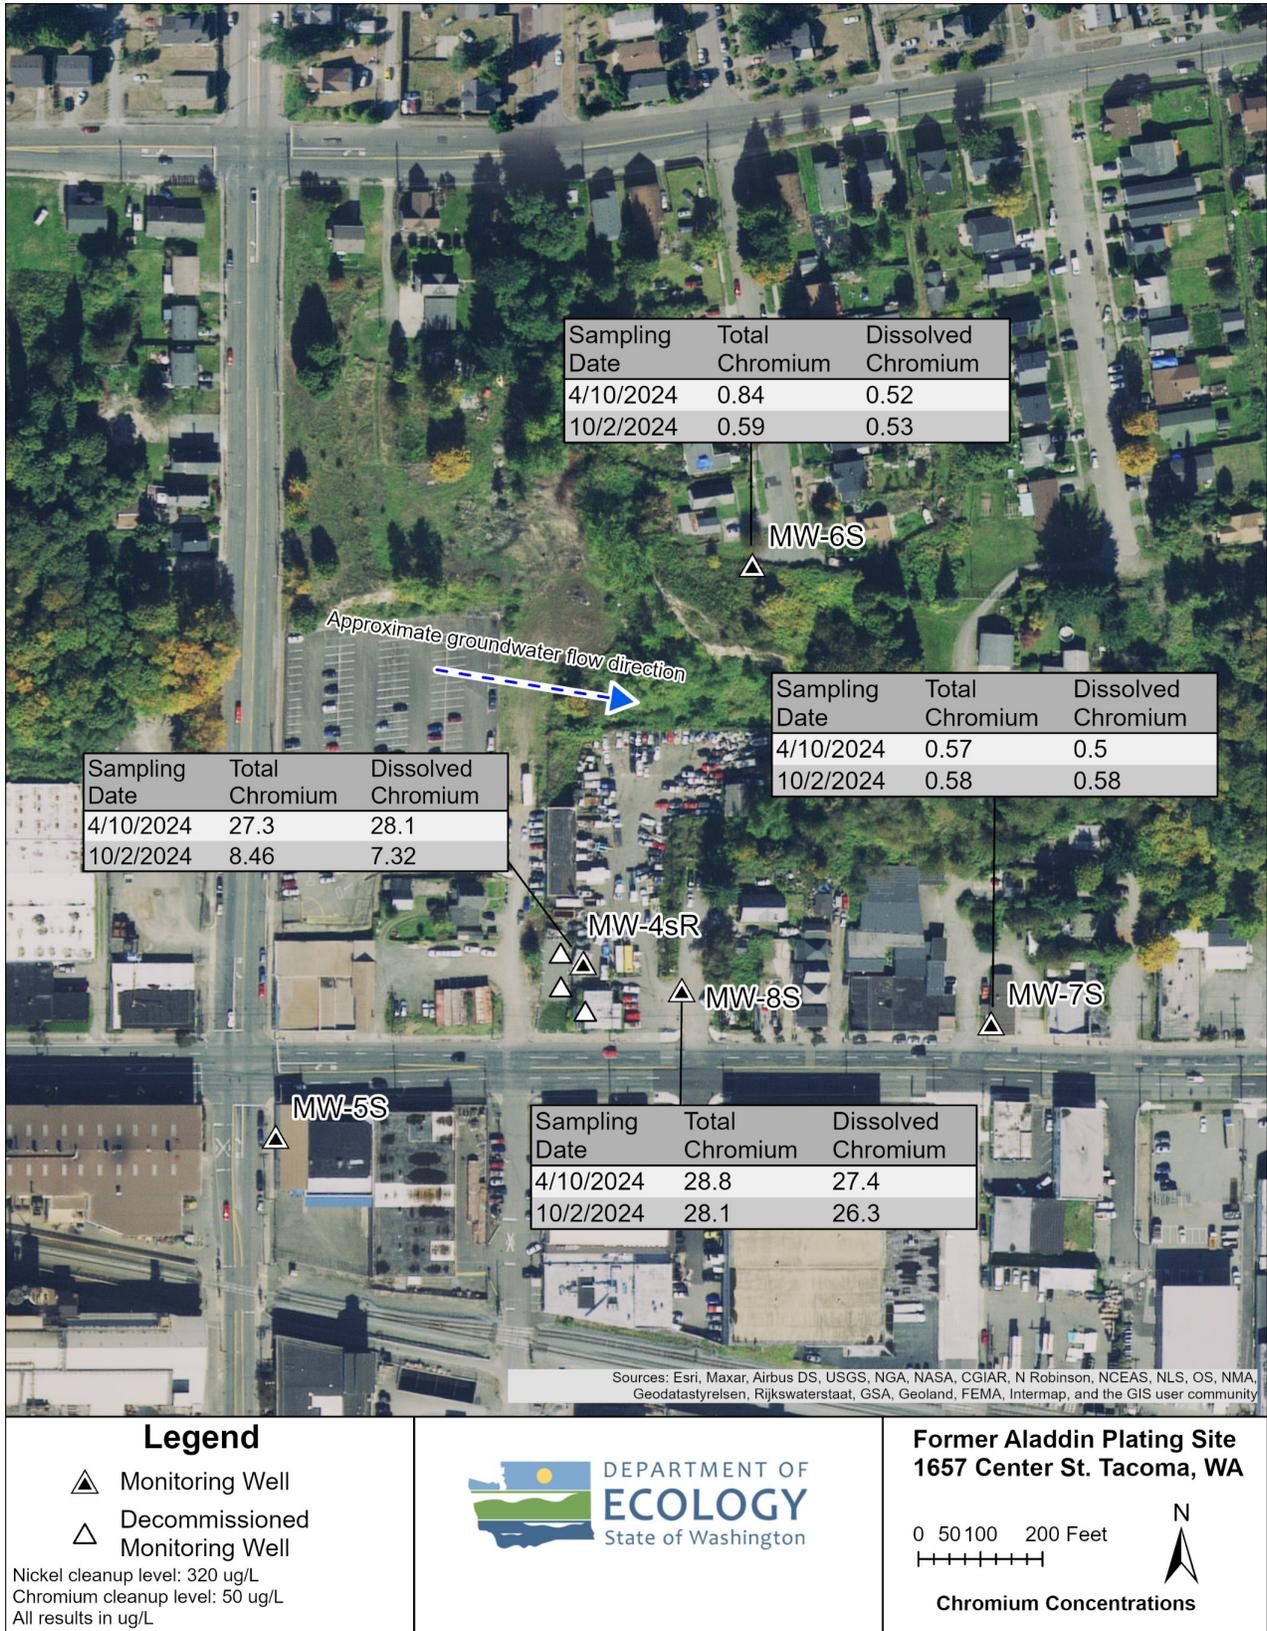
Figure 3. Total and Dissolved Chromium Concentrations (µg/L) in 2024

Historical results demonstrate significant decreases in nickel and chromium concentrations following excavation activities in 2005 and 2019 (Appendix A and Appendix B), however, concentrations of site contaminants remain significantly elevated above cleanup levels in MW-8s. While MW-4sR historically reported high concentrations of total and dissolved chromium, and dissolved nickel since Ecology began monitoring the site, recent concentrations reflect a significant decrease from historical concentrations in the footprint of the former electroplating facility. Samples collected at the remaining site wells were below cleanup levels and were consistent with those throughout Ecology's monitoring of the site (Tables 5, and 6, Appendix A, Appendix B, Figures 3 through 8).
