## **TECHNICAL MEMORANDUM**

**DATE:** February 18, 2026

**FROM:** Timothy S. Brown, LHG, Madrona Environmental Consulting, LLC

**RE:** **Former Mill E / Koppers Facility  
2025 Annual Performance and Compliance Monitoring Report**

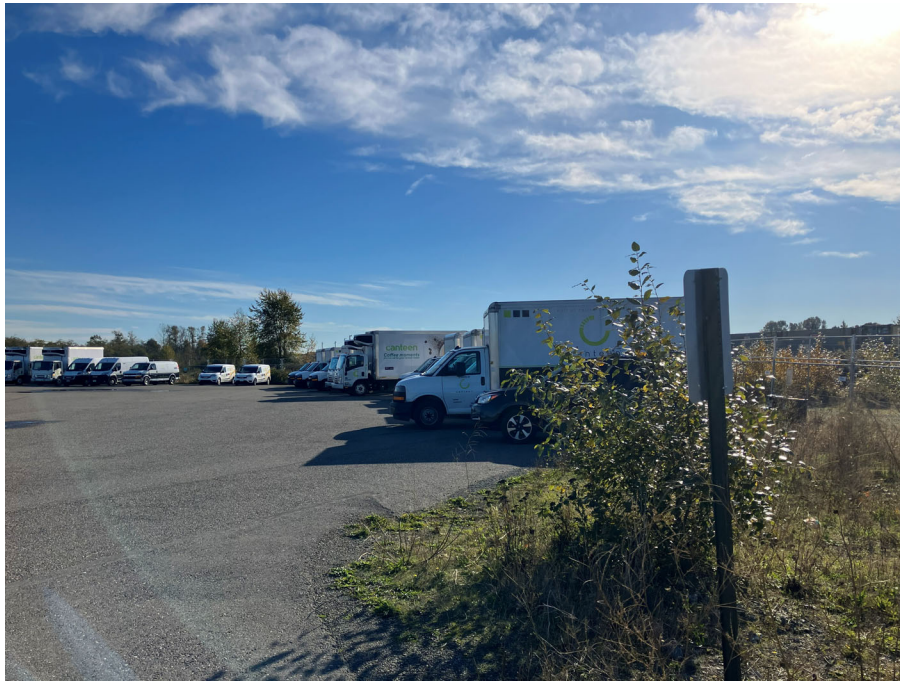
Most of the asphalt cap, about 85 to 95 percent, was visible at the time of the site visit. The asphalt cap was observed to be in serviceable condition. Most minor cracks in the asphalt cap from the previous year were observed to have been repaired with asphalt crack filler/sealer. New minor surficial cracks, not sealed, were observed in areas generally near repaired asphalt surfaces.

Photograph 1 – Looking south at the western portion of the asphalt cap with parked cargo vans and box trucks.

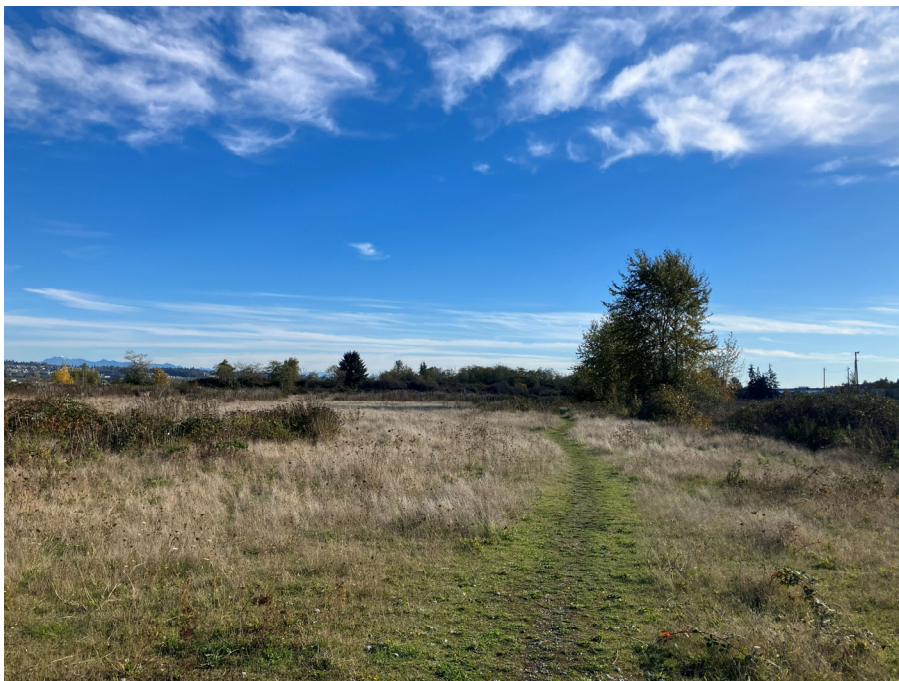
The soil cap to the south of the asphalt cap was covered in grass, thorny shrubs, and other prairie type plants. The soil cap appeared intact and performing as intended. No major ponding or erosion was observed.

Photograph 8 - Looking south at western portion of the soil cap.

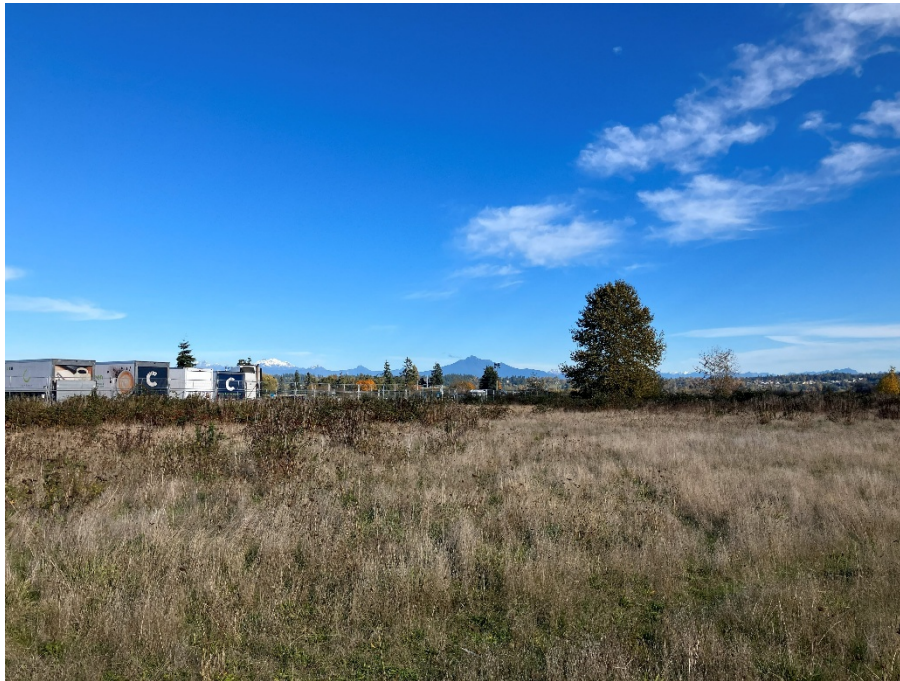
Photograph 9 - Looking east at north central portion of the soil cap.
