**UNDERGROUND STORAGE TANK  
SITE CHECK/SITE ASSESSMENT REPORT  
FOR  
WHITTEN OIL, INC.  
COLVILLE, WASHINGTON  
SEACOR Job No. 00004-008-01**

**Submitted by  
SEACOR**

**For  
Whitten Oil, Inc.  
P.O. Box 150  
Colville, Washington 99114**

October 1, 1993

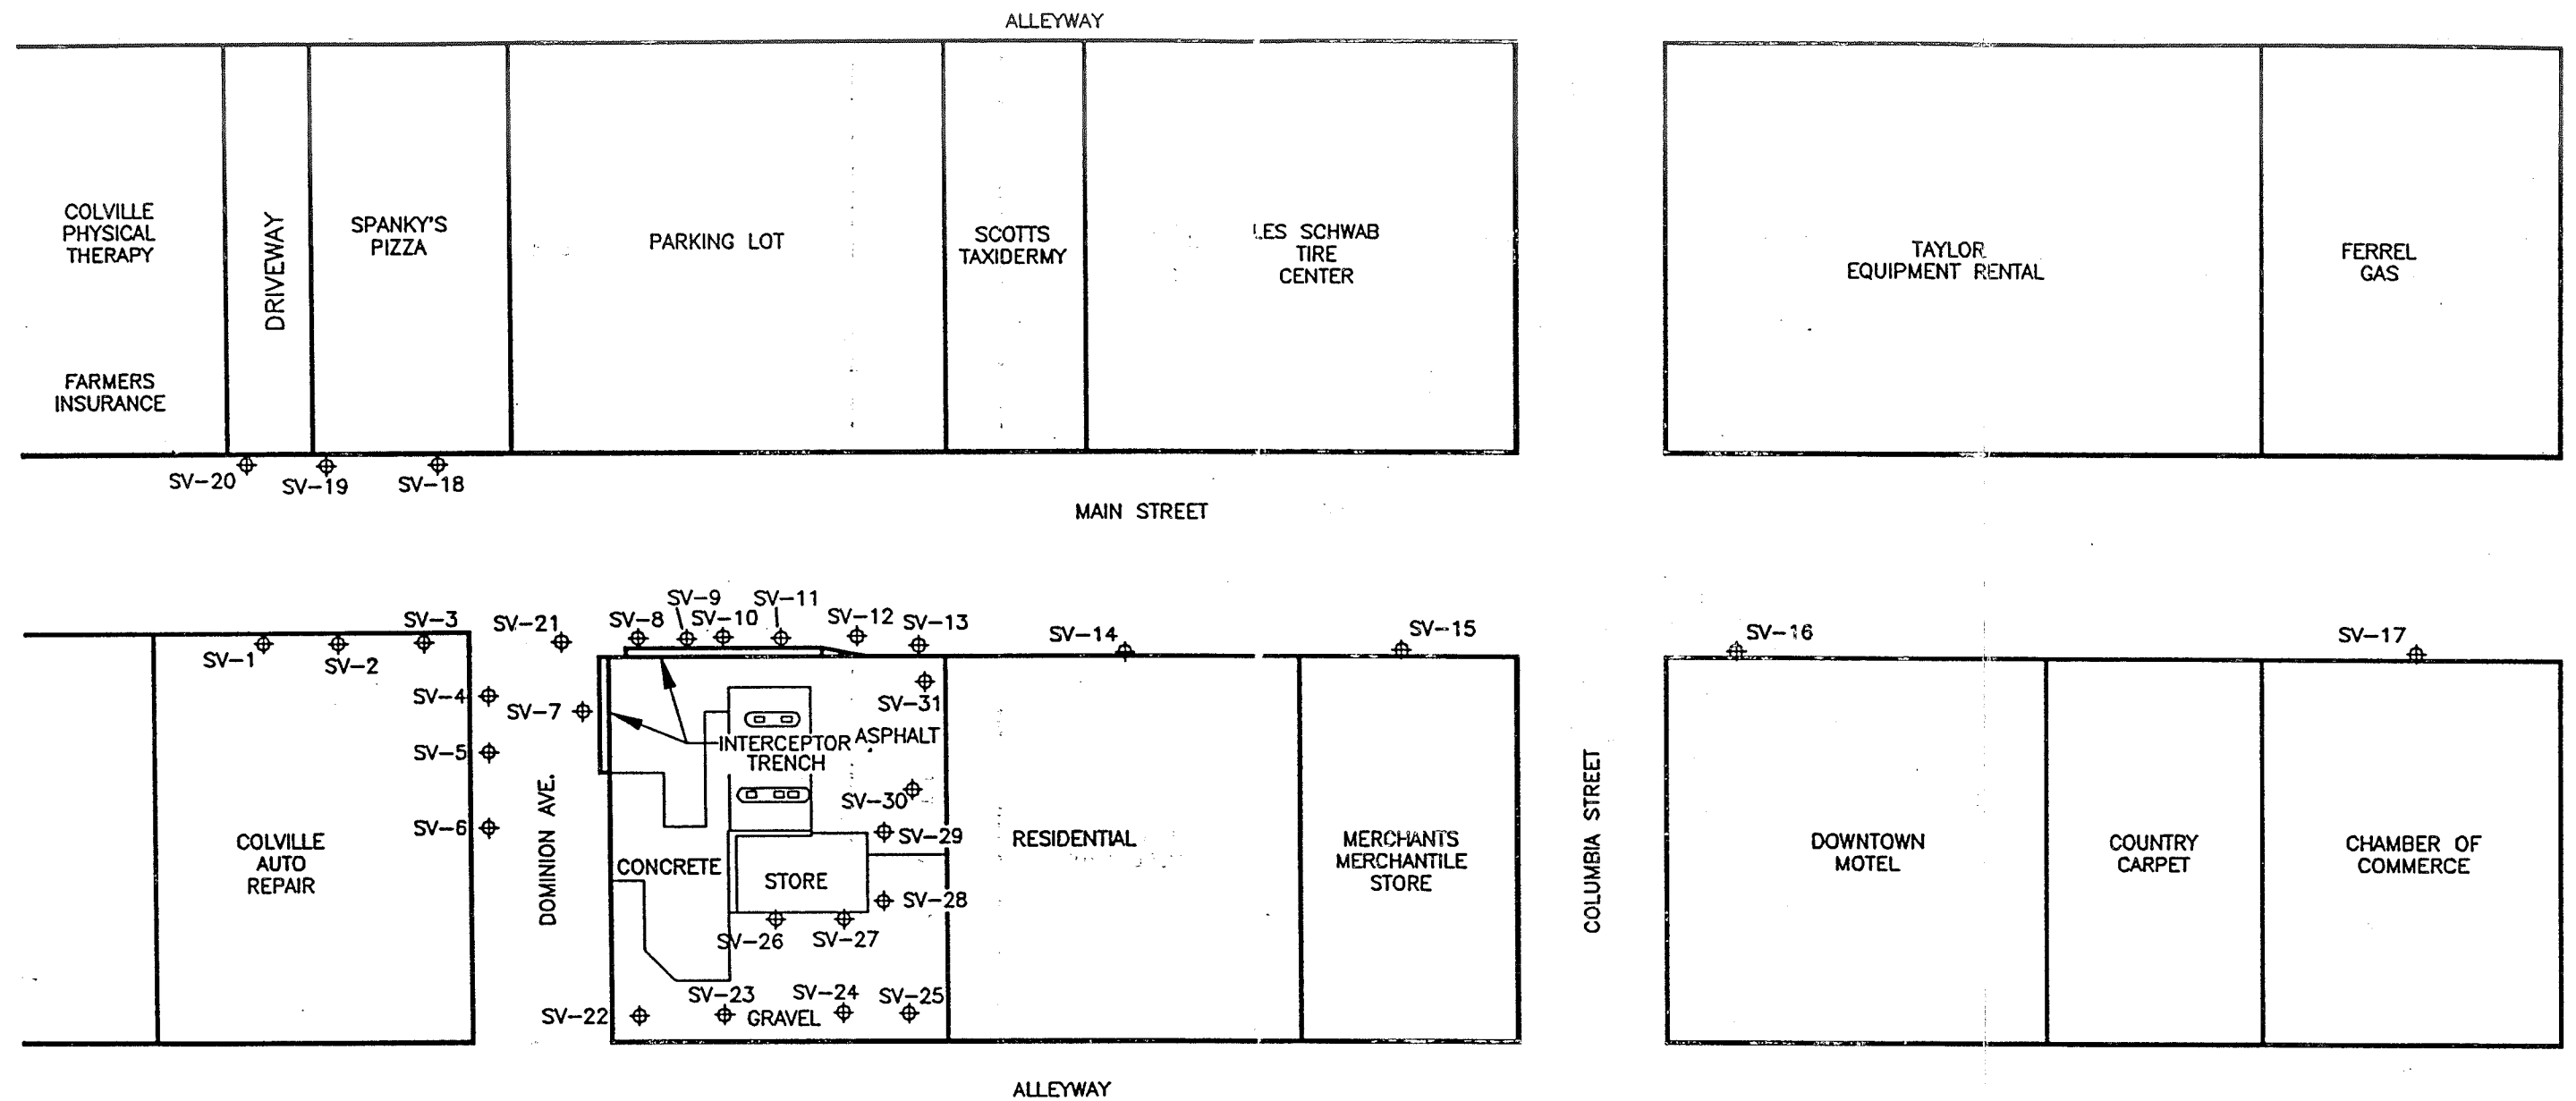
FIGURE 5  
SOIL TPH CONCENTRATION  
CONTOUR MAP  
WHITTY'S MINIMART  
COLVILLE, WASHINGTON

Based on the results of the soil vapor and soil samples collected as part of the RI, there are three areas that exhibit concentrations of petroleum hydrocarbons in excess of MTCA Method A soil cleanup levels. These areas are shown on Figure 5. These areas include soil sampled from the boring for MW-16 located west of the Colville Auto Repair facility, MW-11 located in Dominion Avenue south of the Whitten Oil facility, and the Minimart site as evidenced by samples from Well MW-10 southwest of the pump islands and by borings B-10 and B-11 located immediately north of the pump islands. The Minimart site appears to be the source for the petroleum hydrocarbons detected in soil at the Minimart and under Dominion Avenue. Colville Auto Repair appears to be the source for the petroleum hydrocarbons detected in the soil at boring MW-16. The highest concentrations of petroleum hydrocarbons in the soil were detected at, or very near, the groundwater

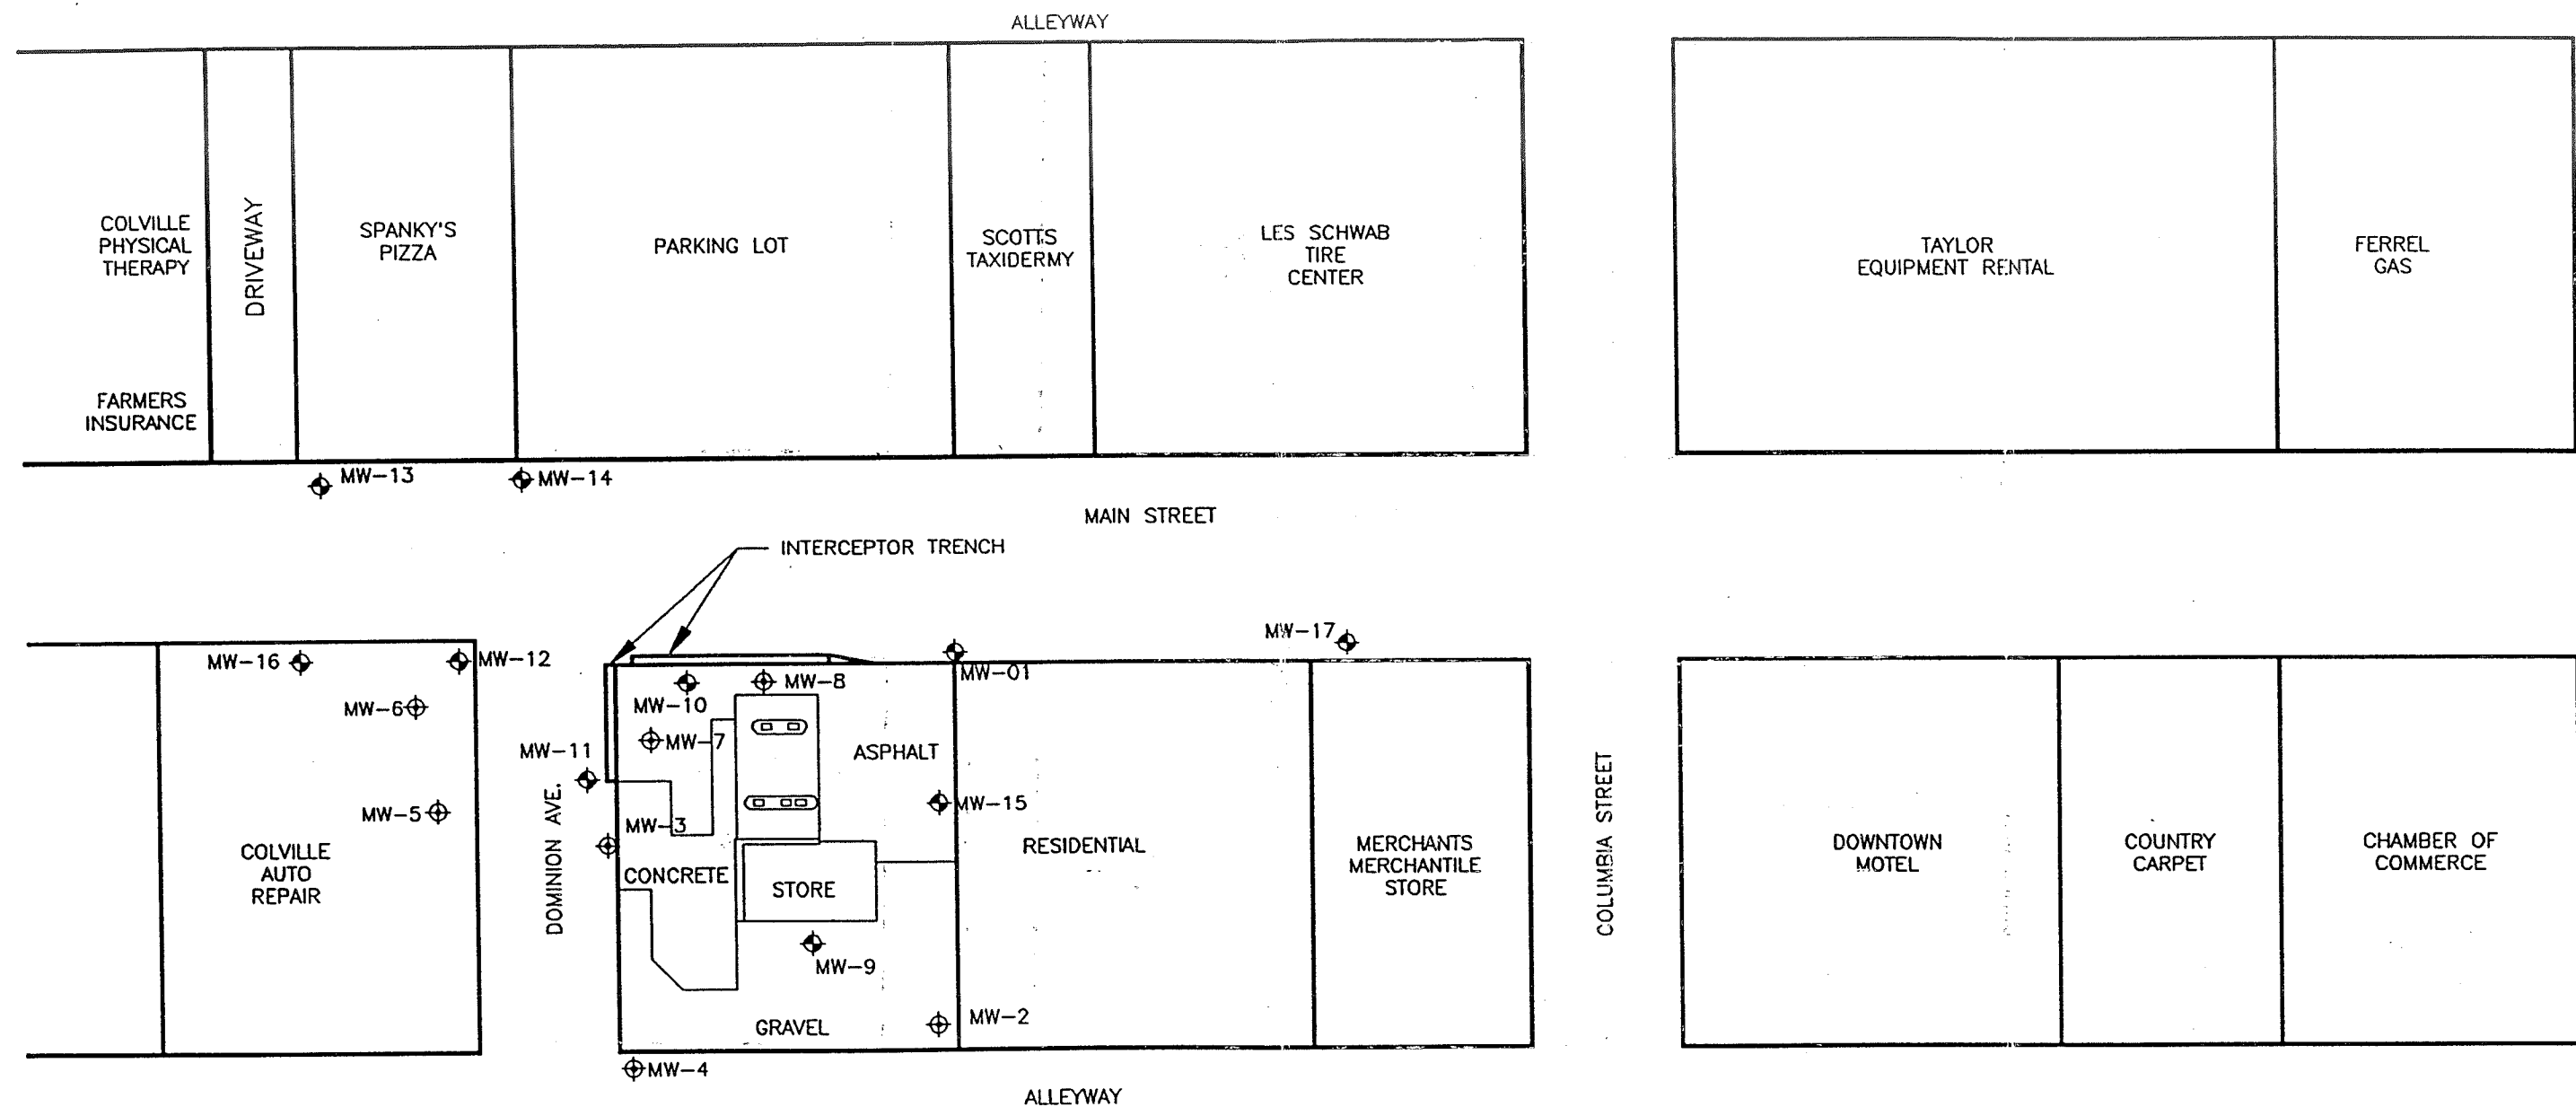
FIGURE 8  
SURFACE WATER SAMPLE LOCATION MAP  
WHITTY'S MINIMART  
COLVILLE, WASHINGTON

Water samples from the storm drains and the unnamed creek were collected at the locations shown on Figure 8. Analytical results of surface water samples indicate that the concentration of petroleum hydrocarbons in the storm sewer located upstream of the site (SD-5) contained diesel fuel constituents during the first sampling episode. This was not verified during subsequent sampling. The sump water at the Colville Auto Repair site (SD-2) contained diesel constituents and low levels of toluene. This sump does not appear to be downgradient of the SD-3 or SD-4 locations on the Minimart and may be a separate contributing source for hydrocarbons observed in the storm sewer.
