# Memorandum

**To:** Ron Woolworth, W&W Everett Investments, LLC  
**Copies:** Frank Winslow, Washington State Department of Ecology  
**From:** Kristin Anderson, LHG, Floyd|Snider  
**Date:** June 16, 2026  
**Site Name:** Jeld-Wen Site  
**Re: Cap Condition Survey**

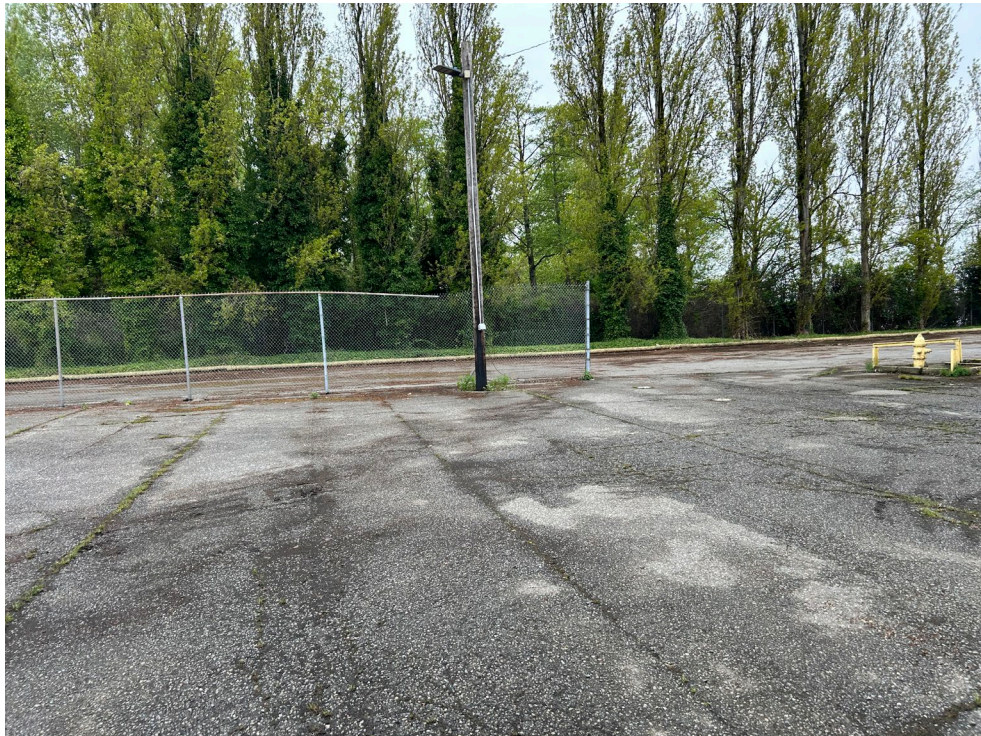
Photograph 2. Polygon A1 in southwest corner of the Site.

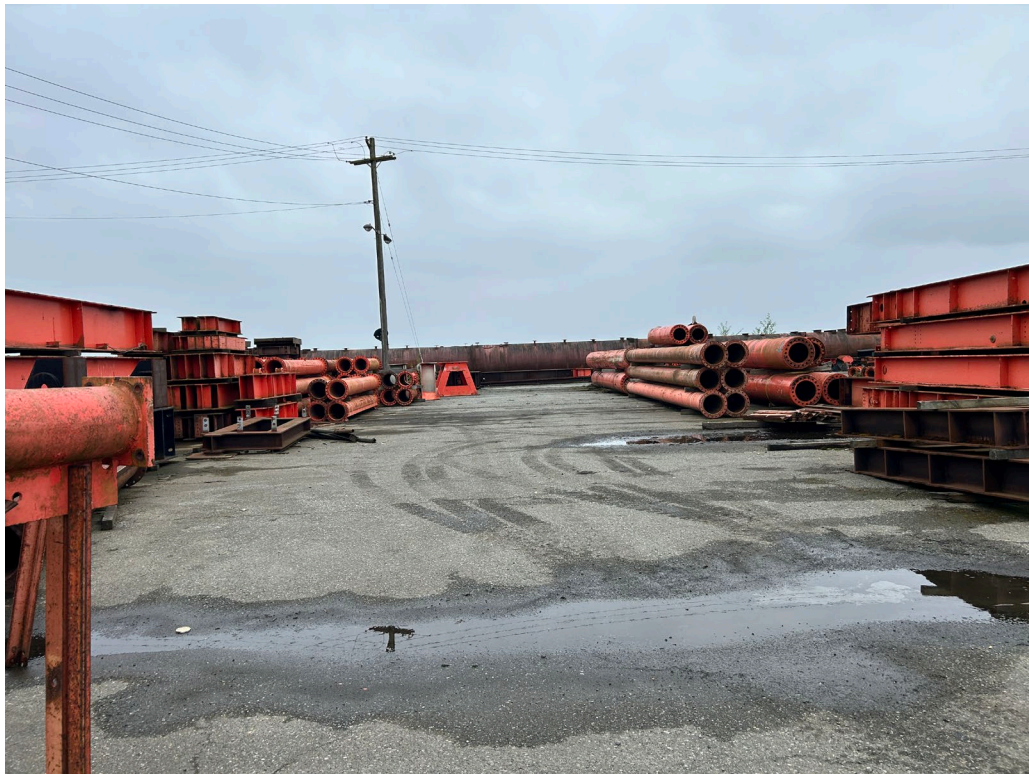
Photograph 4. Polygon A1 with stored materials on the southwest side of the parcel.

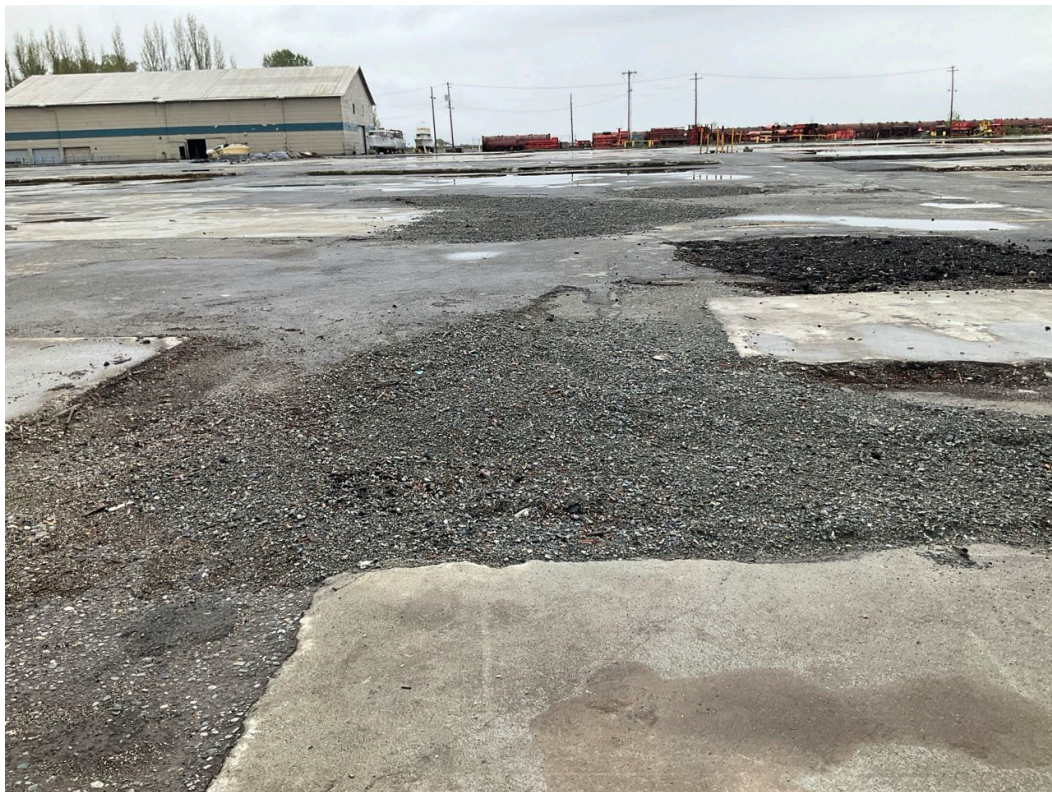
areas are labeled on Figure 1 as C1 through C20. Polygons C1-C8 and C15-C20 were identified as having the potential to wash out during storm events due to their exposed configuration and lack of containment by berms or curbing. Erosion or migration of gravel from these areas could contribute suspended solids to stormwater runoff; however, the gravel is from a clean quarry source provided by HM and is therefore unlikely to contribute contaminants to stormwater. Polygons C9-C14 were observed to be contained within concrete berms, which are expected to reduce the transport of sediment during precipitation events.

Photograph 10. Polygon C4 with crushed gravel.

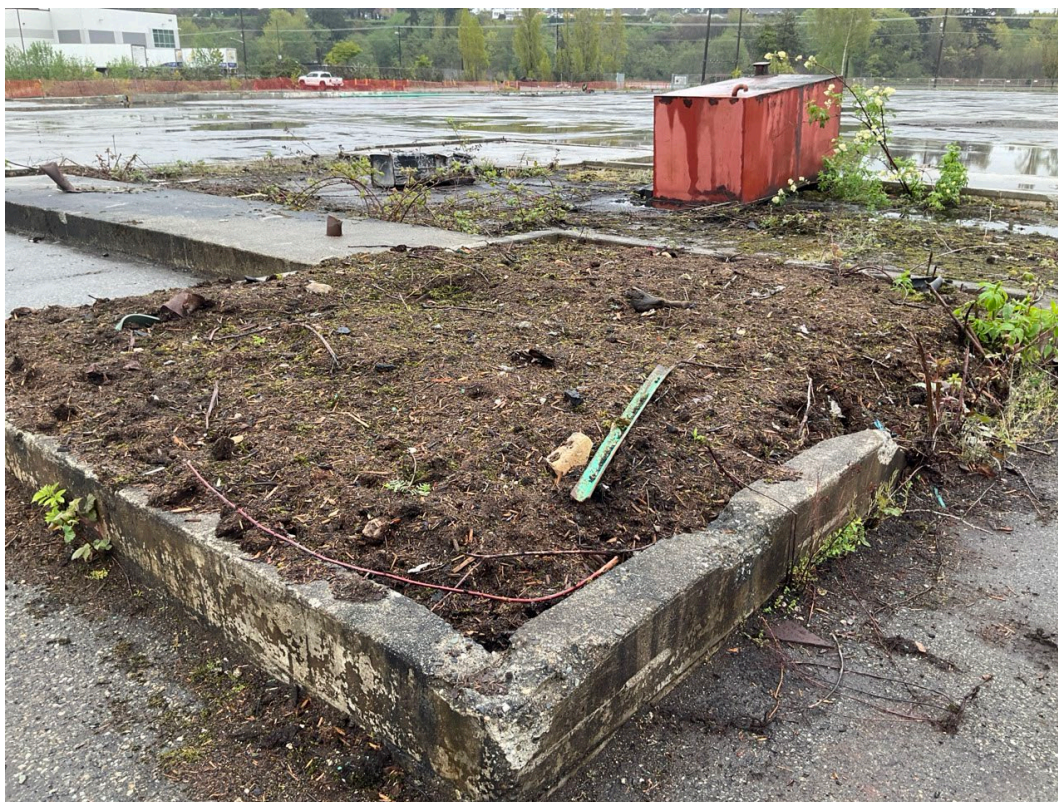
Photograph 13. Polygon D1: exposed soil and debris contained within a concrete berm.

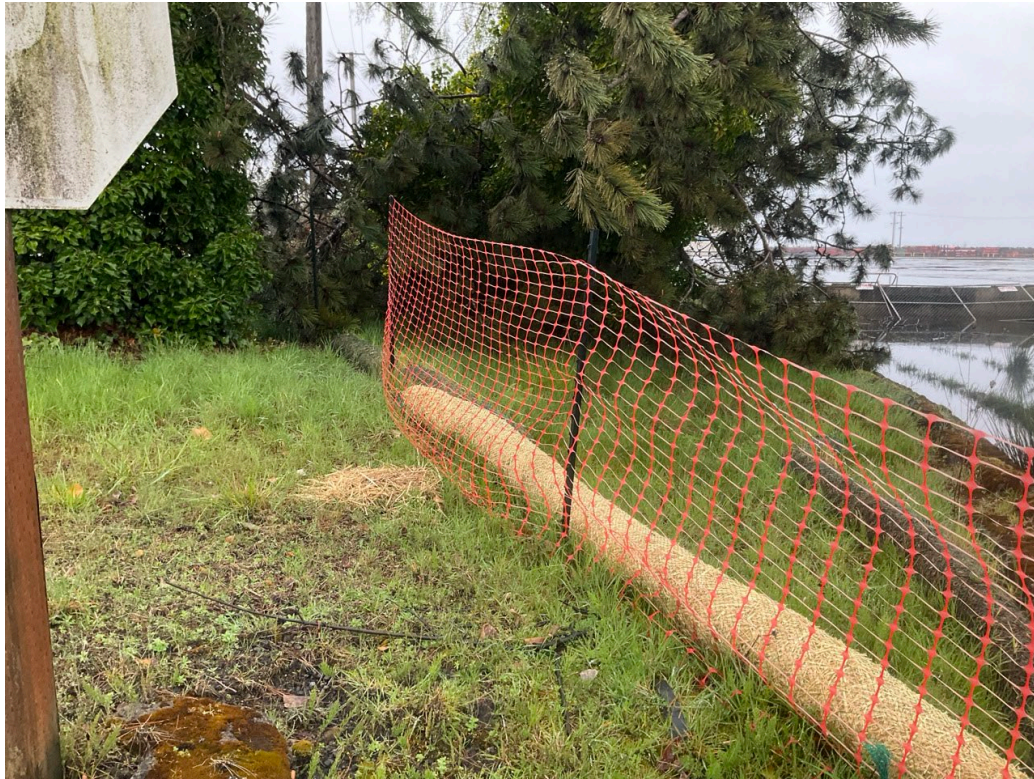
Photograph 17. Polygon E1: vegetated area near the north truck bay.

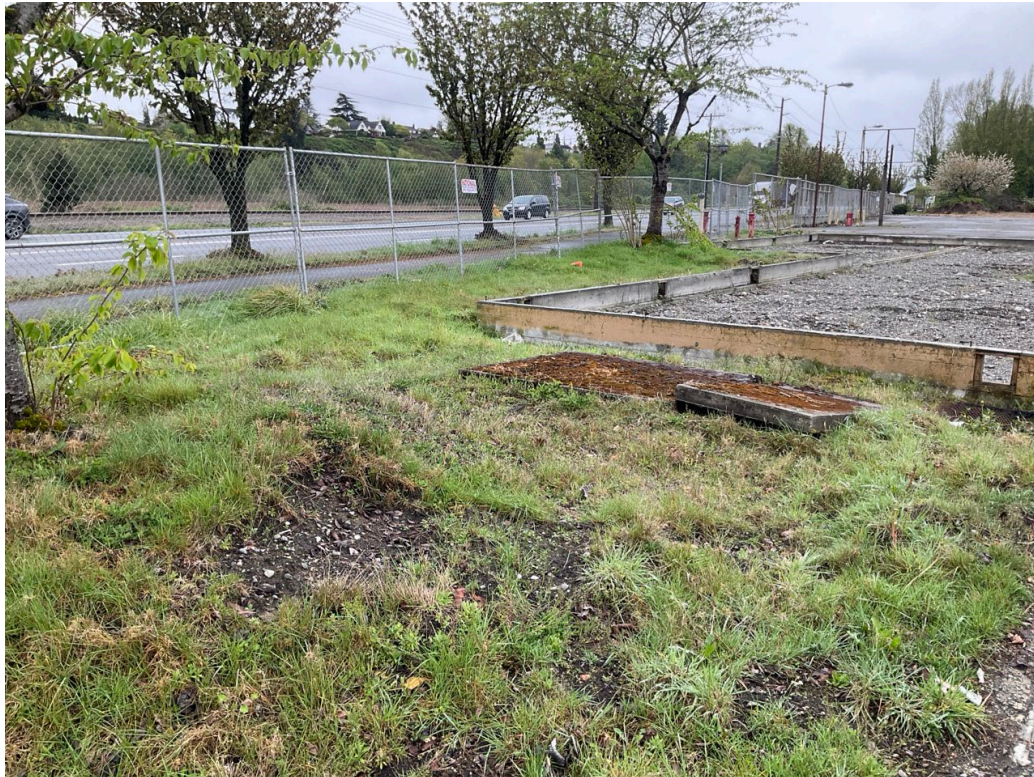
Photograph 18. Polygon E3: vegetated area along the southeast parcel boundary.

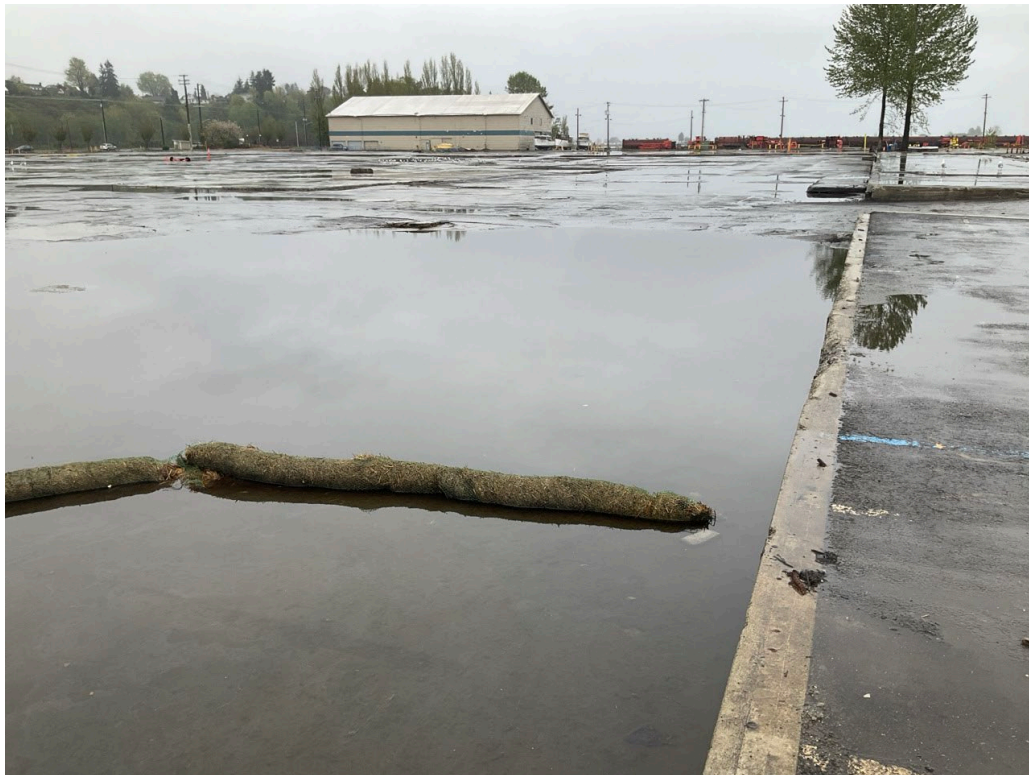
Photograph 22. Polygon F3: ponding near Outfall 4.

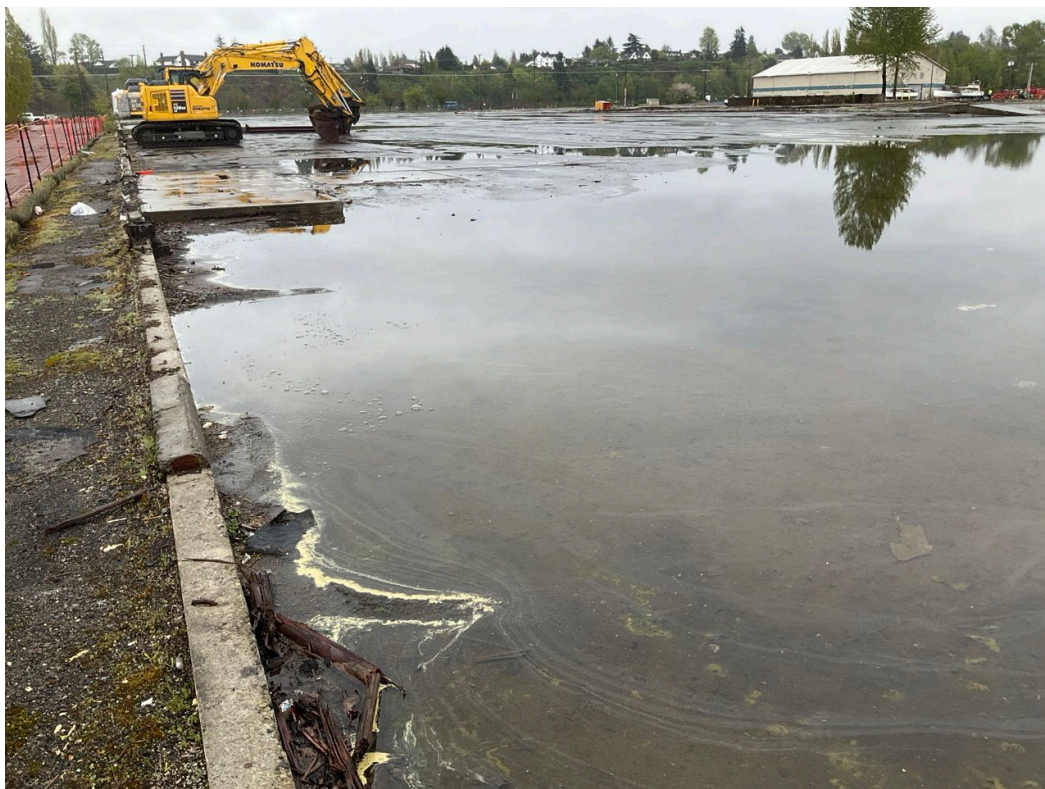
Ponded areas (as shown in Figure 1) with the potential to discharge to surface water include polygons F1, F2, F4, F5, F7, F8, F10, F16, and F17. These areas were generally associated with depressional and impermeable surfaces of the Site where accumulated stormwater could overflow, migrate across impermeable surfaces, or flow toward surface water during precipitation events. The proximity of ponded water to drainage pathways or sloped surfaces increases the likelihood that suspended sediment could be transported in stormwater during precipitation events. A pump was observed at the north truck bay ponding (polygon F1), with piping extending along the north side of the concrete pad, consistent with active water management to maintain driveway access in this area. However, no water flow from the pump was observed during the site visit.

Photograph 23. Polygon F4: ponding near northwest parcel corner.

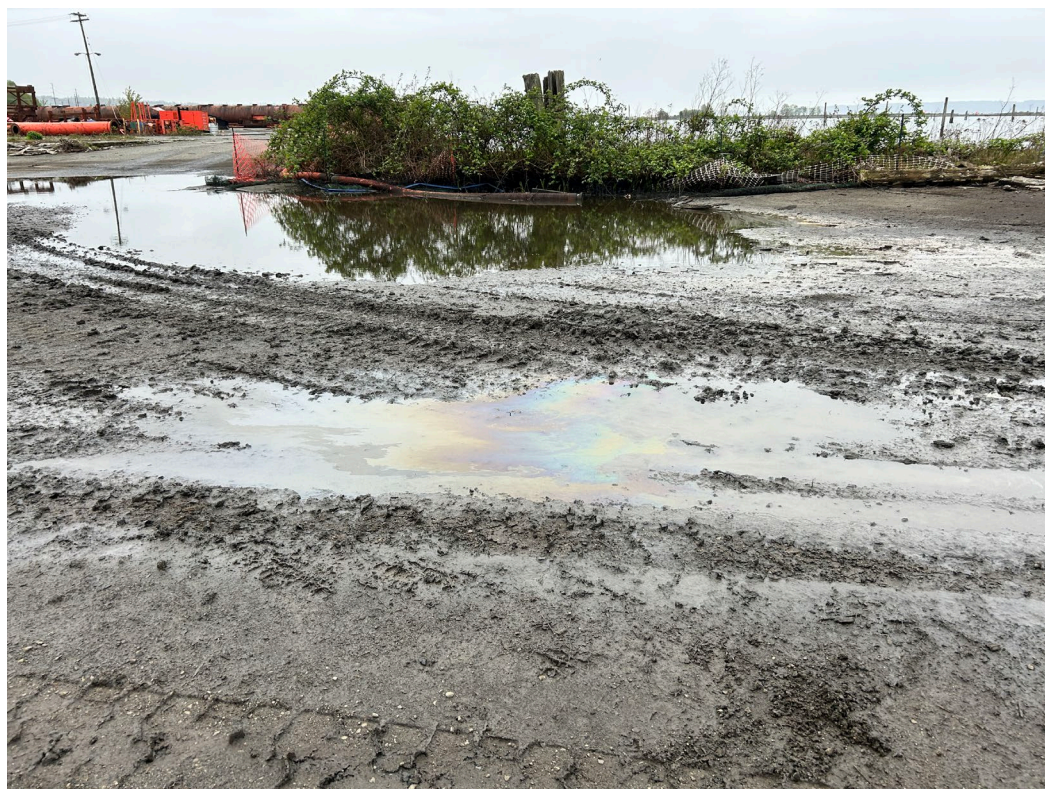
Photograph 24. Polygon F13: ponding near Outfall 5.

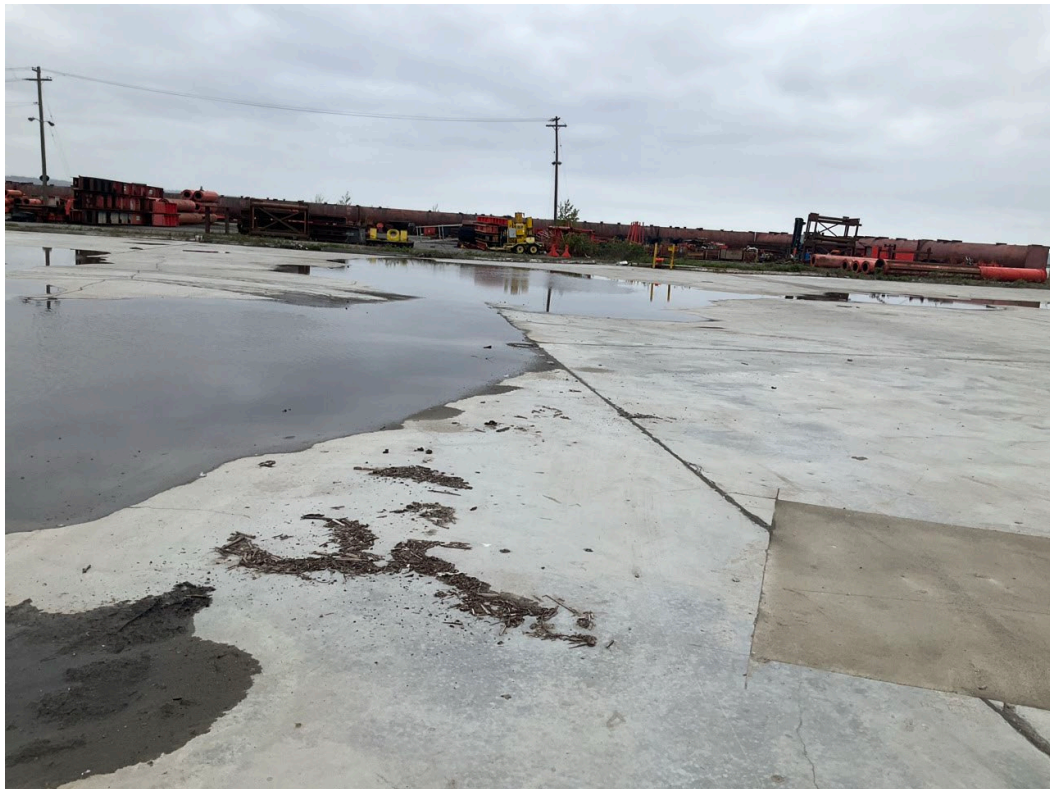
Photograph 25. Polygon F16: ponding over intact concrete.
