***Emergency Remedial Action  
Construction Completion Report  
Upper Tailings Pile  
Van Stone Mine***

***Prepared for  
Washington State  
Department of Ecology***

***December 26, 2012  
17800-34***

Prepared by  
**Hart Crowser, Inc.**

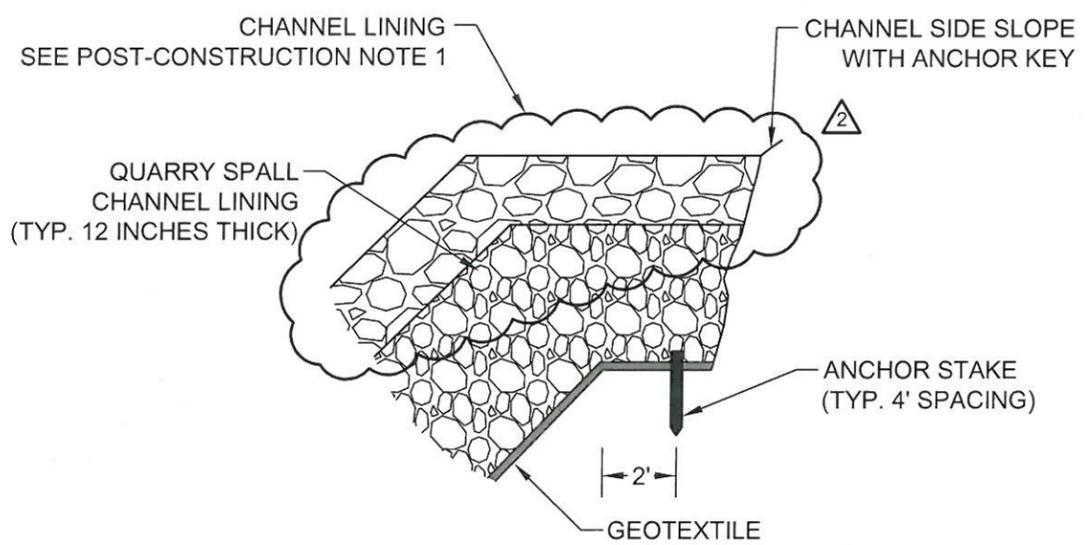
**TYP. ANCHOR KEY DETAIL**  
(NOT TO SCALE)

**POST-CONSTRUCTION NOTE:**  
1. DUE TO UNAVAILABILITY OF SPECIFIED ROCK MATERIAL AT THE TIME OF CONSTRUCTION, THE CHANNEL WAS LINED WITH A 12-INCH LAYER OF 3-INCH MINUS CRUSHED ROCK TOPPED WITH A 6-INCH LAYER OF 4- TO 10-INCH QUARRY SPALLS.
