MEMORANDUM

From: David Templeton and Joy Dunay, Anchor QEA, LLC
Project: 040289-02.07

Re: Eddon Boat Park Long-Term Monitoring Plan Year 4 Memorandum

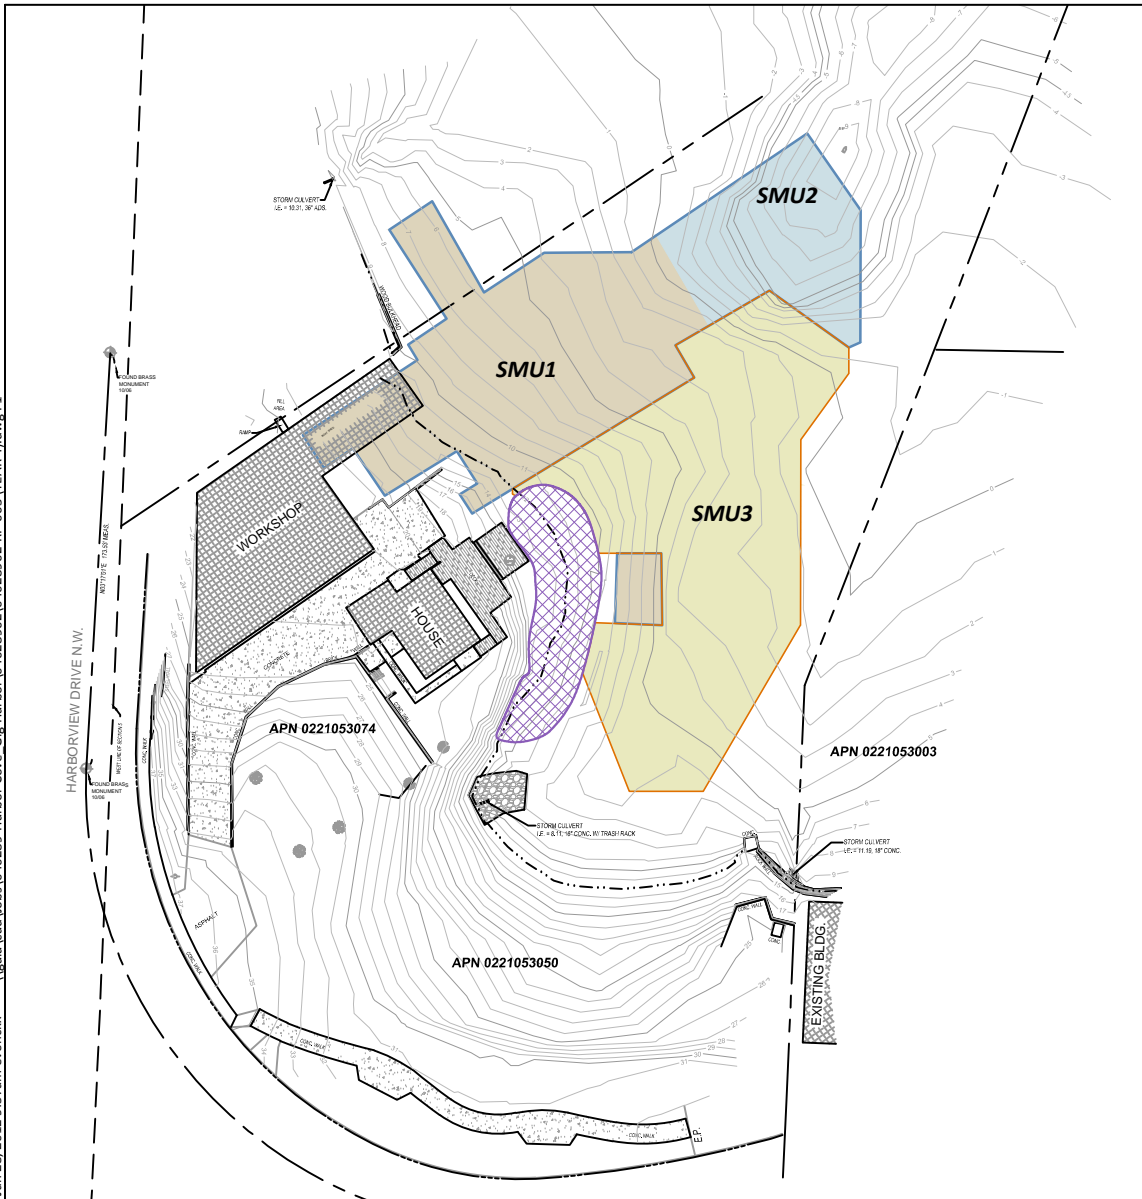
Jun 28, 2012 9:57am evonckx \\gala\card\jobs\040289-Harbor Cove_Gig_Harbor\04028902\04028902-RP-003 (YEAR 4).dwg F1

The LTMP requires five years of visual monitoring and one year of chemical testing. The areas assessed in the LTMP are cap area SMU-3 and enhanced natural recovery (ENR) area SMU-2 (Figure 1). SMU-3 contained three of ten sample locations that exceeded the total mercury sediment quality standard cleanup levels. Additionally, three samples in this area contained tributyltin (TBT) above benchmark values established by Ecology, as described in the CAP. As part of the cleanup action, this area was capped with 12 inches of sand and overlain by 6 inches of habitat mix. SMU-2 contained total mercury above the cleanup screening level and TBT porewater above Site cleanup levels (0.15 micrograms per liter) and was dredged to 2 feet below mudline and then overdredged to remove possible contaminated residuals. Post-construction, one location in this area (SE-03) exceeded the TBT Site cleanup level; therefore, ENR material consisting of a 1-foot sand layer was placed, followed by a 6-inch habitat mix layer. Year 3 monitoring included chemical analysis of the cap sand layer at three locations in SMU-2 and SMU-3 to determine if TBT or mercury were migrating to the surface layer. All samples yielded non-detects of these chemicals, concluding that the remedy is successful and additional chemical monitoring is not required.
