RE: Final Report 2013 Annual Performance Monitoring Black Sand Beach Project Stevens County, Washington URS Job No. 36310197

Presented in this letter report is a summary of the third annual performance monitoring event conducted at Black Sand Beach in Stevens County, Washington on October 9, 2013. The purpose of this report is to document changes in the Black Sand Beach, including sediment erosion and/or re-deposition, since completion of the Black Sand Beach project in October 2010. The 2013 annual performance monitoring event was performed in accordance with a Washington Department of Ecology (Ecology) – approved Performance Monitoring Plan dated March 2010.

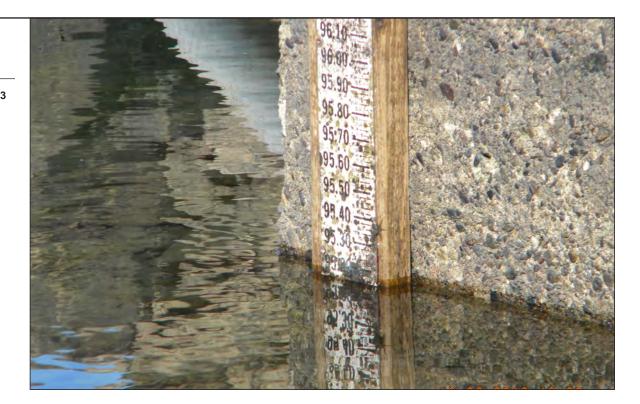
Photo Taken: 10/09/13 Direction Taken: Description: USGS Gage
