LANDSBURG MINE COAL MINE HAZARD ASSESSMENT

**Landsburg Mine Site PLP Group
31407 Highway 169
P.O. Box 10
Black Diamond, WA 98010**

**SubTerra, Inc.
PO Box 520
218 East North Bend Way
North Bend, WA 98045**

**Project No. 2001-45
May 2005**

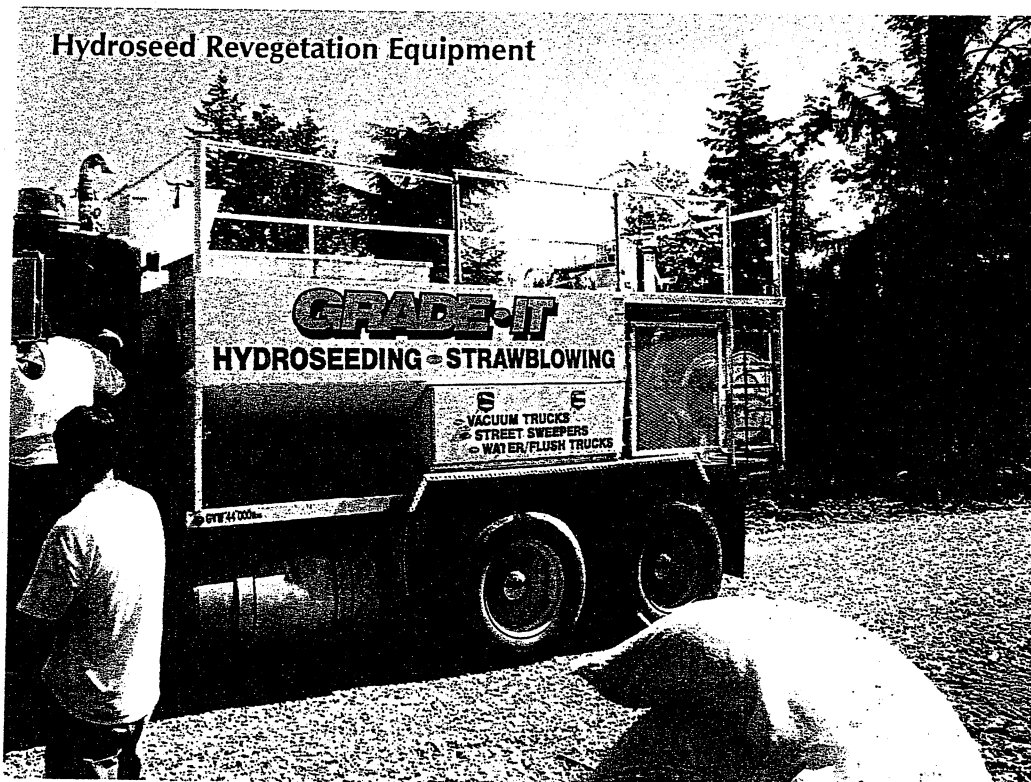
Photograph 6 Truck-mounted hydroseed equipment used for revegetation of the features.
(WA-009_RV-01_082903a_HydroseedEquipment.jpg)
