Historical Site Development Analysis
North Marina Ameron/Hulbert Site
Everett, Washington

The North Marina Ameron/Hulbert Site PLP Group

May 11, 2010

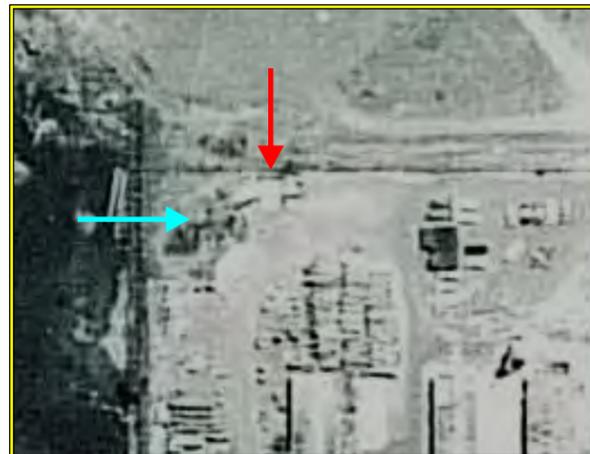
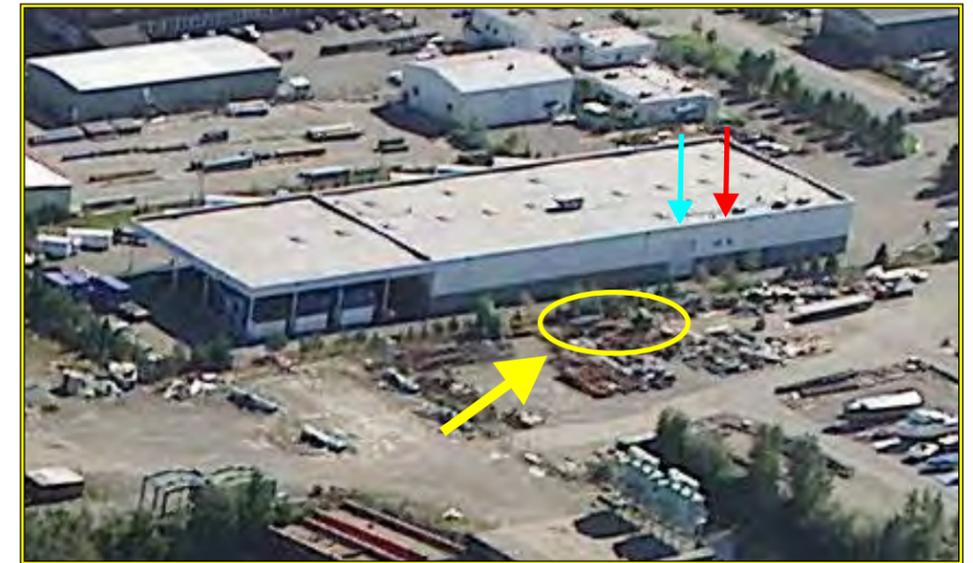
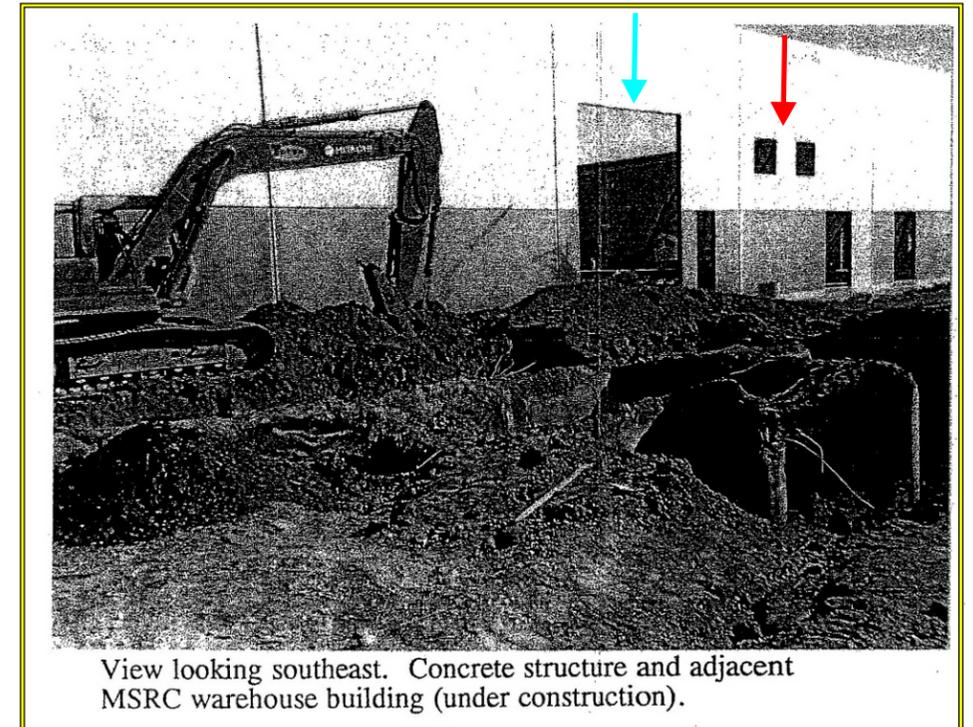
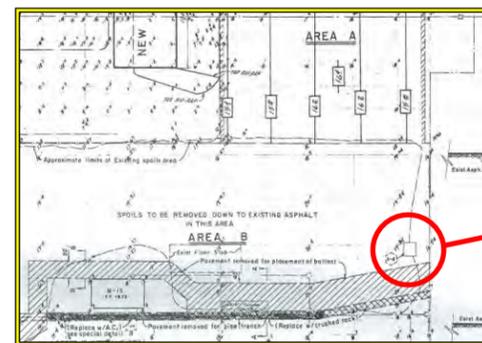
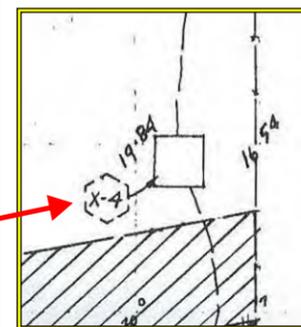
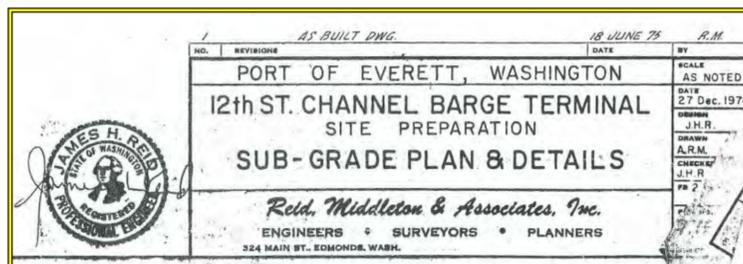
Figure 12
Concrete Structures in Area J
North Marina Ameron/Hulbert Site
Everett, Washington
Pinnacle GeoSciences

prepared by Reid Middleton Associates for the 12th Street Channel Barge Terminal, identifies this feature, along with other features as "Old concrete foundations to be removed." This drawing places that feature at the same location of the irregular vault shown in the Sanborn map and in the aerial photography. Figure 12 provides an overlay of these locations on the pertinent part of Figure 8 from the Landau 2009 report.

The actual locations of both of these concrete structures is shown in Figure 12. Both features lie within Area J. The source of the waste materials buried within the irregular vault was not identified but they were likely placed in the vault prior to it being covered over in late 1973 to early 1974. Section 5.7 of this report documents that activities in this part of Area J were largely related to and under the control of business to the west of Area J at that time.

The west wall of this fill formed a natural division of the site which then continued to propagate through future uses of this part of the site. The 1957 and 1968 Sanborn maps describe an eight foot high wire fence at the western margin of this wall (see Figure 12). Land use of the area west of this wall was tied to the activities of businesses west of Area J and west of the Agreed Order site. The area immediately next to the west side of this wall became a parking and equipment laydown area apparently associated with the business activities to the west. The two areas, east and west of the boundary had their own separate access roads from 13th Street. Traffic flow patterns and visual evidence of site access suggests that activities in Area I and the filled part of Area J did not encroach on the part of Area J west of the wall and fence.

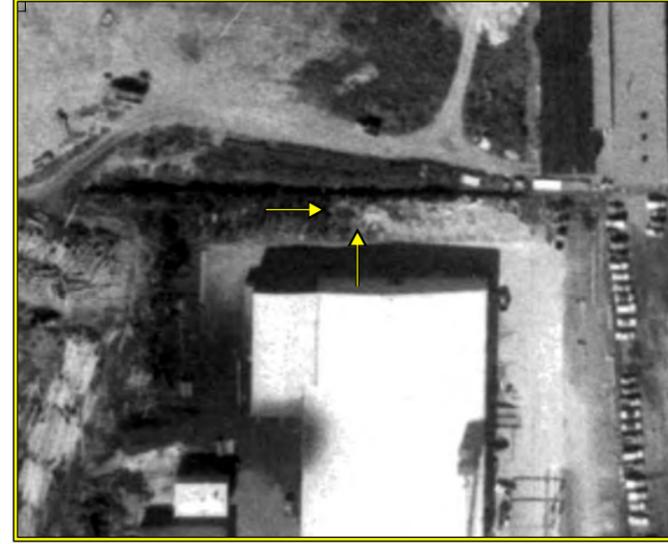
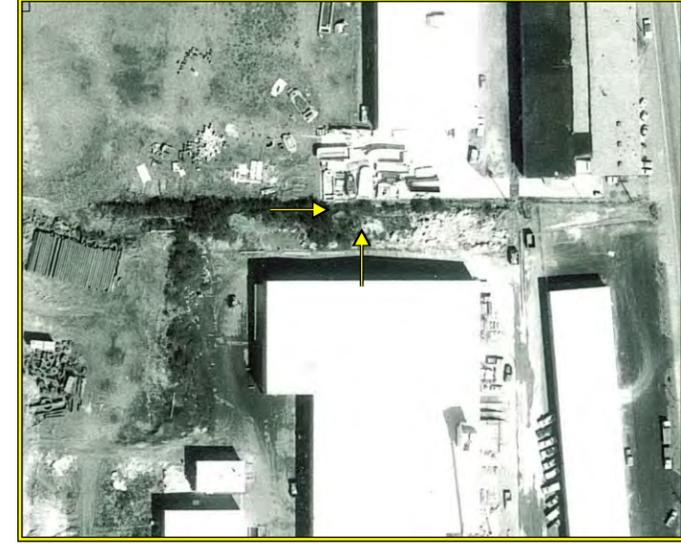
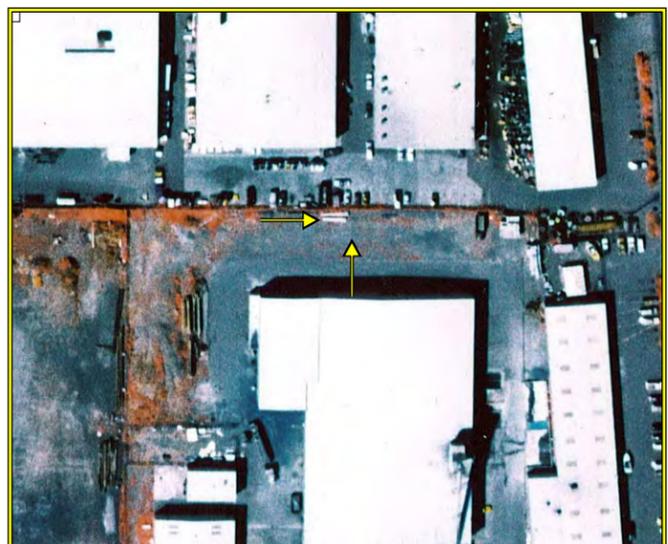
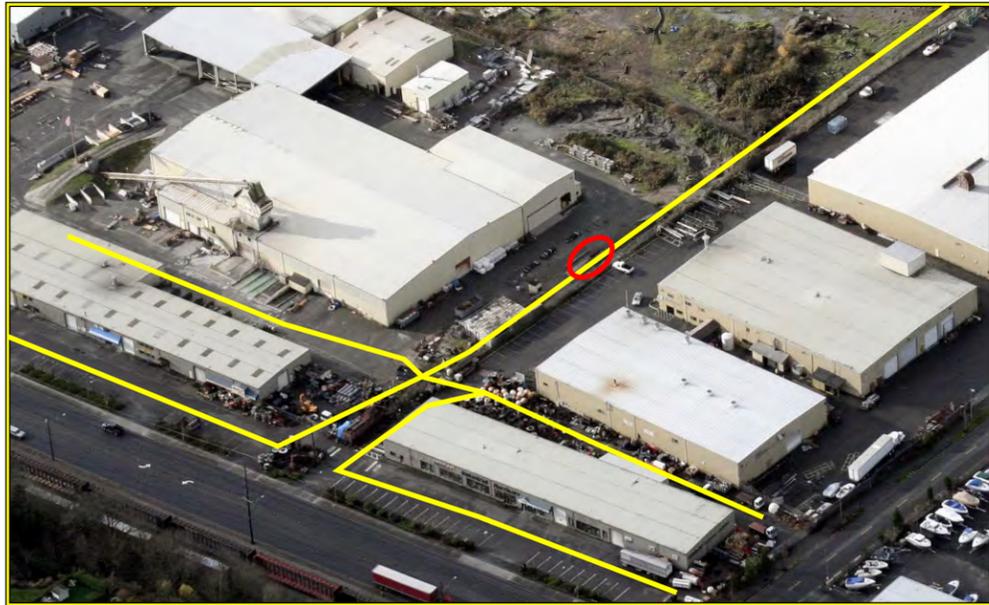
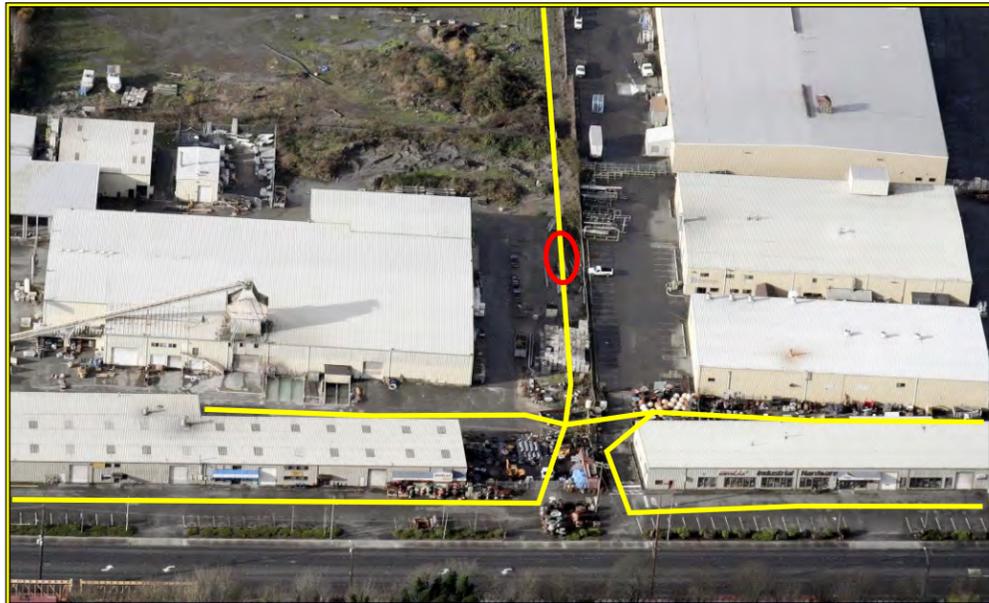
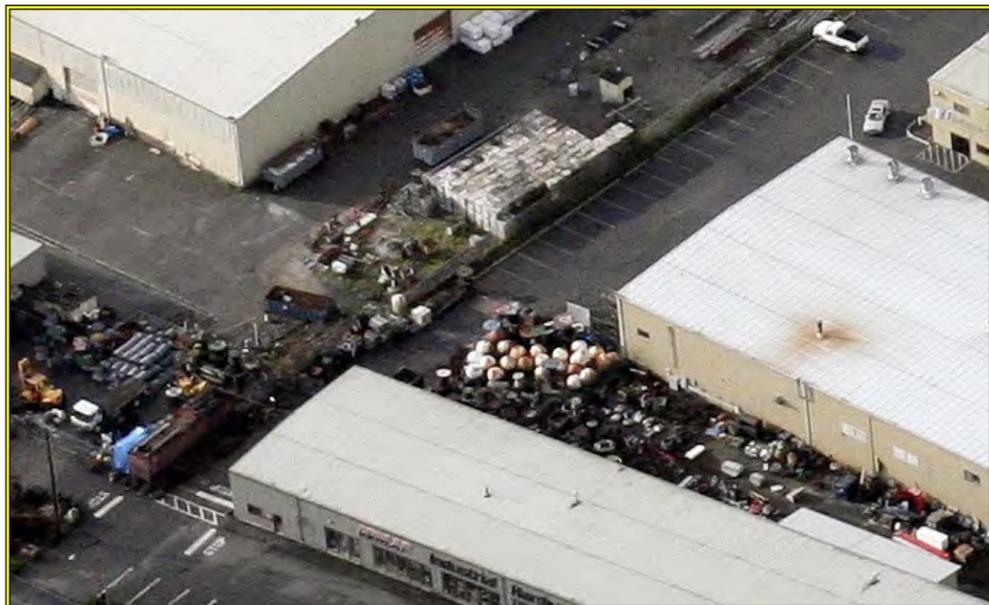
Figure 13
Sewer Line Repair Area on
Northern Area G
North Marina Ameron/Hulbert Site
Everett, Washington

The northern boundary of Area G is presently occupied by an underground storm sewer line. In late 2004 a repair was made to a storm drain line and evidence of contamination was noted in excavated soils. The location of this repair is shown in Figure 13. Analytical testing of the soil stockpile from the excavation showed low concentrations of mid-range to heavy-range petroleum hydrocarbons, several PCB aroclors and cPAHs. Furthermore, the soils encountered included concrete fragments and mixed fill suggesting that this area was used for disposal of demolition debris. Follow up testing by Landau Associates shortly after the repair (early 2005) encountered the mixed fill and found the contamination to be localized to the general area of the repair excavation. Samples tested by Landau found evidence of PCBs, PAHs and low concentration petroleum contamination. PCBs and PAHs were found in a soil sample from the initial excavation stockpile. Relatively high concentrations of volatile organic compounds were found in a sample obtained from a depth at or near the top of the storm drain line, close to the repair area. The suite of analyses performed was not consistent from sample to sample so it is difficult to identify patterns between different samples evaluated.

The area of concern lies between the Ameron Building and the northern property line. Figure 13 shows the succession of change in the area of concern between 1967 and 2005. This area was originally tide land and the first construction there was a pile supported dock used for storage. We do not know specifically when this area was initially filled, but by the 1960s the former mill dock structures appeared to be largely underlain by fill, including this area. Until mid-1977, the northern property line along most of Area G is clearly identified by the piling at the edge of the former dock and the much lower grade on the adjacent property to the north. Although the property to the north had been partially filled, a drainage ditch remained along its southern margin – just north of Area G. By mid-1978 the property to the north was filled to approximately the same grade as area G, including this drainage ditch. The storm line, which was likely installed in about 1981-1982, lies several feet south of the northern property line and discharges at the northwestern corner of Area I. The catchment for the portion of the drain line upgradient of the release location encompasses the building east of the Ameron Building and the eastern-most building on the property to the north. The basis for our estimate of the 1981-1982 date range for the installation of the storm sewer system is based on a combination of site development factors evident in aerial photographs including the presence and subsequent removal of substantial fill along the northern margin of Area G and the paving of areas where the storm sewer is now present.

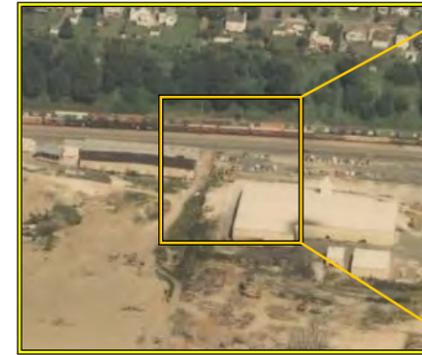
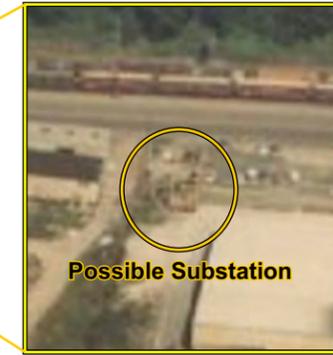
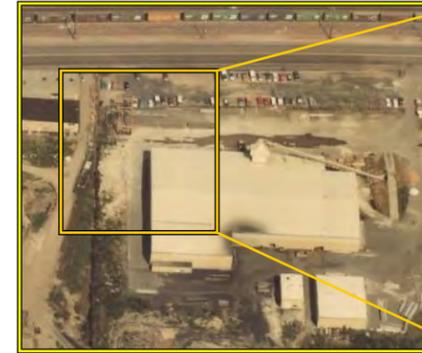
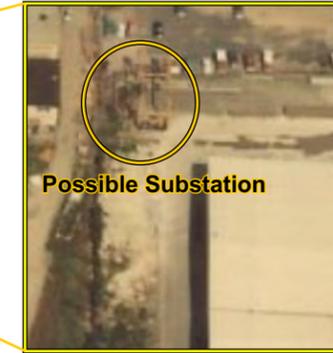
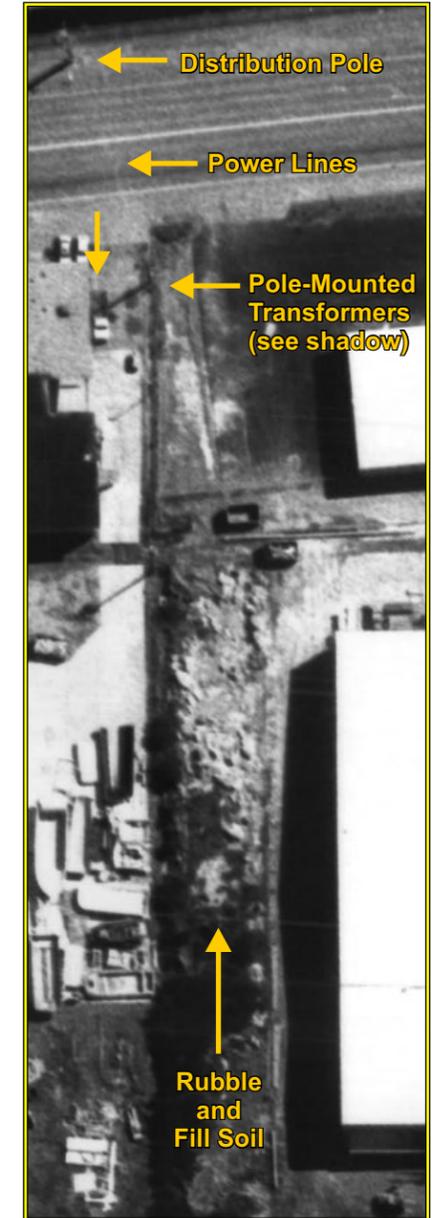
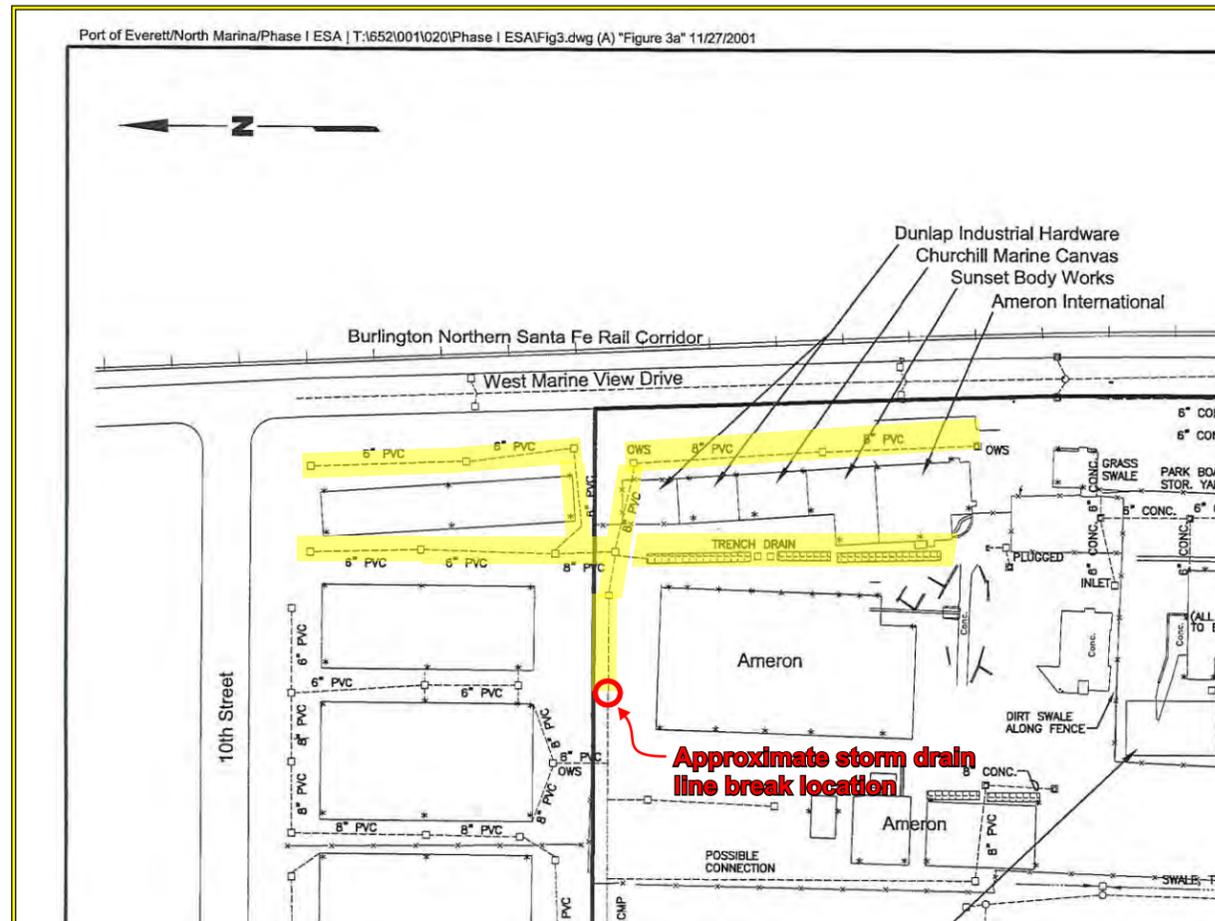
Figure 14
Storm Sewer System on
Northern Area G
North Marina Ameron/Hulbert Site
Everett, Washington

The portion of the sewer line upgradient to the contaminated area of the northern part of Area G collects storm water from portions of Areas M and G and from the east and west side of the eastern-most building on the property to the north. Figure 14 shows the drainage system configuration in this area.

As mentioned in the previous section, there are also likely sources for these contaminants on the subject property (Areas G and M) which also drain into the storm drain system. In addition to active business operations areas, the 1995 photograph shown in Figure 14 shows that the northeastern corners of both Areas M and G were used for storage of equipment and waste accumulation (note the blue dumpster).

The 1977 photographs show a structure that might be an electrical substation-type structure. The photographs are not suitable to clearly identify the item. The 1980 photograph documents the presence of pole mounted transformers at the northeastern corner of the subject property.

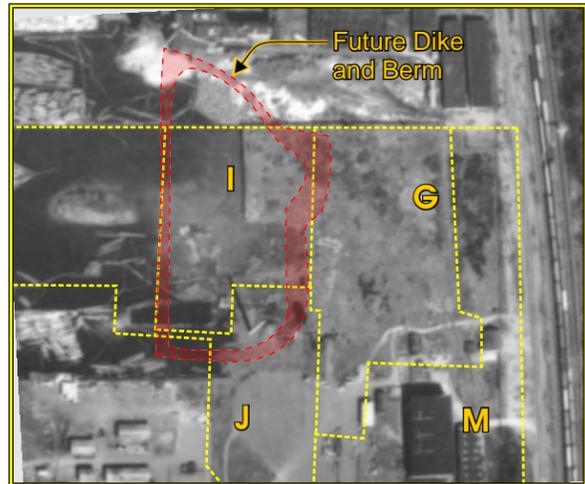
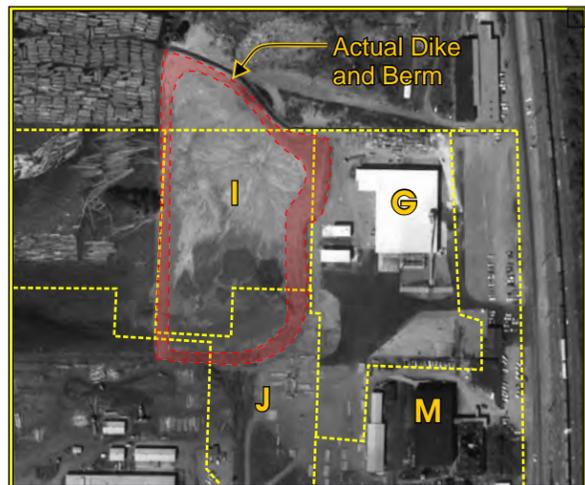
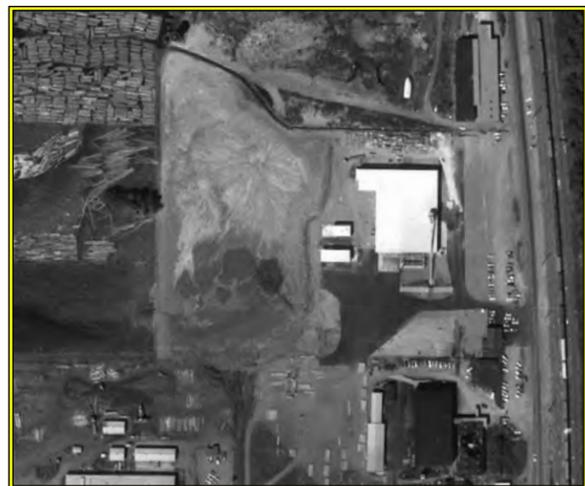
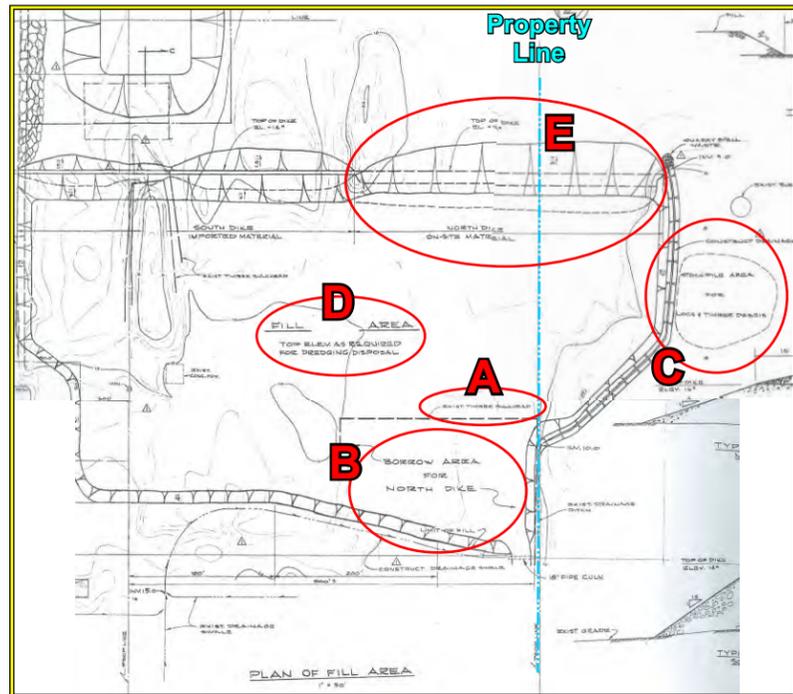
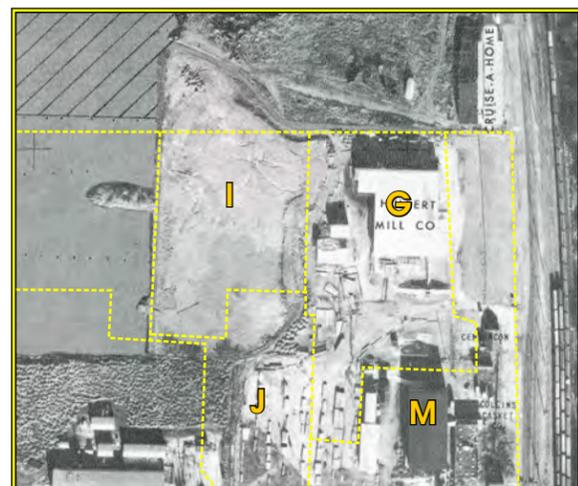
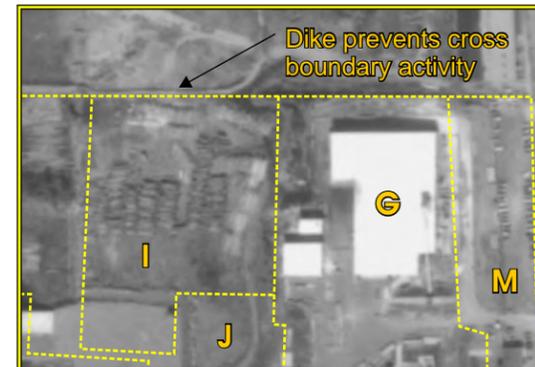
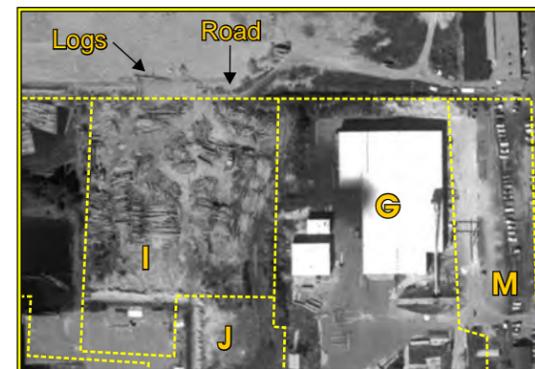
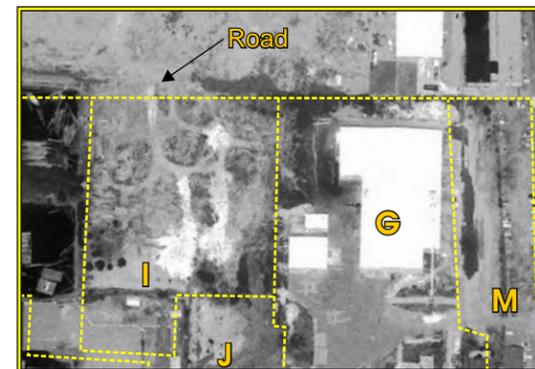
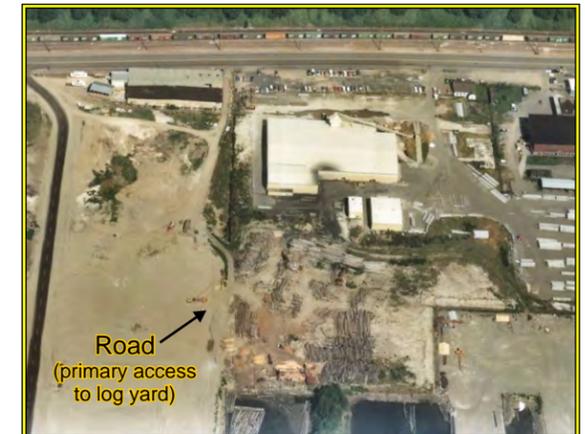
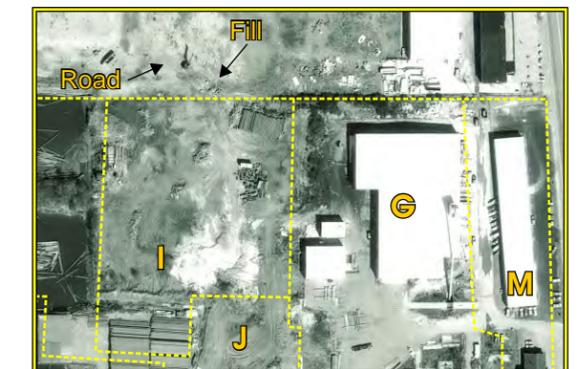
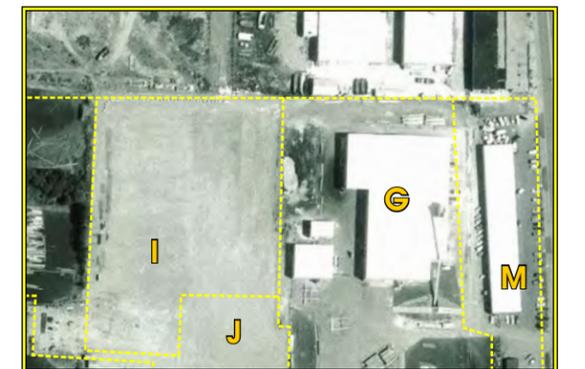
Figure 15
Cross Property Activity to the North
North Marina Ameron/Hulbert Site
Everett, Washington

Area I was originally filled in 1973 as part of the 12th Street Channel dredging project. In preparation for the fill placement, a dike was constructed along the west side of Area I and a berm constructed on the north, east and south sides to contain the dredge fill. Figure 15 shows the location of the dike and berm. The portion of the engineering drawing reproduced on Figure 15 also shows that the northeastern corner of Area I served as a borrow source for construction of the northwestern part of the dike. The engineering drawing does not specify the source or character of the fill used to construct the berm on the north, east and south sides of the fill.

The boundary between Area I and the property to the north was also partially characterized by the same dock structure. The western-most part, however, was common intertidal land until a major dredge fill placement in 1973. This engineered dredge fill placed in 1973 spanned the subject property, including parts of Areas J, I and G. Figure 15 shows the engineered fill placed in 1973. As as-built drawing by Reid Middleton Associates shows the dike and berm structures that were constructed on Areas J, I and G and extended onto the property to the north, as did the dredge spoil fill. The dike was constructed, at least in-part, from soils excavated from the northeastern corner of Area I and described in the 1973 engineering drawing. Furthermore, log and timber debris from the fill project was stockpiled north of the fill on the property to the north. This is also shown on the engineering drawing.
