EVALUATION OF POTENTIAL
SOIL AND GROUND WATER CONTAMINATION
AT THE ISAACSON CORPORATION PROPERTY
SEATTLE, WASHINGTON

December 21, 1983

Isaacson Corporation
8620 East Marginal Way South
Seattle, WA 98108

Patrick H. Wicks, P.E.
Consultant in Hazardous Waste Management
2535 - 152nd N.E., Suite A
Redmond, WA 98052

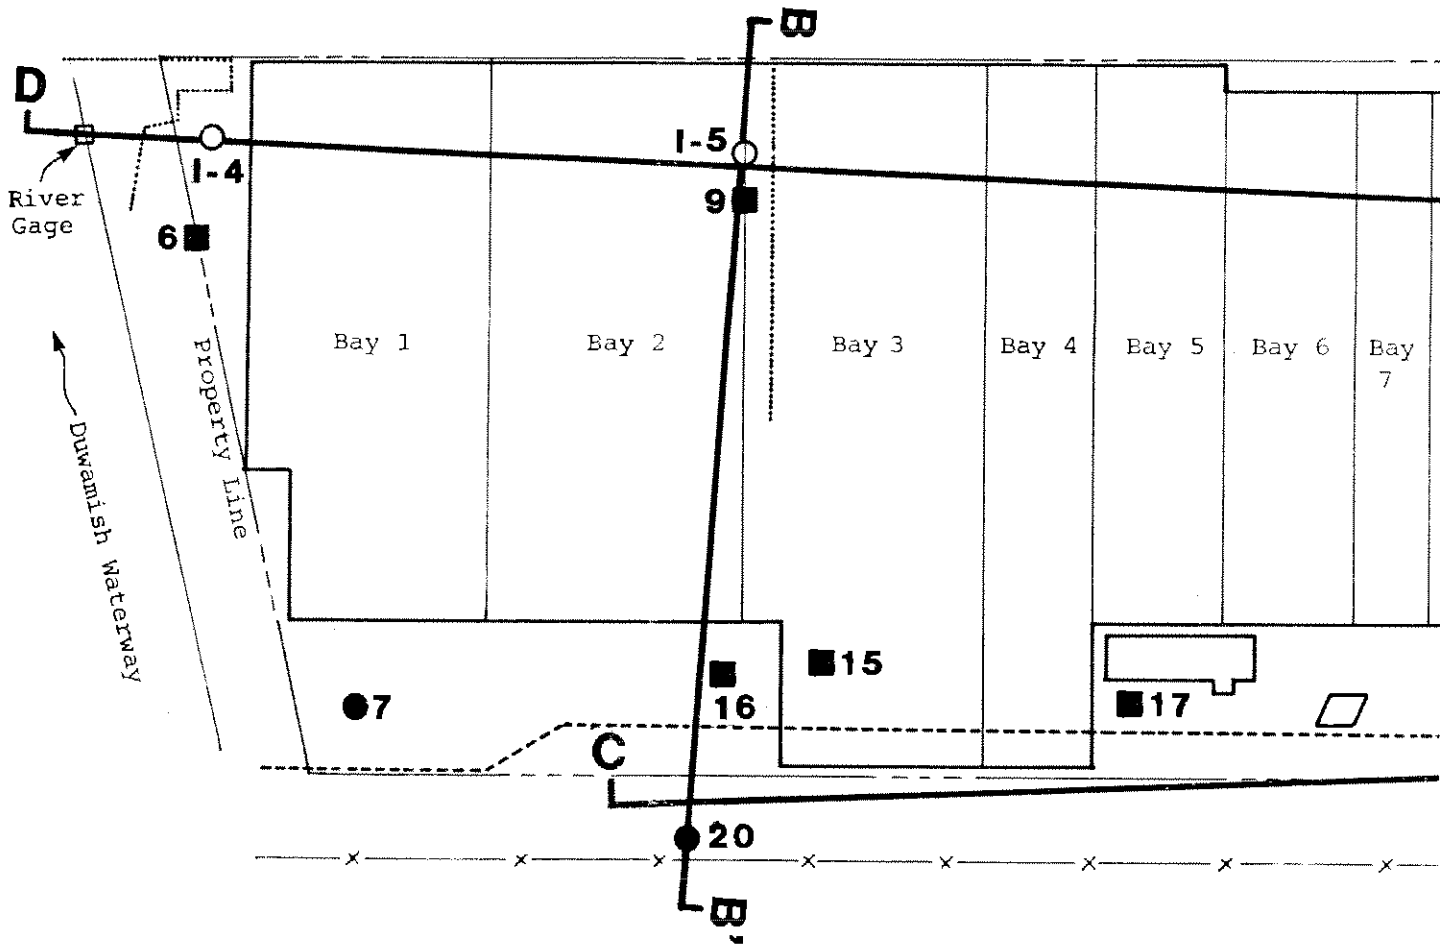
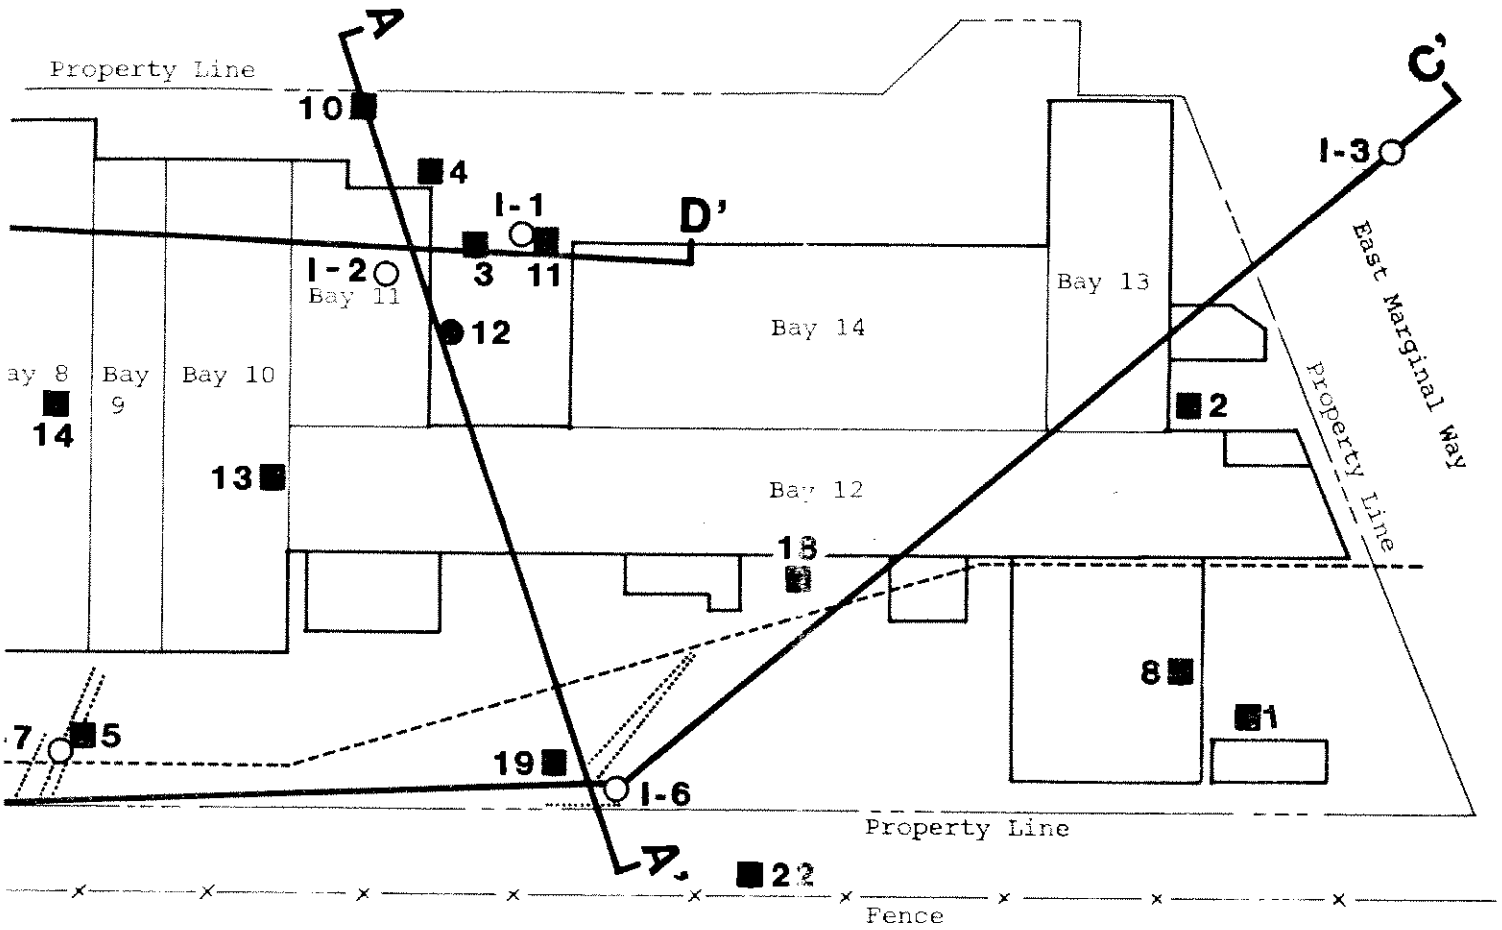
Figure 3

Task 1 - The locations of monitoring wells I-1 through I-7 were influenced by the factors of site configuration, locations of potential contaminant sources and buried utilities, hydrology in the site vicinity, and the existing monitoring wells installed by others. These factors were evaluated during the site reconnaissance, and seven monitoring wells were sited as shown on Figure 3.

To complete the monitoring well installations in the general locations initially planned, it was decided to conduct predrilling shallow subsurface exploration using ground penetrating radar (GPR) and backhoe test pit exploration. Details of the GPR survey and test pit work are provided in APPENDIX B. The GPR survey traverse locations are shown on Figure 3.

Test pits I-4 through I-7 were excavated in the areas considered to be free of large slag fragments, based on the GPR survey. These test pits were excavated in the locations shown for monitoring wells I-4 through I-7 on Figure 3.

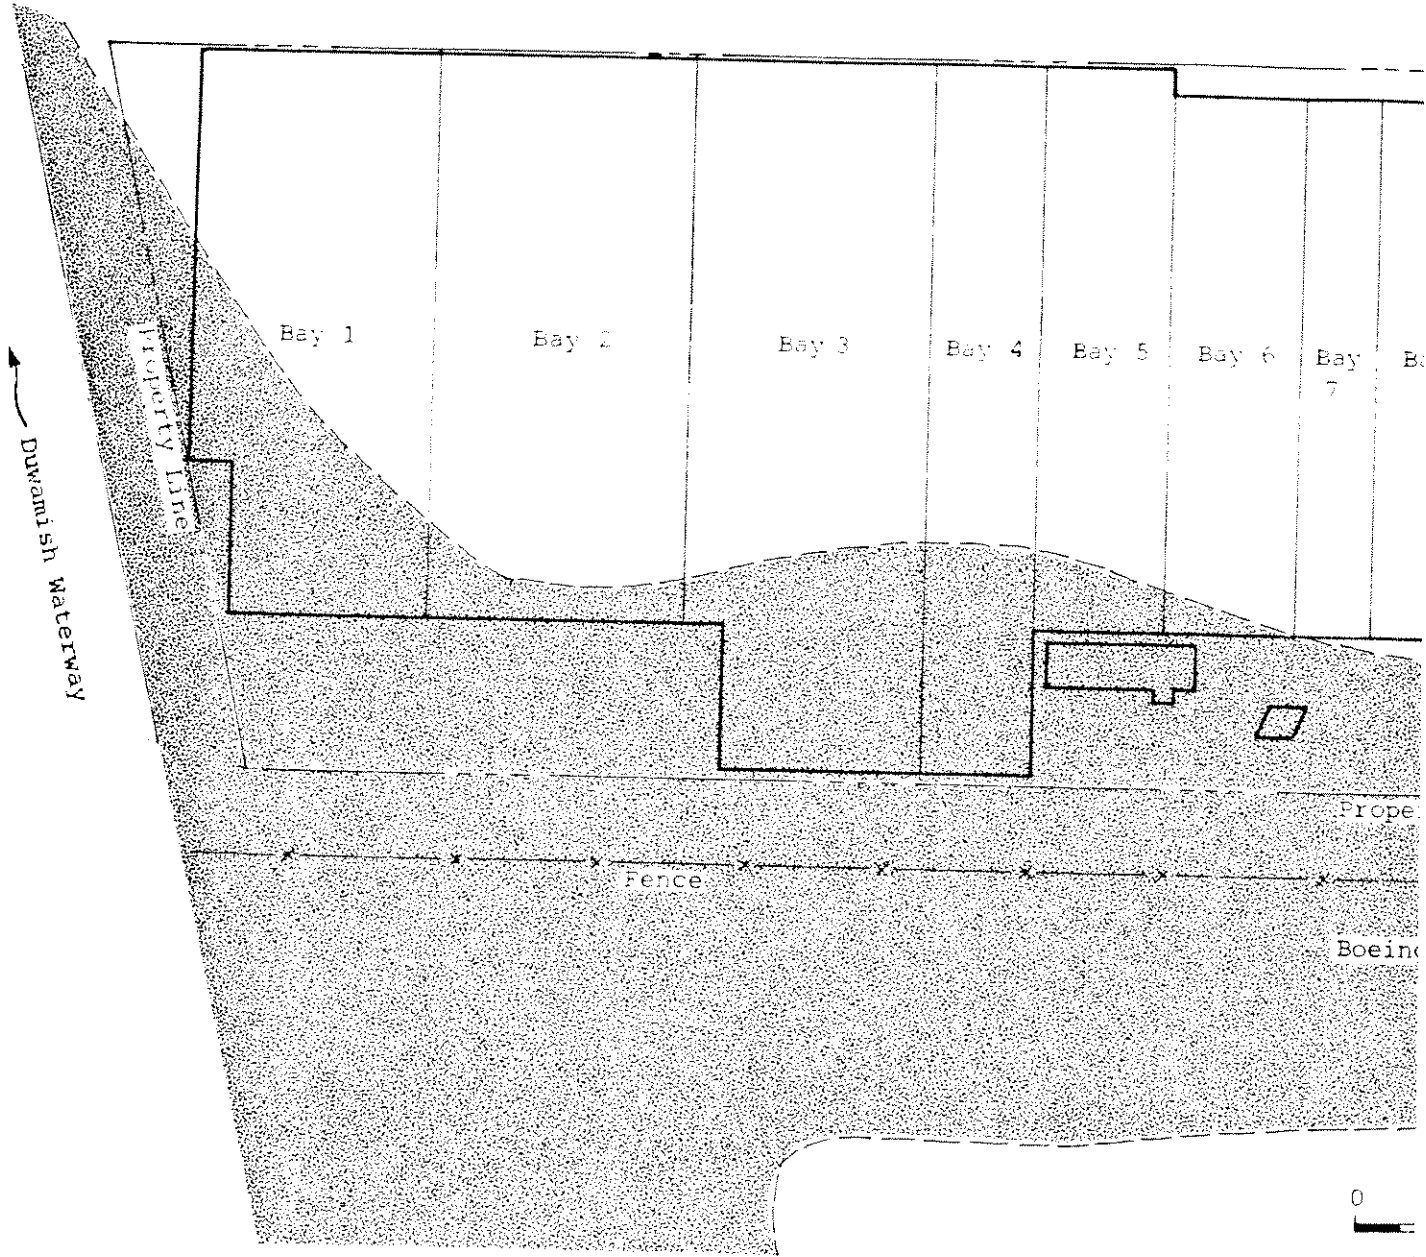
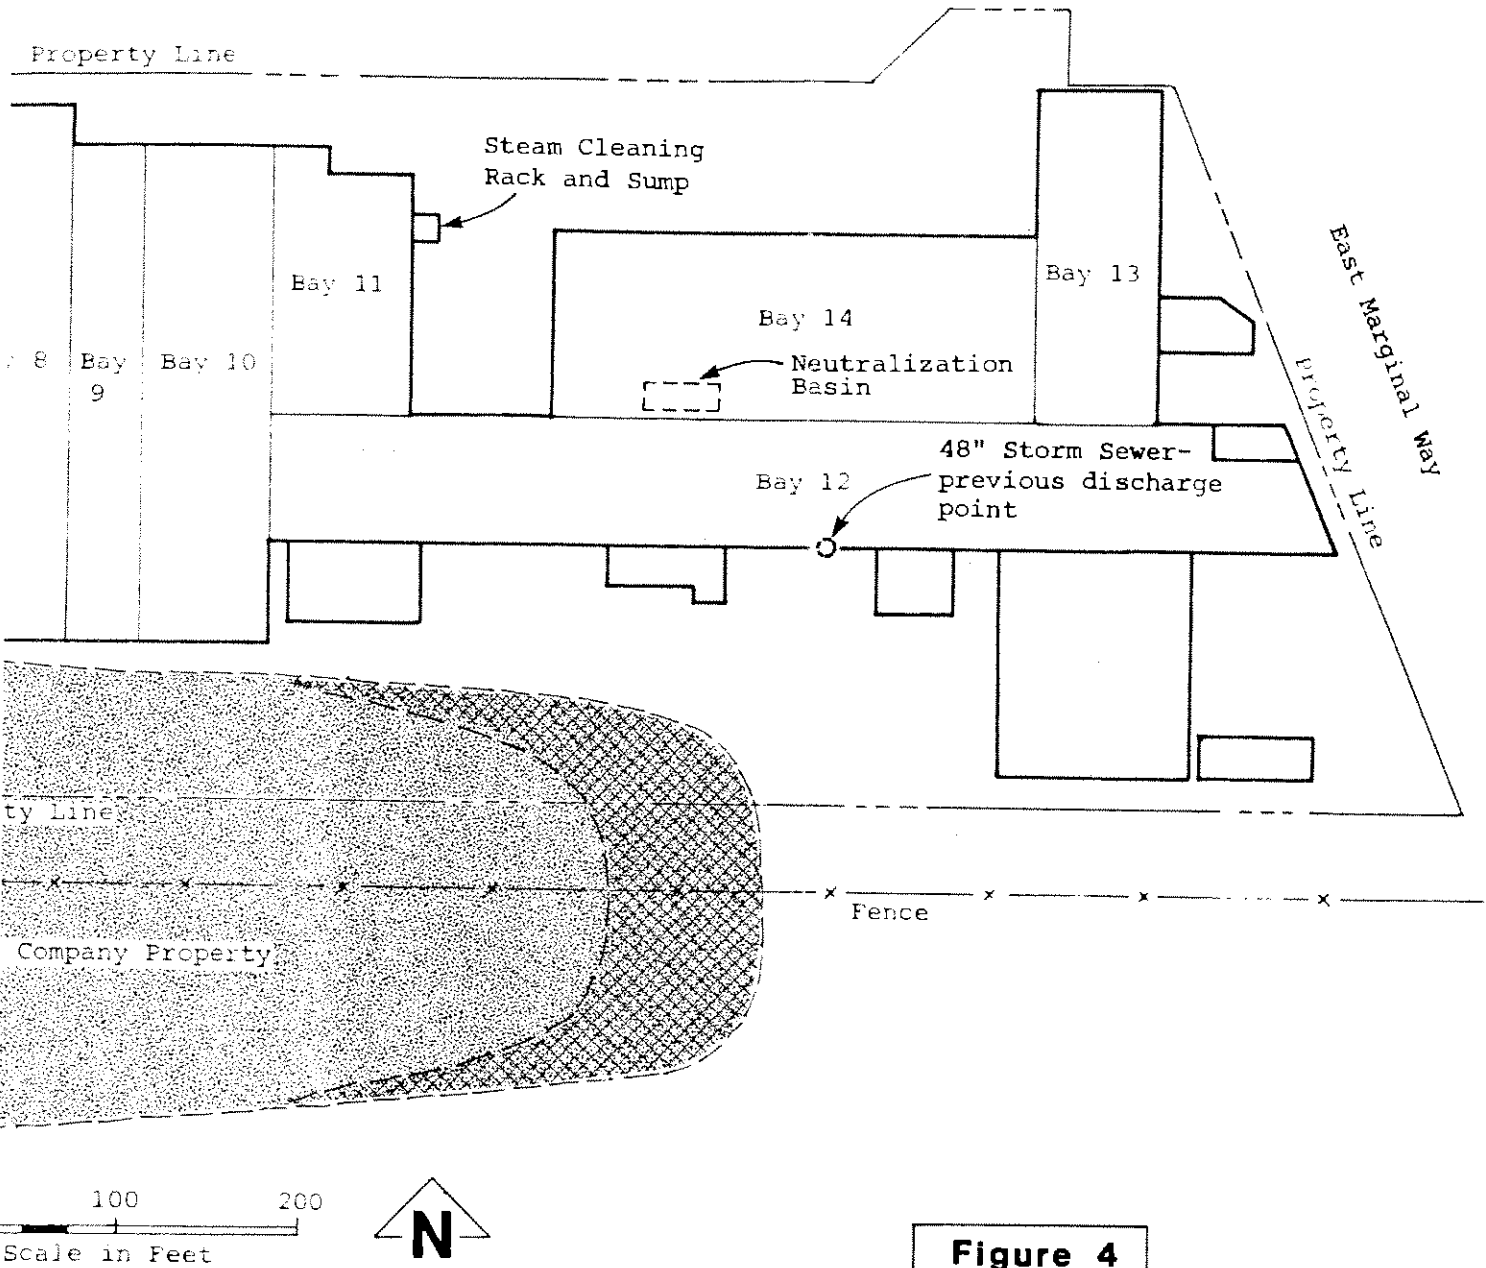
Figure 4

Based on personal communications with Isaacson personnel, only surface drainage from the plant is discharged to the 48" storm drain that runs beneath the Isaacson property as shown in Figure 3. This storm drain also apparently drains most of the Boeing Field area to the east of East Marginal Way South. In the last several years there have been no process discharges from the Isaacson plant to the storm sewer. However, previous to the last several years, process effluents were discharged to this storm sewer as discussed below. The 48" storm drain, prior to its being extended to the river, emptied into Slip 5 at the approximate location as shown on Figure 4.

The steam cleaning rack and sump are located as shown on Figure 4. They consist of a metal grate supported over a concrete walled

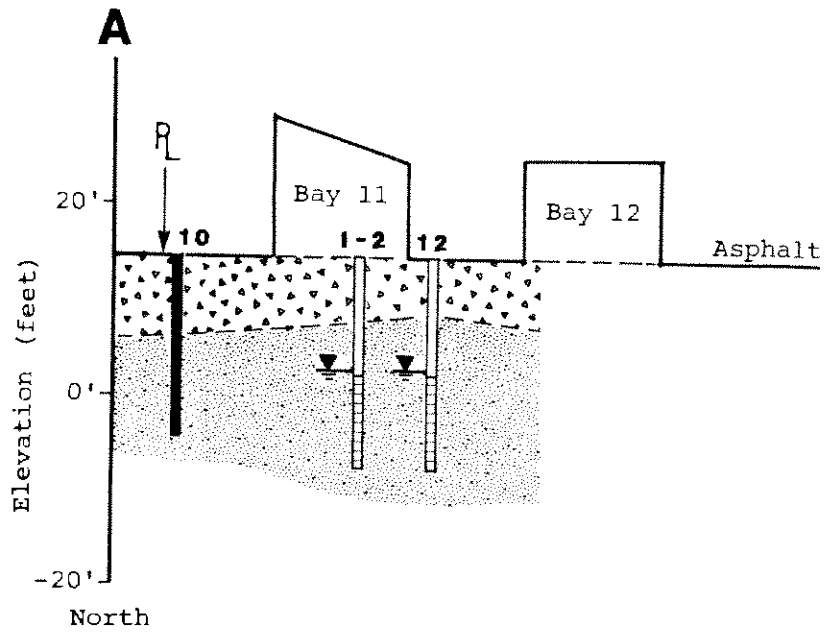
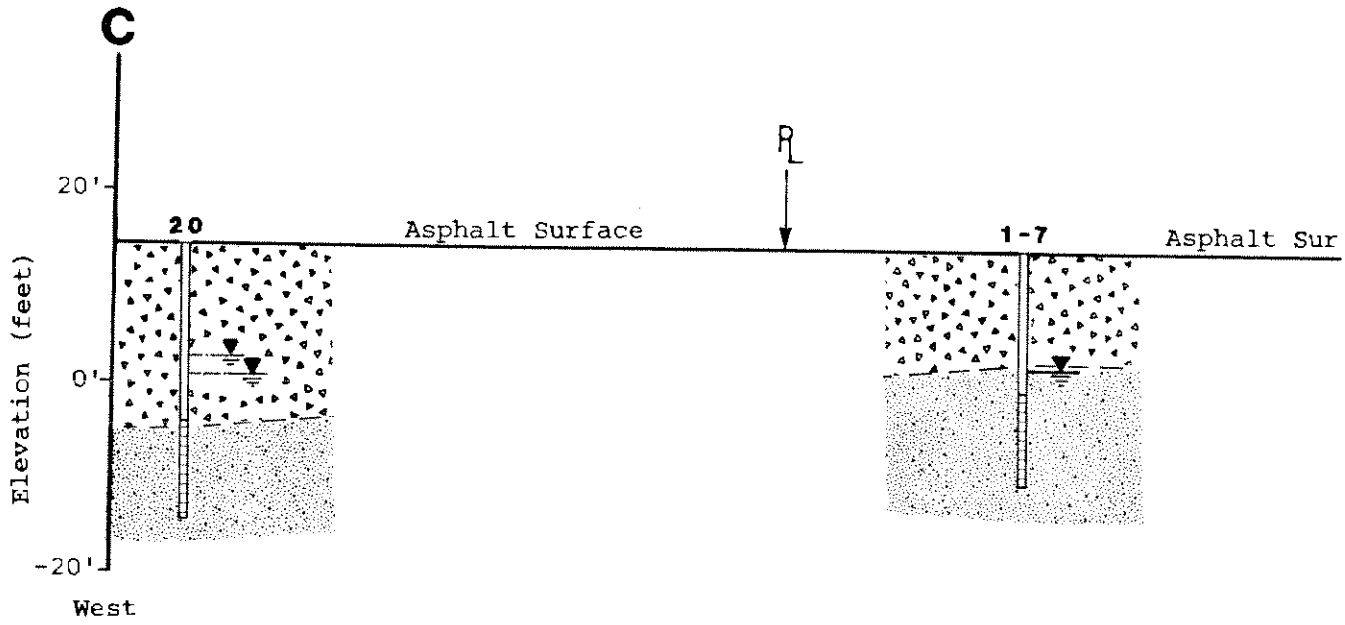
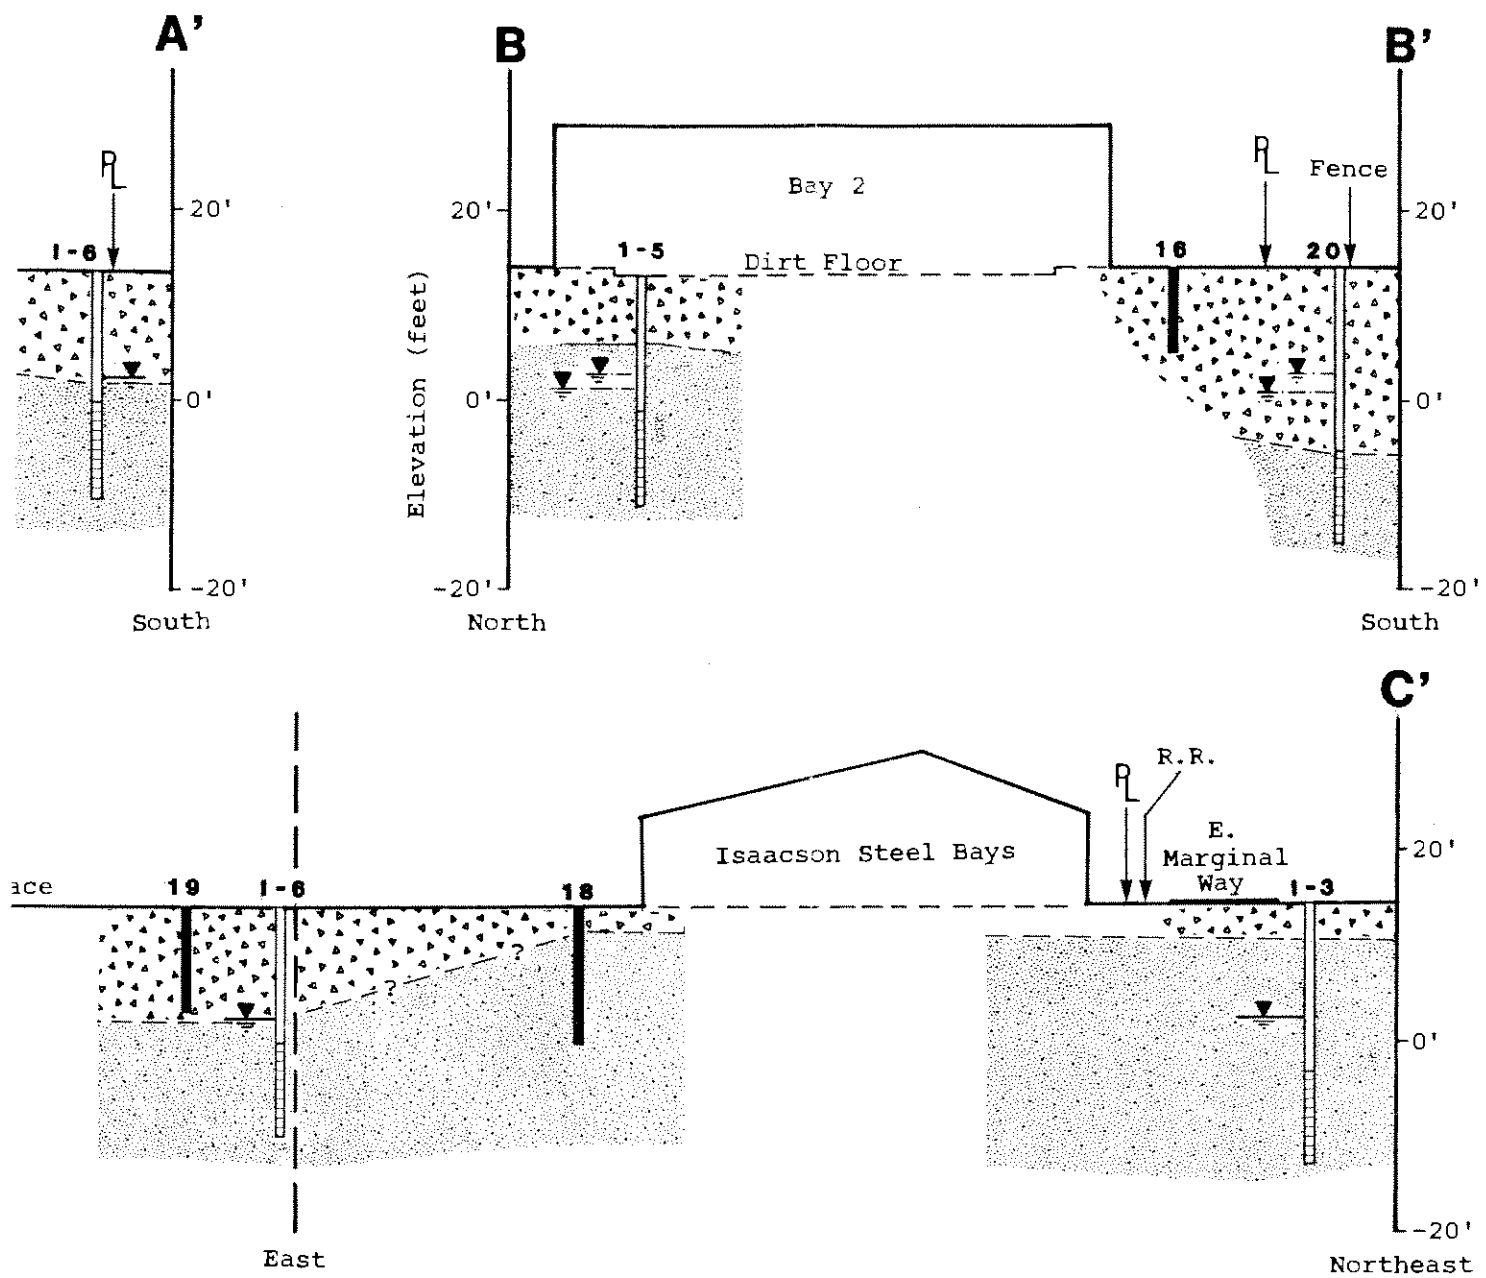
Figure 5

The surface unit of random fill apparently covers the entire Isaacson site, and, where observed, varies in thickness from less than 5 feet to greater than 12 feet. The greatest observed thickness of random fill as shown on Figure 5, sheets 1 and 2, is in the south and western portions of the site where Slip 5 was filled. As shown on Figures 4 and 5, the random fill is generally greater than 10 feet in thickness in the southern and western portions of the site and less than 10 feet in thickness in the northern and eastern portions of the site. The composition of the random fill and underlying soils are described in detail in the appended site boring logs.

As shown on the appended boring logs and Figures 5 and 6, the surface layer of random fill consists primarily of soil, demolition waste, fire bricks, and slag. In all discussion, the random fill is divided into fill soil and slag because these were lab tested separately as shown on Table 1. The firebrick and demolition waste components of the random fill were not specifically lab tested in this study.

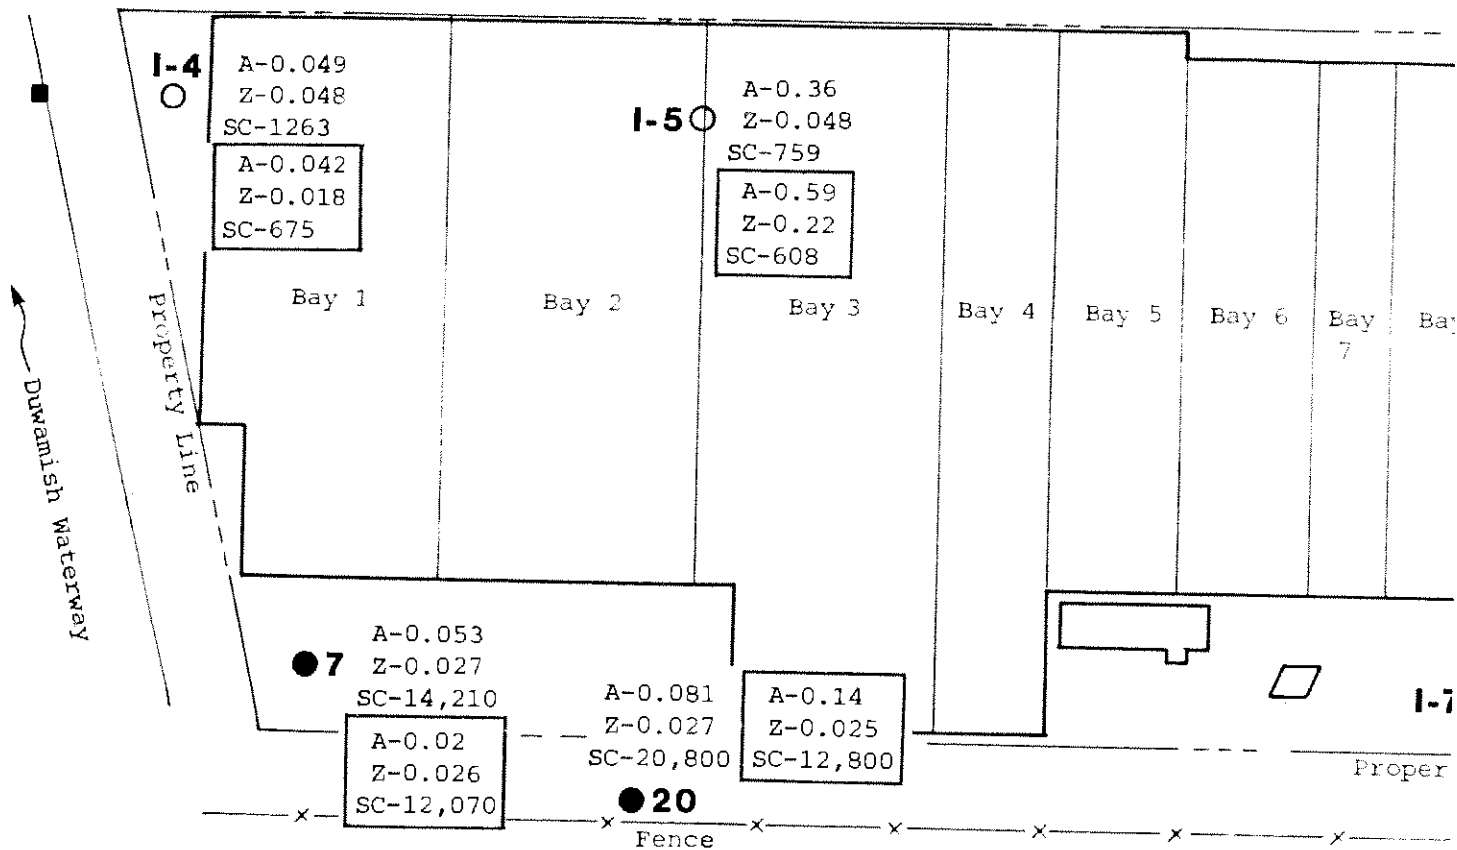
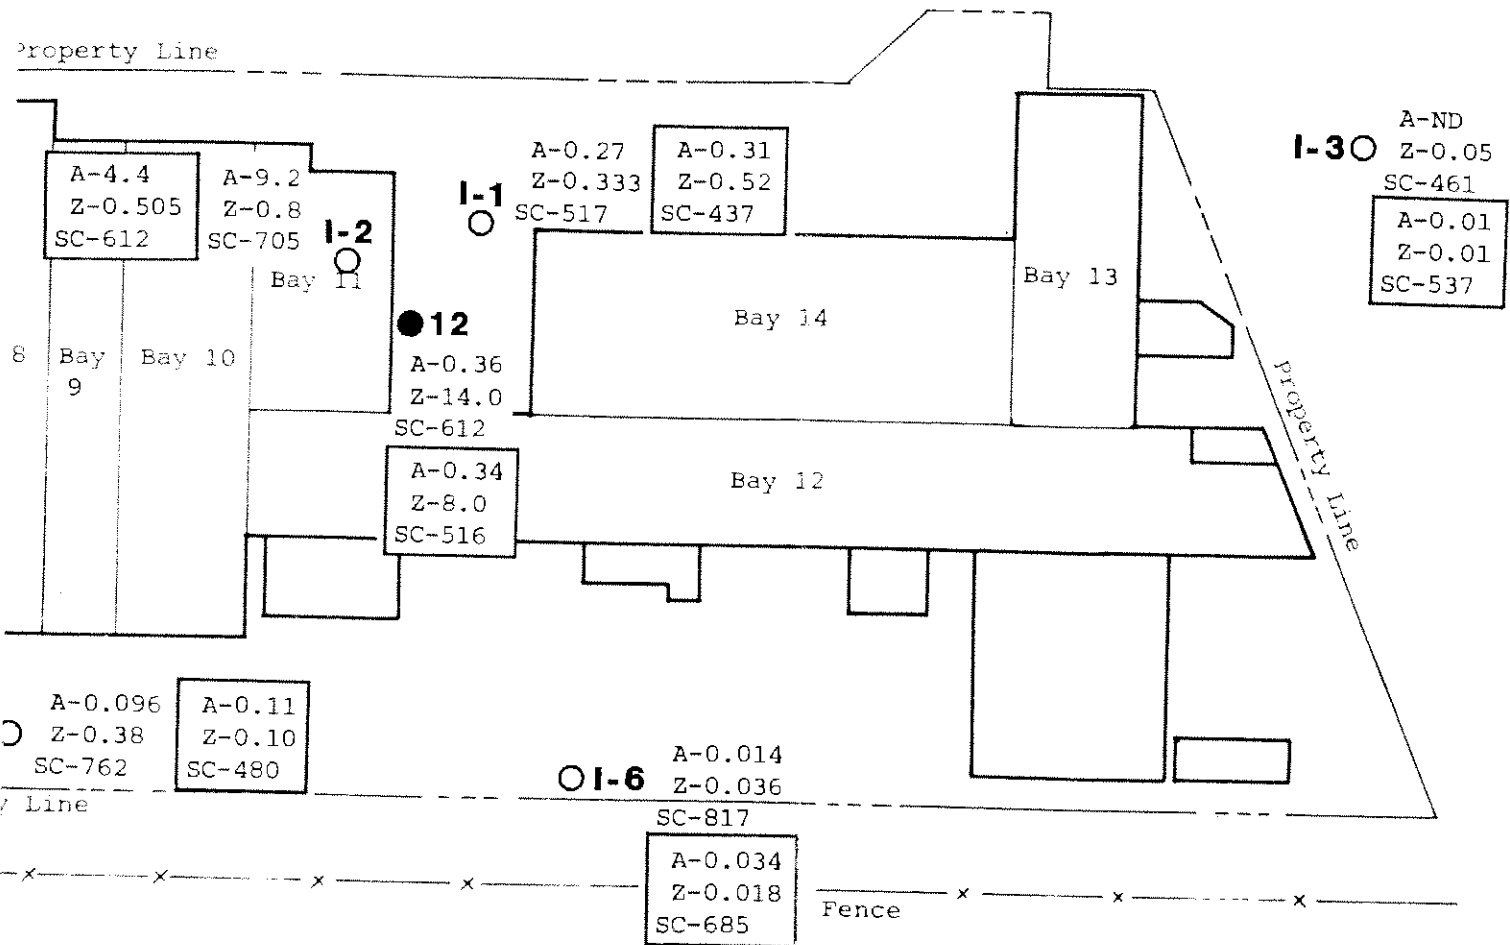
Figure 9

Lab results from the current study show that arsenic concentrations in ground water exceed the EPA Primary Drinking Water Standard maximum contaminant level (MCL) of 0.05 mg/l in all monitoring wells except I-3, I-4, and I-6. Arsenic was detected in all wells except well I-3 on the first sampling run (see Figure 9). The arsenic concentrations ranged from 0.010 to 9.2 mg/l in wells I-3 and I-2, respectively. Excluding wells I-3 and I-2, the average arsenic concentration for the remaining eight wells was 0.17 mg/l. Review of Table 1 shows generally good agreement between laboratories for the split samples.

The arsenic and zinc concentrations measured in ground water during the current study are shown on Figure 9. The highest concentrations are in monitoring wells around the steam clean pit and west of the previous location of the galvanizing plant (now Bay 14). These monitoring wells include I-1, I-2, and I2. Potential sources of ground water contamination are shown on Figure 4, including random fill, steam clean sump, abandoned neutralization basin, and the sludge disposal area at the east end of Slip 5.

The presence of salt water elevated the specific conductivities of ground water at wells 7 and 20 to 14,210 and 20,800 umho/cm, respectively, during the first sampling and to 12,070 and 12,800 umho/cm, respectively, during the second sampling, as measured in the field and shown on Figure 9. The specific conductivities of ground water from the other wells were less than 1,000 umho/cm except well I-4, which was 1263 umho/cm on the first sampling run.
