Data Report

**BUILDING 14-09
THOMPSON-ISAACSON
SITE INVESTIGATION**

Prepared for
The Boeing Company

May 4, 1988

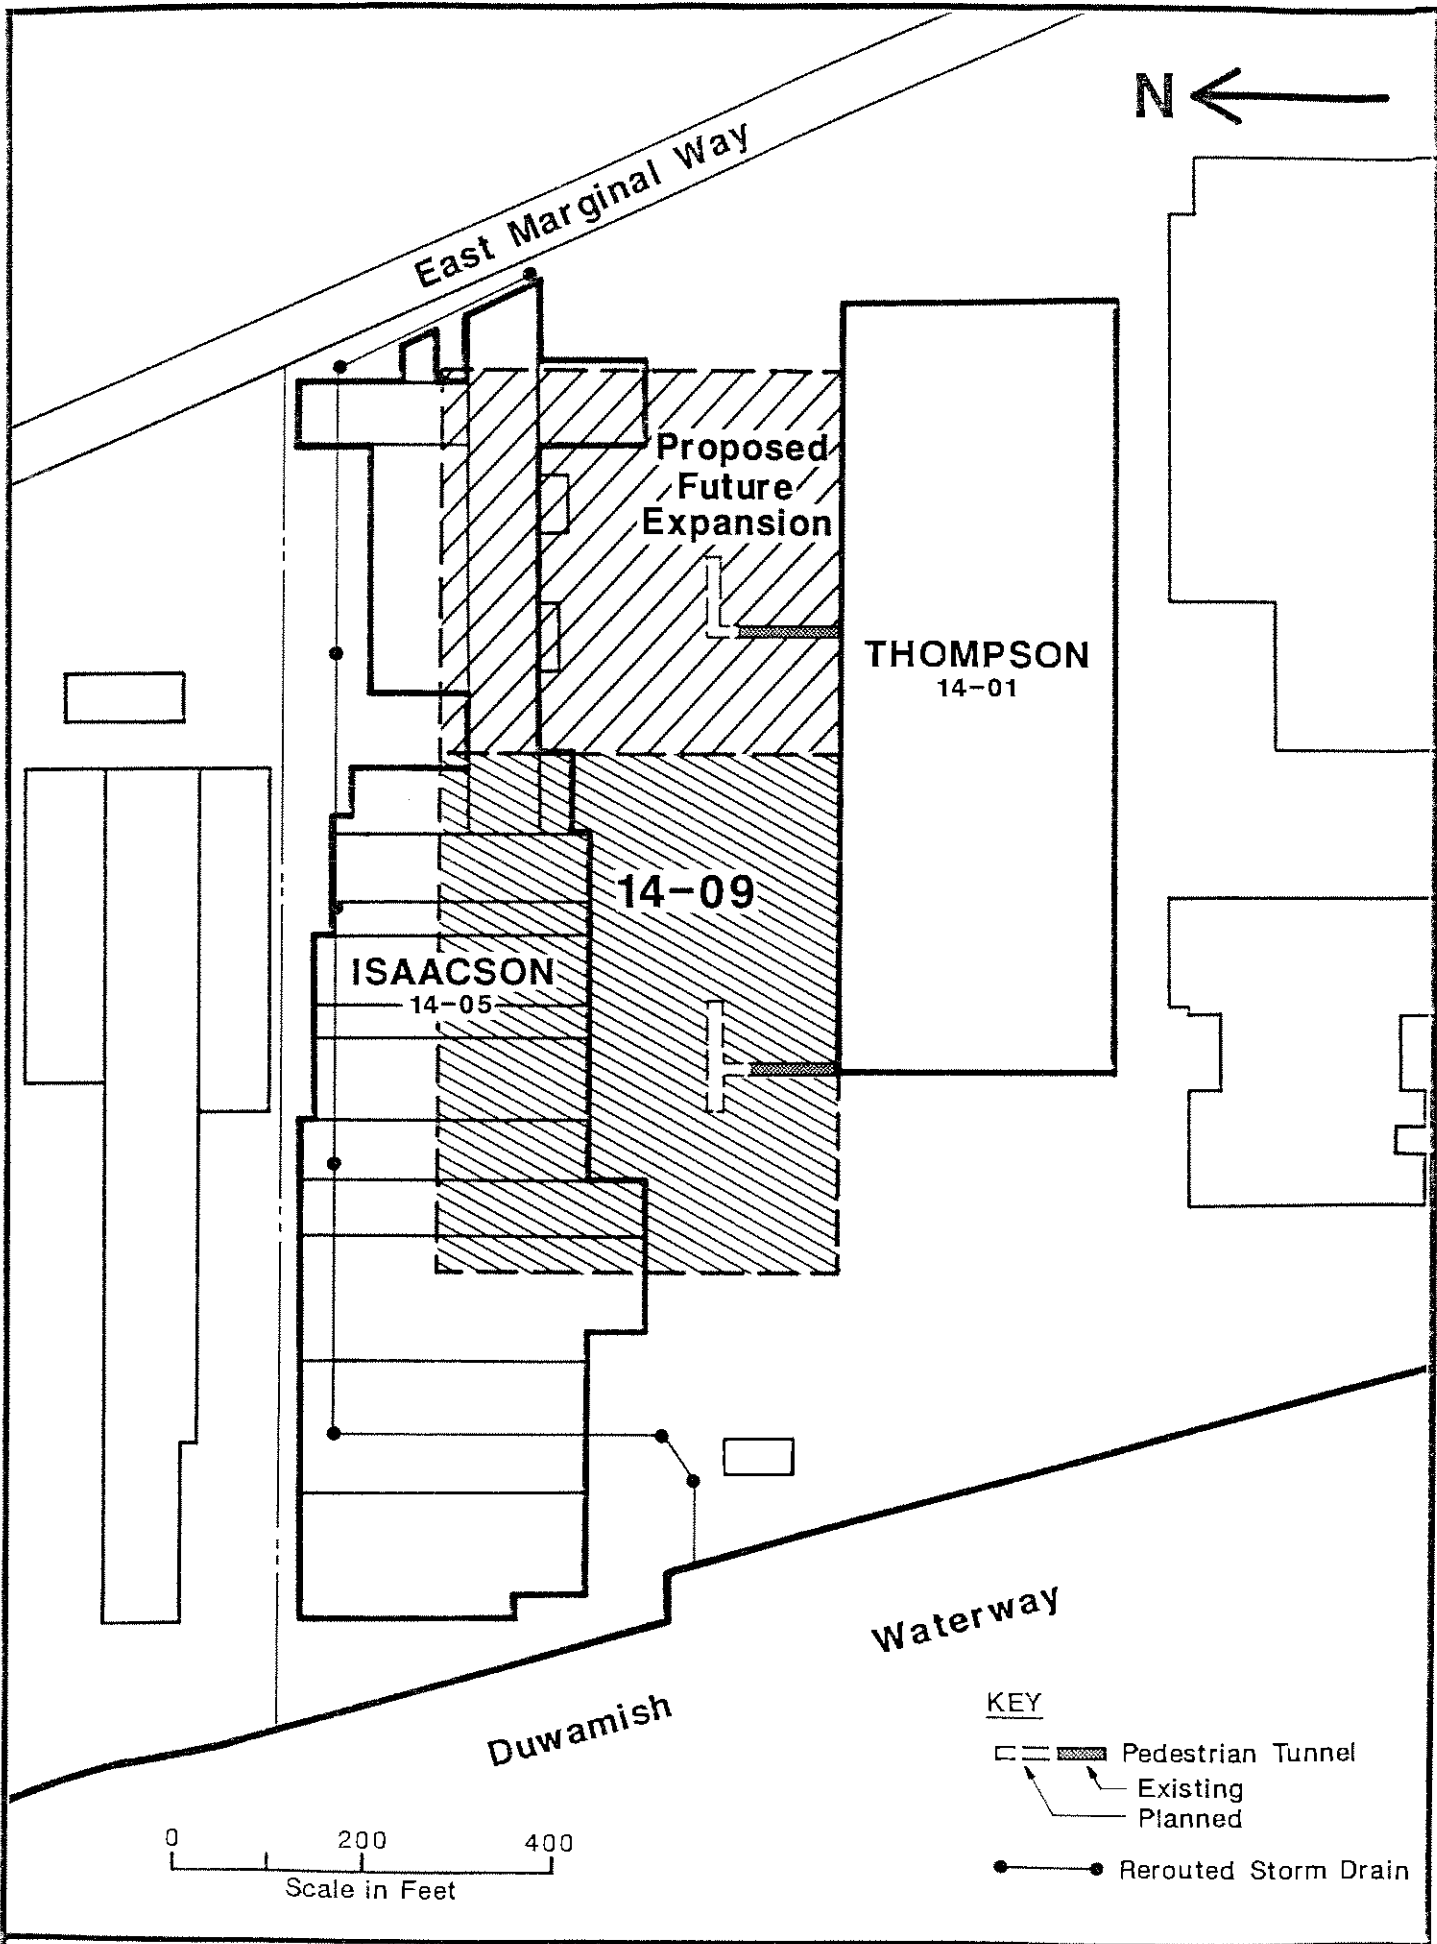
Thompson - Isaacson Site:
Proposed Building 14-09

BASC proposes to construct an industrial structure (designated as Building 14-09) on the Thompson-Isaacson site (Figure 2-3). Building 14-09 will be approximately 420 feet wide by 550 feet long by 60 feet high. The structure will be attached to a portion of the north side of existing Building 14-01, and will be similar in construction. Building 14-09 will be used primarily for manufacturing; however, internal space also will be made available for office and related use.

Existing Building 14-05 will be demolished as part of the project. Pedestrian tunnels also will be constructed and the existing 48-inch storm drain will be rerouted as shown on Figure 2-3.
