**Lower Duwamish Waterway
Early Action Area 4
Final Summary of Existing
Information and Identification of
Data Gaps Report**

**Contract No. C0700036
Work Assignment No. EANE001**

June 2007

**WASHINGTON DEPARTMENT OF ECOLOGY
Toxics Cleanup Program
3190 160th Avenue SE
Bellevue, WA 98008-5452**

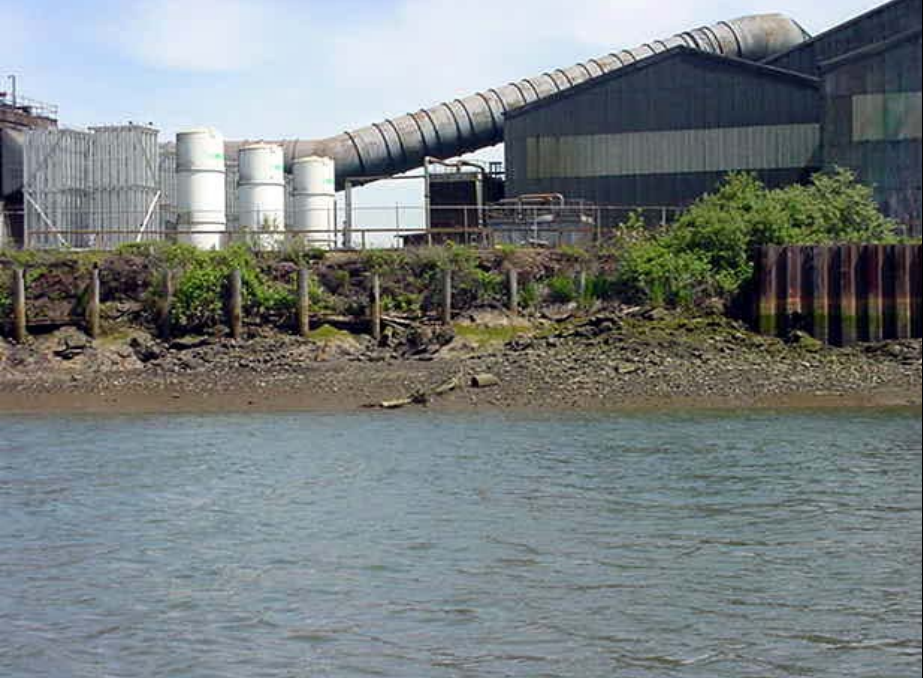
| EAA-4 PHOTOGRAPHIC LOG: 1 | |

| EAA-4 PHOTOGRAPHIC LOG: 1 | |
|--|---|
| Description: View of the Jorgensen Forge from the LDW. | A wide-angle photograph showing the Jorgensen Forge industrial facility. In the foreground, there is a body of water (the Lower Duwamish Waterway). The middle ground features a rocky and vegetated bank. Behind the bank, several large white cylindrical tanks are visible, along with a large, dark industrial building with a prominent, curved, corrugated metal roof structure. The sky is clear and blue. |
