Scoping of Lateral Loading Study Lower Duwamish Waterway, WA

Site Reconnaissance Report

FINAL

June 2009

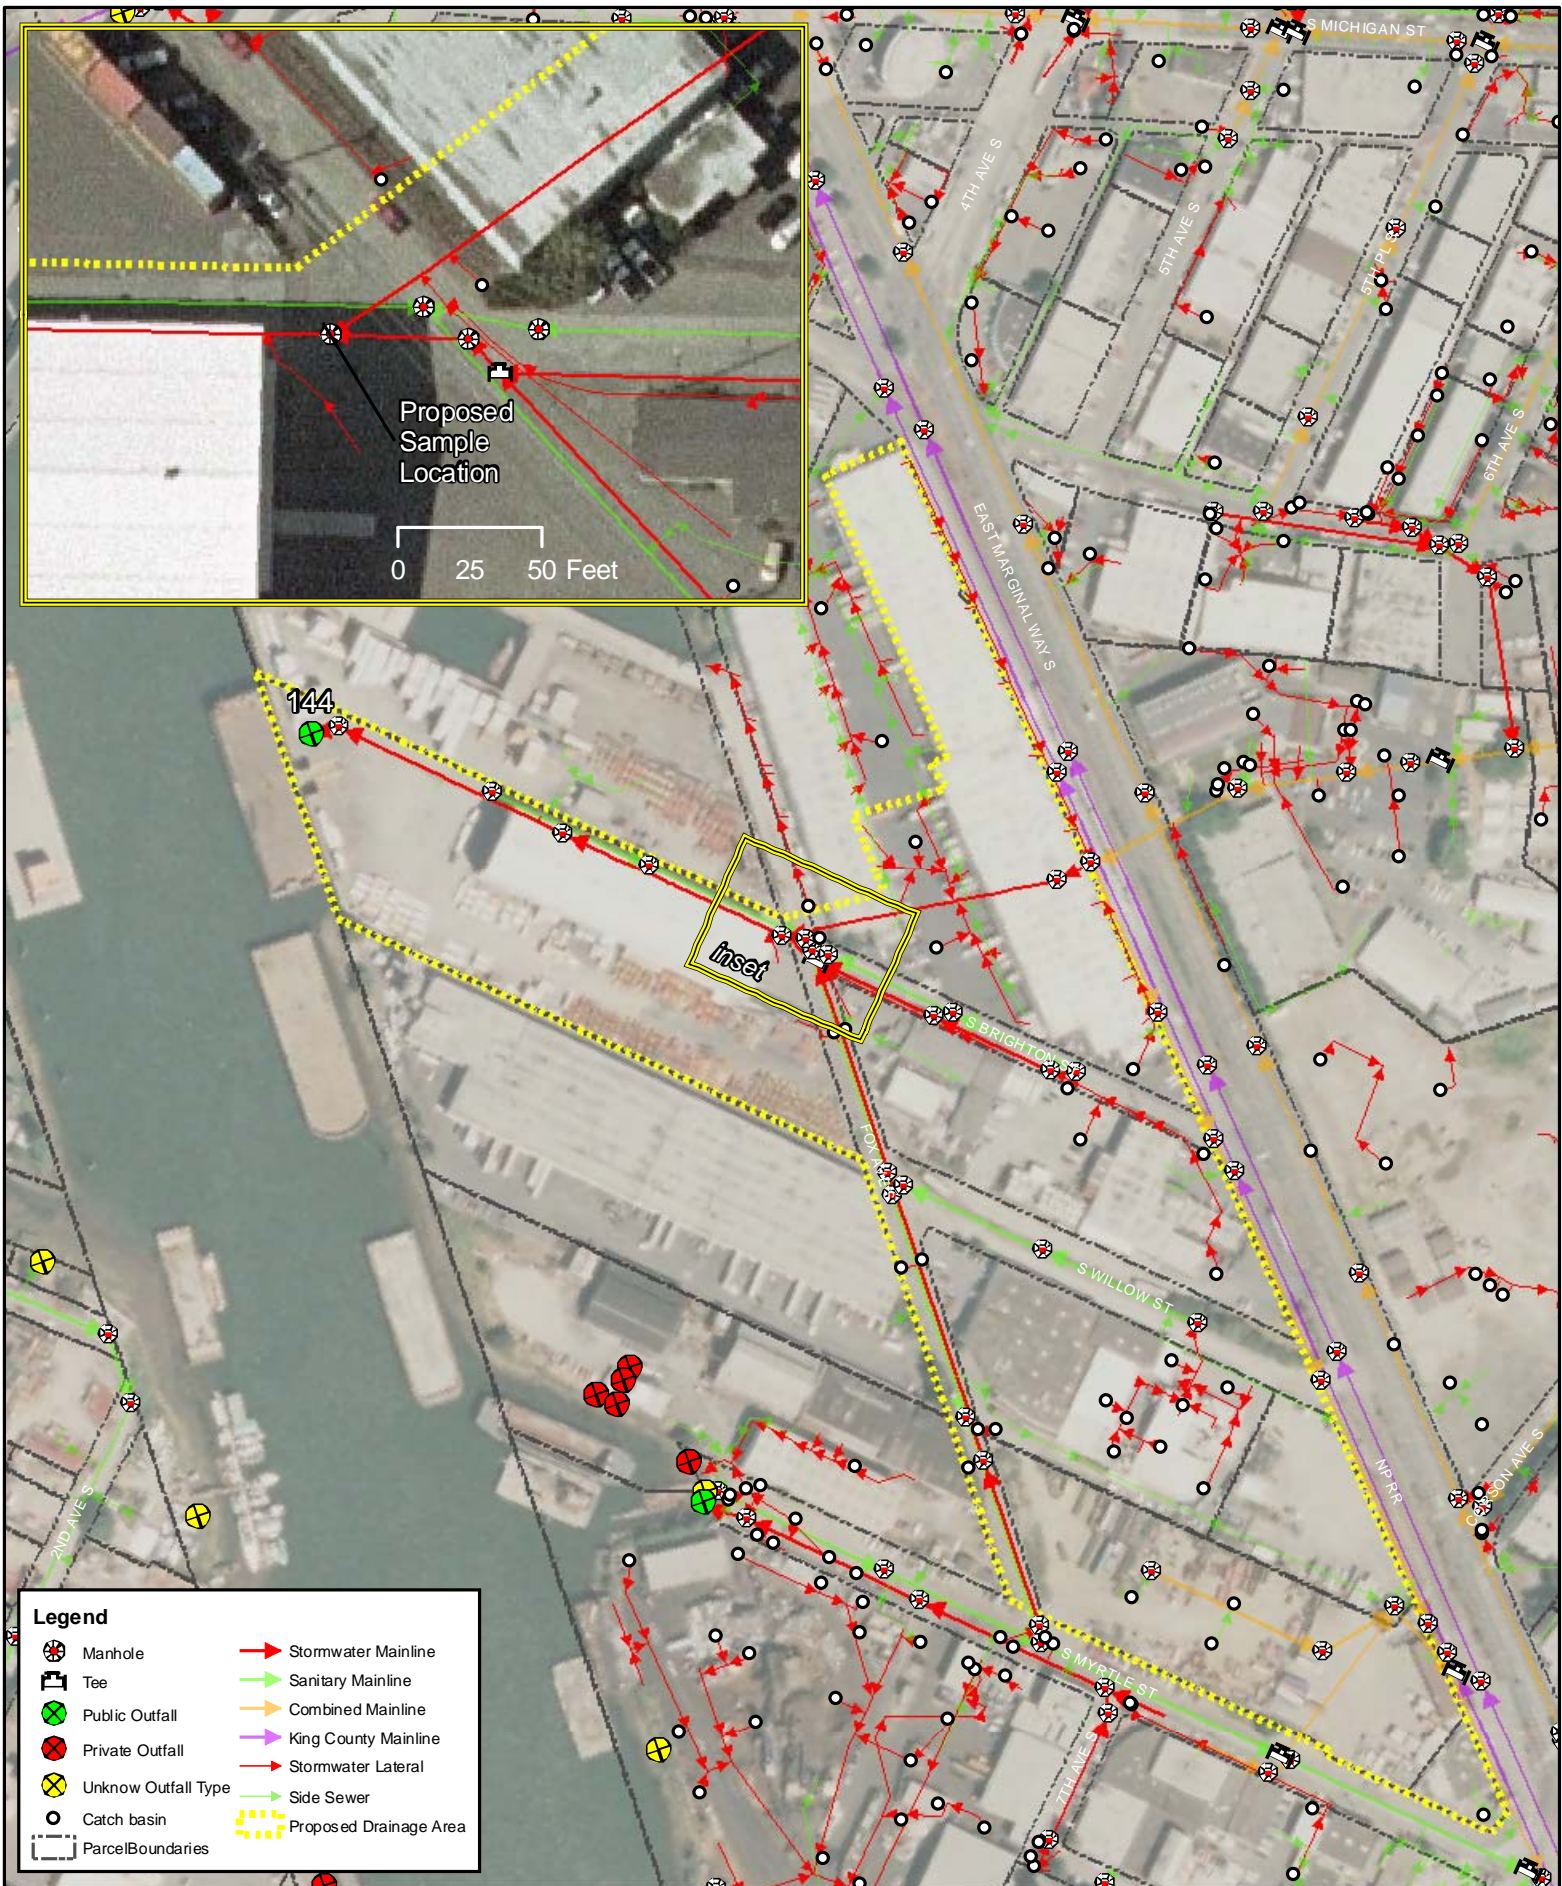
Figure 5. Locations of SPU #144 Outfall and Access

Outfall SPU #144 consists of a 30-inch diameter, open-ended concrete pipe that emerges from a bulkhead underneath a pier (see Figure 5 and Appendix A, p. A-6). Flow through the outfall was approximately 10 gpm at the time of observation. The most appropriate sampling access manhole is located just west of the intersection of S Brighton Street and Fox Avenue S, outside of the Delta Marine North gate.

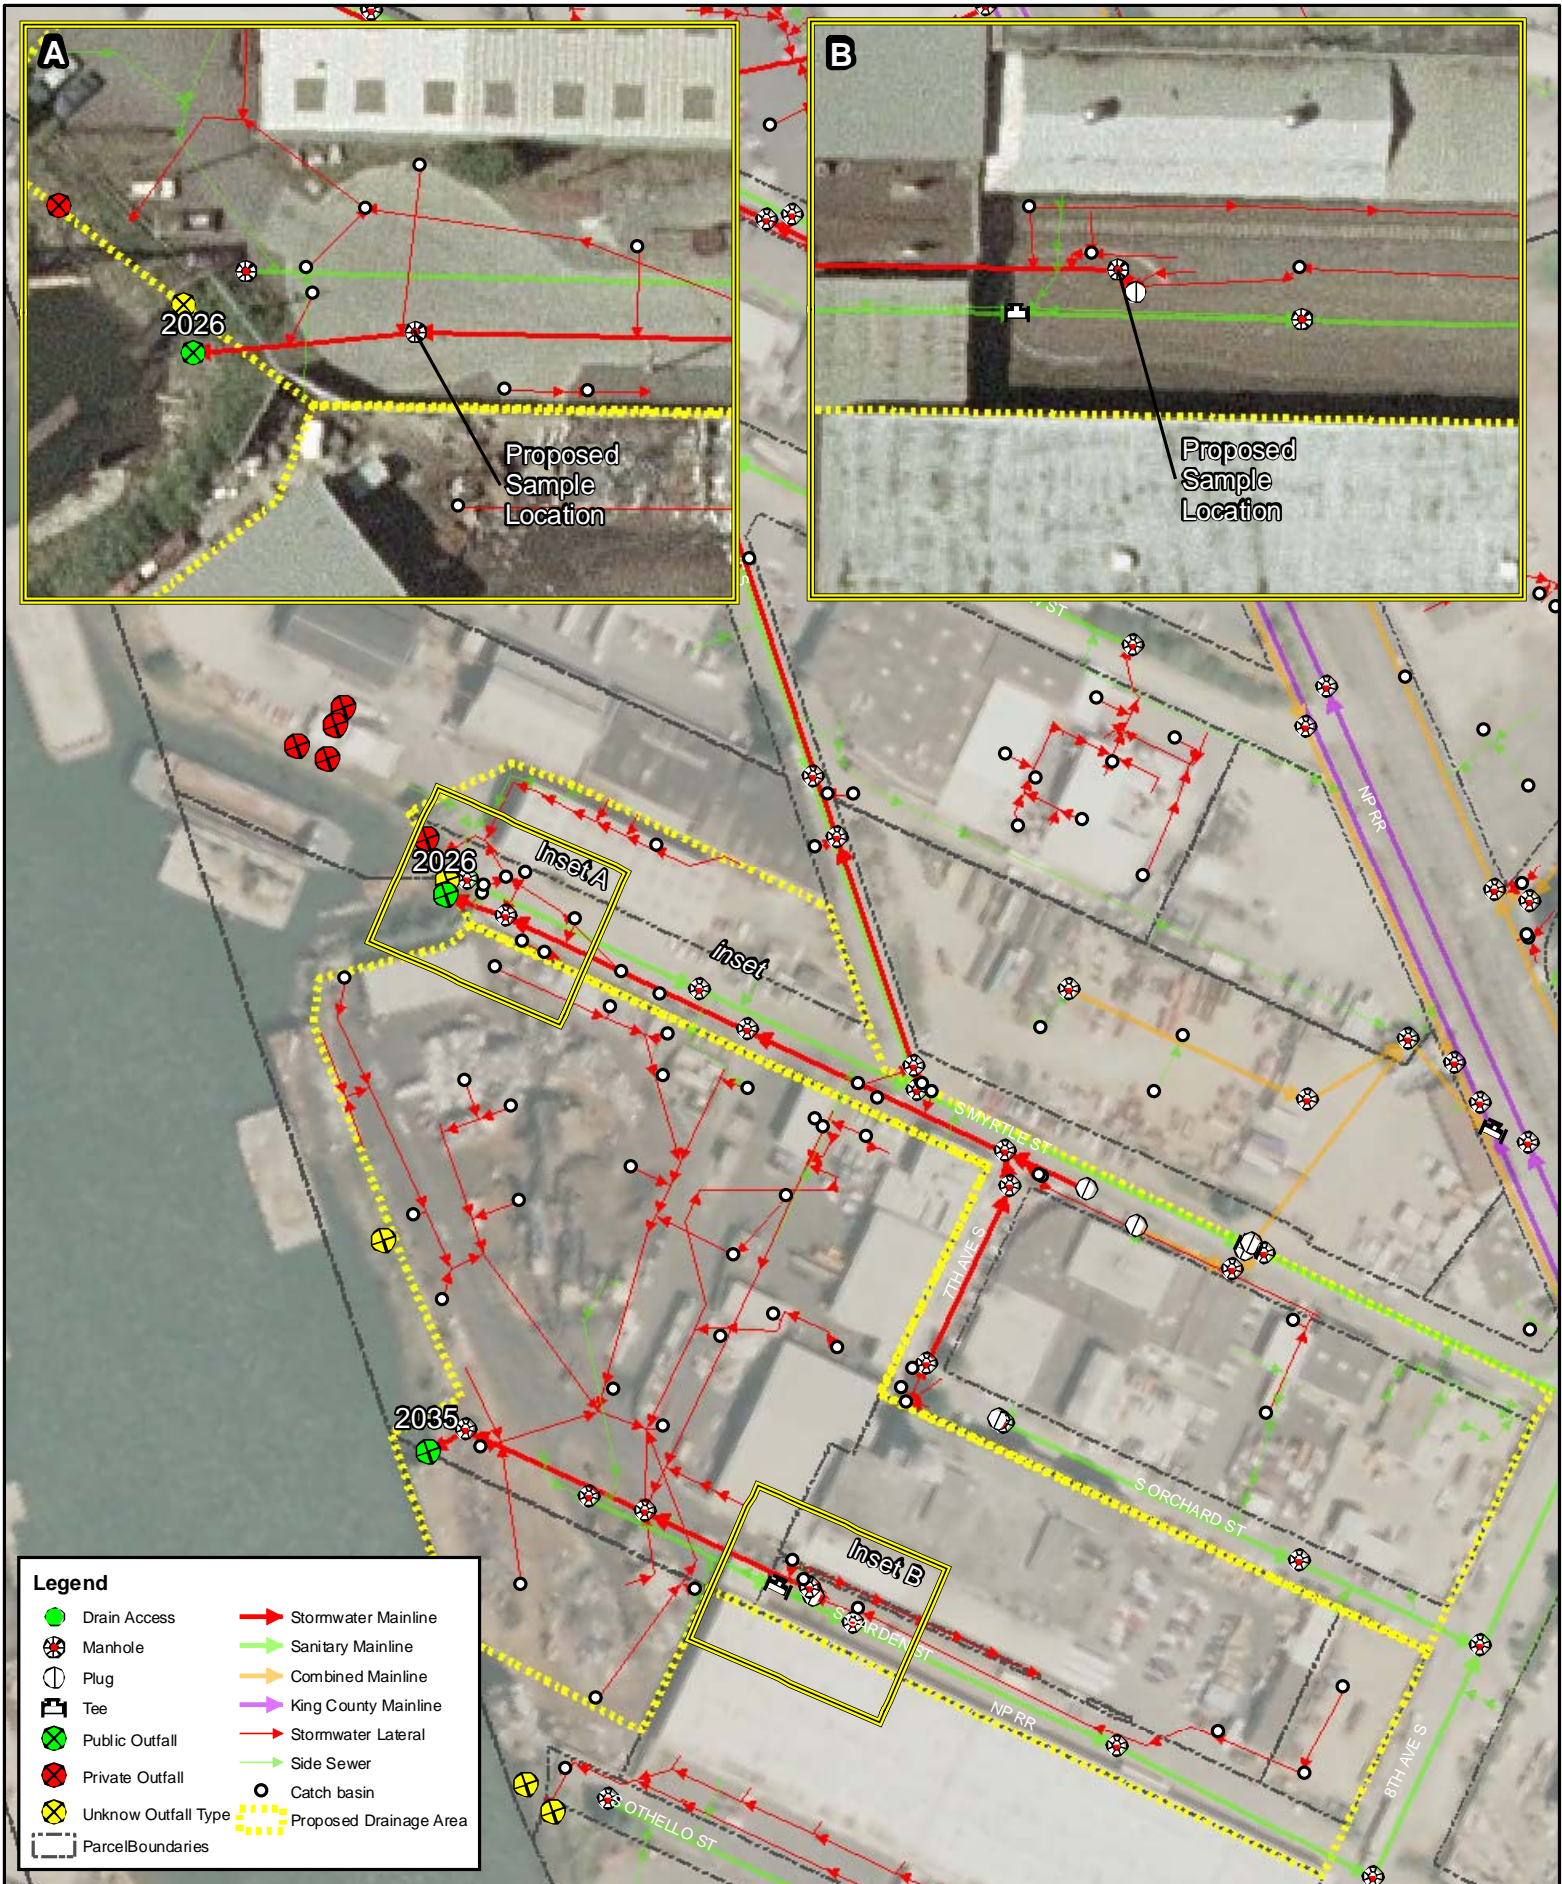
Figure 6. Locations of RI #2026 and RI #2035 Outfalls and Access

Outfall RI #2026 consists of a 30-inch diameter concrete pipe capped with a pinch valve (see Figure 6 and Appendix A, p. A-7). The pipe emerges from riprap in a small cove at the end of S Myrtle Street. Suitable access to the drain line is found at a manhole located in the turnaround at the west end of S Myrtle Street.

Similar to Outfall RI#2026, Outfall RI #2035 consists of a 30-inch diameter concrete pipe capped with a pinch valve (see Figure 6 and Appendix A, p. A-8). The pipe emerges from riprap adjacent to a pier. Access to this drain line is available at a manhole found in the turnaround at the west end of S Garden Street.

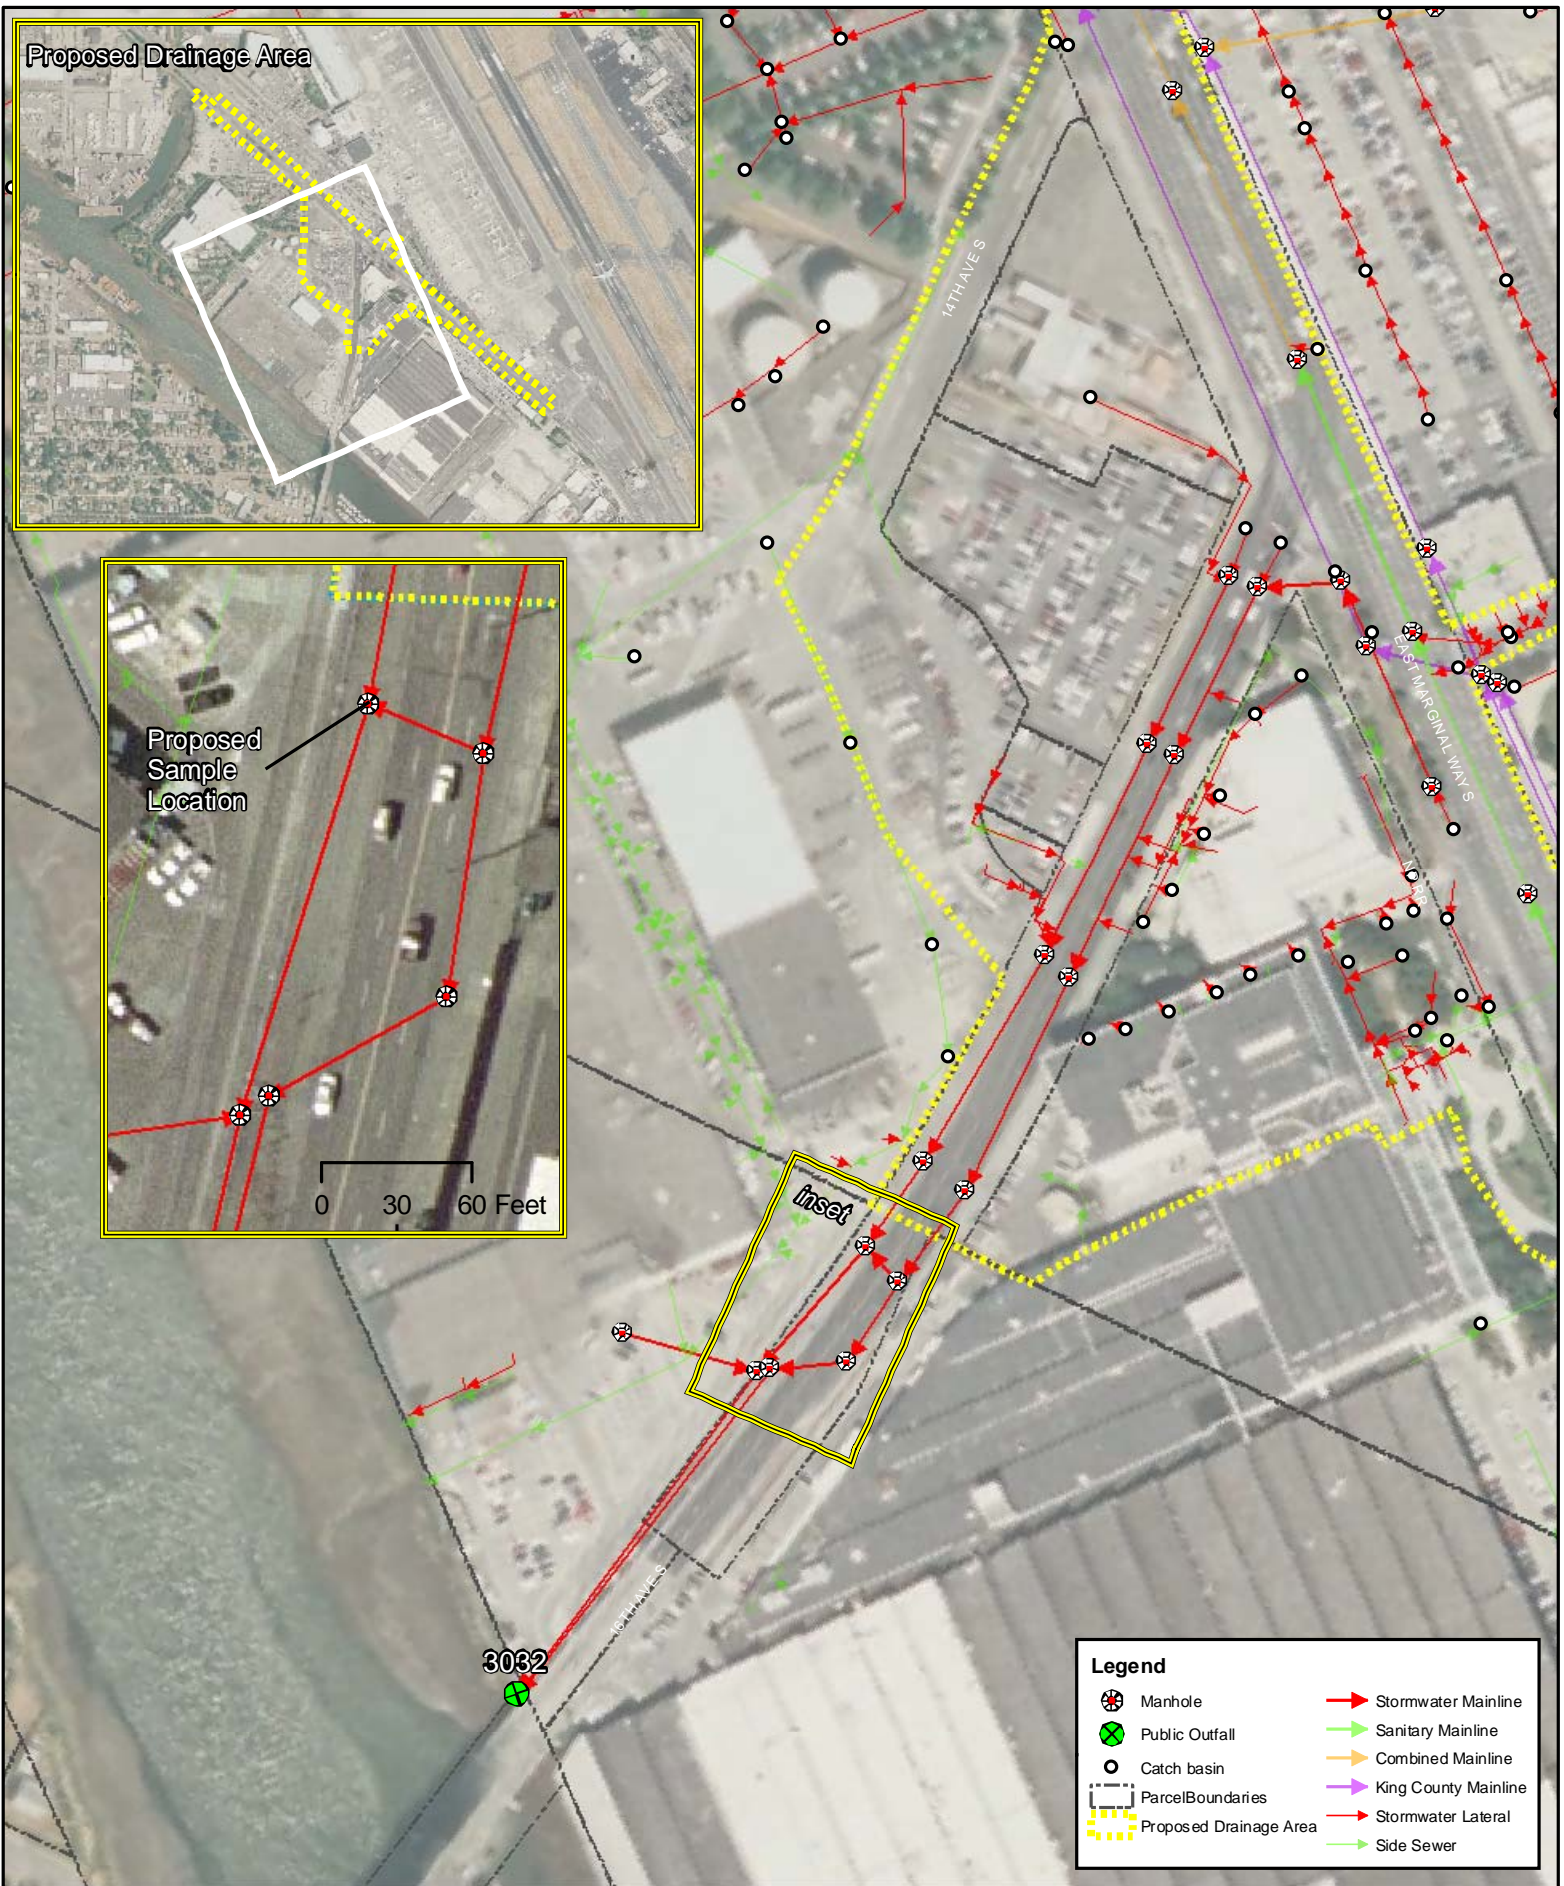
Figure 7. Locations of RI #3032 Outfall and Access

Outfall RI #3032 was not identified in the field but is believed to empty into the LDW under the 16th Avenue S Bridge (see Figure 7 and Appendix A, p. A-13). The most appropriate manhole access to this outfall's drain line is found on the sidewalk along southbound 16th Avenue S. Although the outfall was not identified, water flowing southward in the drain line suggests that the outfall is actively emptying into the LDW.

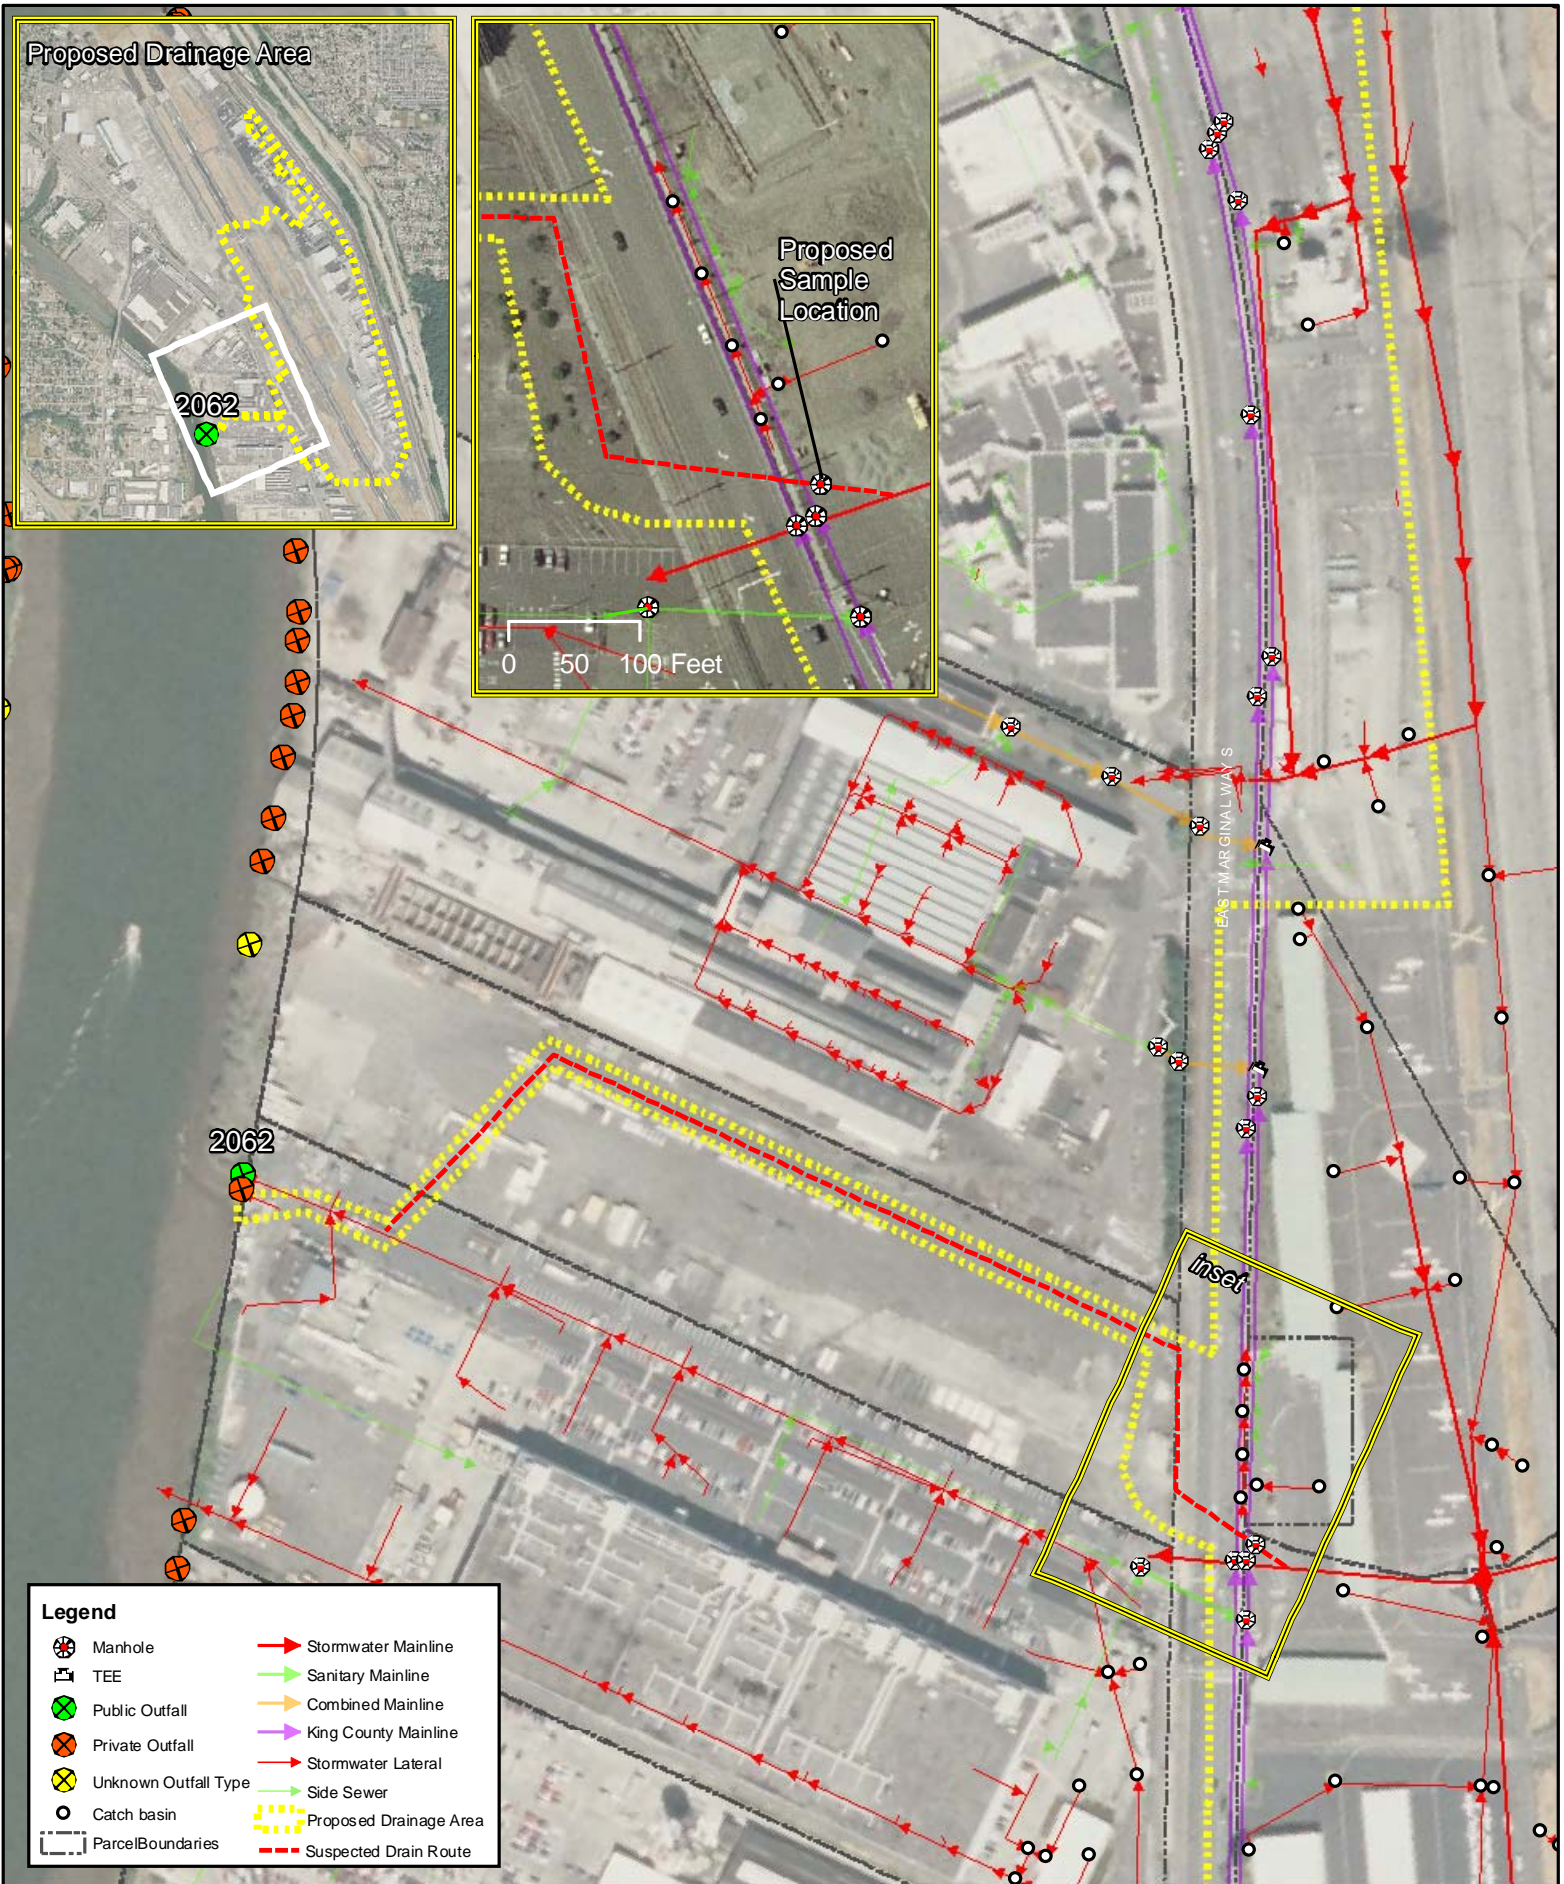
Figure 8. Locations of RI #2062 Outfall and Access

Outfall RI #2062 consists of a 48-inch diameter, open-ended steel pipe that protrudes from a bulkhead (see Figure 8 and Appendix A, p. A-14). Water flow was approximately 20 gpm at the time of observation. This outfall drains the northern portion of the King County Airport. The most suitable manhole access to this outfall's drain line is located in the roadway of S 87th Place, a King County Airport access road parallel to East Marginal Way S.

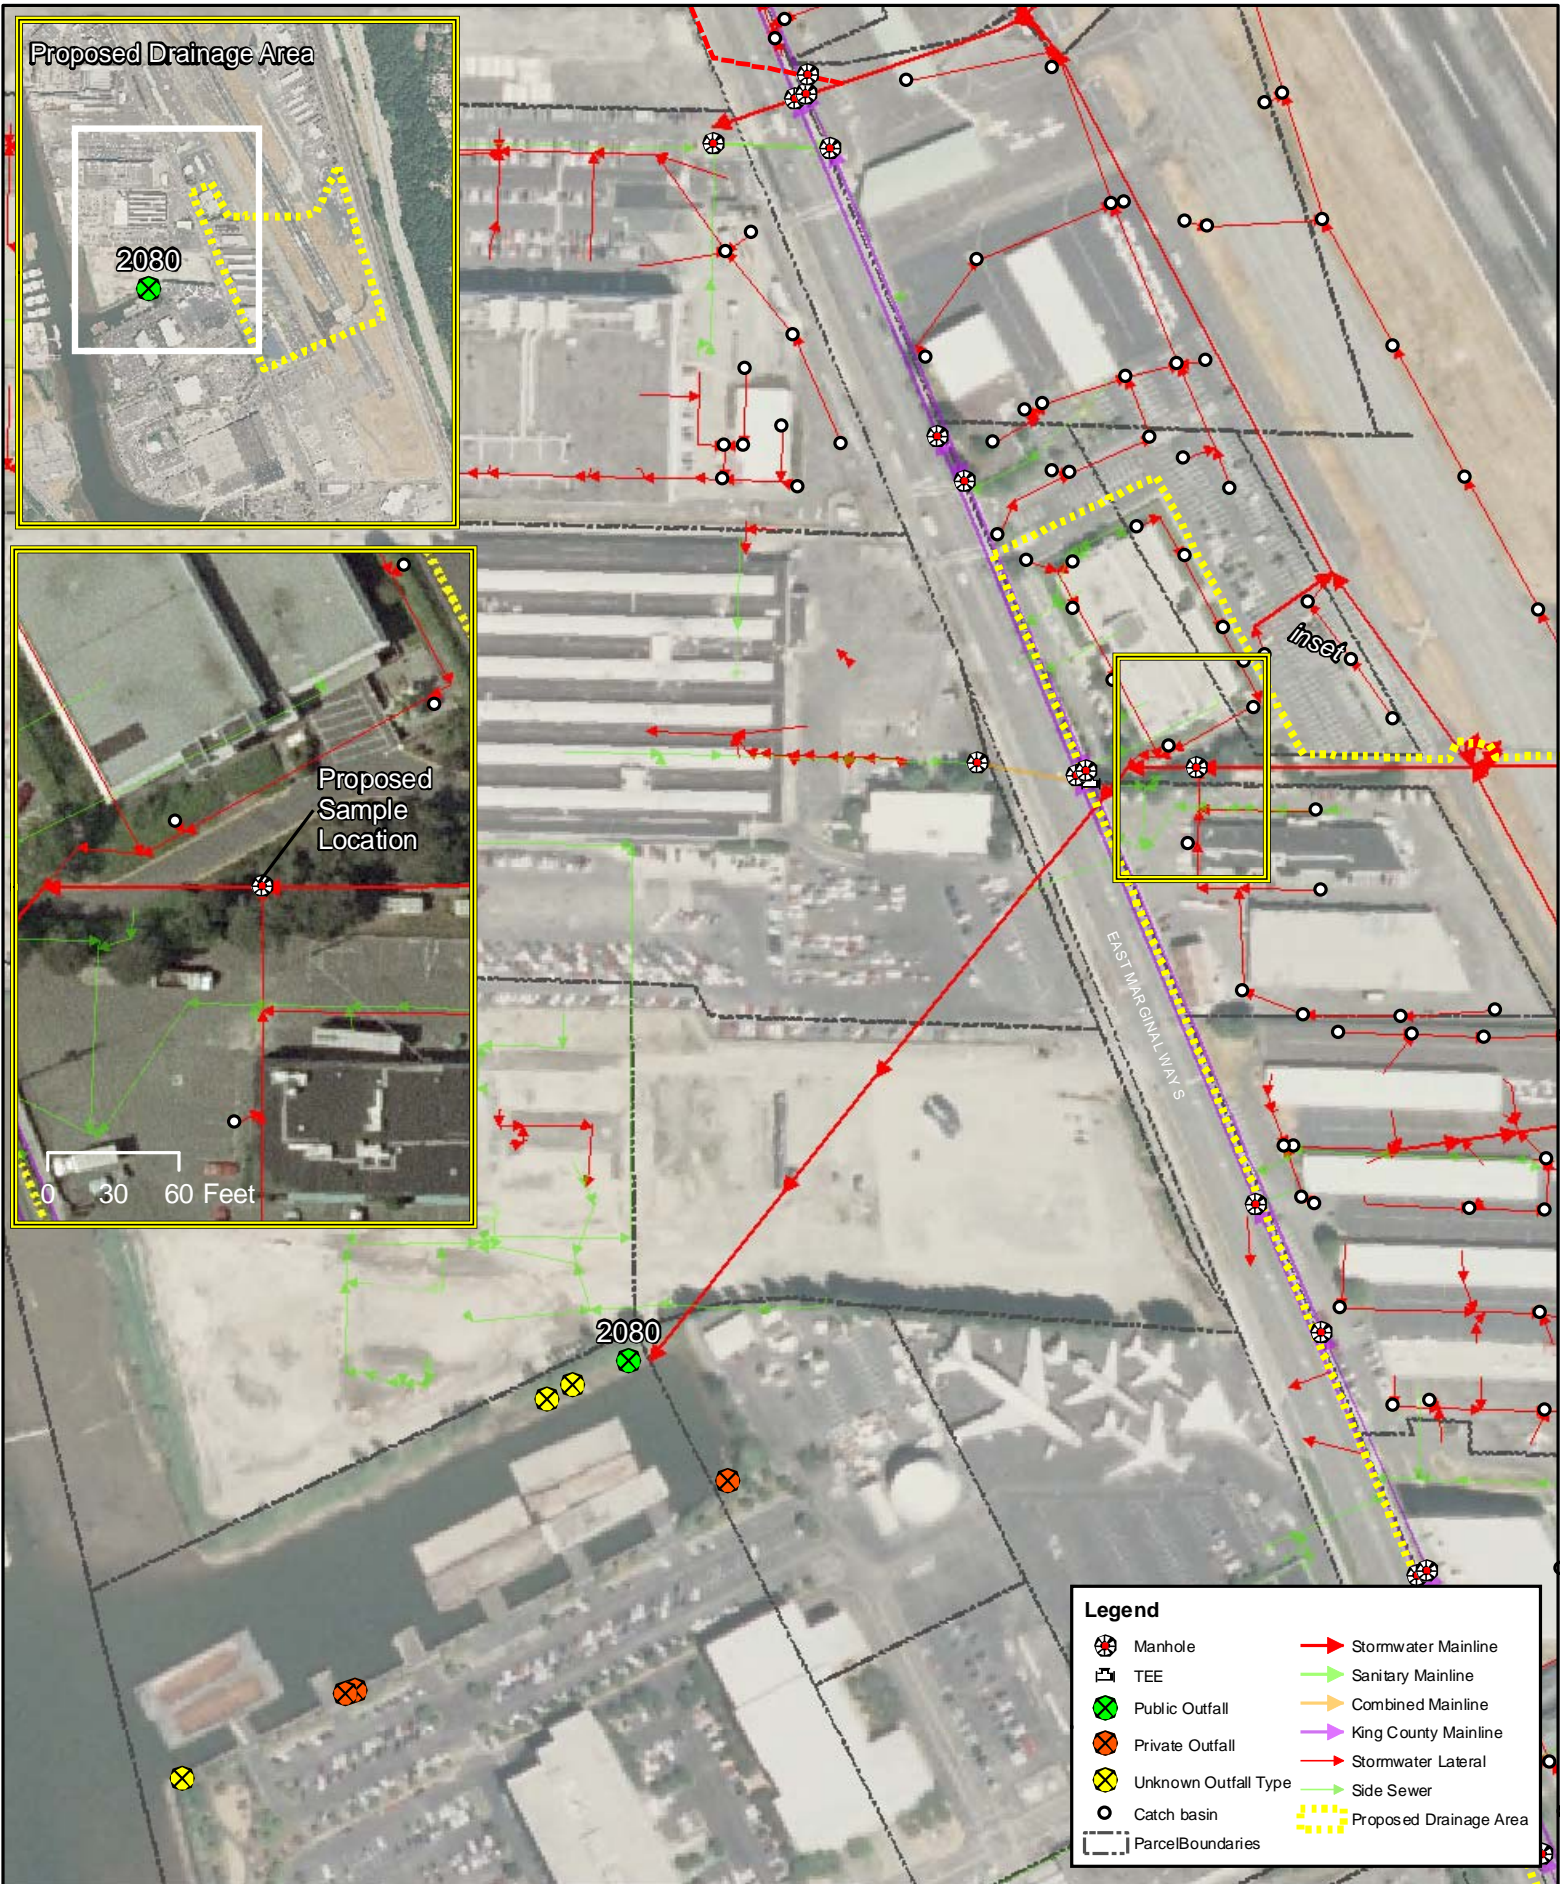
Figure 9. Locations of RI #2080 Outfall and Access

Outfall RI #2080 is a 24-inch diameter, riveted, steel pipe with a pinch valve closure at its end (see Figure 9 and Appendix A, p. A-15). The pipe extends out from bank riprap near the high water mark. Water flow was approximately 30 gpm at the time of observation. The most appropriate manhole access to the drain line is found in a grassy median east of East Marginal Way S.

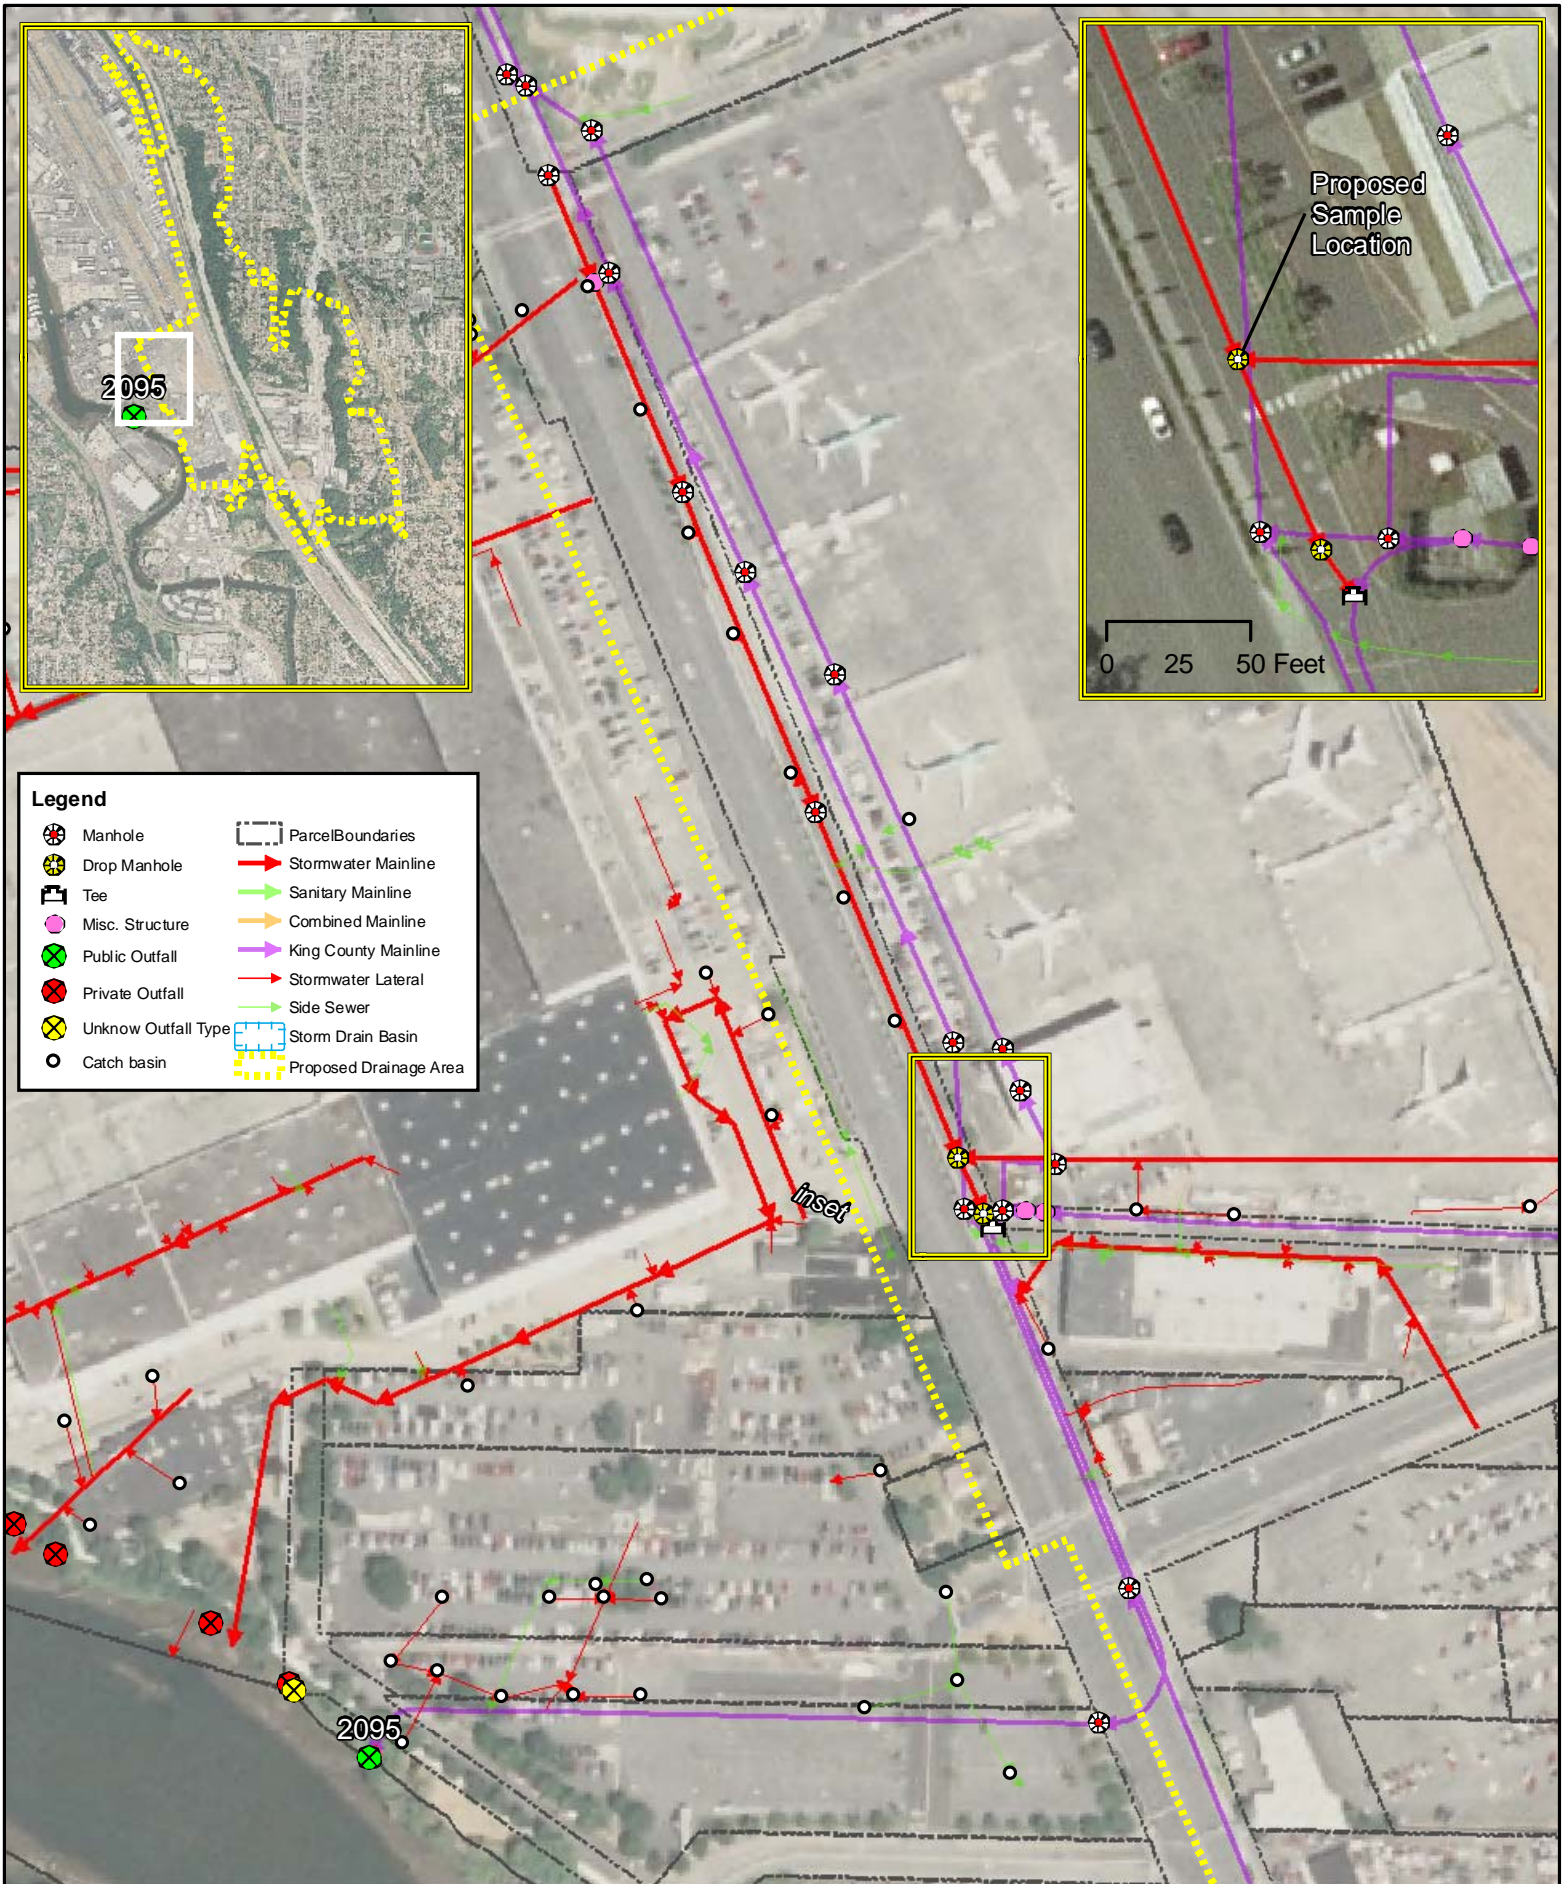
Figure 10. Locations of RI #2095 Outfall and Access

Outfall RI #2095 consists of an 84-inch diameter pipe that empties into the LDW at a concrete wall with wing walls (see Figure 10 and Appendix A, p. A-16). The opening is covered by a tide gate that hangs from the concrete wall. Drain water pours over a concrete platform before reaching the LDW. The most suitable manhole access to the drain line upstream of the CSO is found along a Boeing access road parallel to E Marginal Way. A bottle-type sediment trap was observed within the drain line attached to the wall of the pipe.

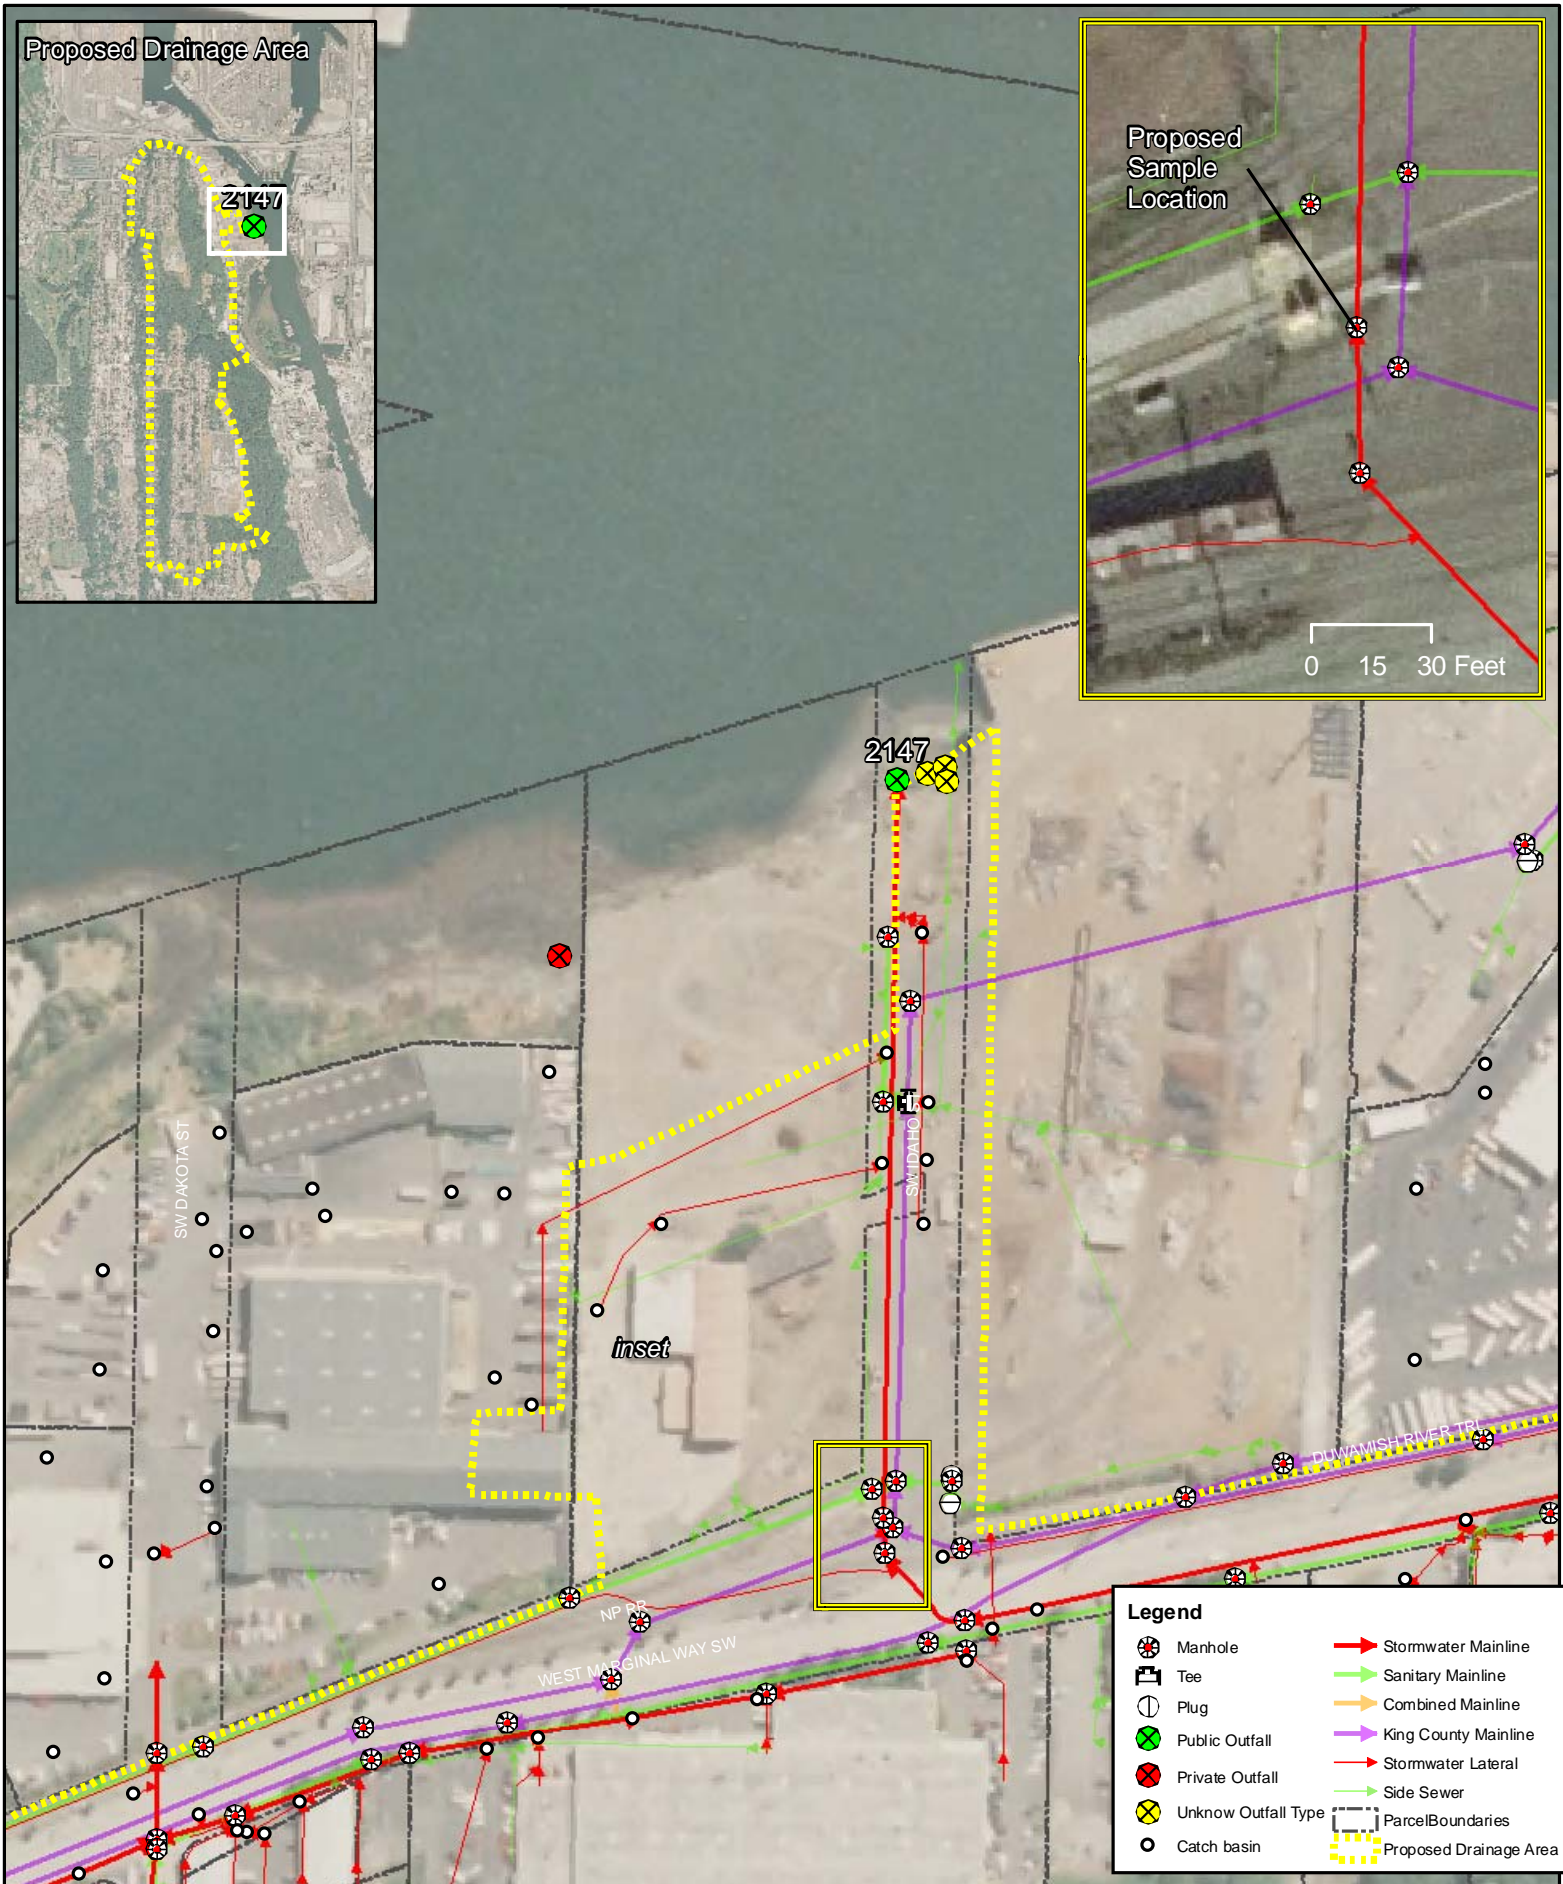
Figure 11. Locations of RI #2147 Outfall and Access

Outfall RI #2147 consists of a 72-inch diameter pipe that empties into the LDW at a concrete wall (with wing walls) surrounded by bank riprap (see Figure 11 and Appendix A, p. A-18). The opening of the pipe is partially blocked by the remnants of a metal gate. The most appropriate access to the drain line is found at a manhole located outside the T-105 gate along SW Idaho
