Scoping of Lateral Loading Study Lower Duwamish Waterway, WA

Site Reconnaissance Report

FINAL

June 2009

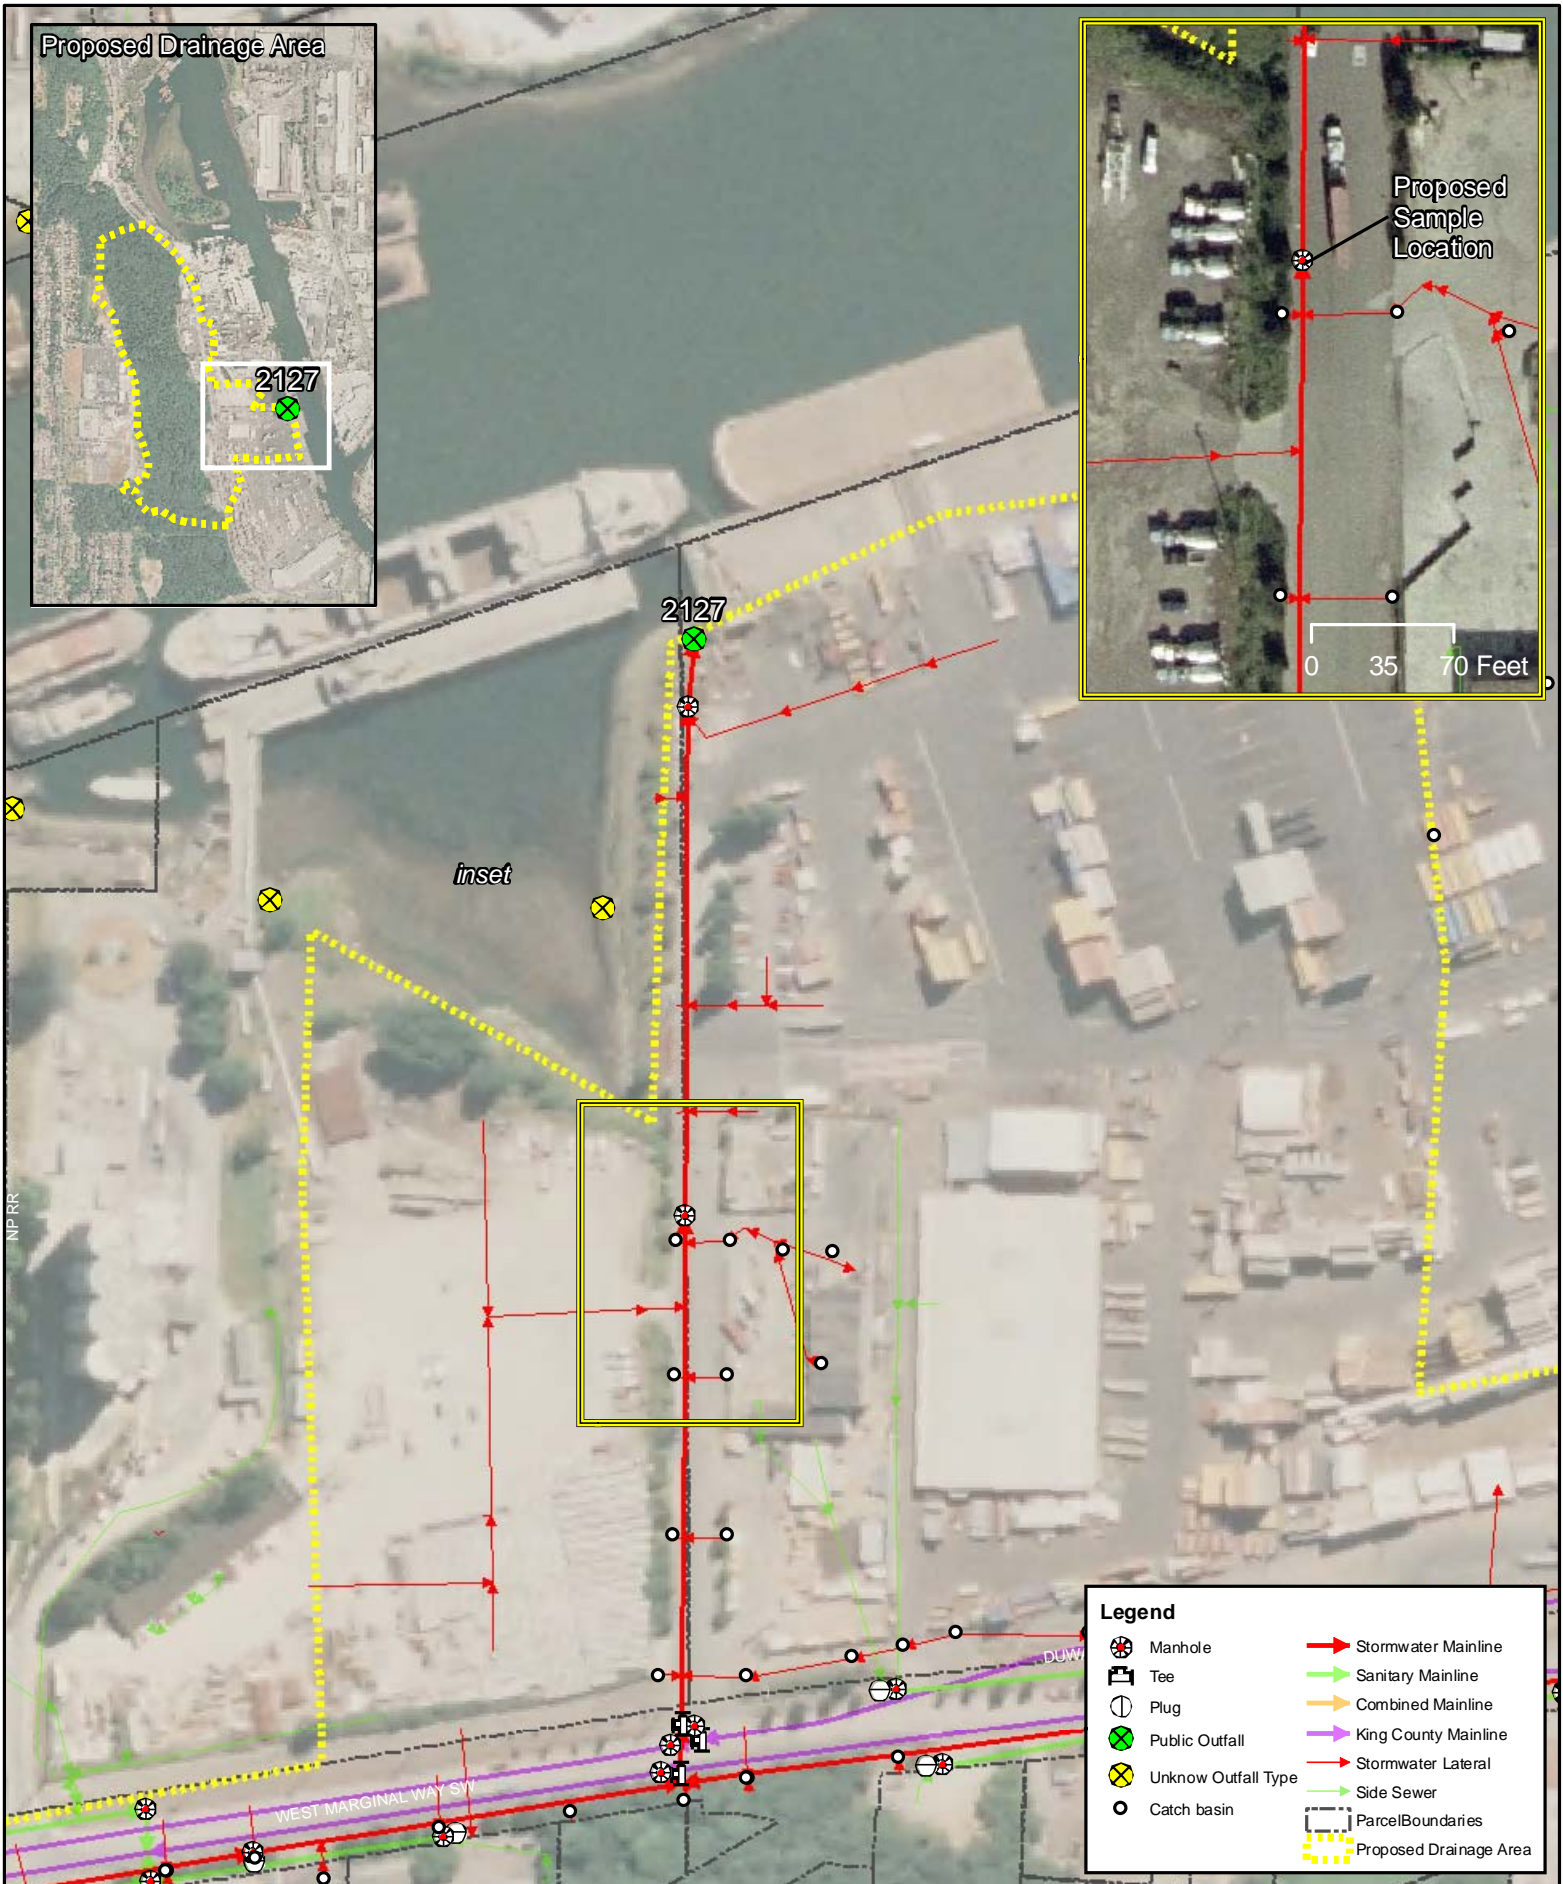
Figure 12. Locations of RI #2127 Outfall and Access

Outfall RI #2127 consists of a 48-inch diameter pipe that empties into the LDW at a concrete wall (with wing walls) surrounded by bank riprap (see Figure 12 and Appendix A, p. A-19). The opening of the pipe is covered with a tide gate attached to the wall. At the time of observation, flow out of the pipe was approximately 50 gpm. The most appropriate manhole access to the drain line is located outside the exit gate of the Port of Seattle. This manhole is located in a roadway used by truck traffic exiting the Port.

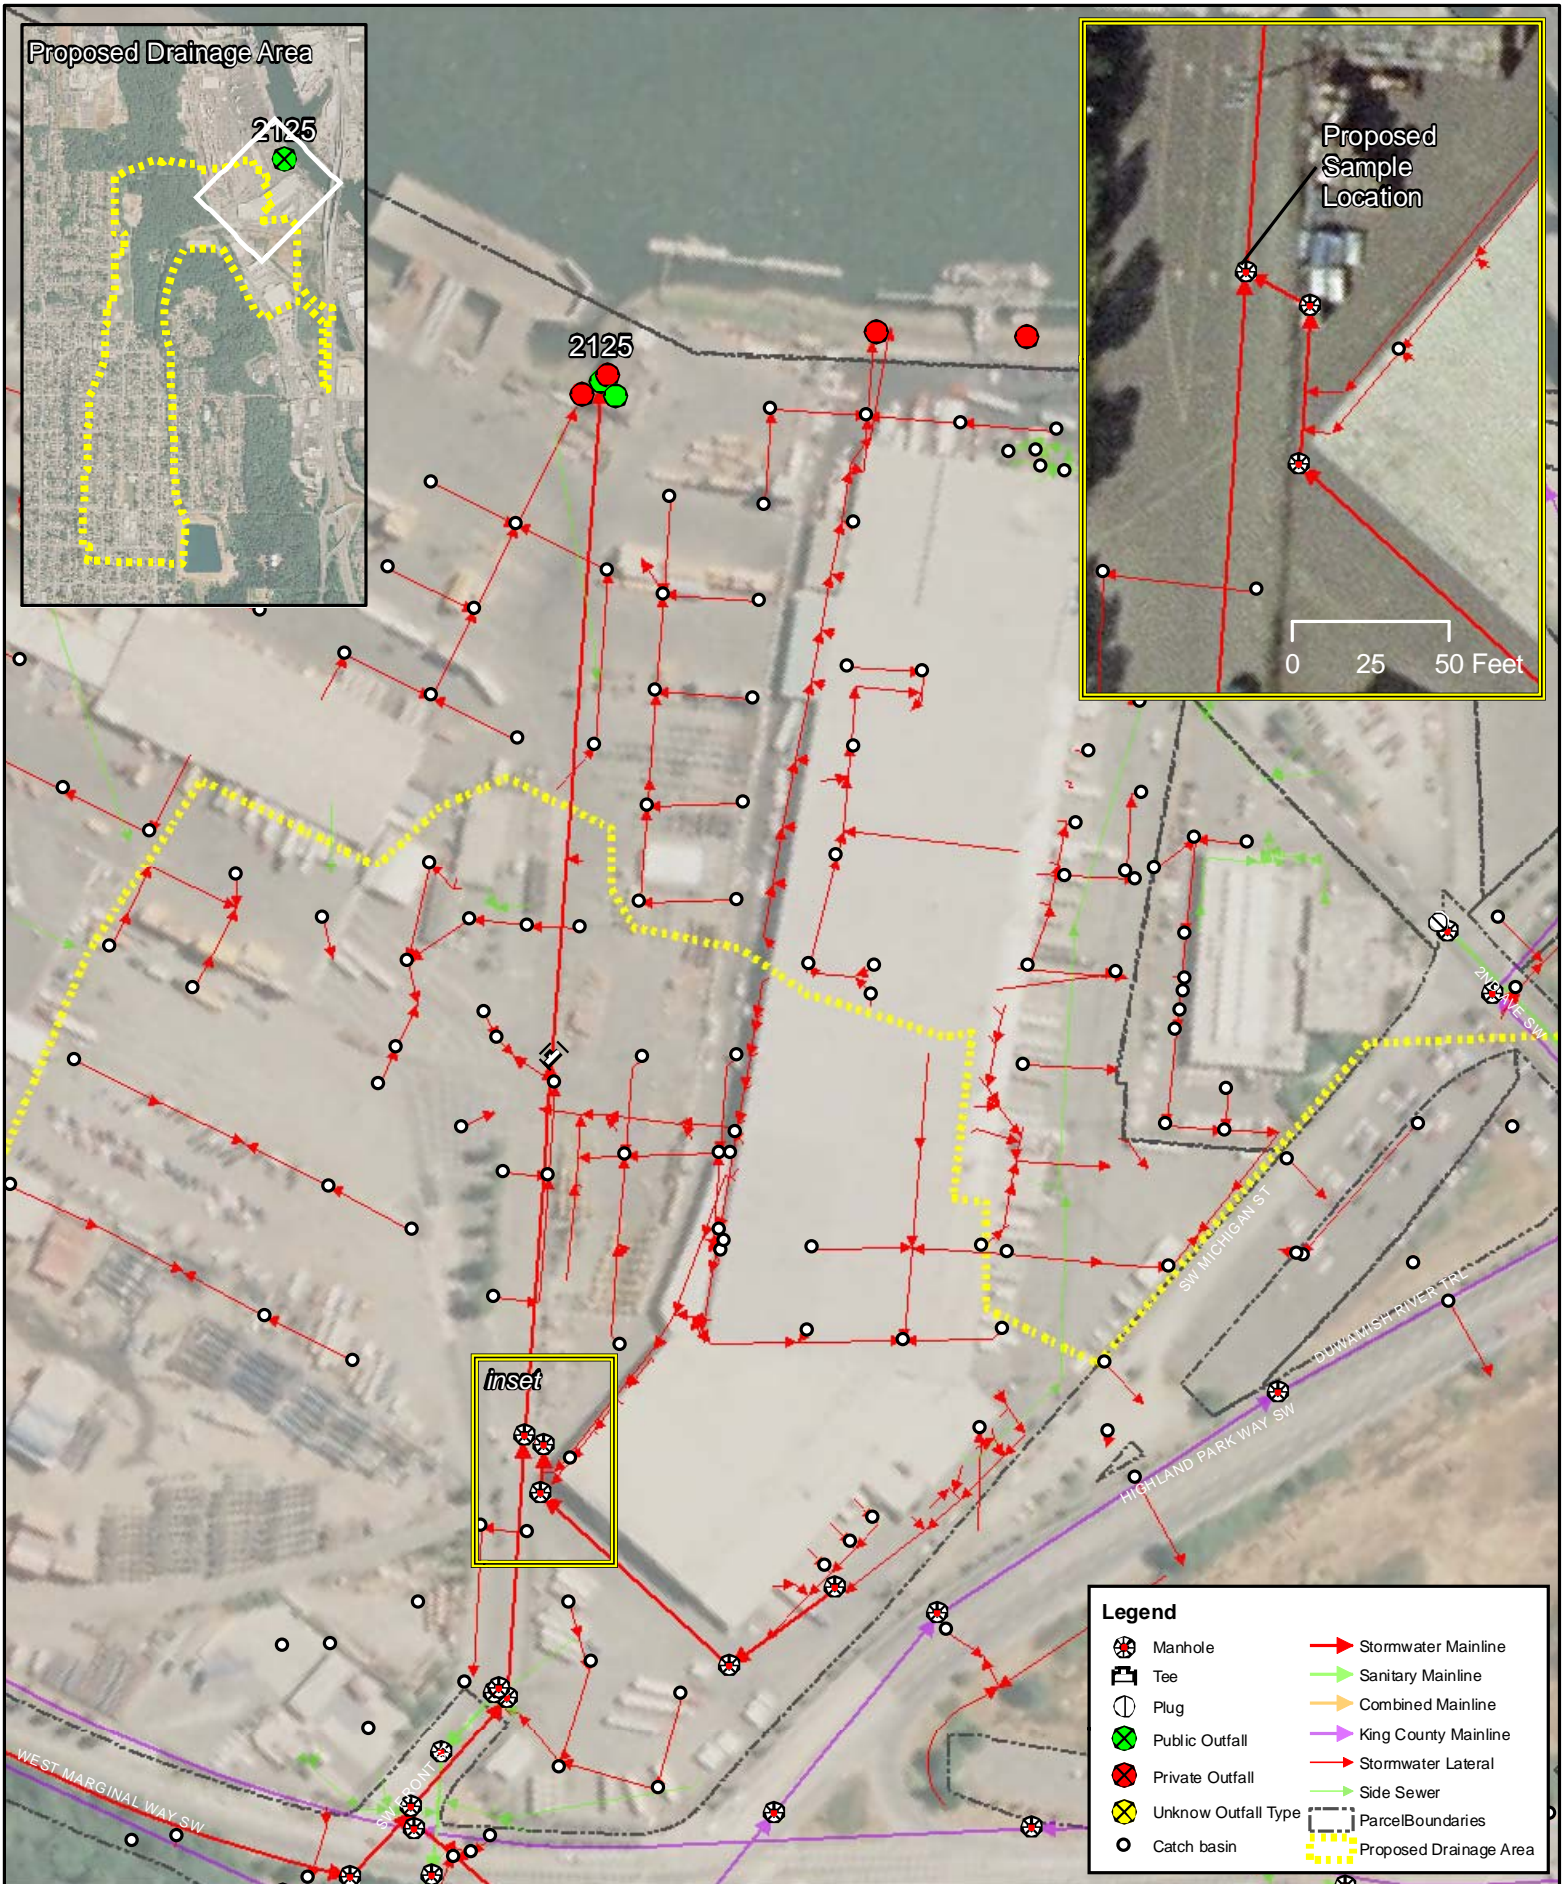
Figure 13. Locations of RI #2125 Outfall and Access

Outfall RI #2125 consists of a 72-inch diameter pipe that emerges from riprap at a concrete wall (see Figure 13 and Appendix A, p. A-21). The pipe opening is securely covered by a grate. The most appropriate manhole access to this drain line is located along SW Front Street, behind a guard house inside the entrance to the Port of Seattle.

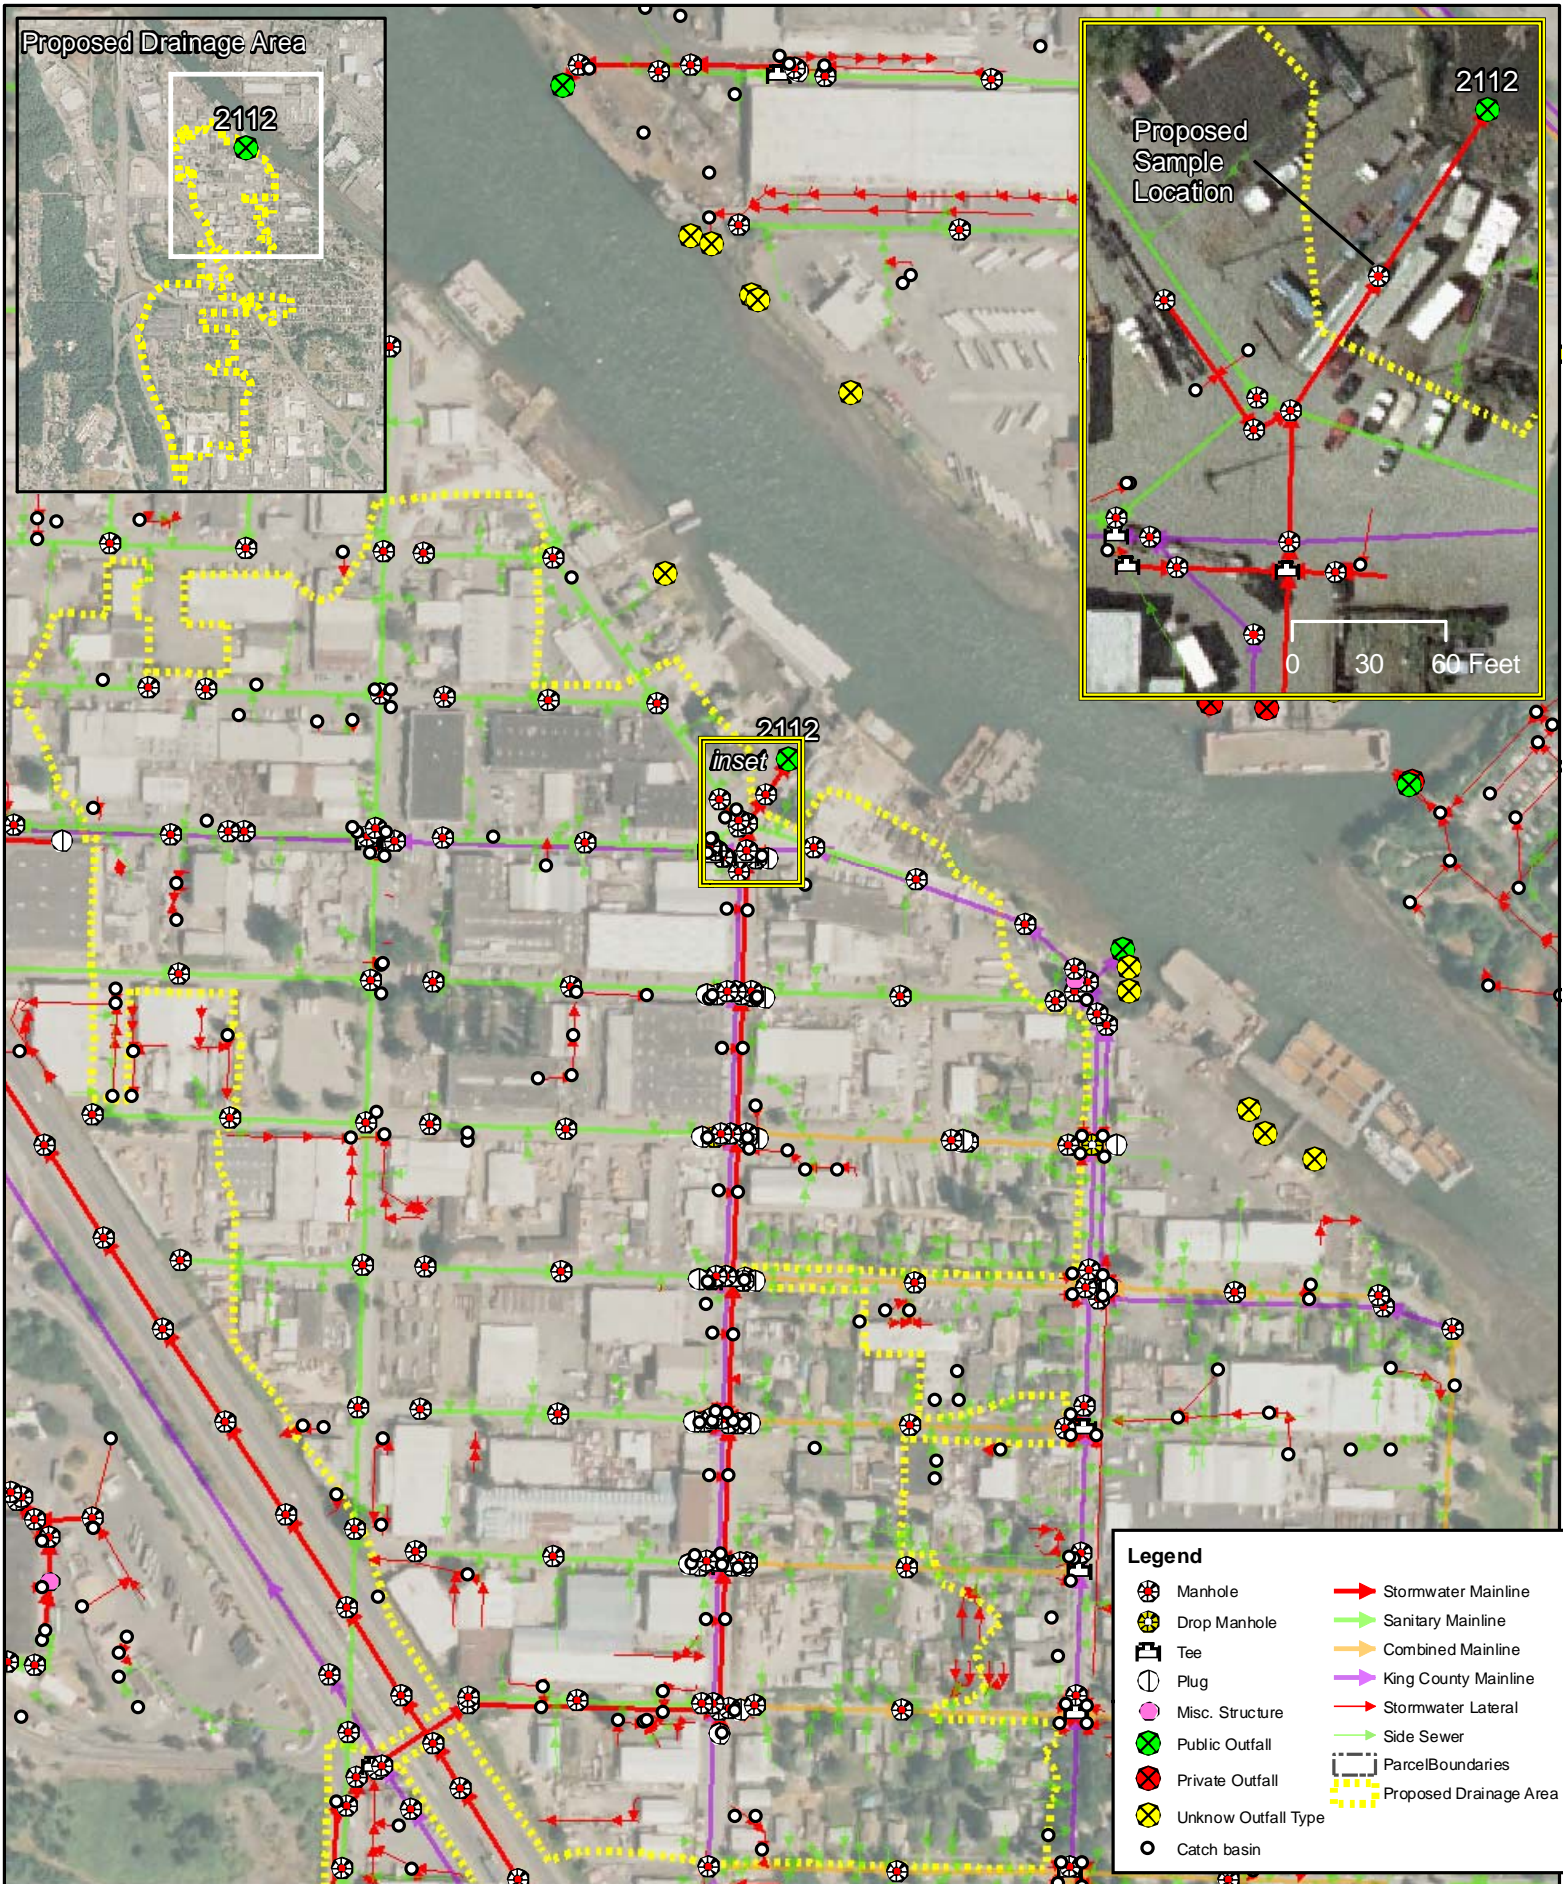
Figure 14. Locations of RI #2112 Outfall and Access

Based upon SPU data, Outfall RI #2112 is believed to empty into the LDW in a small cove (see Figure 14 and Appendix A, p. A-26). River access to the outfall is blocked by piers and barges, while upland access is blocked by a chain-link fence. Manhole access to the drain line is found next to a fence in a gravel lot at the end of 7th Avenue S.

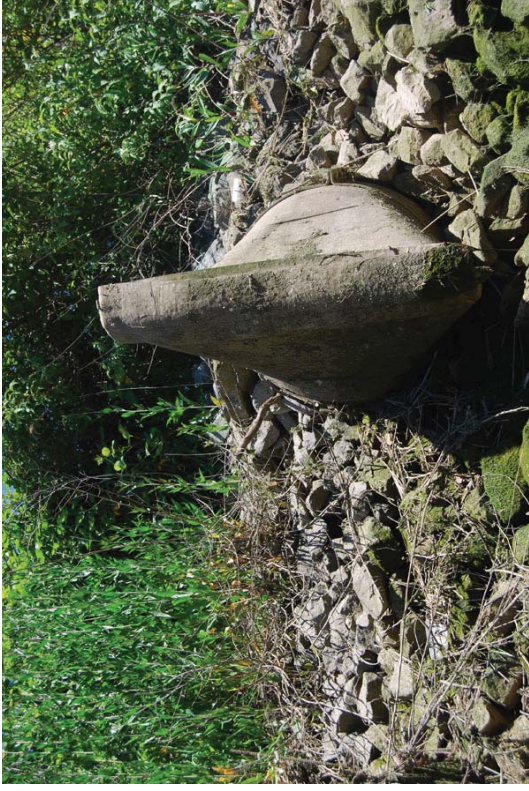
Outfall RI #2026 consists of a 30-inch diameter concrete pipe capped with a pinch valve (see Figure 6 and Appendix A, p. A-7). The pipe emerges from riprap in a small cove at the end of S Myrtle Street. Suitable access to the drain line is found at a manhole located in the turnaround at the west end of S Myrtle Street.

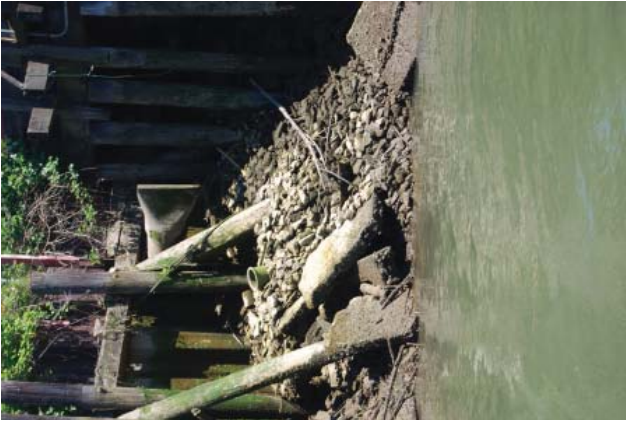
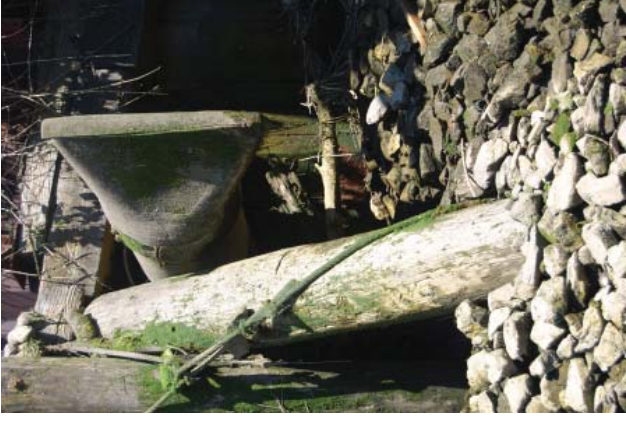
Similar to Outfall RI#2026, Outfall RI #2035 consists of a 30-inch diameter concrete pipe capped with a pinch valve (see Figure 6 and Appendix A, p. A-8). The pipe emerges from riprap adjacent to a pier. Access to this drain line is available at a manhole found in the turnaround at the west end of S Garden Street.

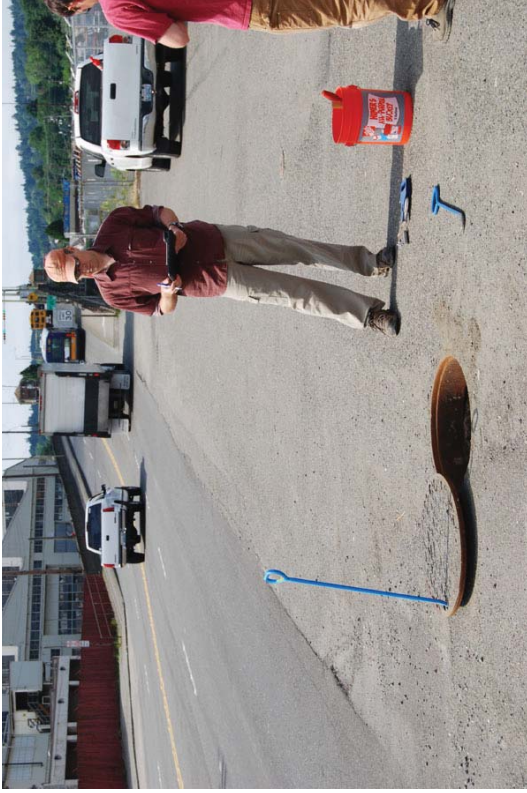
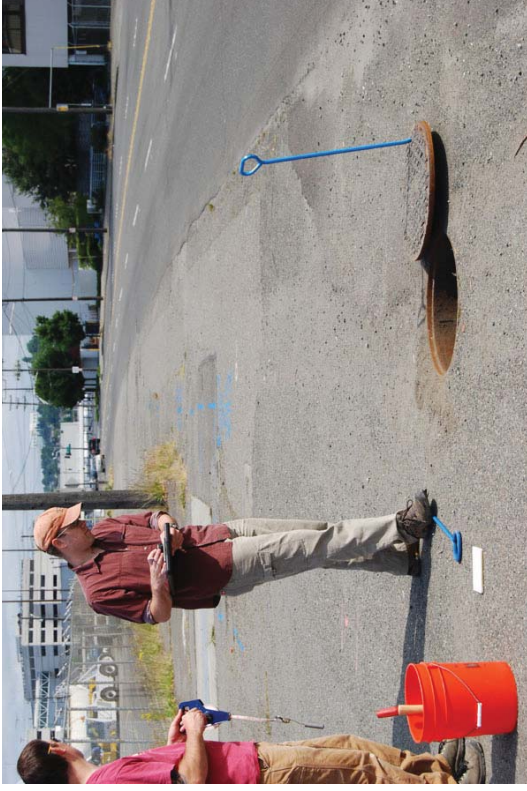
Outfall RI #3032 was not identified in the field but is believed to empty into the LDW under the 16th Avenue S Bridge (see Figure 7 and Appendix A, p. A-13). The most appropriate manhole access to this outfall's drain line is found on the sidewalk along southbound 16th Avenue S. Although the outfall was not identified, water flowing southward in the drain line suggests that the outfall is actively emptying into the LDW.

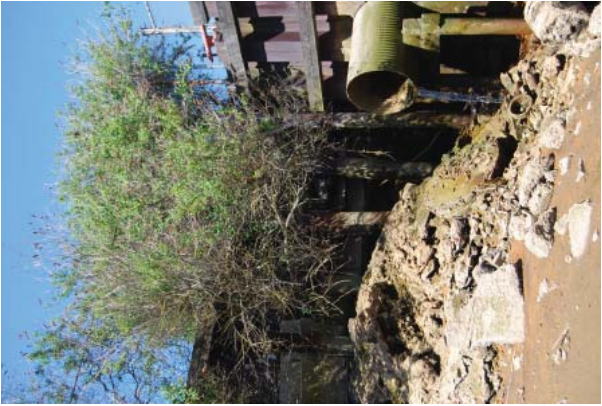
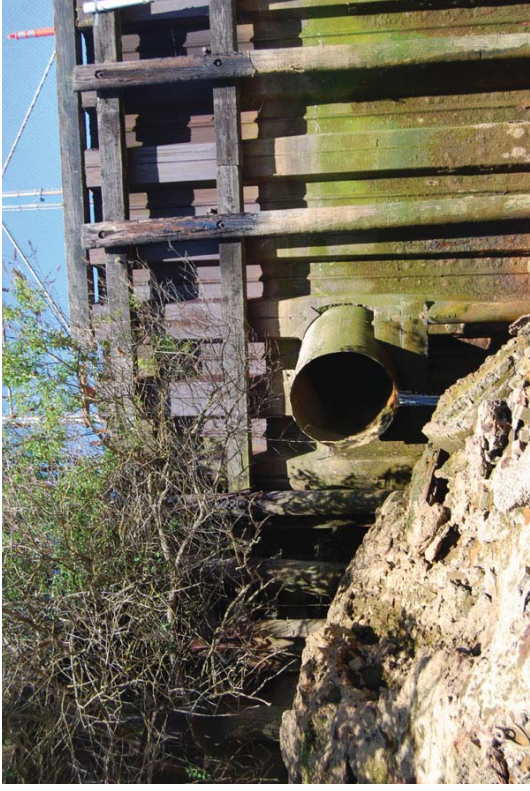
Outfall RI #2062 consists of a 48-inch diameter, open-ended steel pipe that protrudes from a bulkhead (see Figure 8 and Appendix A, p. A-14). Water flow was approximately 20 gpm at the time of observation. This outfall drains the northern portion of the King County Airport. The most suitable manhole access to this outfall's drain line is located in the roadway of S 87th Place, a King County Airport access road parallel to East Marginal Way S.

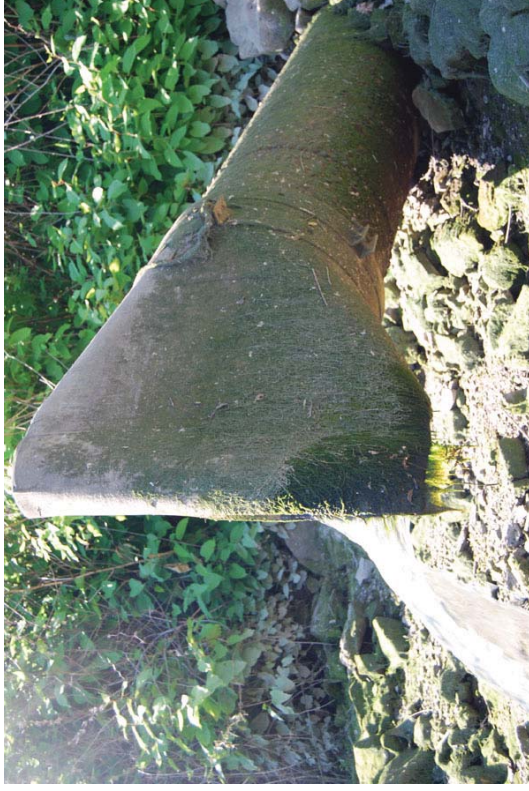
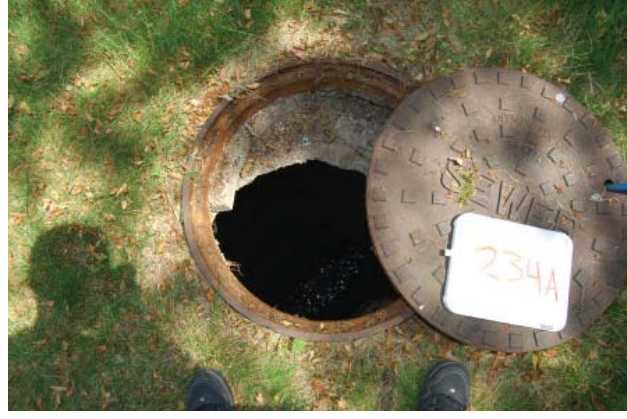
Outfall RI #2080 is a 24-inch diameter, riveted, steel pipe with a pinch valve closure at its end (see Figure 9 and Appendix A, p. A-15). The pipe extends out from bank riprap near the high water mark. Water flow was approximately 30 gpm at the time of observation. The most appropriate manhole access to the drain line is found in a grassy median east of East Marginal Way S.

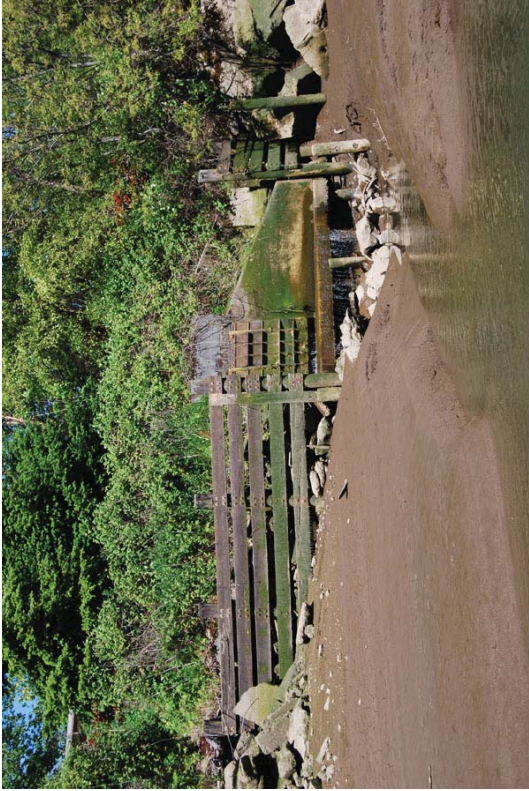
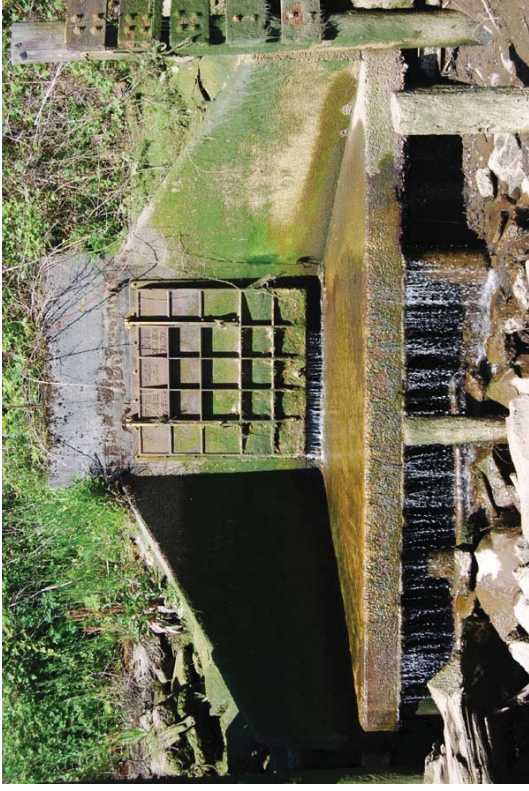
Outfall RI #2095 consists of an 84-inch diameter pipe that empties into the LDW at a concrete wall with wing walls (see Figure 10 and Appendix A, p. A-16). The opening is covered by a tide gate that hangs from the concrete wall. Drain water pours over a concrete platform before reaching the LDW. The most suitable manhole access to the drain line upstream of the CSO is found along a Boeing access road parallel to E Marginal Way. A bottle-type sediment trap was observed within the drain line attached to the wall of the pipe.
