Re: **Stormwater Video Survey Report**
Shell Oil Products US Harbor Island Terminal
Seattle, Washington
Consent Decree No. 99-2-07176-0SEA

On behalf of Shell Oil Products US (Shell), URS Corporation (URS) is providing the Washington Department of Ecology (Ecology) this Stormwater Video Survey Report conducted near the Shell Harbor Island Terminal located in Seattle, Washington (Figure 1). This report summarizes the findings of the video survey conducted in accordance with the *Stormwater Survey Work Plan – TX-03A Area* dated September 6, 2013.

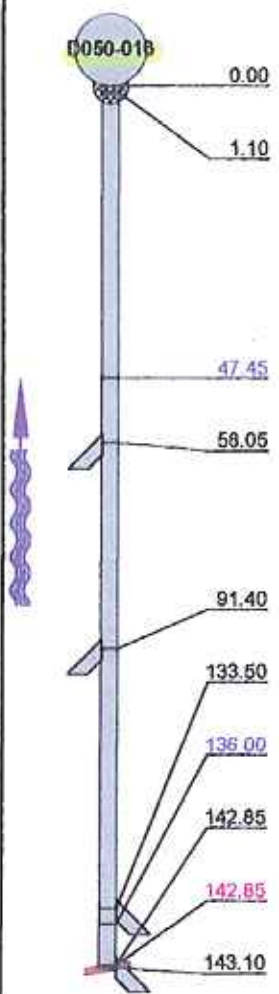
Water was observed in the stormwater pipe at manhole D050-016. The stormwater pipe was approximately 24 inches in diameter. No cracks or water was observed infiltrating the stormwater pipe. An absorbent boom was observed at 142.85 feet and the survey was abandoned before manhole D050-17 at 143.10 feet east of manhole D050-016. See Note 1 on the attached Figure 2 and photographs included Section 1 in Attachment B.

142.85	TFA	Tap Factory Made Active, at 10 o'clock, 8", within 8 inches of joint: NO		
	142.85	OBZ	Obstacles Other, 25 %of cross sectional area, from 04 to 08 o'clock / Absorbent Boom	D050-017_D050-016_ SW Florida St_15112013_083630_A.JPG	M 4

143.10	MSA	Survey Abandoned / Obstacle In Invert

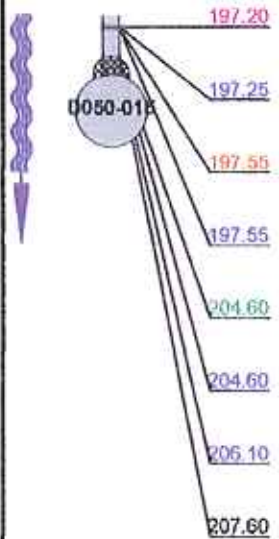
Cracks were observed at 143.60 feet, 143.65 feet, and 204.60 feet west of manhole D050-16. Water infiltration was observed weeping from the crack at 174.60 feet and also running at 197.20 feet west of manhole D0550-16. See Notes 2 through 5 on Figure 2 for the location of these observations and photographs included in Section 2 of Attachment B.

106.85	TFC	Tap Factory Made Capped, at 09 o'clock, 8", within 8 inches of joint: NO		
	143.60	CC	Crack Circumferential, 6", from 09 to 12 o'clock, within 8 inches of joint: YES	D050-016_D050-015_SW Florida St_15112013_085950_A.JPG	S 1

143.65	CC	Crack Circumferential, 5", from 03 to 06 o'clock, within 8 inches of joint: YES		S 1
	145.40	TF	Tap Factory Made, at 02 o'clock, 8", within 8 inches of joint: NO

174.60	CC	Crack Circumferential, 15", from 08 to 04 o'clock, within 8 inches of joint: YES		S 1
	174.60	IW	Infiltration Weeper, at 12 o'clock, within 8 inches of joint: YES		M 2

1:486	Position	Code	Observation	Photo	Rate
	197.20	IR	Infiltration Runner, from 07 to 08 o'clock, within 8 inches of joint: YES	D050-016_D050-015_ SW Florida St_15112013_091045_A.JPG	M 4

204.60	CC	Crack Circumferential, 10", from 09 to 03 o'clock, within 8 inches of joint: YES	D050-016_D050-015_ SW Florida St_15112013_091446_A.JPG	S 1
	204.60	DAE	Deposits Attached Encrustation, 5 %of cross sectional area, from 03 to 09 o'clock, within 8 inches of joint: YES	D050-016_D050-015_ SW Florida St_15112013_091446_A.JPG	M 2

206.10	DAE	Deposits Attached Encrustation, 10 %of cross sectional area, from 04 to 08 o'clock, within 8 inches of joint: YES	D050-016_D050-015_ SW Florida St_15112013_091446_A.JPG	M 2
