April 2, 2014

Re: Draft Phase I Environmental Site Assessment Update
Cue Apartment Property
721 East Pine Street and 1523 Harvard Avenue
Seattle, Washington
19019-00

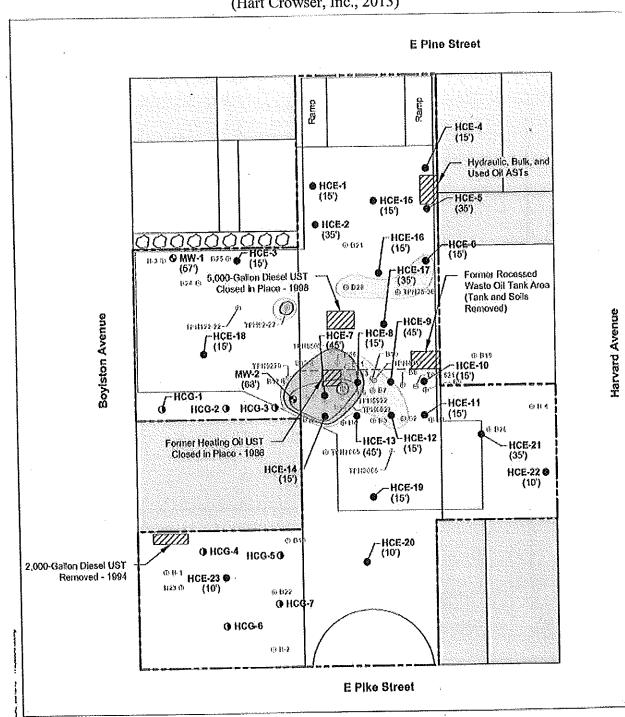
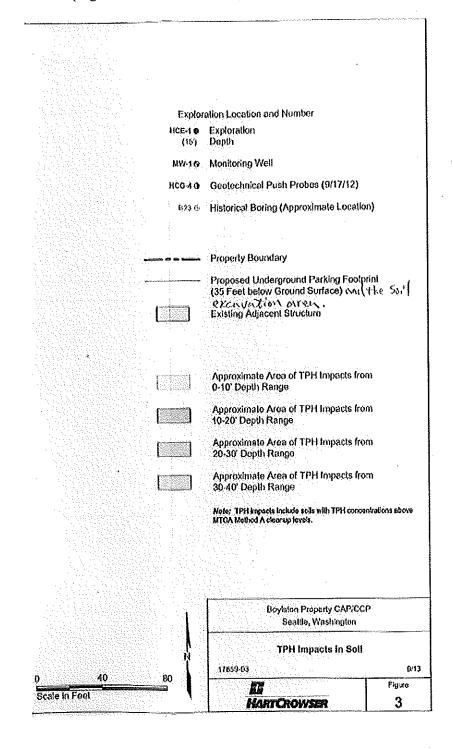
Figure 1 Figure 1 Proposed Impacted Soil Excavation Area and Monitoring Well Locations (Hart Crowser, Inc., 2013)

The remedial investigation conducted at this Site in 2012 concluded the presence of petroleum hydrocarbons and metals contamination in soil at concentrations exceeding MTCA Method A cleanup levels. In accordance to the feasibility study, over-excavation is selected as the remedy to remove and dispose all the contaminated soils from the Site. Ecology concurs with your proposal, which includes to remove the impacted soil as demonstrated on Figure 1.

- Ecology considers the selected cleanup alternative developed in the focused feasibility study report as a preferred remedy as well. The cleanup alternative includes removal and off-Site disposal of all the USTs and the impacted soils from the Site. The excavated area will be within the proposed underground parking (Figure 1).
