Subject: As-Built Report
Shoreline Habitat Restoration
Irondale Iron and Steel Plant
Irondale, Washington
File No. 0504-042-02

Irondale Iron and Steel Plant
Shoreline Habitat Restoration
Jefferson County, Washington

File No. 0504-042-02

November 17, 2014

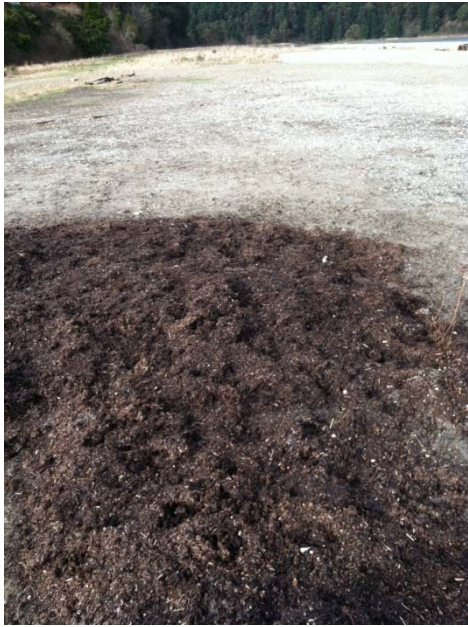
Photograph 28
Monitoring station 5 looking northwest.
