Subject: Year-One Post-Construction Monitoring Report  
Shoreline Habitat Restoration  
Irondale Iron and Steel Plant  
Irondale, Washington  
File No. 0504-042-02

**Year-One Post-Construction  
Monitoring Report**

Irondale Iron and Steel Plant  
Shoreline Habitat Restoration  
Jefferson County, Washington

**File No. 0504-042-02**

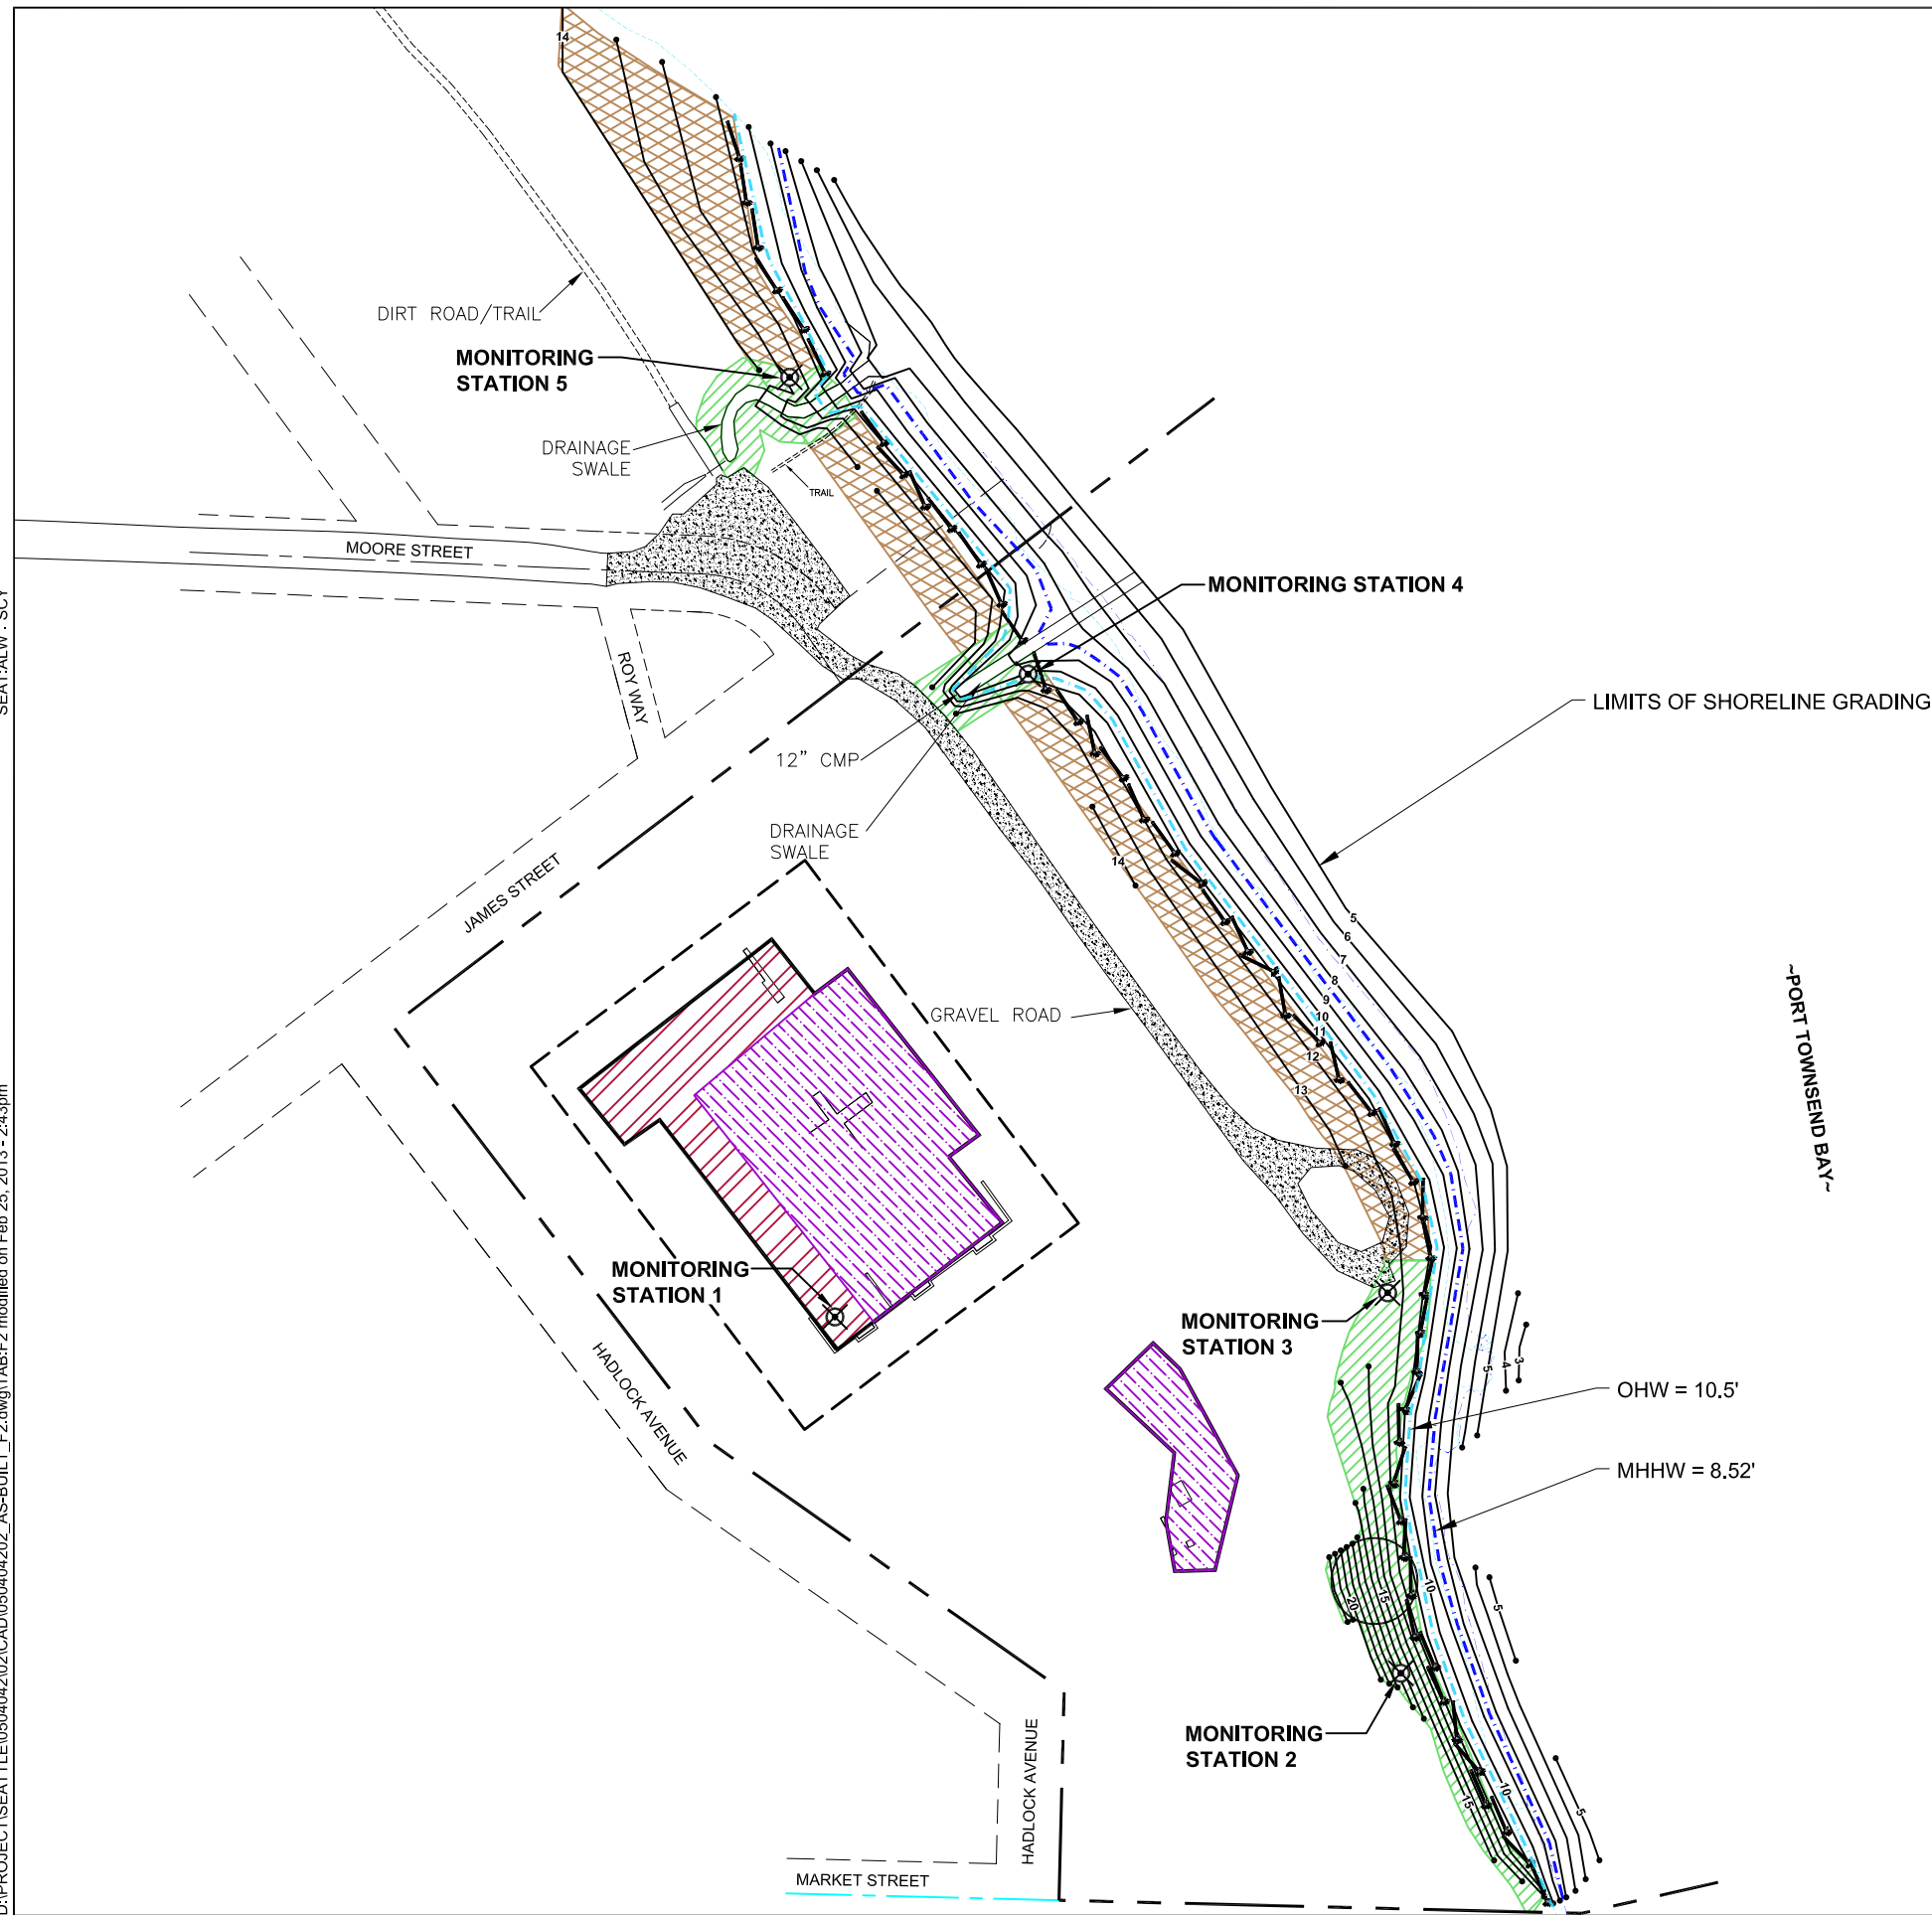
The main surface of each upland cap was hydroseeded rather than planted with shrubs. The cap areas were observed to be intact, with no visible signs of erosion or sloughing. The riprap armored edges of the caps were observed to be intact and no geotextile fabric was visible. The hydroseed had germinated throughout both cap areas and grass coverage was estimated to be 95 percent. Several small areas contained approximately 50 percent coverage with grasses; however, additional seed was observed to have recently been placed in these areas to encourage additional grass growth. The grass areas had been recently mowed, which may have contributed to the lower coverage levels of grass in several areas. Also, an area approximately 20 feet wide was planted with shrubs along the northwest and southwest borders of the larger soil cap (Figure 2).

Monitoring Station 1 is located in the southern portion of the larger upland soil cap within the hydroseed and shrub planting areas (Figure 2). Photographs were taken facing northwest, northeast, southeast and southwest to better align with local conditions (Appendix A). Plant species and quantities are presented below in Table 3 and the areal cover values in Table 4.
