INDEPENDENT REMEDIAL ACTION REPORT
WEYERHAEUSER ABERDEEN SAWMILL
ABERDEEN, WASHINGTON

Prepared for
Weyerhaeuser Company
January 17, 1997

Prepared by
EMCON
18912 North Creek Parkway, Suite 100
Bothell, Washington 98011-8016

Project 40141-077.001

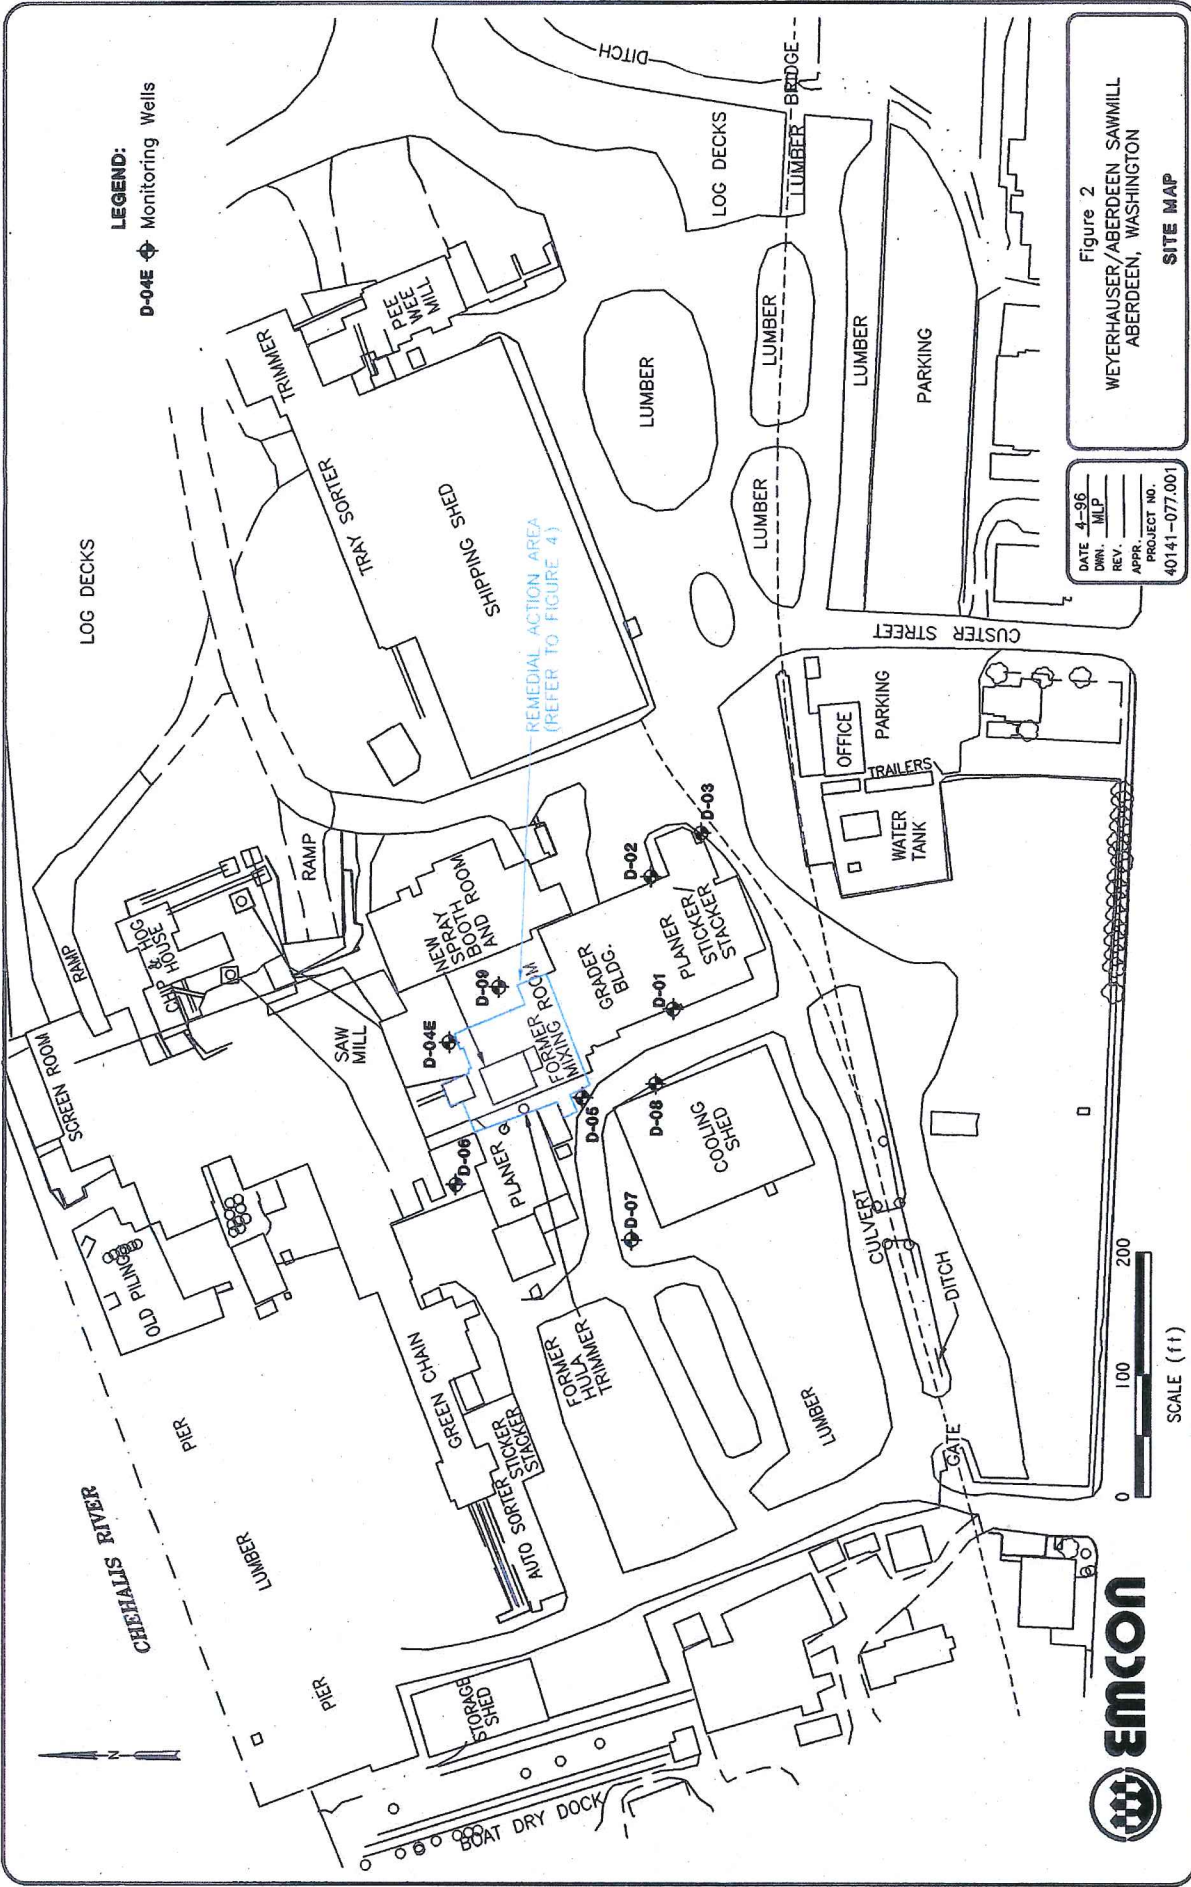
Ecology stated that prior to granting "No Further Action" status for the site, Weyerhaeuser would have to demonstrate that PCP in groundwater was not bypassing the monitoring well network hydraulically downgradient of well D-05 (see Figure 1). Ecology agreed that this demonstration could be made by collecting a one time groundwater sample from a location between monitoring well D-06 and D-07 as shown on Figure 1.
