MEMORANDUM

To: Joyce Mercuri, Washington State Department of Ecology
Date: July 22, 2011, 2011

Re: Eddon Boat Park Long-Term Monitoring Plan Year 3 Memorandum

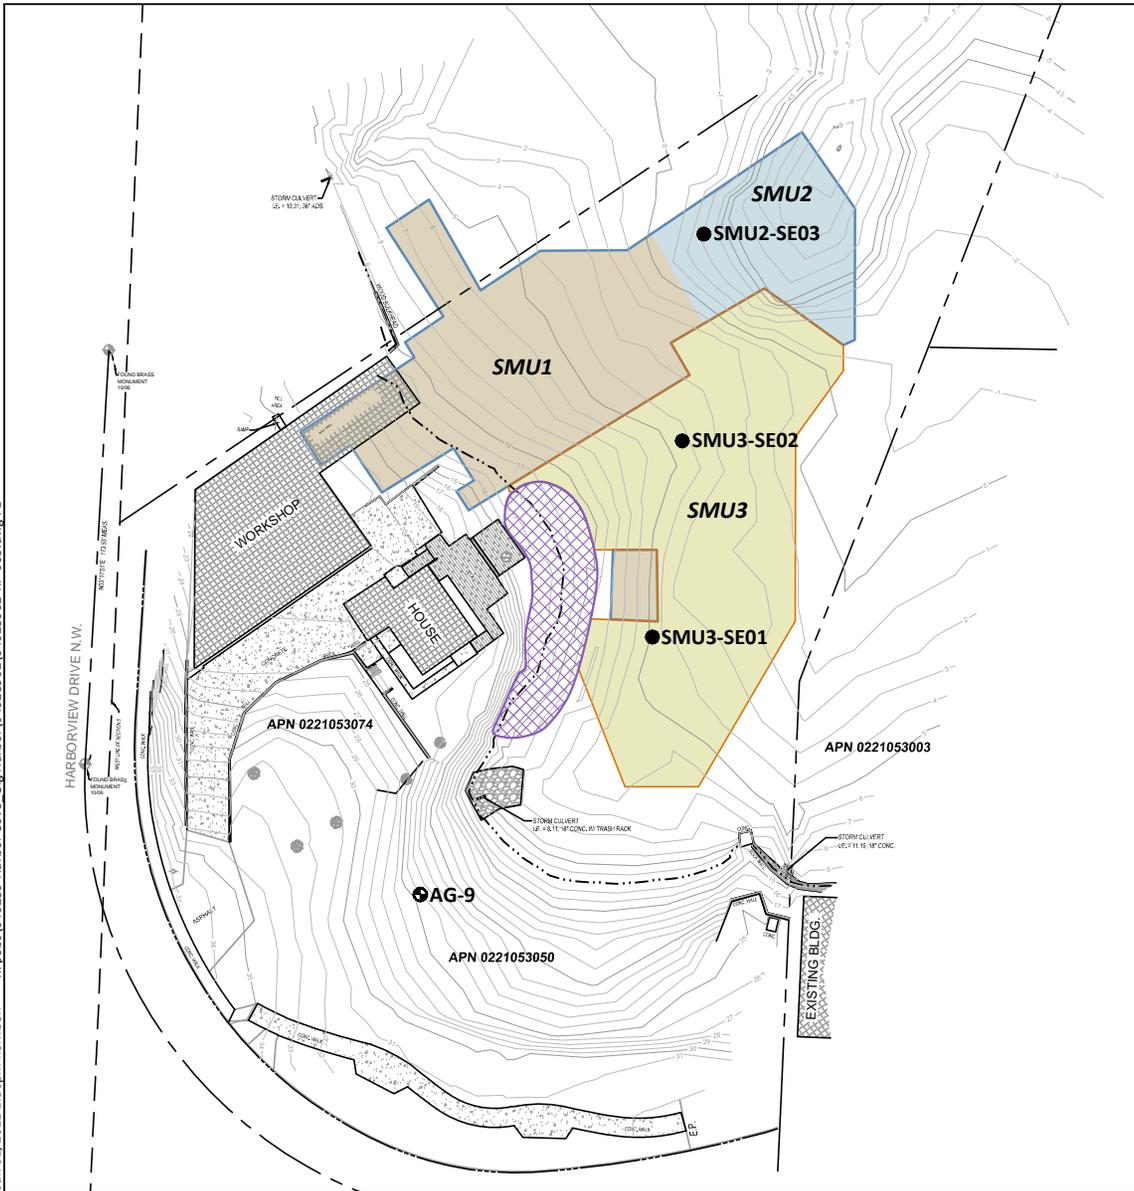
Figure 1
Site Areas, Features, and Sample Locations
Long-Term Monitoring Plan - Year 3 Report
Eddon Boat Park

Chemical monitoring was performed on May 18, 2011, between 1100 and 1210 hours. During this time, the tidal elevation ranged from -1.2 to -3.1 MLLW. This allowed exposure of all proposed sampling locations. Cores were collected using a polycarbonate coring device that was penetrated approximately 1.5 feet below the mudline with a hammering device to reach the sand layer below the gravel surface within the cap material. The core was then extruded with a plunger and the sand layer was carefully segregated into a stainless steel bowl. The sand was then homogenized, placed in the appropriate laboratory sample containers, labeled, placed on ice, and delivered to the laboratory. The analyses performed were total mercury, total organic carbon, total solids, and TBT in bulk sediment (the material was too coarse to extract an adequate volume of porewater). No mercury or TBT were detected in any samples. Actual sample locations are presented in Figure 1. Chemical testing results are provided in Table 1.

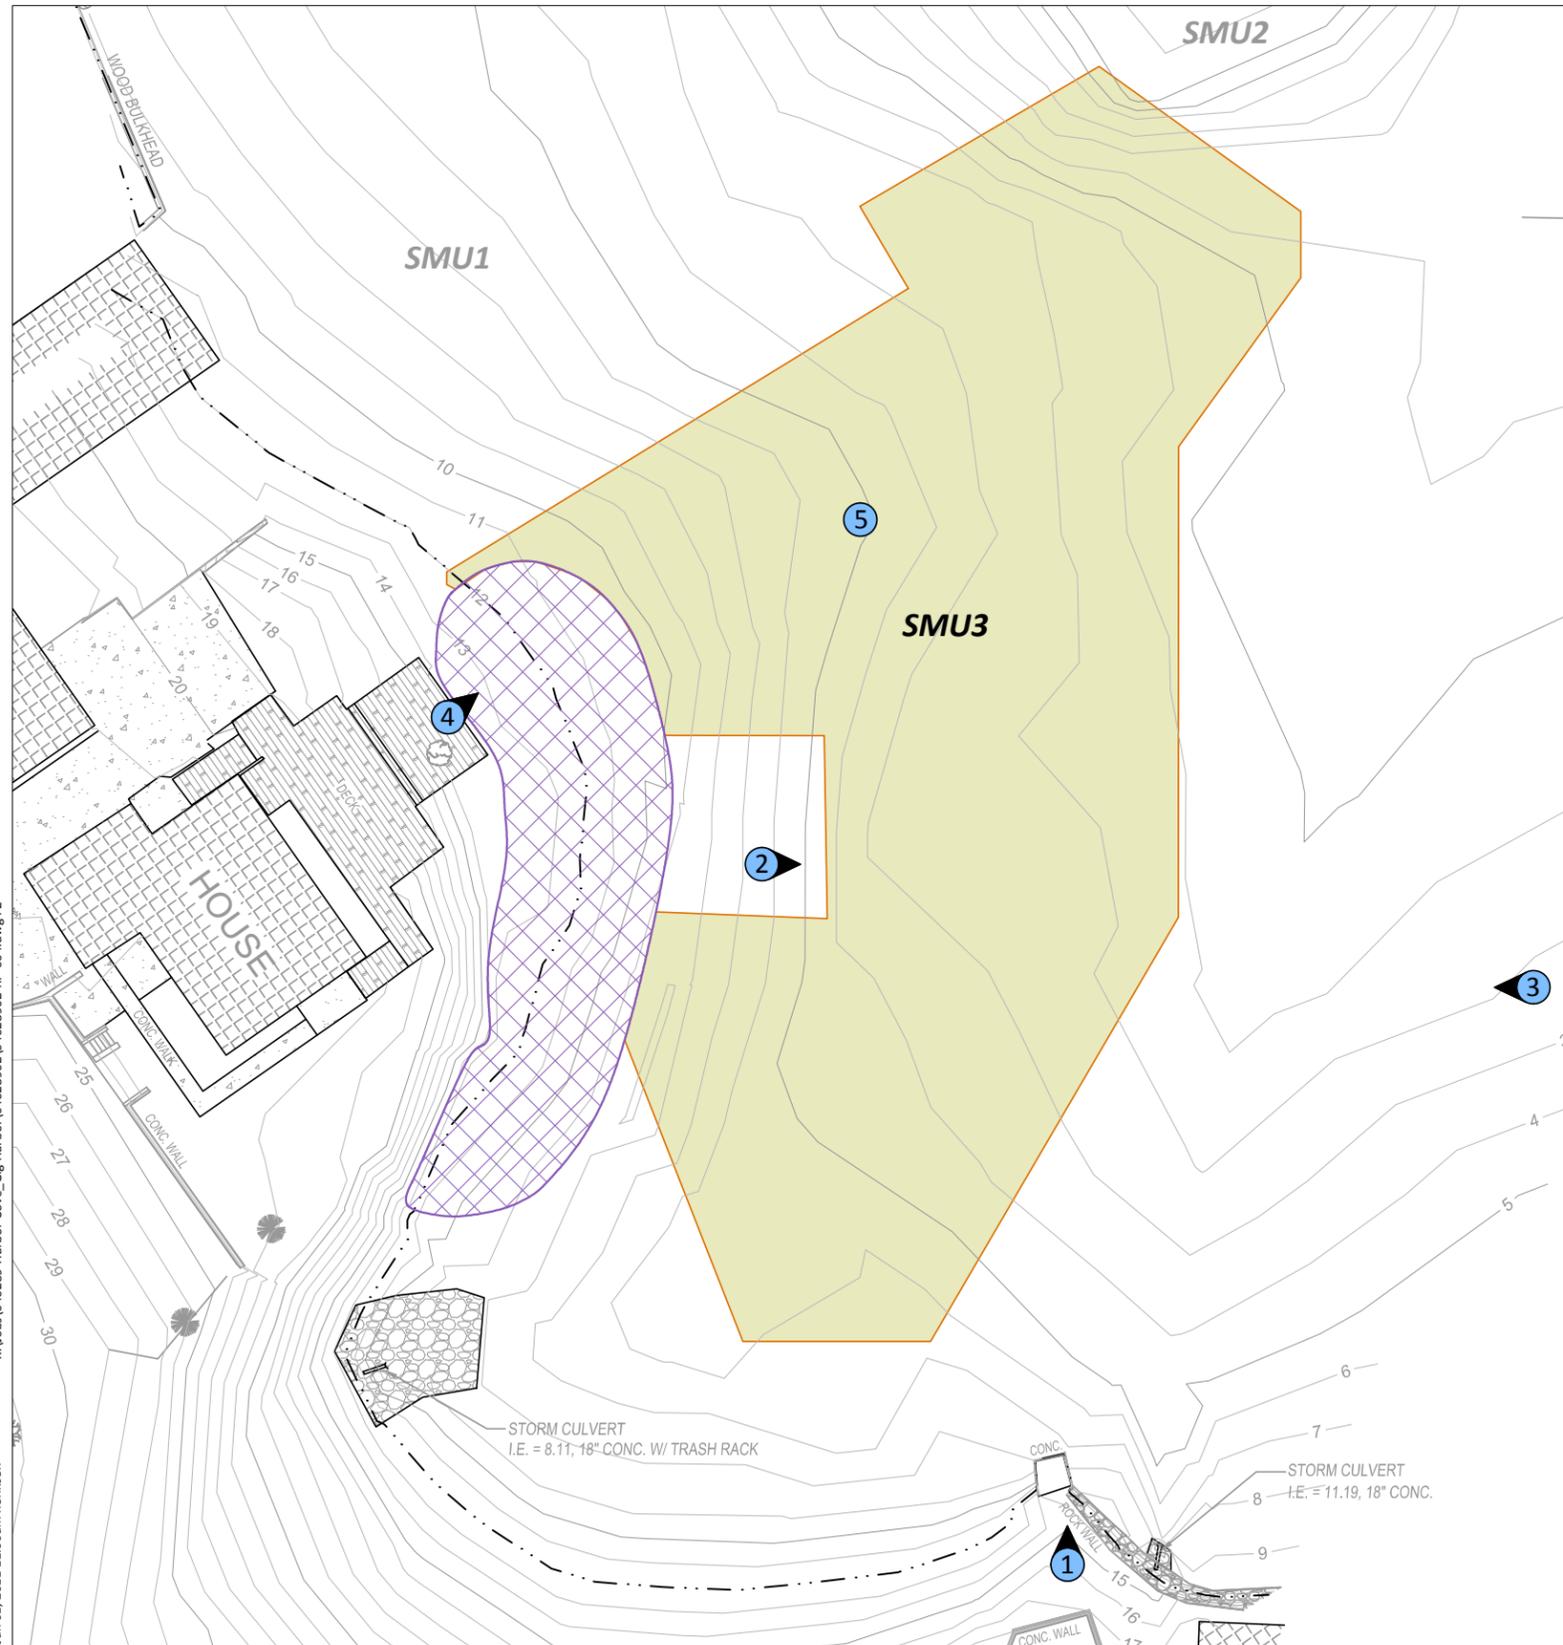
Figure 2
 SMU-3 Visual Inspection Results
 Long-Term Monitoring Plan - Year 3 Report
 Eddon Boat Park

Visual inspections were performed on May 18, 2011, between 0900 and 1100 hours. During this time, the tidal elevation ranged from +4.8 to -1.2 mean lower low water (MLLW). This allowed exposure of most of SMU-3 and part of SMU-2. Digital photographs were taken in each area from locations marked on Figure 2 and Figure 3. As shown in the photographs, the cap material is present in all areas with minimal (fewer than 2 cm) accumulation of fine-grained material. The visual inspection did not identify any areas of concern (i.e., areas where cap material is no longer present). Based on the visual survey and associated photographs, the cap and ENR areas are achieving performance standards and no additional remedial actions are recommended.
