MEMORANDUM

To: Joyce Mercuri, Washington State Department of Ecology **Date:** July 28, 2010
From: David Templeton and Joy Dunay, Anchor QEA **Project:** 040289-02
Cc: Steve Misiurak, City of Gig Harbor
William Joyce, Salter Joyce Ziker, PLLC
Re: Eddon Boat Park Long-Term Monitoring Plan Year 2 Report

Figure 1
Site Areas and Features
Long-Term Monitoring Plan - Year 2 Report
Eddon Boat Park

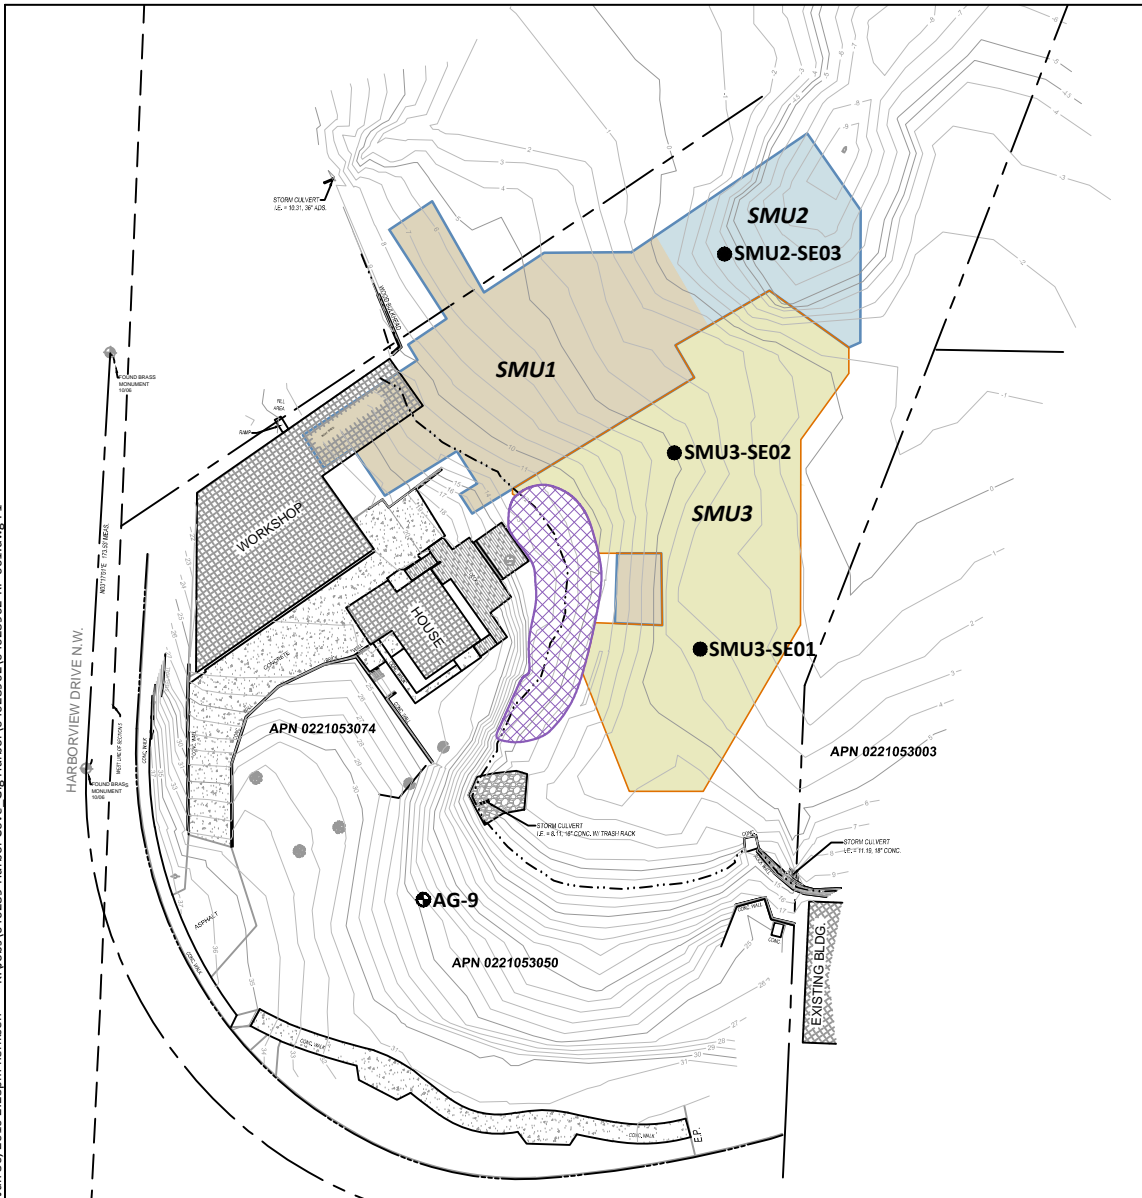
Figure 1 Site Areas and Features

The areas included in the LTMP are cap area SMU-3 and enhanced natural recovery (ENR) area SMU-2 (Figure 1). SMU-3 contained three of ten sample locations that exceeded the total mercury sediment quality standard (SQS) cleanup levels. Additionally, three samples in this area contained tributyltin (TBT) above benchmark values (established by Ecology) as described in the CAP. As part of the cleanup action this area was capped with 12 inches of sand and overlain by 6 inches of habitat mix. SMU-2 contained total mercury above the cleanup screening level (CSL) and TBT porewater above Site cleanup levels (0.15 micrograms per liter [$\mu\text{g/L}$]) and was dredged to 2 feet below mudline and then overdredged to remove possible contaminated residuals. Post-construction, one location in this area (SE-03) exceeded the TBT Site cleanup level, so ENR material consisting of a 1-foot sand layer was placed followed by a 6-inch habitat mix layer.
