MEMORANDUM

To: Joyce Mercuri, Washington State Department of Ecology **Date:** September 2, 2009
From: David Templeton and Joy Dunay, Anchor QEA **Project:** 040289-02
Cc: Steve Misiurak, City of Gig Harbor
William Joyce, Salter Joyce Ziker, PLLC
Re: Eddon Boat Park Long-Term Monitoring Plan Year 1 Report

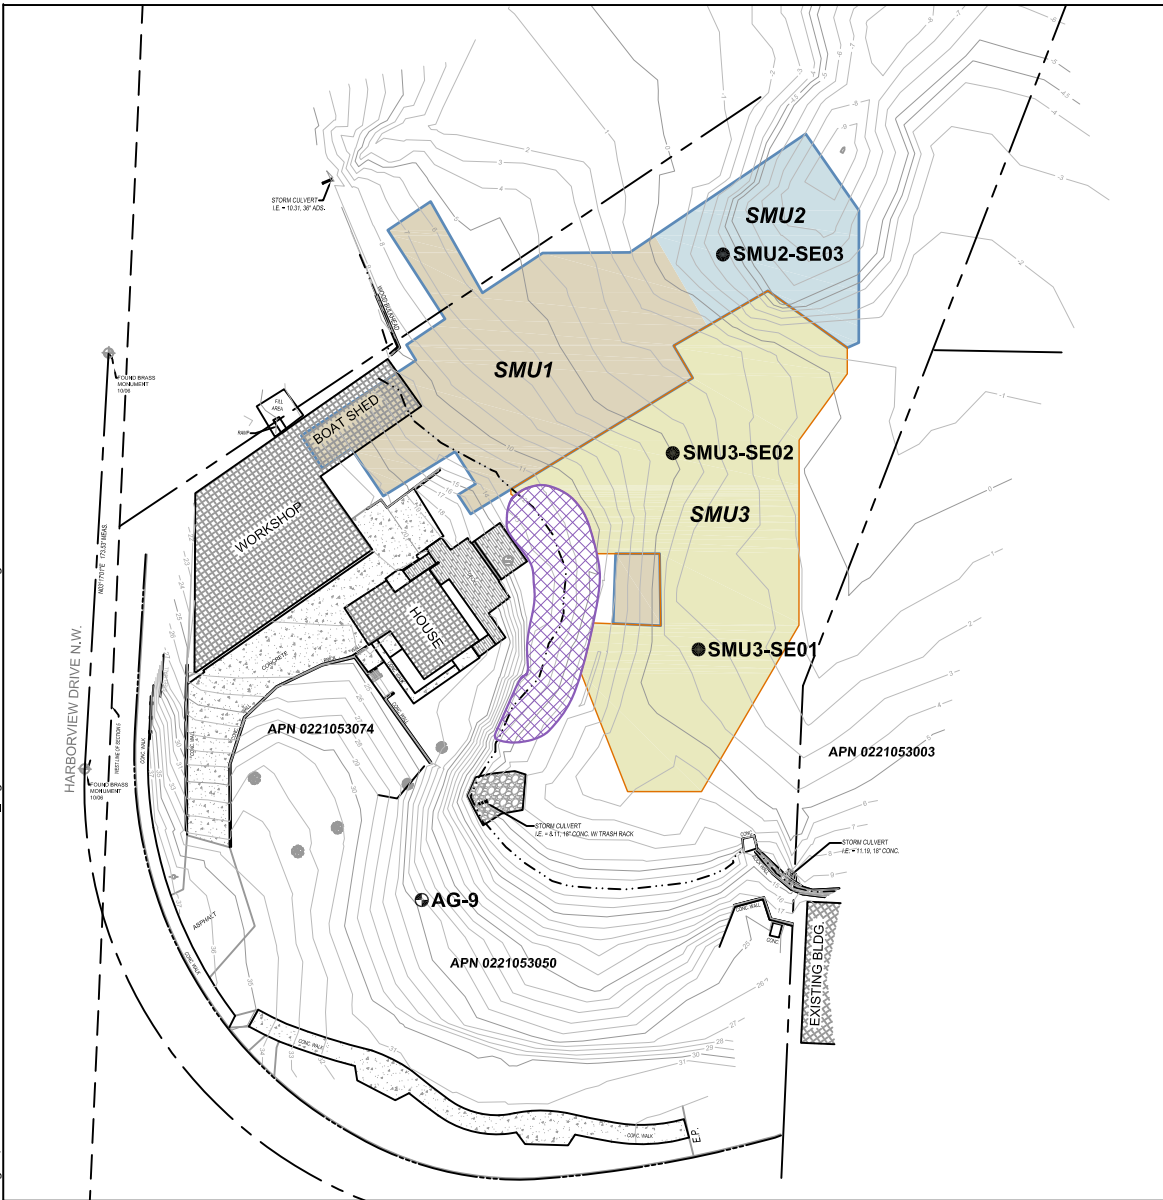
The areas included in the LTMP are cap area SMU-3 and enhanced natural recovery (ENR) area SMU-2 (Figure 1). SMU-3 contained three of ten sample locations that exceeded the total mercury sediment quality standard (SQS) cleanup levels. Additionally, three samples in this area contained tributyltin (TBT) above benchmark values as described in the CAP. As part of the cleanup action this area was capped with 12 inches of sand and overlain by 6 inches of habitat mix. SMU-2 contained total mercury above the cleanup screening level (CSL) and TBT porewater above Site cleanup levels (0.15 micrograms per liter [$\mu\text{g/L}$]) and was dredged to 2 feet below mudline and then overdredged to remove possible contaminated residuals. Post-construction, one location in this area (SE-03) exceeded the TBT Site cleanup level, so ENR material consisting of a 1-foot sand layer was placed followed by a 6-inch habitat mix layer.
