STATE OF WASHINGTON  
DEPARTMENT OF ECOLOGY

**Re: No Further Action at the following Site:**

- **Site Name:** Ralph Rush Property Well
- **Site Address:** 5003 Flagler Road, Nordland
- **Facility/Site No.:** 8707950
- **VCP Project No.:** SW0961

## Enclosure A

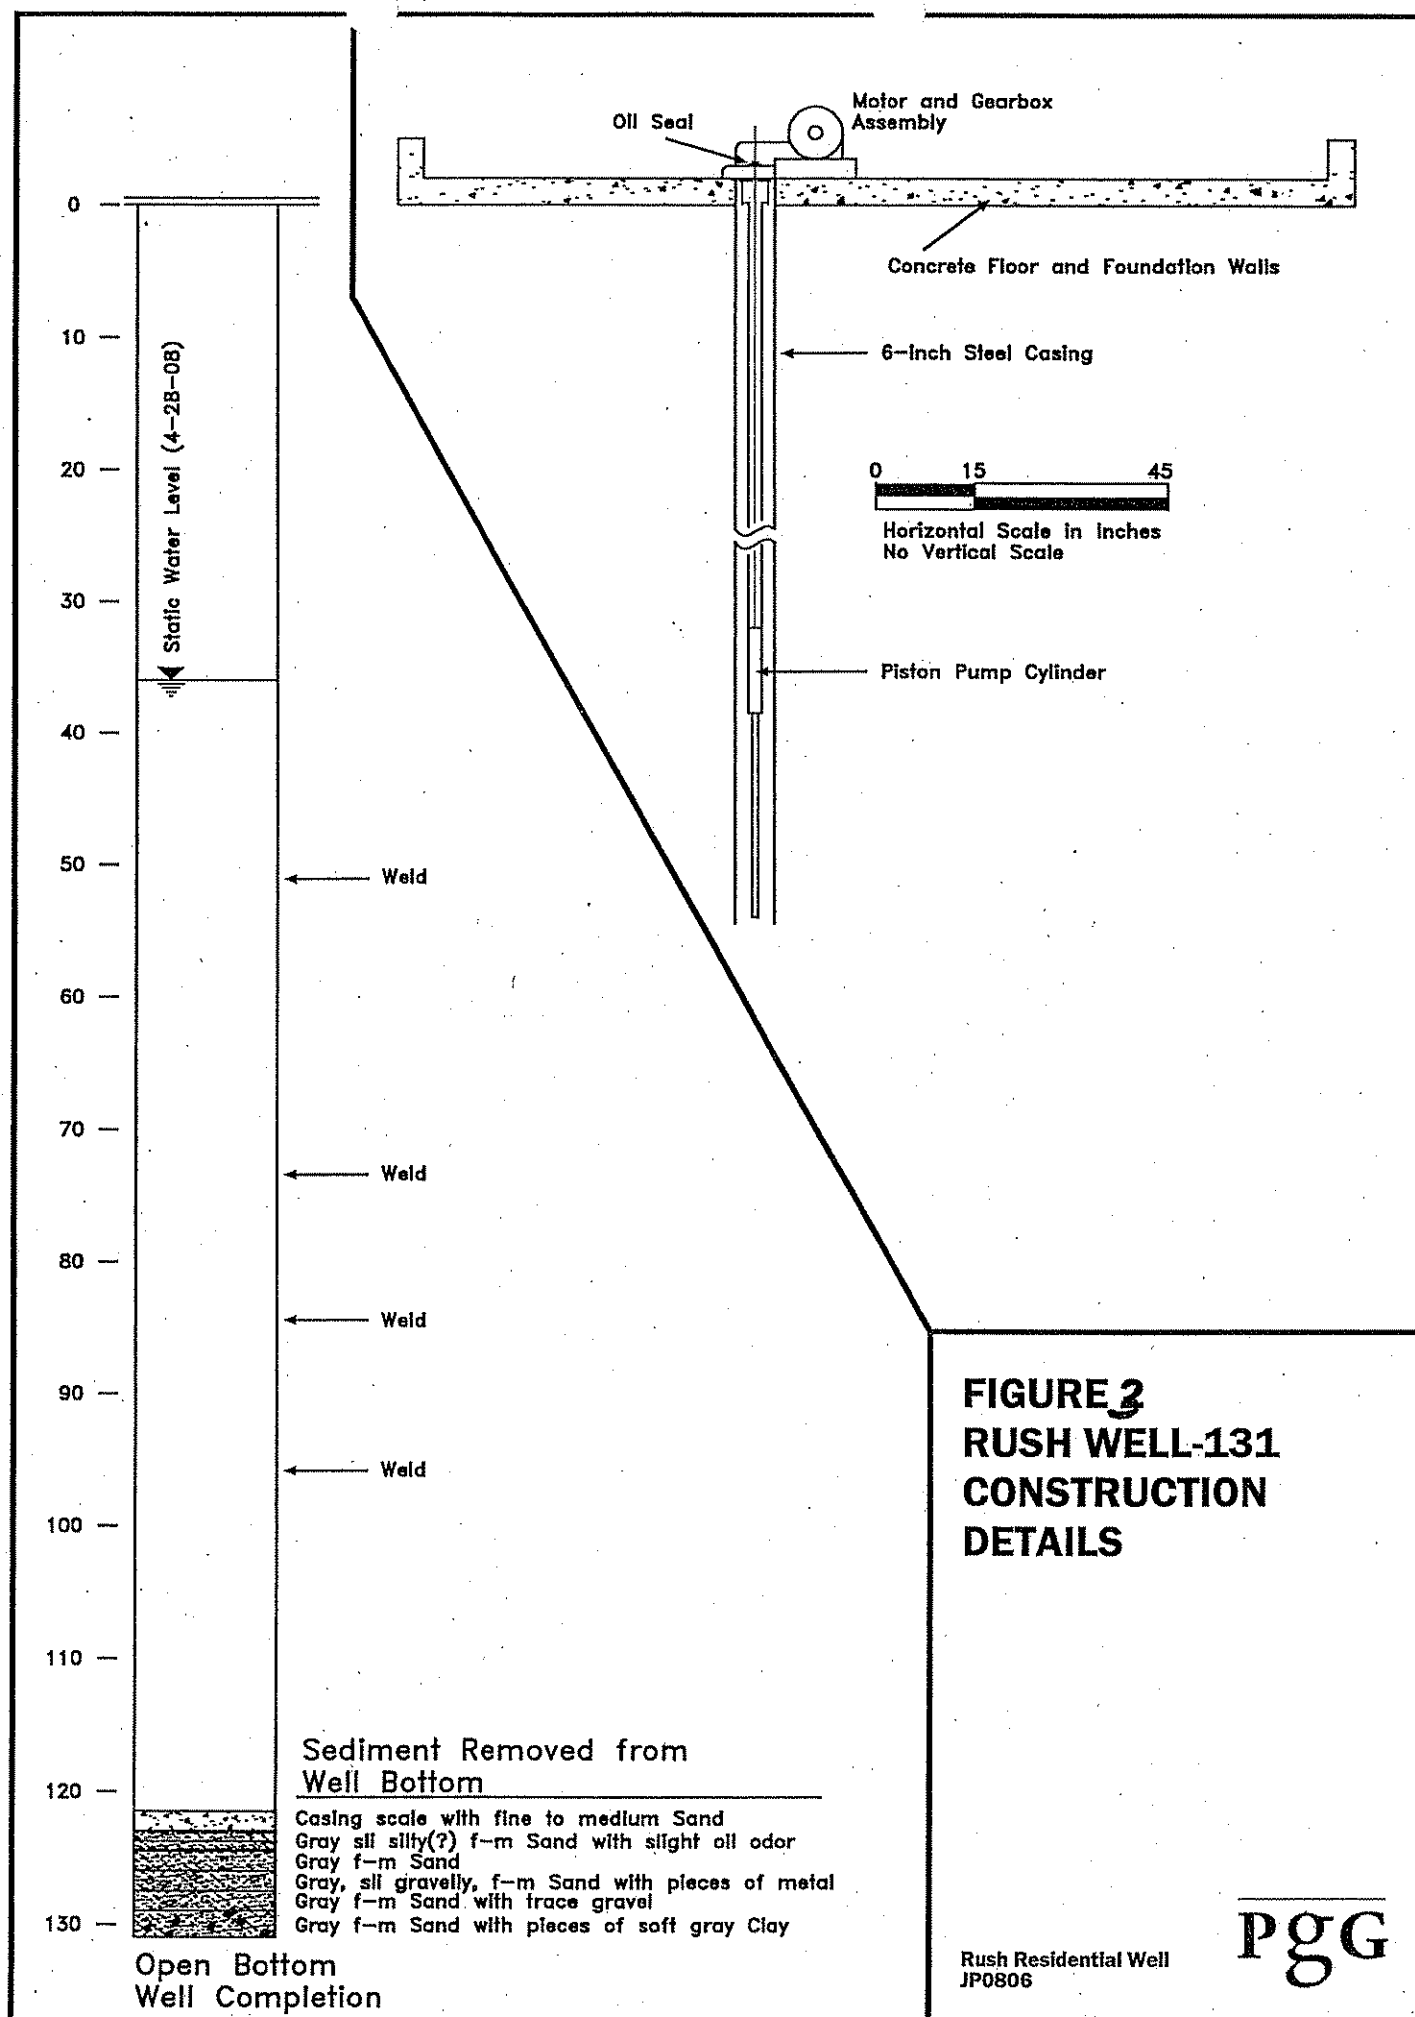
**FIGURE 4**  
**PUMP TOP AND MOUNTING PLATE**

The well pump is a 1½-inch diameter piston pump. The pump cylinder and 15 ft of pump intake combination extended to 97 ft btoc. The piston pump works by actuation of a central rod in a reciprocating motion. This motion is developed by a gearbox located at the top of the casing. The gearbox contains approximately one quart of oil for lubrication. For Well-131, the pump was powered by an electric motor that operated a pump jack through the gearbox. The understanding is that the motor and gearbox formed an integral unit bolted to a mounting plate shown in Figure 4. The mounting plate was bolted to a 4-inch thick concrete slab. The slab was 12 ft by 18 ft with 4- to 6-inch thick foundation walls that supported a well house. A 100-gallon pressure tank was located inside the well house. The concrete floor and foundation walls would have precluded leakage of oil outside of the well casing.
