Report
Property Boundary Investigation
Thompson-Isaacson Property
Tukwila, Washington

September 9, 2009

The Boeing Company

**LANDAU
ASSOCIATES**
130 2nd Avenue South
Edmonds, WA 98020
(425) 778-0907

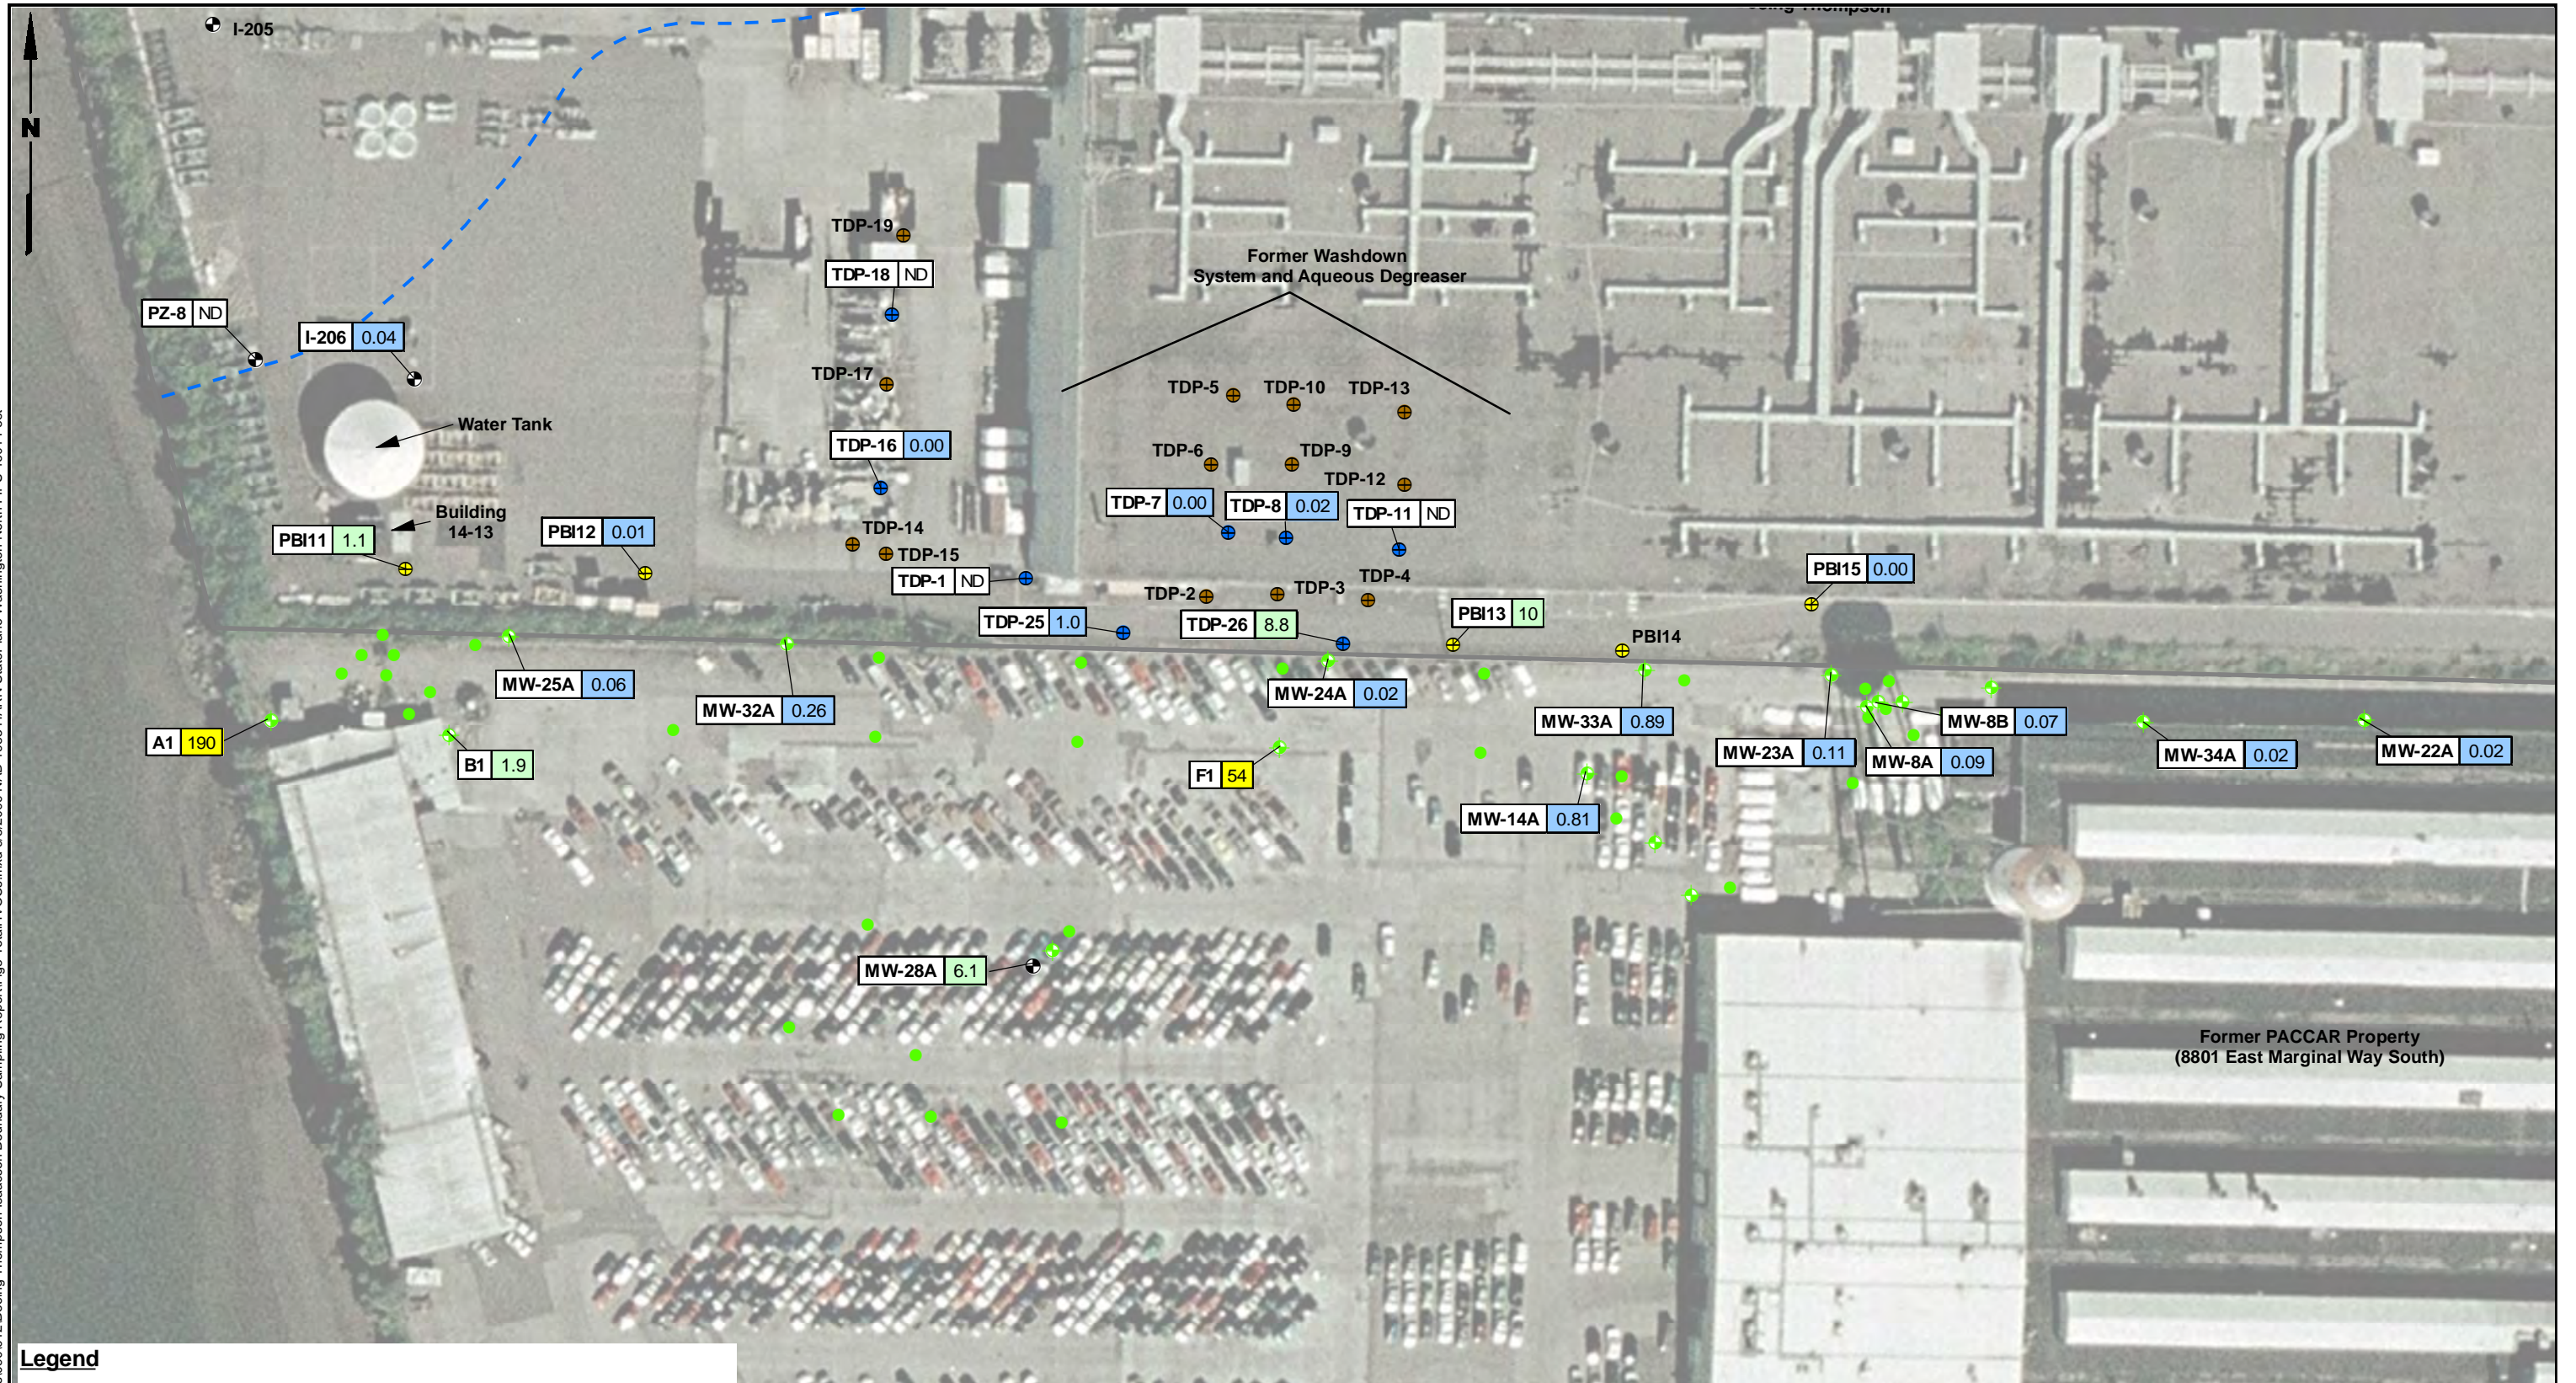
- The total HVOC concentrations in groundwater are significantly higher on the PACCAR property than on the Boeing Thompson property. Degradation of PCE and TCE is apparently occurring, making it more difficult to compare concentrations on individual compounds from one location to another. To compare the total HVOC concentrations in groundwater at each location, the measured concentration of each compound was converted from µg/L to micromoles/L (µmoles per liter) by dividing the concentration in µg/L by the gram molecular weight of the compound and correcting for units. The resulting concentrations at each location are provided in Table C-1 in Appendix C and are shown on Figure 8. The two highest total HVOC concentrations are 190 µmoles/L at location A1 and 54 µmoles/L at location F1; both of these locations are on the PACCAR property. The two highest concentrations on the Boeing Thompson property are much lower, 10 µmoles/L at PBI-13 and 8.8 µmoles/L at TDP-26. Both of these samples were located adjacent to the Boeing Thompson/PACCAR property boundary.
