## **PERIODIC REVIEW**

**Park 90/5 Office Park,  
now Airport Way Office Park  
Facility Site ID#: 76316149**

**2203 Airport Way South,  
Seattle, Washington**

**November 2016**

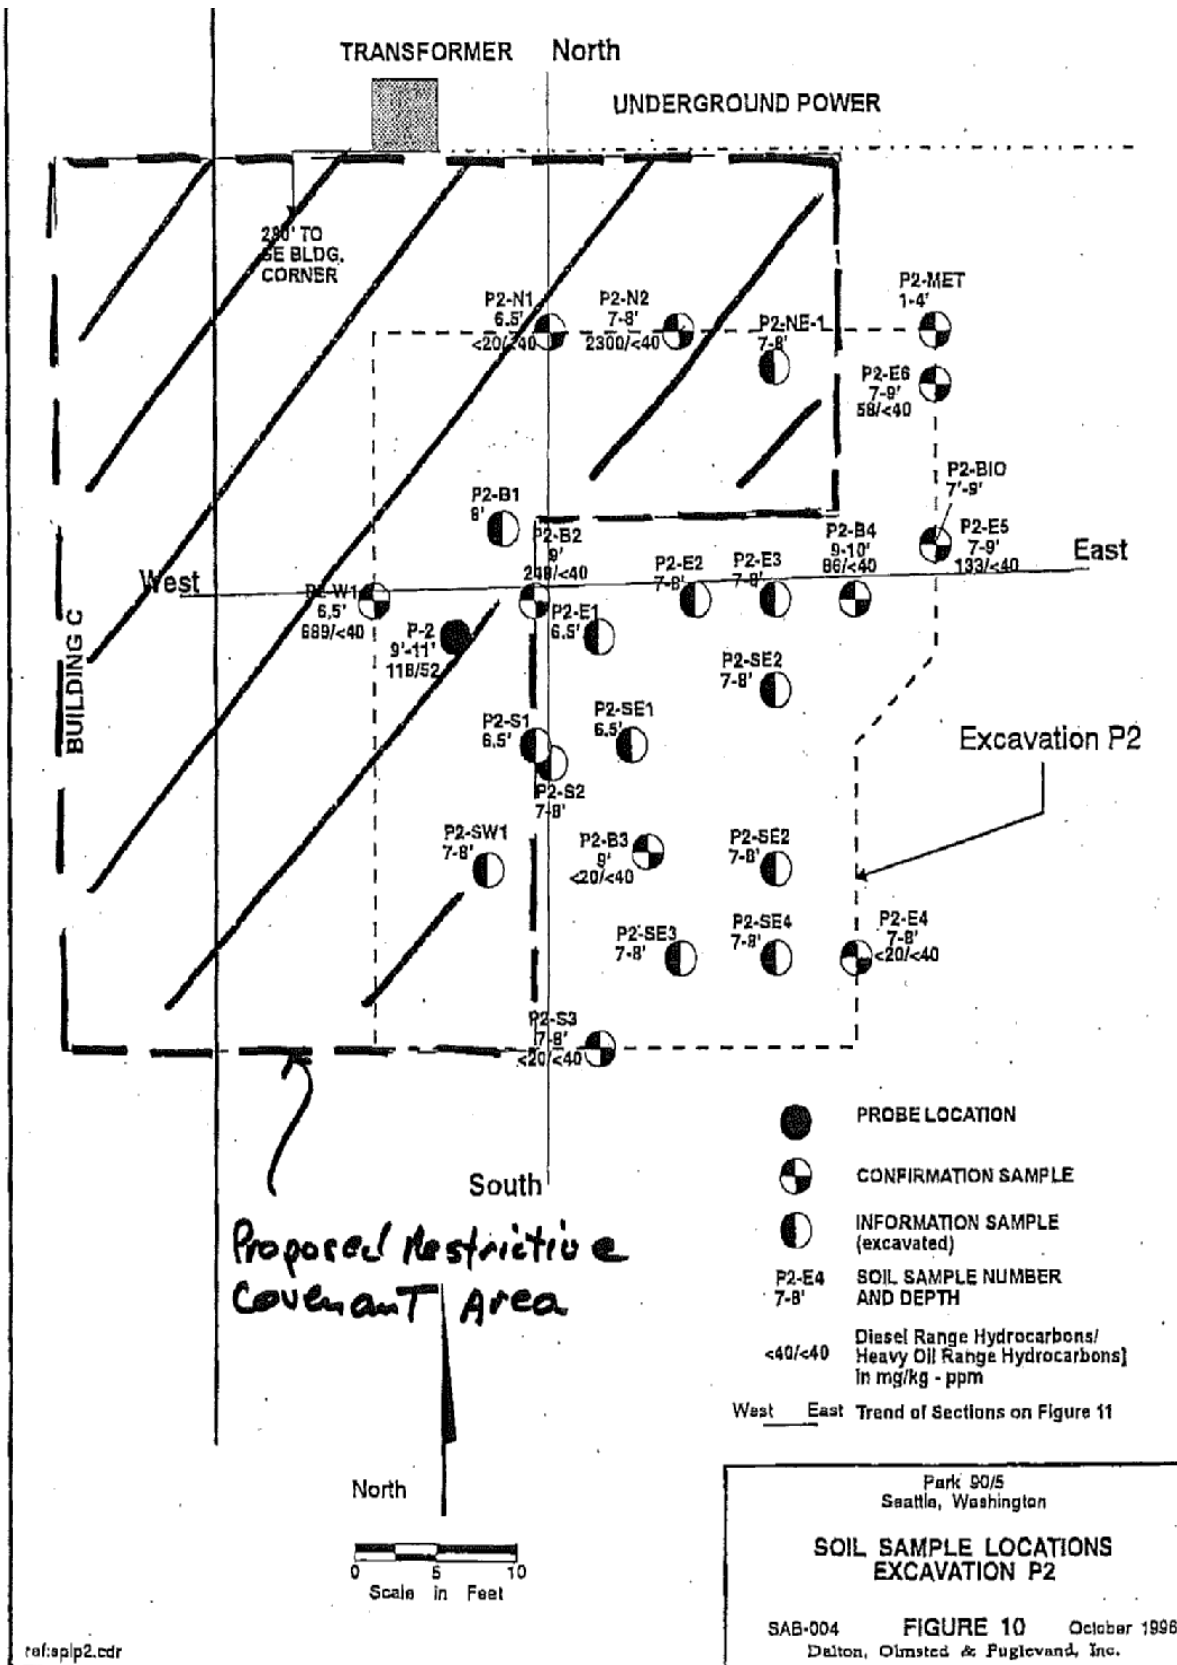
SAB-C04 **FIGURE 4** October 1996  
Dalton, Olmsted & Fuglevand, Inc.

This Restrictive Covenant is required because the Remedial Action resulted in residual concentrations of petroleum hydrocarbons that exceed the Model Toxics Control Act Method A Cleanup Level for soil established under WAC 173-340-740. Some of this soil extends under the existing building and thus could not be excavated. Attached Figures # 4 and # 10 delineate the geographic area subject to the Restrictive Covenant. Areas on the Property outside of the dashed area shown on Figures #4 and # 10 are not subject to this Restrictive Covenant.

Section 1. A portion of the Property contains petroleum hydrocarbon contaminated soil located under the southeast side of Building C, as shown on attached Figures #4 and #10. The City shall not alter, modify, or remove the existing structure (Building C) in any manner that may result in the release or
