TACOMA PUBLIC UTILITIES
SOIL REMEDIATION
NEAR PORT OF TACOMA, PIER 7
TACOMA, WASHINGTON

JULY 2015

TACOMA PUBLIC UTILITIES
Soil Remediation Near Port of Tacoma, Pier 7
Tacoma, Washington
July 2015

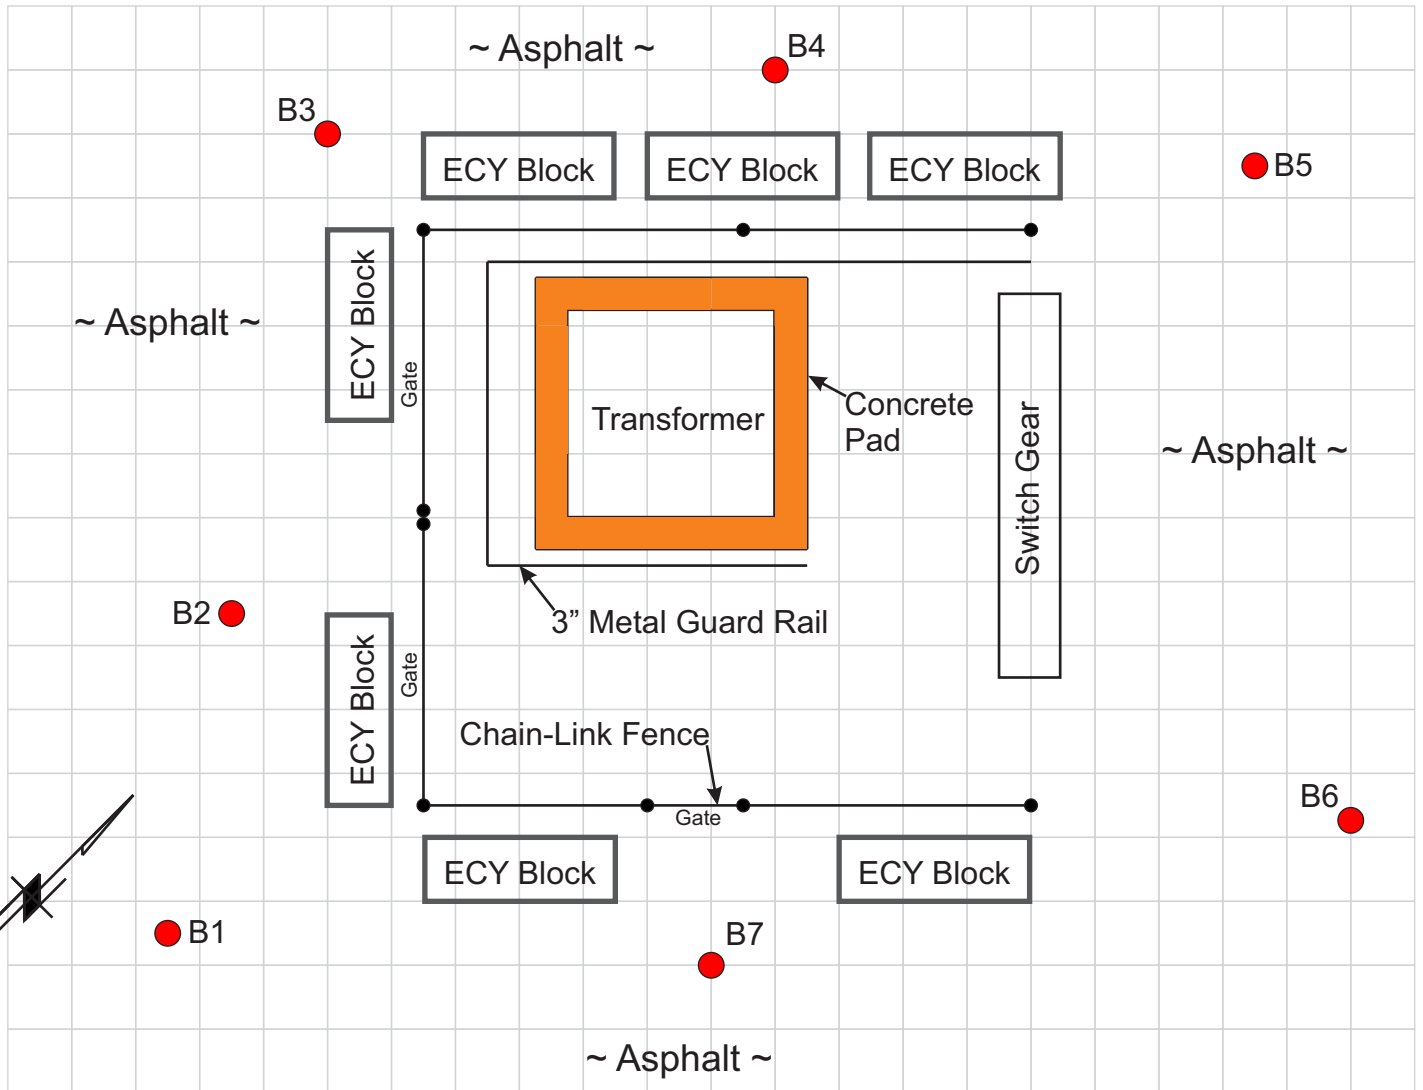
Figure 2
Site and Sample Location Diagram
Tacoma Public Utilities: Pier 7 Transformer Cleanup

Upon removing the pad, impacted soils were observed to be constrained primarily in the small area of the well pad (Figures 2 and 3). Field screening did not indicate impacts to the soils in the other areas directly below the pad. At this point, NRC began to vacuum excavated soils from the area of the release using a Vactor truck (Figure 4). The remedial excavation initially pro-
