**ENVIRONMENTAL CAP
INSPECTION REPORT
FORMER PORTAC FACILITY**

**Order on Consent DE 88-S326 (September 22, 1988)
Washington State Department of Ecology Facility ID # 1215
Inspection Date: February 8, 2017**

March 30, 2017

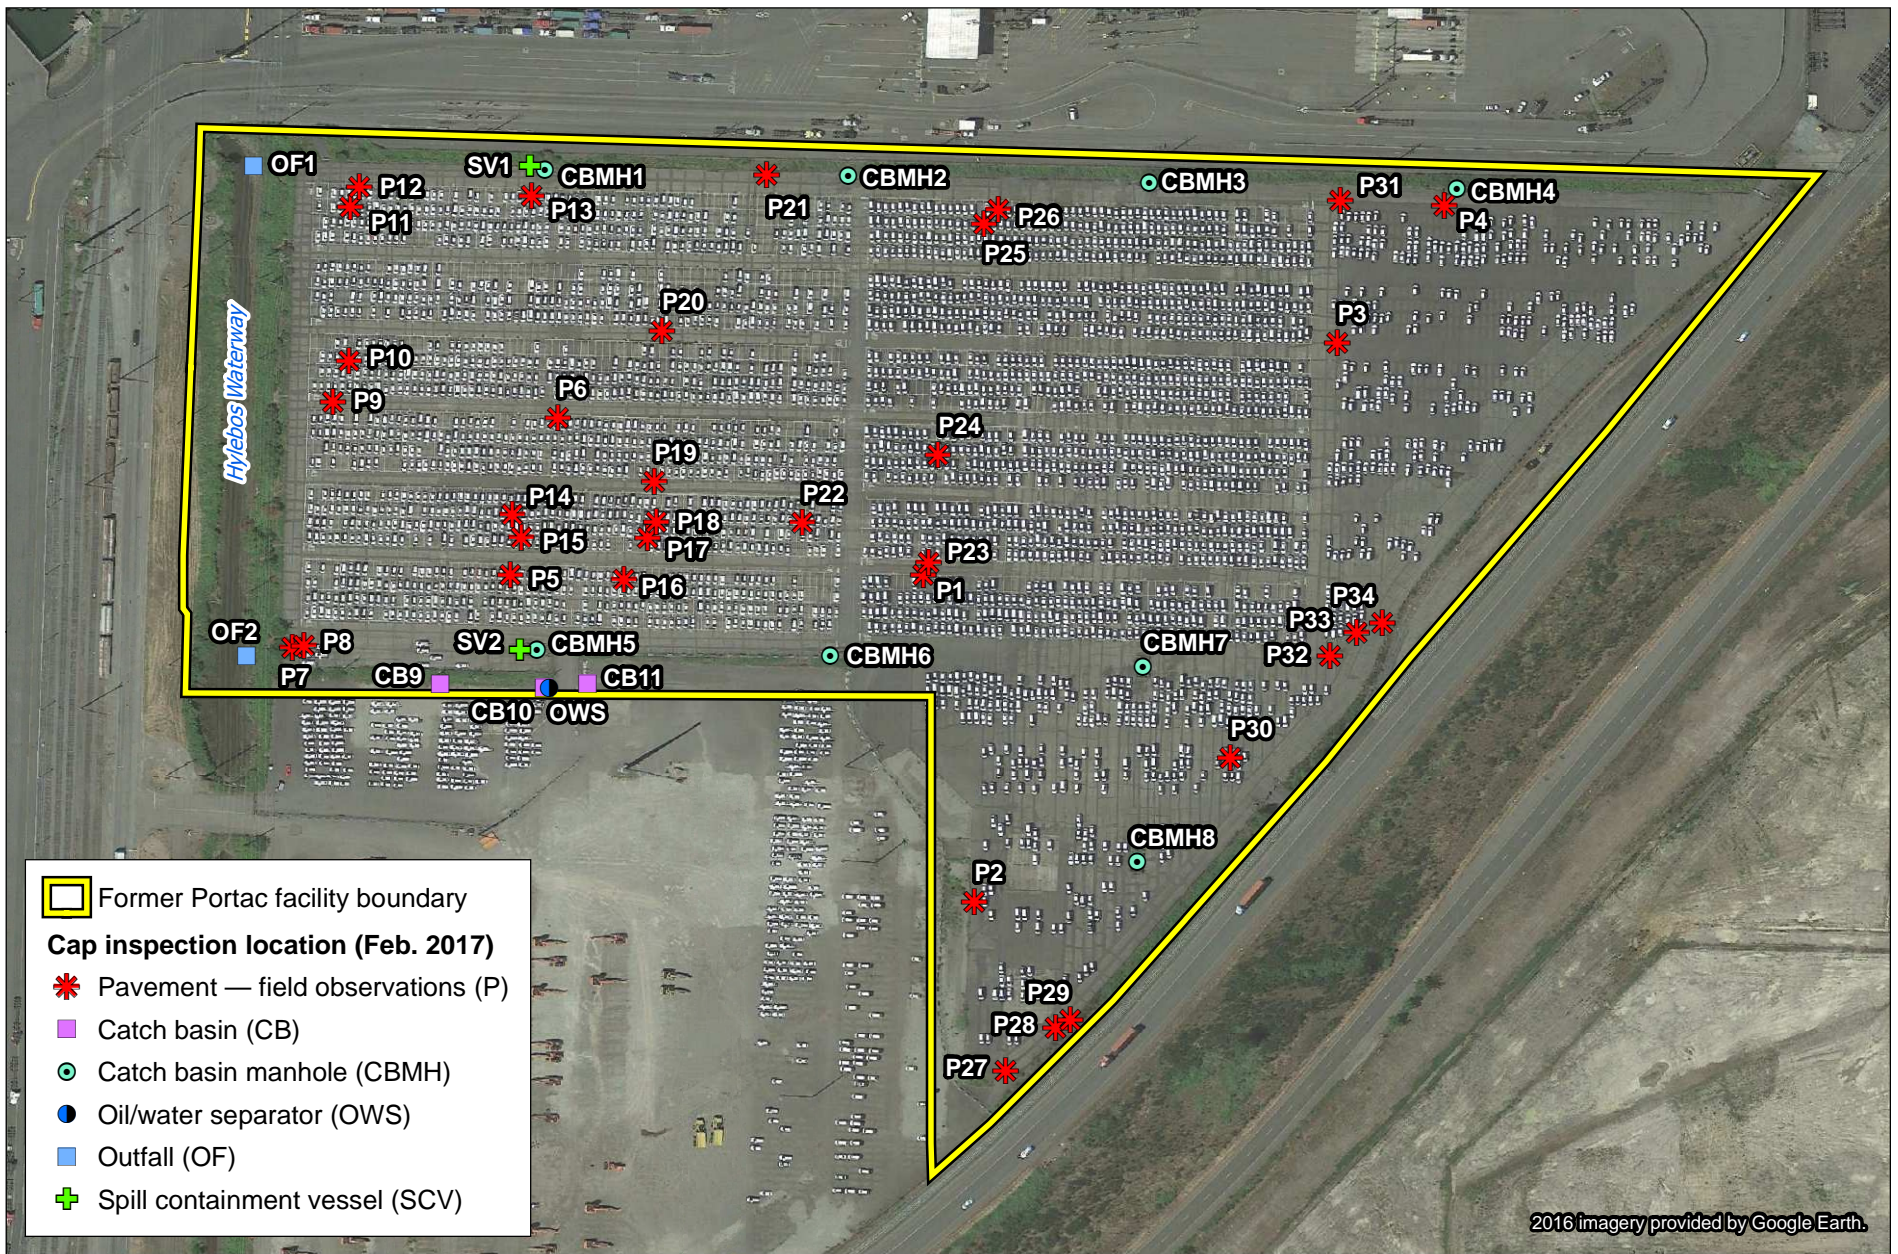
Figure 2. Former Portac facility field observations

At the time of Windward's inspection, the general appearance of the environmental cap at the former Portac facility was good. Numerous cap repairs, including those made with slurry overlay, caulking, and sealant, were observed. However, re-emerging cracks were observed in many of these repaired areas. In general, cracks that seemed to have been repaired in the past with slurry overlay or caulking appeared to exhibit new cracks during the inspection. Some cracks were also observed in areas that had not been previously repaired. Many cracks were narrower than 1/8 in. and therefore did not require immediate repair. Some of the observed cracks, however, were wider than 1/8 in.; these cracks were documented (Figure 2, Appendix A) and should be repaired. Because of the number of narrow, potentially "emerging" cracks that were observed, the next inspection should include another site-wide evaluation of pavement condition.

Moss was observed growing on portions of the caulking used to repair pavement cracks. In some areas, the moss on top of the caulking created the appearance of an open crack where there was none.

Required Inspection Elements	Observed Condition	Recommended Actions
Presence of cracks wider than 1/8 in.	Cracks wider than 1/8 in. were observed throughout the cap.	See Figure 2 and Appendix A for the locations of cracks and recommended repairs.
Sub-base material exposed	No sub-base material was exposed.	none
Pavement edge deterioration	No pavement edge deterioration was observed.	none
Degradation, subsidence, general appearance	No degradation or subsidence was observed.	none

All cracks wider than 1/8 in. and a gouge in the pavement surface have been identified as specified in Appendix A and shown on Figure 2. Since the Site is under an Agreed Order with Ecology to complete a remedial investigation and feasibility study, alternative metrics and methods for cap repair will be evaluated as part of the upcoming Site feasibility study.

All stormwater structures should continue to be maintained under the Port's municipal stormwater permit. The broken grate on catch basin CB10 should be replaced (Figure 2; Table 2). It is also recommended that the broken booms observed at catch basins CB10, CBMH2, CBMH3, CBMH5, and CBMH6 be removed, and that accumulated sediment and debris be removed from inside and around these structures (Figure 2; Table 2).
