## ENVIRONMENTAL CAP INSPECTION REPORT

### FORMER LOUISIANA PACIFIC/ PONY LUMBER FACILITY

Enforcement Order No. DE 92TC-S312 (December 21, 1992)  
Washington State Department of Ecology Facility Site ID# 1209  
Inspection Date: February 15, 2017

March 31, 2017

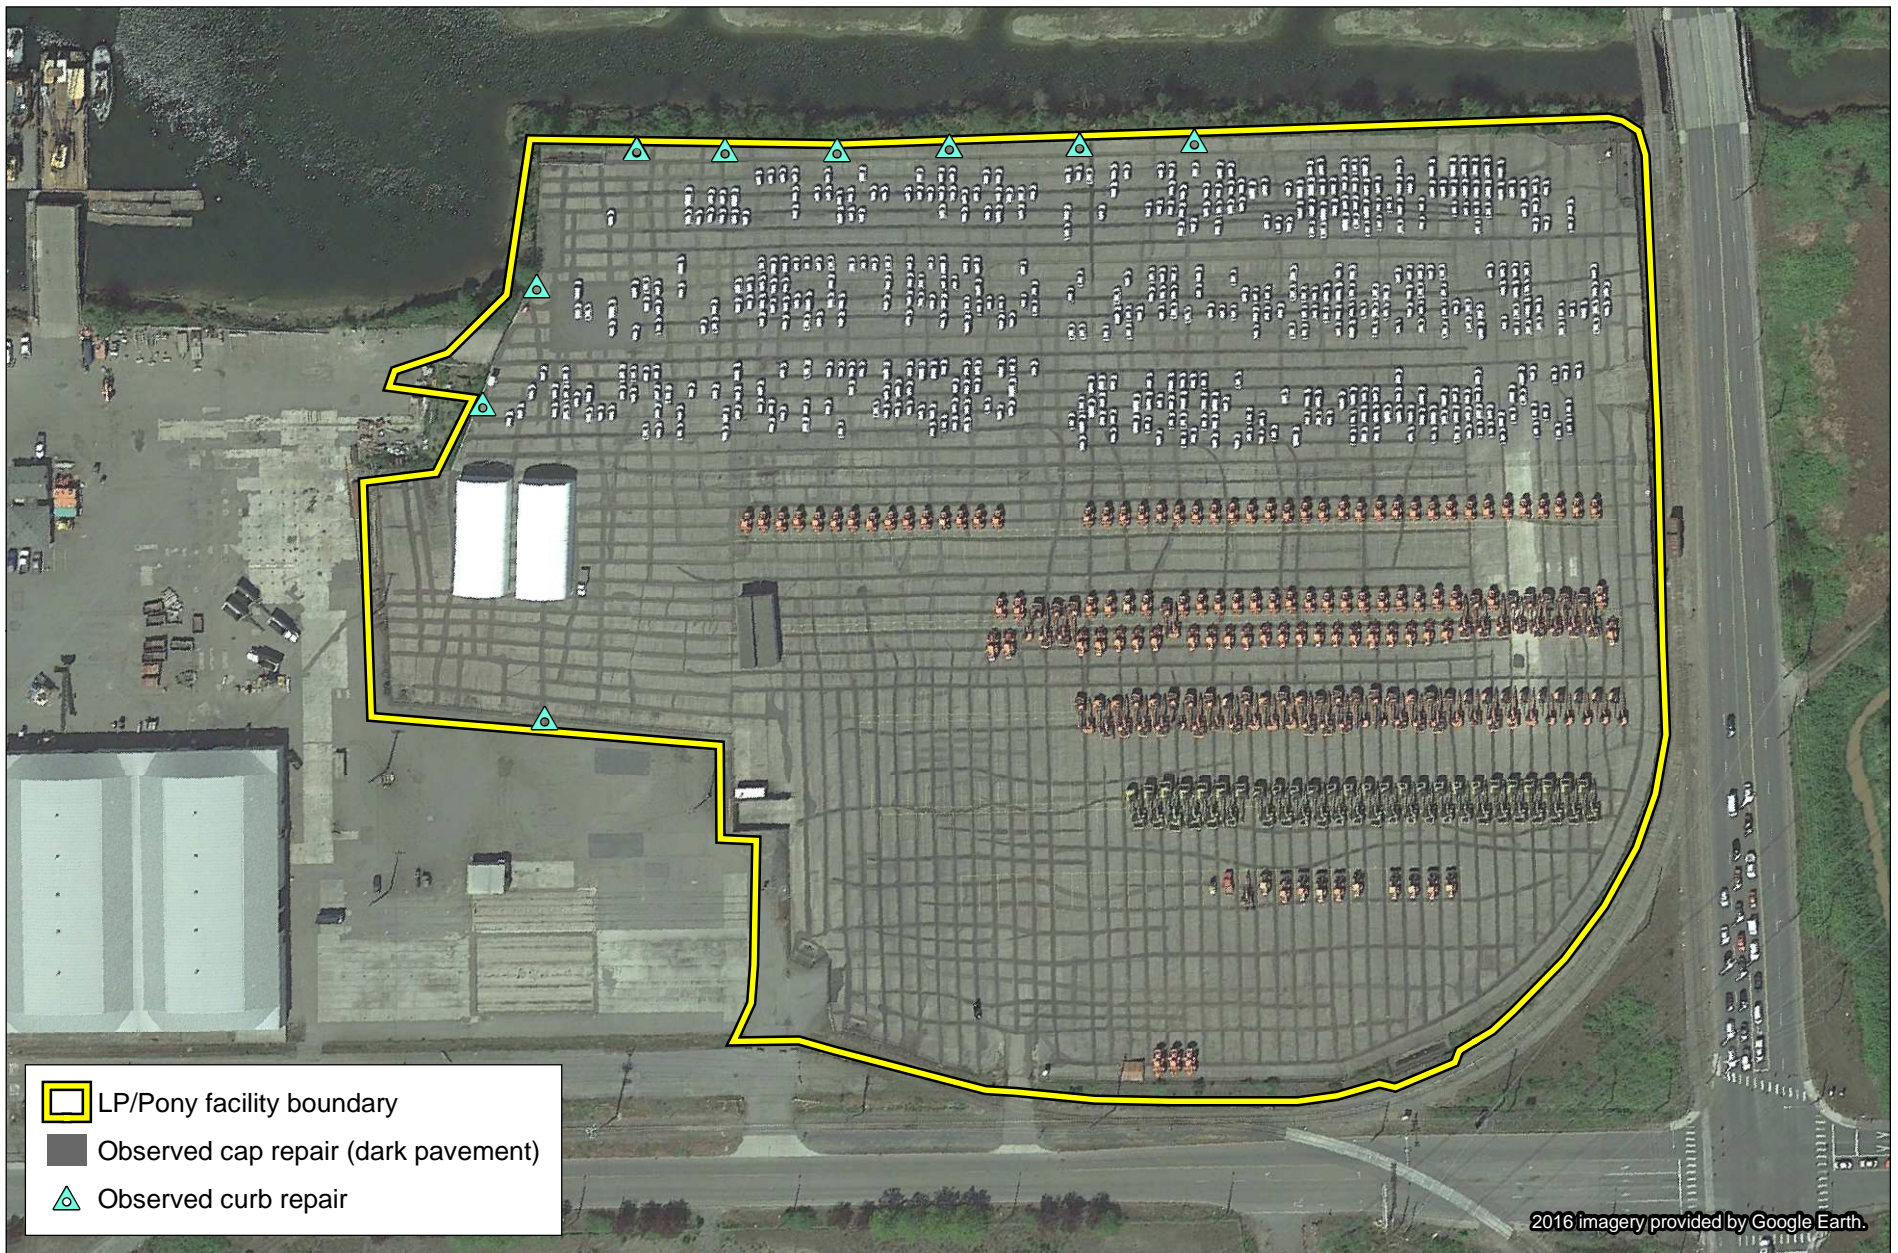
Figure 3. LP/Pony cap repair — 2015

The general appearance of the environmental cap was good. Many cap repairs, including those made with slurry overlays and caulking, were observed. No sub-base material was exposed. The curb surrounding the facility was functioning as intended. Repairs to the curb were observed on the north side of the facility at locations that had been noted for repair during the previous inspection (Hart Crowser 2014). These locations are shown on Figure 3. Table 1 provides a summary of the cap condition observed during the inspection.

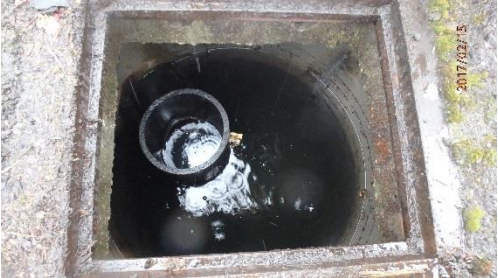
Location ID <sup>a</sup>	Type of Structure	Observed Condition	Sediment Accumulation (inches)	Additional Observations	Recommended Actions	Photos
CB3	catch basin	structurally sound, functioning normally	0	insert in catch basin; no sediment in insert; catch basin elevated relative to surroundings, does not appear to collect substantial flow	none

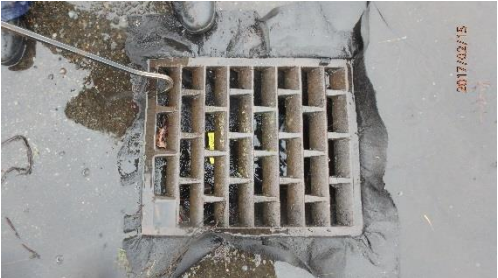
CB4	catch basin	structurally sound, functioning normally	0	insert in catch basin; no sediment accumulation in insert	none

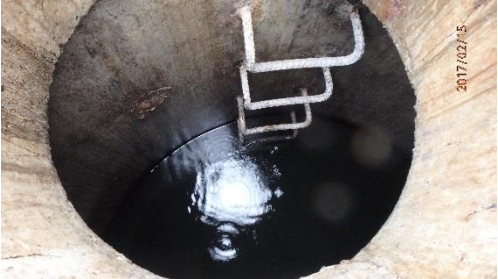
MH1	manhole	structurally sound, functioning normally	structure too deep to measure	no debris inside structure	none

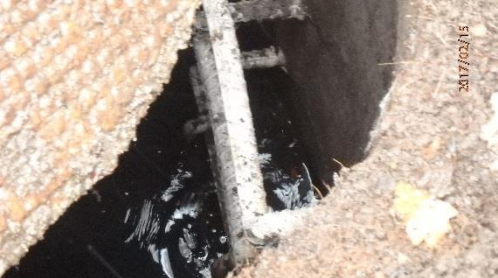
MH2	manhole	structurally sound, functioning normally	structure too deep to measure	no debris inside structure	none

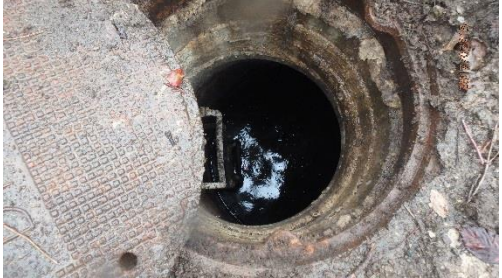
Location ID <sup>a</sup>	Type of Structure	Observed Condition	Sediment Accumulation (inches)	Additional Observations	Recommended Actions	Photos
MH3	manhole	could not locate	nm	none	Observe during next inspection.	[no photo]
MH4	manhole	structurally sound, functioning normally	structure too deep to measure	no debris in structure	none

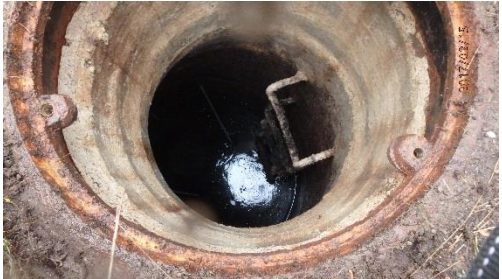
MH5	manhole	structurally sound, functioning normally	structure too deep to measure	no debris in structure	none

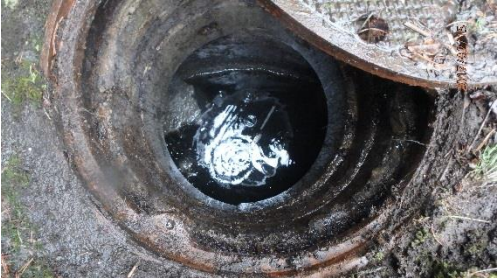
Location ID <sup>a</sup>	Type of Structure	Observed Condition	Sediment Accumulation (inches)	Additional Observations	Recommended Actions	Photos
MH7	manhole	structurally sound, functioning normally	structure too deep to measure	some foam floating in structure	none

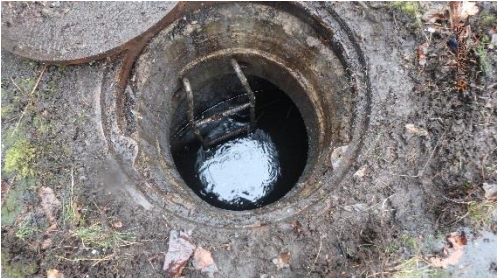
MH8	manhole	structurally sound, functioning normally	structure too deep to measure	no debris in structure	none

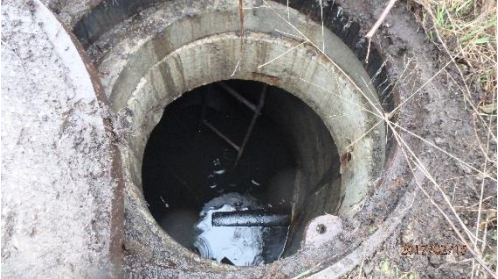
MH9	manhole	structurally sound, functioning normally	structure too deep to measure	no debris in structure; high water level in structure	none

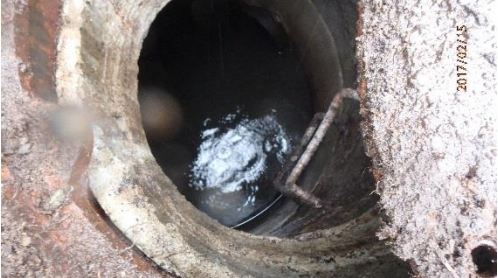
MH10	manhole	structurally sound, functioning normally	structure too deep to measure	no debris in structure	none

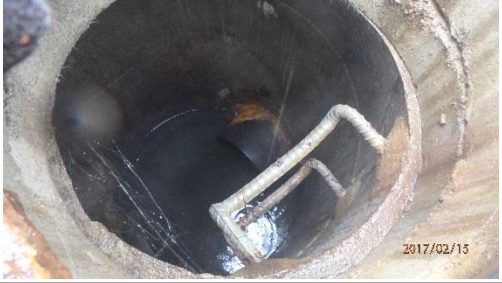
Location ID <sup>a</sup>	Type of Structure	Observed Condition	Sediment Accumulation (inches)	Additional Observations	Recommended Actions	Photos
MH11	manhole	structurally sound, functioning normally	structure too deep to measure	no debris in structure	none

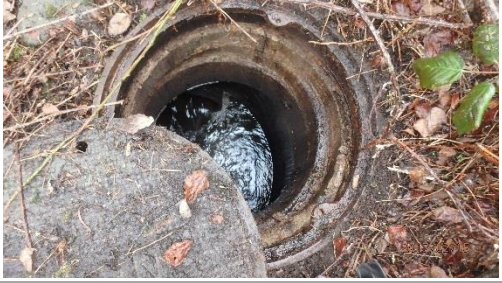
A photograph looking down into a manhole. The interior is dark and appears clean. A metal ladder is visible on the right side. A date stamp '2017/02/13' is in the bottom right corner.
MH12	manhole	structurally sound, functioning normally	structure too deep to measure	no debris in structure; high flow at time of inspection	none

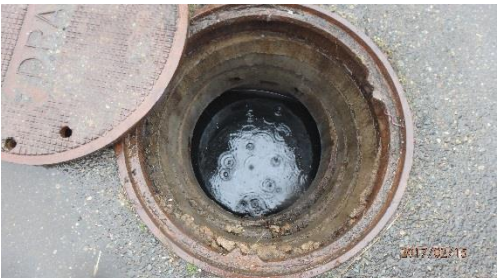
MH16	manhole	structurally sound, functioning normally	structure too deep to measure	high water level	none

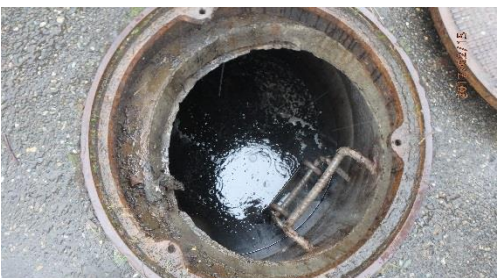
MH17	manhole	structurally sound, functioning normally	structure too deep to measure	high water level; some foam on water surface	none

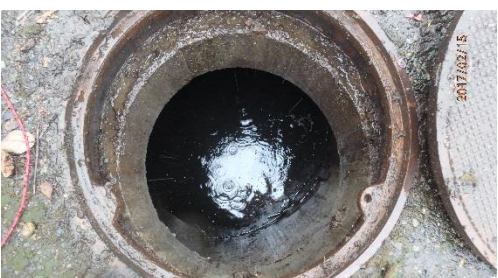
MH18	manhole	structurally sound, functioning normally	structure too deep to measure	no debris in structure	none

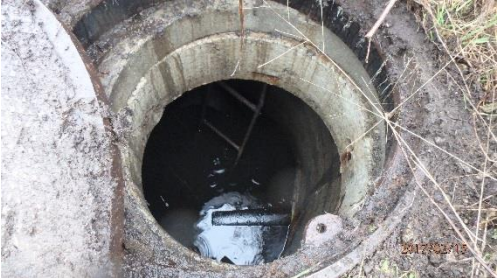
Location ID <sup>a</sup>	Type of Structure	Observed Condition	Sediment Accumulation (inches)	Additional Observations	Recommended Actions	Photos
MH19	manhole	structurally sound, functioning normally	structure too deep to measure	no debris in structure	none
