PHOTOGRAPH LOG

Environment and Infrastructure, Inc.
7376 SW Durham Road
Portland, Oregon 97224

PROJECT NAME: Pasco Landfill Cap Project - Cap Construction Project

Project No: 4-61M-10705-1 P-02

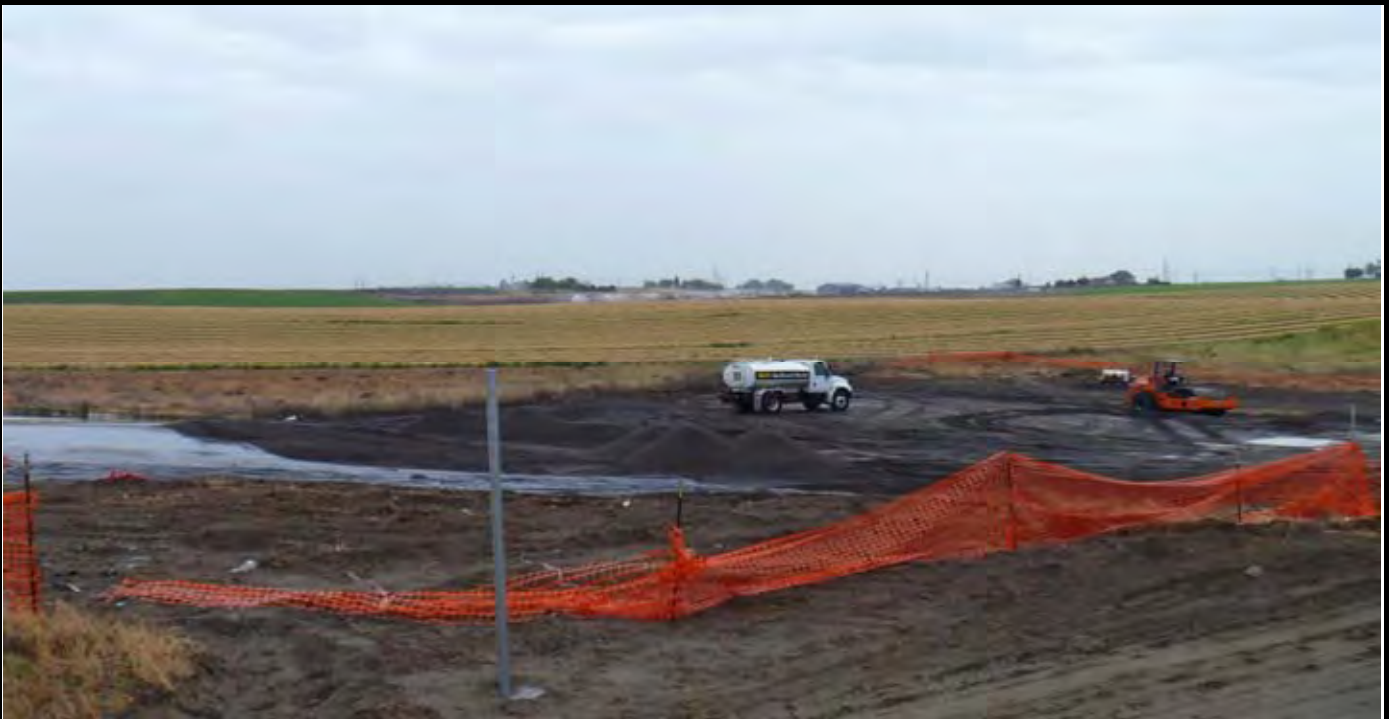
Photo 1: View of the site at the beginning of work for the day. View looking to the SE towards the Roller. Note that all of the surface is wet due to early morning rain.

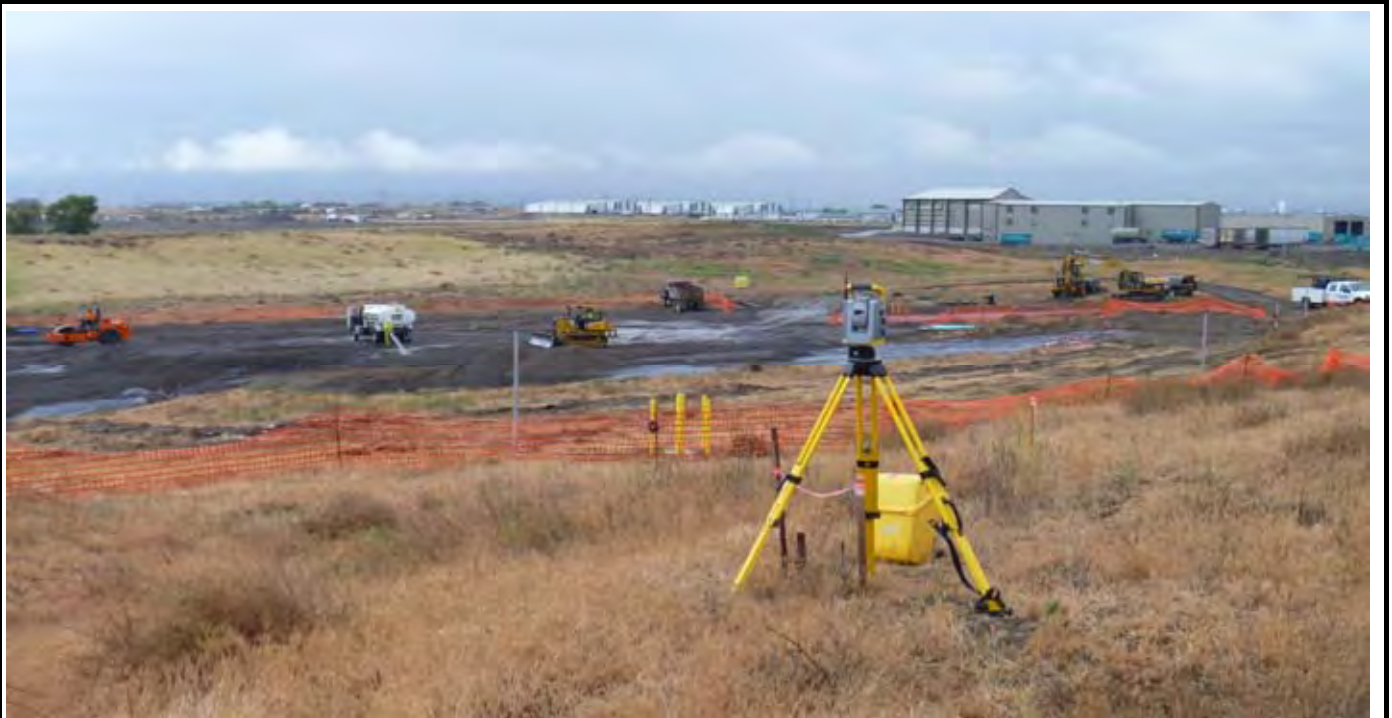
Photo 2: View of the site and AEC's surveyor setting up over northern control point to set out stakes for G-layer grade. View looking south from northern end of site.

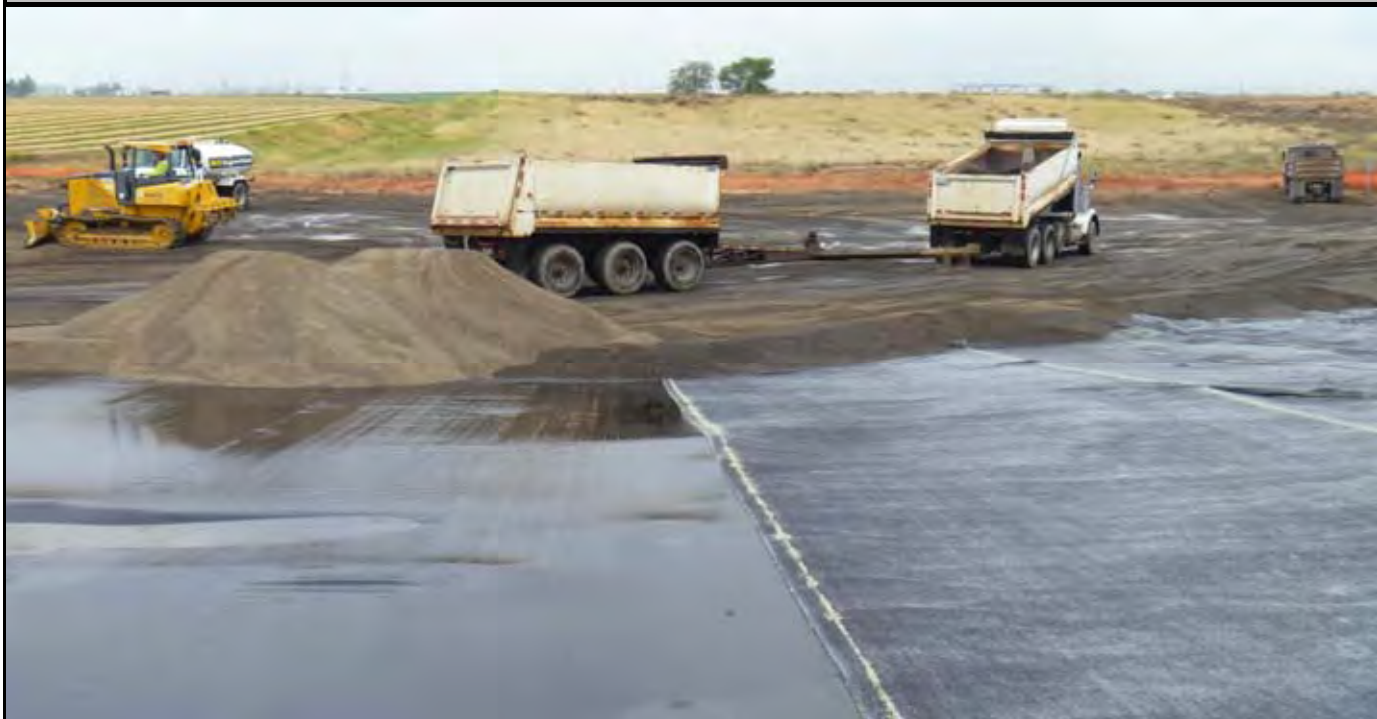
Photo 3: View of gravel trucks dropping gravel on G-layer on top of old GCL rolls and original cap liner. View looking south from northern edge of original cap liner.

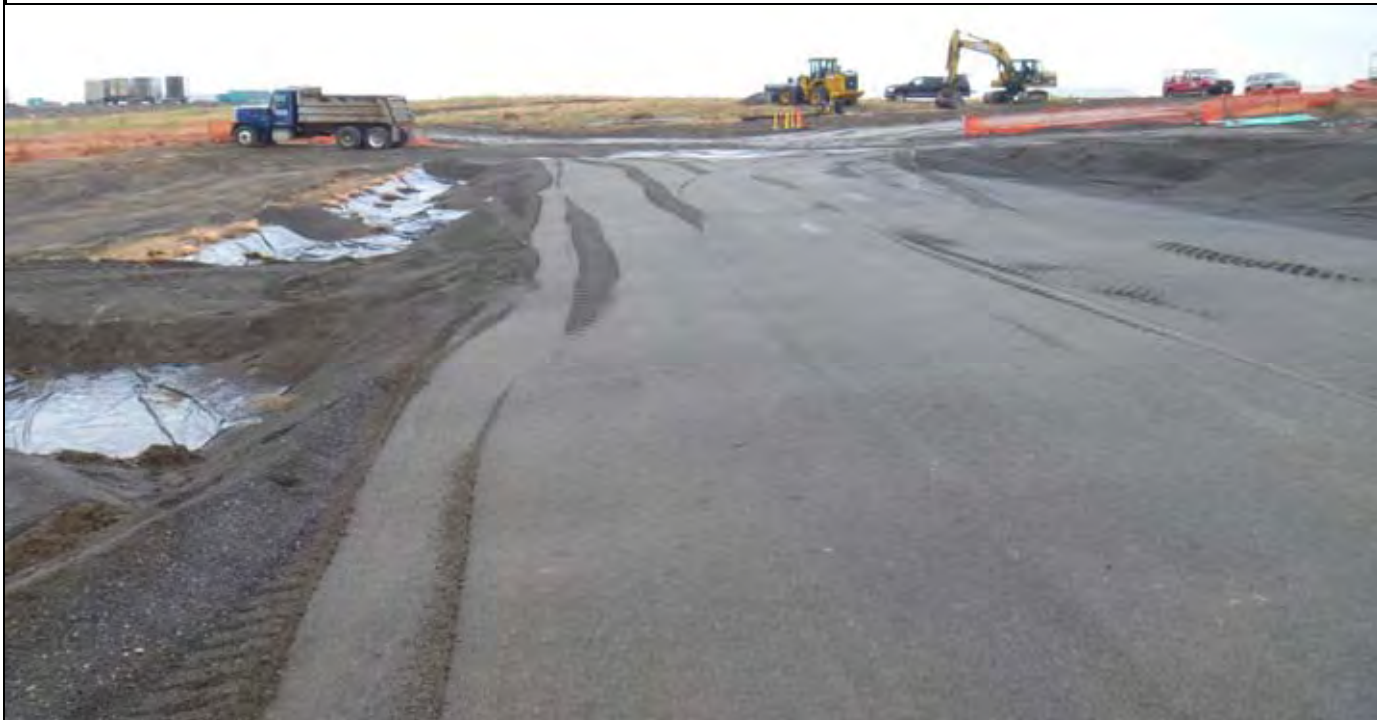
Photo 4: View of the southern edge of the G-layer. Note southern edge of shallow excavation on left site. View of site looking west from area near southern end of AE-4.

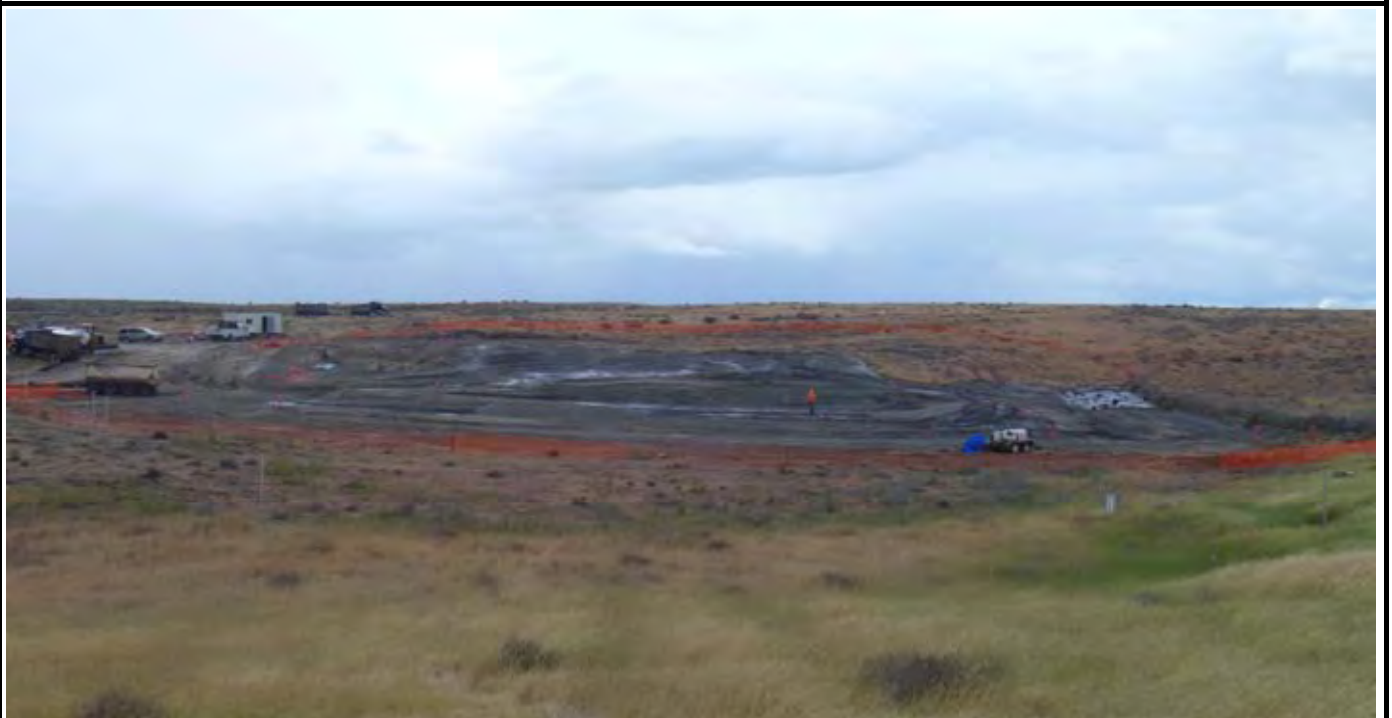
Photo 6: View of the site from the end of the day. Note that almost all of the original cap liner is cover (except for small area on NE corner) with G-layer gravel. View looking north from area beyond southern end of site.

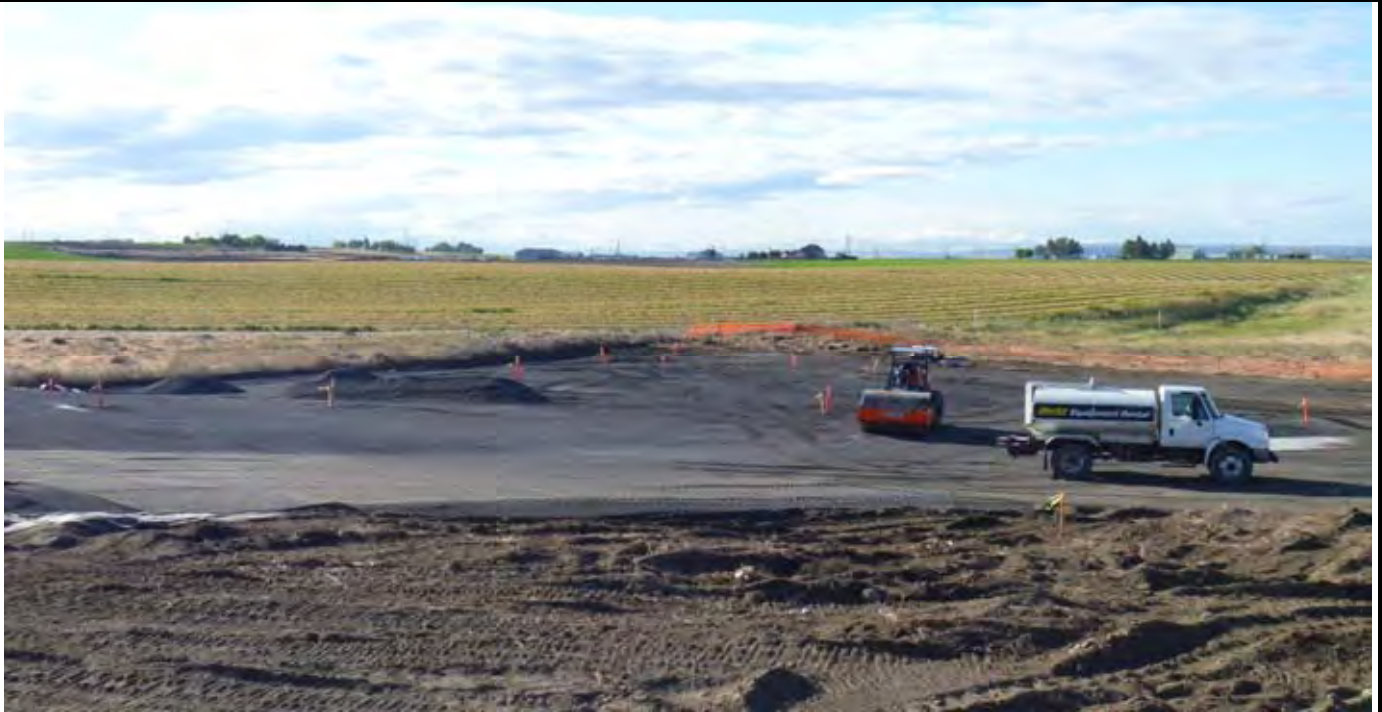
Photo 1: View of the site at the beginning of work for the day. View looking to the South / SE towards the roller.

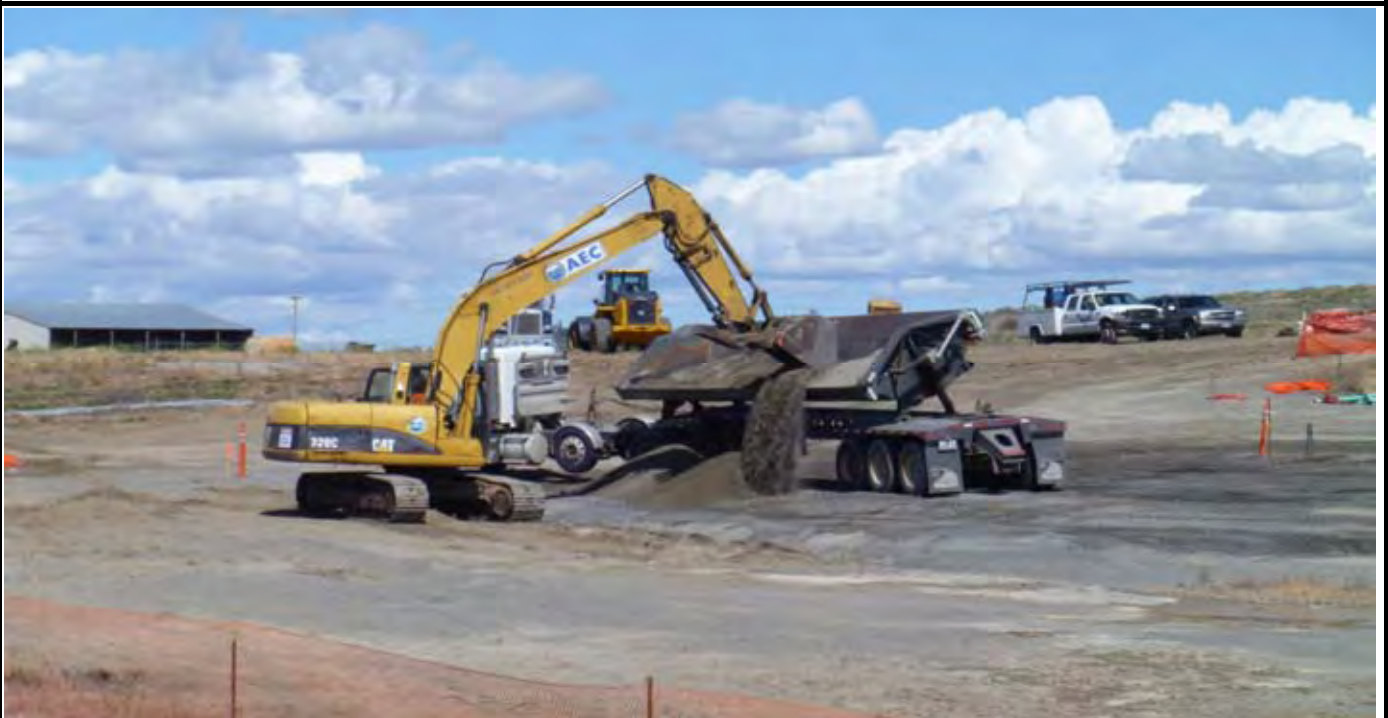
Photo 2: AEC using the trackhoe to empty the gravel from the trailer that is having mechanical issues. View looking west from SE corner.

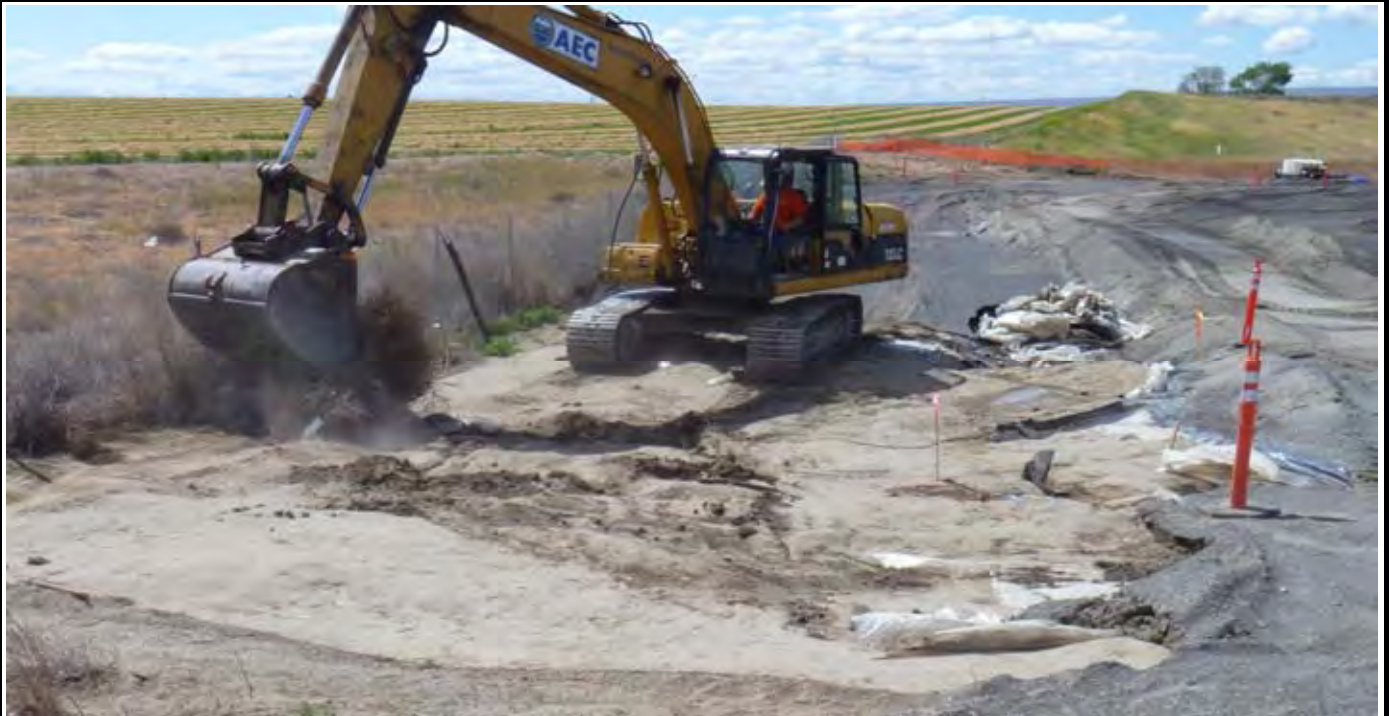
Photo 3: View of AEC trackhoe cleaning up sand area along the eastern edge of the site. View looking south from NE corner.

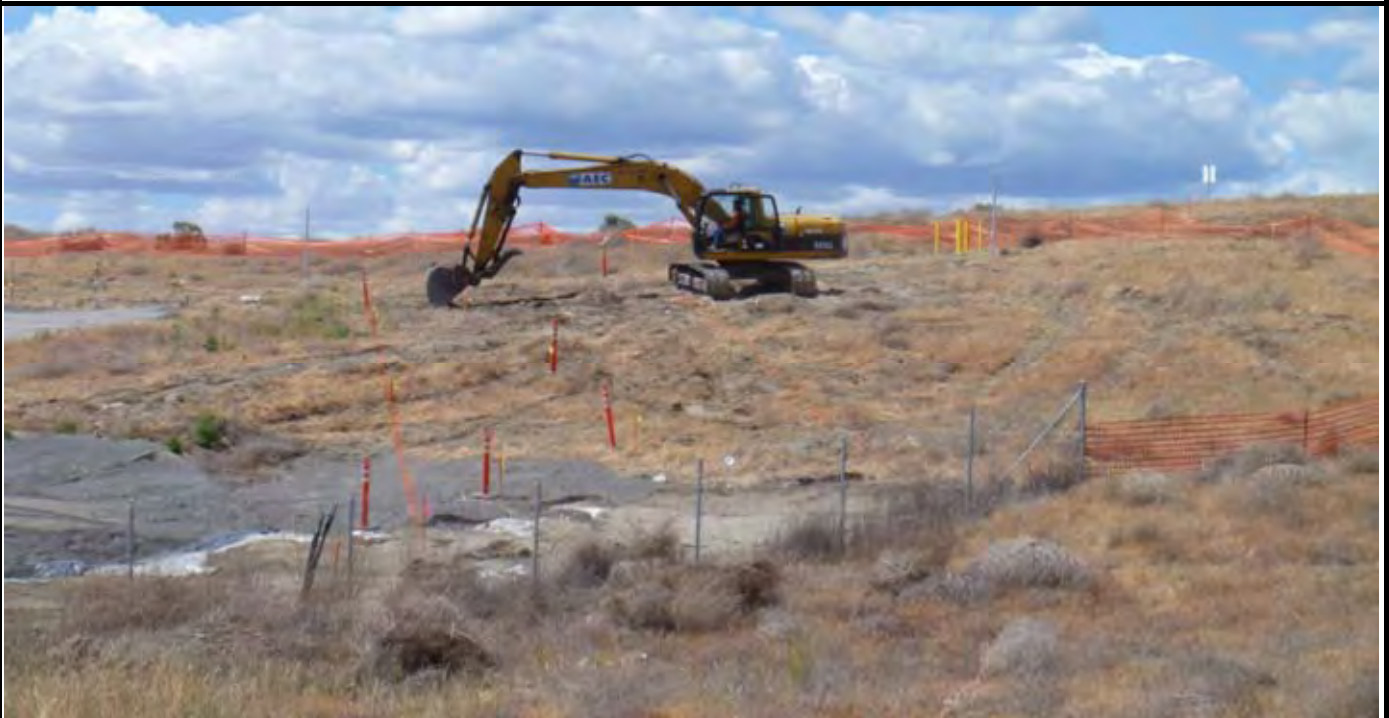
Photo 4: AEC begins grubbing for NE swale area. Note orange lines that locate the EOL and EOC for the NE swale. View looking North to Northwest from east side of site.

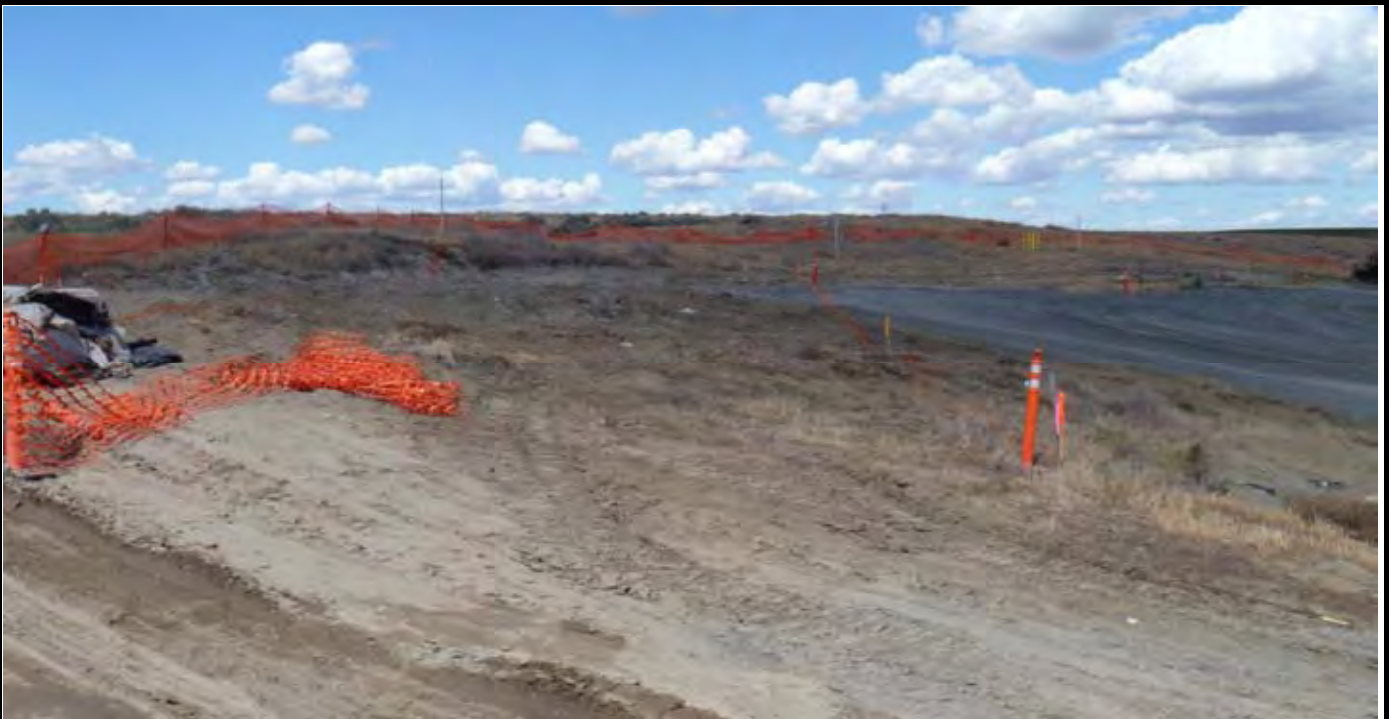
Photo 5: View of the layout lines (orange) for NW swale between the EOC and EOL. View looking NE from the western edge of the site.

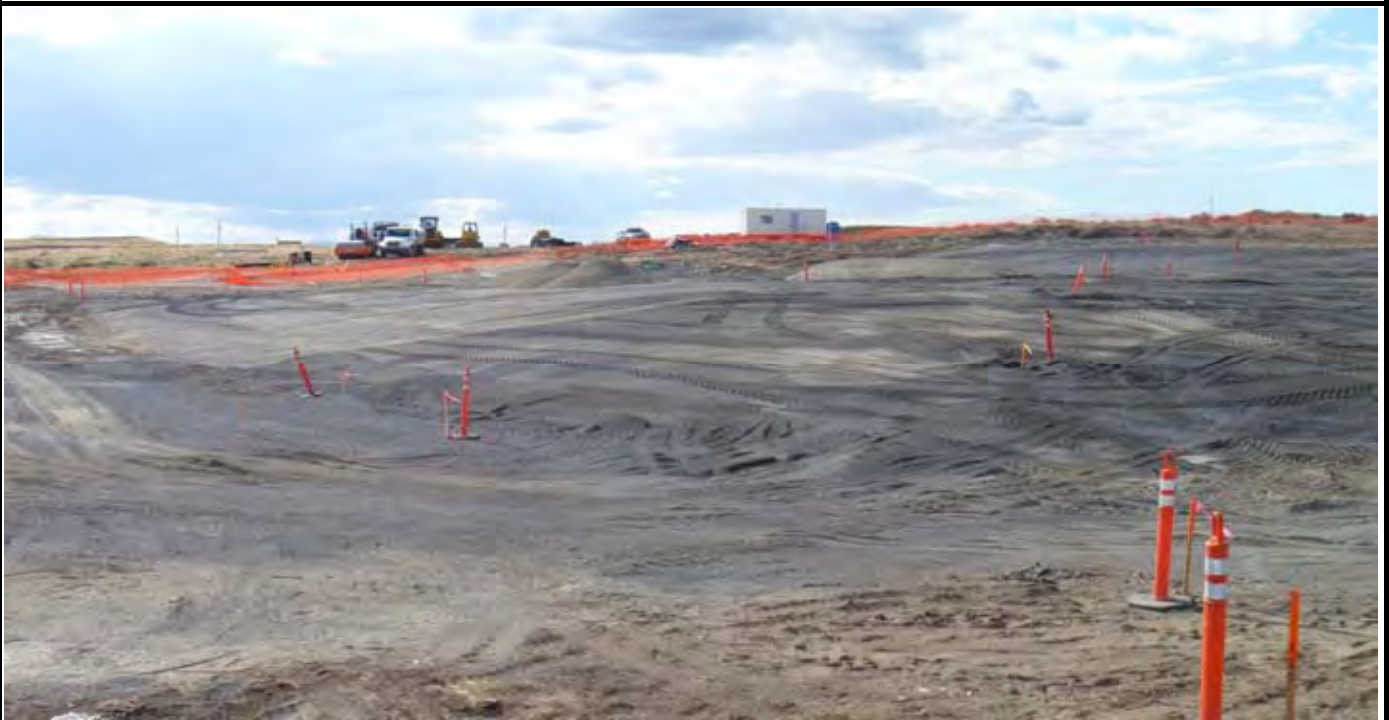
Photo 6: View of the south side of the cap at the end of the day. The G-layer is near final G-layer grade. View looking NW towards the job trailer.

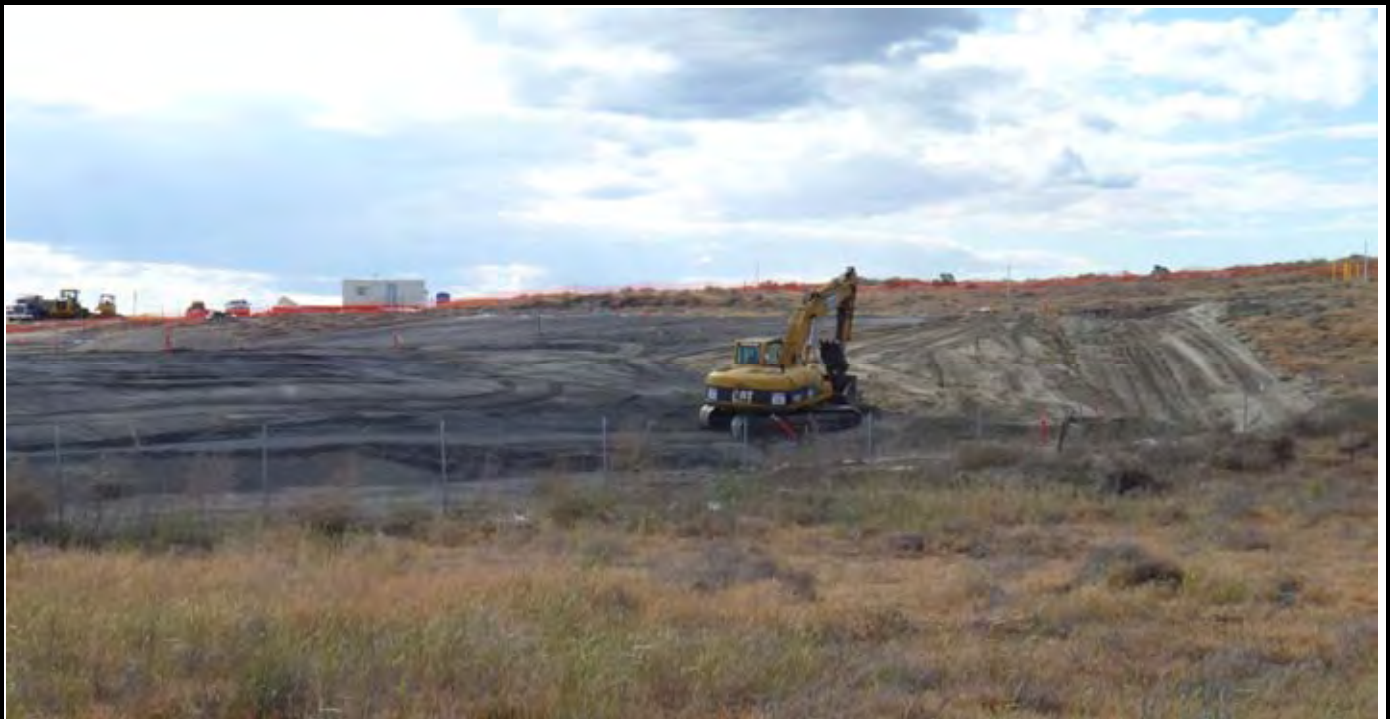
Photo 7: View of the NE swale after grubbing work at the end of the day. View looking NW from eastern side of the site.

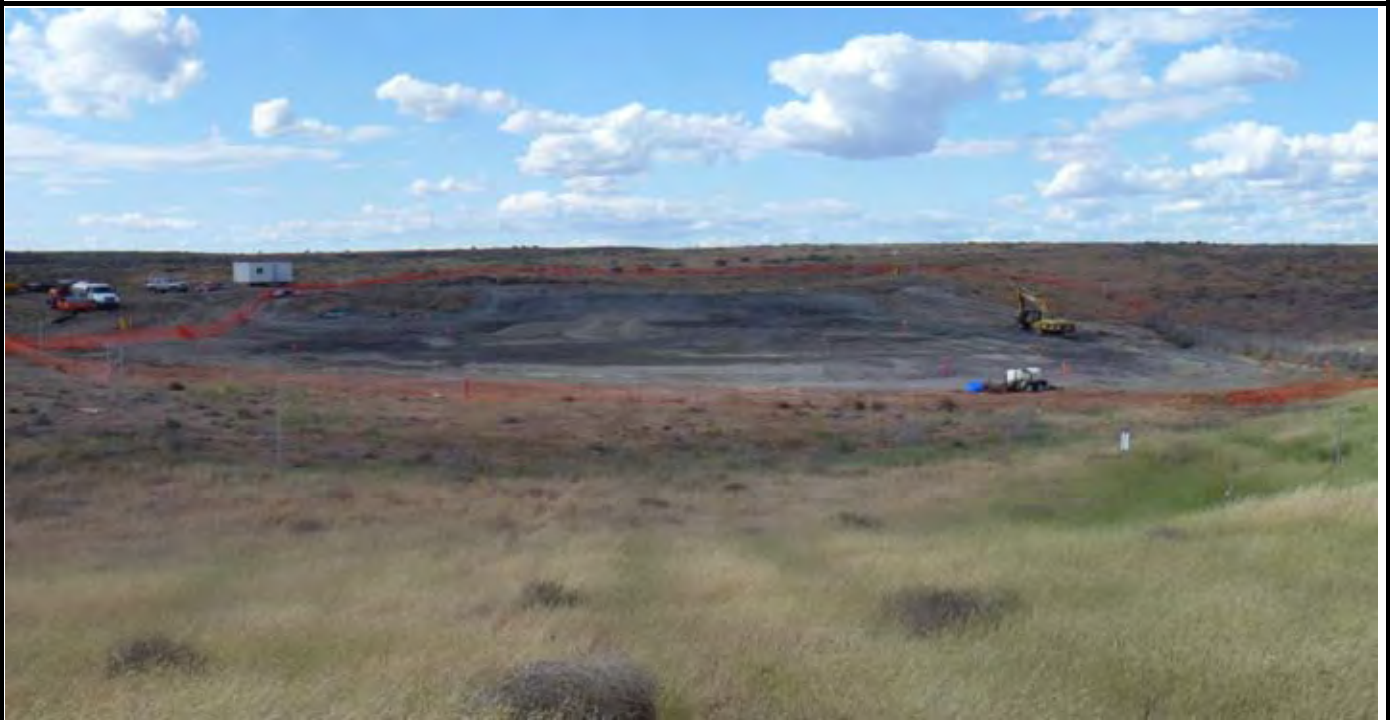
Photo 8: View of the site from the southern end of the property. View looking north.

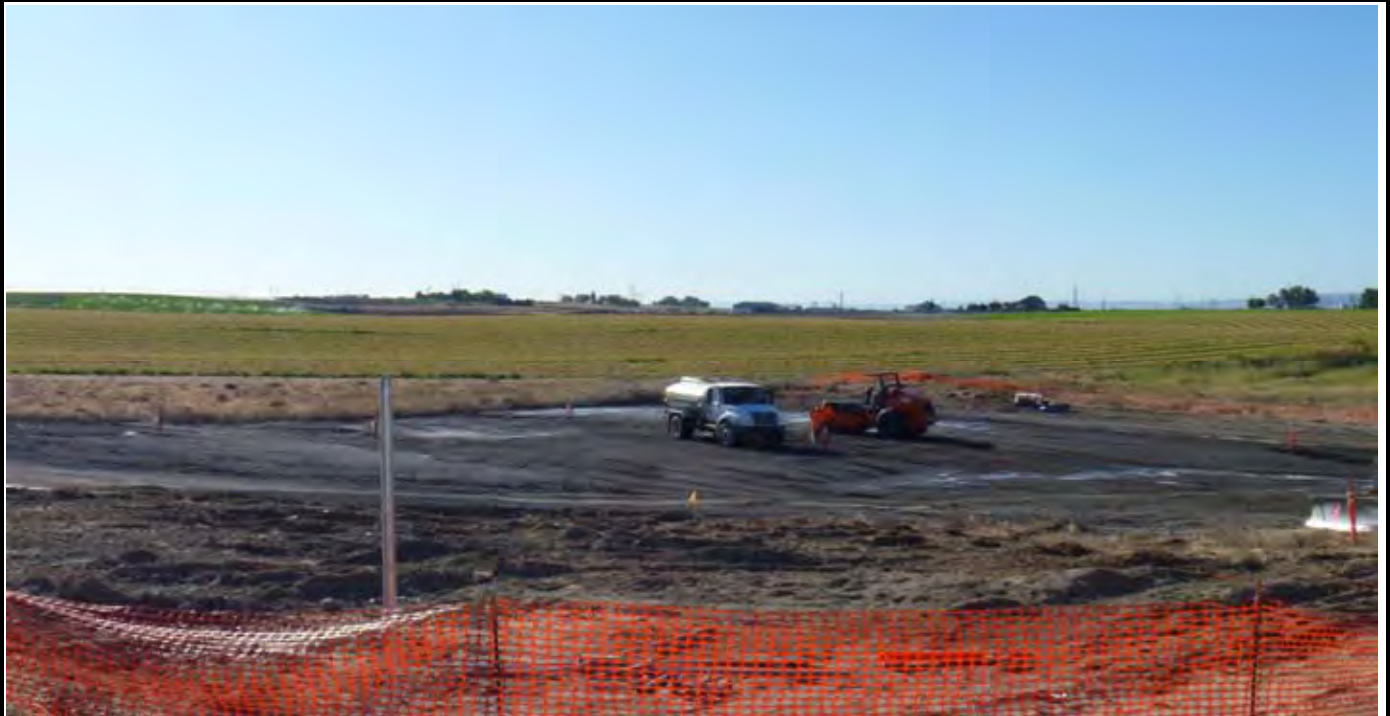
Photo 1: View of the site at the beginning of work for the day. View looking to the South / SE towards the roller.

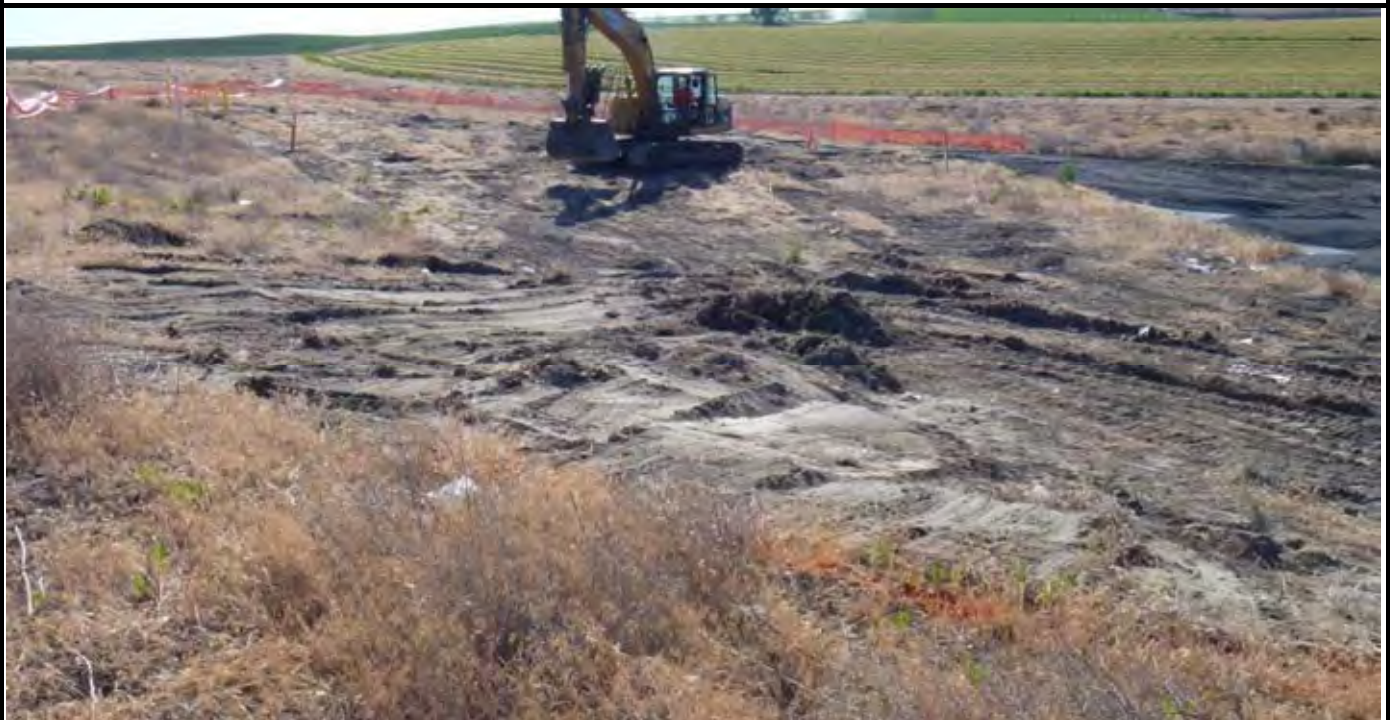
Photo 2: AEC beginning grubbing work on northern end of the site between Edge of Cap and Edge of Liner extension. View looking to the east from the NW corner of the site.

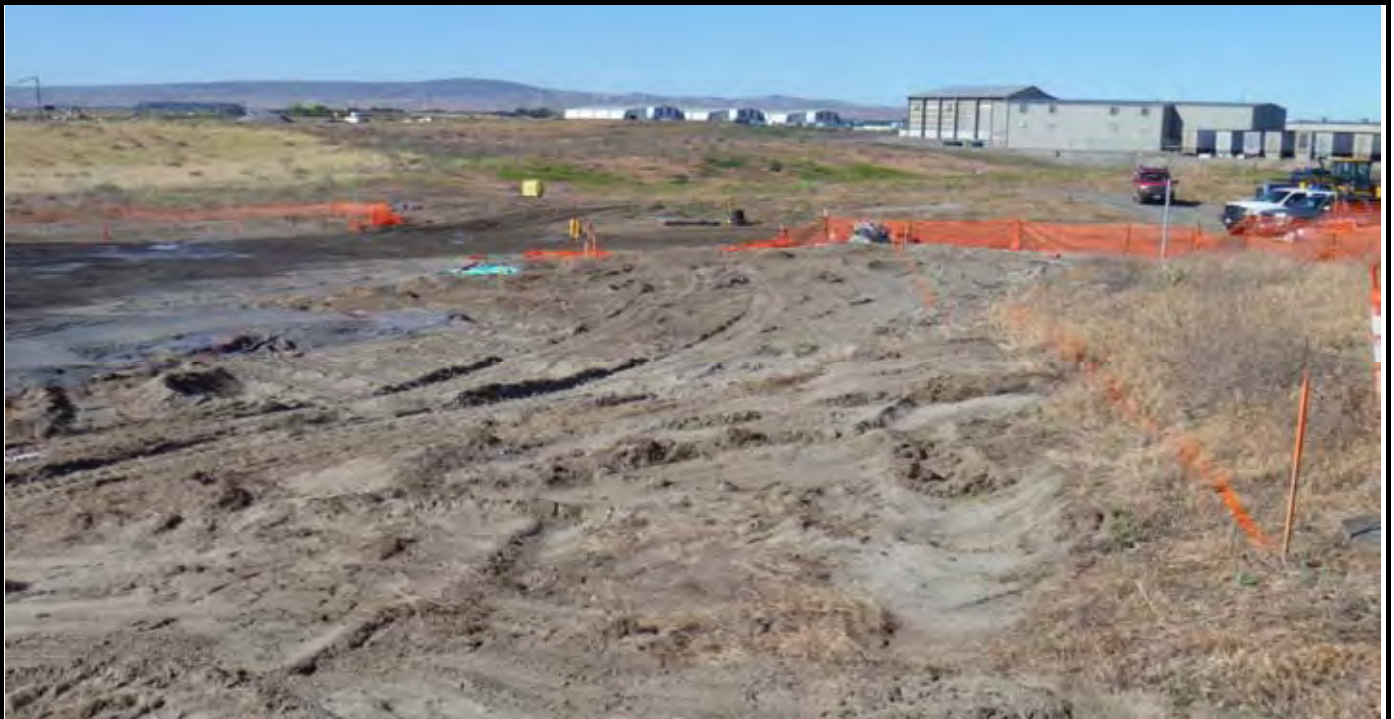
Photo 3: View of the Liner extension area / NW swale area prior to grubbing work by trackhoe. Note orange line denoting edge of liner extension. View looking to the southwest from the northwest corner of the site.

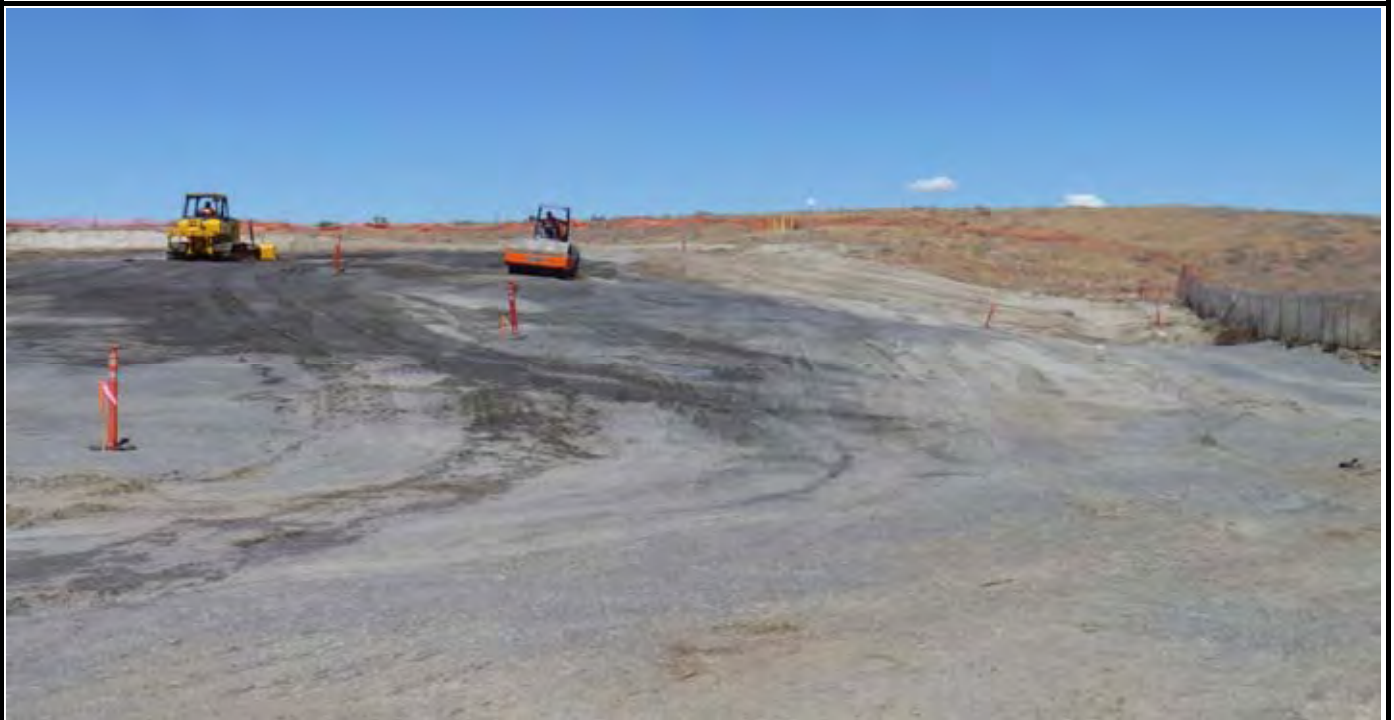
Photo 4: View of the eastern side nearing completion and the NE corner / swale area after grubbing completed. View looking north from the SE corner of the site.

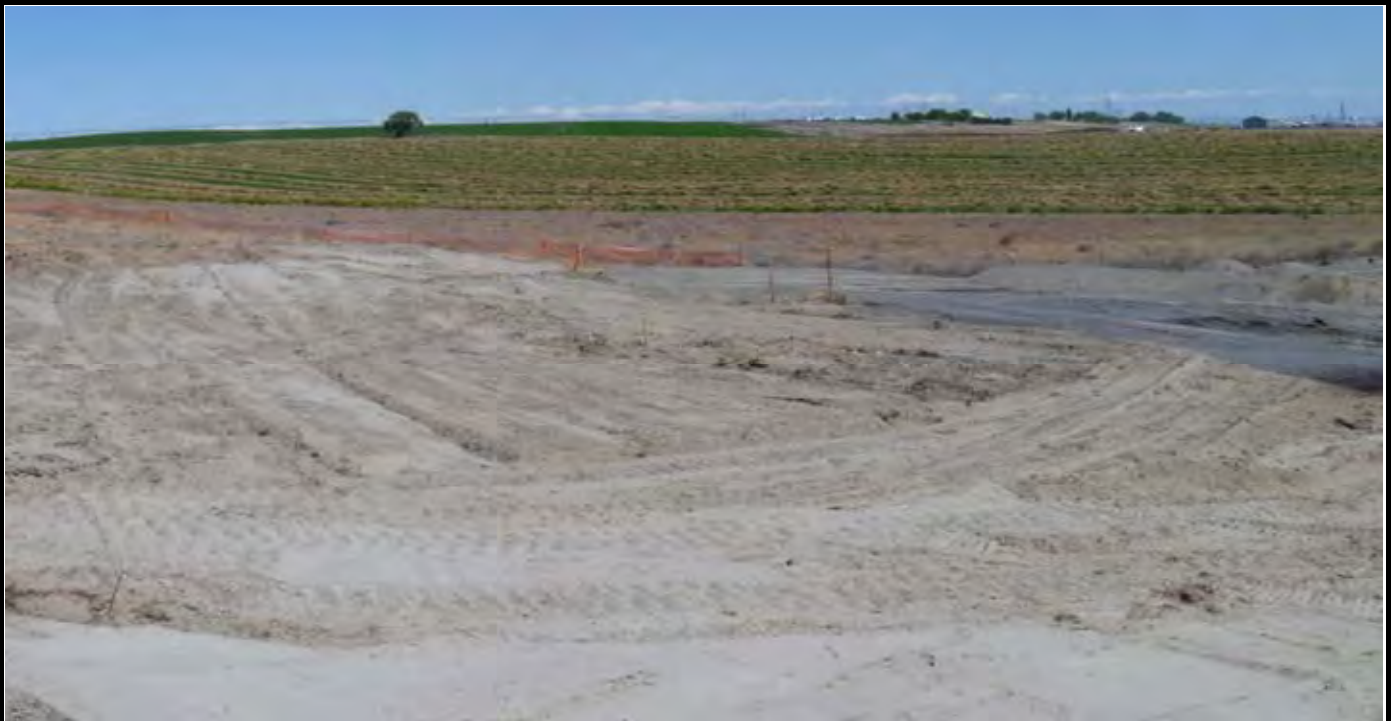
Photo 5: View of the northern end of the liner extension area after majority of grubbing completed. View looking to the east from the NW corner of the site.

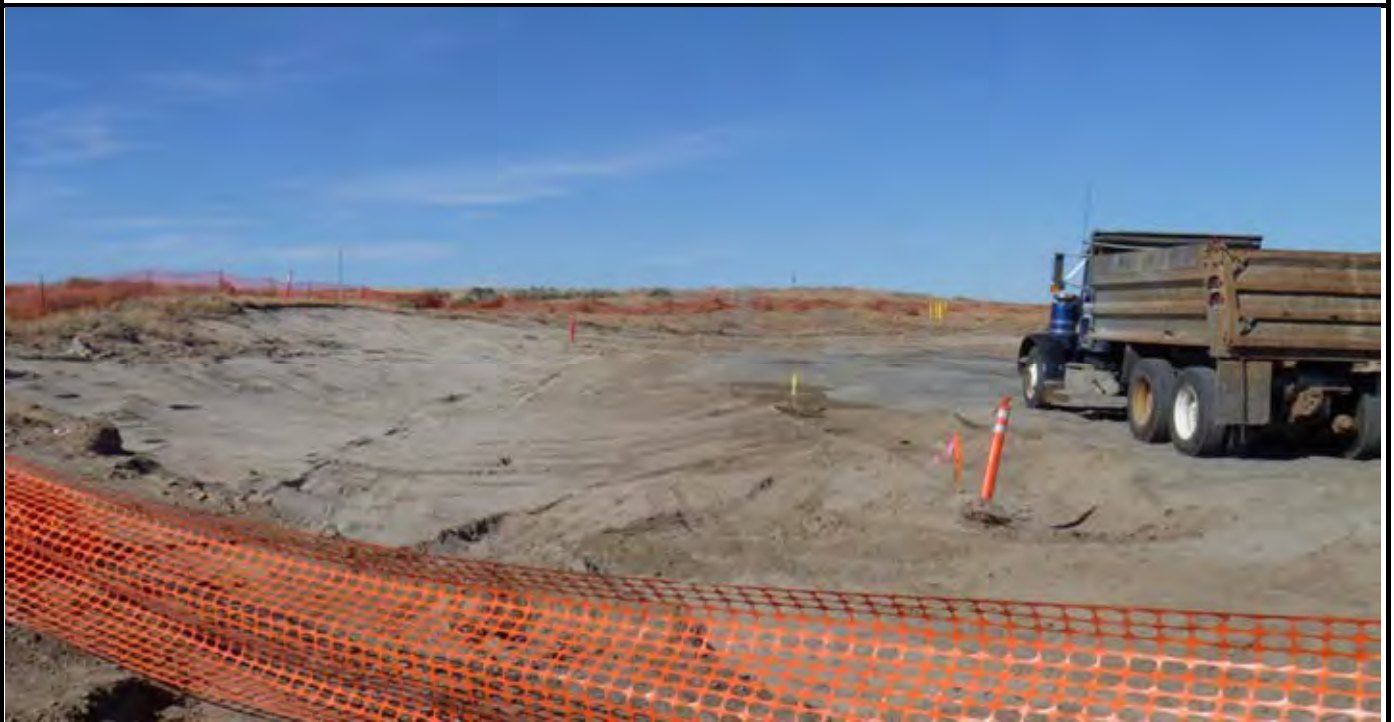
Photo 6: View of the NW corner of the liner extension/swale area after grubbing work. View looking NE from the western side of the site.

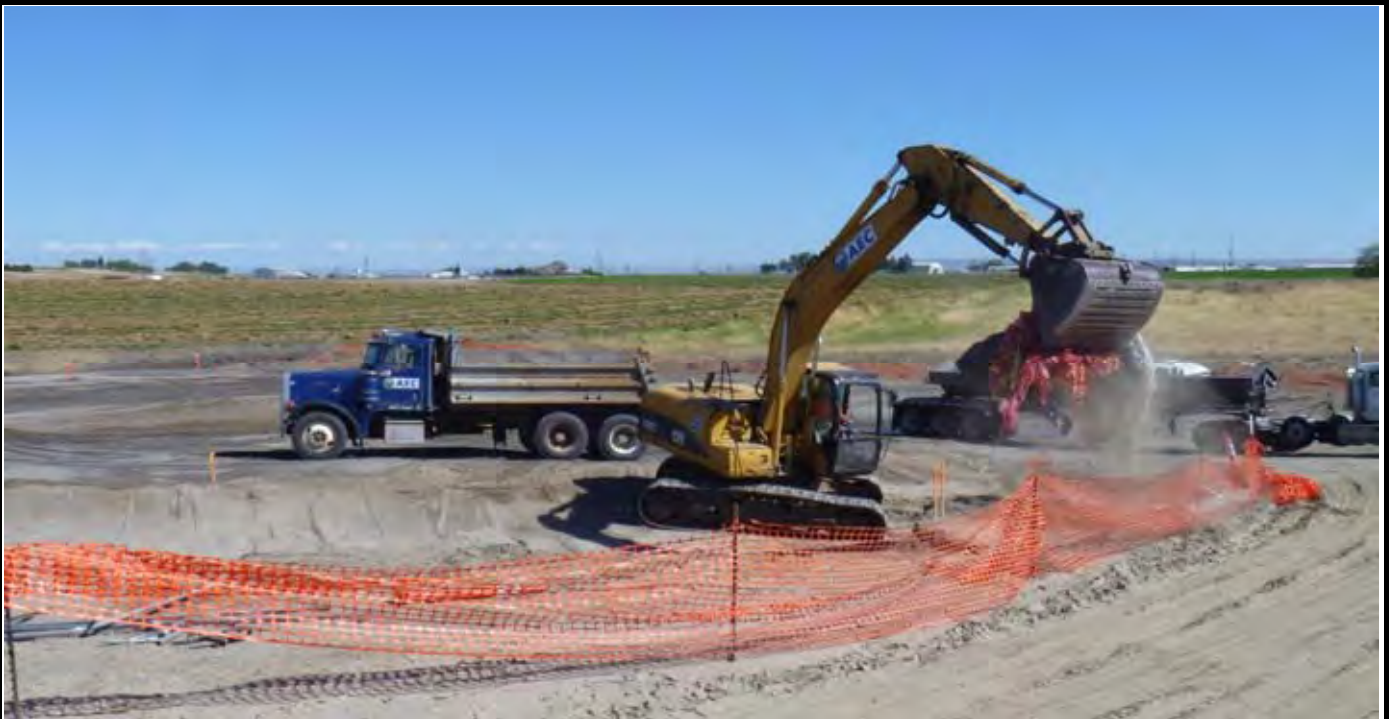
Photo 7: View of the AEC trackhoe loading remaining debris and garbage into the AEC dump truck along the western side of the site. View looking to the SE from the NW corner of the site.

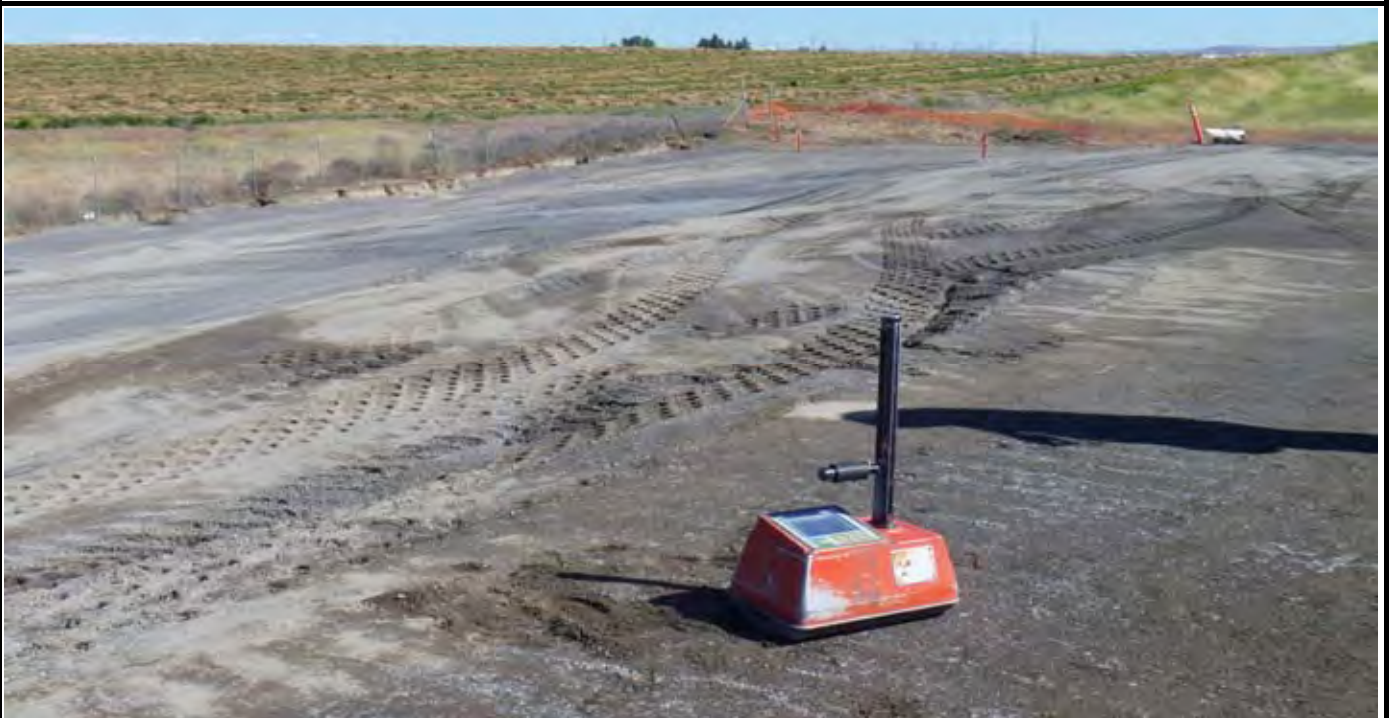
Photo 8: View of compaction density testing along the eastern side of the G-layer. View looking to the SE from the northern end of the CAP area.

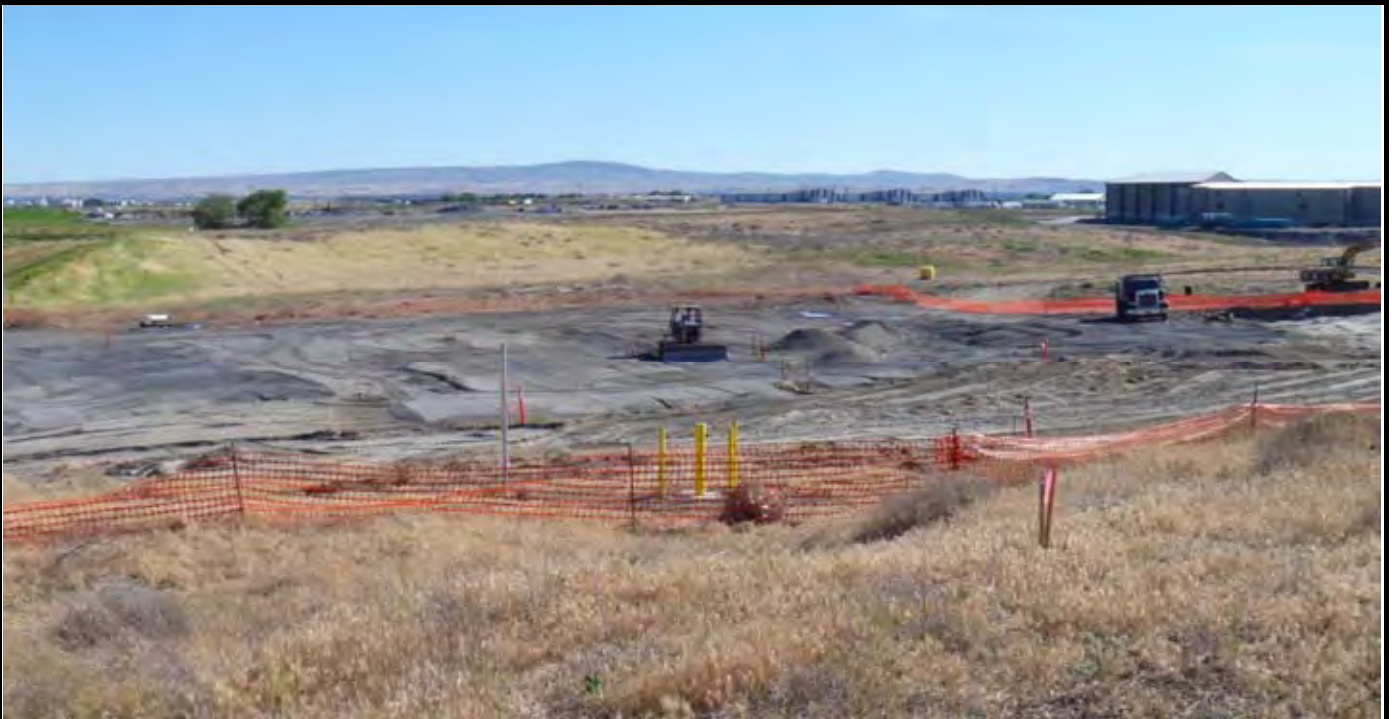
Photo 9: View of the site at the end of the work day. View looking to the south from beyond the northern end of the site.
