PHOTOGRAPH LOG

Environment and Infrastructure, Inc.
7376 SW Durham Road
Portland, Oregon 97224

PROJECT NAME: Pasco Landfill Cap Project - Cap Construction Project

Project No: 4-61M-10705-1 P-02

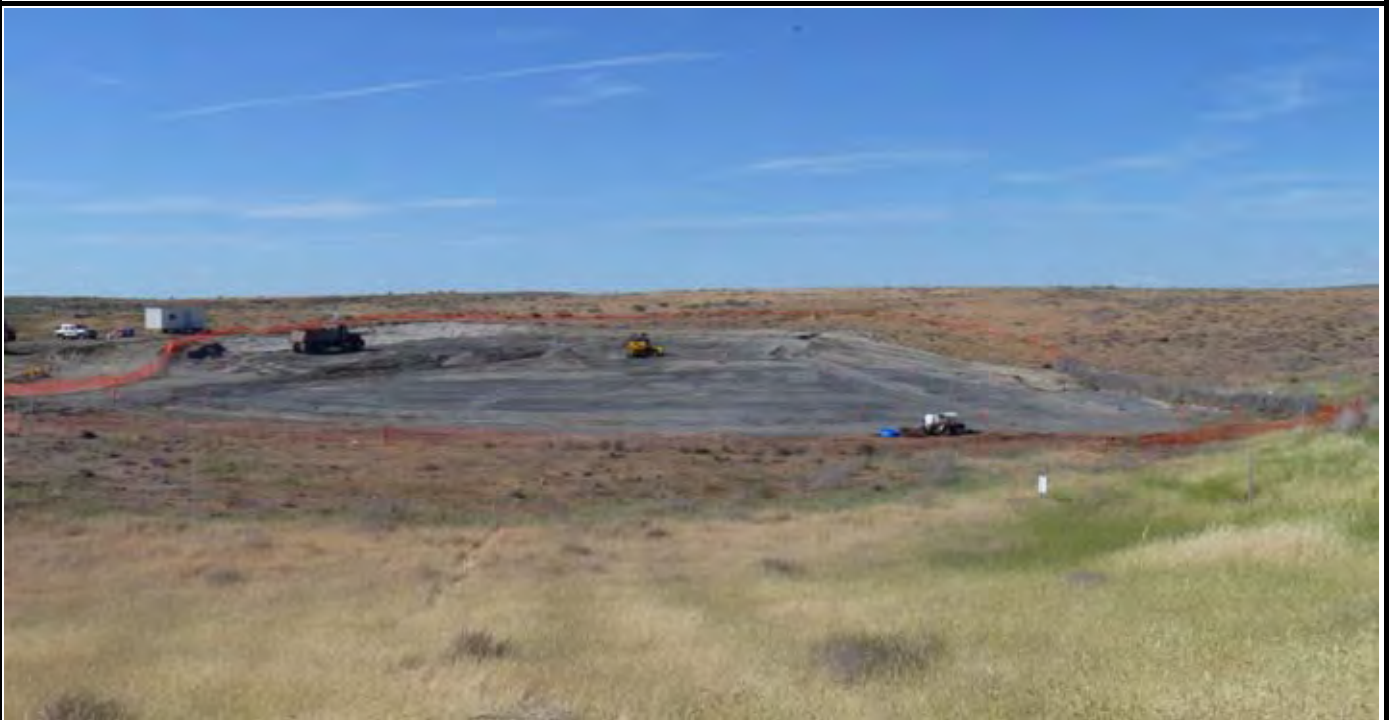
Photo 10: View of the site at the conclusion of work for the day. Orange construction fence is up around the site and all crews gone. View of the site looking north from beyond the southern edge of the site.

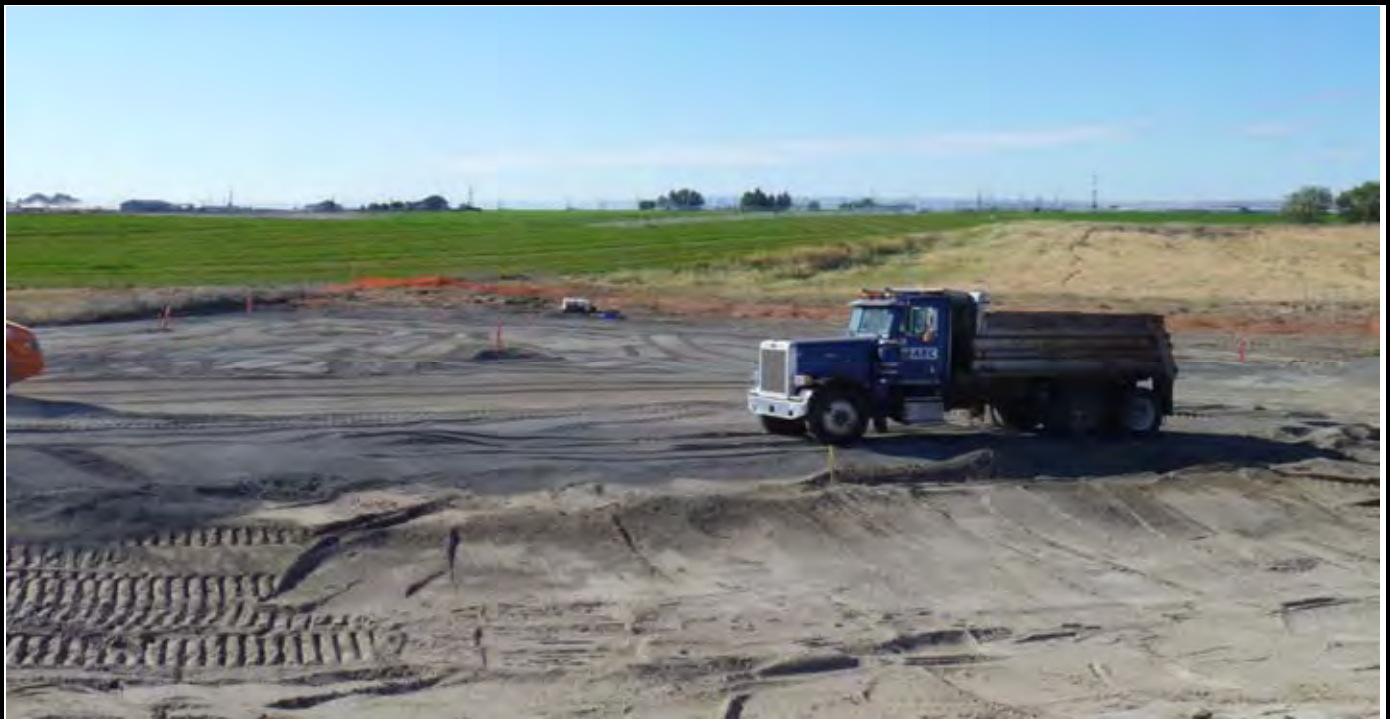
Photo 1: View of the site at the beginning of work for the day. View looking to the South / SE beyond the dump truck. Note the NW swale in the foreground and grading control points.

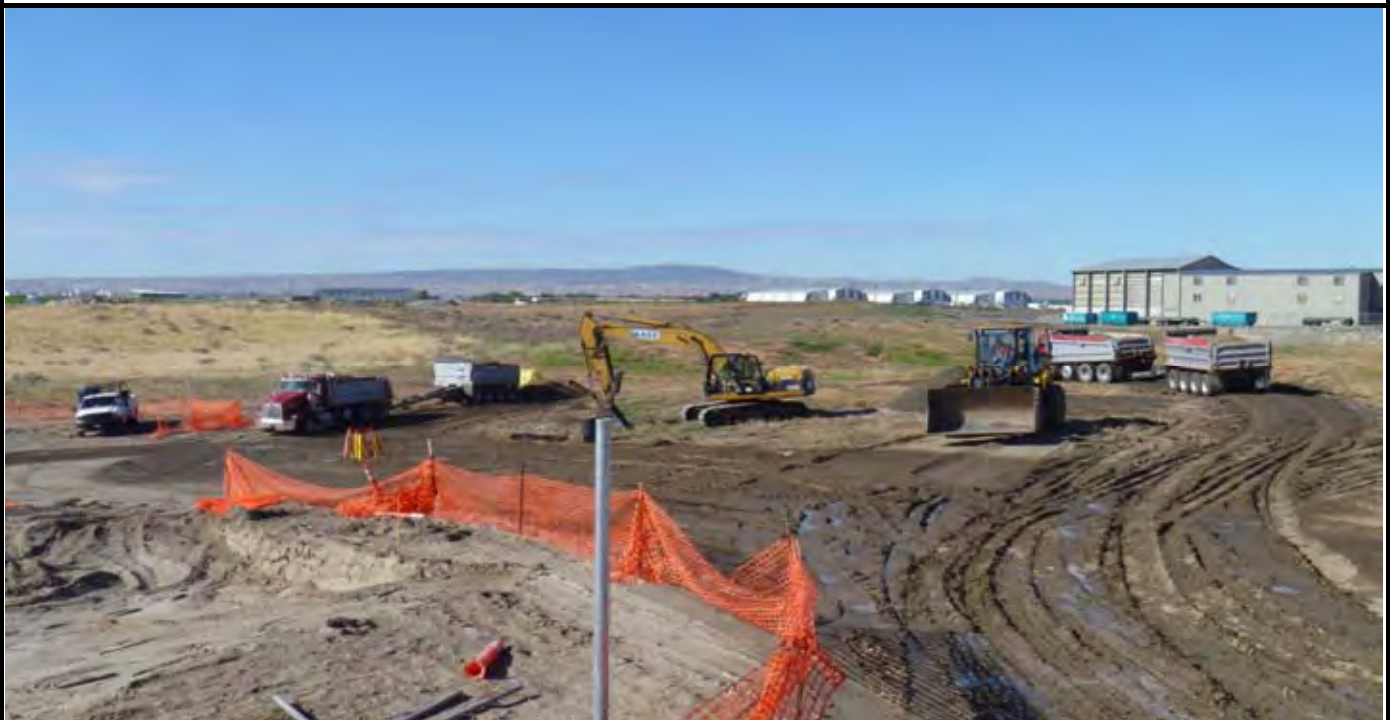
Photo 2: View of the first sand (interior of "loop" - trackhoe is in "loop") and topsoil (down below sand - see red truck) stockpiles on the site. View looking to the SW from the NW corner of the site.

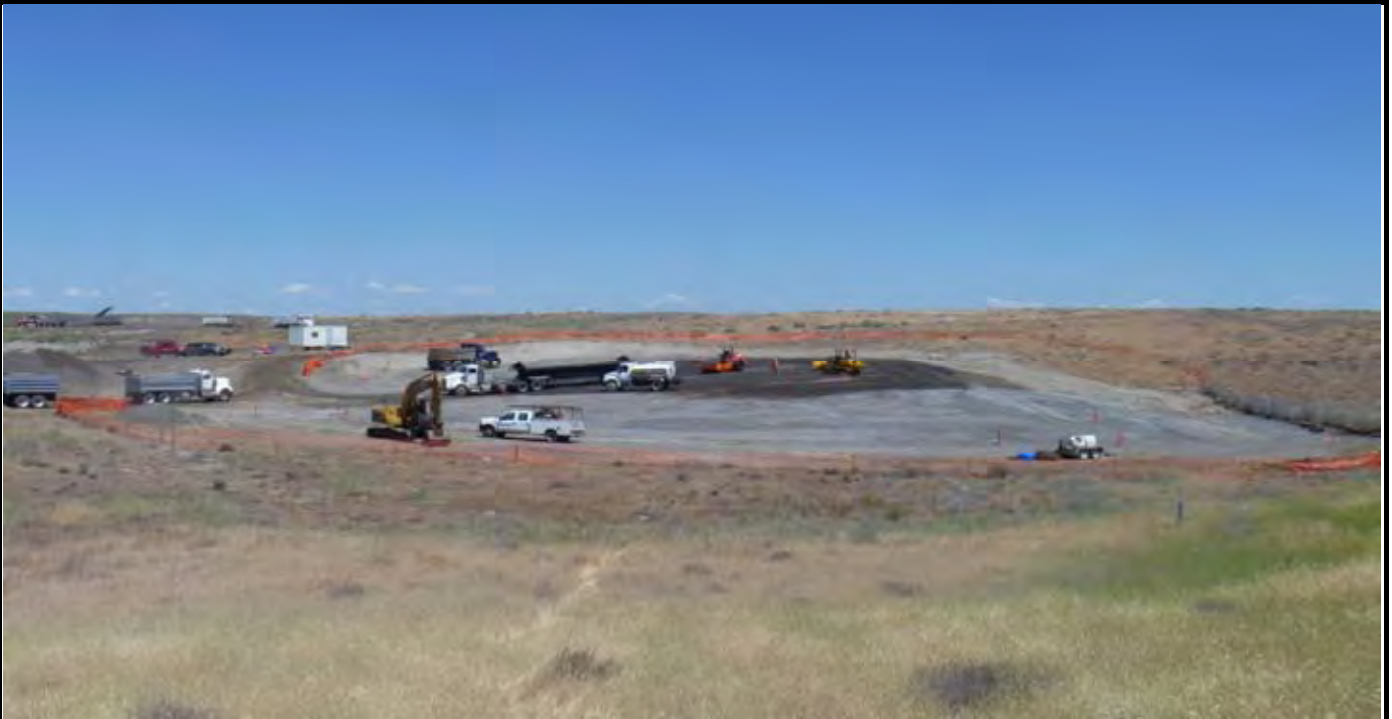
Photo 3: View of the Cap area during G-layer grading work. Note side dump truck, roller, bulldozer, and watering truck on cap. View looking north from area beyond south end of the site.

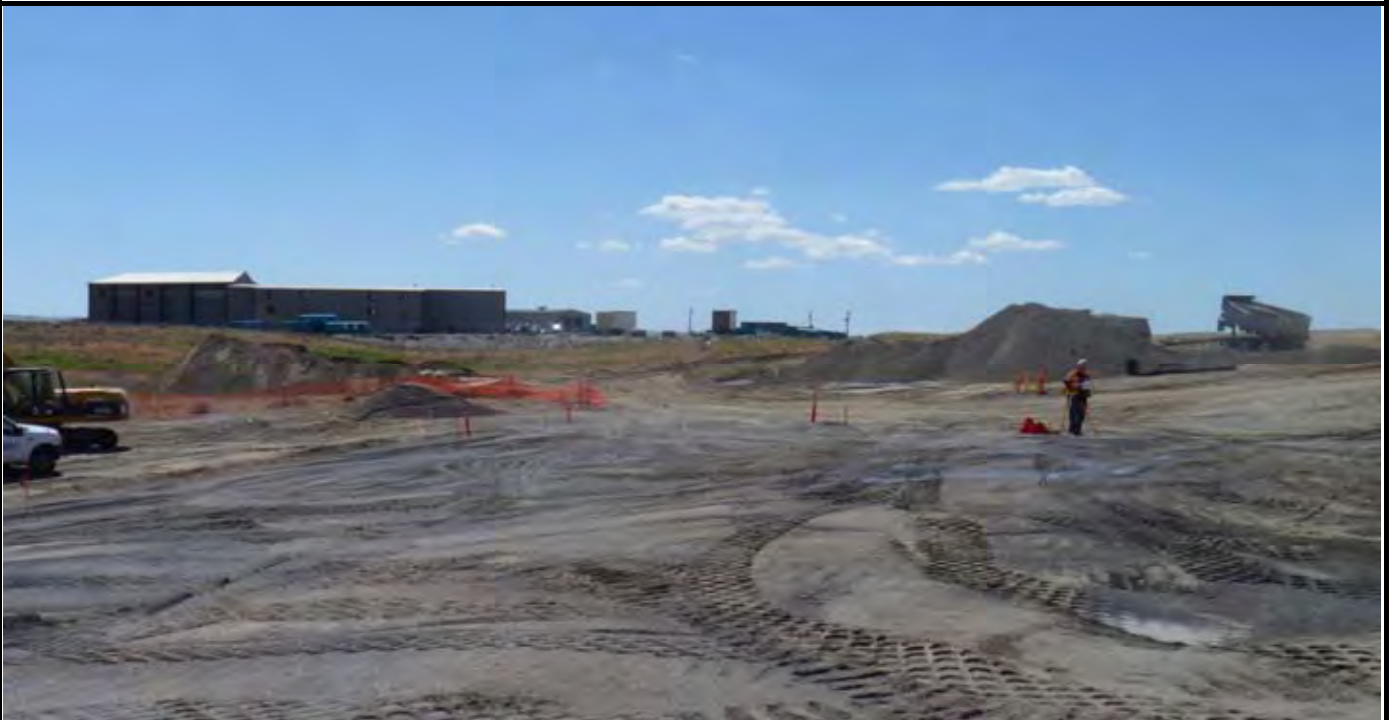
Photo 4: View of AEC's surveyor (Tim Scott) installing grade control points with topsoil (left) and sand (right) layer stockpiles behind him. View looking west from eastern side of the cap.

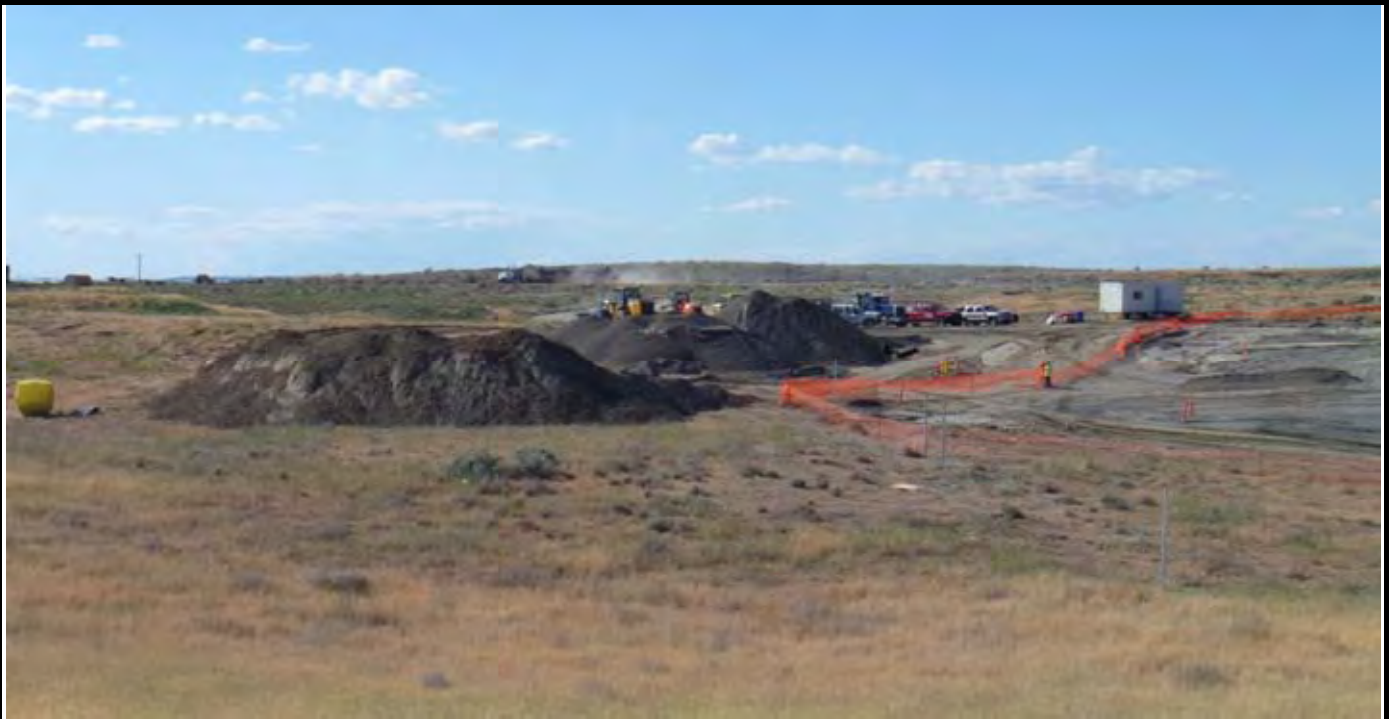
Photo 5: View of the topsoil (foreground) and sand (behind topsoil) stockpiles at the end of the day. View looking north from area beyond south side of site.

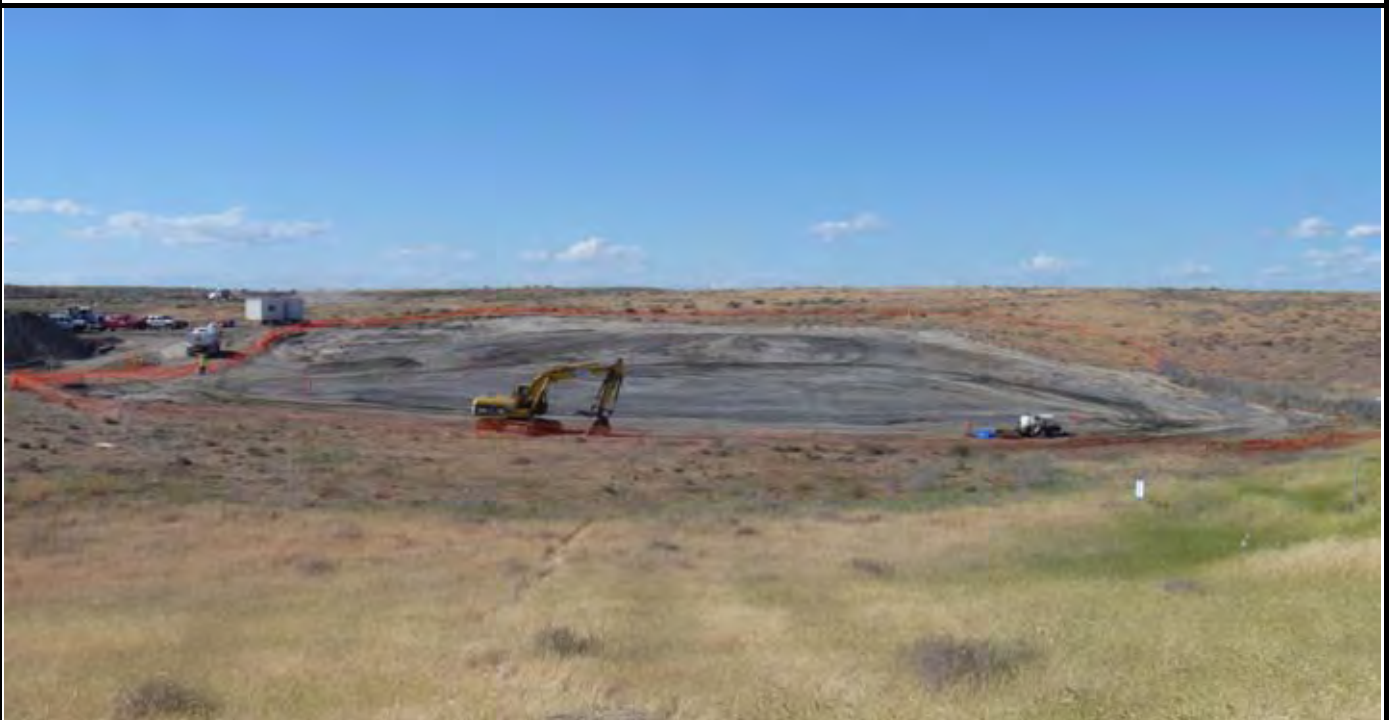
Photo 6: View of the cap at the end of the day. View looking north from area beyond the south end of the site.

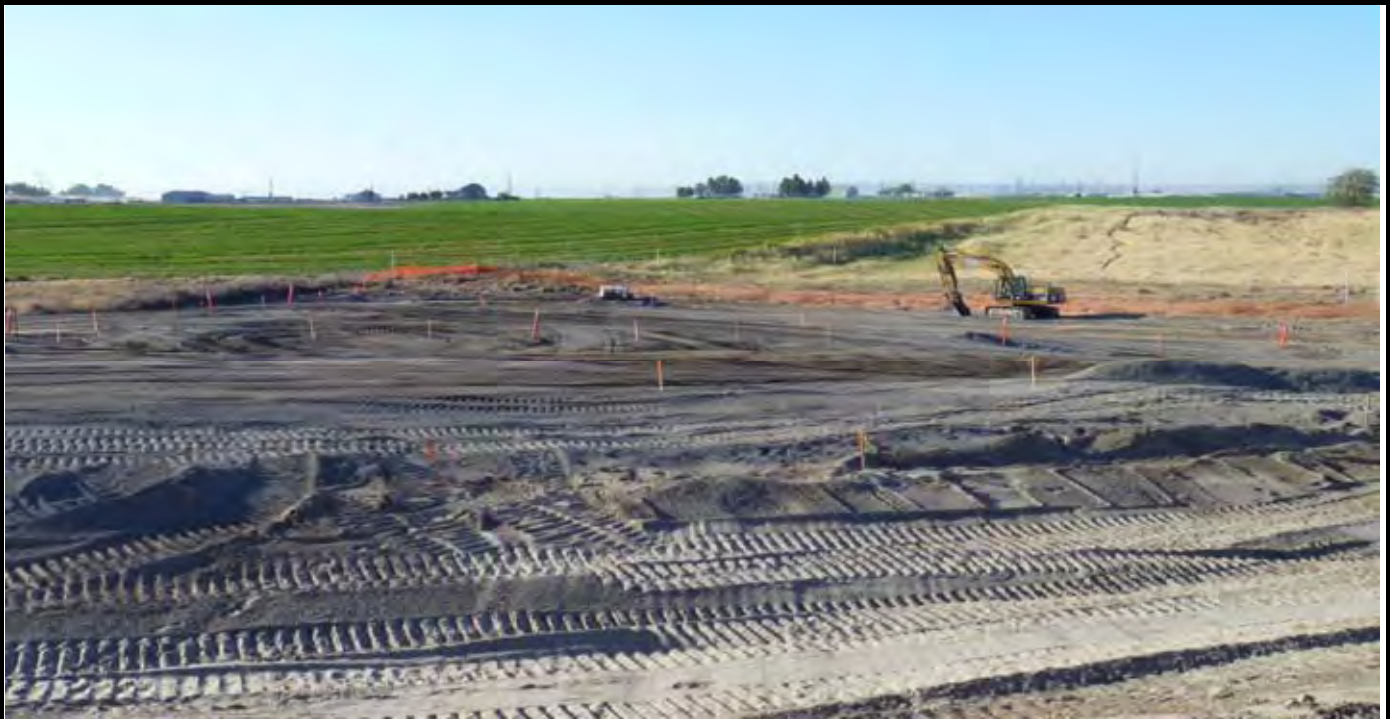
Photo 1: View of the site at the beginning of work for the day. View looking to the South / SE towards the trackhoe.

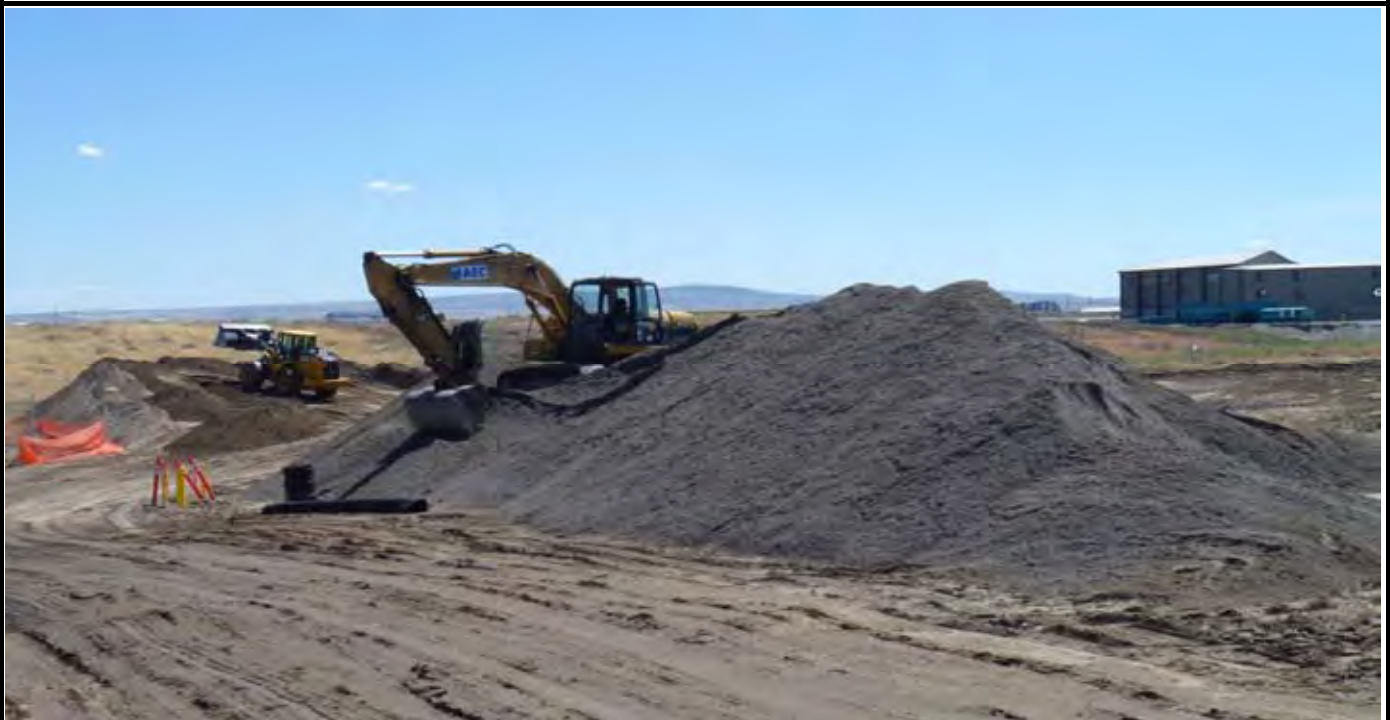
Photo 2: View of AEC managing sand (foreground) and topsoil (background) stockpiles during the day. View looking south from northwest corner of the site.

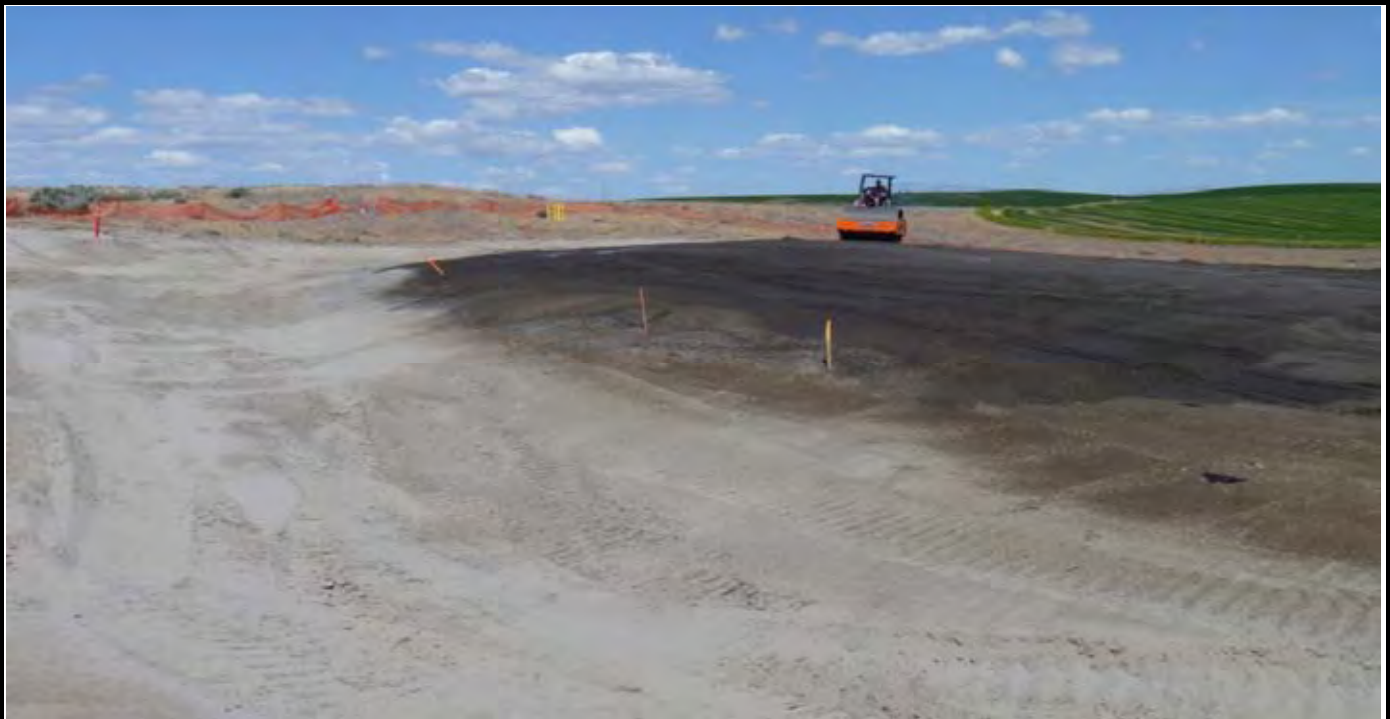
Photo 3: View of the northern end of the G-layer. Note the peak along the northern edge of the cap area. View looking northeast by east from western side of site.

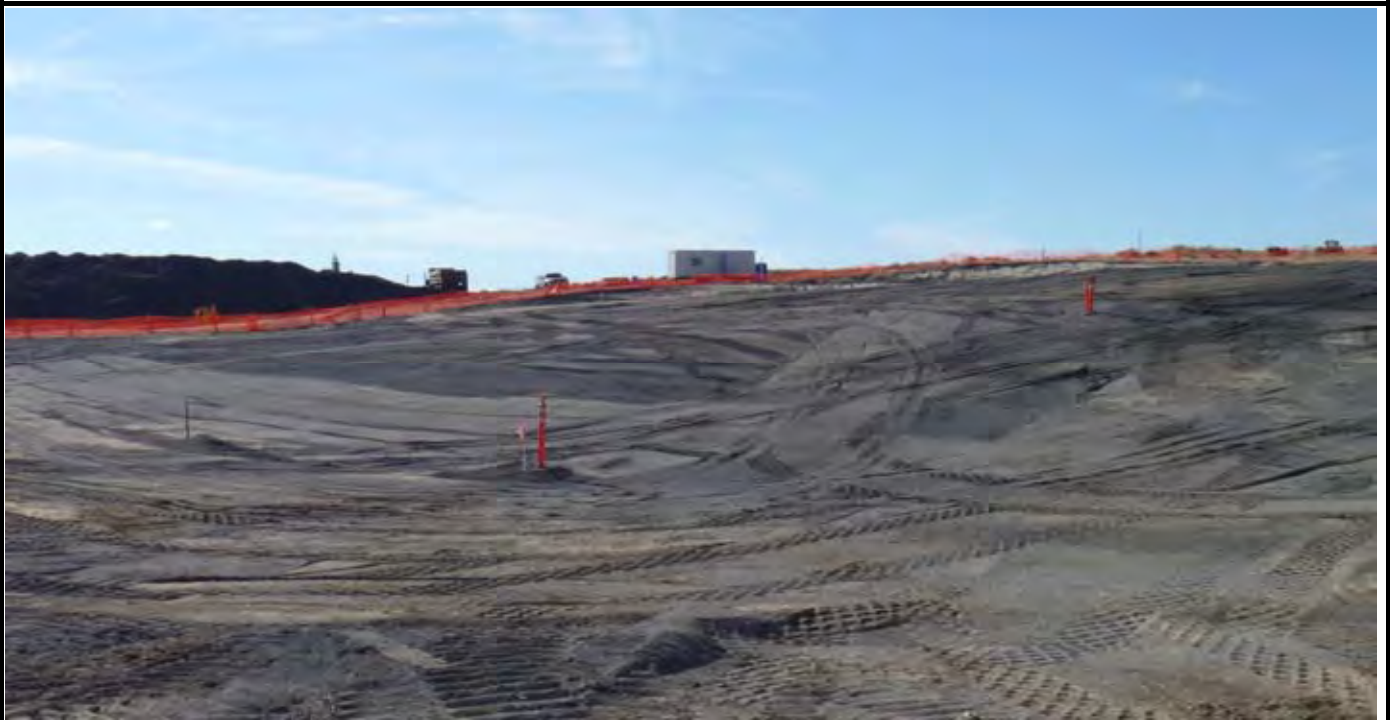
Photo 4: View of the southern end of the G-layer. View looking west from SE corner of the site.

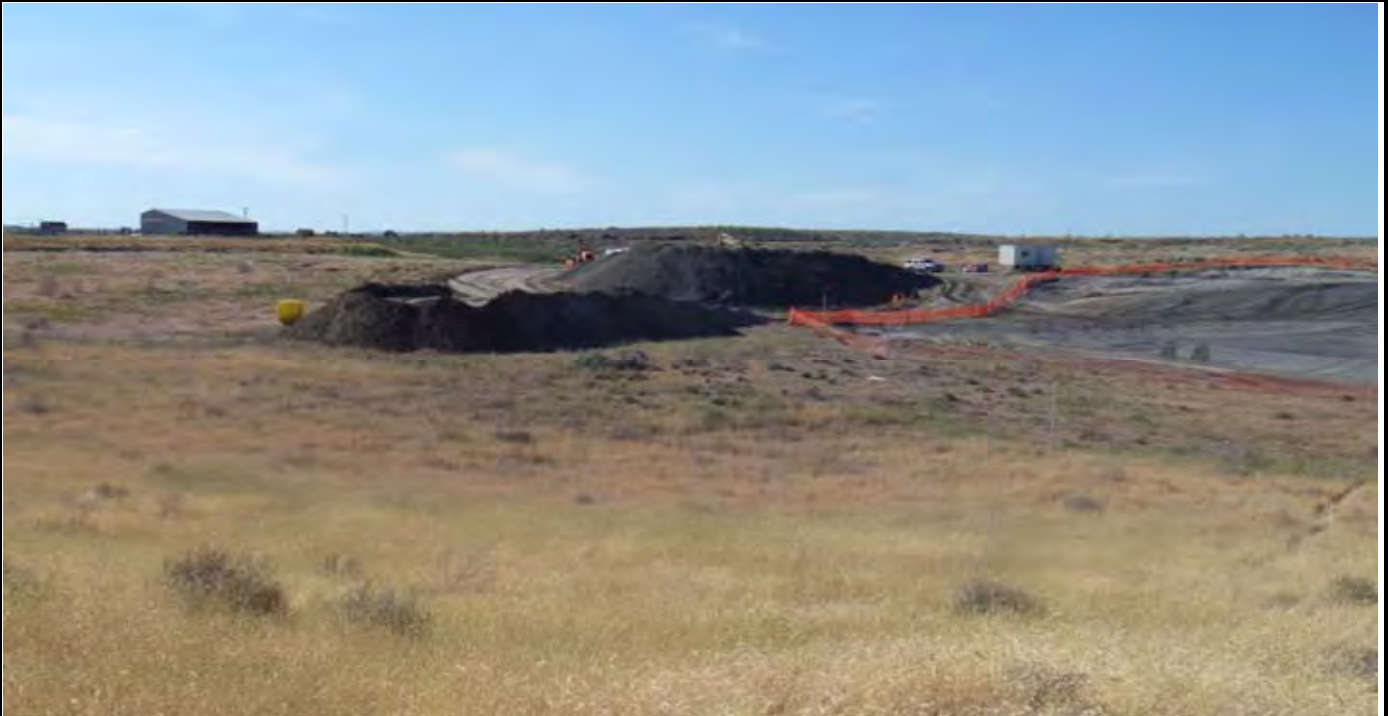
Photo 5: View of the topsoil (front) and sand (back) stockpiles at the end of the day. View looking NW from area beyond south side of site.

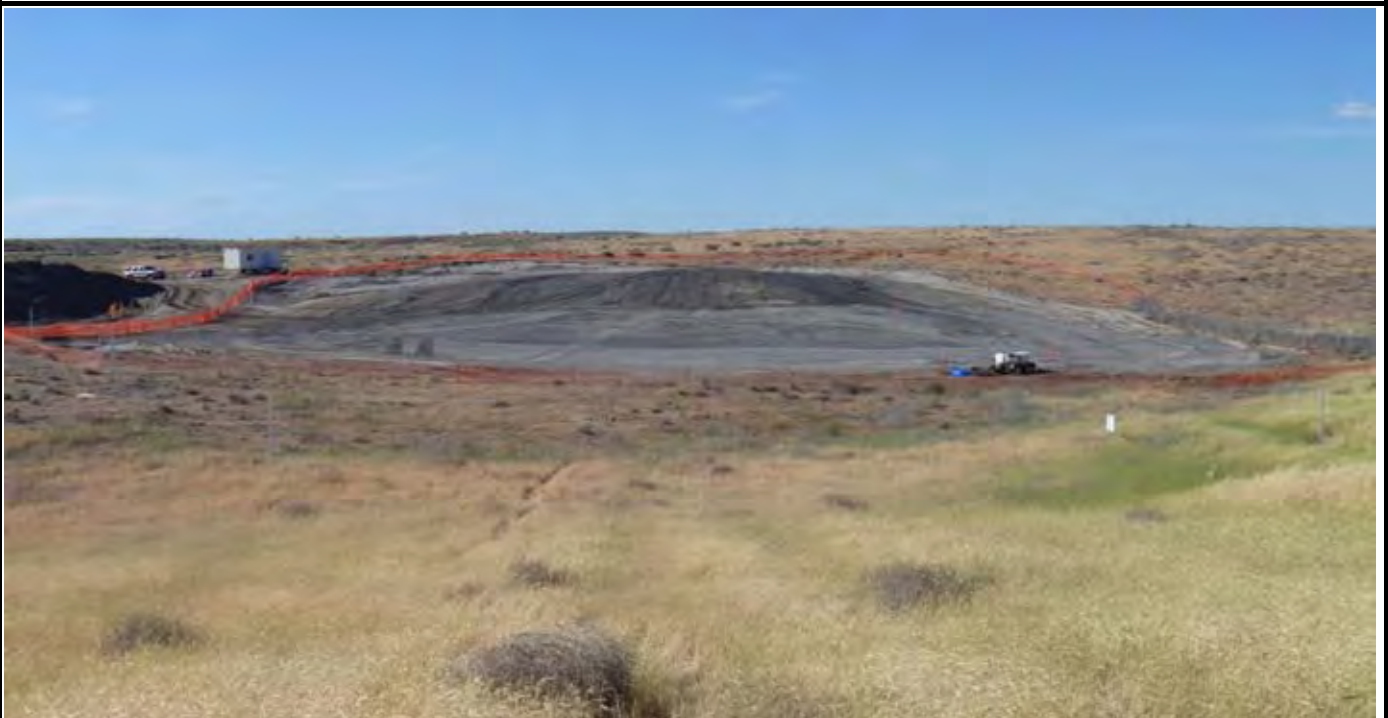
Photo 6: View of the site and G-layer near completion. Small area in SW corner is unfinished. View looking north from area beyond south end of site.

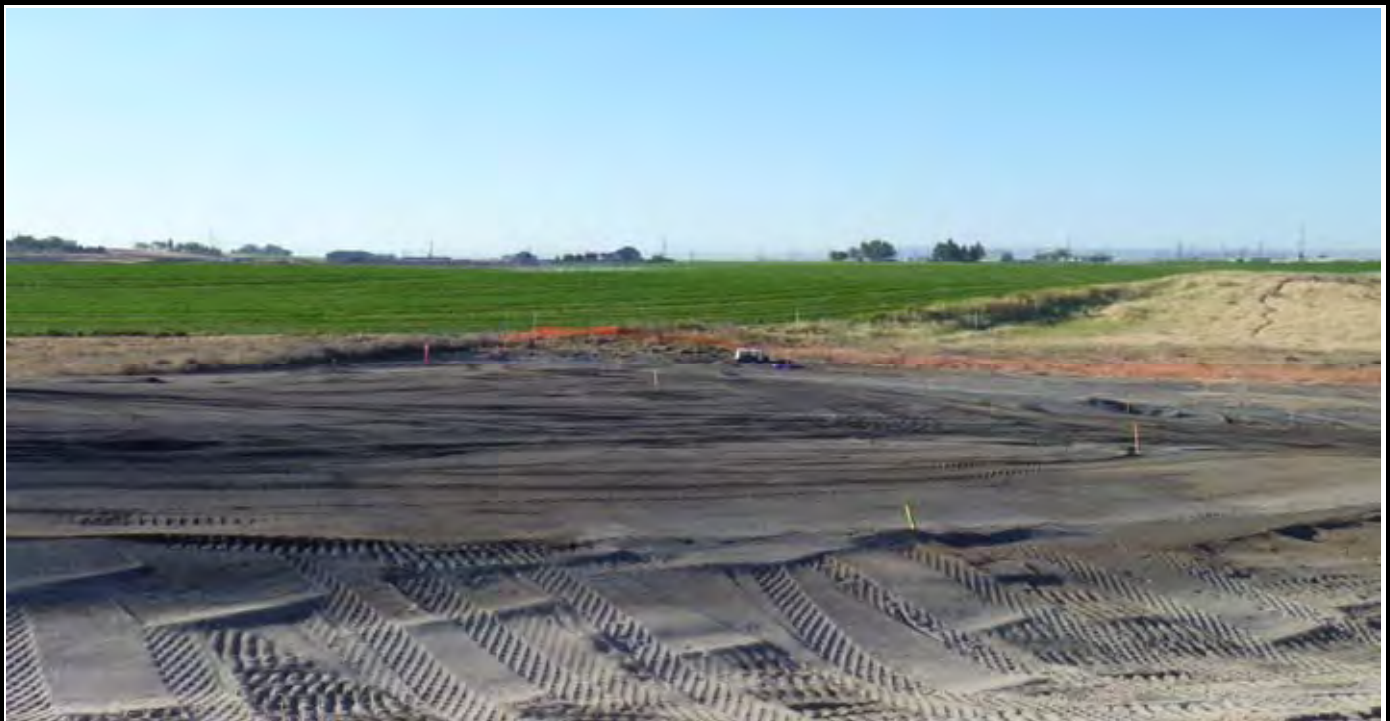
Photo 1: View of the site at the beginning of work for the day. View looking to the South / SE towards the water trailer.

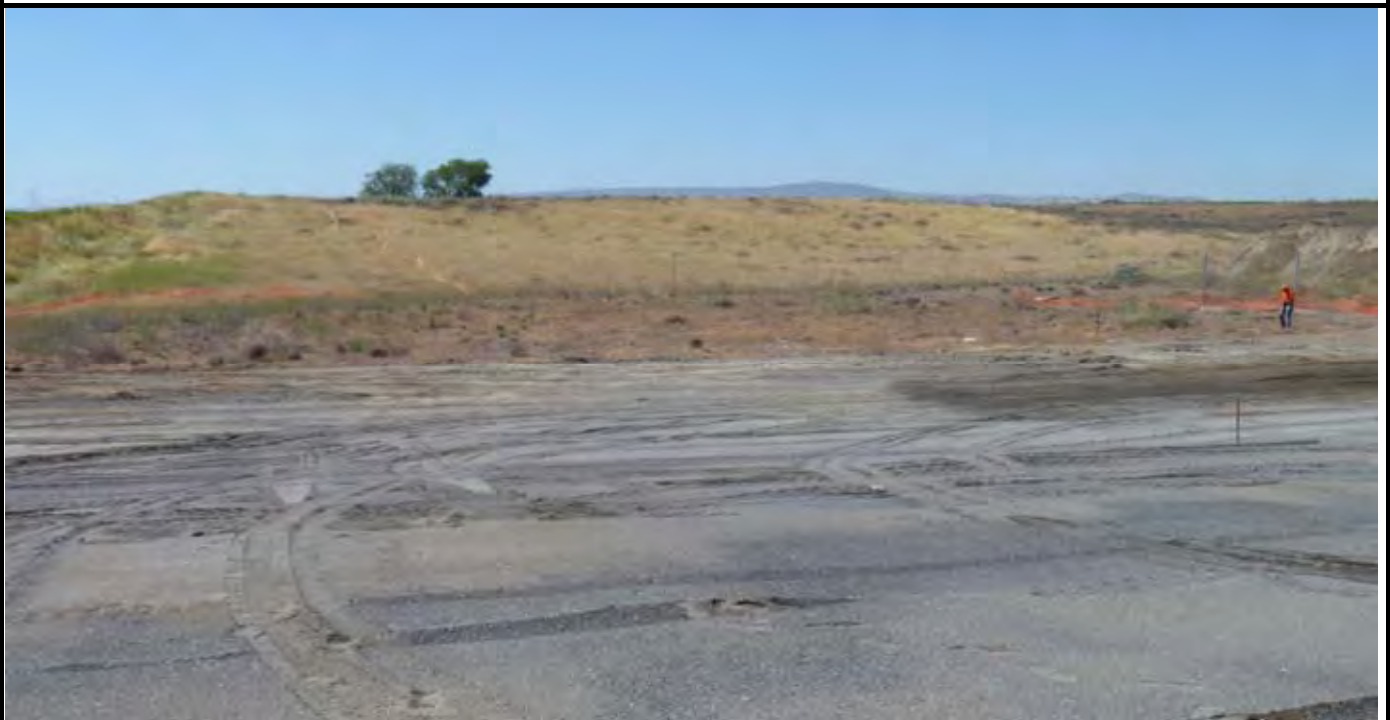
Photo 2: View of infiltration basin area prior to grubbing/grading work. Note AEC is moving OCF back to posts for the new perimeter fencing. View looking south from south end of cap.

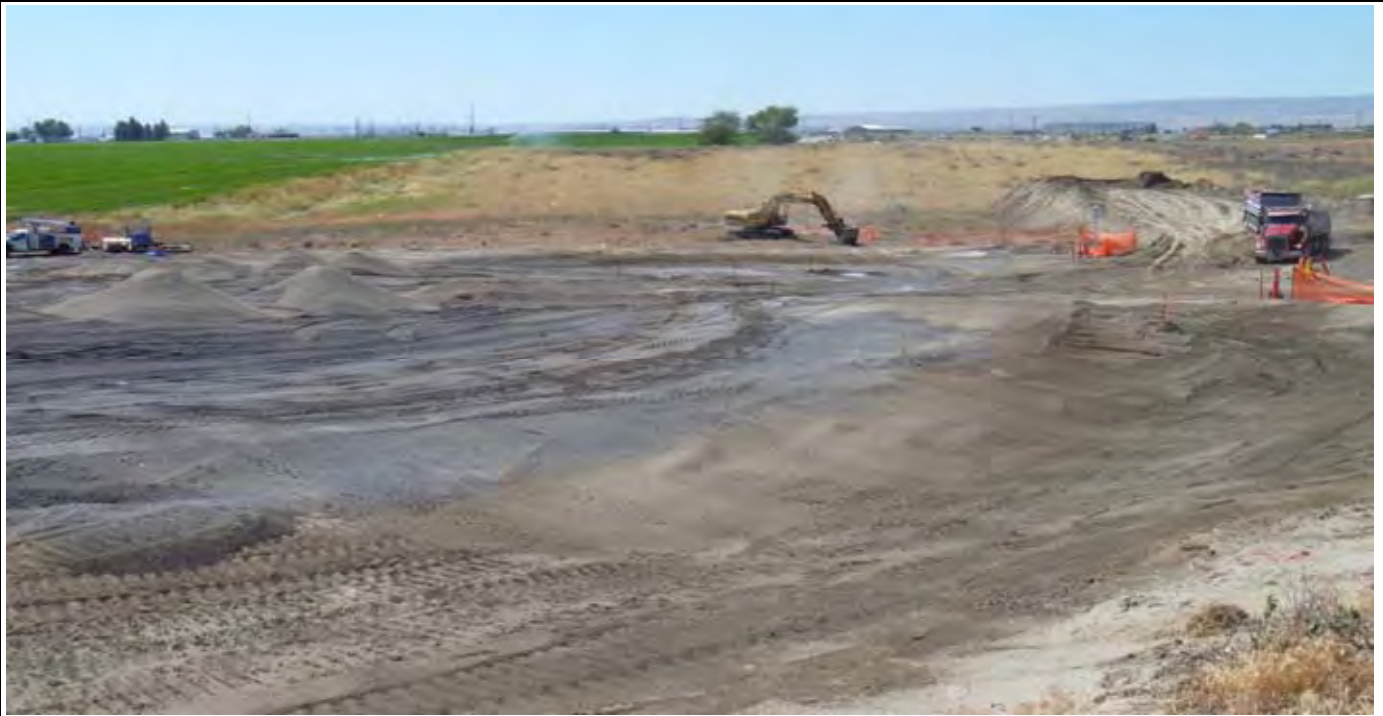
Photo 3: View of SW corner of cap nearing completion and AEC trackhoe beginning grubbing/grading work in the infiltration basin area during bulldozer repair. Note OCF installed along new outer fence posts. View looking south from NW corner of site.

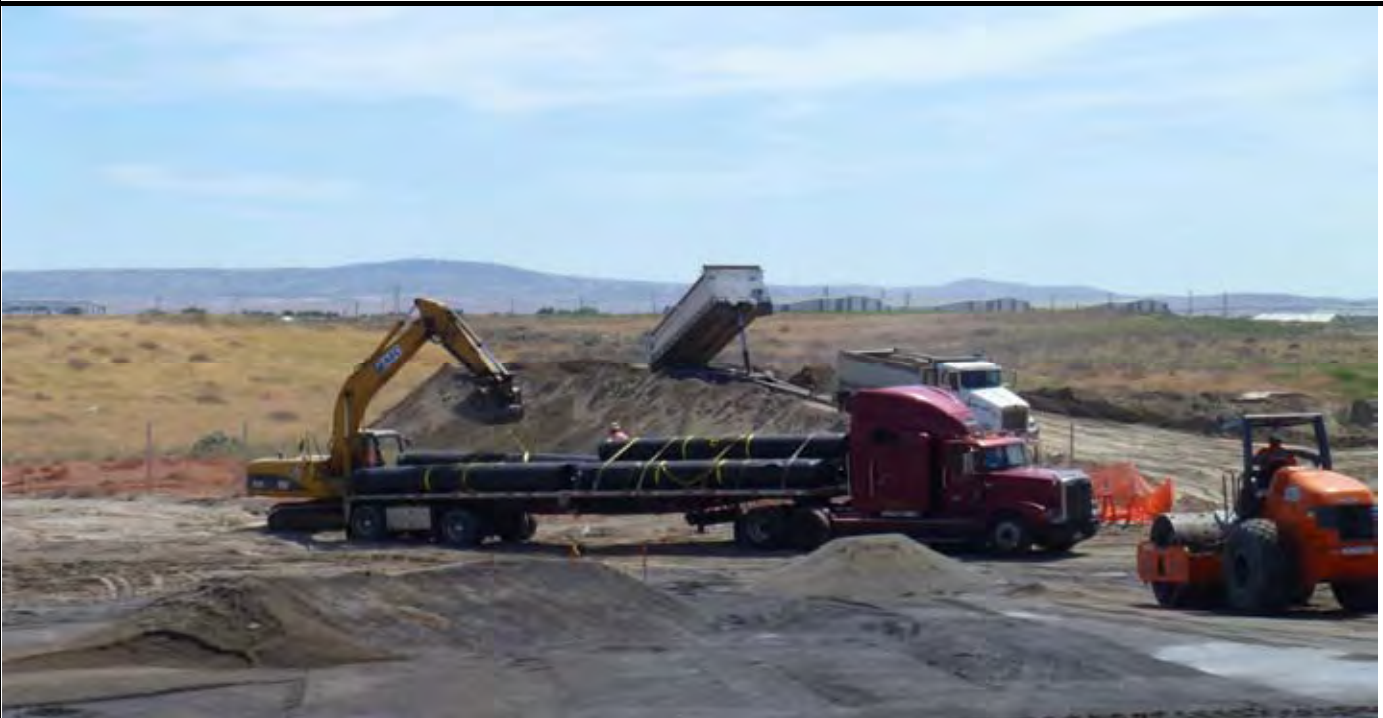
Photo 4: View of AEC off loading three rolls of geomembrane from NW Linings truck. Note trailer in background dumping load of topsoil on stockpile. View looking SW toward SW corner of cap from northern end of site.

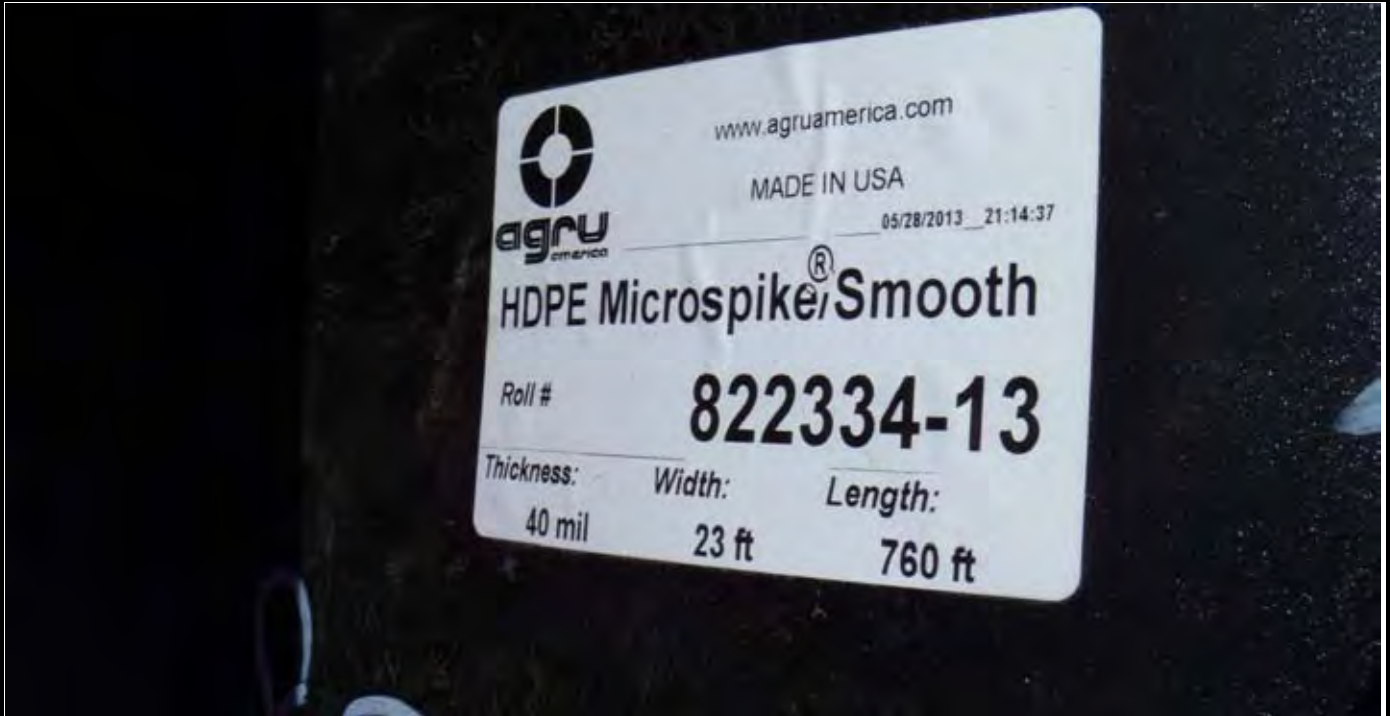
Photo 5: View of label on first roll of 40-mil HDPE Microspike / smooth geomembrane. Roll # = 822334-13
Thickness = 40-mil, Width = 23-ft, Length = 760-ft for a total area of roll = 17,480-sf
Microspike side is considered "textured".

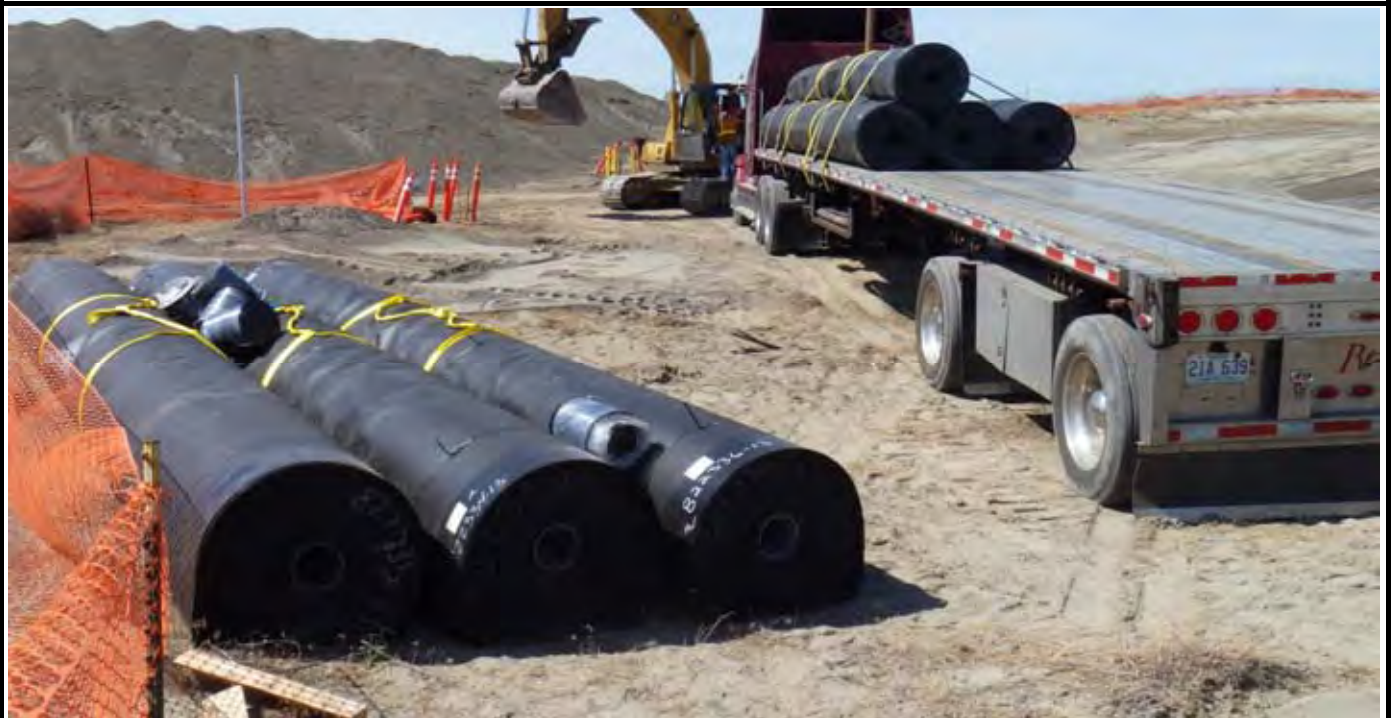
Photo 8: View of the three new rolls of geomembrane liner delivered and stockpiled beyond SW corner of the cap with five rolls of plastic welding cord. View looking NW from the SW corner of the site.

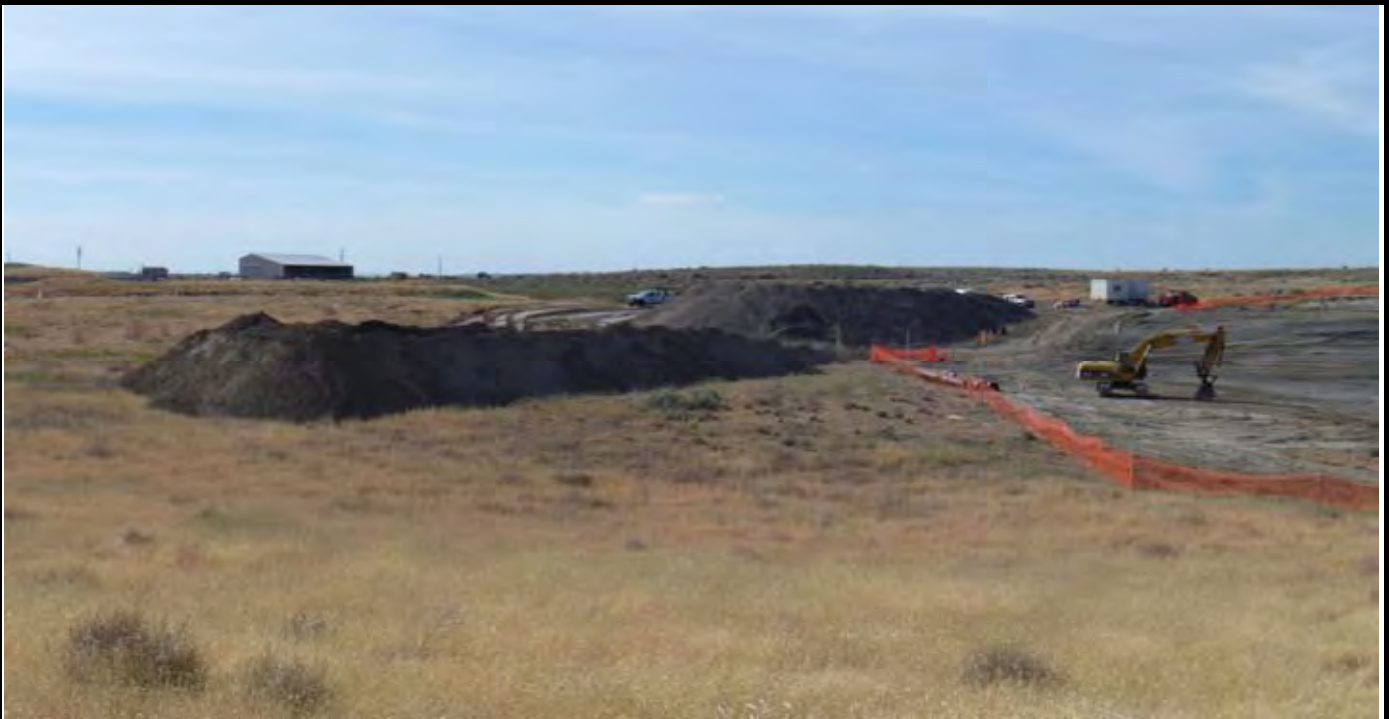
Photo 9: View of the topsoil (front) and sand (back) stockpiles at the end of the work day and three new rolls of geomembrane (left of trackhoe). Note that the other two geomembrane rolls are stockpiled up on the road and will be brought down to the others tomorrow. View looking NW from area south of the site.

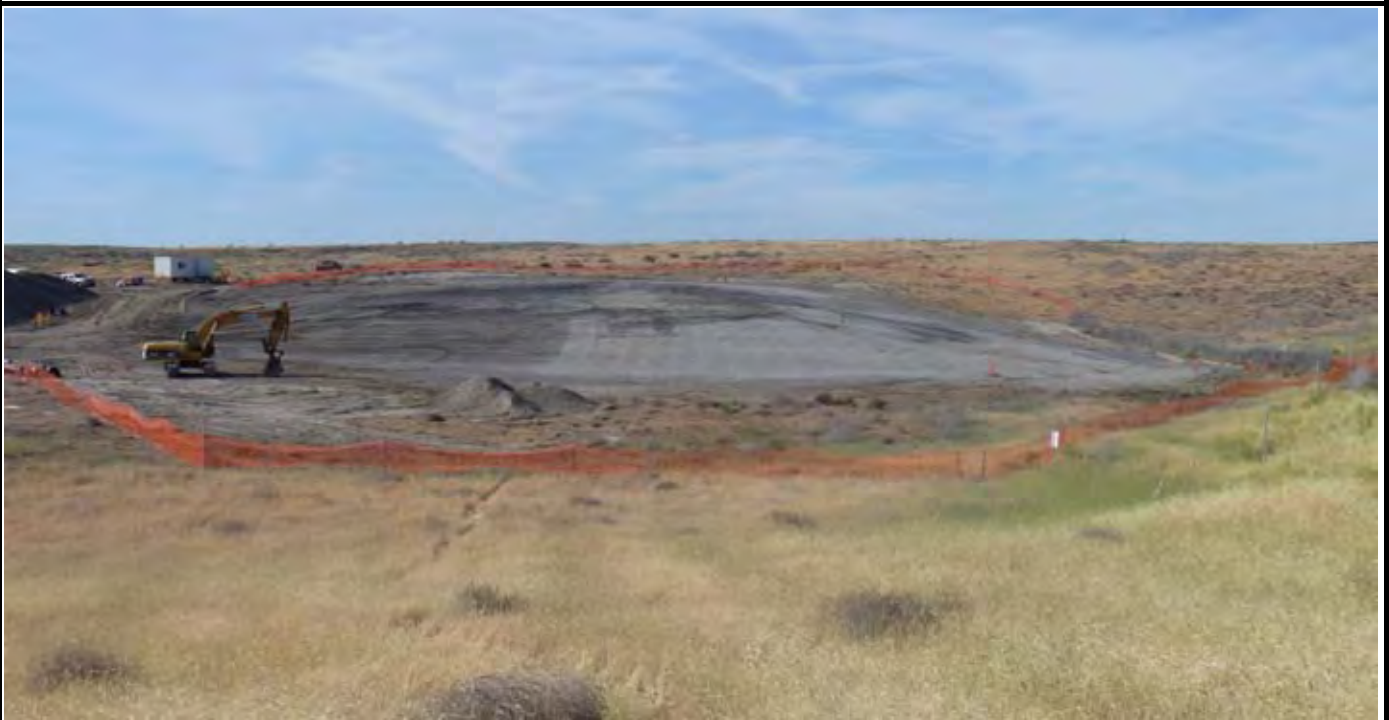
Photo 10: View of the site at the conclusion of work for the day. OCF has been installed along the south end of the new perimeter fencing posts. Note infiltration basin grading stockpile that will be installed in the G-layer along the eastern edge of the cap (along AE-4 western edge). View looking north from area beyond south end of site.

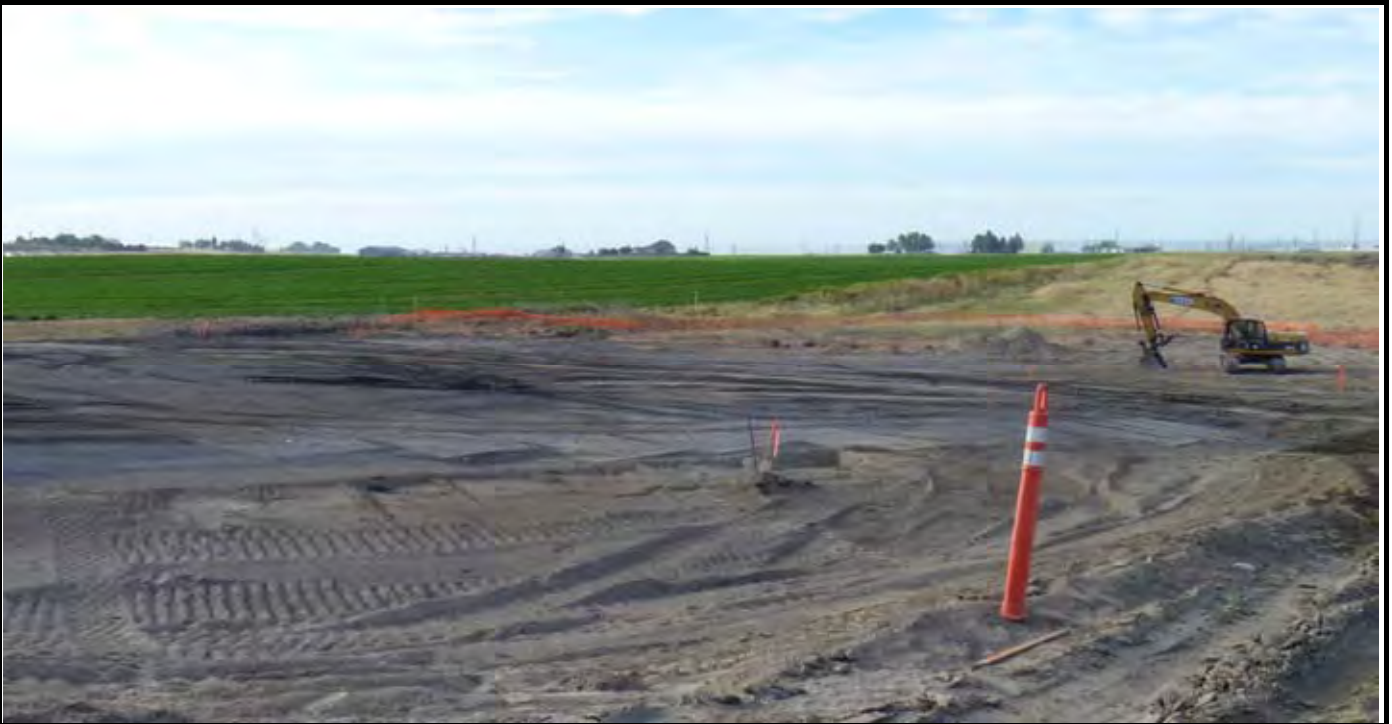
Photo 1: View of the site at the beginning of work for the day. View looking to the South / SE.
