PHOTOGRAPH LOG

Environment and Infrastructure, Inc.
7376 SW Durham Road
Portland, Oregon 97224

PROJECT NAME: Pasco Landfill Cap Project - Cap Construction Project

Project No: 4-61M-10705-1 P-02

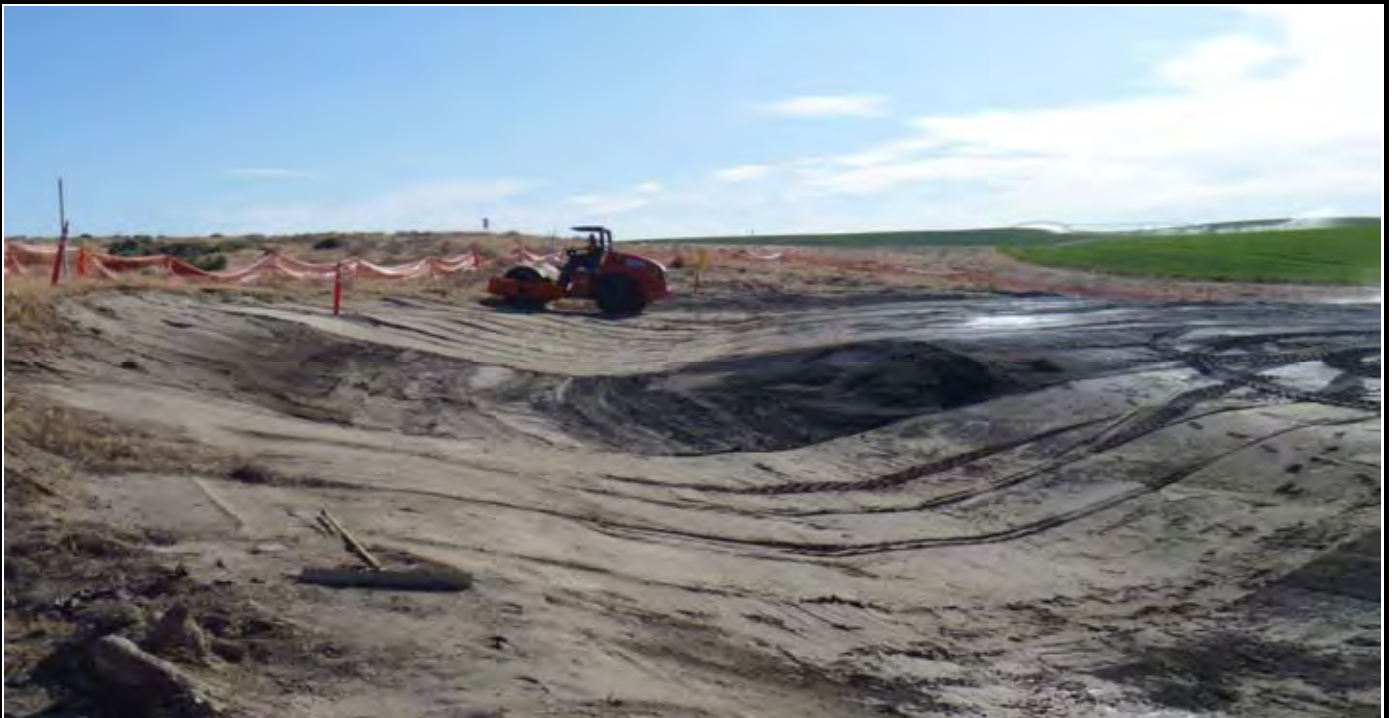
Photo 2: AEC compacting NW swale area and northern edge of cap for preparation for GLC/geomembrane
View looking east from NW corner of the site. Un-compacted area needs slight grading work.

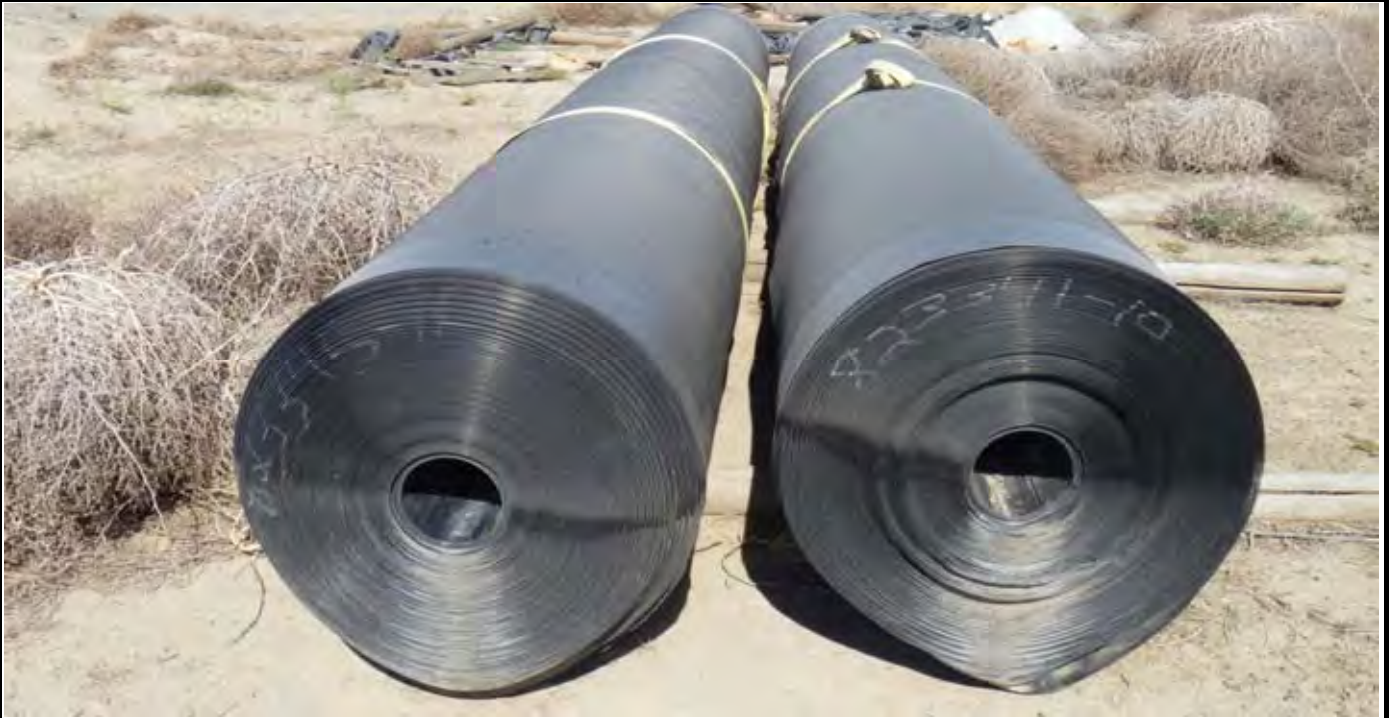
Photo 3: View of the two geomembrane rolls from original work that are accepted by geosynthetic vendor. See field notes for specs/roll number. Rolls located up on roadway near original g-layer stockpile area. View looking west.

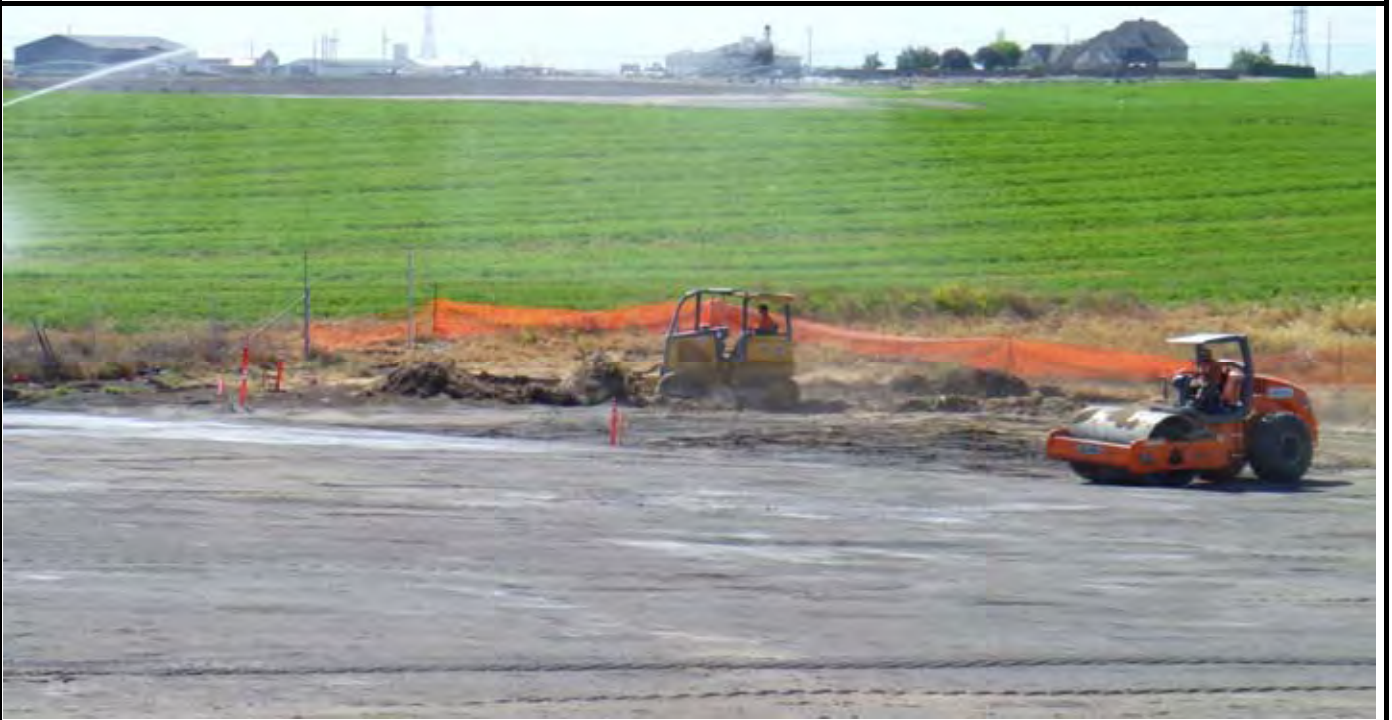
Photo 4: AEC begins grading area beyond the SE corner of the cap in accordance with design. Note AEC roller compacting area along SE corner of g-layer cap. View looking SE from center of cap

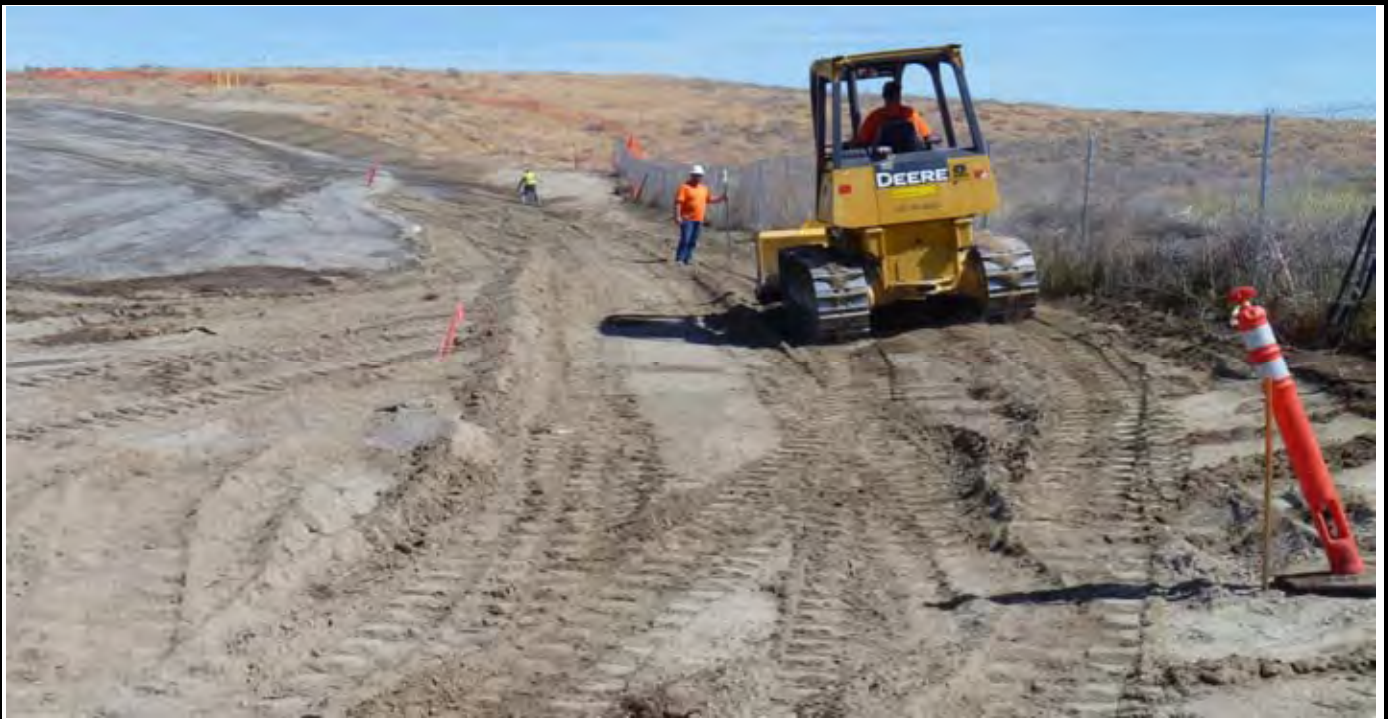
Photo 5: View of AEC grading eastern edge of the site between the EOC (edge of cap) and fence line in accordance with the design. View looking north from SE corner of the site. Note AEC laborer in background smoothing out compaction edges with rake.

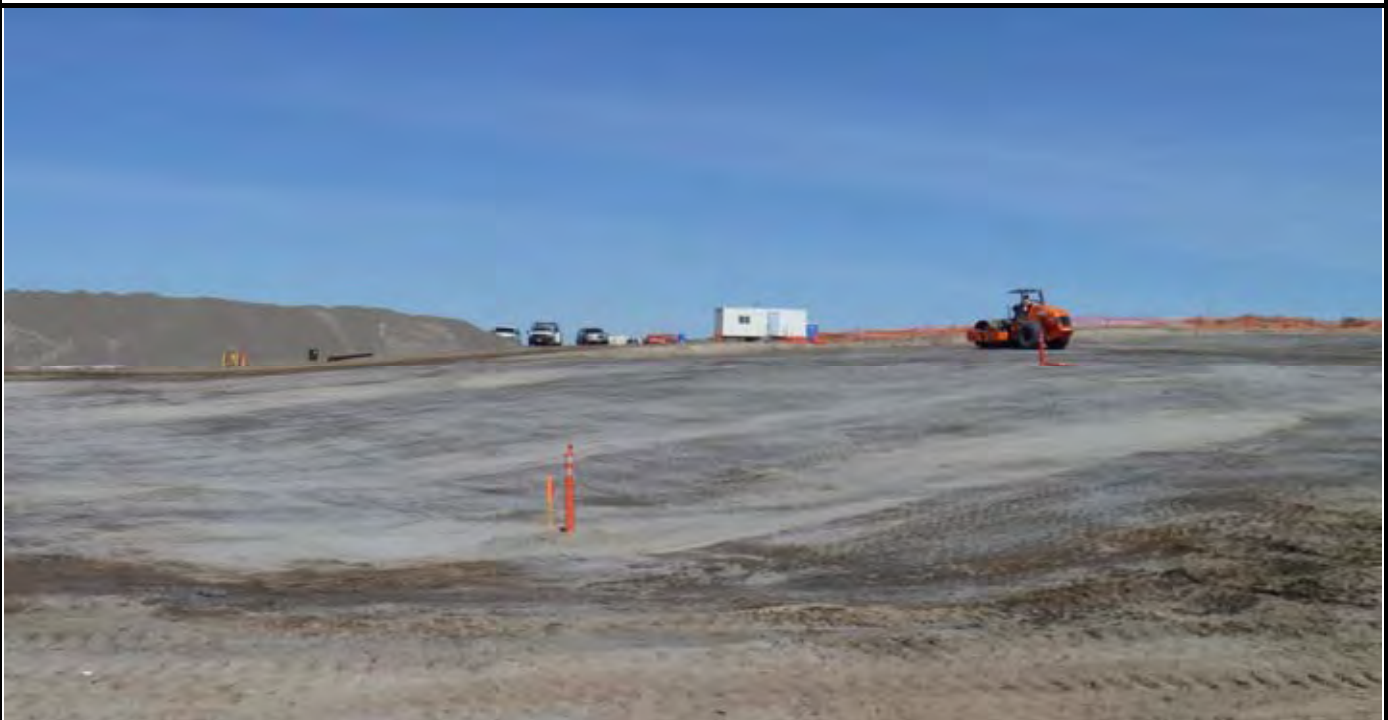
Photo 6: View of AEC compaction roller nearing completion of compacting and smoothing the top of the G-layer cap. View looking NW from SE corner of the site.

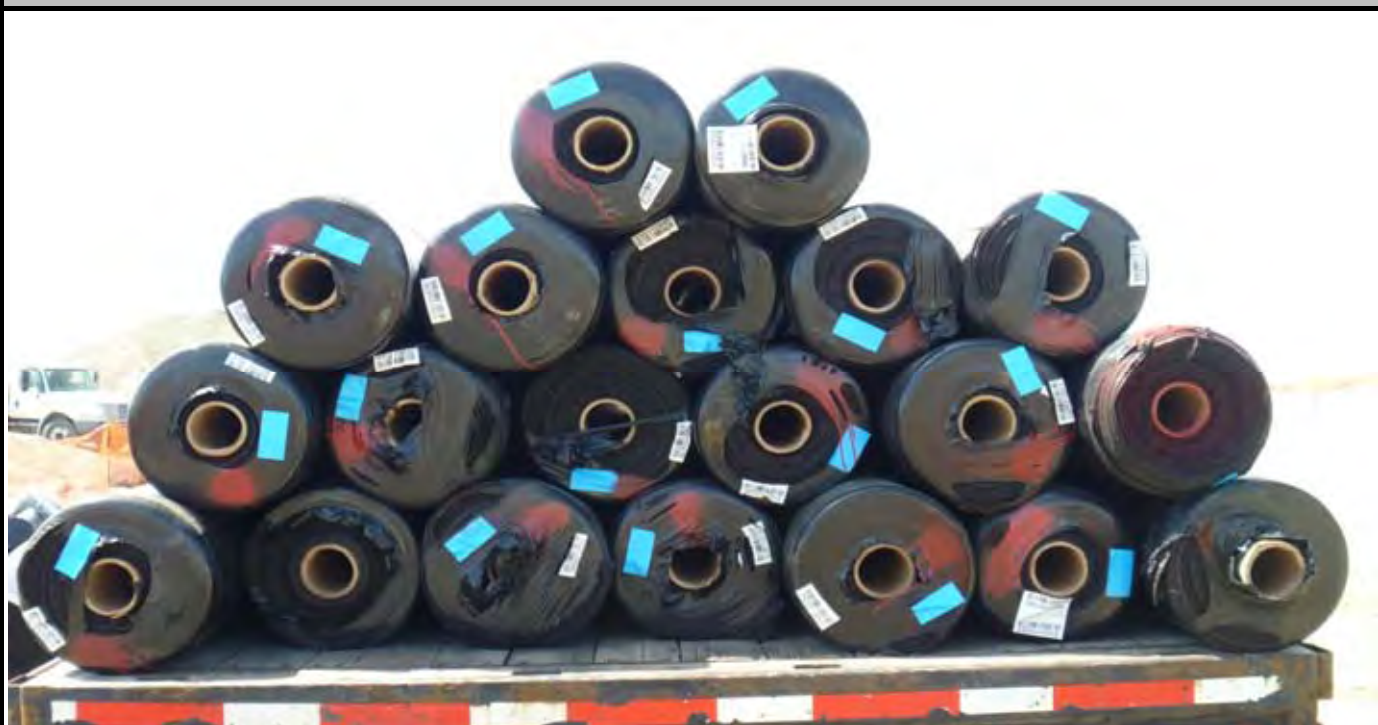
Photo 7: View of the ends of the 20 geosynthetic rolls (barrier between sand and topsoil layers) on delivery truck. View looking west from area near SW corner of the CAP.

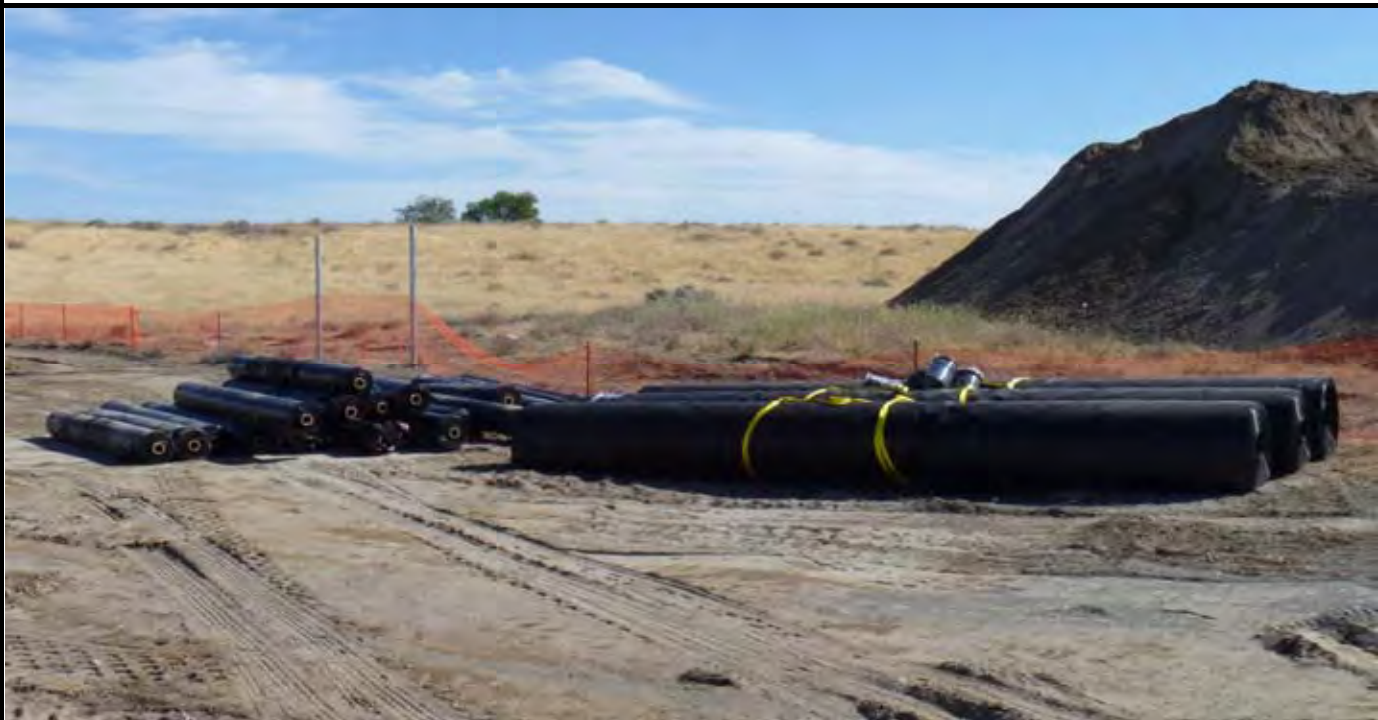
Photo 8: View of 3 geomembrane rolls (new ones) and 20 geosynthetic rolls stockpiles in area just SW of the SW corner of the CAP. Note the double fence posts in background for fence gate. View looking south from the SW corner of the CAP.

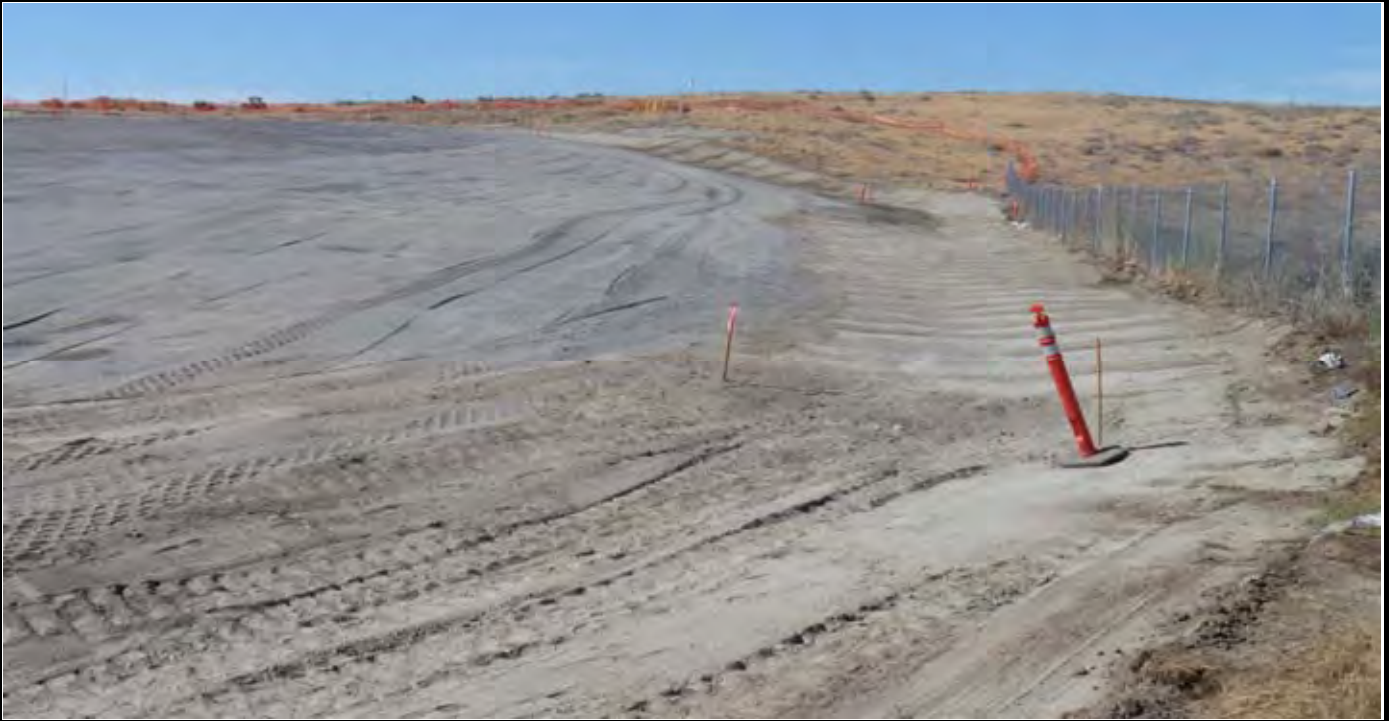
Photo 9: View of the completed and compacted area along the eastern side of the cap and area along the eastern fence line and NE swale area. View looking north from the SE corner of the CAP. Note the stakes in the foreground for EOC and EOL in SE corner.

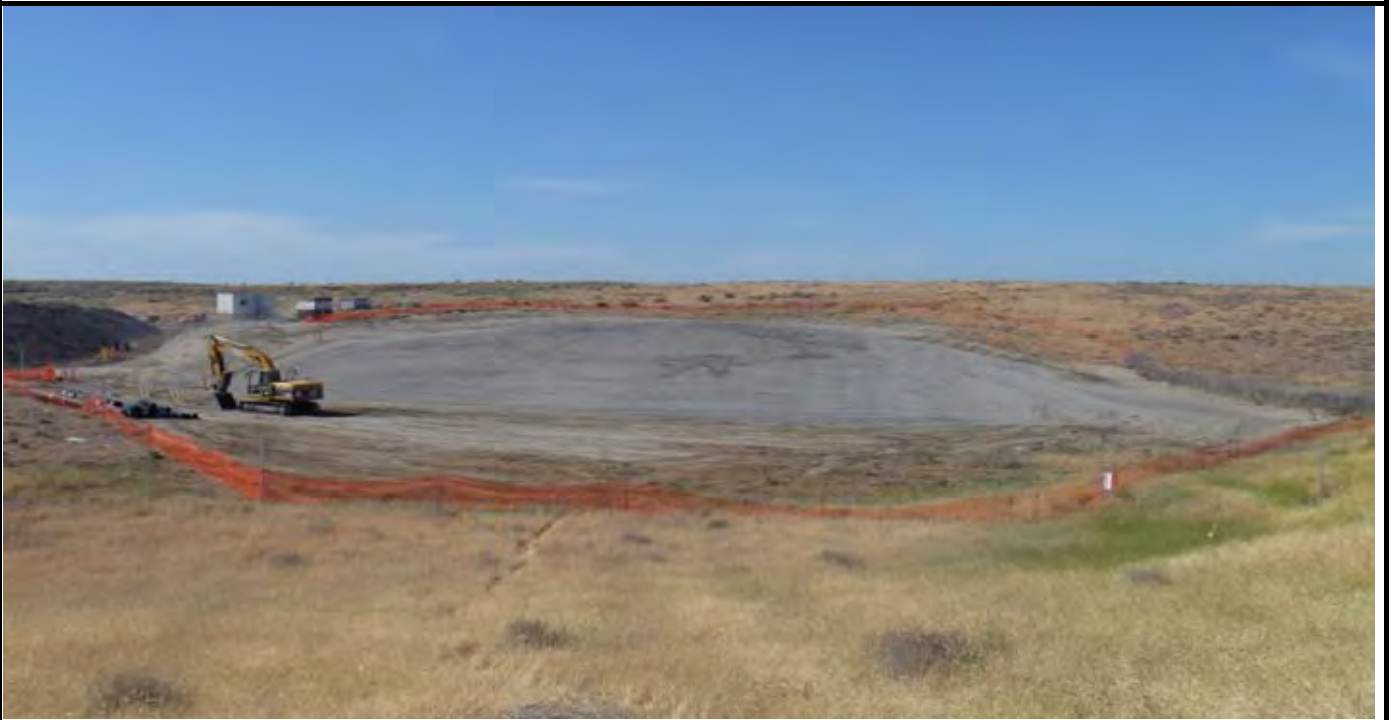
Photo 10: View of the site at the conclusion of work for the day. Orange construction fence is up around the site. Note geomembrane and geosynthetic stockpiled on left side of picture next to trackhoe. G-layer is complete and prepared for GCL and geomembrane installation.

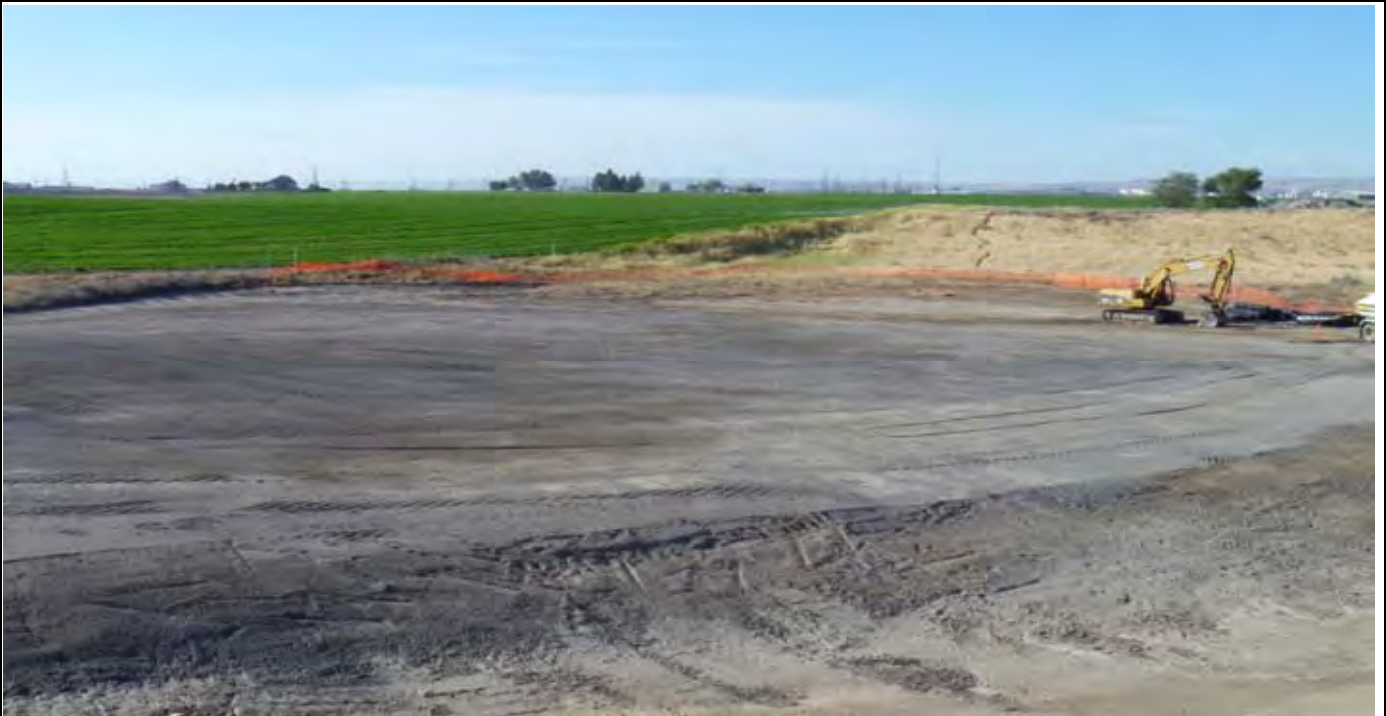
Photo 1: View of the site at the beginning of work for the day. View looking to the South / SE towards the trackhoe.

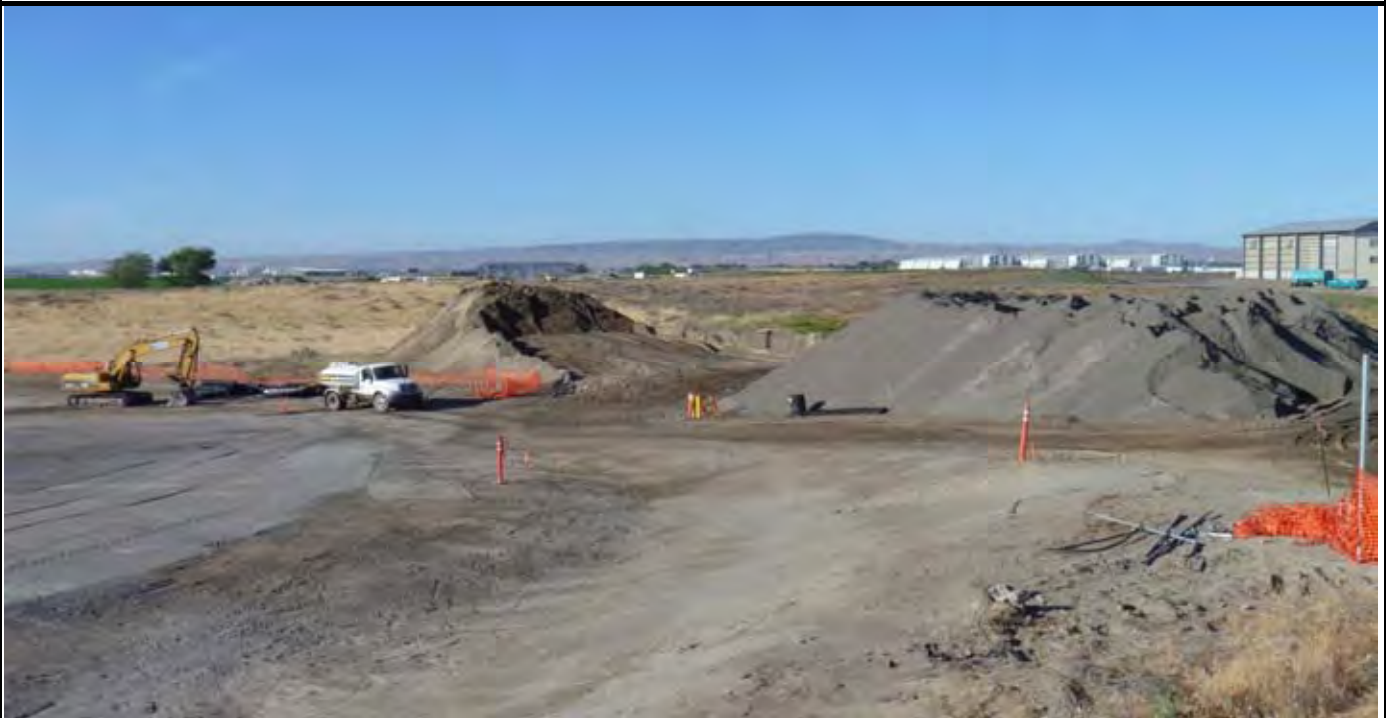
Photo 2: View of the sand (right side) and topsoil (left) stockpiles located to the west and southwest of the CAP. View looking south from NW corner of the site.

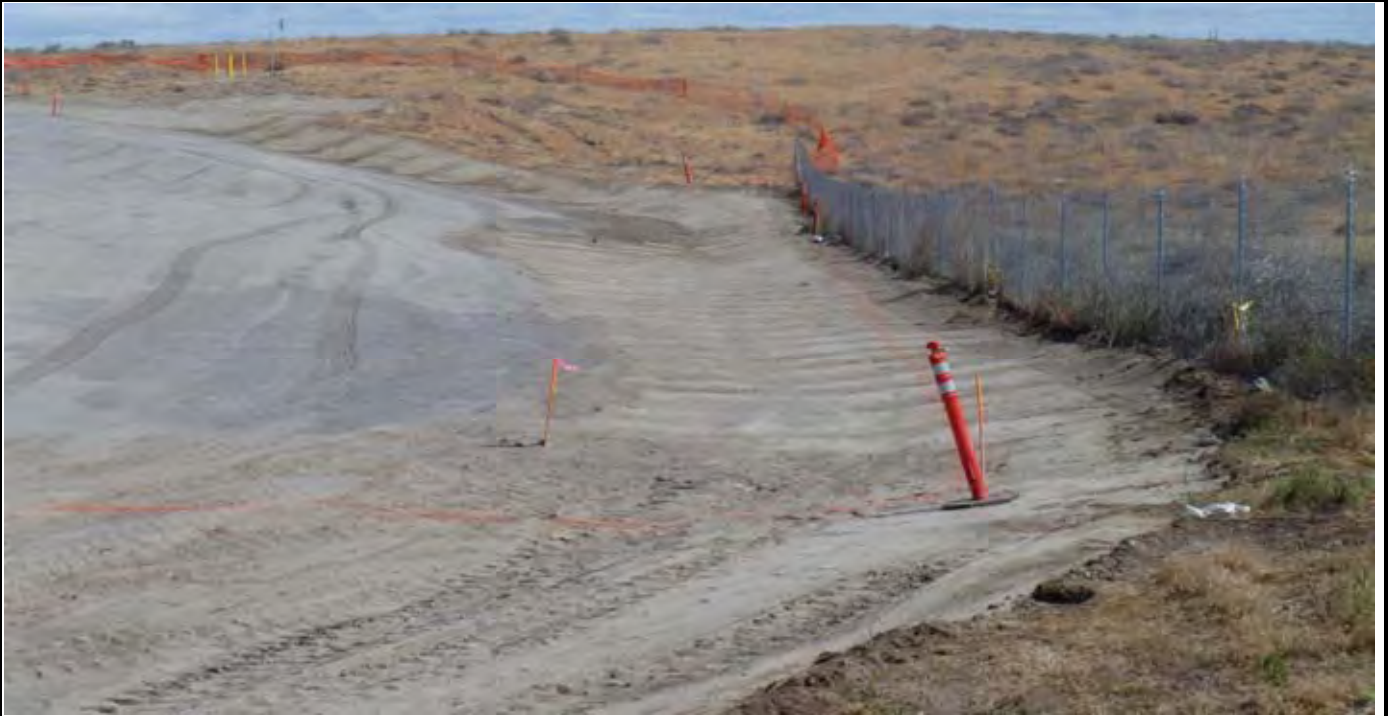
Photo 3: View of the EOC and EOL stakes and orange lines showing the boundaries of the EOL. View looking north from SE corner (note eastern cyclone fencing).

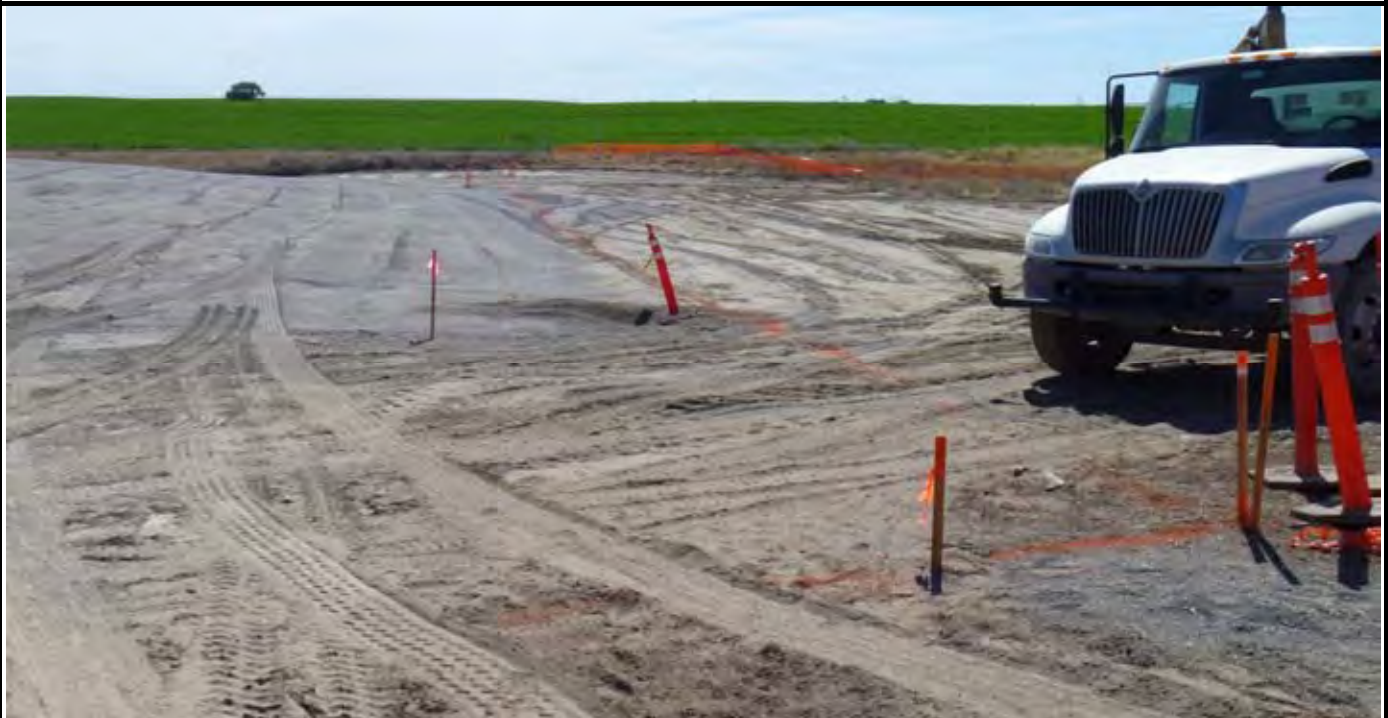
Photo 4: View of the SW corner and the stakes for the EOC and EOL corners and orange marking lines for the boundaries of the EOL. View looking east from SW corner of CAP.

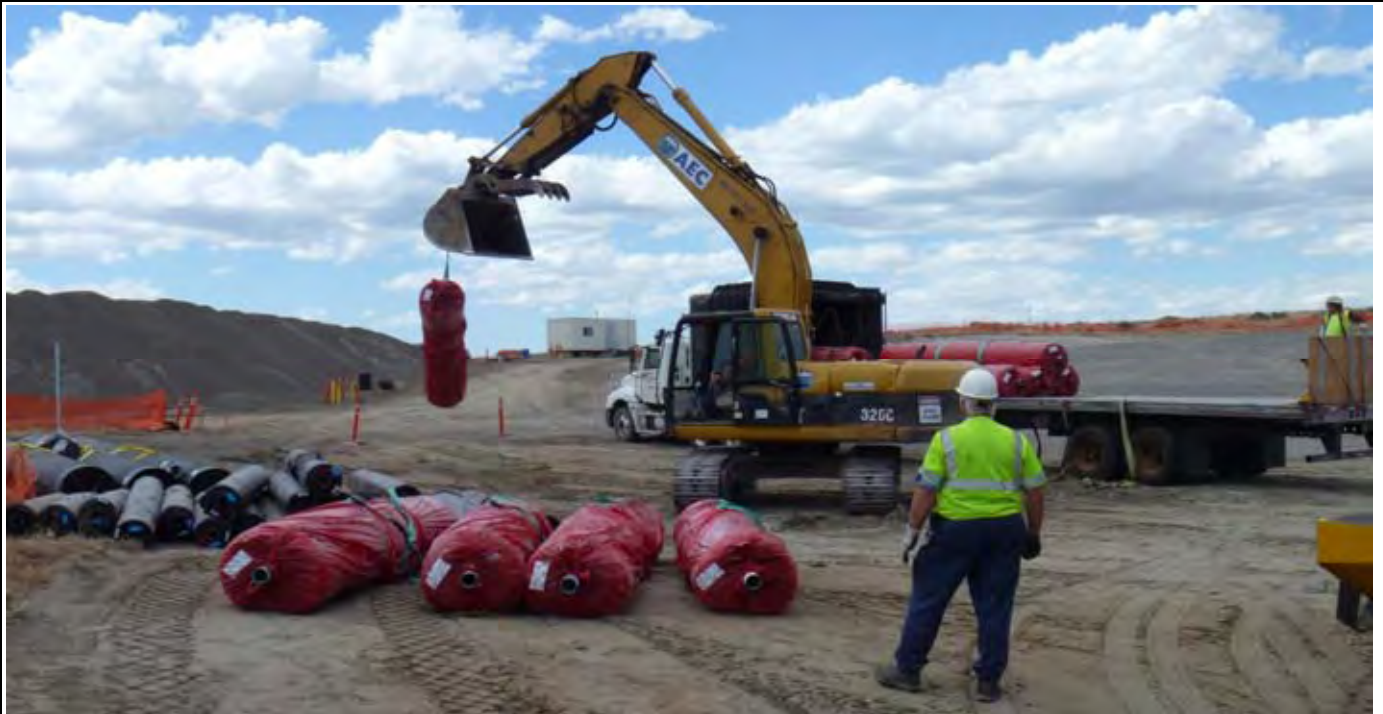
Photo 5: View of AEC trackhoe off loading the rolls of GCL (red rolls) from the flat bed truck. View looking NW from southern end (infiltration basin area) of site.

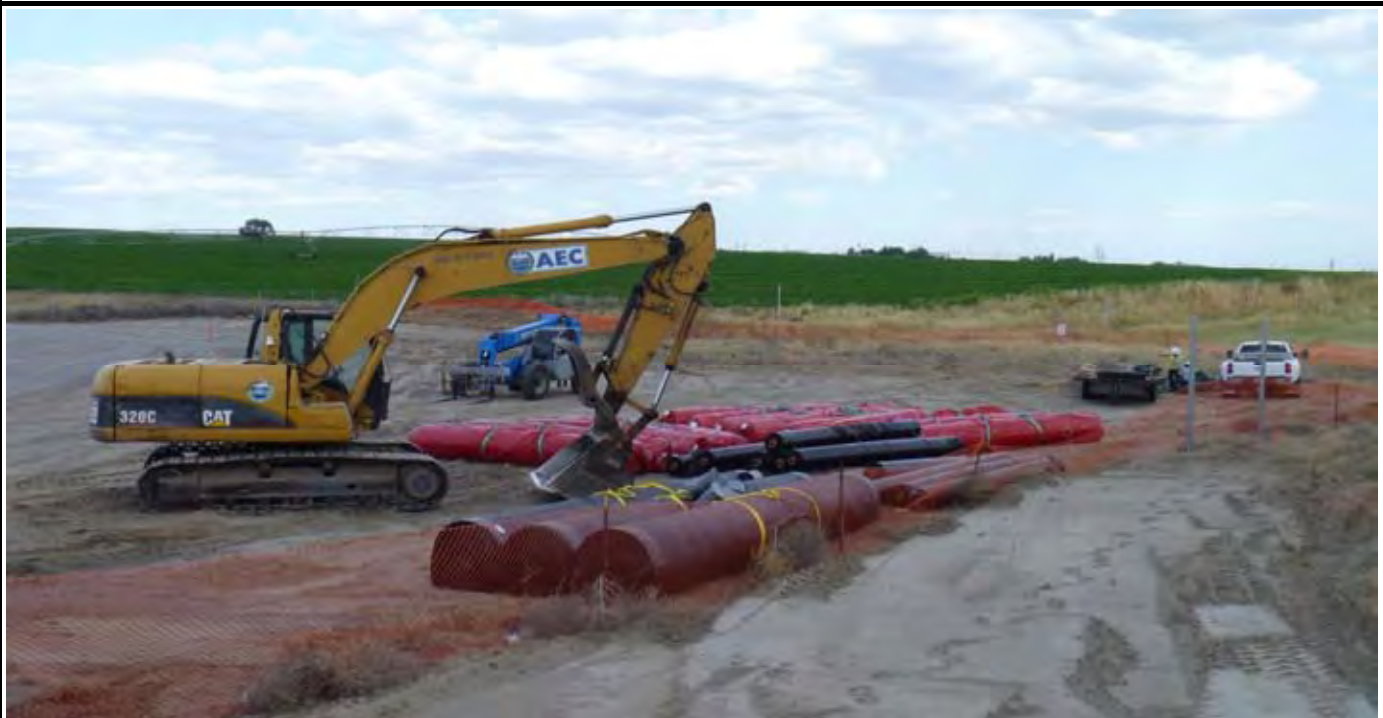
Photo 6: View of all 13 GCL rolls, 3 new geomembrane rolls (black) and 20 geosynthetic fabric rolls (small black rolls). Note NWL crew making sand bags on right side. View looking East from SW corner of the site.

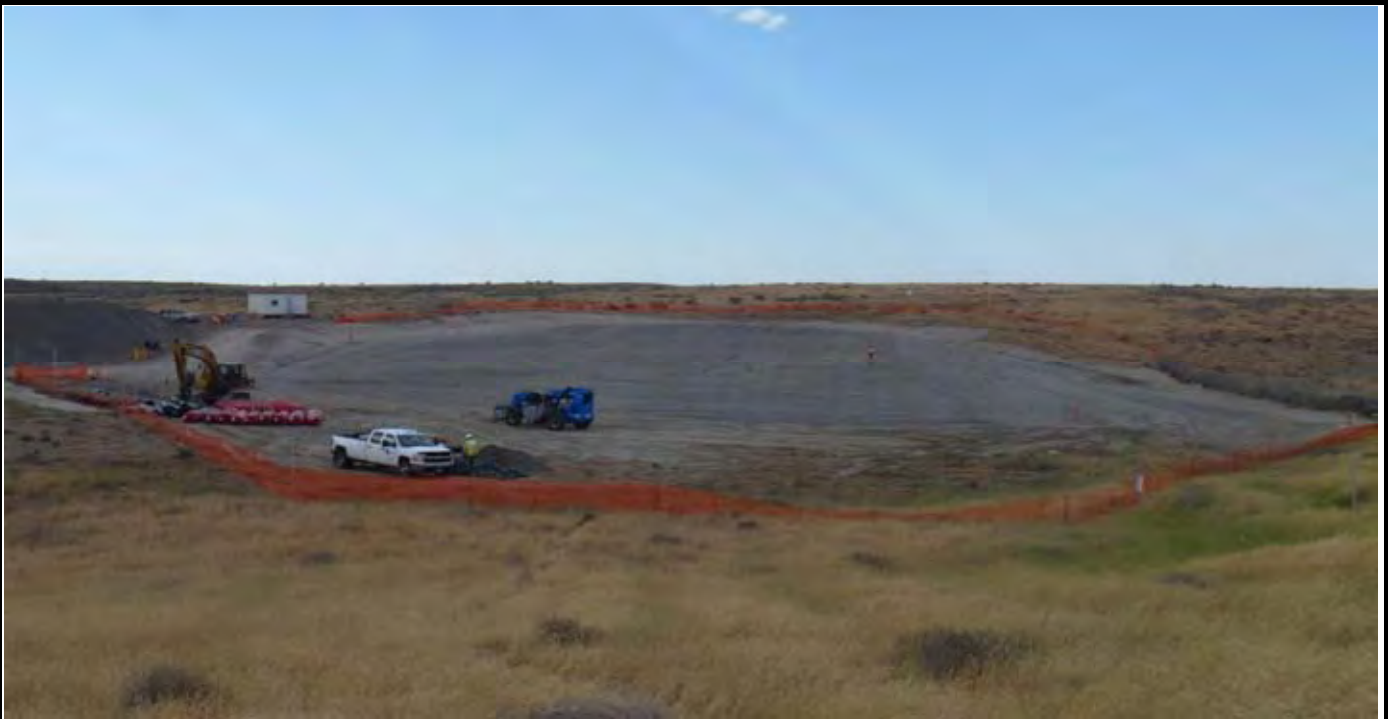
Photo 7: View of the site at the end of the day. Note NWL telehandler, rolls of GCL (red), geomembrane and fabric rolls (black by trackhoe), NWL white truck and sand pile for sand bags. View looking north beyond southern infiltration basin.

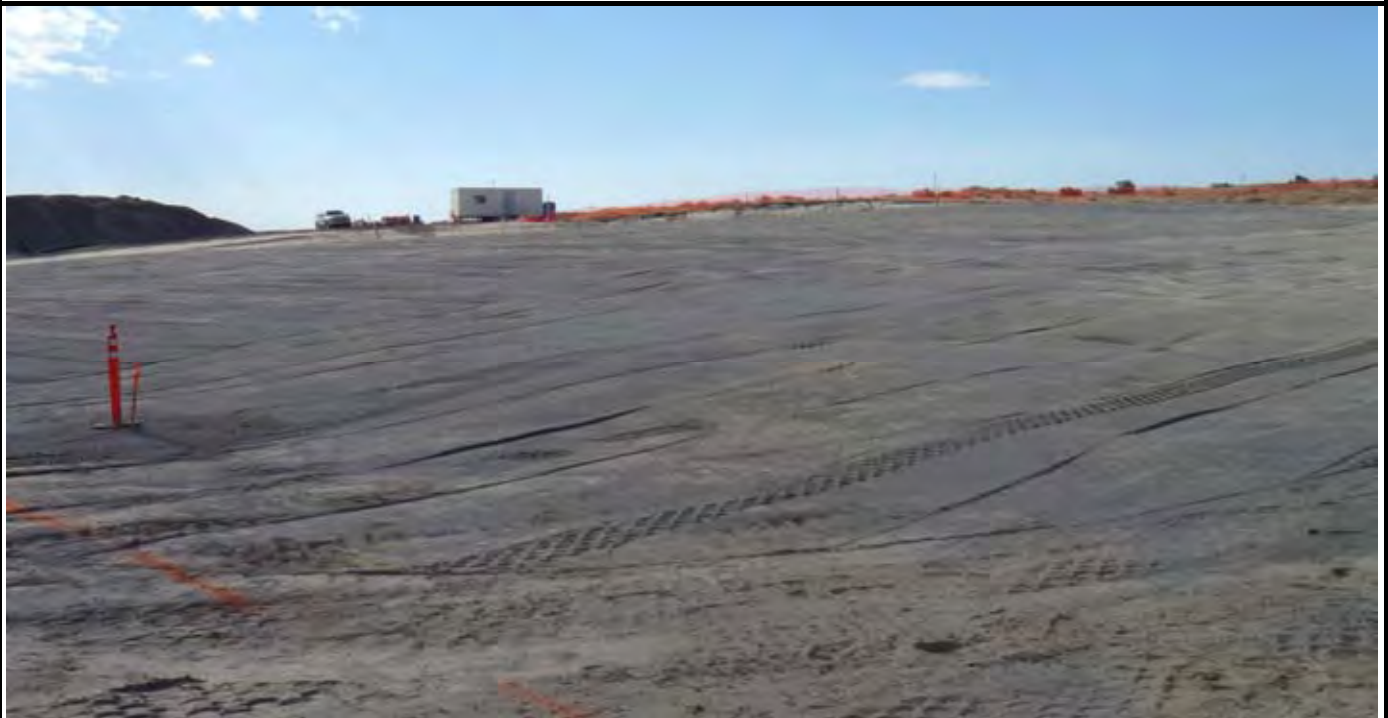
Photo 8: View of the Cap from the SE corner of the Cap (SE EOC). Note the job trailer new the NW corner of the site. View looking NW from SE corner.

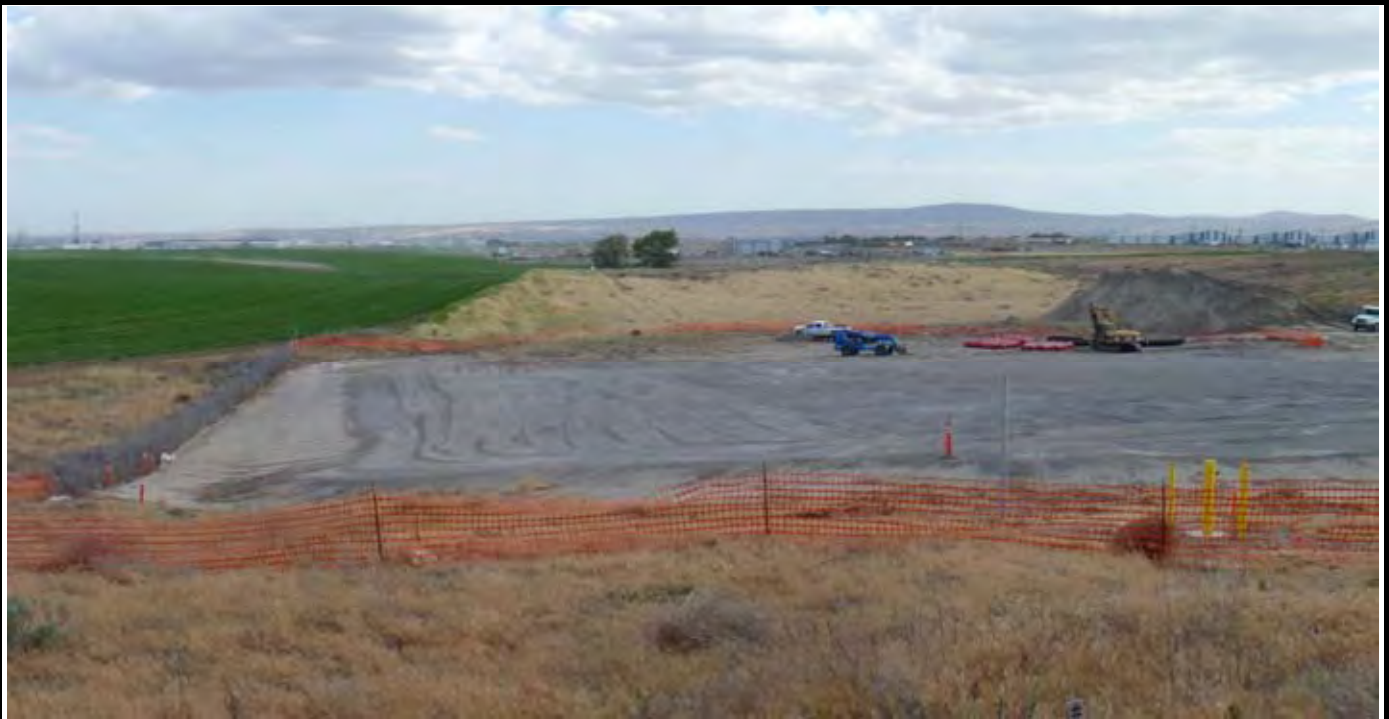
Photo 9: View of the eastern half of the site, cap, and perimeter swale (eastern swale). View from the area beyond the northern end of the site construction fencing looking south.

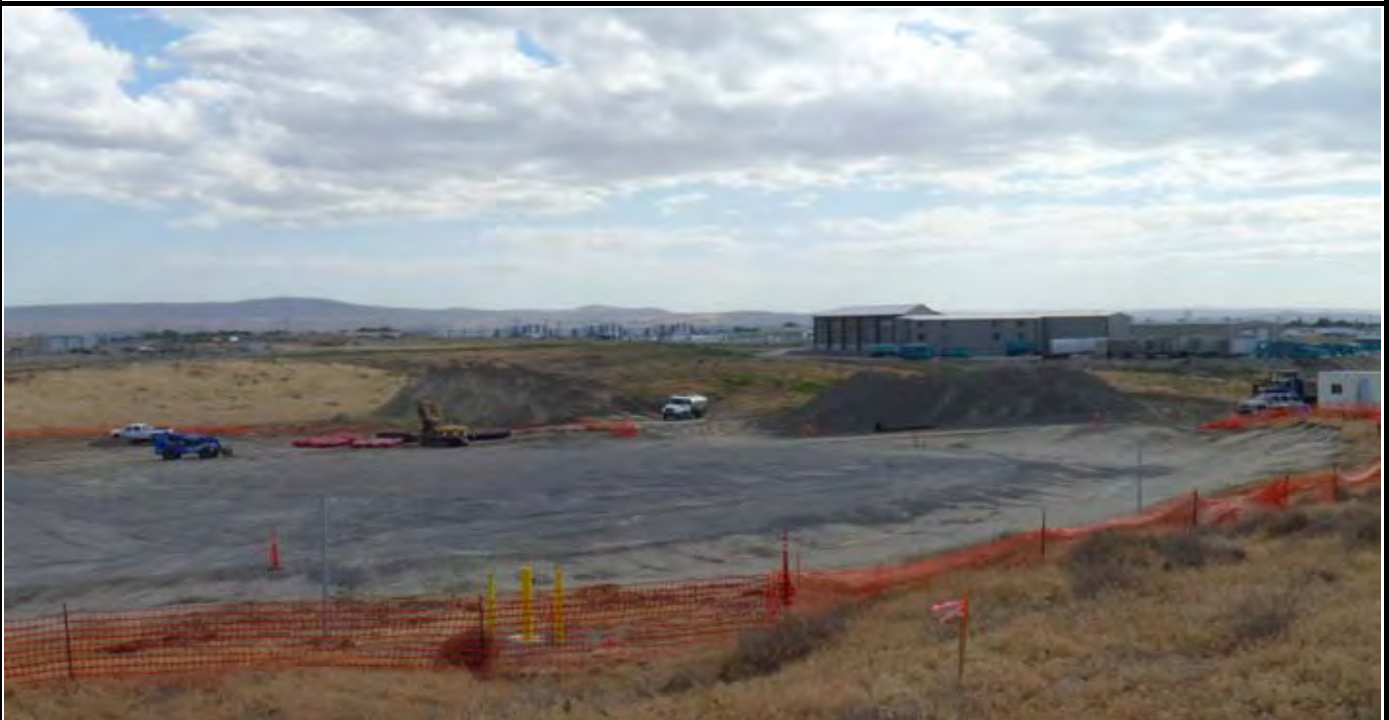
Photo 10: View of the western half of the CAP, NW swale, and soil (right) and topsoil (left) stockpiles. Note geosynthetic stockpile around trackoe near the SW corner of the EOL. View looking south/SW from area north of the site.

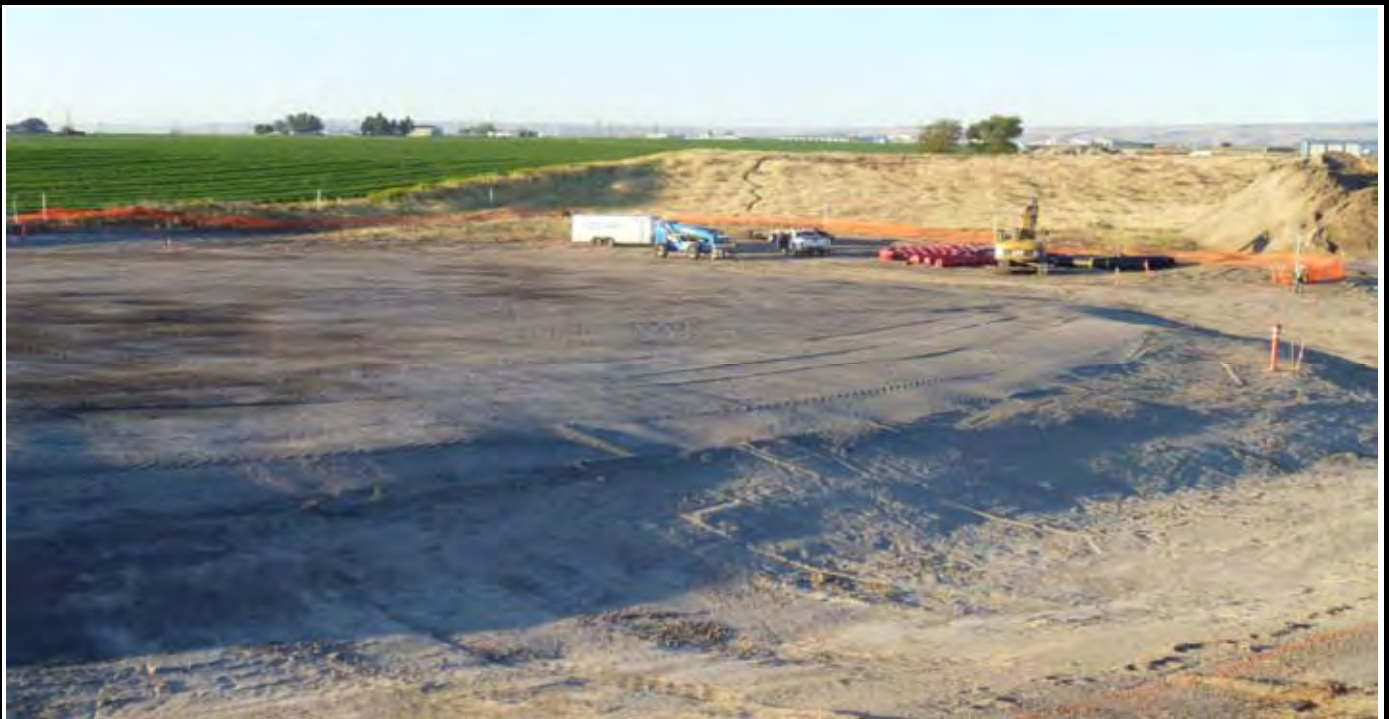
Photo 1: View of the site at the beginning of work for the day. View looking to the South / SE towards the staged materials and NW Linings (NWL) trailer and telehandler.

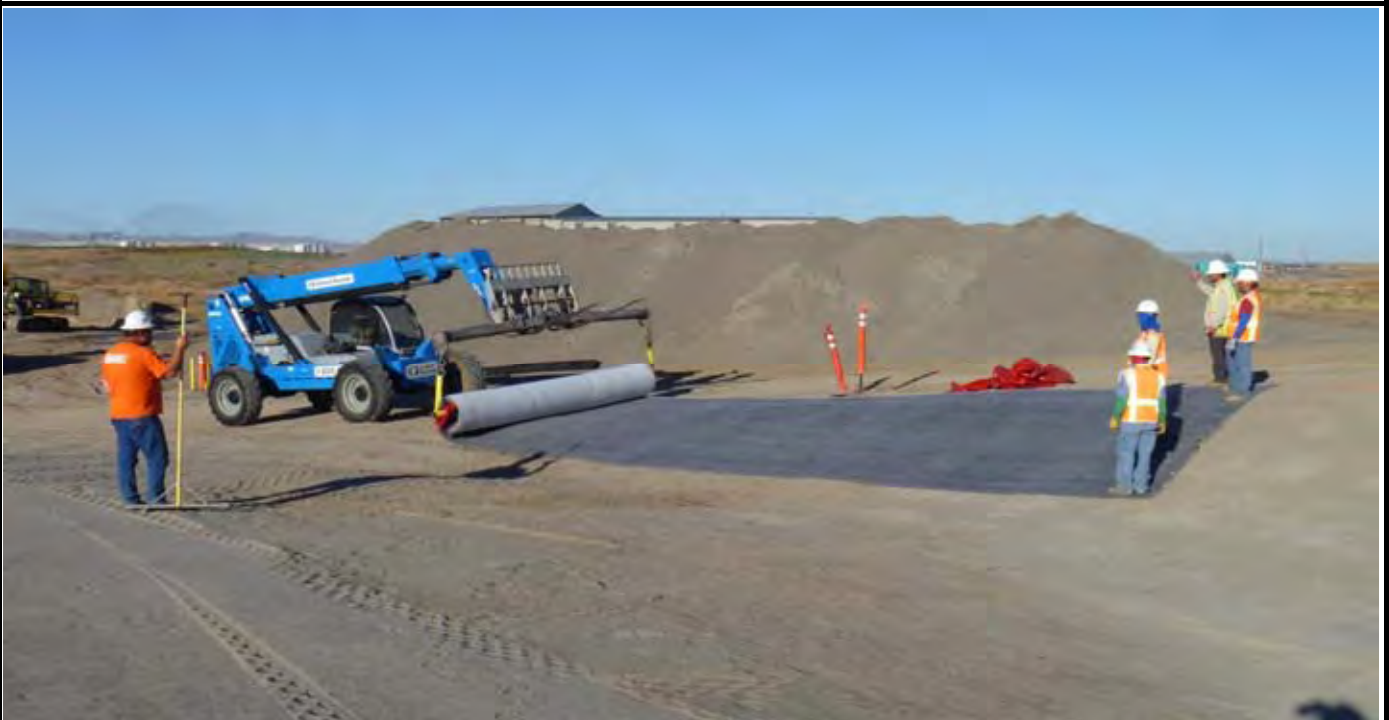
Photo 2: NWL rolling out the first GCL roll with telehandler along the western Edge of Liner (EOL). GCL roll starts at the NW corner of EOL (where NWL crew is standing on it). View looking west from western edge of cap (EOC).

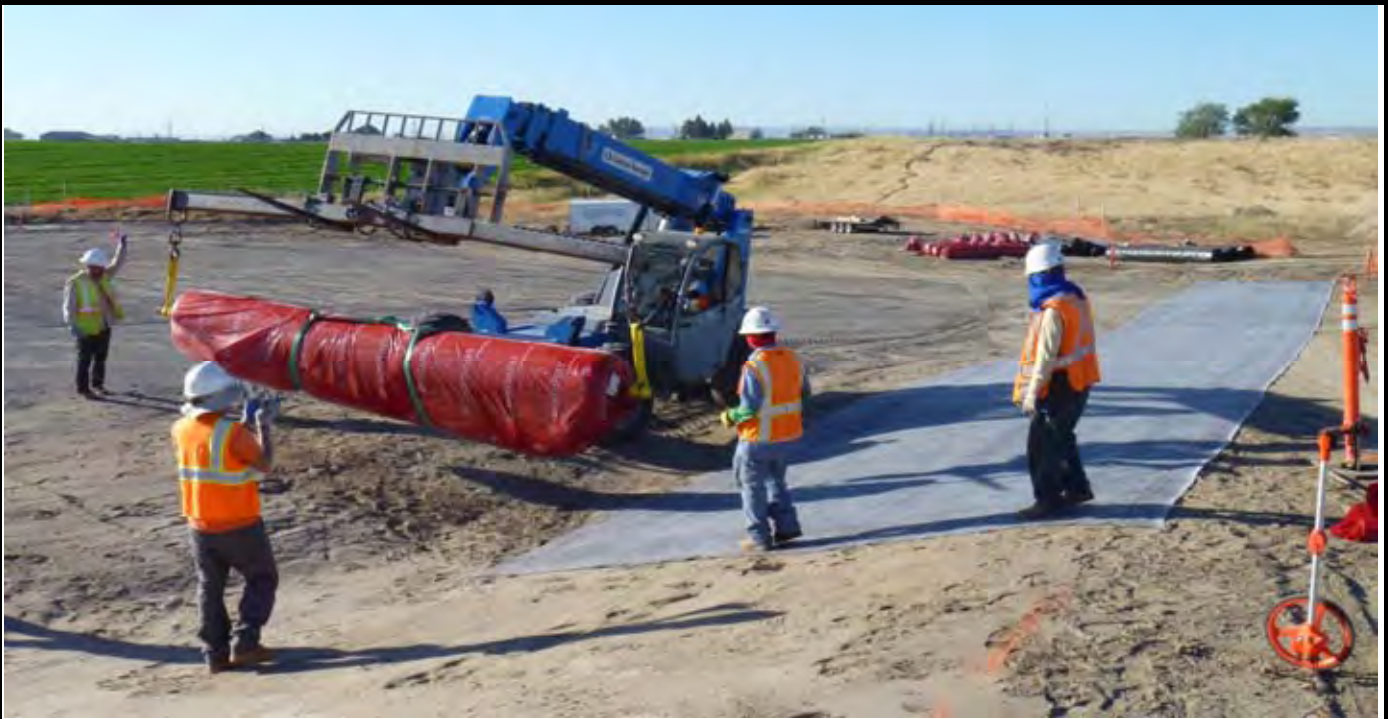
Photo 3: View of NWL positioning to roll out the second GCL roll along the eastern edge of the first GCL roll (which is installed along the western EOL down to the SW corner - see background). View looking south from NW corner of EOL. Note roller assembly held up by telehandler.
