PHOTOGRAPH LOG

Environment and Infrastructure, Inc.
7376 SW Durham Road
Portland, Oregon 97224

PROJECT NAME: Pasco Landfill Cap Project - Cap Construction Project

Project No: 4-61M-10705-1 P-02

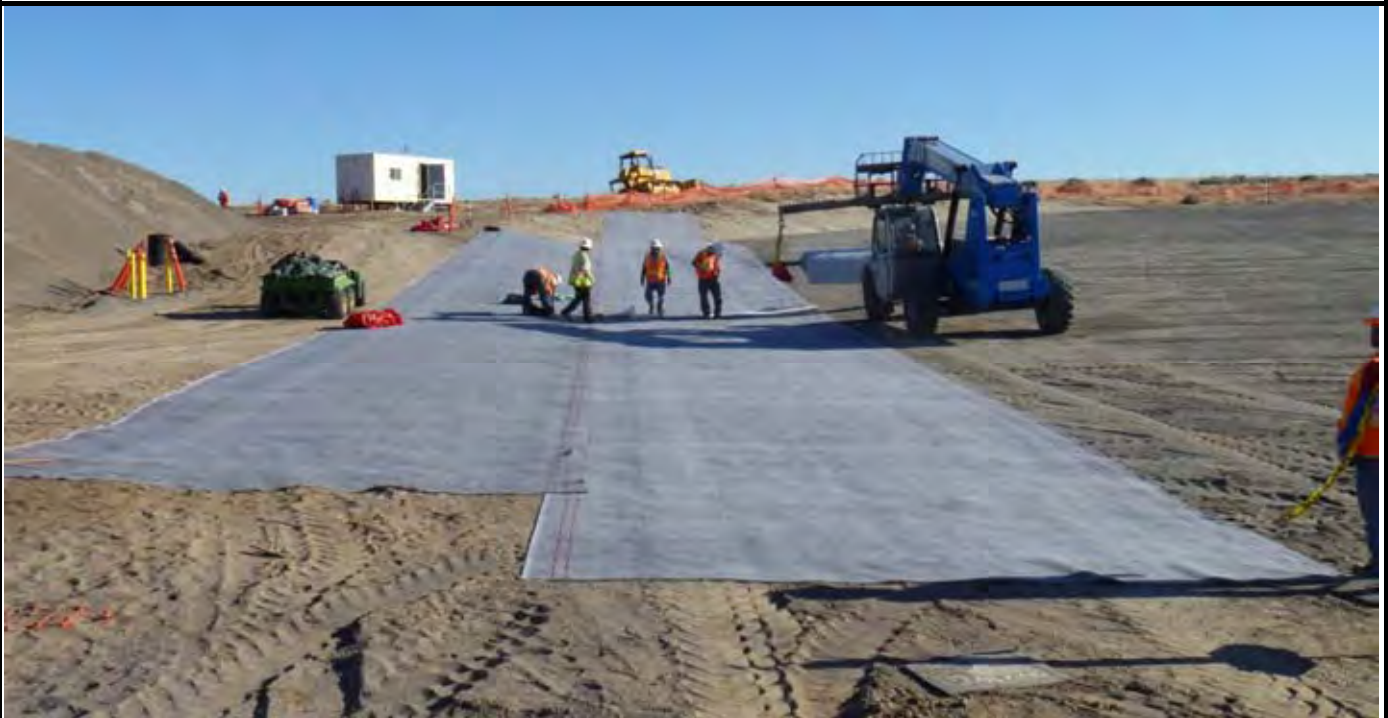
Photo 4: View of the first two GCL rolls laid out along the western side of the EOL and CAP area. Note remaining roll of GCL on telehandler is getting ready to install it along the northern EOL. View looking north from SW corner of EOL. Note that NWL will trim up the southern EOL later.

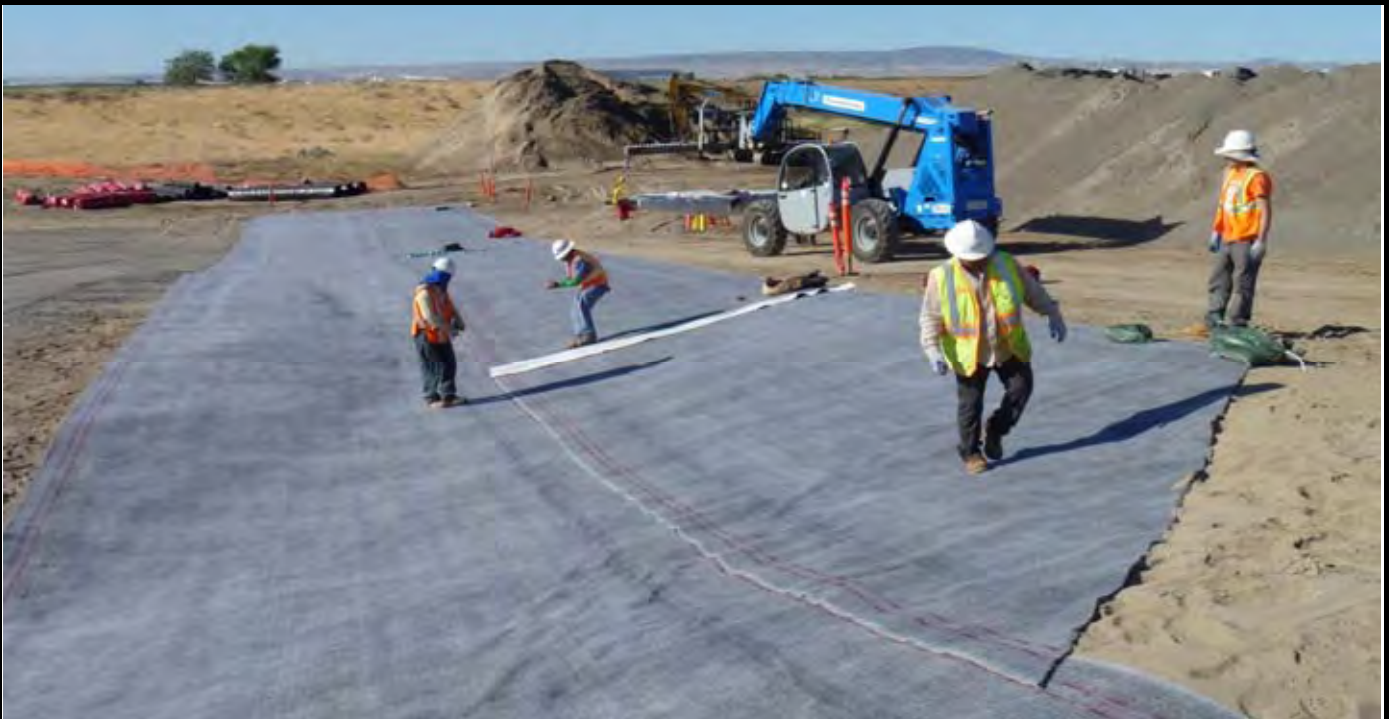
Photo 5: View of NWL installing small piece of GCL just north of the first GCL roll to finish off the western EOL. Note that NWL has cut the northern edge to match the angle of the EOL perimeter. View looking south from the northwestern EOL.

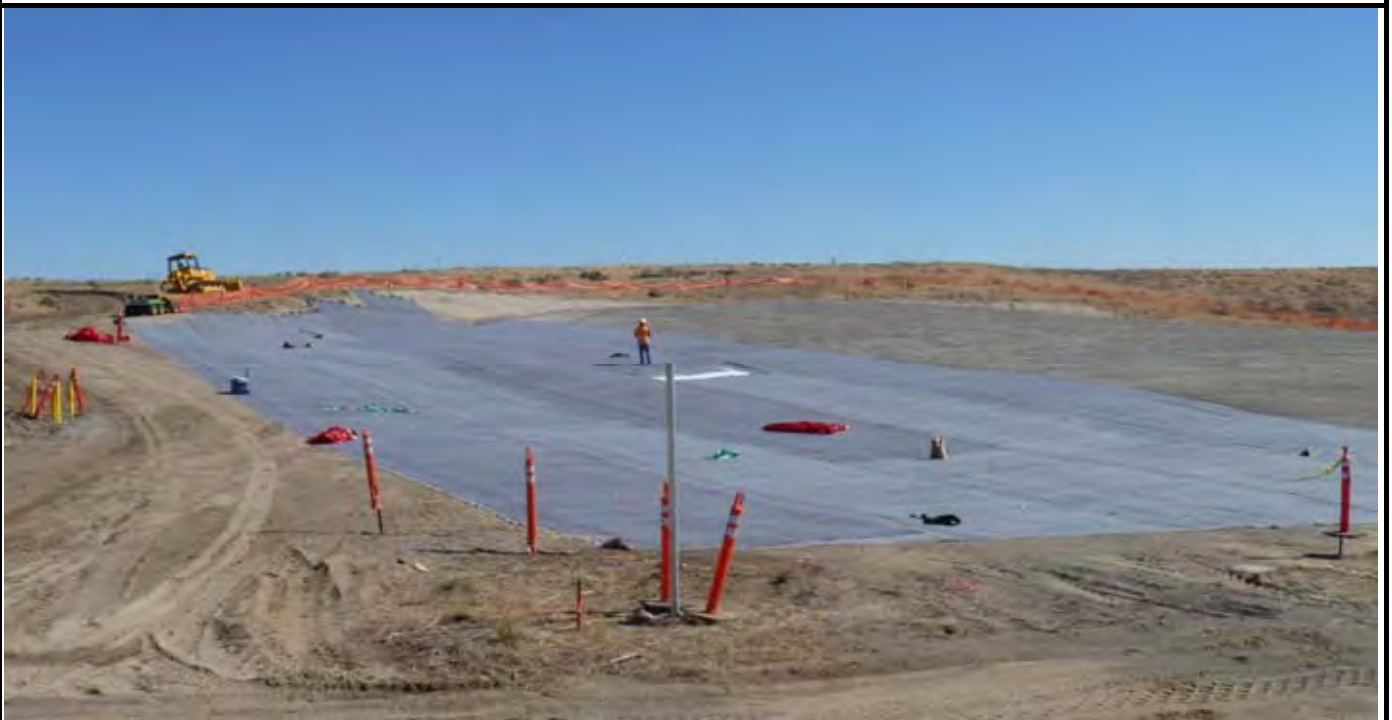
Photo 6: View of about 5 passes of GCL along the western side of the CAP. GCL covers the entire western side of the EOL and part of the western CAP. View looking North to Northeast from area SW of the SW corner of the EOL. Note corner post of the new perimeter fence.

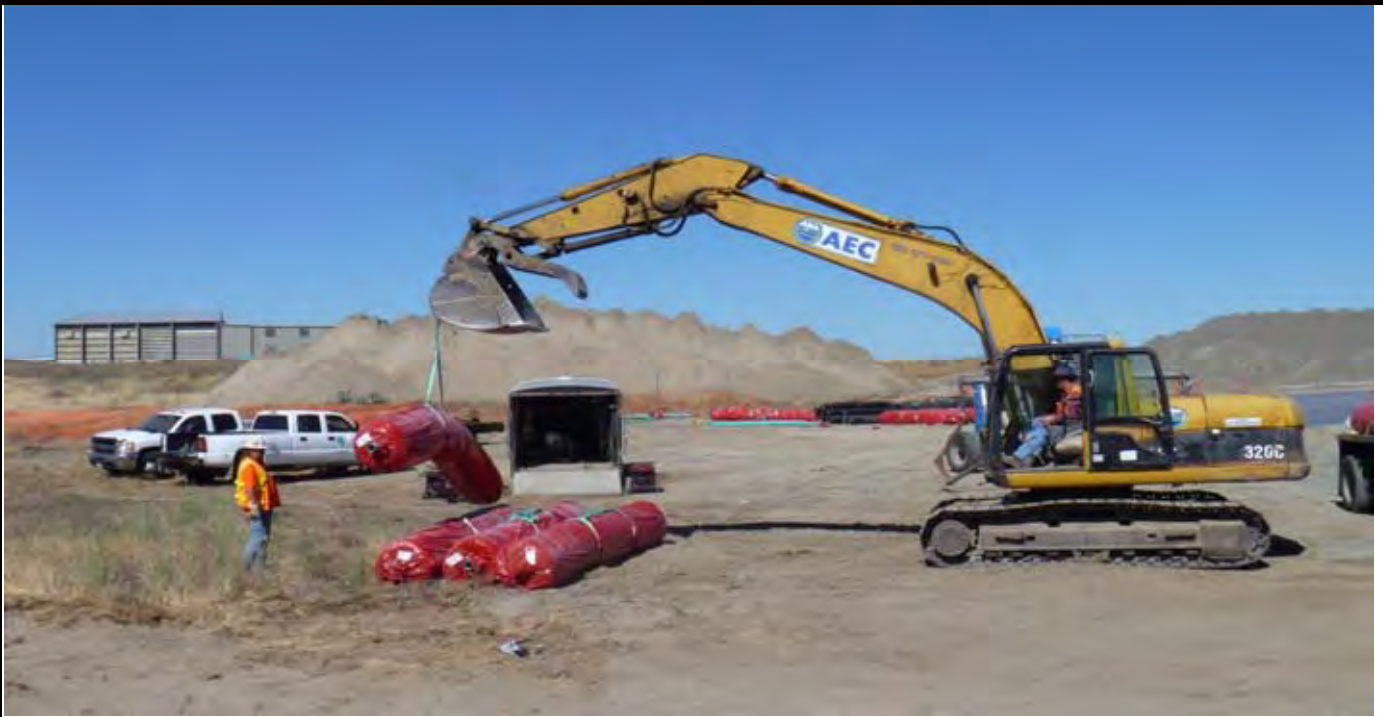
Photo 7: View of AEC trackhoe and crew off loading 14 new GCL rolls from the flatbed truck and staging them in area south/southeast of the CAP (note GCL rolls in the background that were off loaded yesterday). View looking west from area south of the SE corner of the EOL.

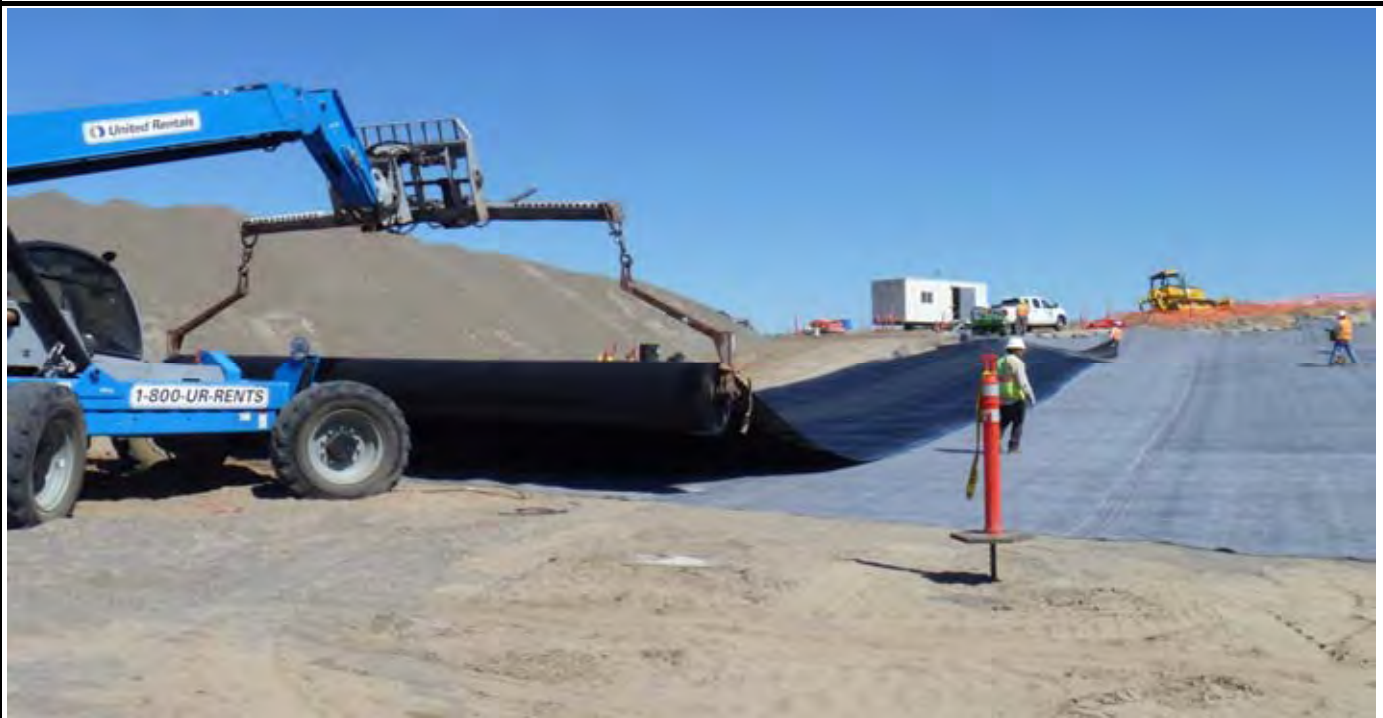
Photo 8: View of NWL rolling out the first pass of geomembrane over the GCL along the western edge of the EOL. Note the different roller assembly held up by the telehandler. View looking north from area near the SW corner of the EOL.

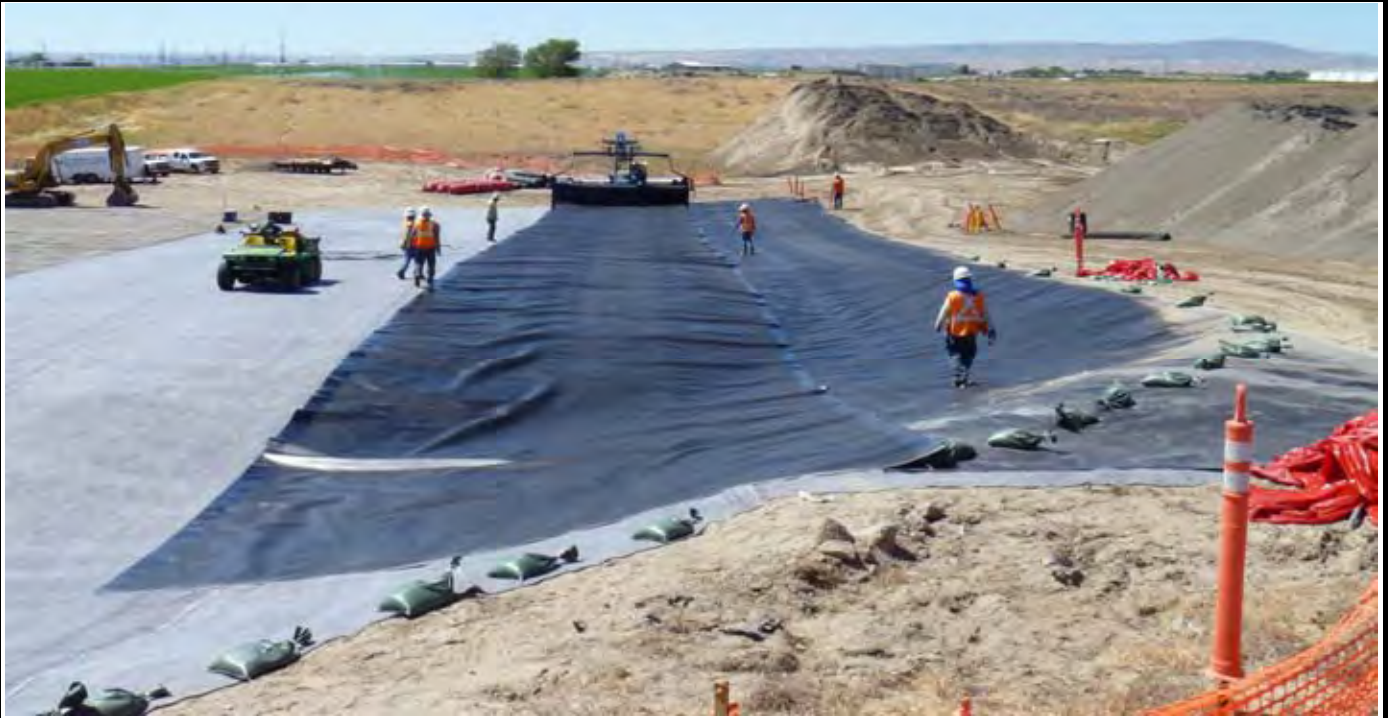
Photo 9: View of the first two passes of the geomembrane (40-mil HDPE liner with microspike texture on one side). Note second liner overlaps the first. View looking south from area north of the NW corner of the EOL.

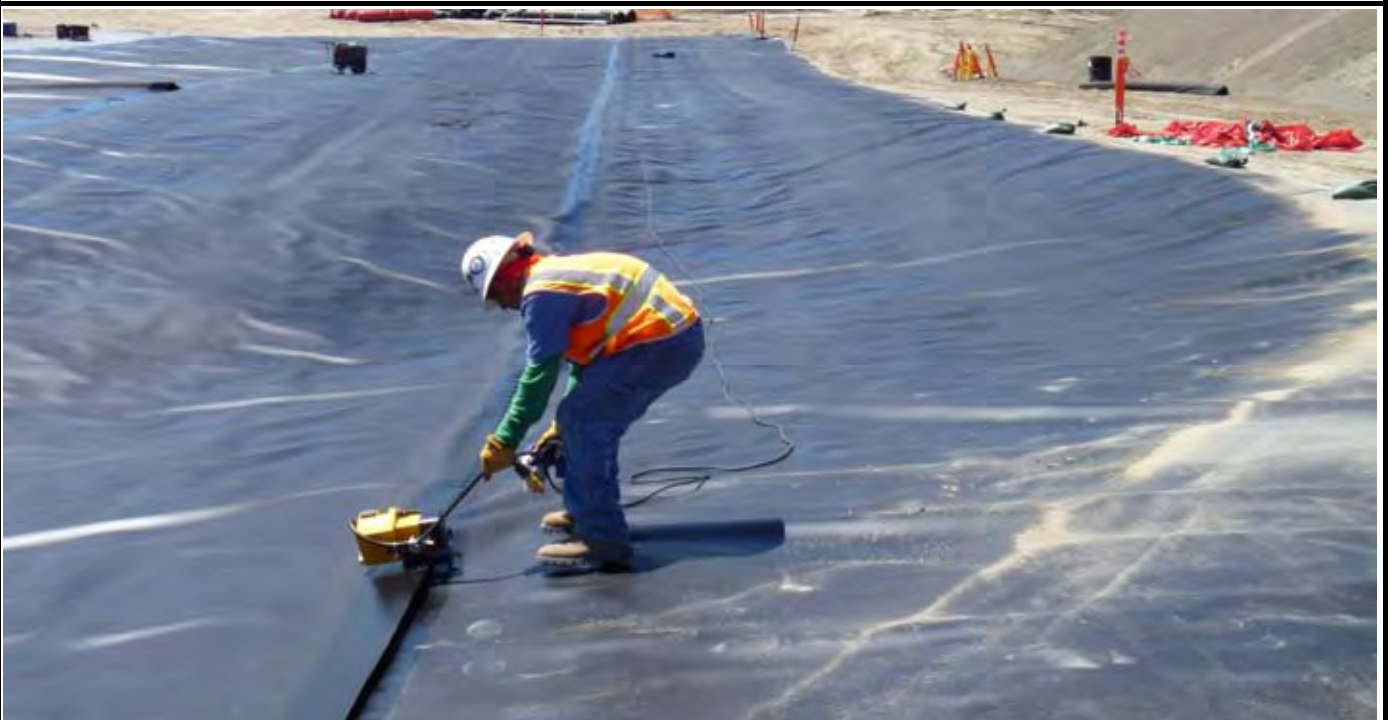
Photo 10: View of NWL worker welding the first and second pass of geomembrane together with welding machine. Note that there are three passes of geomembrane over the GCL now. View looking south from NW corner of EOL.

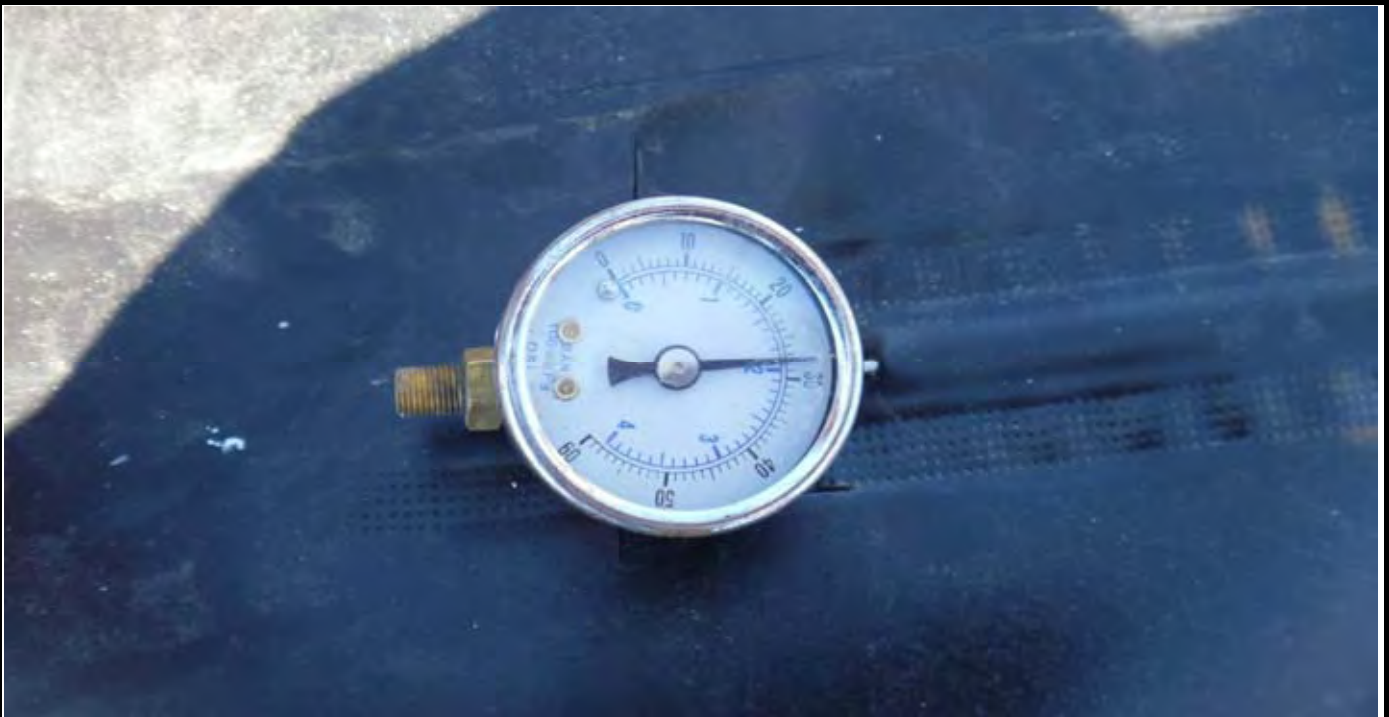
Photo 11: View of the pressure gauge monitoring the inflated welded seam between geomembrane pass P-1 and P-2. Note pressure is about 28 psi. This weld held pressure and was approved by AMEC. View looking down at pressure gauge assembly located new the SW corner of the EOL.

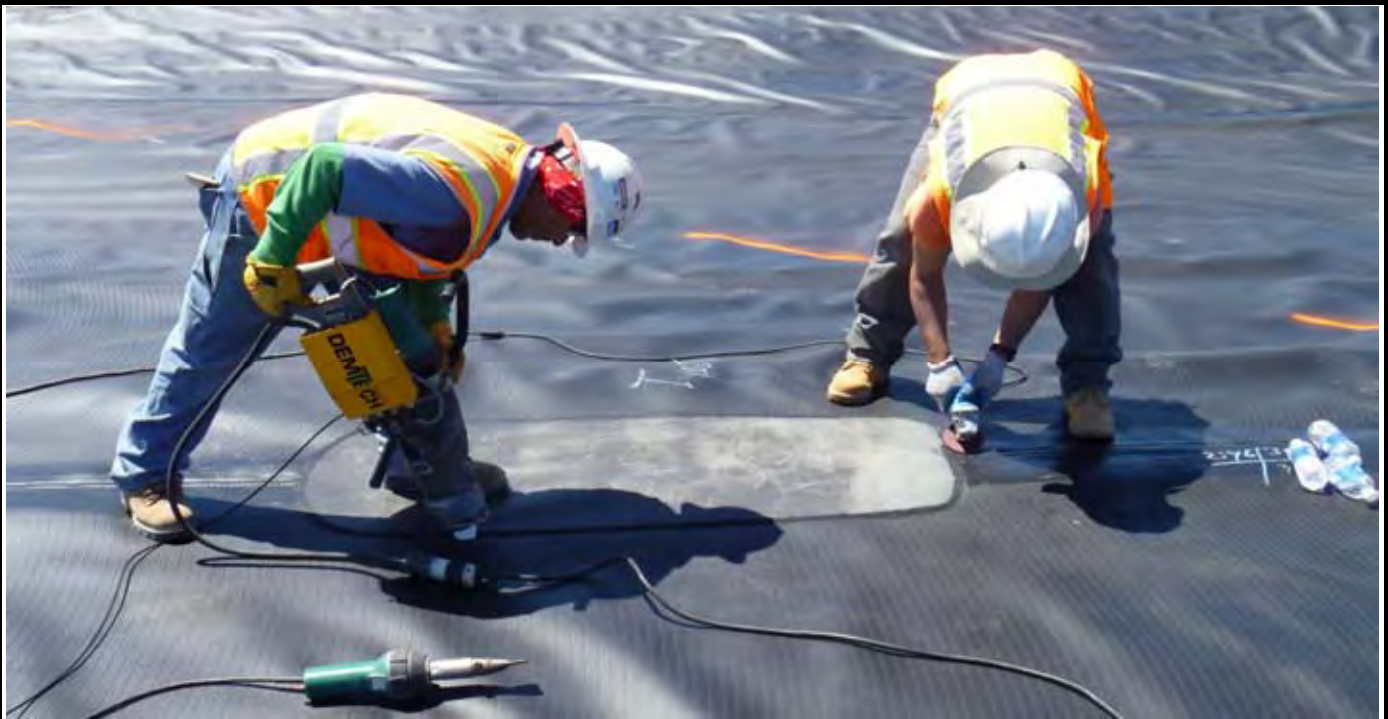
Photo 13: View of NWL installing patch around an area of seam S-2 that was removed for testing. Note tool on left that extrudes bead of molten HDPE along the edge of the patch. Patch was vacuum tested and passed the test and seam S-2 approved. View looking west from geomembrane pass P-3.

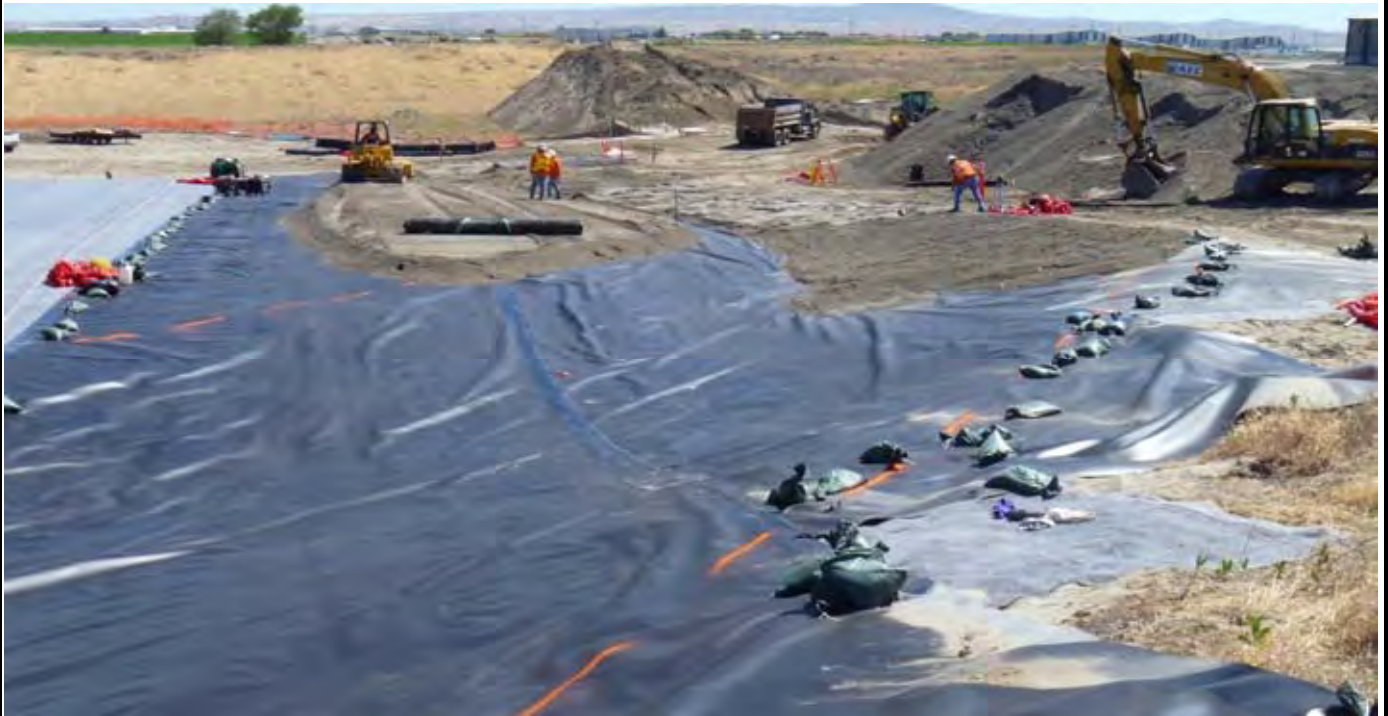
Photo 15: View of EOC installing sand layer over the geomembrane along the western side of the geomembrane (only three passes of geomembrane). Note orange dashed lines (foreground = EOL and center is EOC lines) and geosynthetic fabric (geo-fabric) rolls on sand that AEC is about to roll out over top of sand. View looking south from northern edge of EOL.

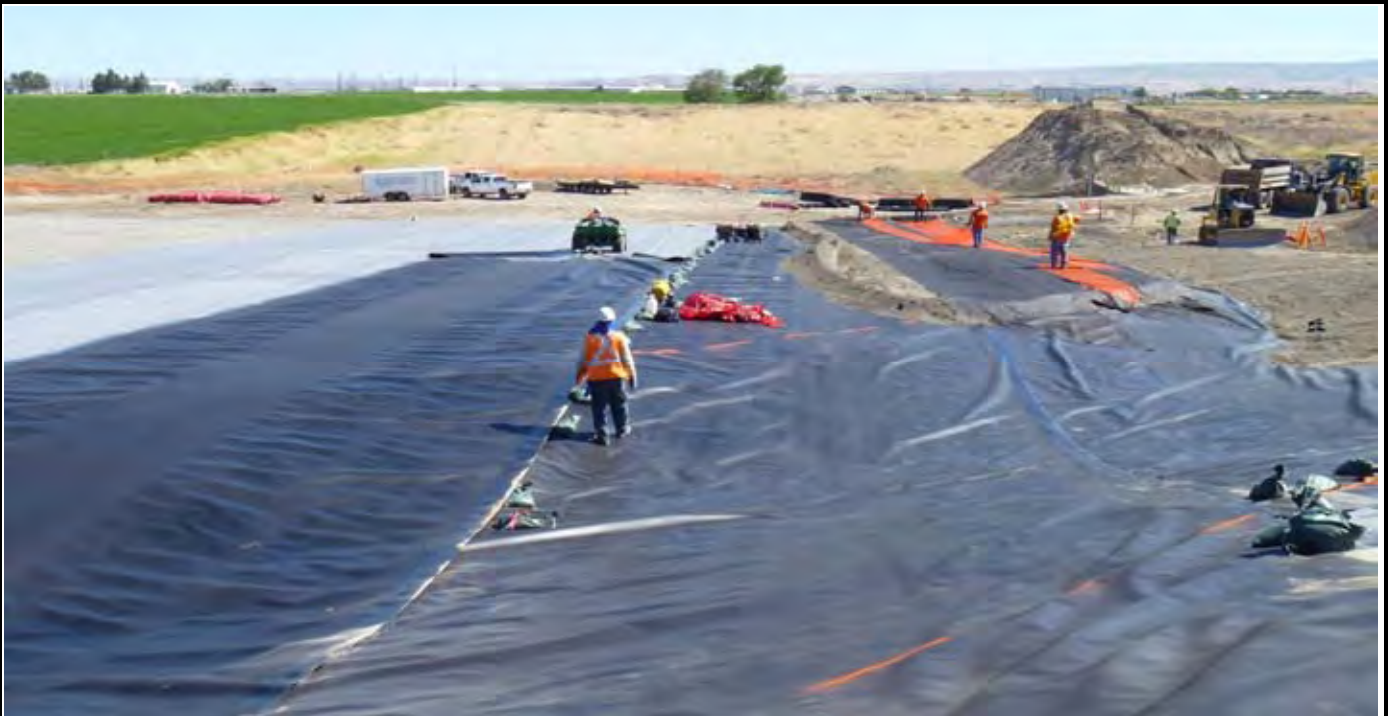
Photo 16: View of NWL installing 4th pass (P-4) of the geomembrane along the eastern edge of pass P-3. View looking south from northern EOL.

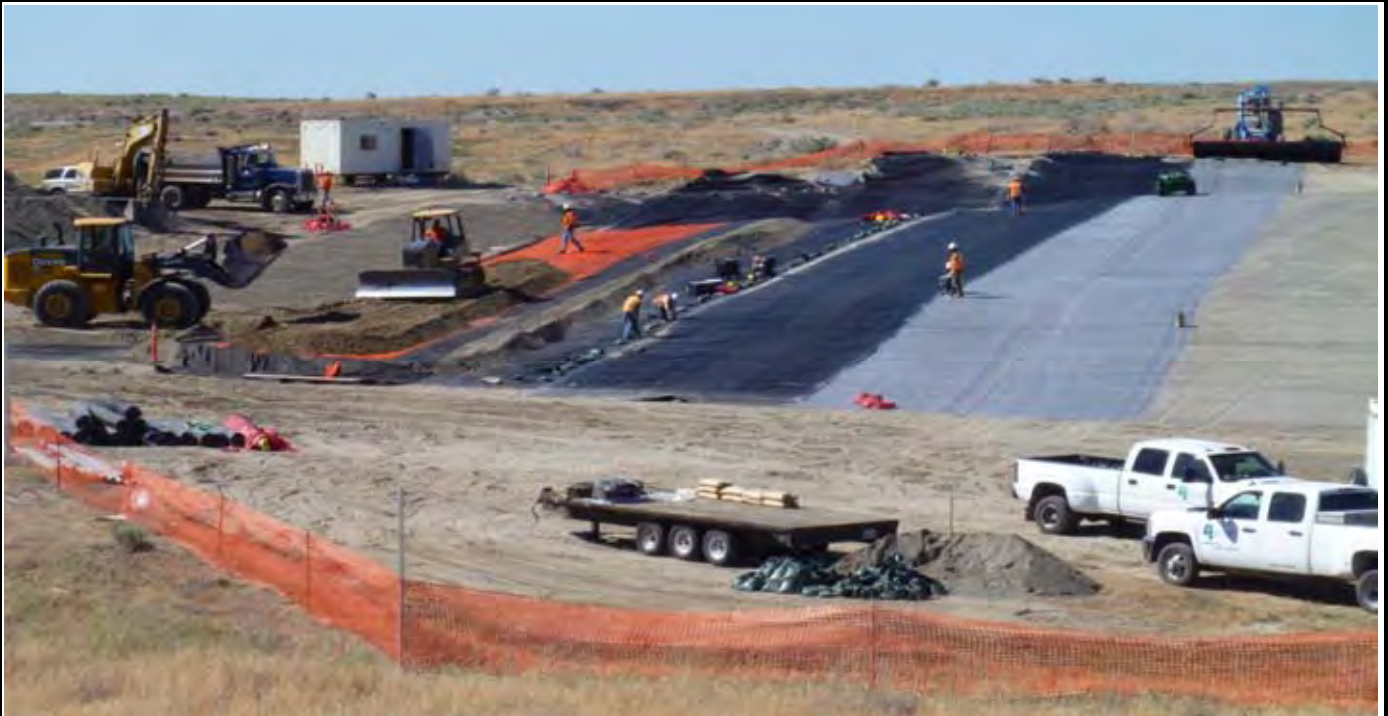
Photo 17: View of western side of the CAP showing NWL installing fifth pass (P-5) of geomembrane and AEC installing topsoil over orange construction fencing (OCF) visual barrier over the Geo-fabric and sand layer along the western edge of the CAP. View looking north by northwest from area south of the southern edge of the infiltration basin (area just inside the installed OCF in foreground).

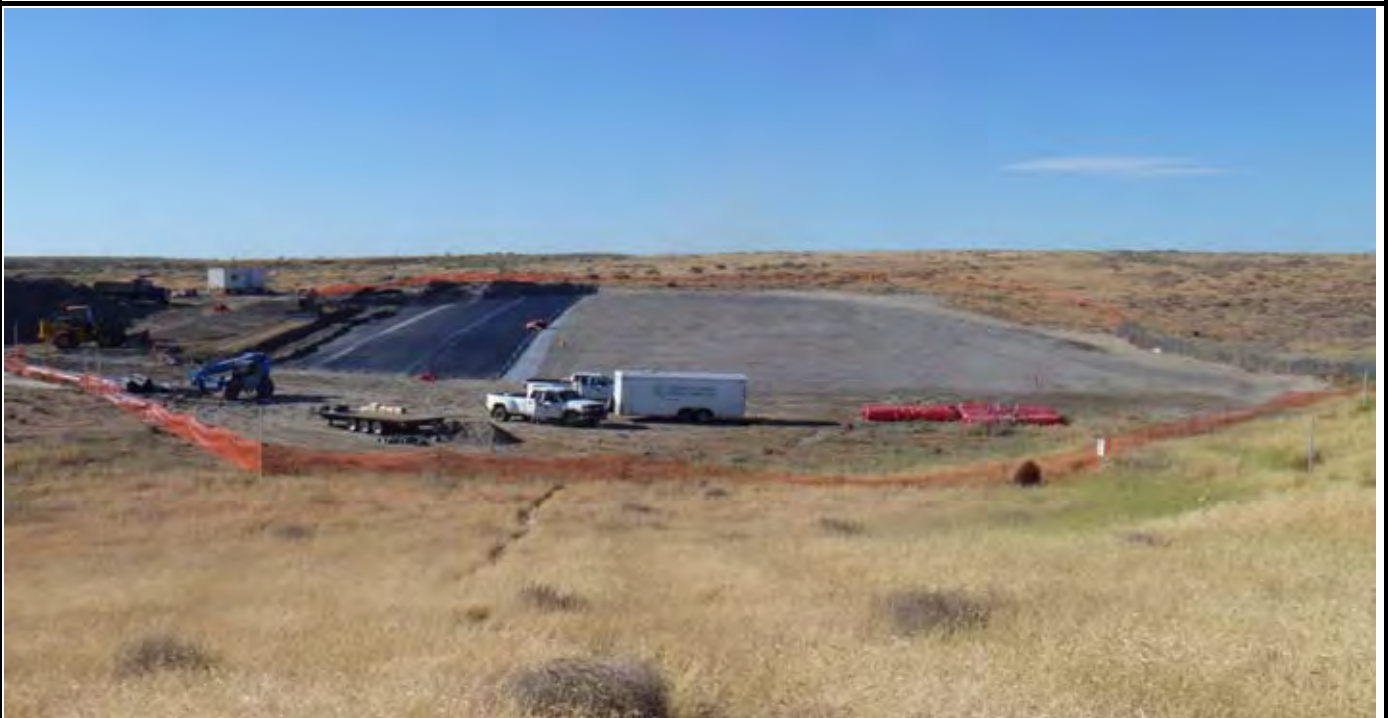
Photo 18: View of the site at the end of the day. NWL has installed approximately 35% of the GCL and geomembrane. AEC has just begun covering the geomembrane with sand and topsoil layers along the western edge of the CAP. View looking north from the area south of the southern end of the site.

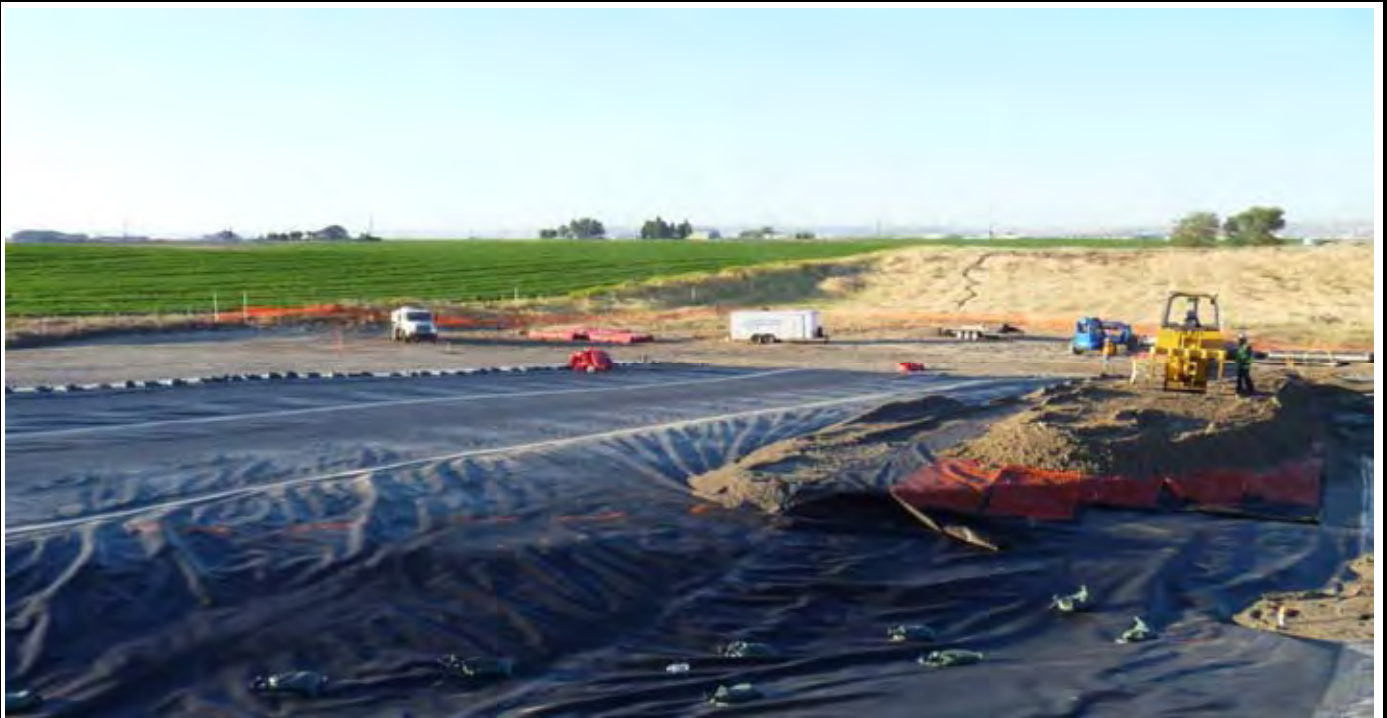
Photo 1: View of the site at the beginning of work for the day. View looking to the South / SE towards the water truck. Note AEC crew prepping for work prior to NWL crew arriving (at 7AM) at about 6:15AM.

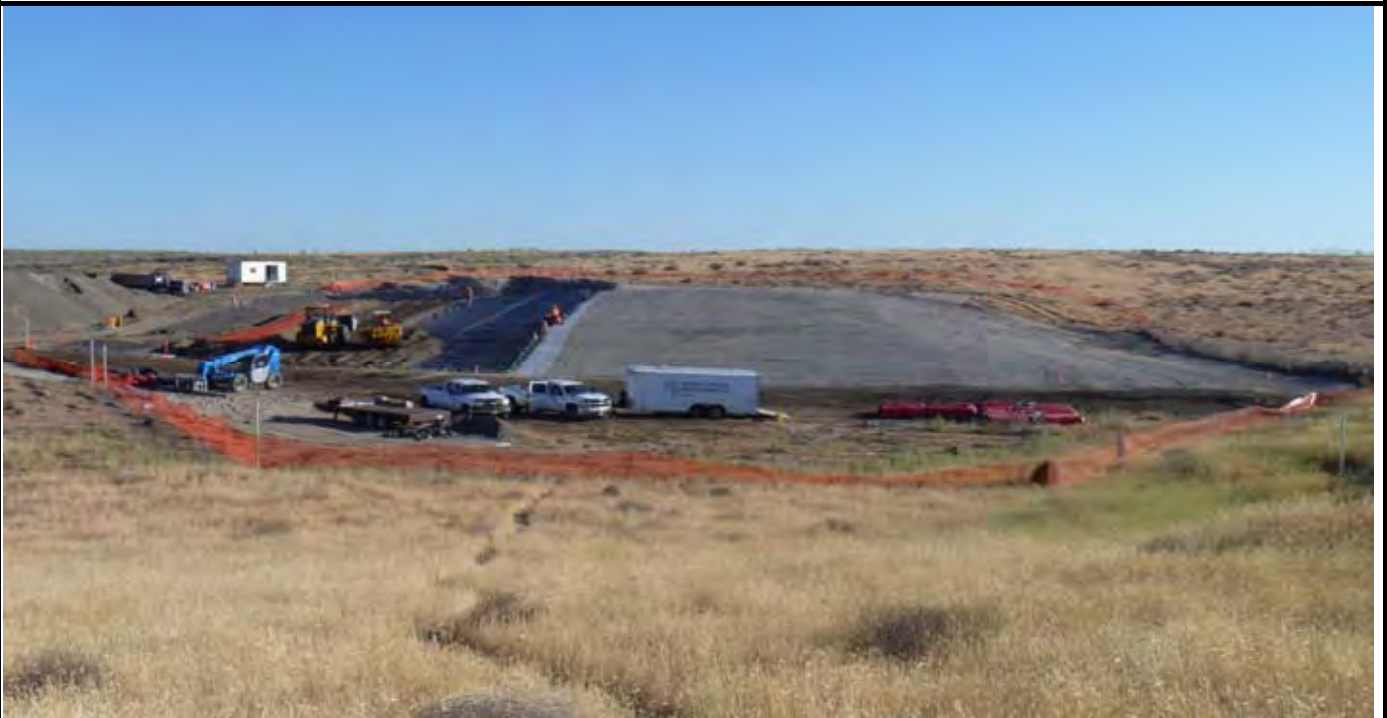
Photo 2: Status of the liner cover at 7AM when NWL crew arrives and begins to install more GCL rolls (see red rolls along southern edge of CAP). View looking North from area south of site.

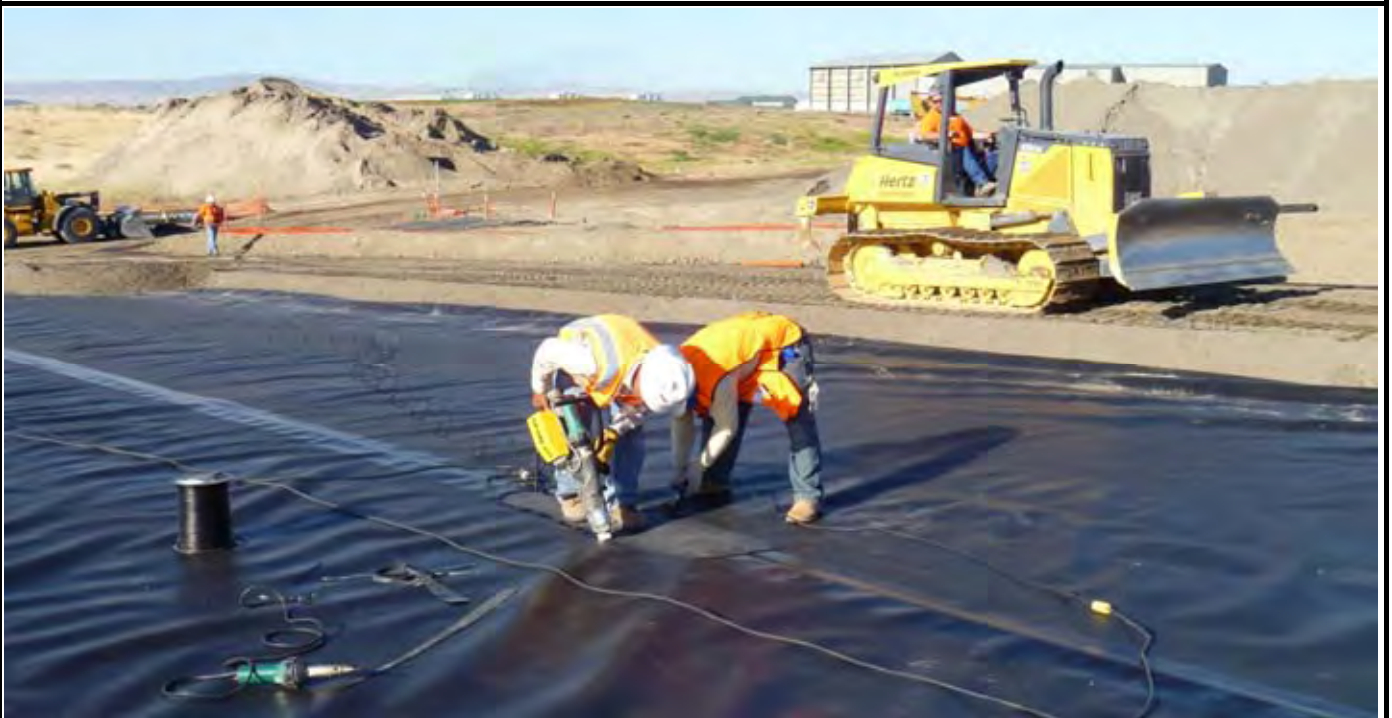
Photo 4: View of NWL crew sealing patch at location of DS-2 sample. Note AEC bulldozer laying out 1-ft thick sand layer on geomembrane panel 3. View looking SW from center of geomembrane panel 5.

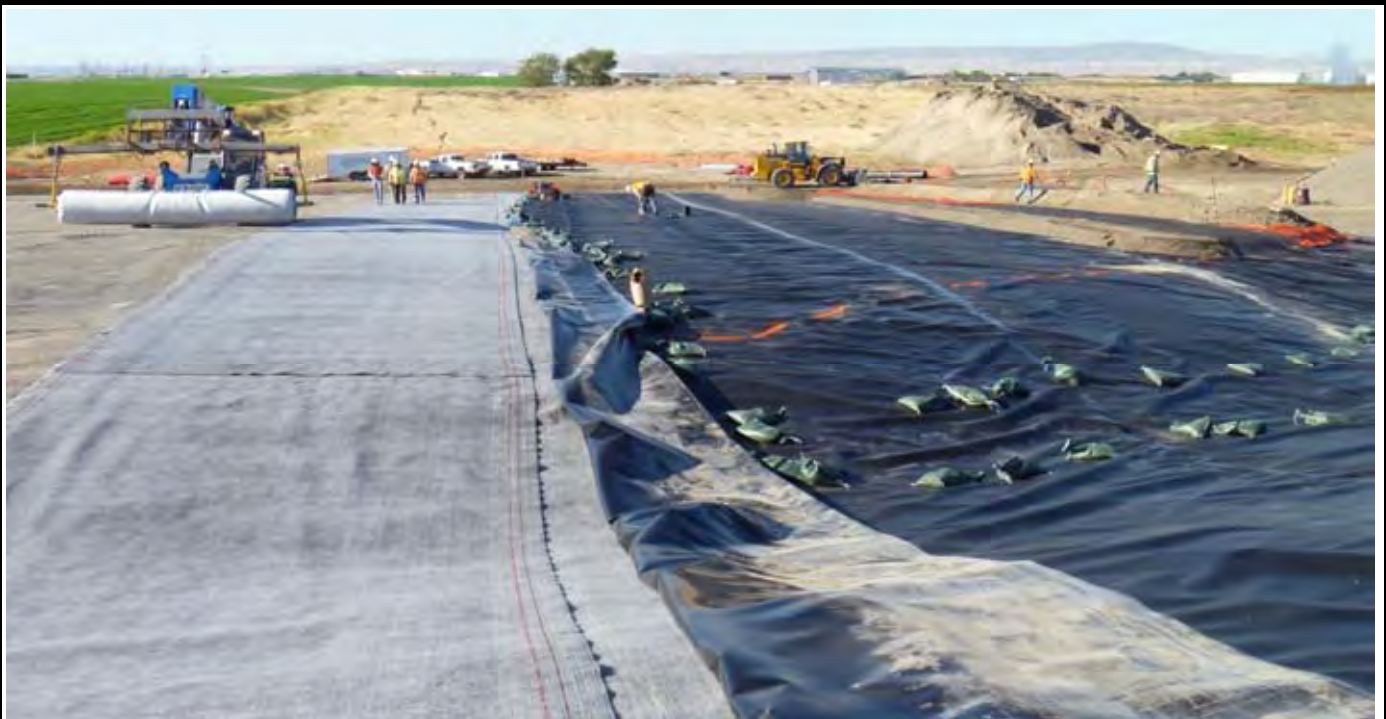
Photo 5: View of NWL starting to lay out rolls of GCL prior to geomembrane installation. Note geomembrane being pulled back (foreground) for GCL installation and orange dash lines (denotes EOC along NW corner of CAP). View looking south from northern EOL. Note GCL roll on telehandler on left side of picture.

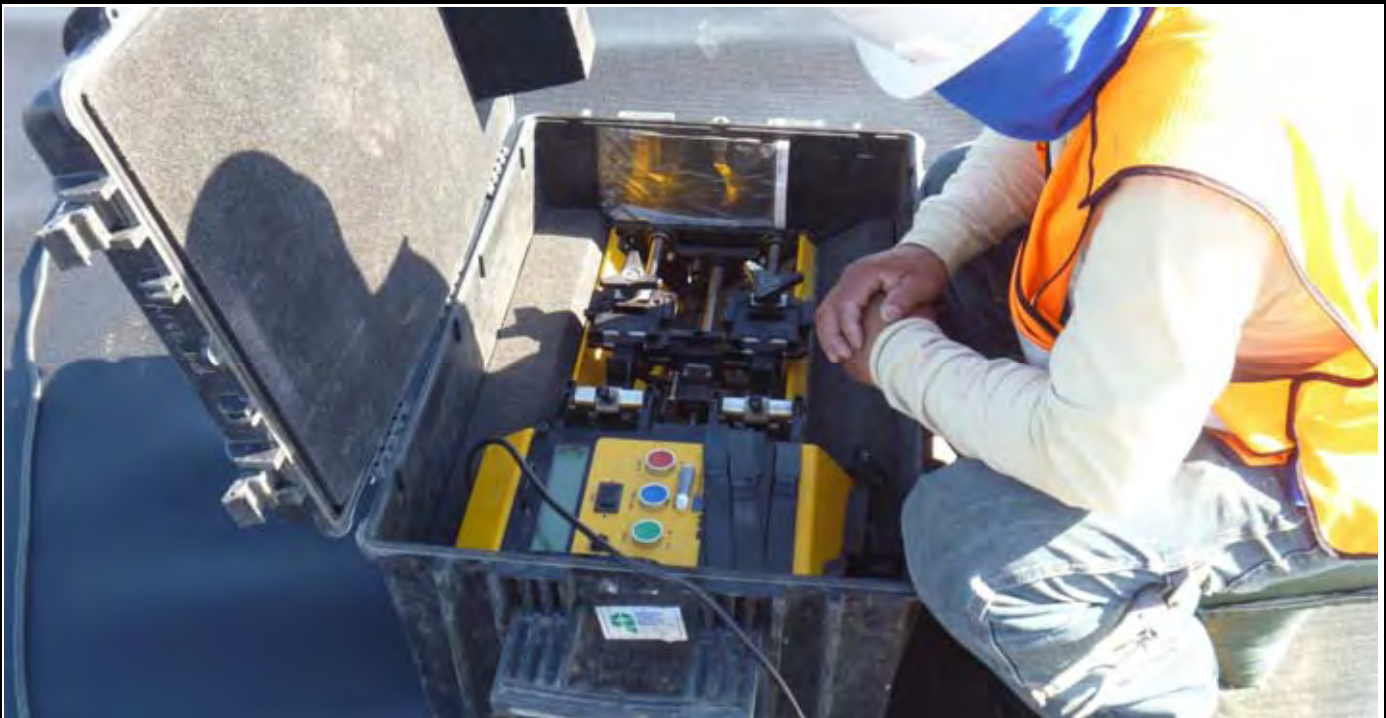
Photo 6: View of field testing equipment used to test the DS samples of the seams. Note two parallel tracks testing two seam samples at the same time.

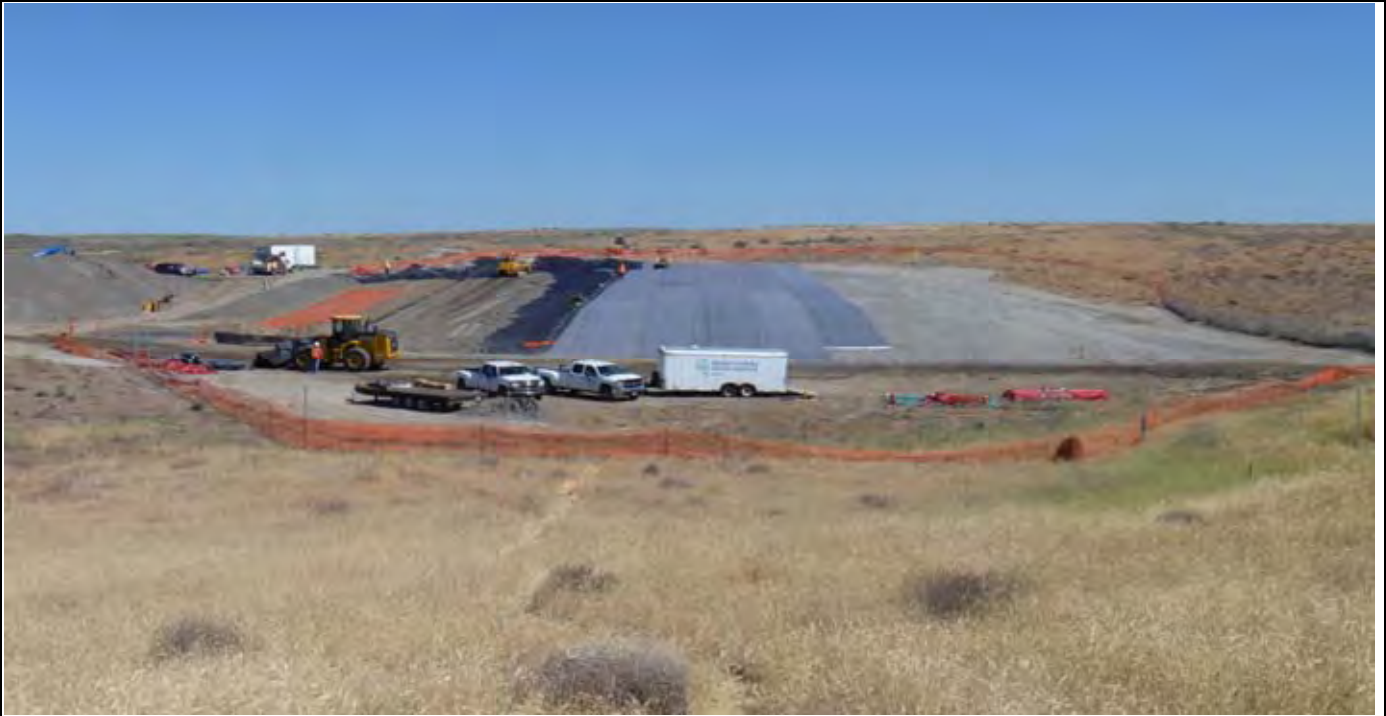
Photo 7: View of the CAP after NWL has exhausted all but three rolls of GCL (left for tomorrow AM work) and is preparing to install geomembrane panels. View looking north from area south of the site.

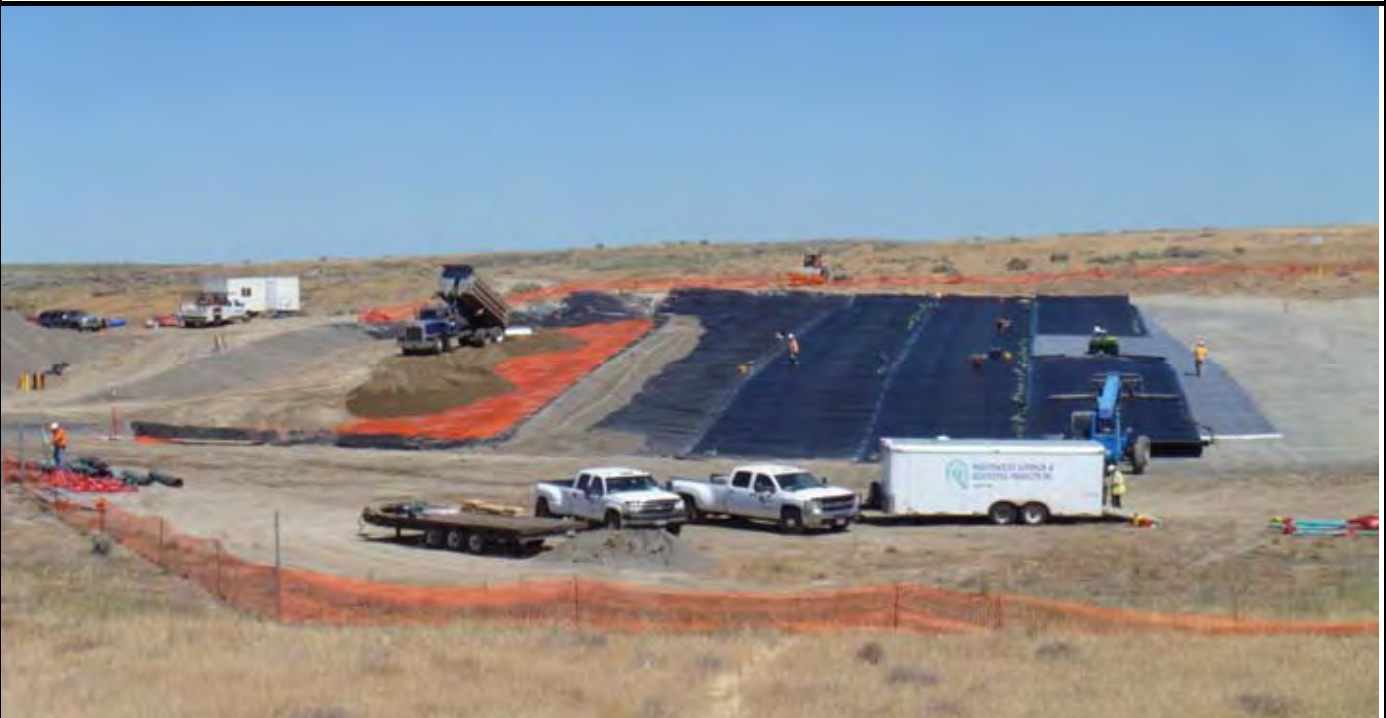
Photo 8: View of NWL pulling last geomembrane panel of the day up to butt joint over final GCL panel. View of AEC dropping and grading topsoil (see dump truck) over OCF overlying black geo-fabric which overlies the 1-ft sand layer. View looking north from area south of the site.

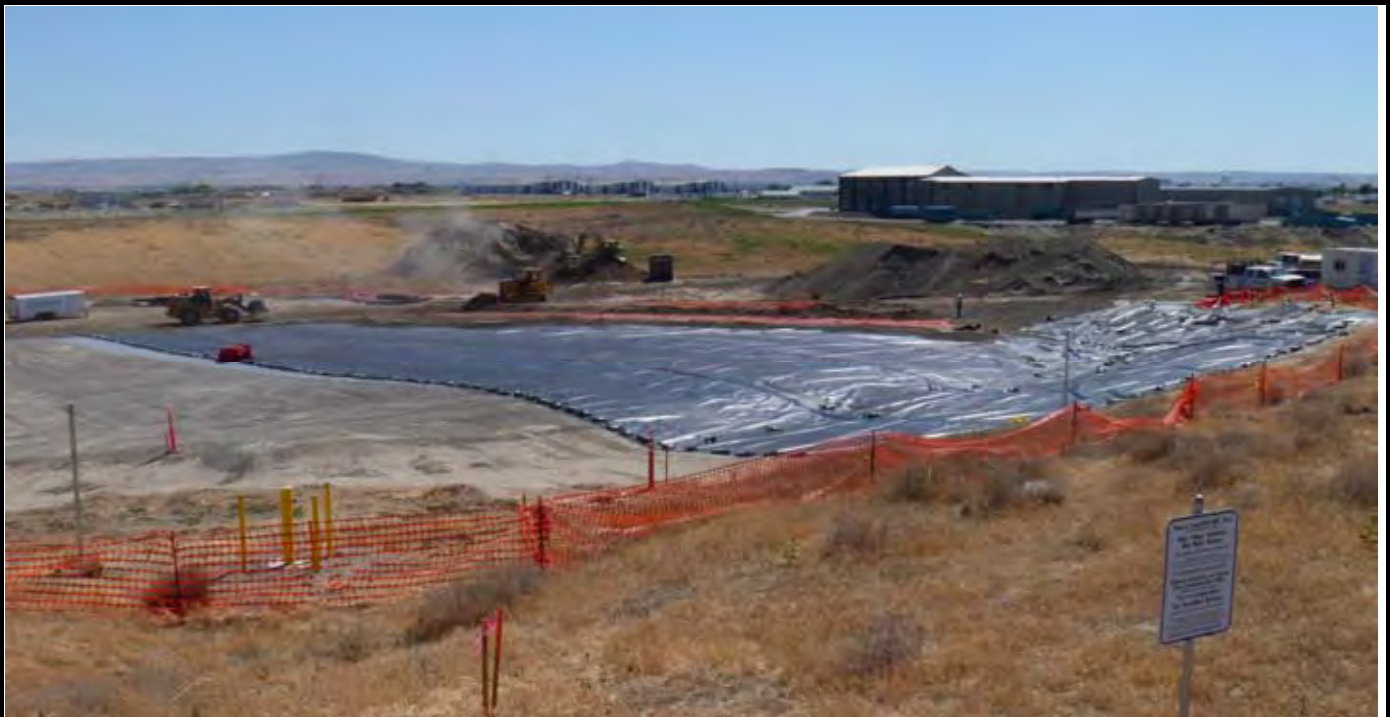
Photo 9: View of the CAP after NWL completes their work for the day. Note sand bags along the outer perimeter of the geomembrane. Note AEC grading topsoil over OCF/geo-fabric layer in background. AEC trackhoe loading AEC dump truck with topsoil and AEC loader moving sand. View looking SW from area NE of the site.
