PHOTOGRAPH LOG

Environment and Infrastructure, Inc.
7376 SW Durham Road
Portland, Oregon 97224

PROJECT NAME: Pasco Landfill Cap Project - Cap Construction Project

Project No: 4-61M-10705-1 P-02

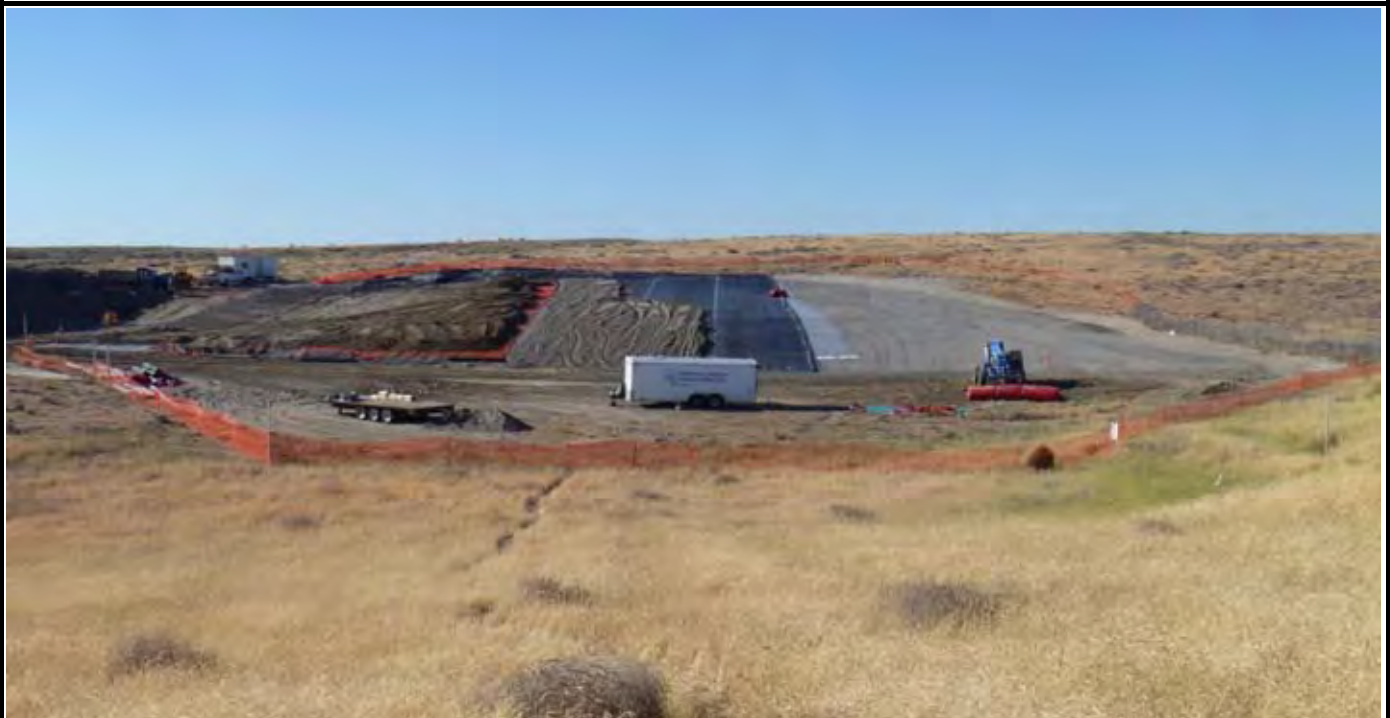
Photo 10: View of the site at the conclusion of work for the day. Note large sand layer over all but one exposed geomembrane panel and topsoil covering nearly all of the exposed OCF/geo-fabric (so it won't blow away). View looking north from area south of the site.

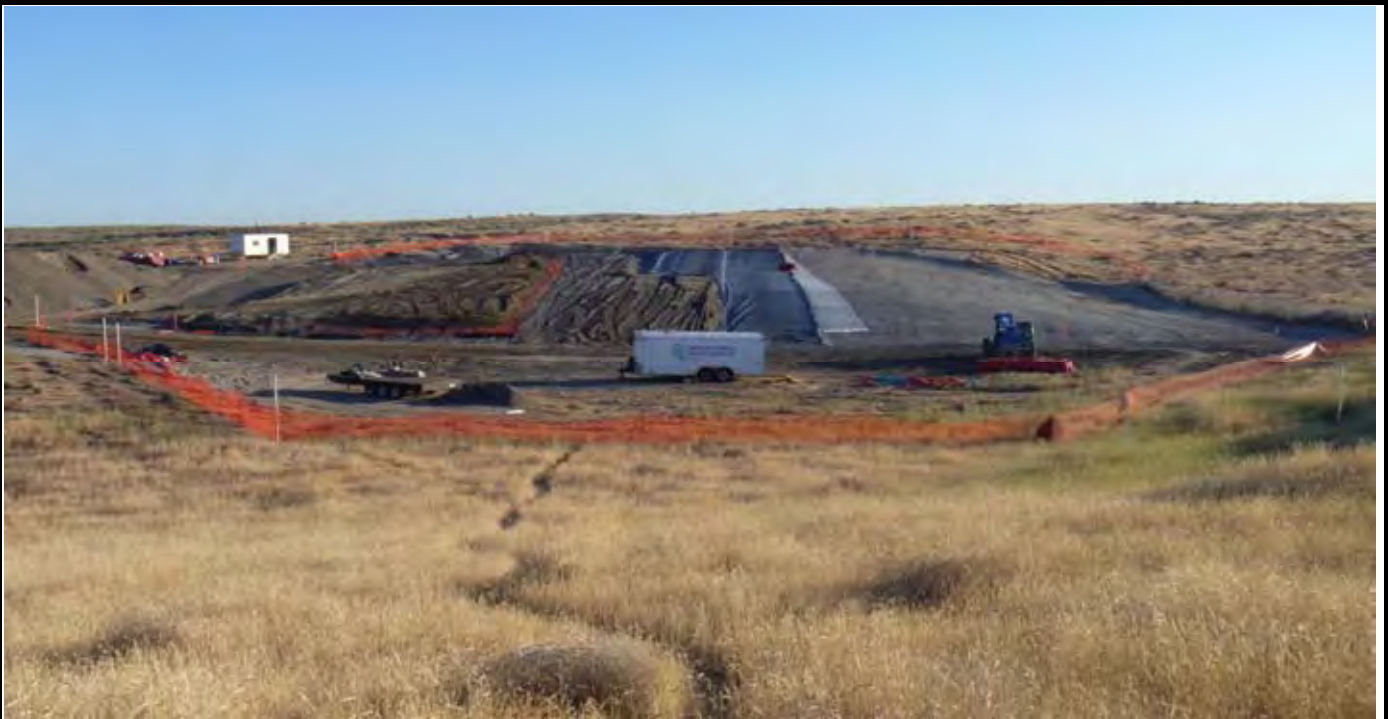
Photo 1: View of the site at the beginning of work for the day. View looking north from area south of the site. Note that geomembrane and GCL layer (small sliver of GCL on eastern edge of geomembrane) are about 55% installed.

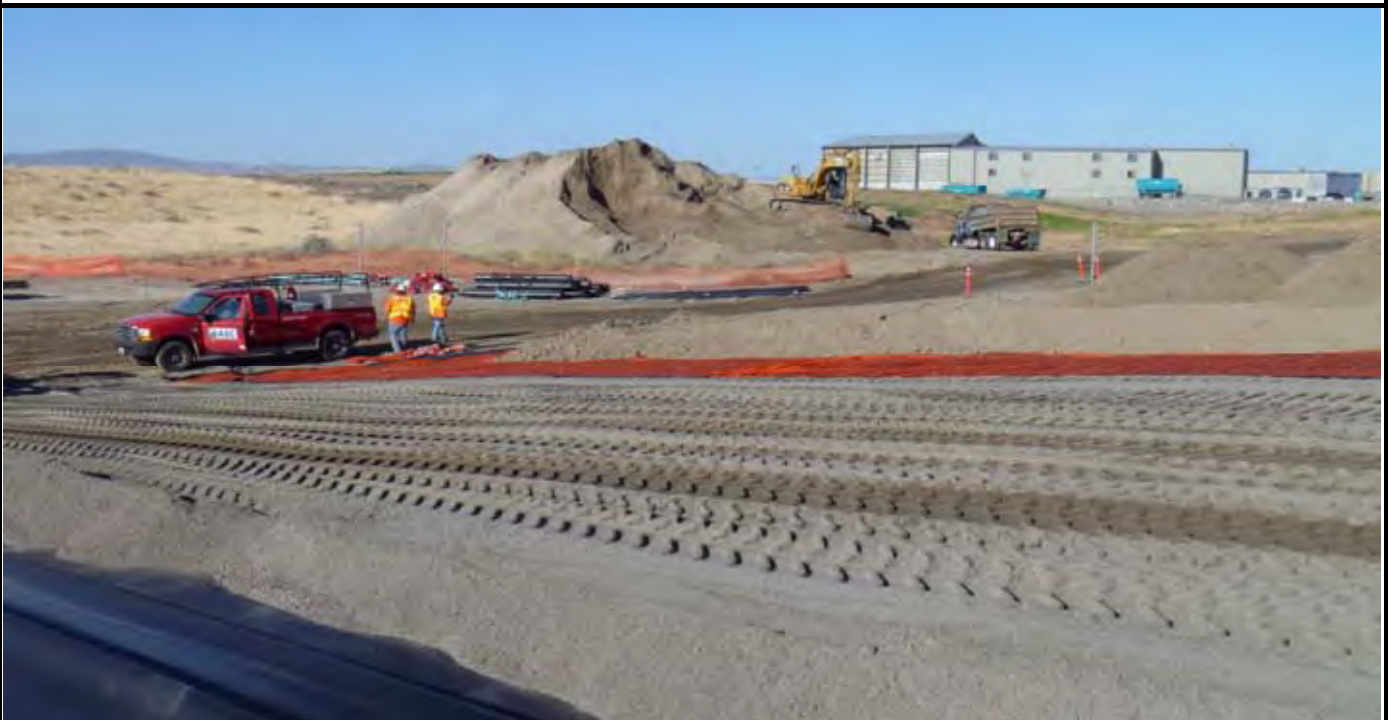
Photo 2: View of graded sand layer ready for Geo-Fabric and OCF installation before topsoil placement (see background of Geo-Fabric and OCF edge along eastern edge of topsoil layer. View looking SW from center of CAP.

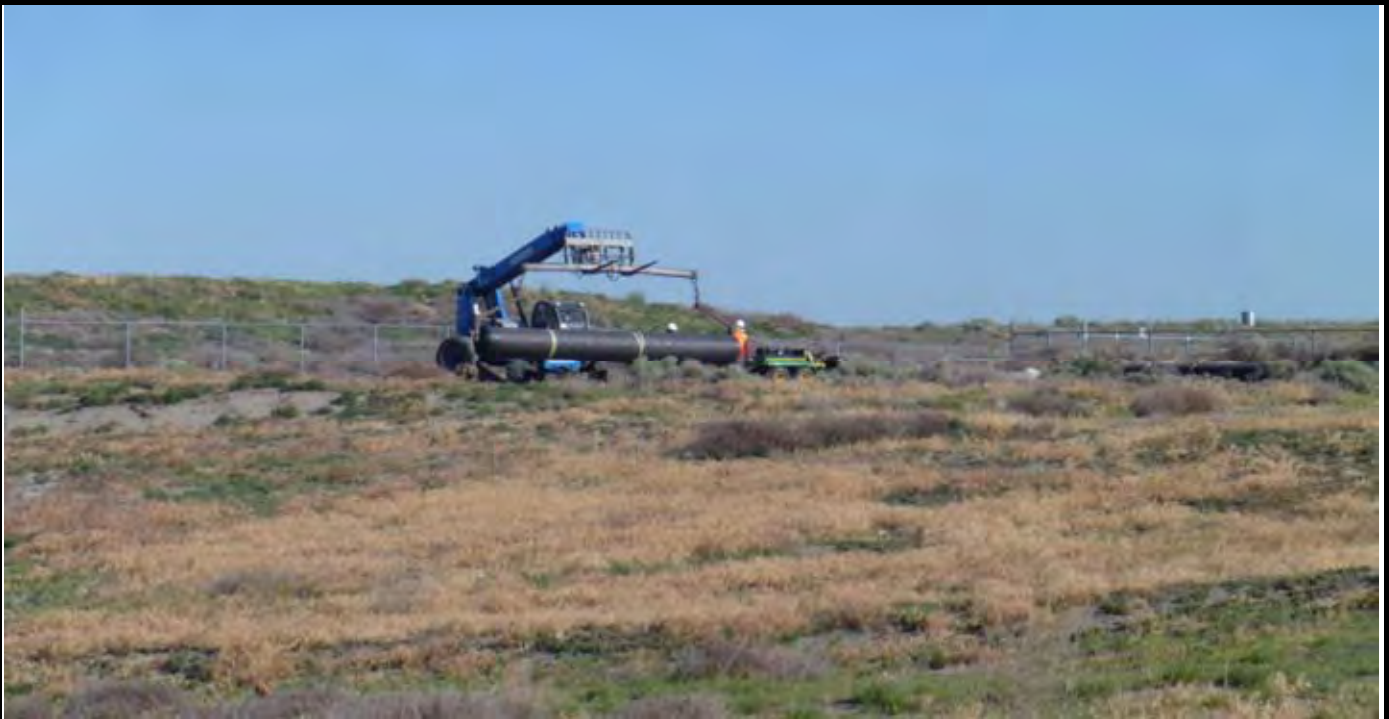
Photo 3: View of NWL recovering geomembrane roll #4 (one of two original rolls) from stockpile area along entry roadway. View looking north to northwest from area adjacent to job trailer (west of NW corner of CAP).

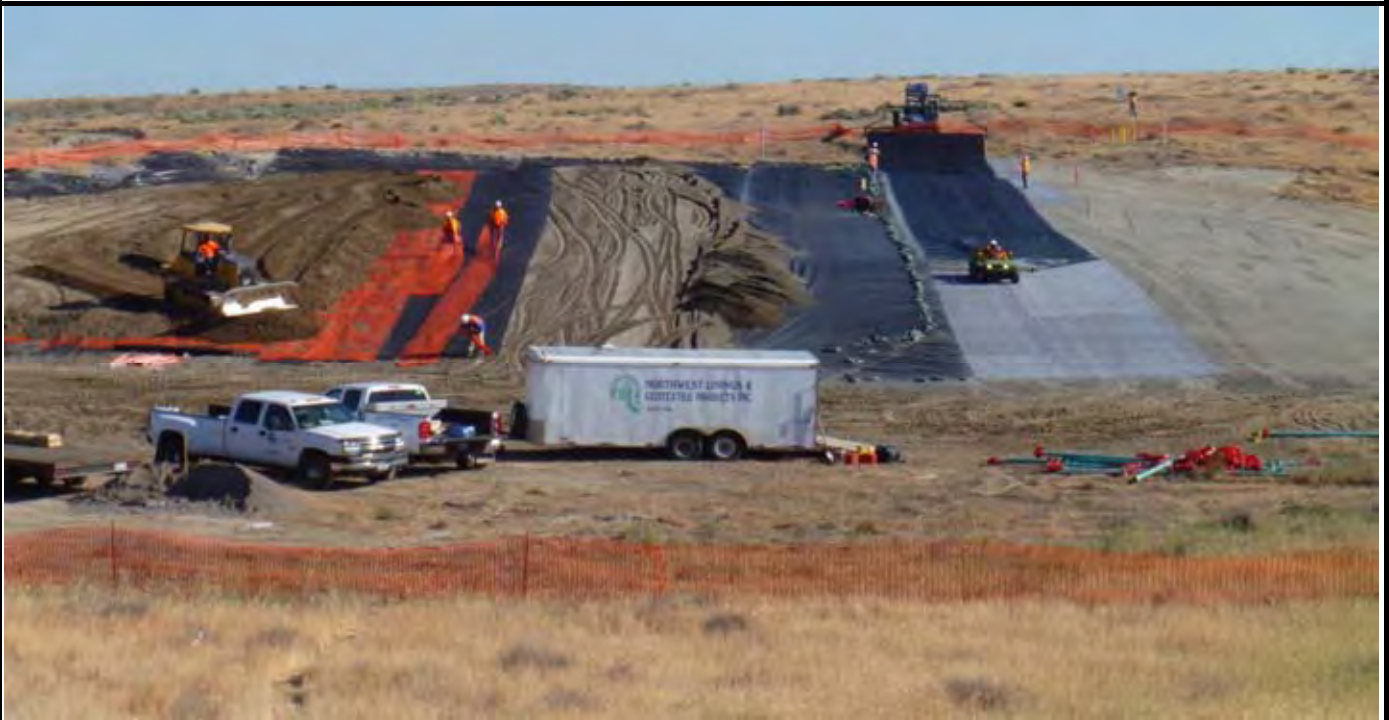
Photo 4: NWL laying out first panel from geomembrane roll #4. Note NWL using JD Gator to pull roll downhill (south) over GCL later. Note AEC laying out OCF over Geo-Fabric (center) and sand layer. View looking north from area south of the south end of site.

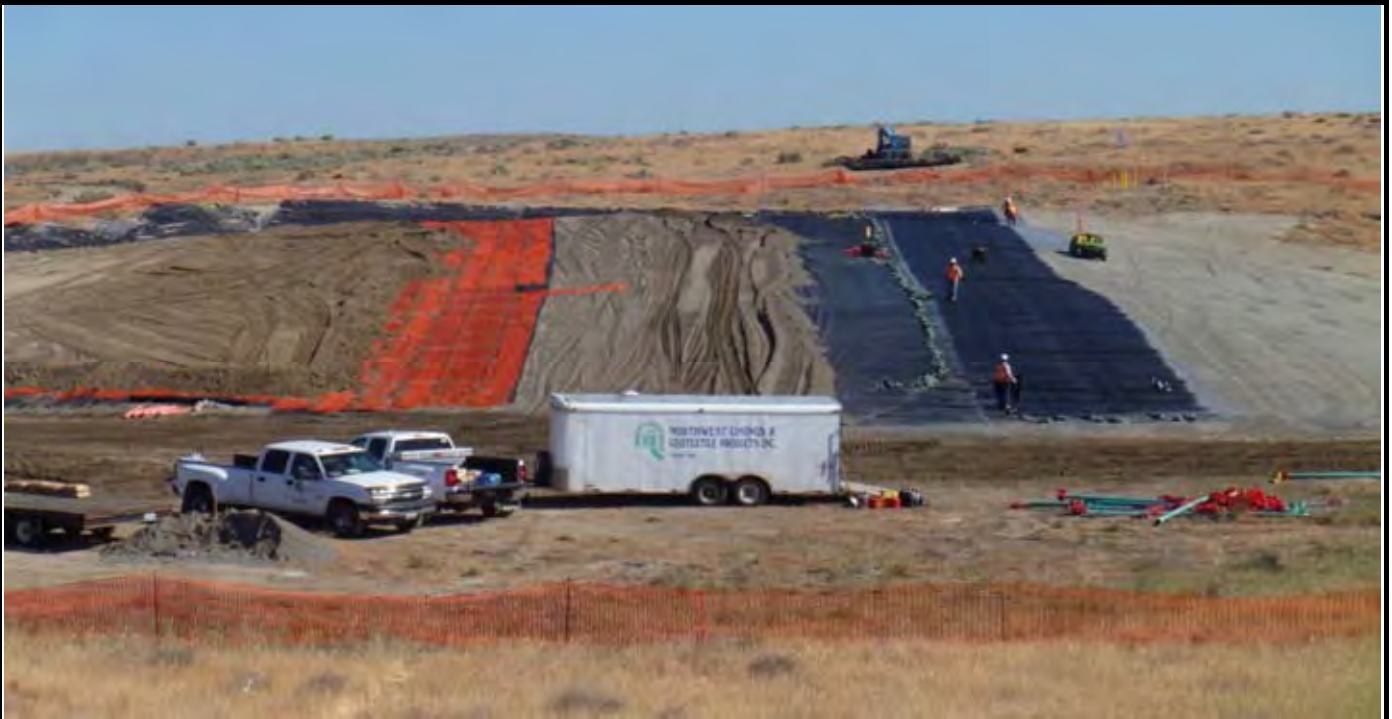
Photo 5: View of geomembrane panel fully laid out and ready for seam welding. NWL is moving sandbags to eastern edge of geomembrane panel. AEC ready for topsoil placement over OCF layer. View looking north from area south of the site.

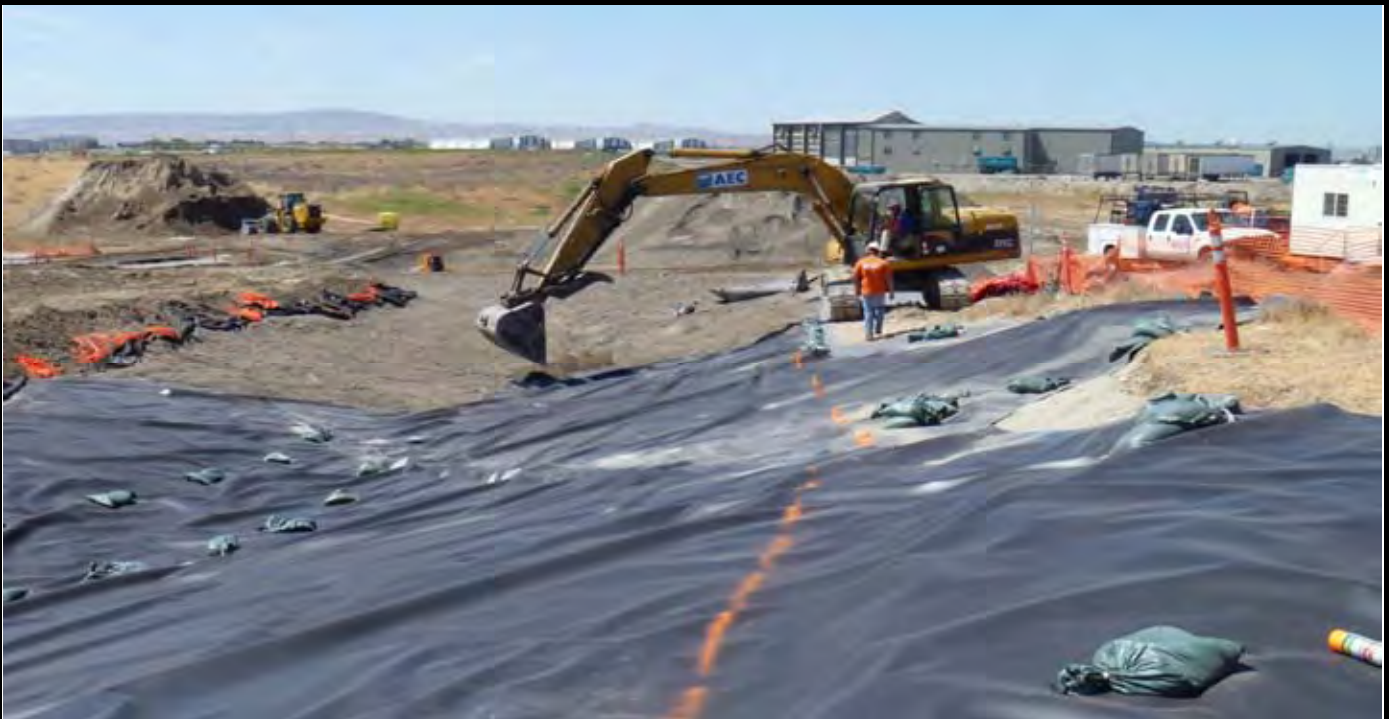
Photo 7: View of AEC laying out thin sand layer over geomembrane in the NW swale area. Note orange dashed line is the EOL for NW swale. View looking SW from northern/northwestern edge of the EOL.

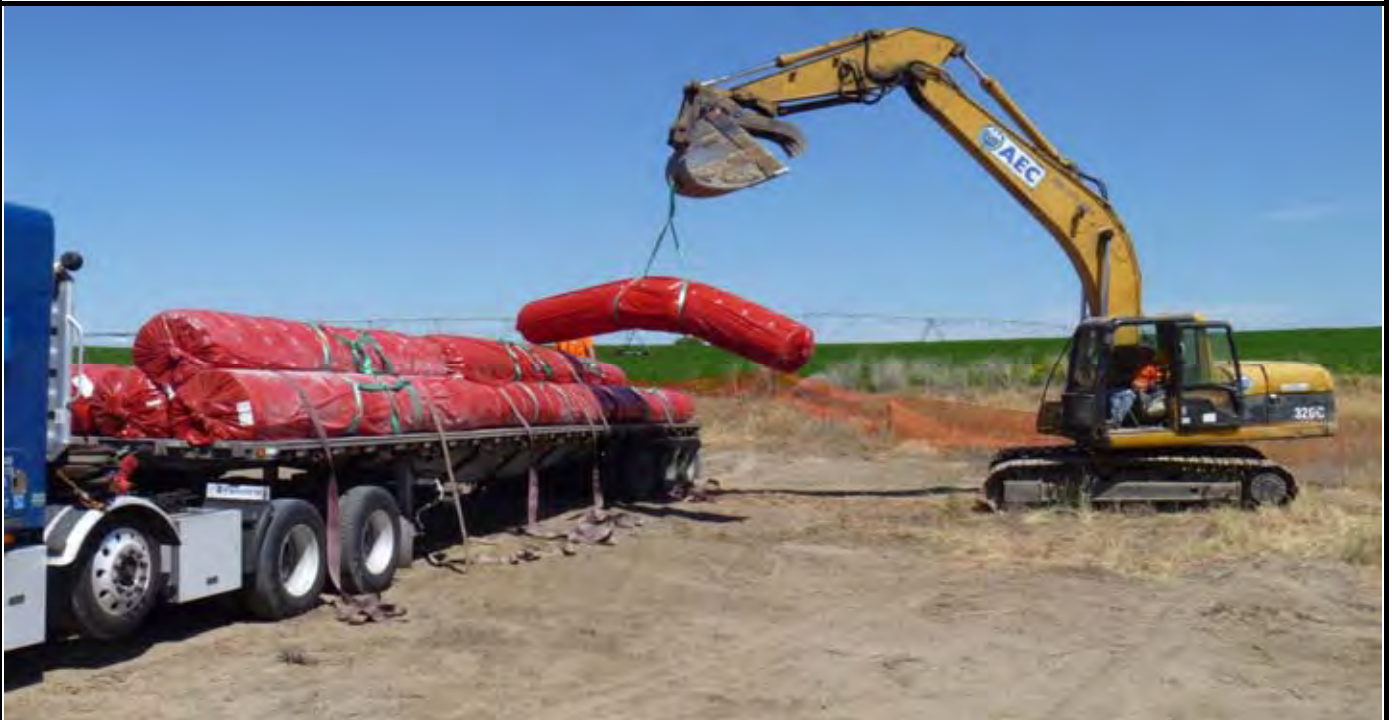
Photo 8: View of AEC off loading last (3rd) shipment of GCL rolls (14 rolls on truck for total of 41 rolls of GCL delivered). View looking east from area south of the southern edge of the EOL.

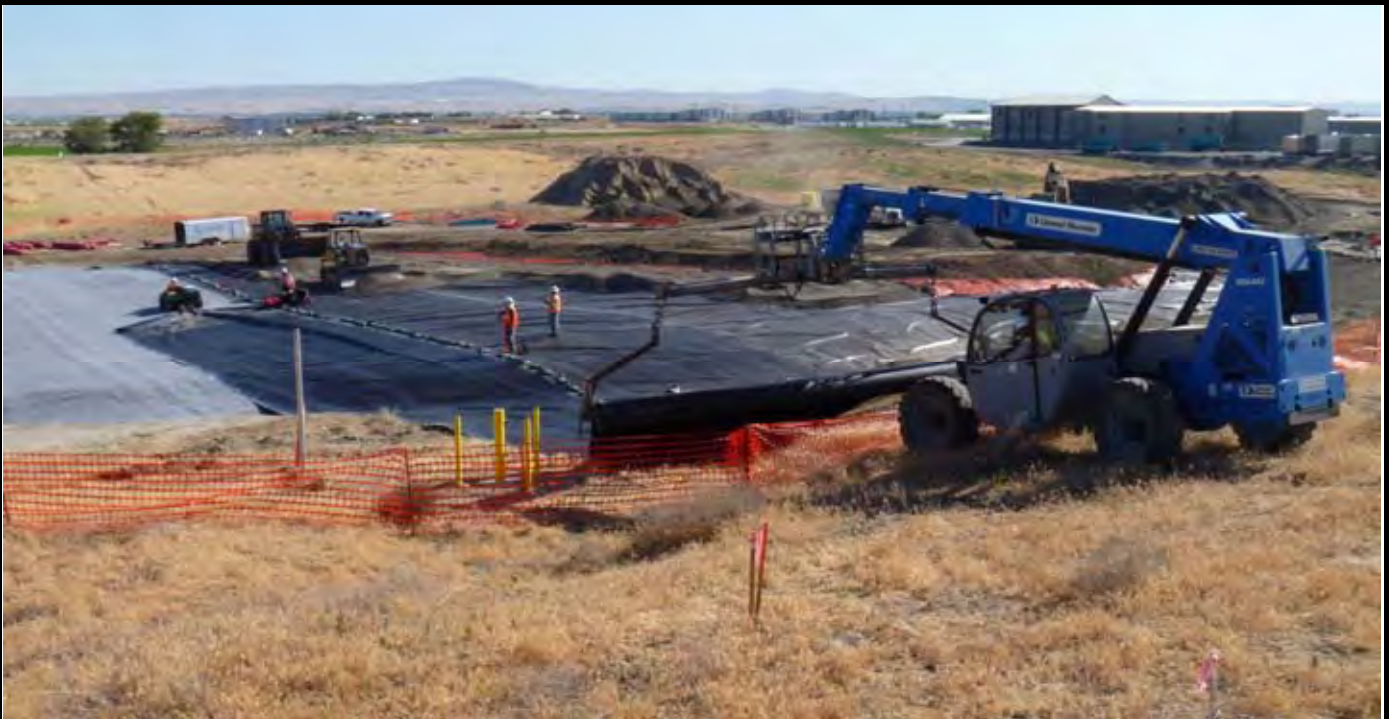
Photo 9: View of NWL laying out geomembrane panel from northern edge of the site with telehandler and JD Gator. Note AEC in background grading and spreading sand layer near the existing eastern edge of the geomembrane. View looking south/southwest from area north of the site.

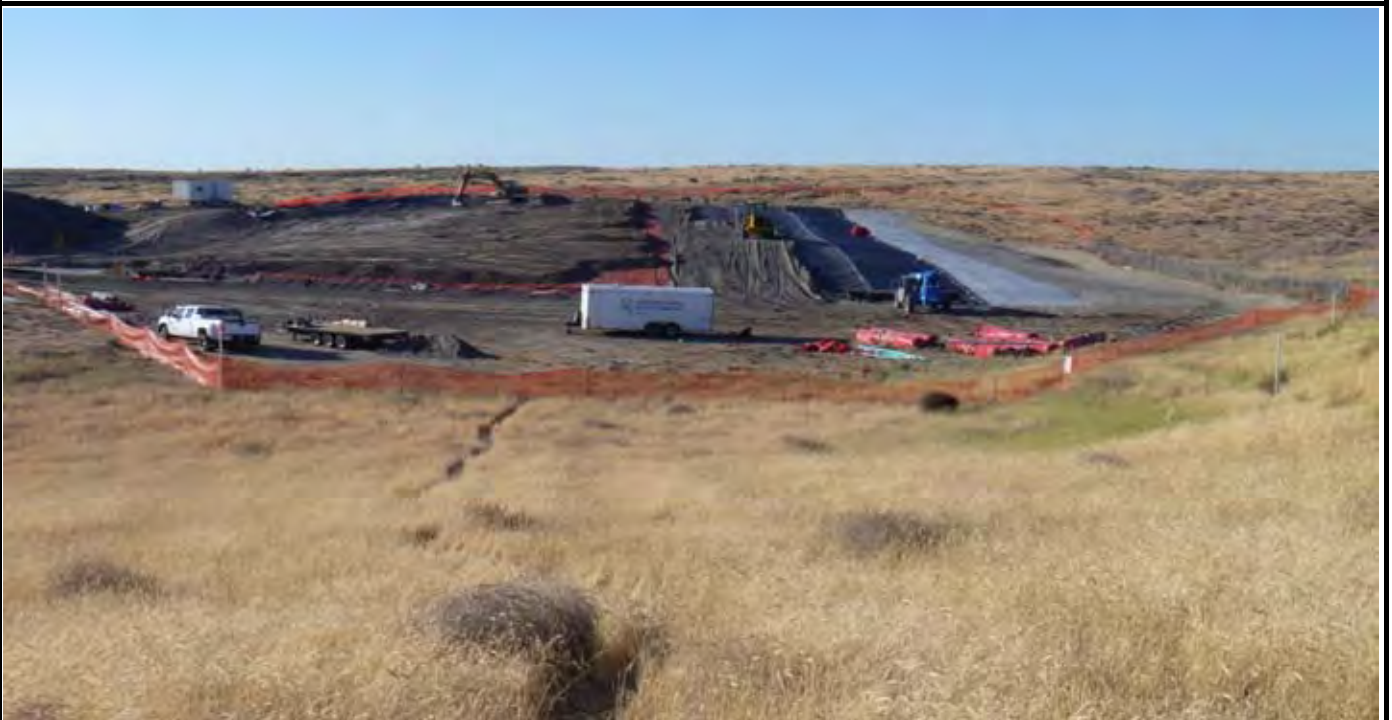
Photo 10: View of the site at the conclusion of work for the day. Note that GCL layer is about 80% done and geomembrane layer is about 75% installed. View looking north from area south of the site.

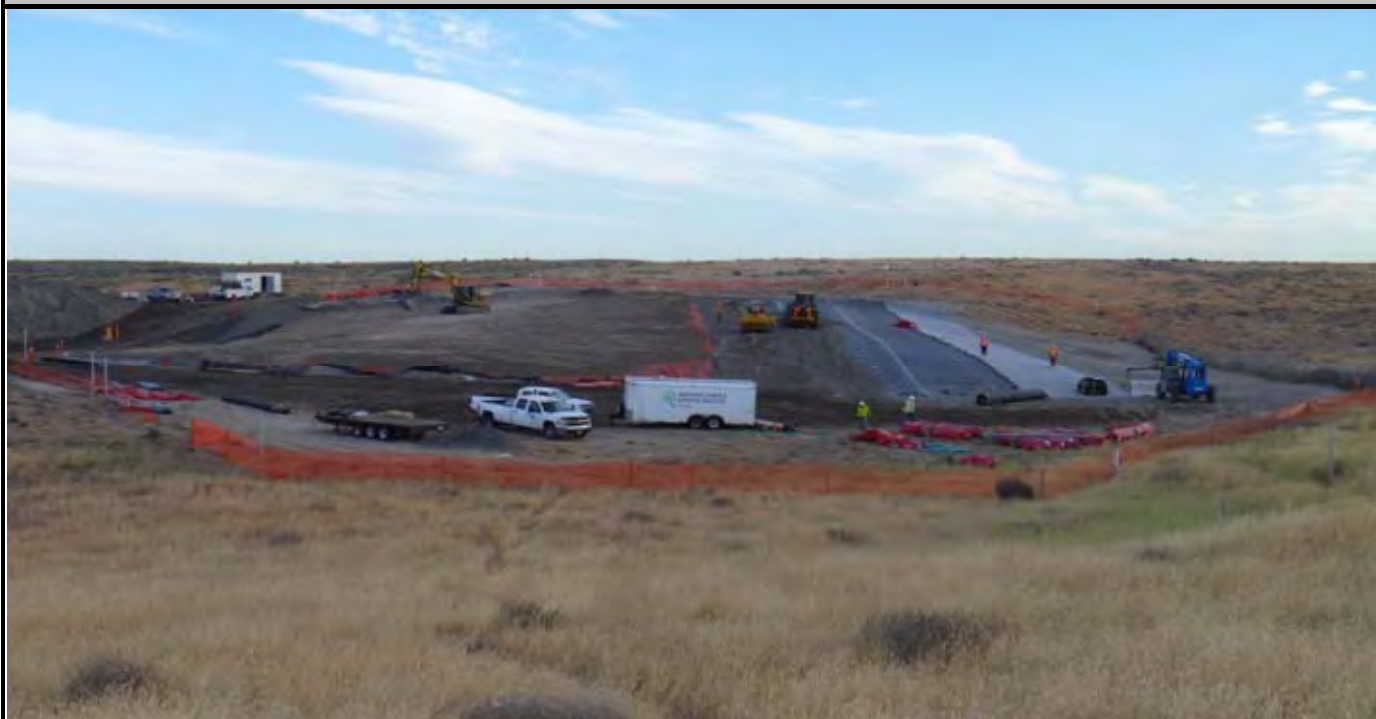
Photo 1: View of the site at the beginning of work for the day. Note NWL setting up to begin rolling out GCL layer on the eastern side of the CAP. View looking north from area south of the south side of the site. Note AEC spreading and grading sand layer just to the west of NWL's workers.

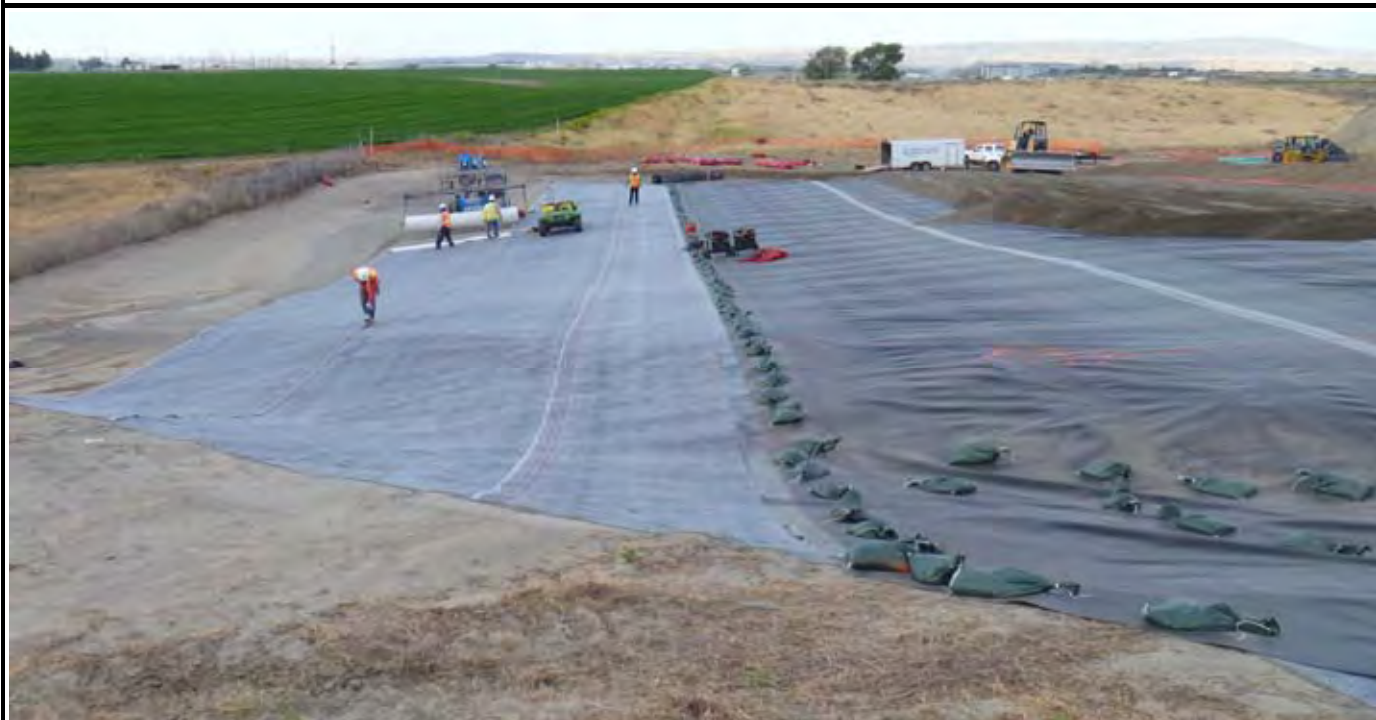
Photo 2: View of NWL rolling out GCL layer on east side of CAP. Note AEC working on sand layer on the right side of the picture. View looking south from north side of the EOL.

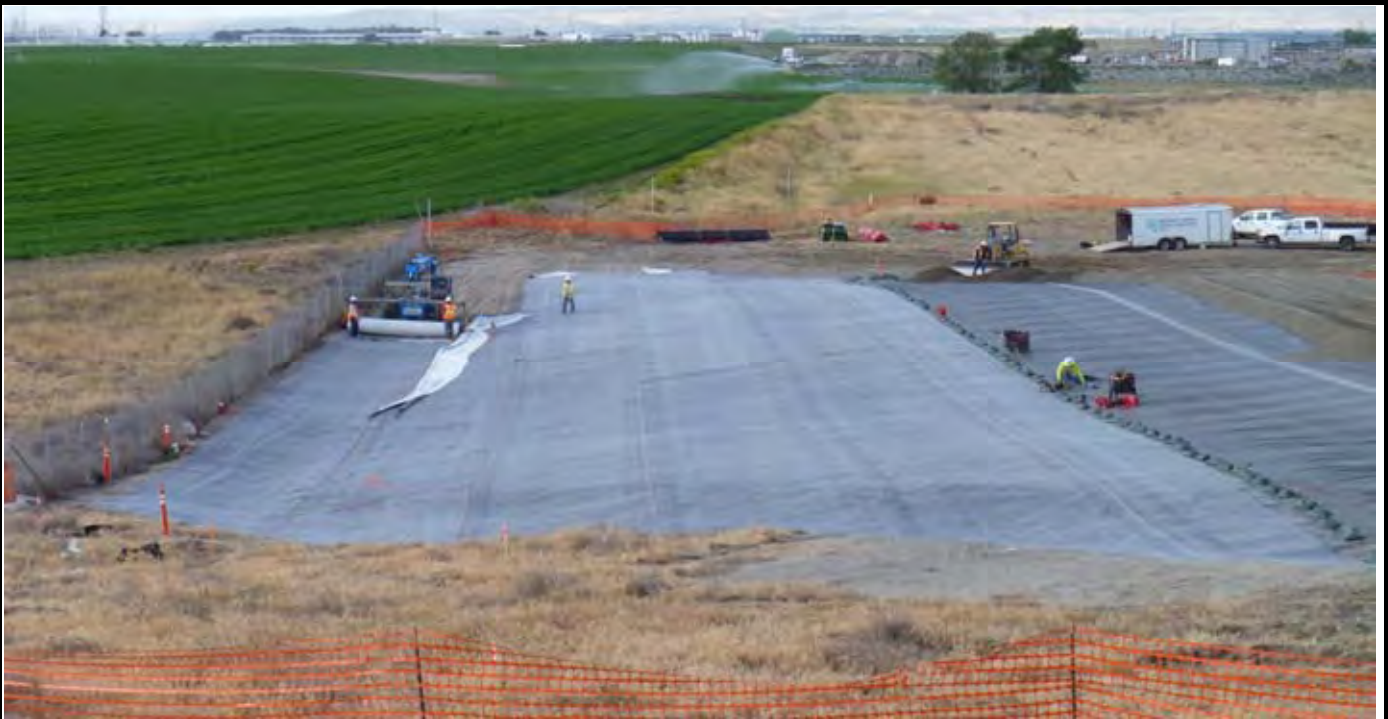
Photo 3: View of NWL rolling out last roll of GCL along the eastern edge of the CAP (EOL zone along fence). View looking south from area north of the northern OCF (see foreground).

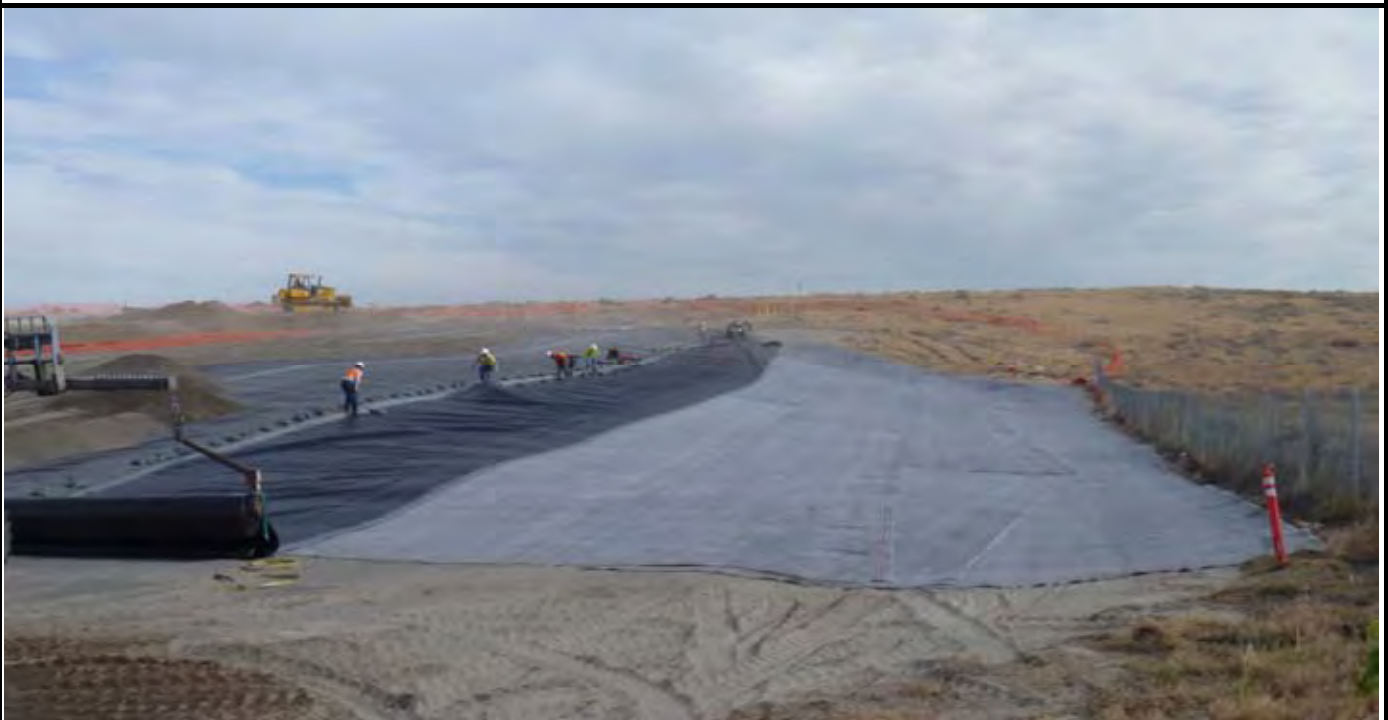
Photo 4: NWL begins rolling out the first geomembrane panel for the day (Panel 11). Note windy conditions and GCL construction along the eastern edge of the CAP. GCL has been installed all the way to the fence line. View looking north from area just south of the SE corner of the CAP.

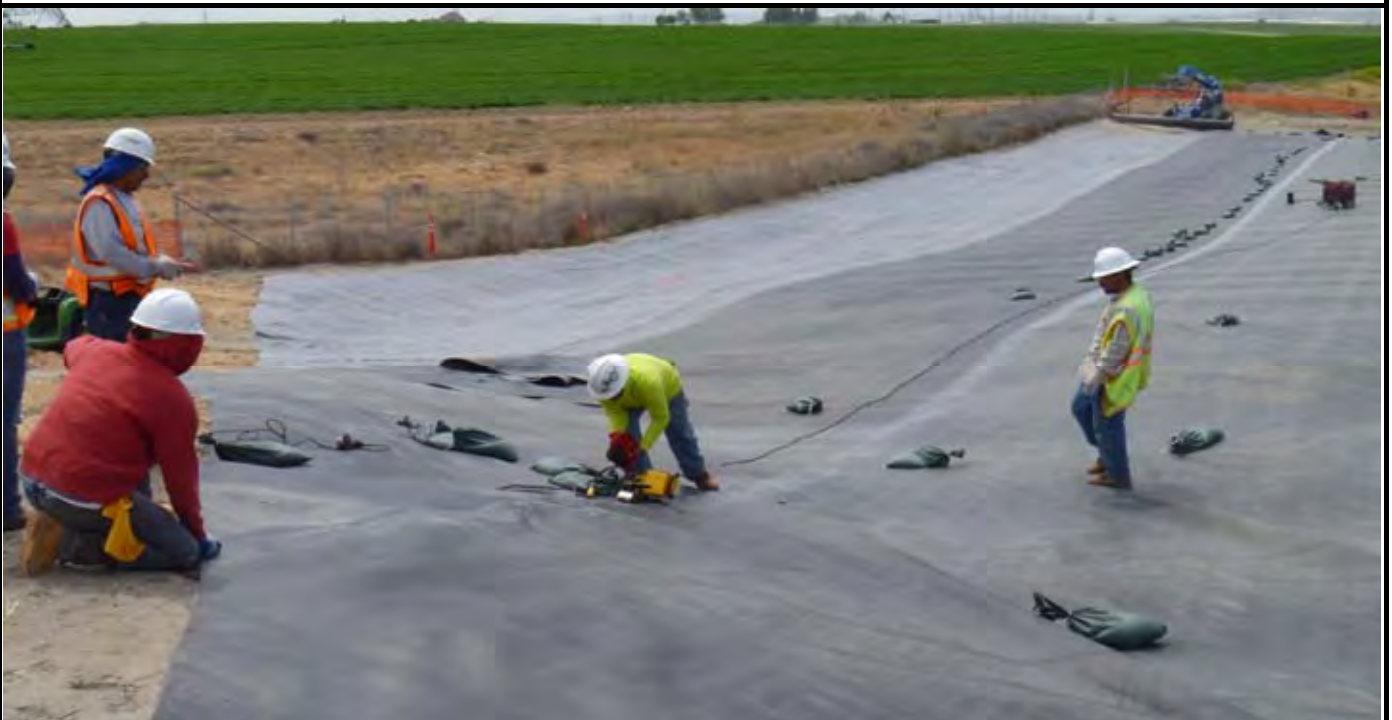
Photo 6: View of NWL starting seam weld between geomembrane panels P-11 and P-12. View looking SE from northern edge of EOL. Note small yellow seam welding machine in center of picture.

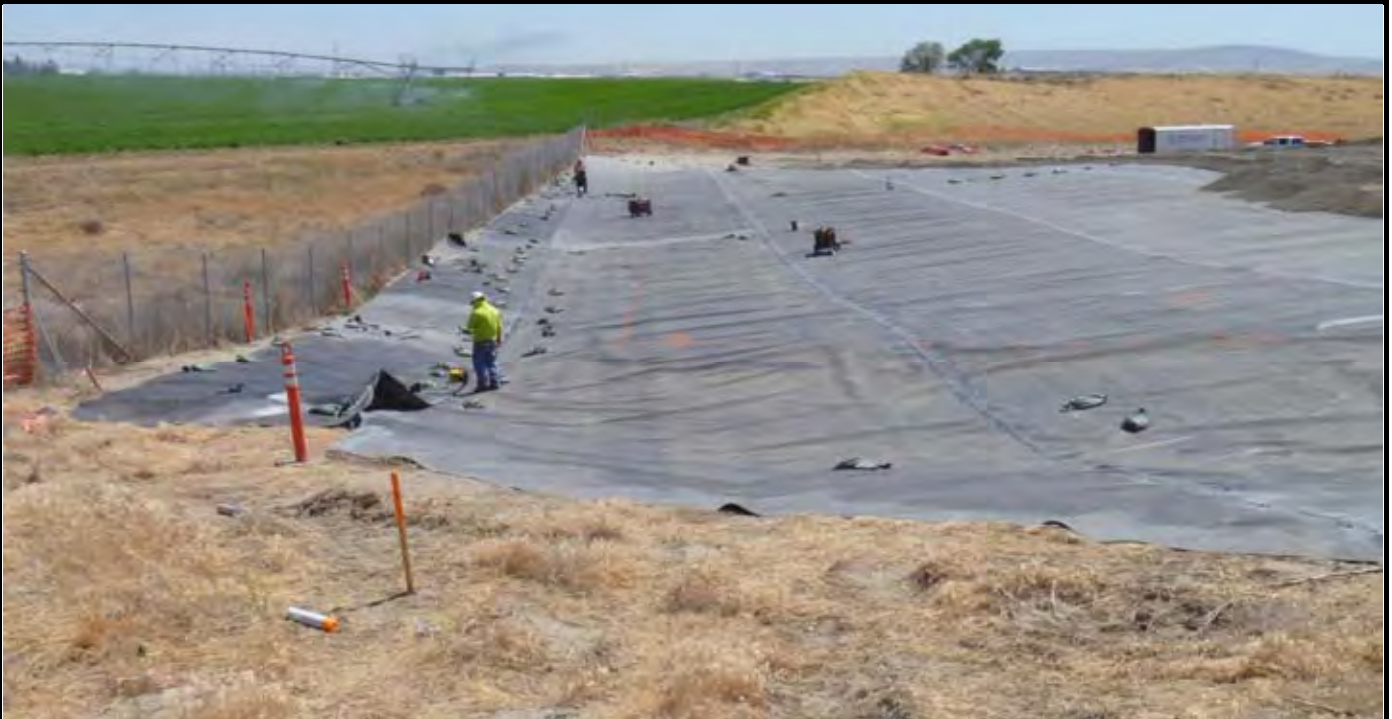
Photo 7: View of the installation and welding (see yellow worker in center of picture) of seam between geomembrane panels P-13 and P-14 (both panels required butt joint welding). Note that geomembrane panel P-14 is installed all the way to the fence line. View looking south from area just north of the NE corner of the EOL.

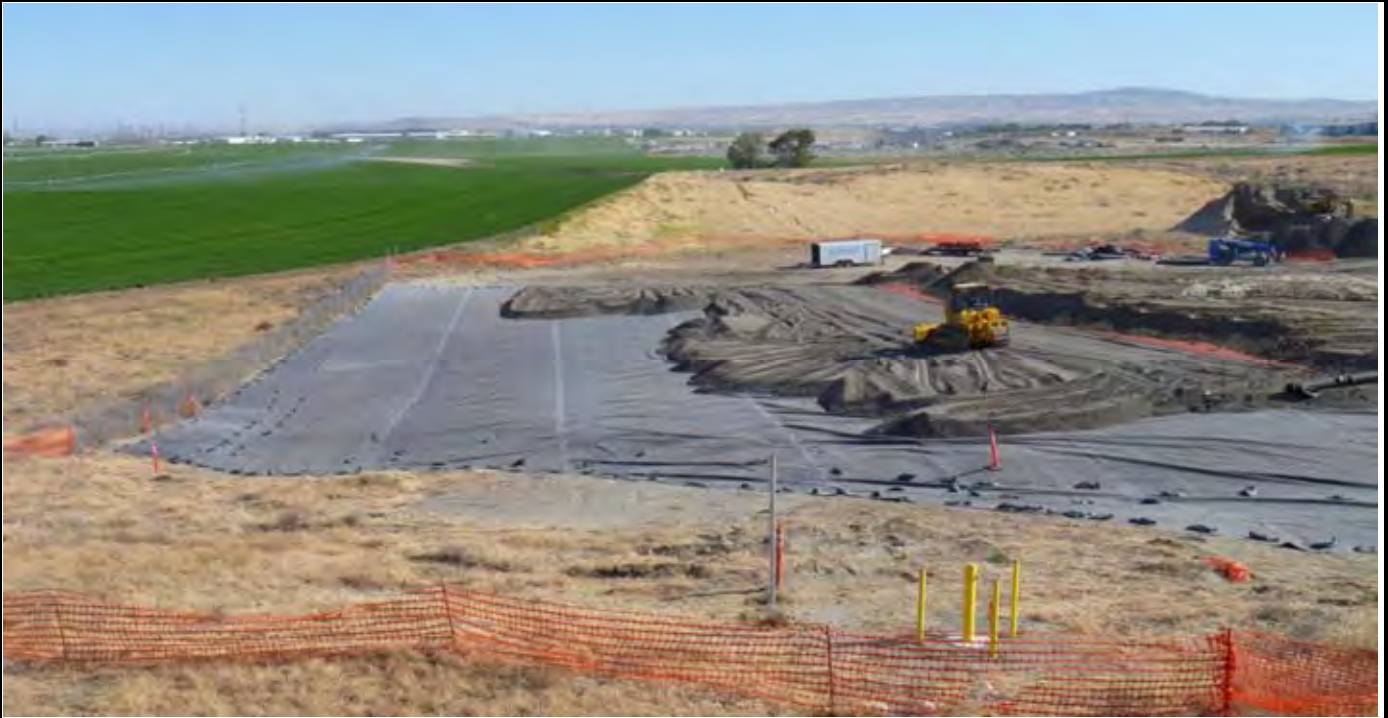
Photo 9: View of the completed geomembrane area (eastern side of CAP) and AEC spreading and grading sand layer. View looking south from area north of the northern OCF edge.

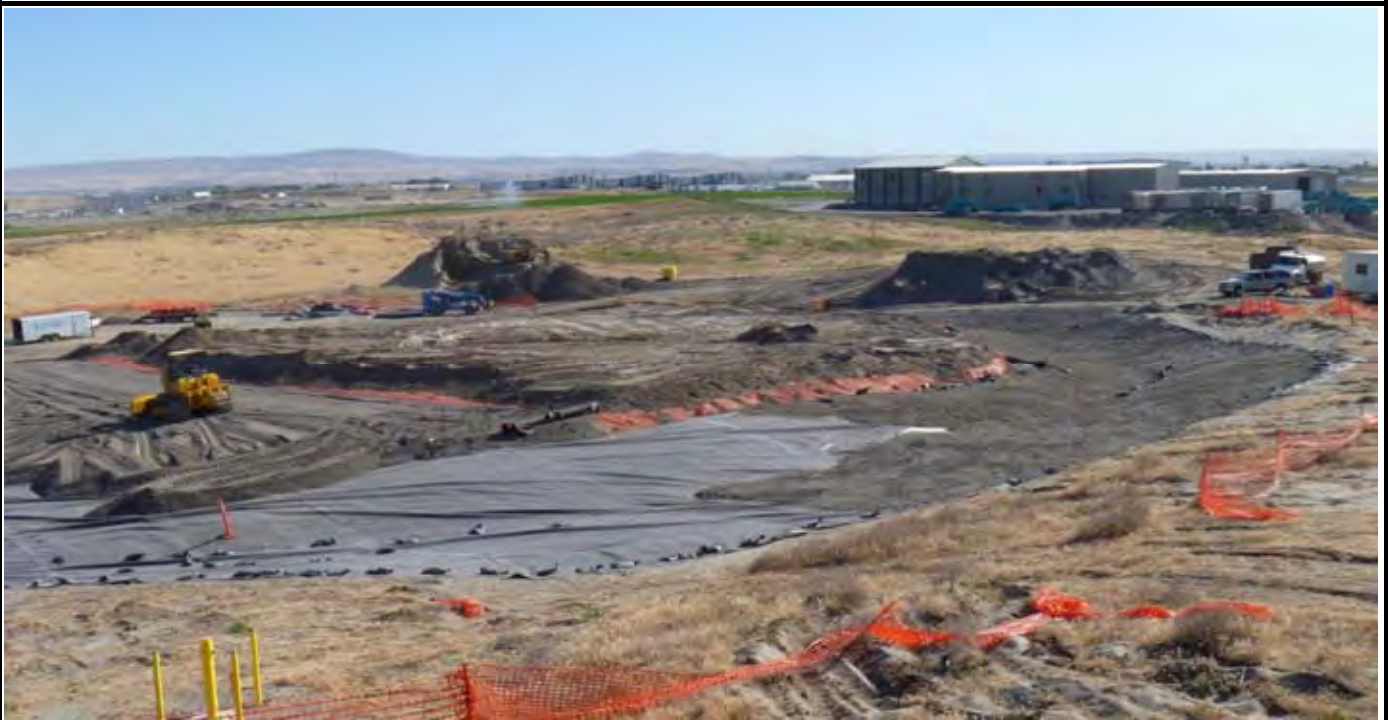
Photo 10: View of the northern and northwestern portions of the CAP. Note sand and topsoil layers (center and left) and the sand layer placed in the northern and northwestern sides of the north and northwestern swale area. View looking southwest to west from area north of the northern OCF.

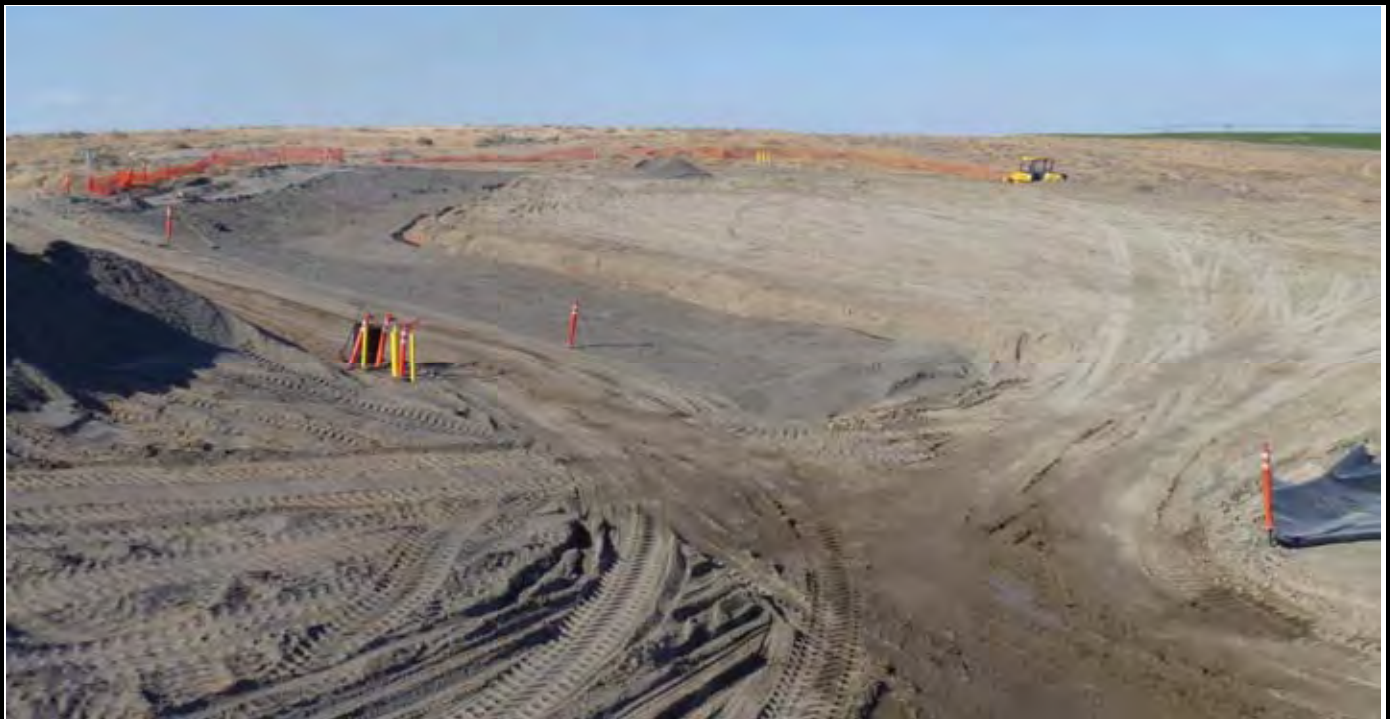
Photo 11: View of the NW and western swale (between EOC and EOL) with sand installed and ready for Geo-Fabric and overlying perimeter rock layer. View looking NE from area just west of the SW corner of the CAP.

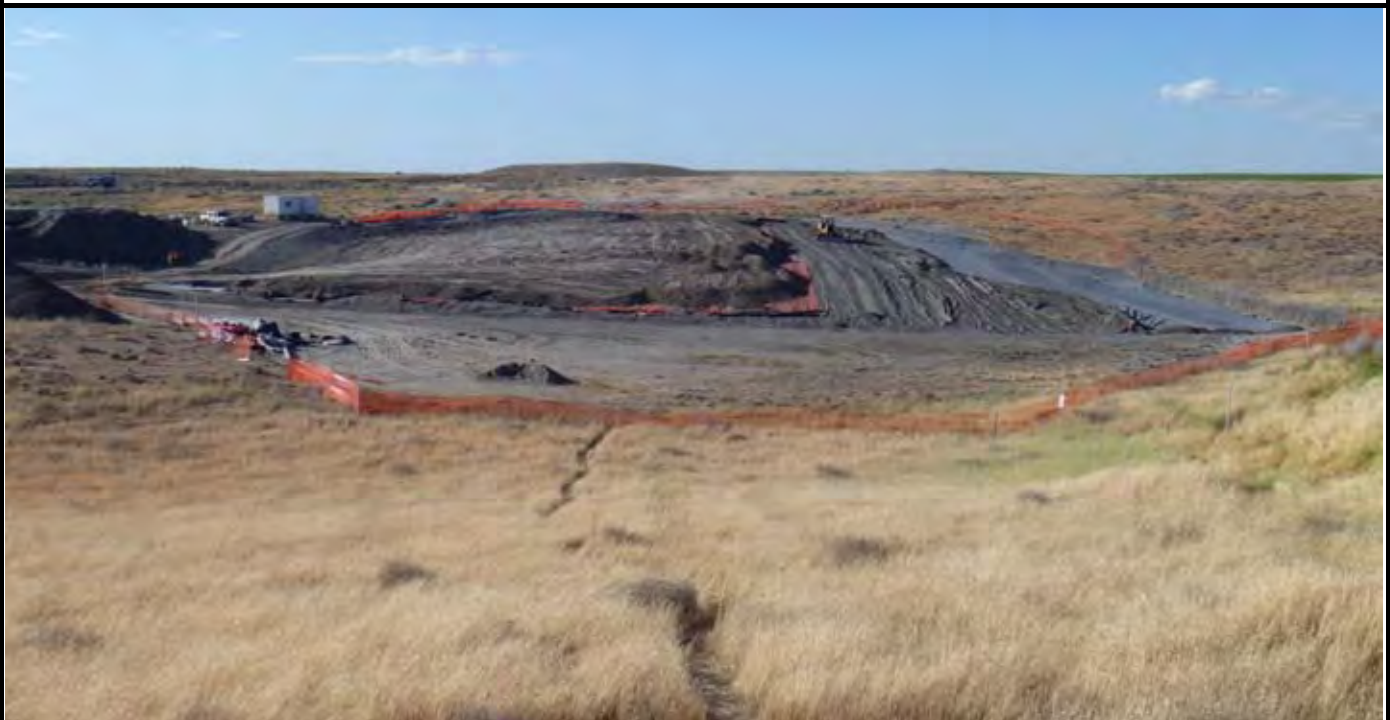
Photo 12: View of the site at the conclusion of work for the day. Note completed geomembrane installation and sand (approximately 75% complete) and topsoil (approximately 60% complete) layers. View looking north from area south of the southern edge of the site.

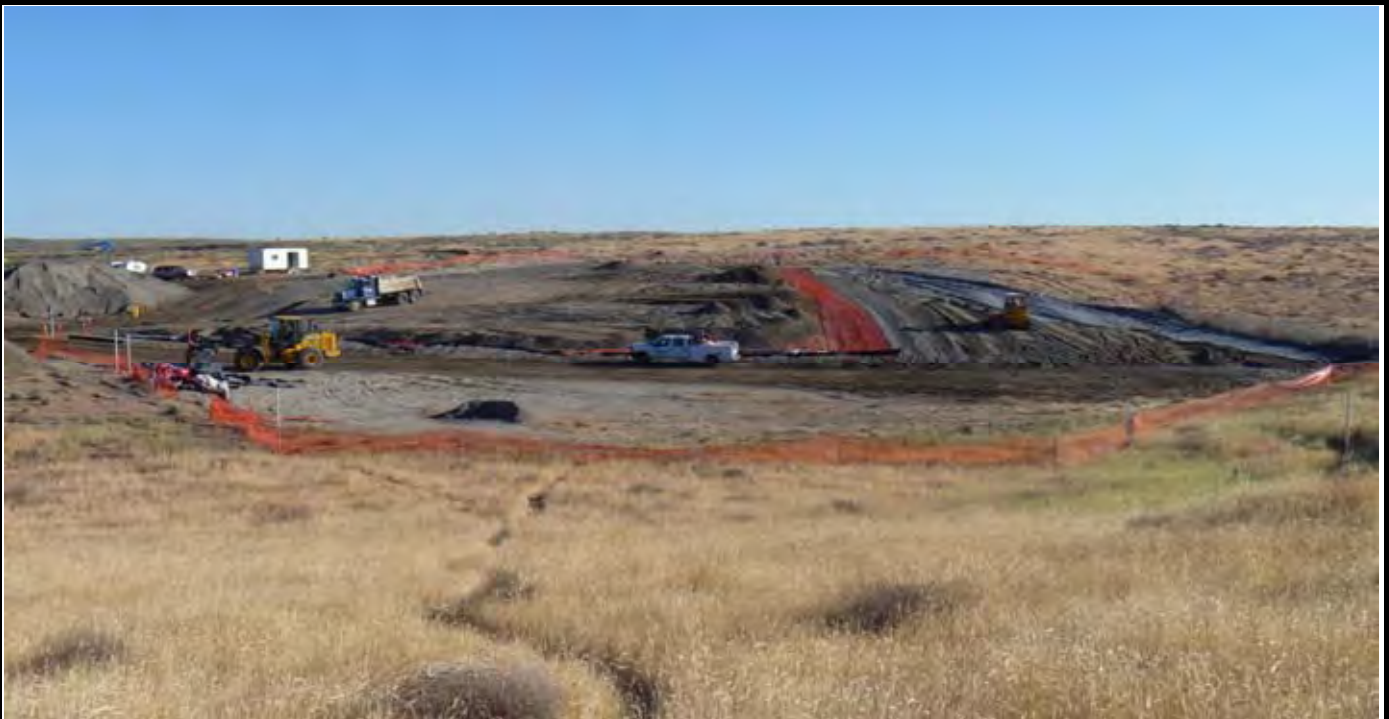
Photo 1: View of the site at the beginning of work for the day. View looking to the north from area south of the site. Note extent of topsoil layer (west edge of OCF shows it) and sand layer (see bulldozer grading it).
