PHOTOGRAPH LOG

Environment and Infrastructure, Inc.
7376 SW Durham Road
Portland, Oregon 97224

PROJECT NAME: Pasco Landfill Cap Project - Cap Construction Project

Project No: 4-61M-10705-1 P-02

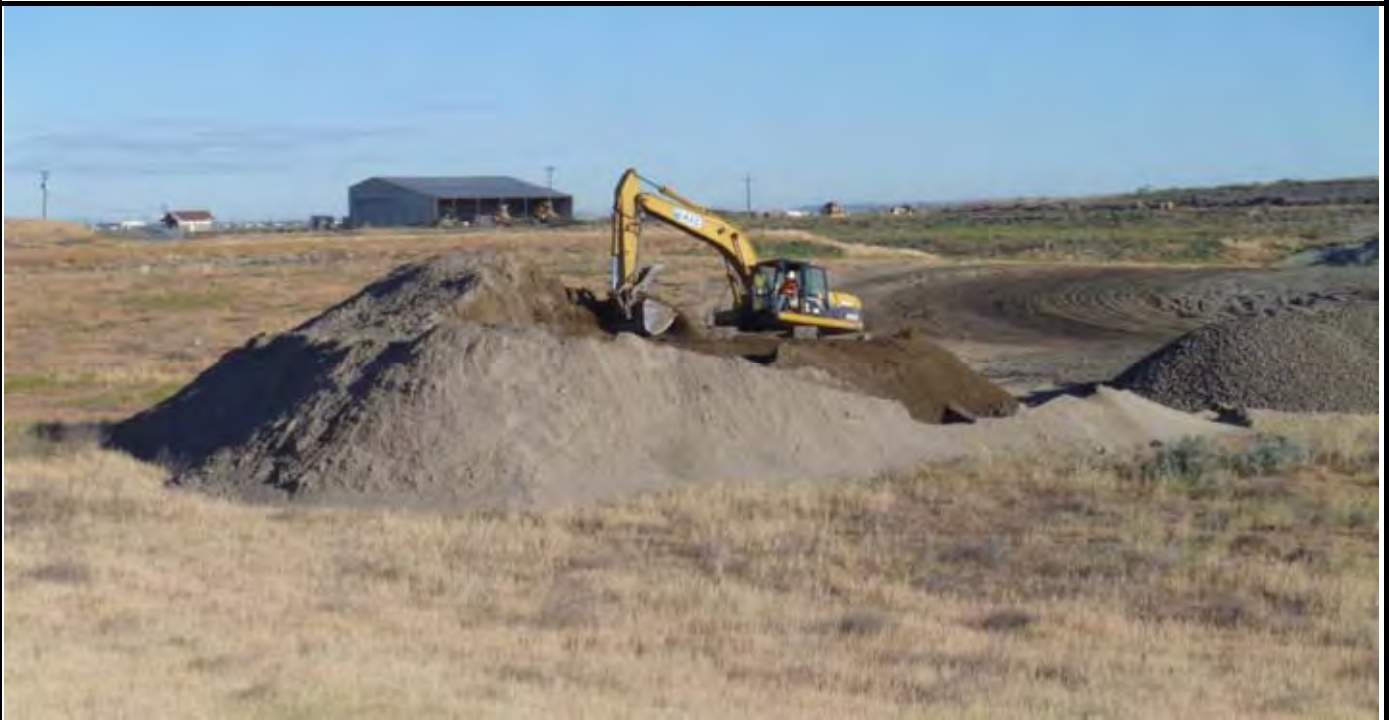
Photo 2: AEC managing the topsoil stockpile. Photo taken near beginning of the work day. View looking NW from area south of the site.

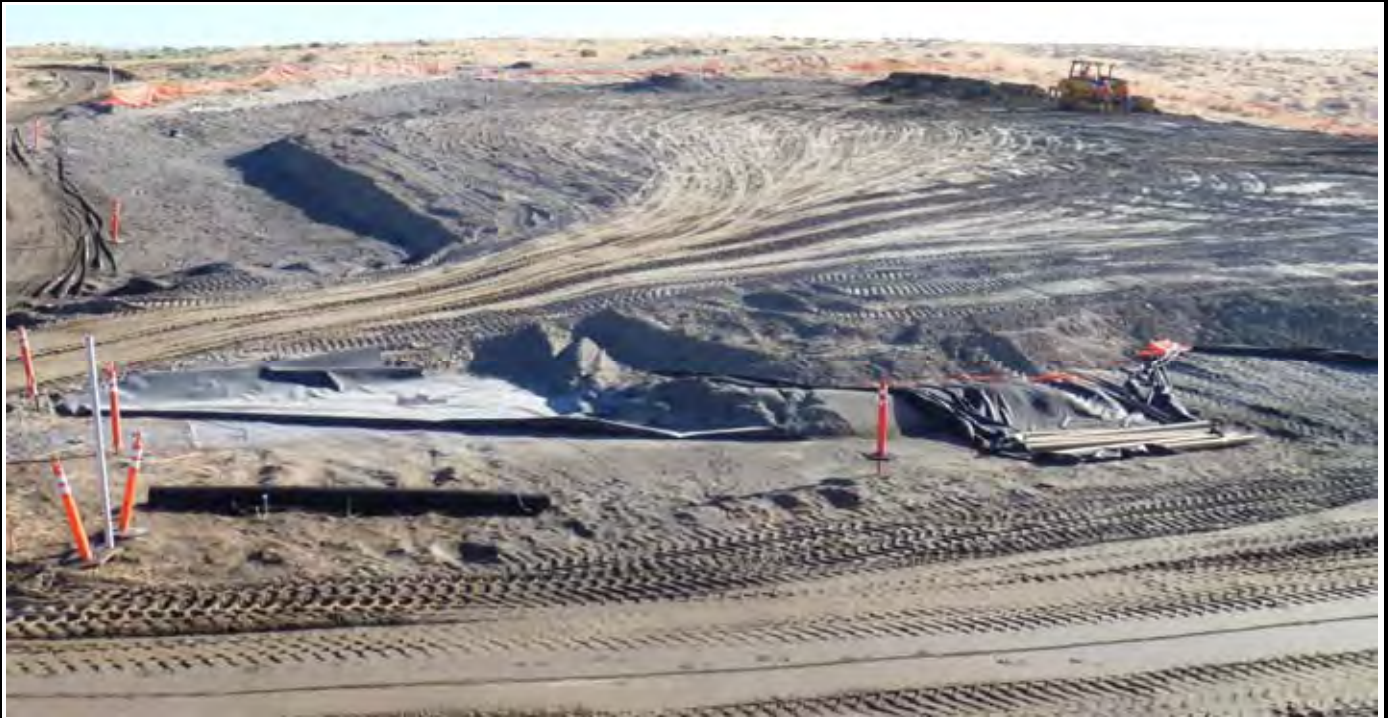
Photo 3: View of the western side of the CAP. Note the western and NW swales have not yet been graded out with the EOC. View looking north from SW corner of the site.

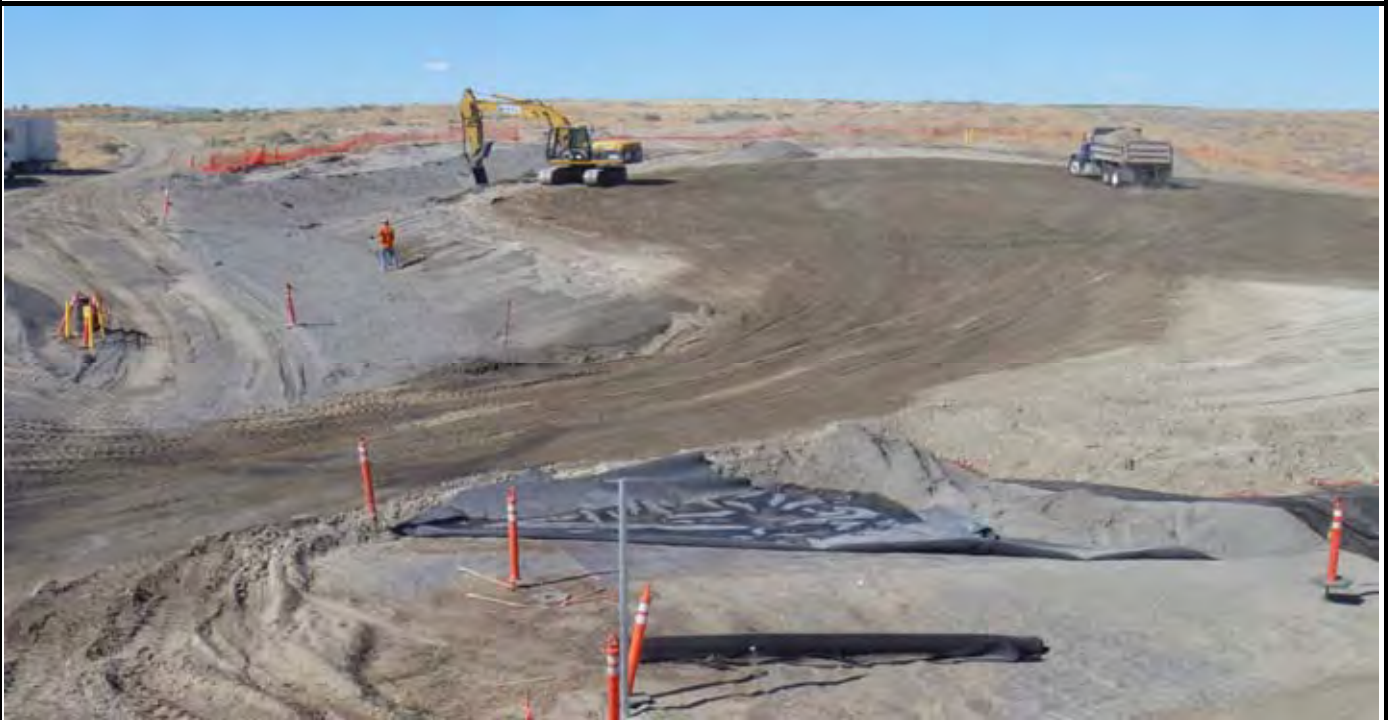
Photo 4: AEC trackhoe grading out the EOC with western and NW swales with sand and topsoils. Note that the water truck has watered the roadway and top of cap to keep dust down. View looking N from SW corner of the site.

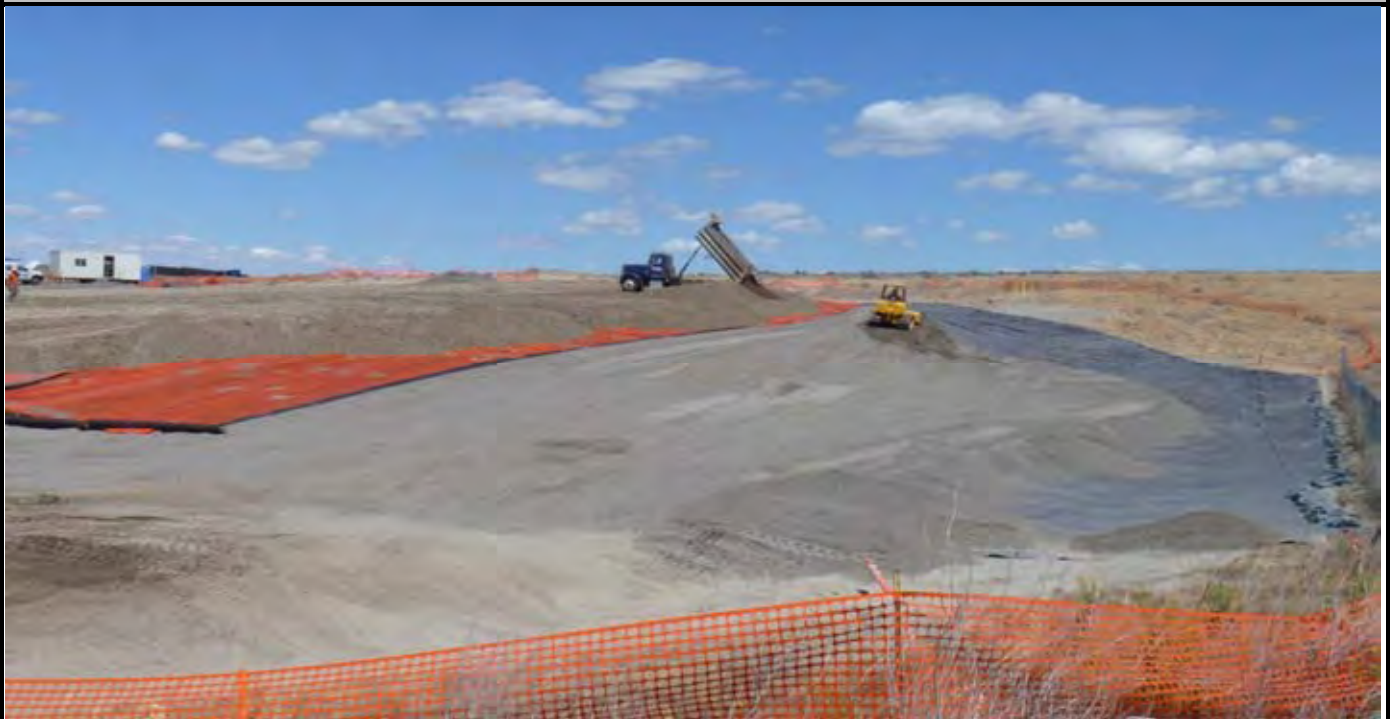
Photo 5: View of the eastern edge of the CAP during mid-day. Note bulldozer grading the sand layer over the geomembrane and AEC dump truck placing topsoil piles for later grading. Note Geo-Fabric and OCF between the sand and topsoil layers. View looking north from the SE corner of the site.

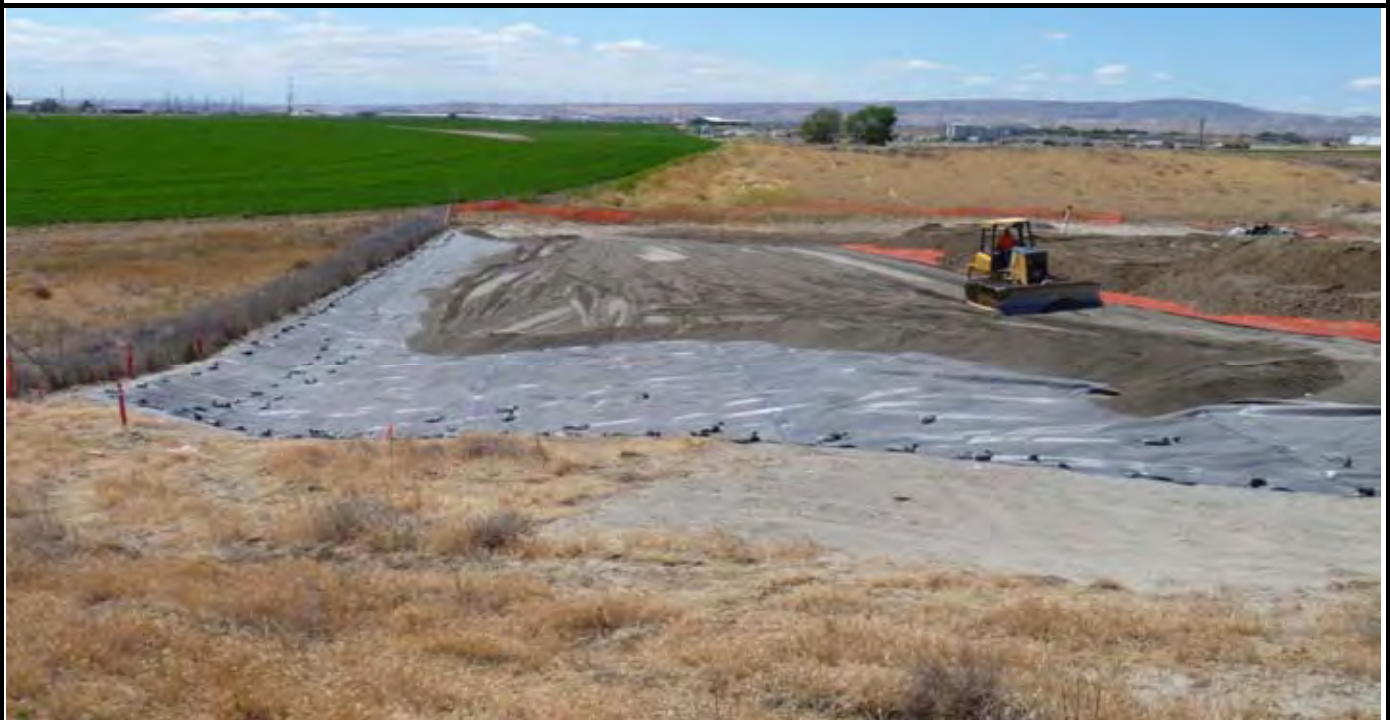
Photo 6: View of the eastern edge of the CAP showing the NE swale prior to sand and grading work. Note bulldozer grading sand layer. View looking south from NE corner of the site.

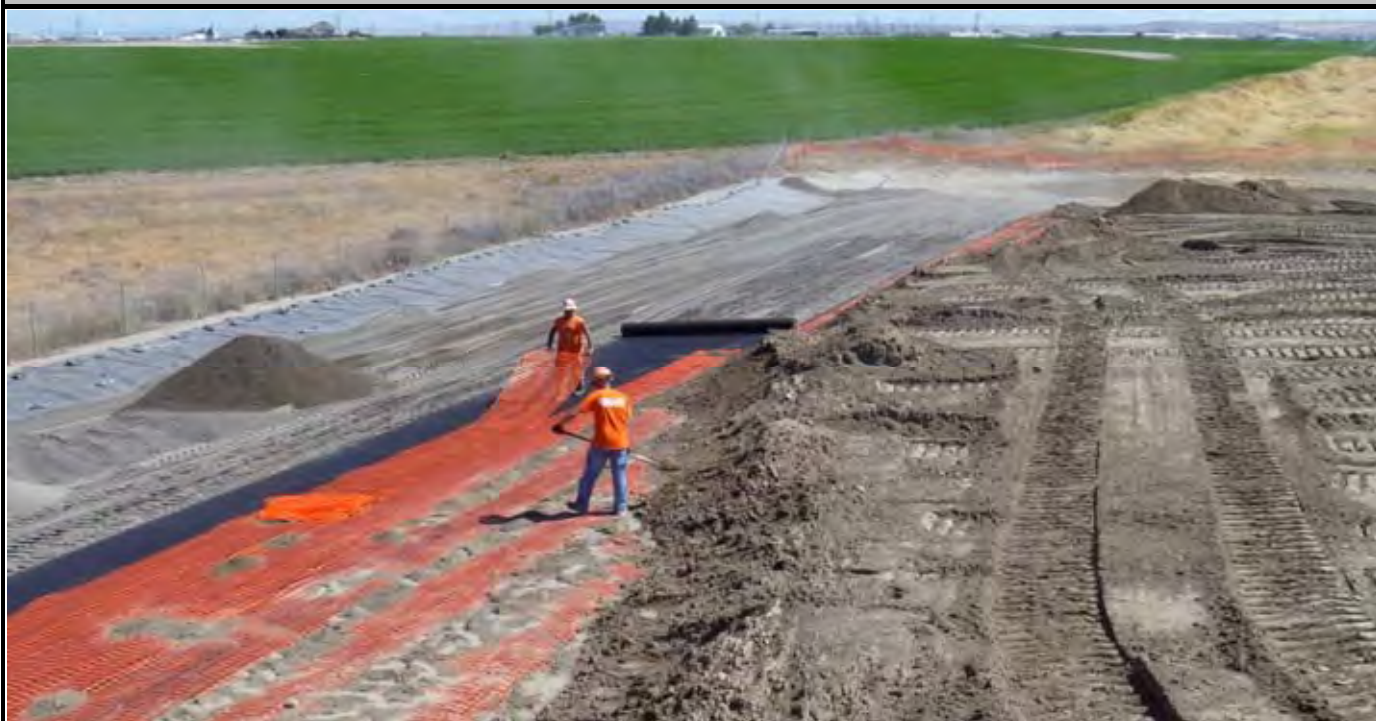
Photo 7: View of AEC personnel laying out Geo-Fabric and OCF over recently graded sand layer. View looking south/southeast from area east of the center of the CAP.

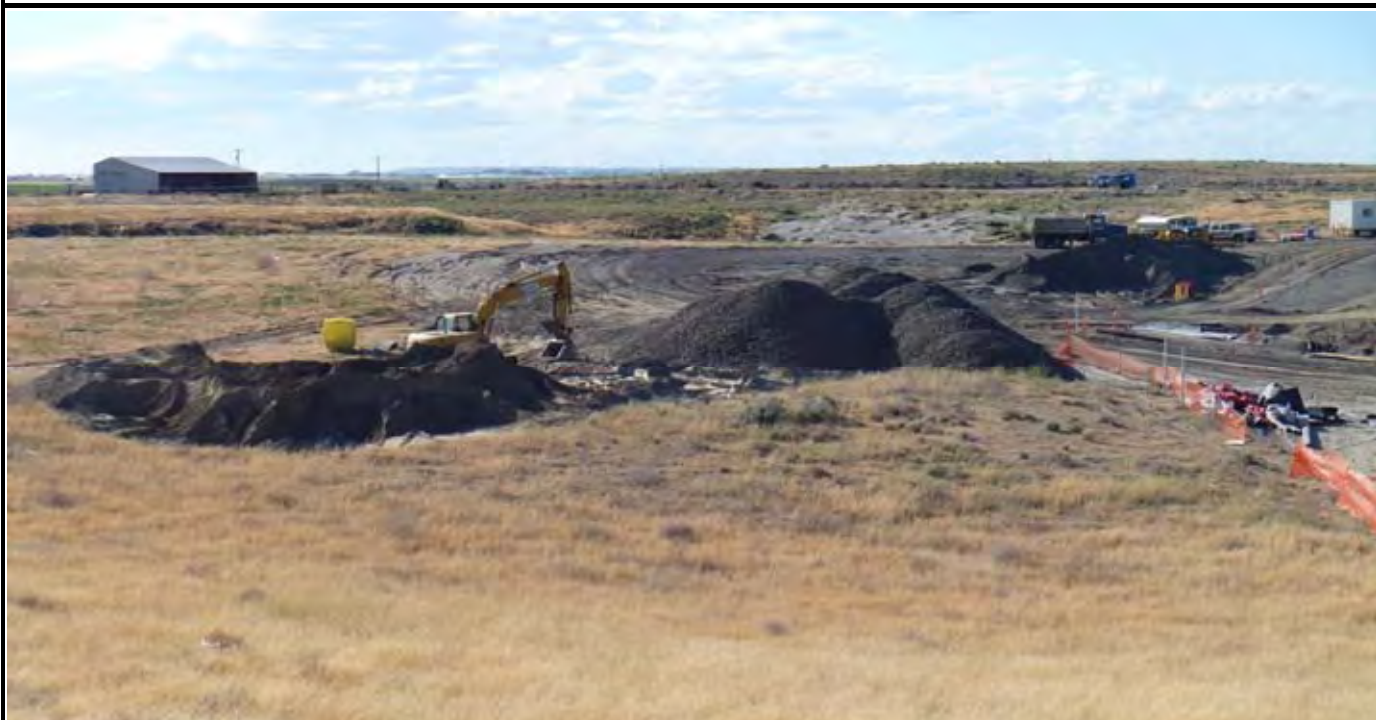
Photo 8: View of the topsoil and perimeter rock stockpiles at the end of the day. View looking northwest from area south of the site.

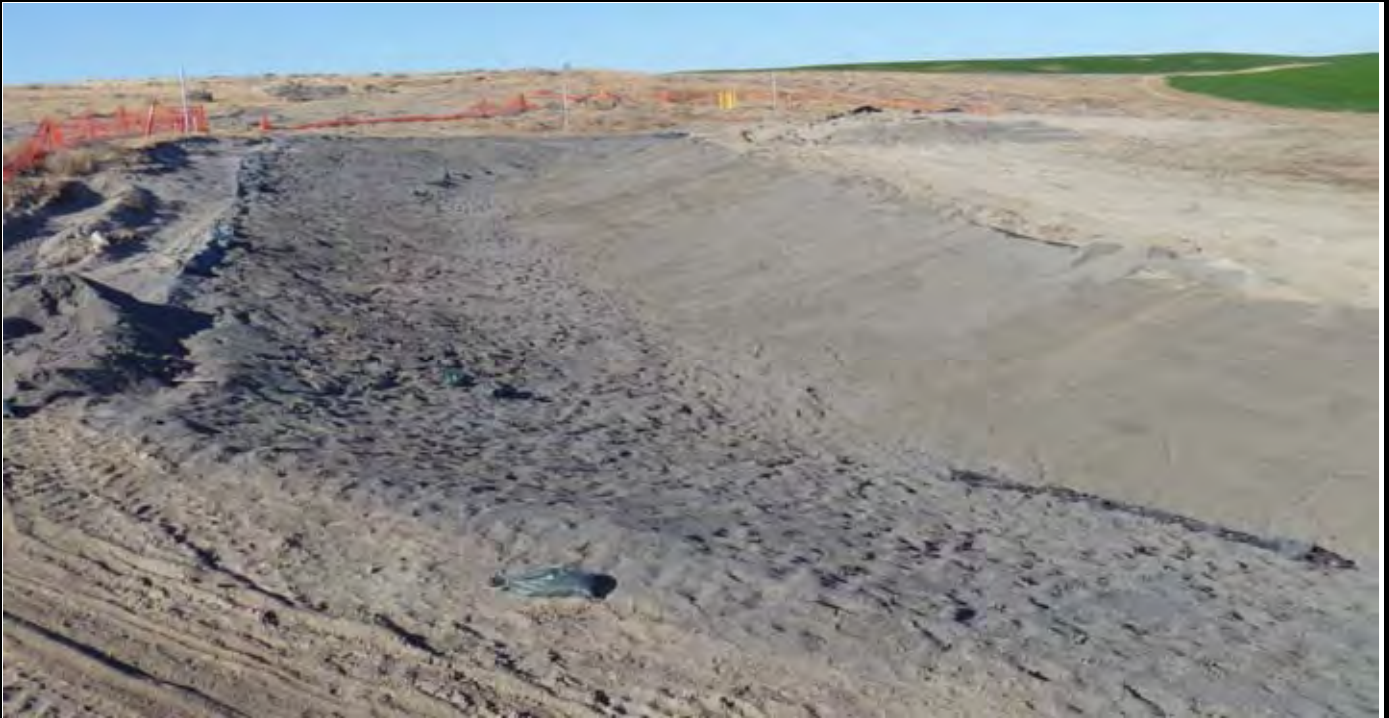
Photo 9: View of the NW and W swale area at the end of the day with sand and topsoil grading completed and ready for perimeter rock and Geo-Fabric placement. View looking NE from western EOL.

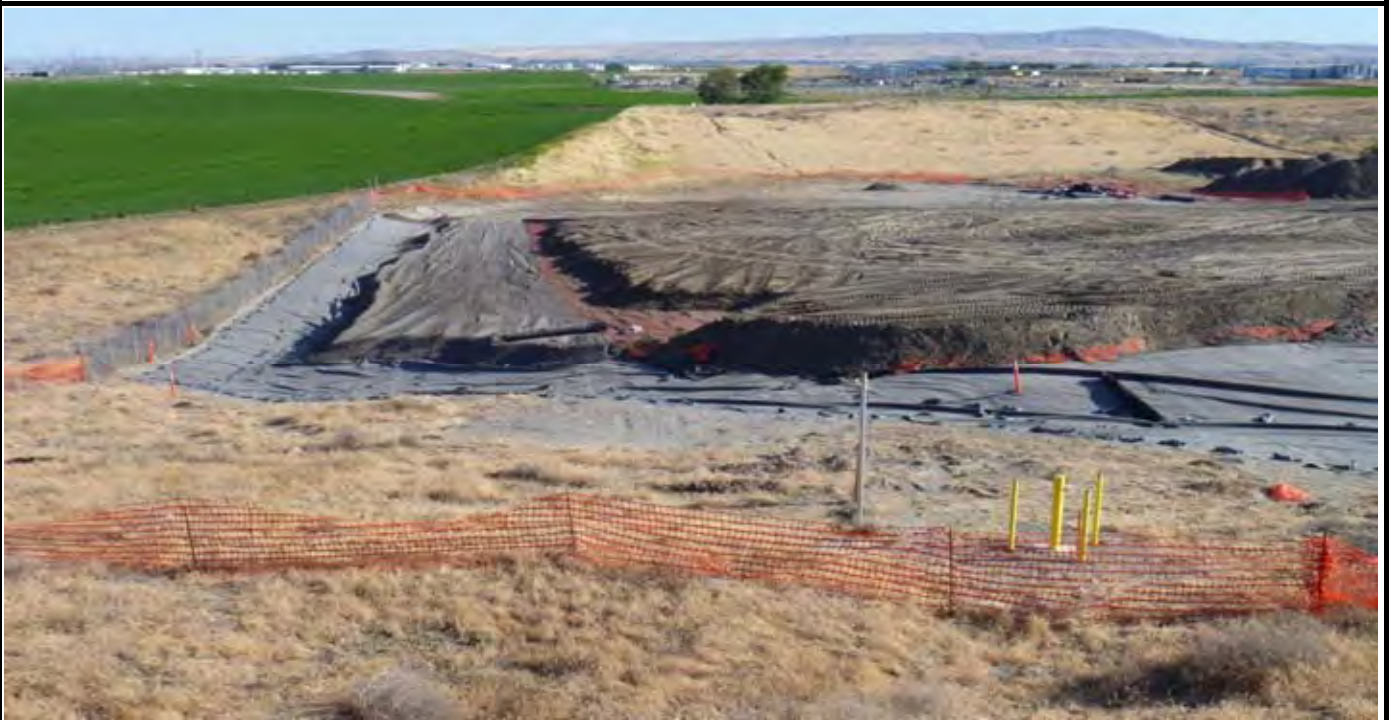
Photo 10: View of the eastern half of the CAP and showing that the sand layer has been completed to the boundaries of the EOC (edge of CAP). Remaining work for CAP include Geo-Fabric/OCF placement and topsoil placement and grading. View looking south from area north of the site (near survey pin).

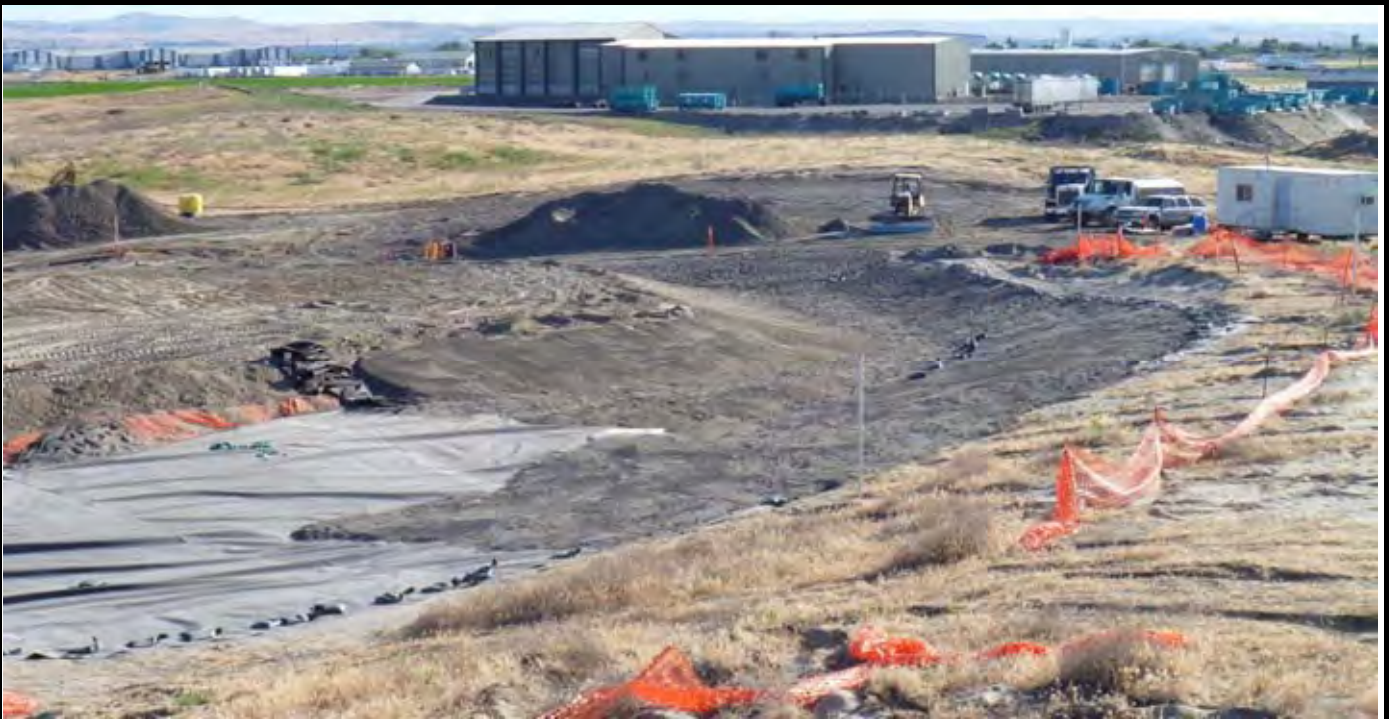
Photo 11: View of the NW corner of the CAP and NW / N perimeter swale areas after completion of sand and topsoil grading work at the end of the day. Note OCF fencing has been opened for trackhoe access to place sand into swale areas. View looking SW from area north of the site.

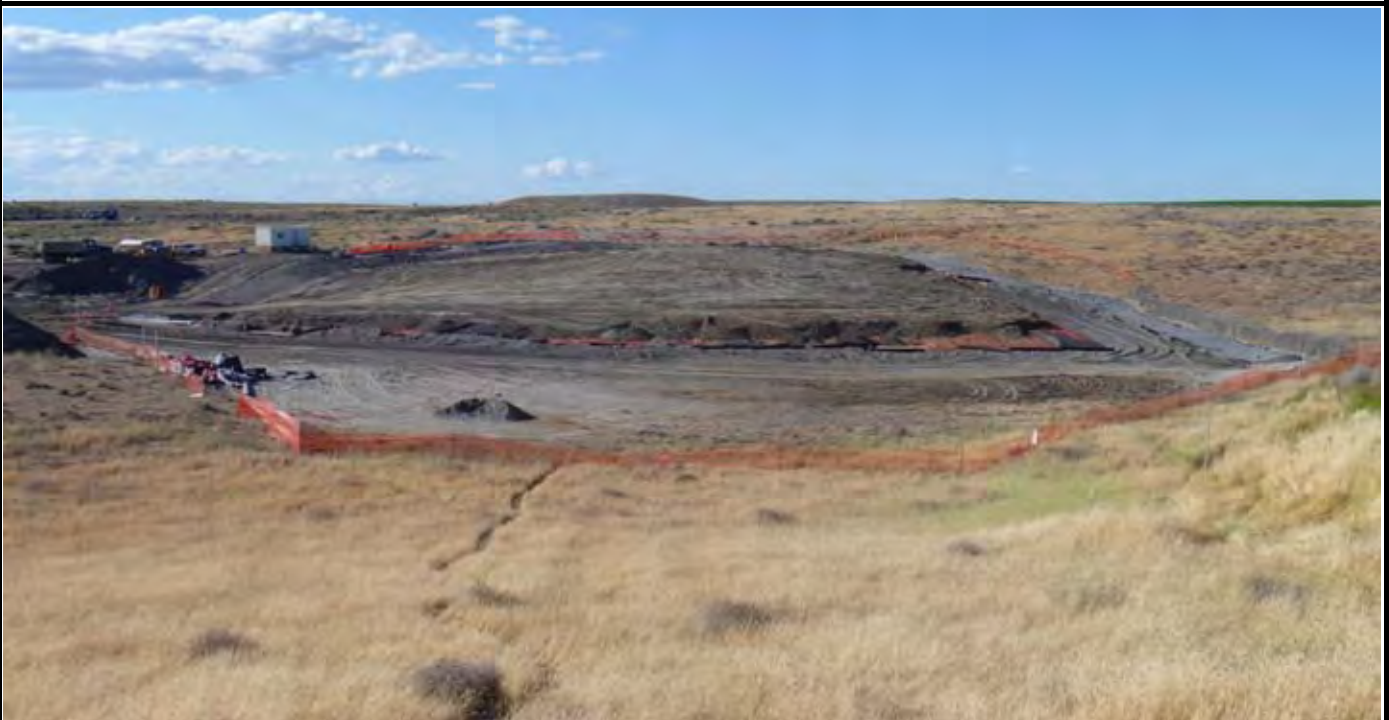
Photo 12: View of the site at the conclusion of work for the day. Note completion of sand layer over entire EOC zone and nearly complete topsoil layer. View looking north from area south of the site.

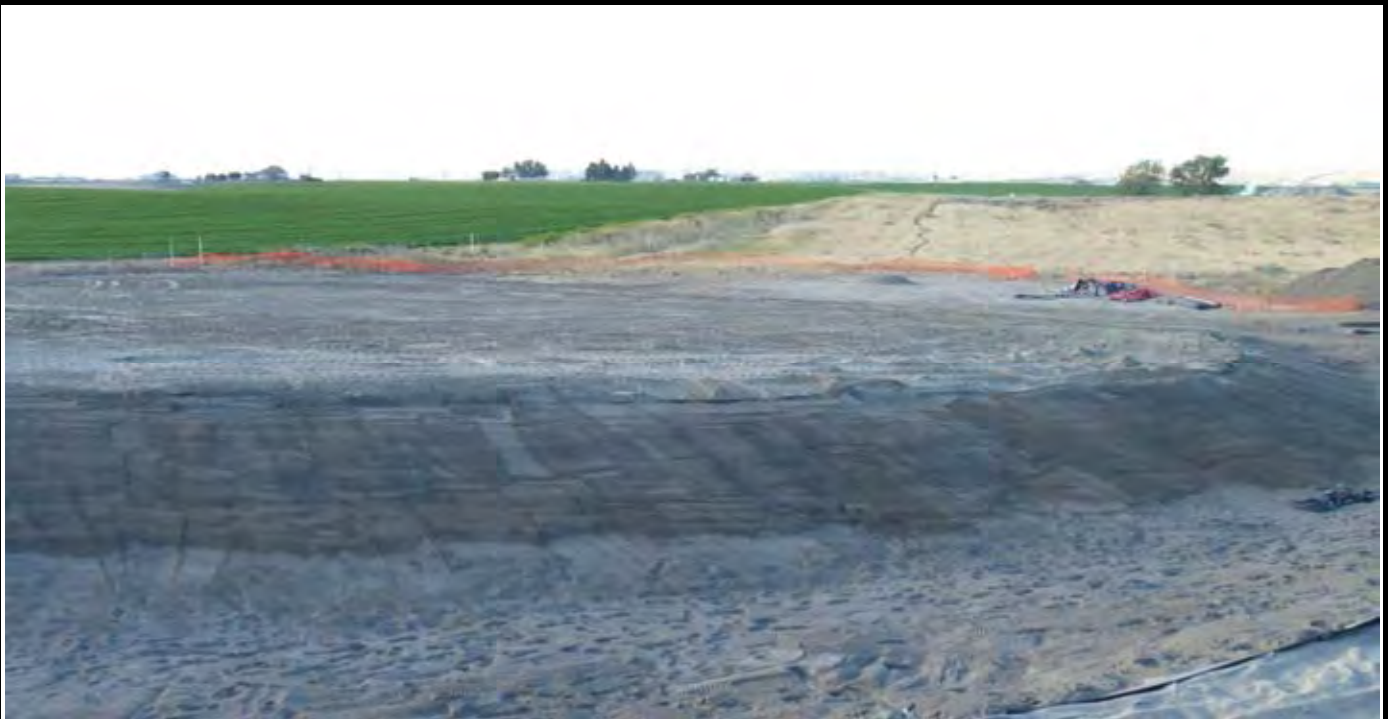
Photo 1: View of the site at the beginning of work for the day. View looking to the South / SE. Note that the NW and western EOC has been graded down into the western and northwestern swales.

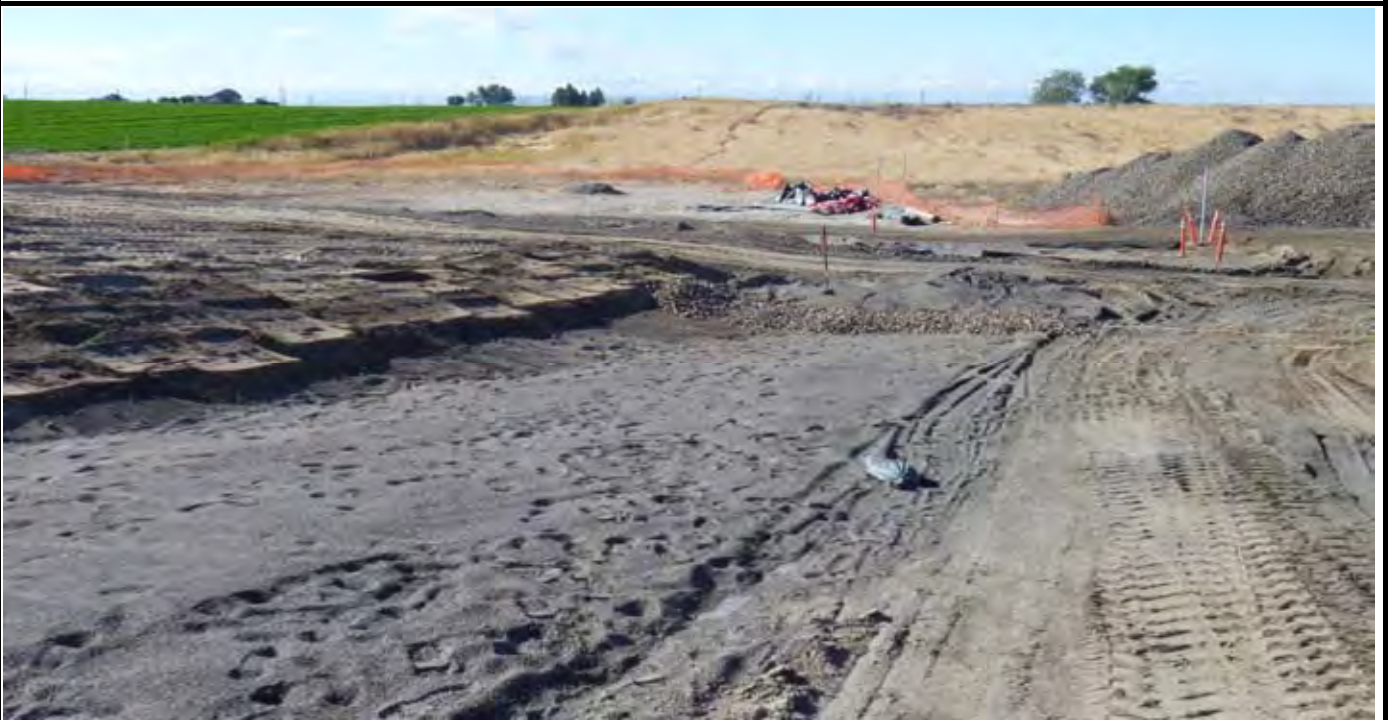
Photo 2: View of the southern end of the western swale as AEC begins to install the perimeter rock. Note perimeter rock stockpile in upper right. View looking south from western EOL.

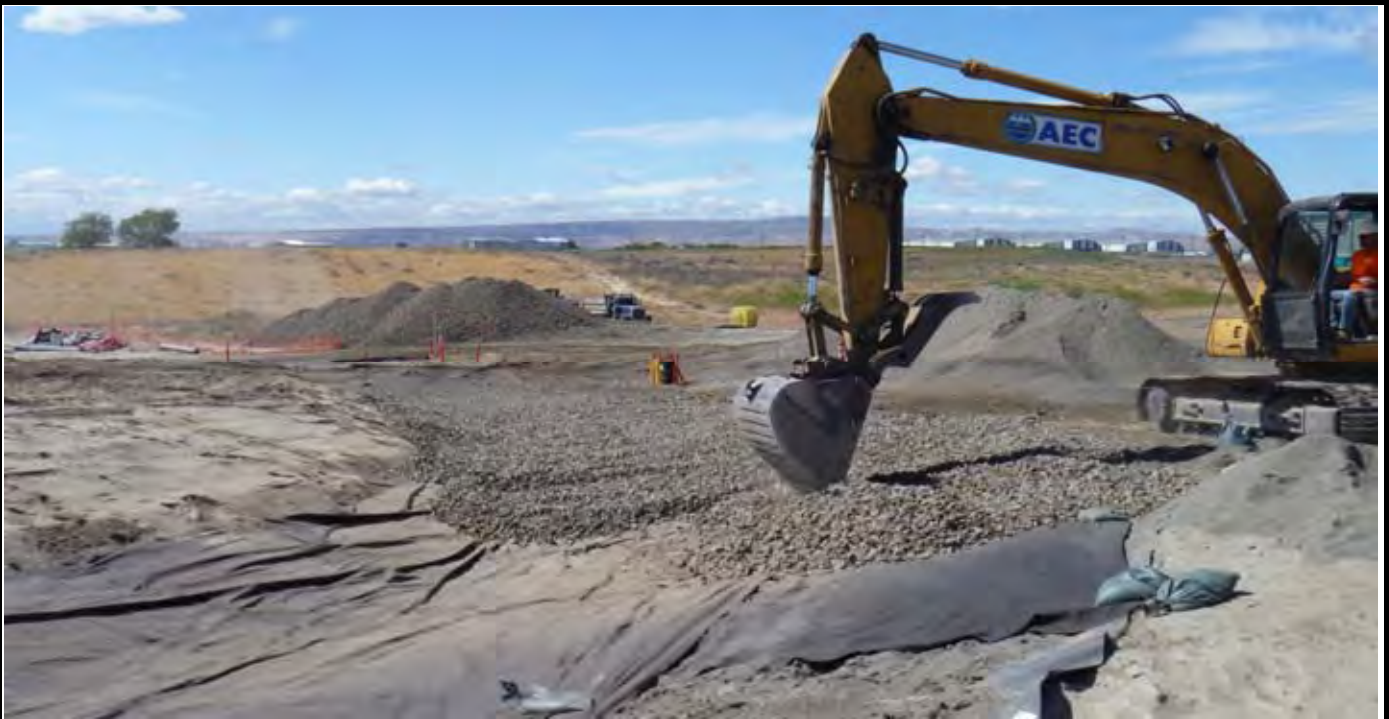
Photo 3: View of AEC installing perimeter rock over the Geo-Fabric (over the sand layer) along the northern end of the western swale area. View looking south from NW corner of the EOL.

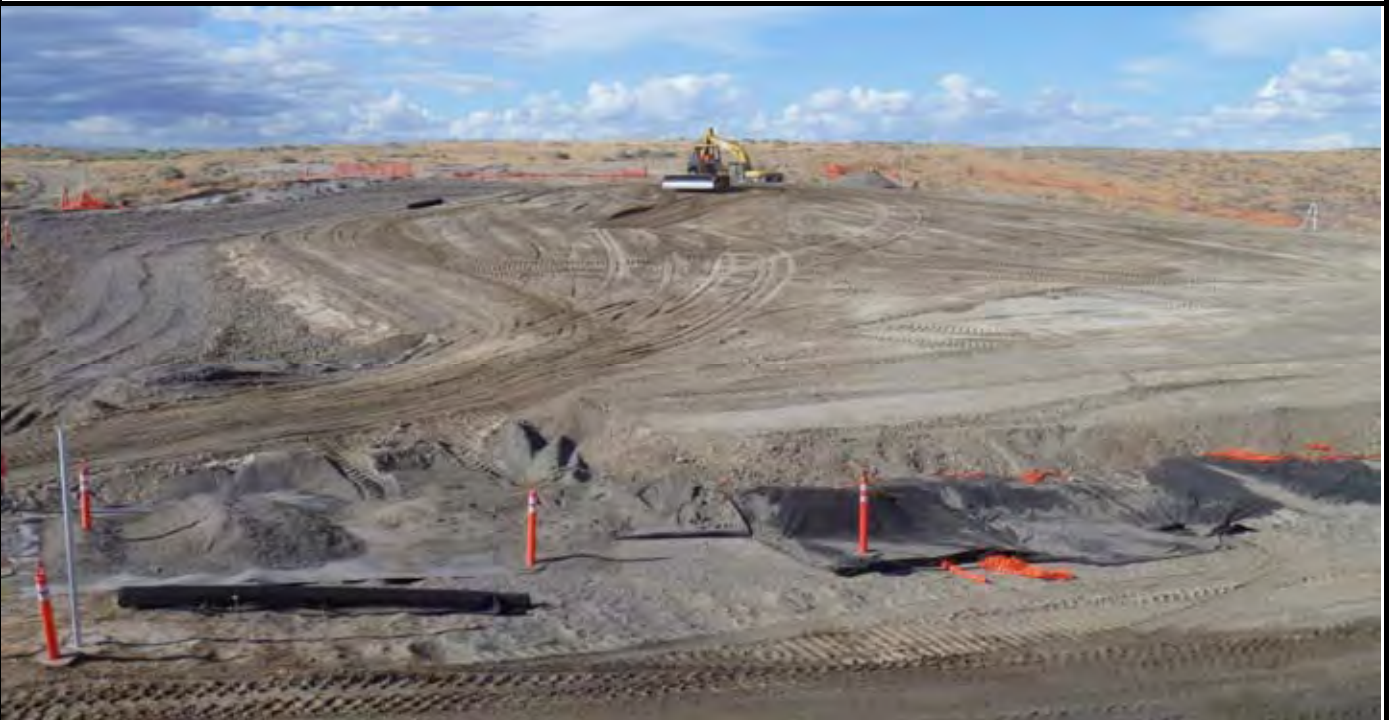
Photo 4: View of the western and northwestern swales (with perimeter rock installed) and top of the western side of the CAP after surface grading. View looking north from point just SW of the SW corner of the EOL.

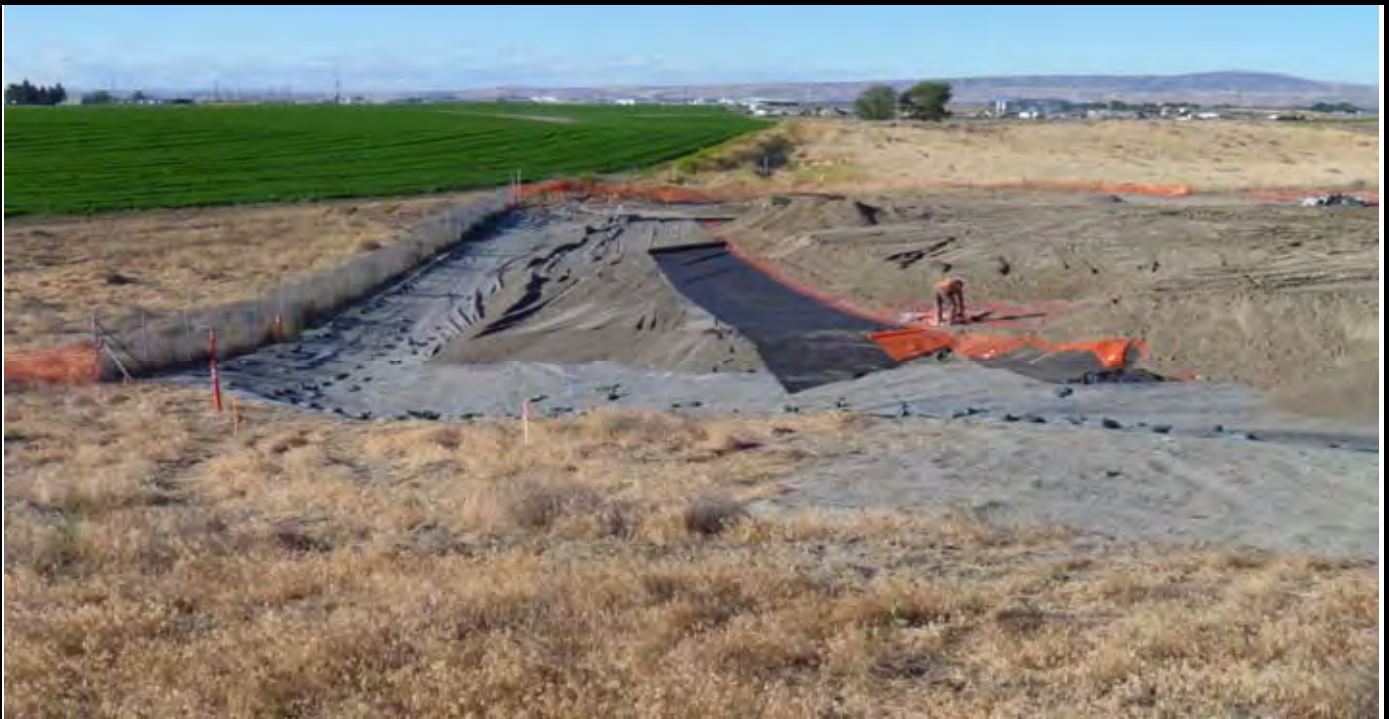
Photo 5: View of the eastern edge of the CAP (EOC) and northeastern and eastern swale areas (showing only the geomembrane liner with sandbags on it). View looking south from NE corner of the site. Note AEC laying out Geo-Fabric and OCF over the sand layer which extends to the EOC and adjacent topsoil layer.

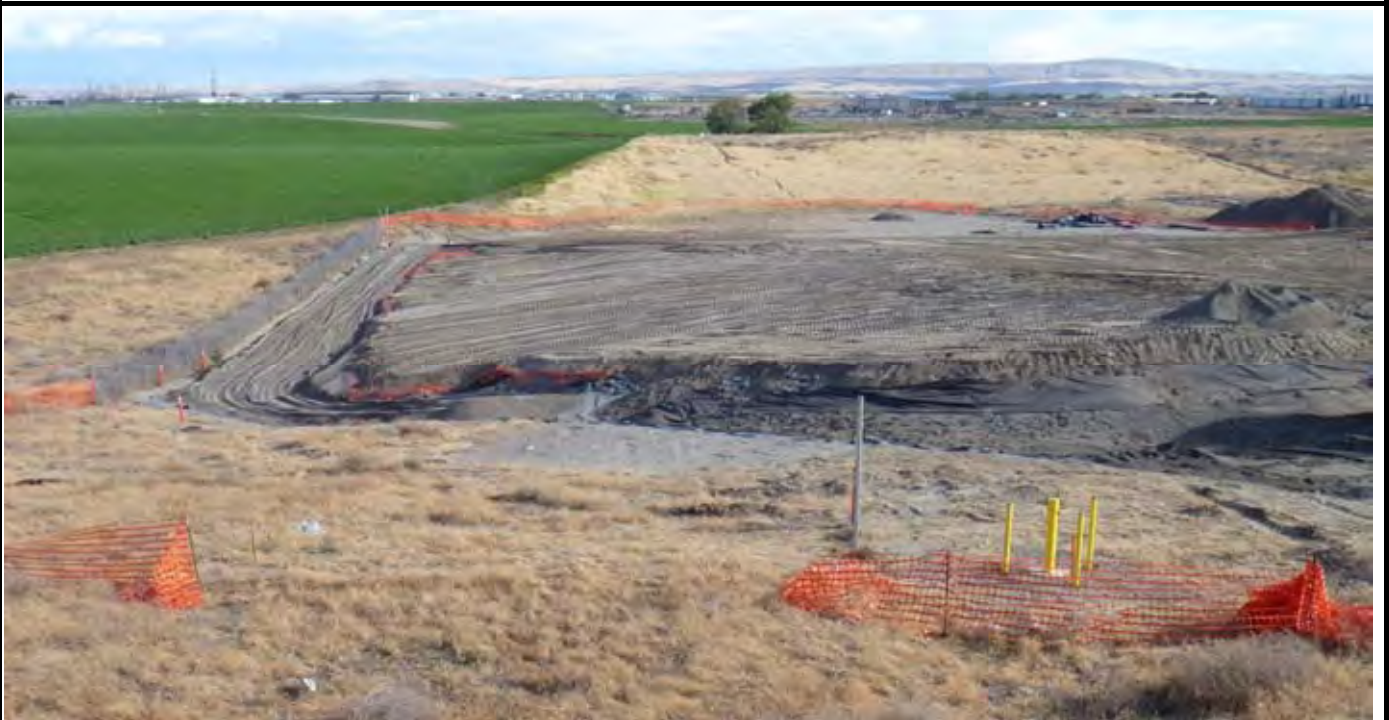
Photo 6: View of the eastern half of the CAP and eastern and northeastern swales with installed sand layer over the geomembrane at the end of the day. View looking south from area just north of the site.

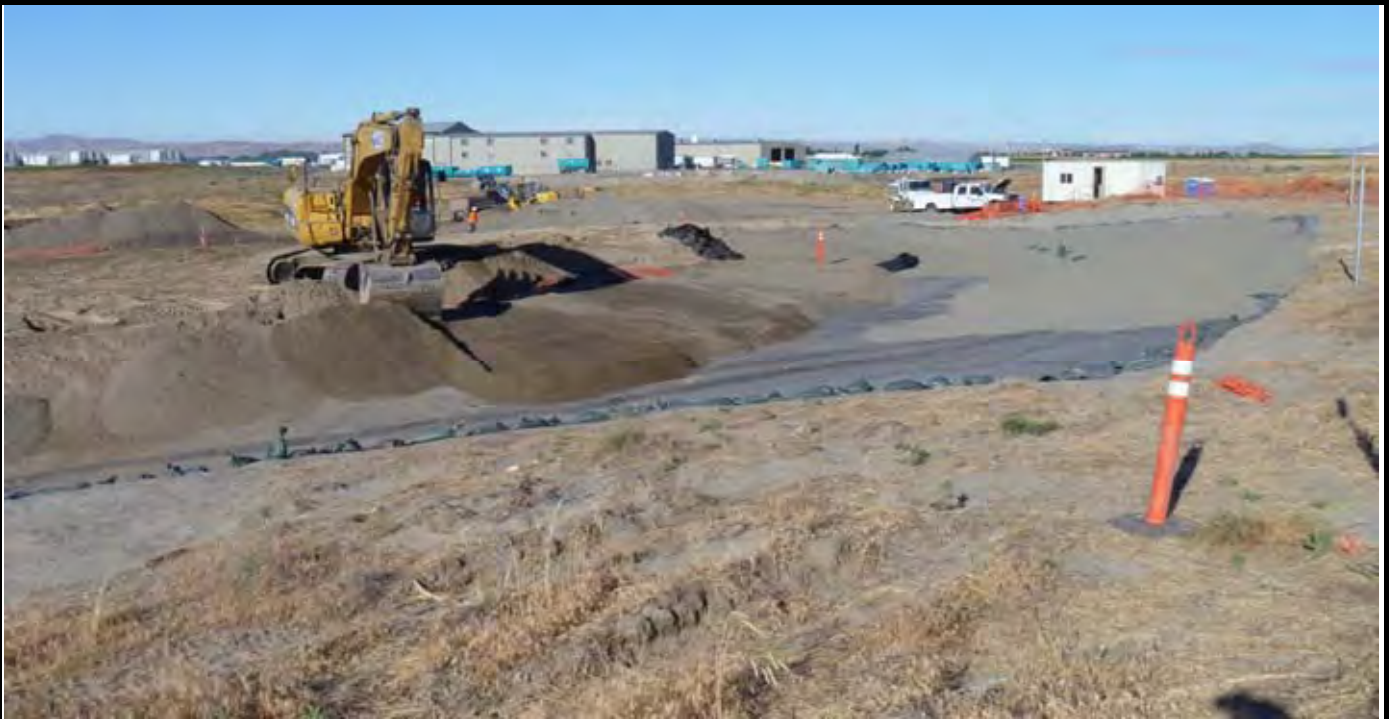
Photo 7: View of the northern swale area as AEC grades the EOC into the swale with topsoil and sand layers. Note the Geo-Fabric and perimeter rock layer installed on NW corner of the swale. View looking west/southwest from area along the northern end of the site.

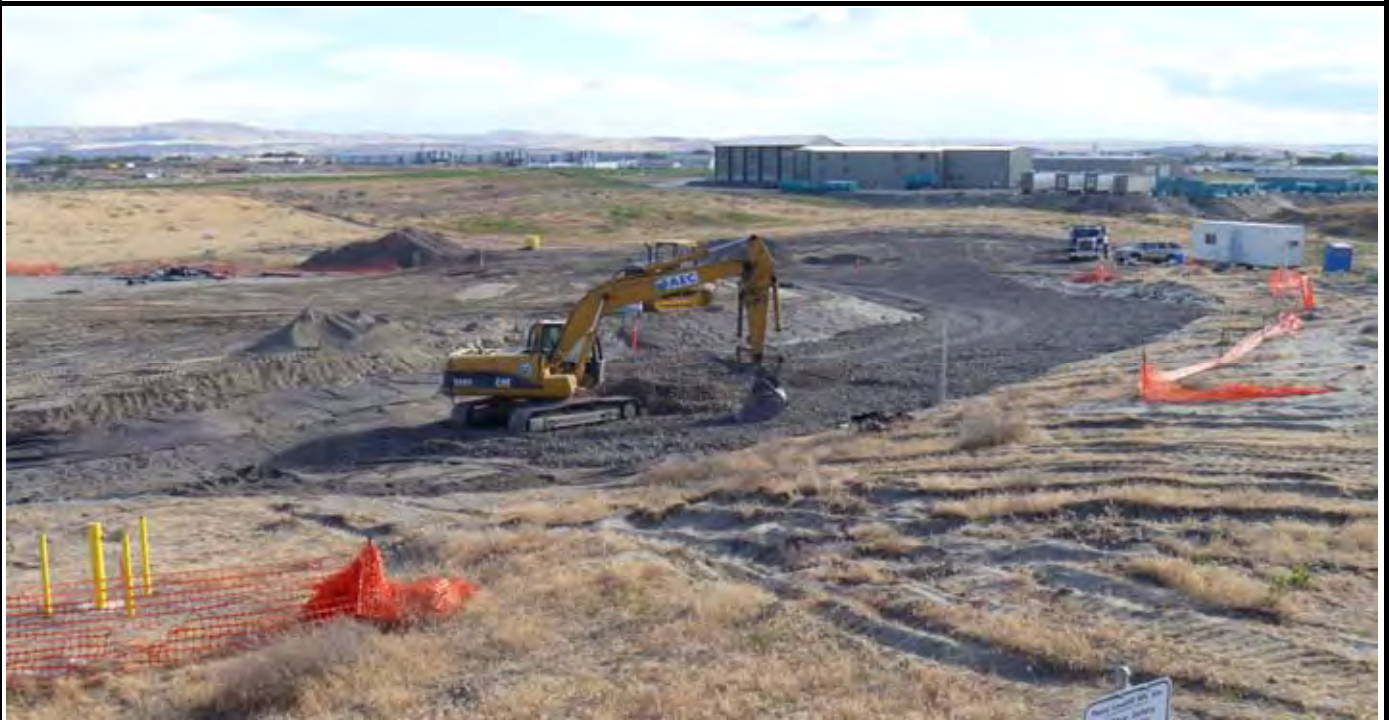
Photo 8: View of the northern swale area at the end of the day. Note that EOC grading is complete and perimeter rock has been installed beyond the swale ridge on the northern end. View looking SW from north end of the site.

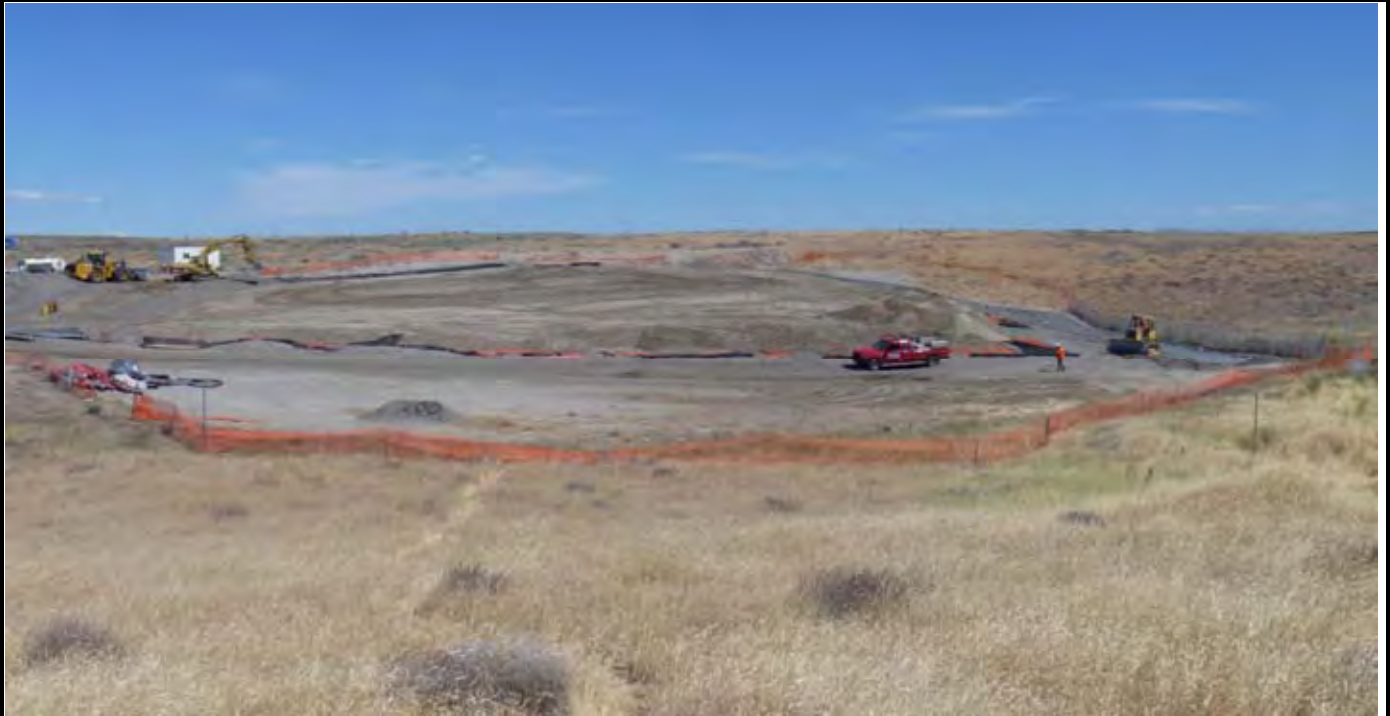
Photo 9: View of the entire CAP near the beginning of the day. View looking north from area south of the site.

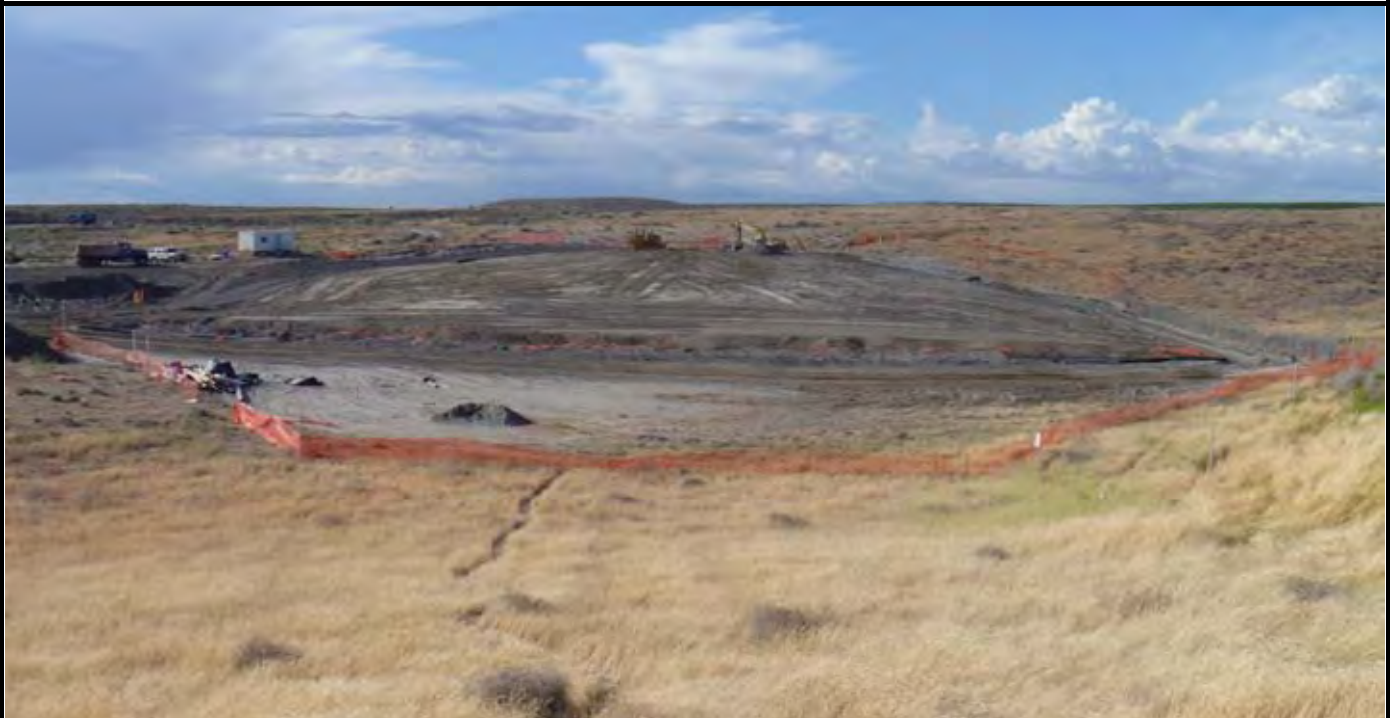
Photo 10: View of the site at the conclusion of work for the day. Note the change in the surface grade of the top of the CAP and the work completed on the SE corner of the CAP and western swale. View looking north from area south of the site.

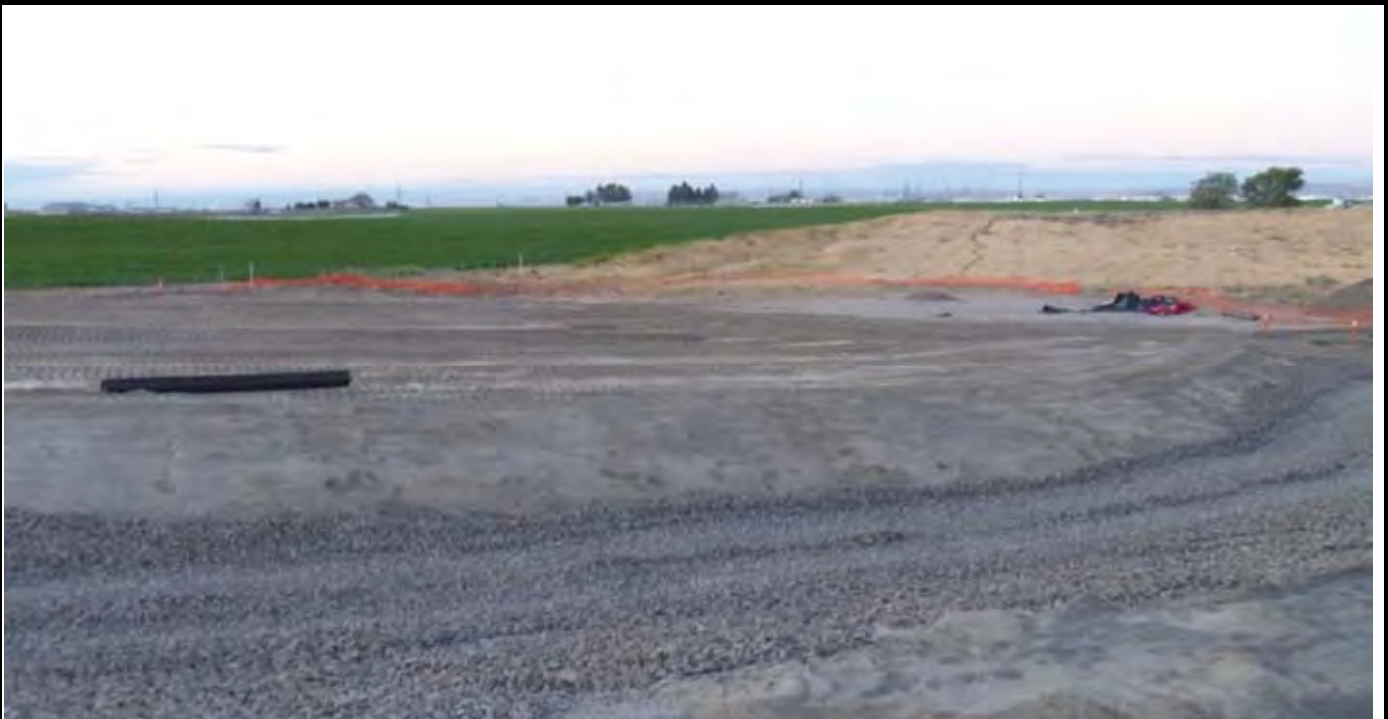
Photo 1: View of the site at the beginning of work for the day. View looking to the south. Note the perimeter rock in the NW and western swale adjacent to the NW side of the CAP.
